APPENDIX D: 2023 HERITAGE COMPLIANCE INSPECTION AUDITS

Hunter Valley Operations South Aboriginal Heritage Management Plan May 2023 Compliance Audit Inspection

Hunter Valley Operations Aboriginal Heritage Management Plans November 2023 Compliance Audit Inspections

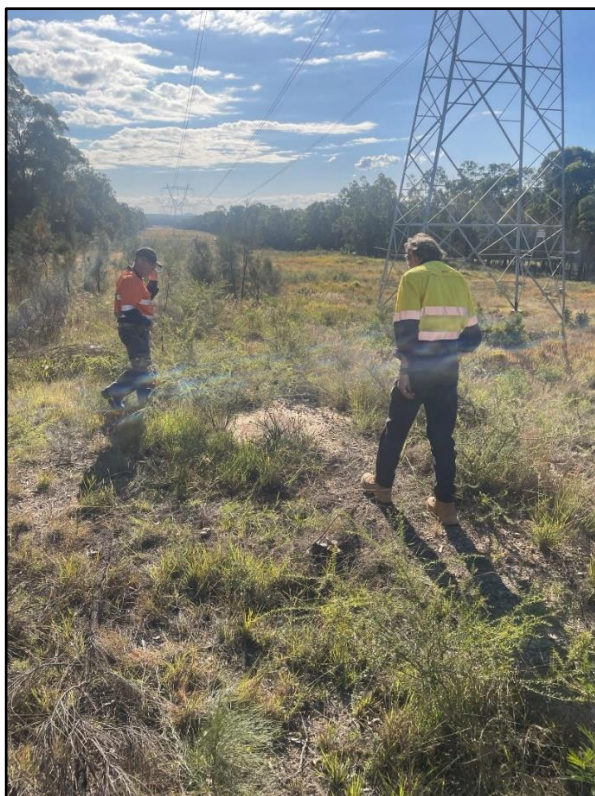
These two sites are located in areas which are currently accessed by light vehicles and power-line work crews. Site 37-6-0640 is located upon a man-made earth bund underneath a powerline. As was evidenced during the current audit, this area is frequently accessed by third parties to maintain vegetation within this easement, which represents a risk of harm to the artefact. Site 37-6-1763 is located on a severely eroded track along the lease boundary, which is accessed by mine personnel as well as third parties. Artefacts at this site were noted as having been washed into erosion gullies along this track. Any future track remediation as well as current track use represent risks of harm to this site.

Field team at 37-6-0640 underneath power-lines

To avoid further harm befalling these two sites, it is recommended that they be salvaged by representatives of the CHWG.

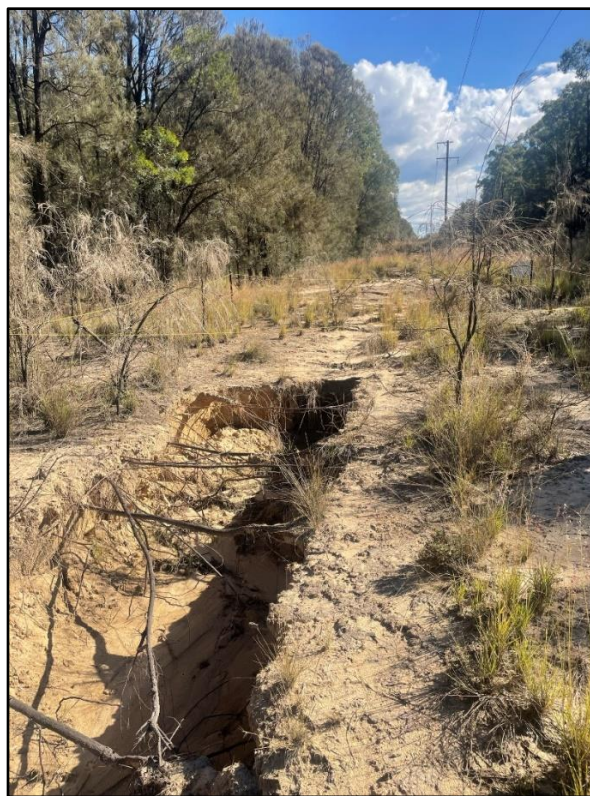
Severe erosion at 37-6-1763

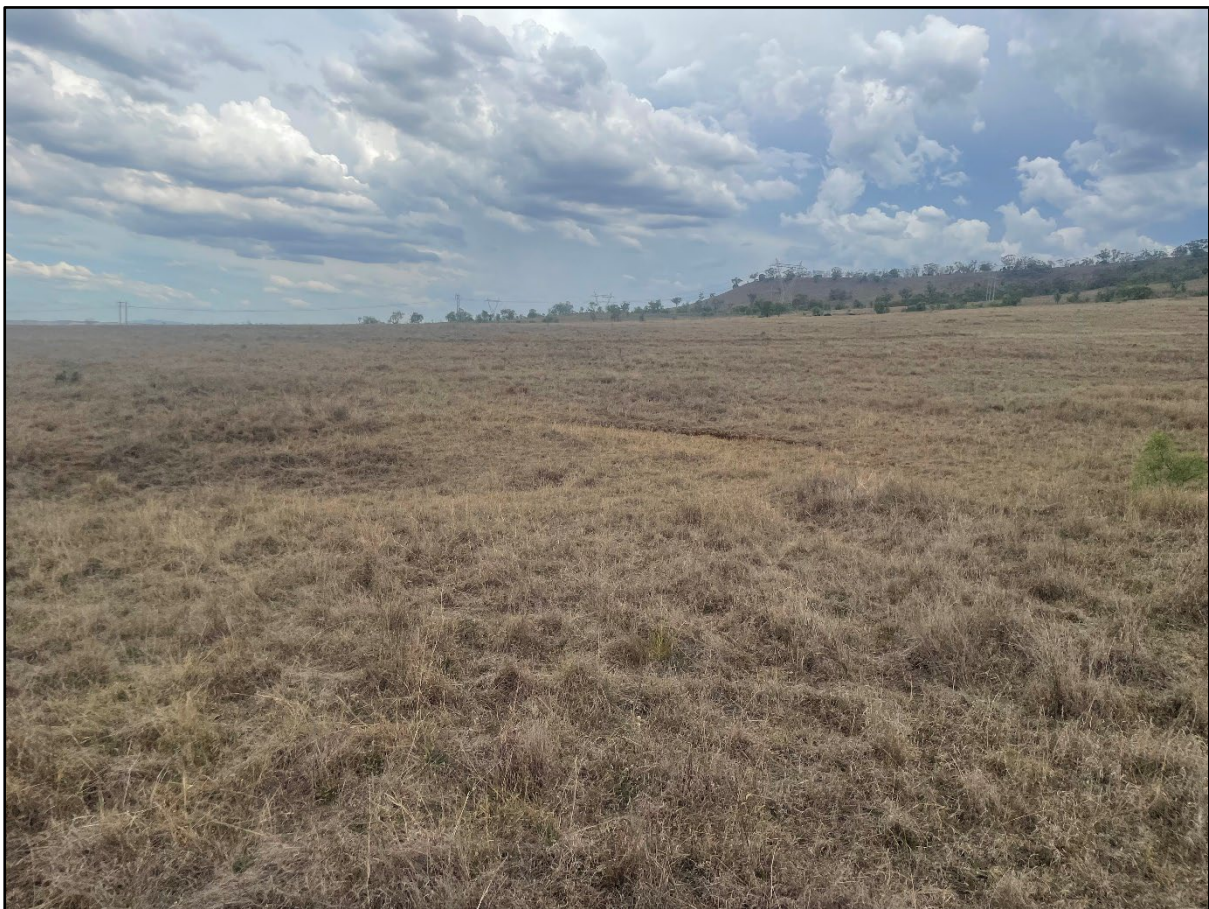
These sites are located in areas where surface vegetation is extremely thick and prevents visibility of the ground surface. It is recommended that the sites are revisited during a future audit inspection when vegetation levels are much lower so that better attempts can be made to relocate their contents. It should be noted, however, that one benefit to such thick vegetation is that this will aid in preventing movement of any artefacts through erosion or other means.

Example of poor GSV at site 37-2-5324

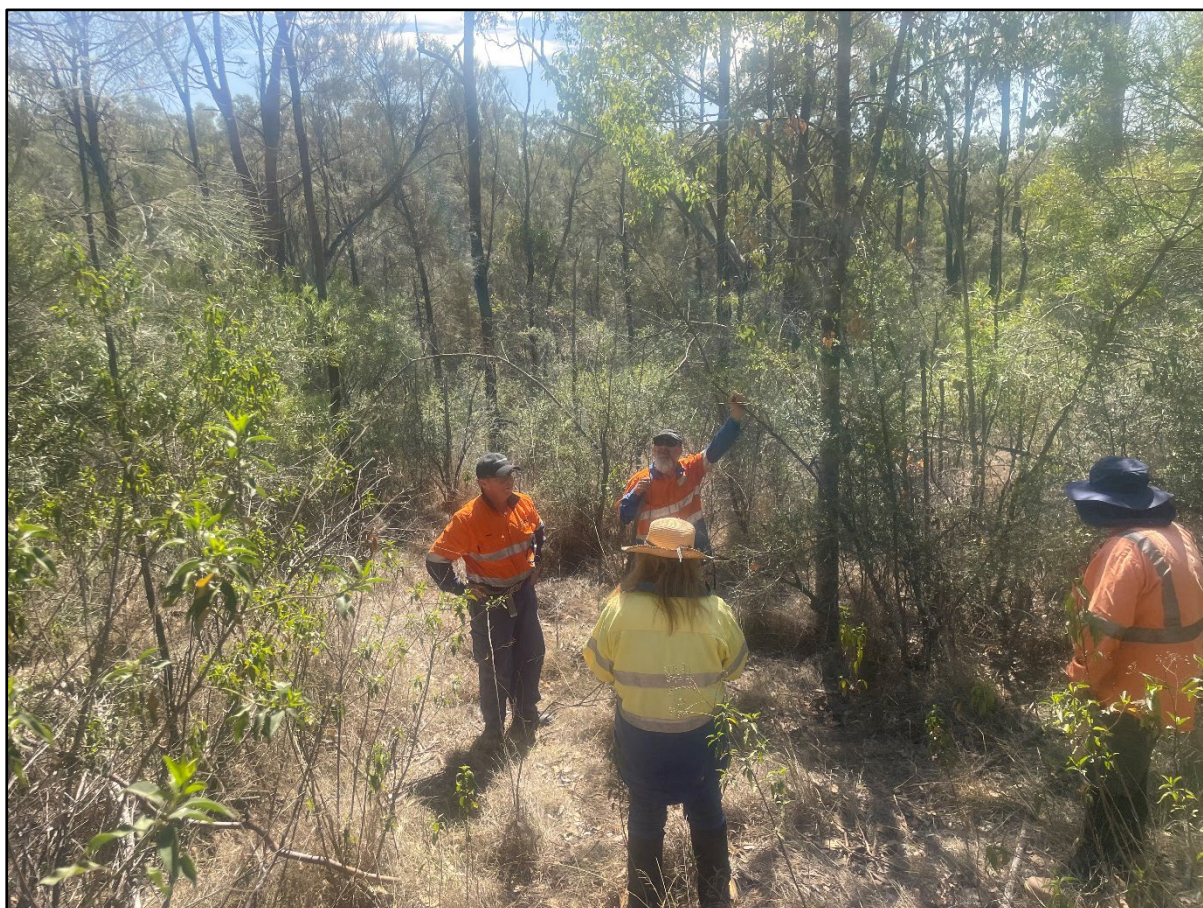
These sites are located in areas where vegetation is extremely thick and prevents visibility of the ground surface. These sites were recorded in 1997, and so it is possible that the registered location of these sites is erroneous. It is recommended that the sites are revisited during a future audit inspection, with reference to report and site card information, when vegetation levels are much lower so that better attempts can be made to relocate their contents.

Field team assessing visibility levels at site 37-5-0269

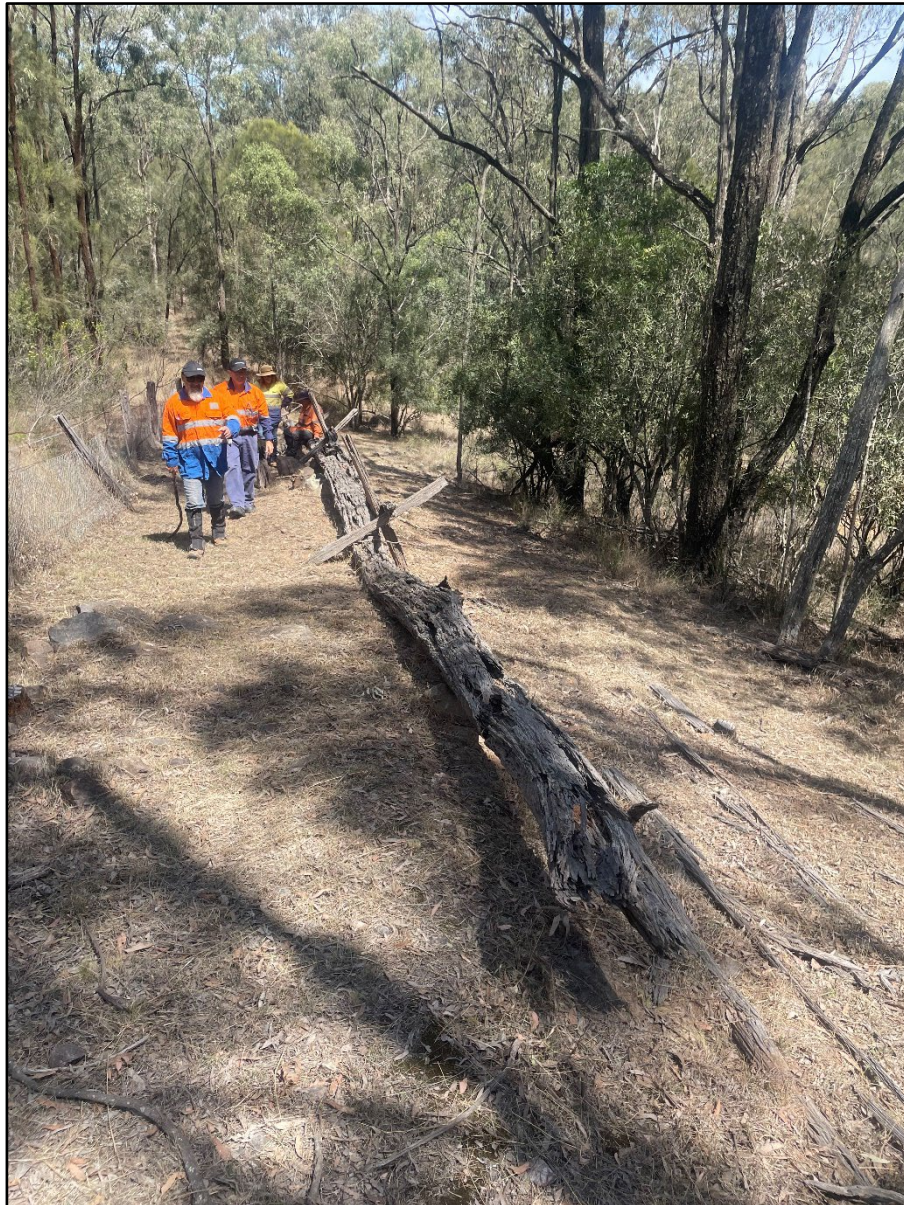
Field team inspecting GDP work area (ACH site located in scrub to left of picture)

The field team inspected the recently slashed area and confirmed that the location for site HVS-47 was undisturbed, although no artefacts were found to be present anywhere in the vicinity. All conditions of the GDP were found to have been complied with and the field team were satisfied that ACH protection measures were adequate and appropriate.
