HUNTER VALLEY OPERATIONS

2019 Annual Environmental Review

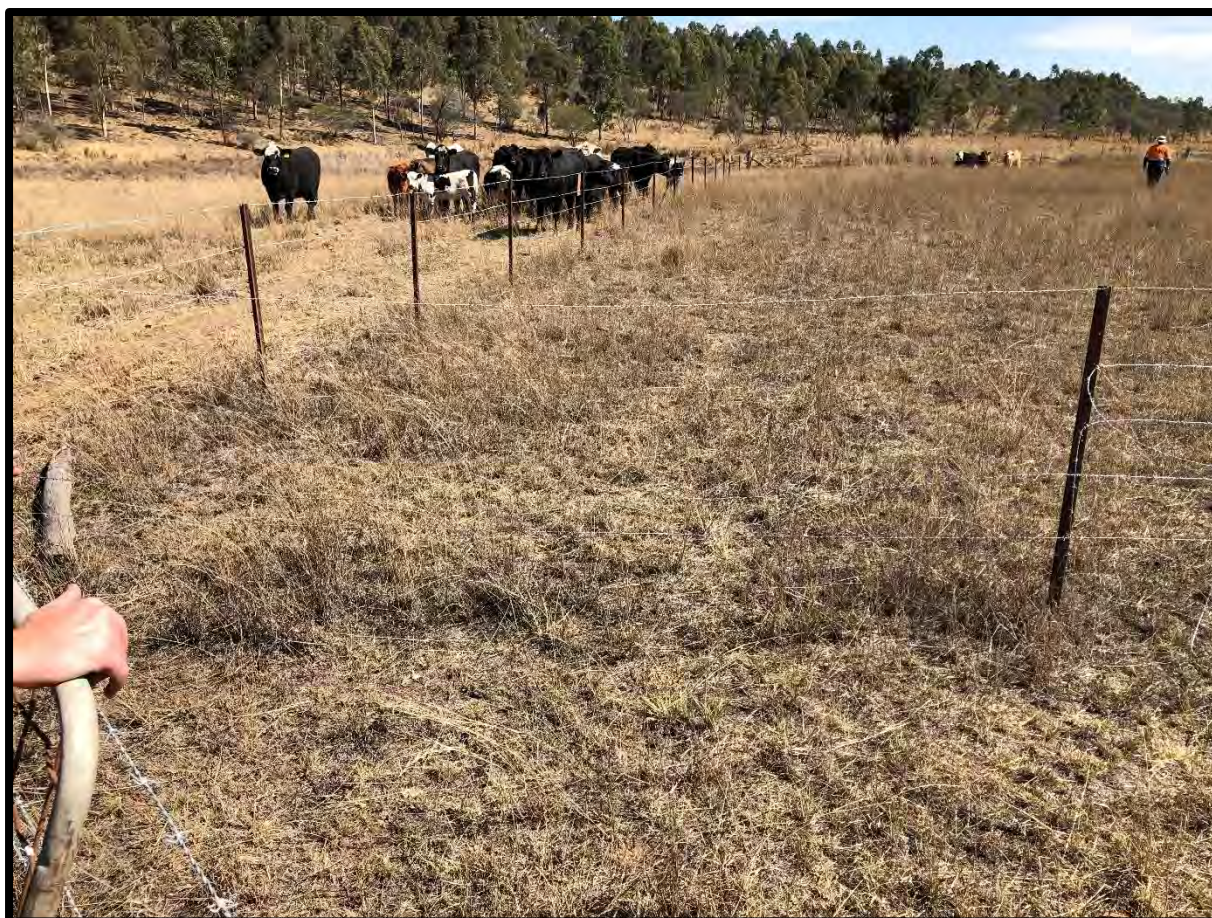
Broken fence wires at HVO-1208

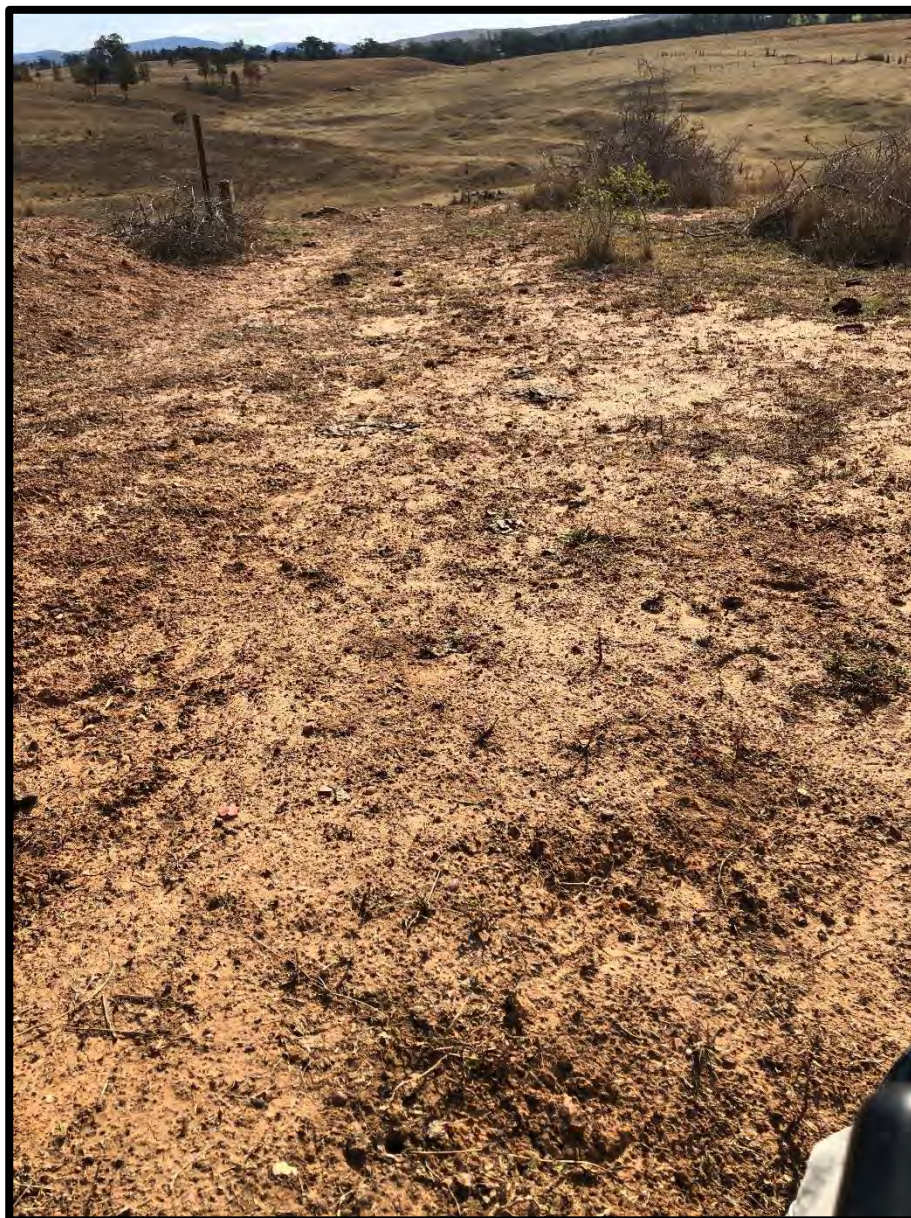
Remnant and poisoned boxthorn at HVO-1277

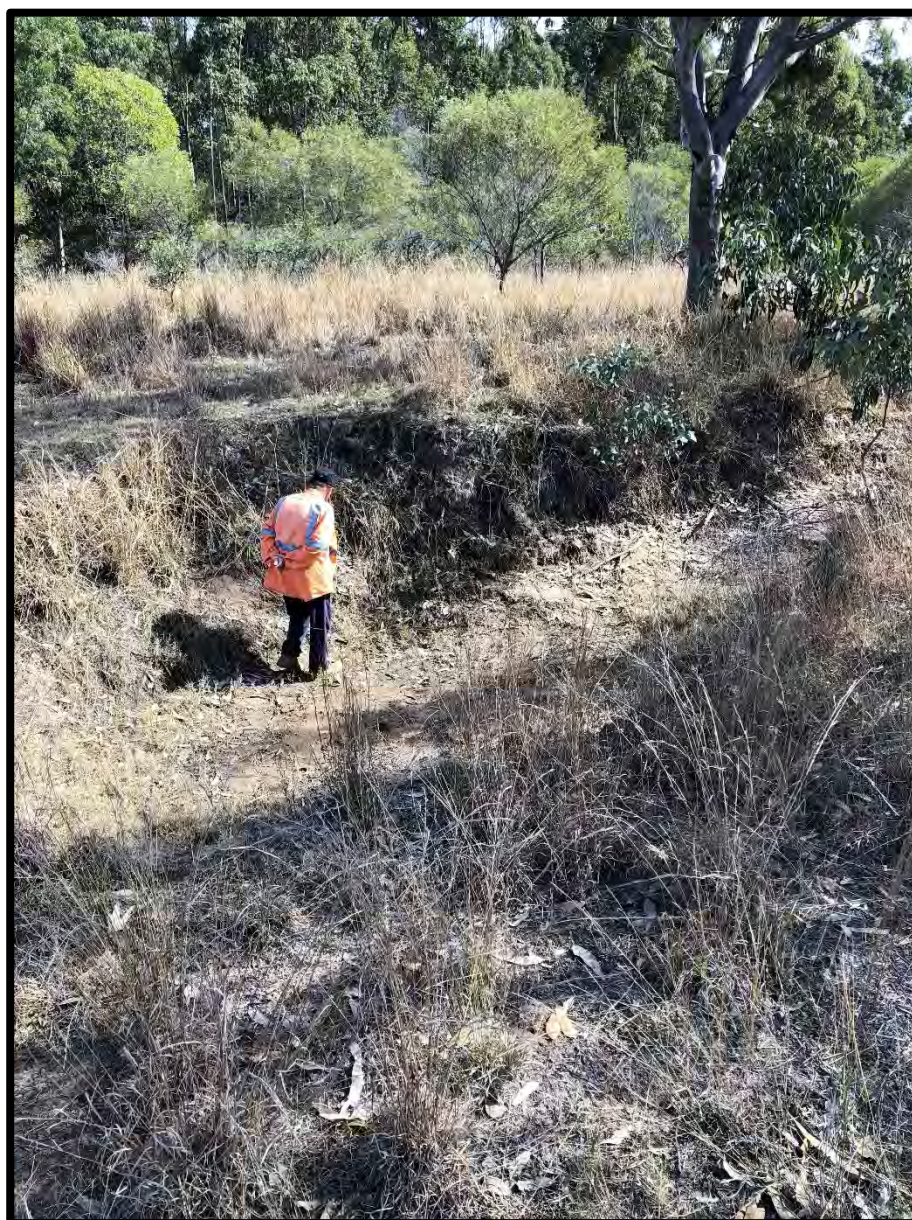
Eroded drainage channel at HVO-1199

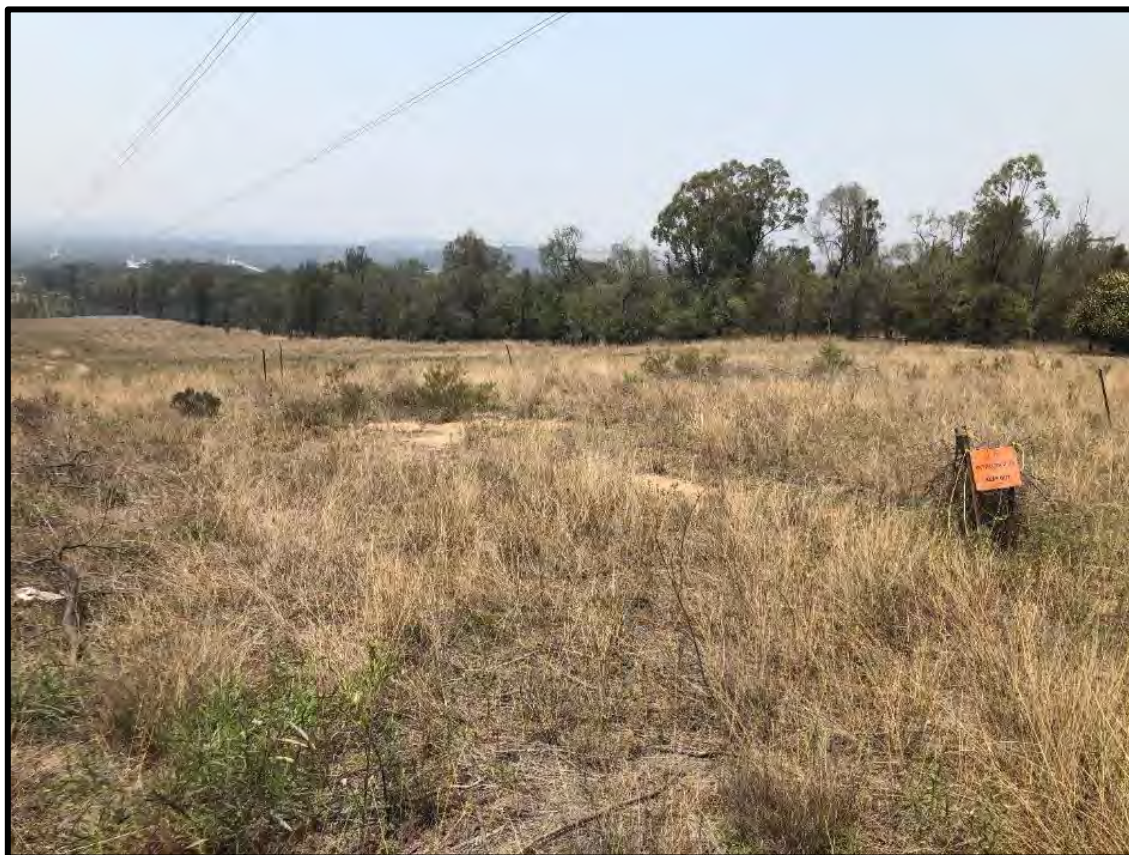
An example of dilapidated barricading at HVS-29
