# HUNTER VALLEY OPERATIONS

**2020 Annual Environmental Review**

Date	31 March 2021

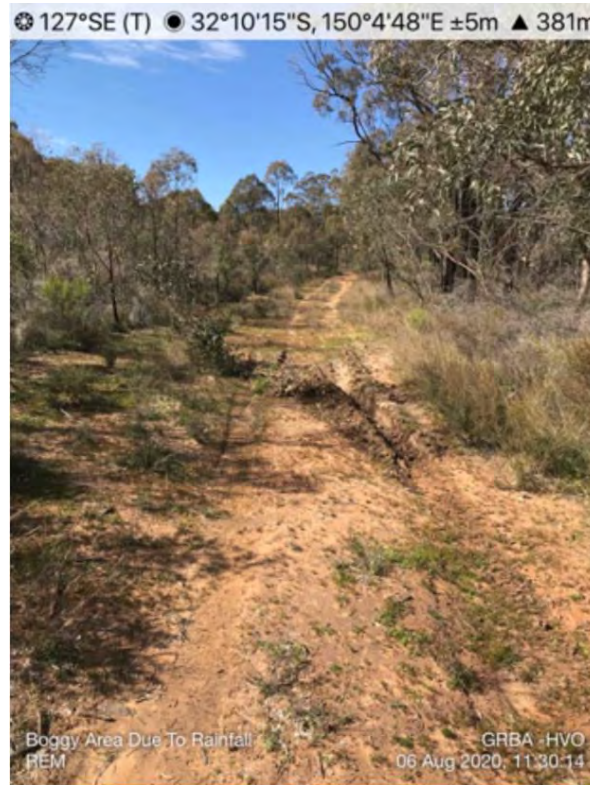
**Figure 109 - Boggy area identified on a track within the HVO portion of the Goulburn River BA.**

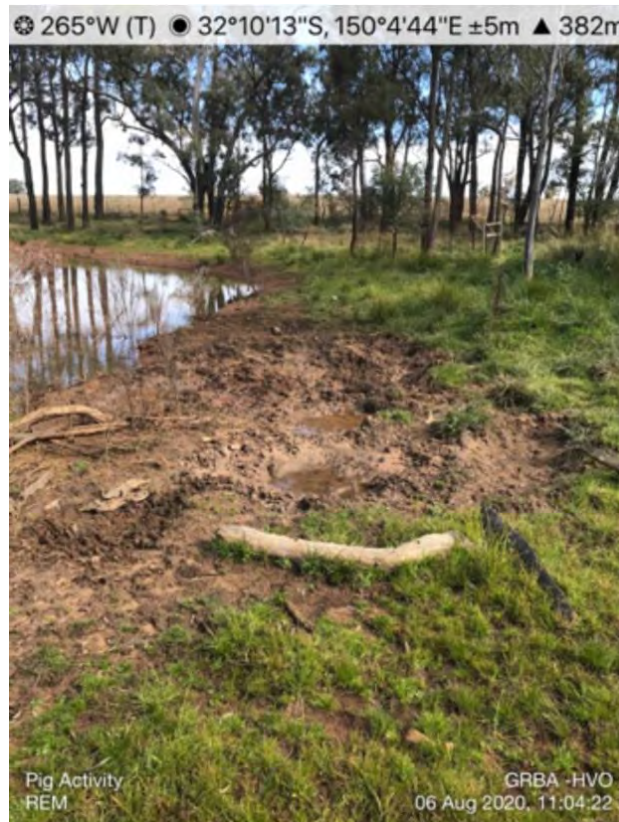
Pig activity was sighted throughout the offset, including wallows near the dam (**Figure 110**), mud rub marks on trees and recent tracks. As mentioned previously, pig management will continue in 2021 and target the locations where pig activity has been found to occur.

**Figure 110 - Pig activity observed within the HVO portion of the Goulburn River BA.**

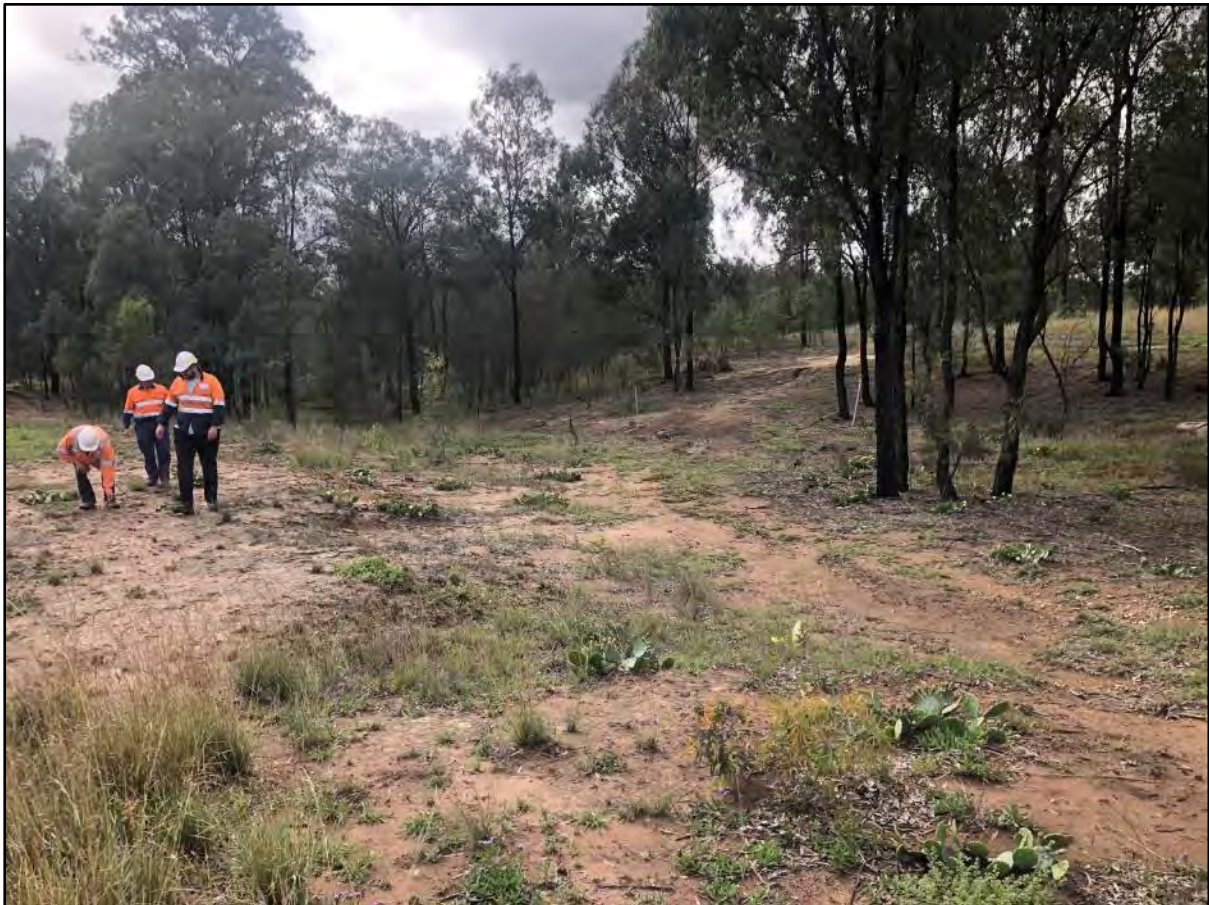
***Area where artefacts were noted on opposite side of creek to currently barricaded 'LID6' site.***

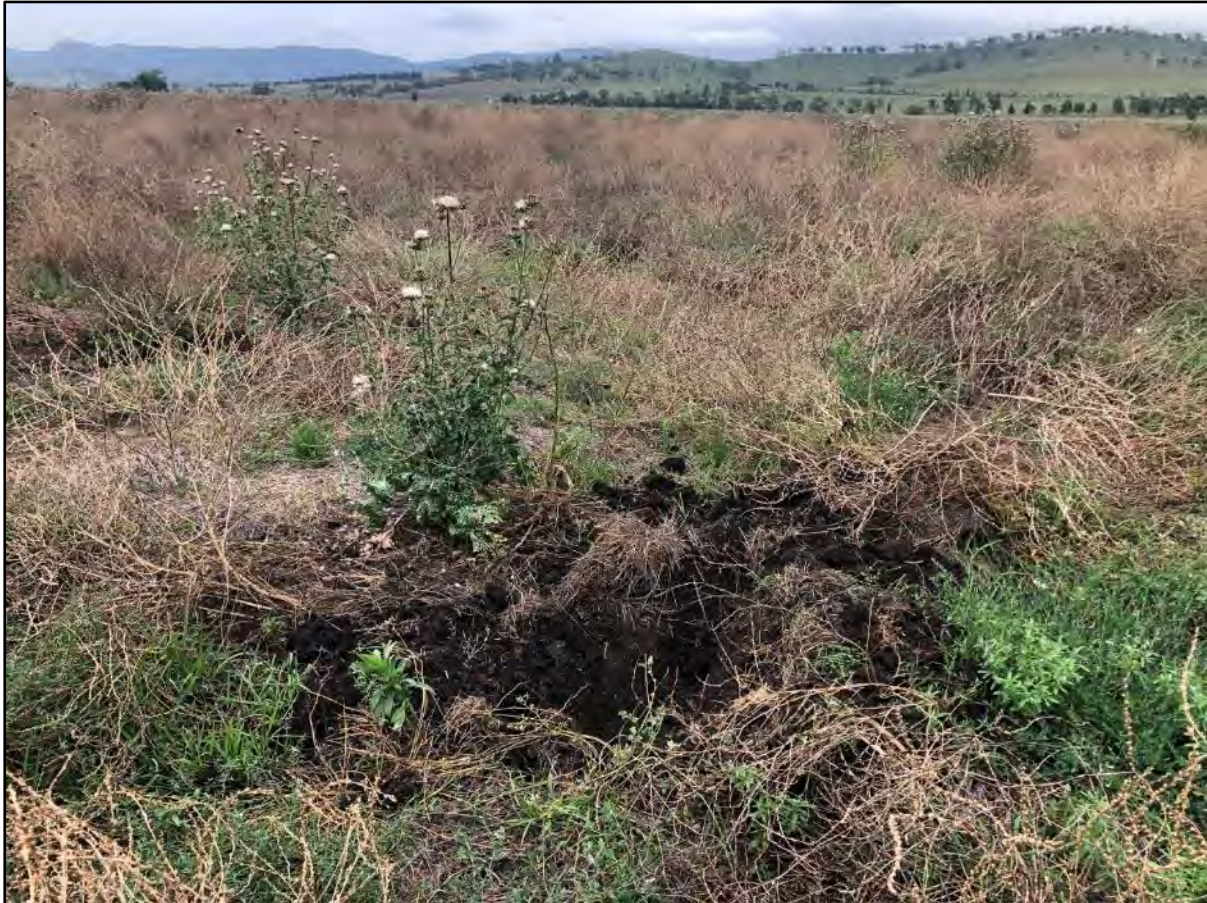
*Evidence of pig digging and weed growth within fenced area but outside of CM-CD1 disturbance exclusion buffer zone.*

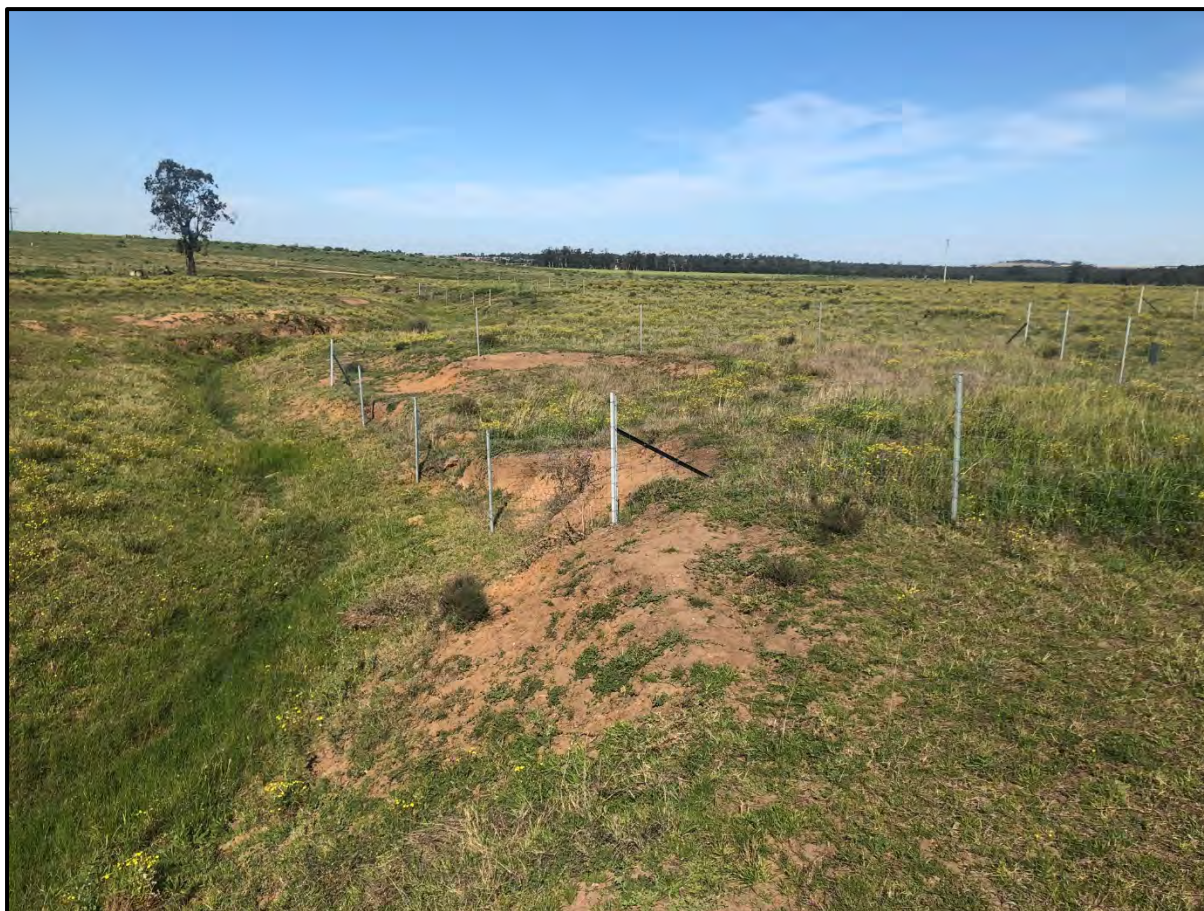
*Example of ACH site where sediment fencing would be useful to the preservation of the site*

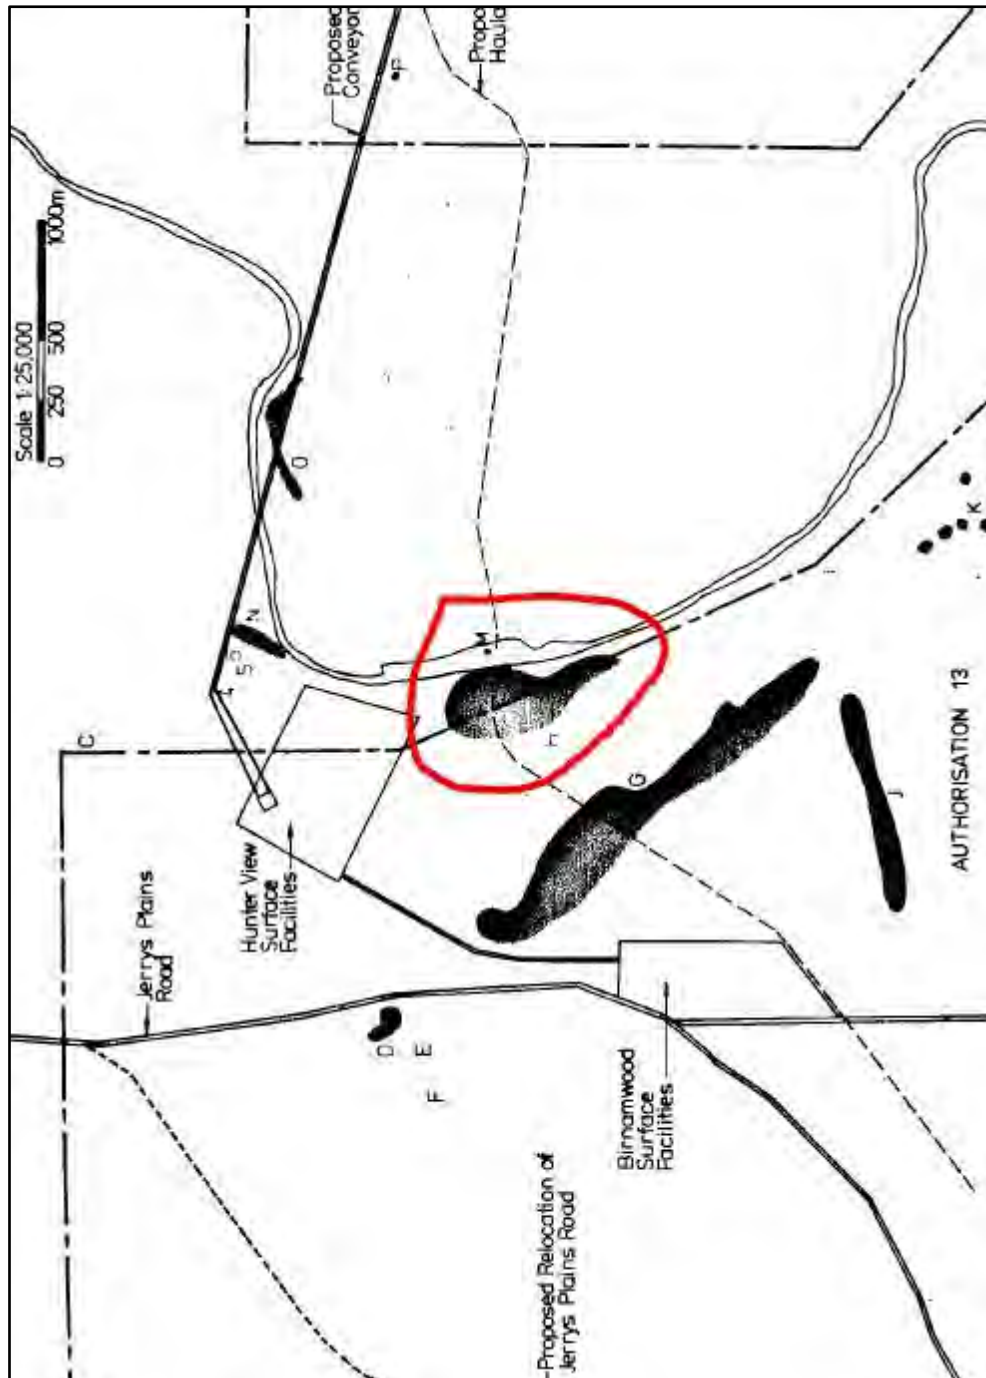
**Original 1981 archaeological survey map showing the location of ACH site 37-5-0047 "H" (circled in red) with the now current haul road (dashed line) intersecting it.**
