Hunter Valley Operations Aboriginal Heritage Management Plans October 2021 Compliance Audit Inspections

Report prepared for
Hunter Valley Operations

November 2021

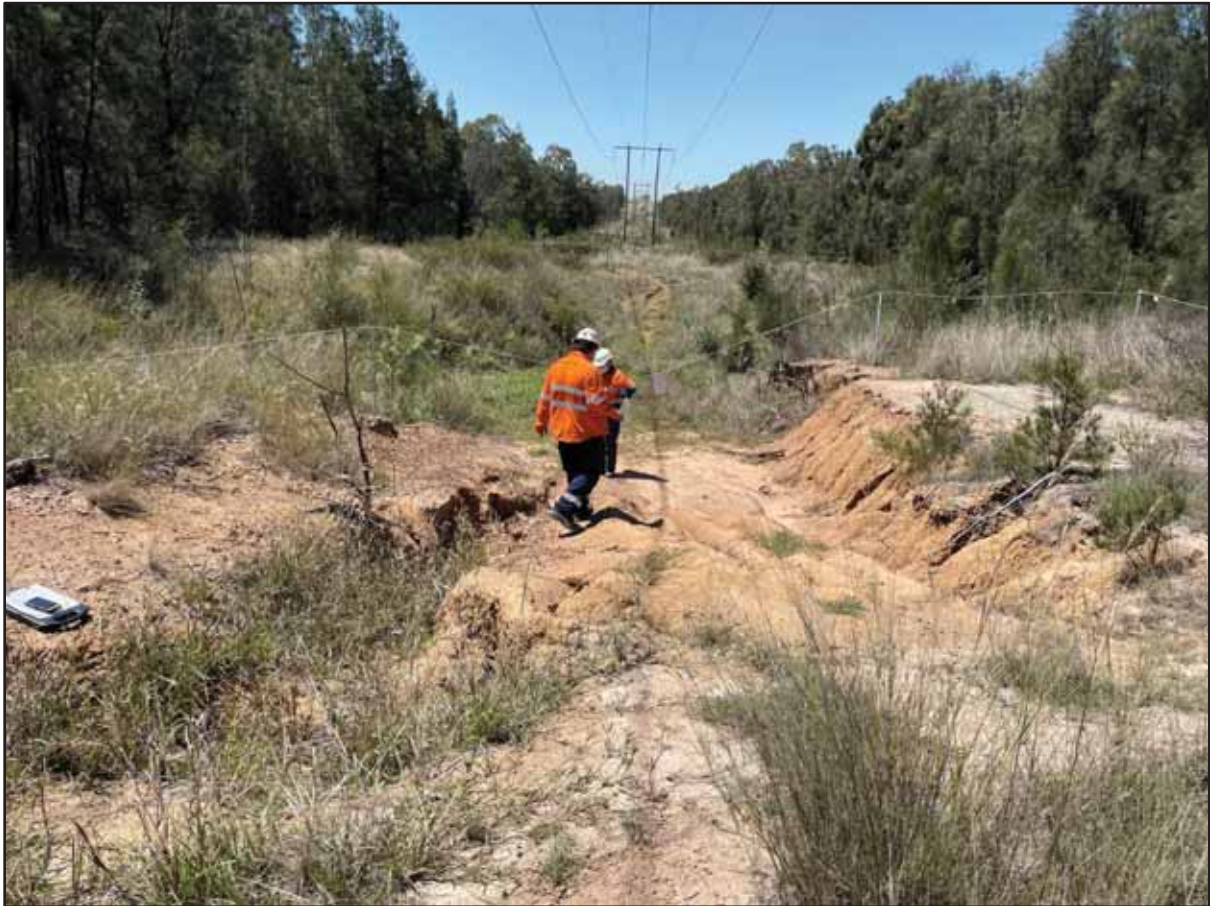
Both of these sites are located adjacent to an eroding gully. During the current inspection, it was noted that artefactual material was located within the erosion zone and in danger of being impacted. Although some previous erosion control measures had been implemented, these have not been entirely successful. It is recommended that structures incorporating coir sediment control logs be installed to help halt erosion and capture sediments prior to their removal by fluvial action.

Example of erosion at site 37-2-0806

3. **To prevent further damage from erosion, install control measures, such as coir logs, at sites 37-2-0806 & 37-2-0807.**
4. **Reassess site 37-6-0166 when vegetation levels are much lower to ascertain actual location of site & amend fencing accordingly.**

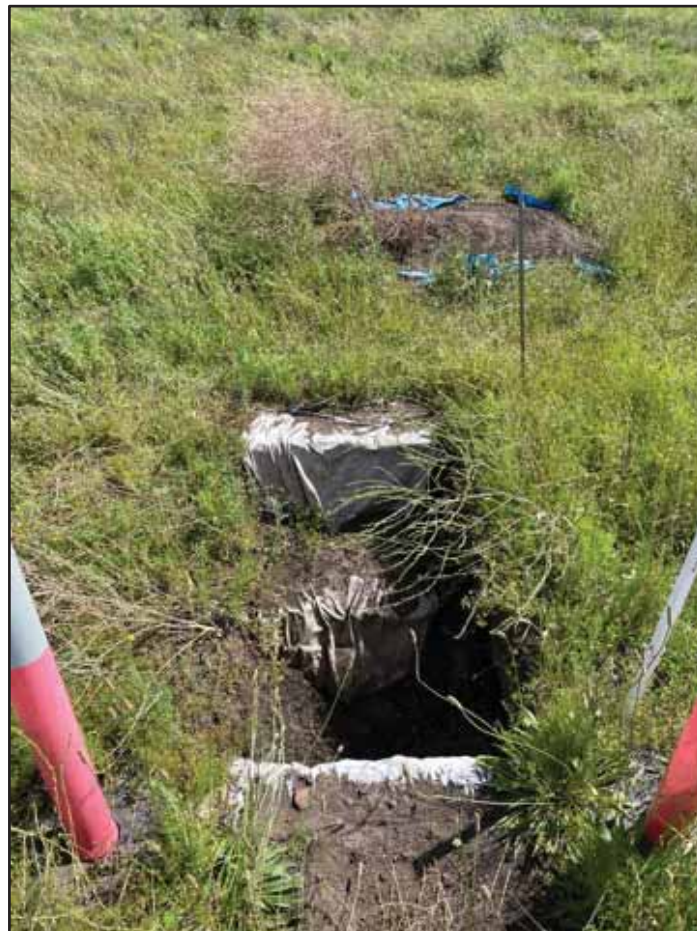
During the October 2021 inspection of CM-CD1 no unauthorised ground disturbance was noted within the disturbance exclusion buffer area (as depicted in Map 4 and the co-ordinates in Point 2 below). It should be noted, however, that the archaeological excavation pits that had been recently conducted as part of studies for the HVO North Continuation project remain open and should be filled in as soon as possible.

Open excavation pit within CM-CD1.

- **The open archaeological pits should be backfilled as soon as possible, ensuring geofabric is in place to delineate the extent of the excavated layers**

5. **Salvage sites 37-6-3316, 37-6-3317 & 37-6-3325 under the auspices of the HVO South AHMP.**
6. **The open archaeological pits located at CM-CD1 should be backfilled as soon as possible, ensuring geofabric is in place to delineate the extent of the excavated layers.**

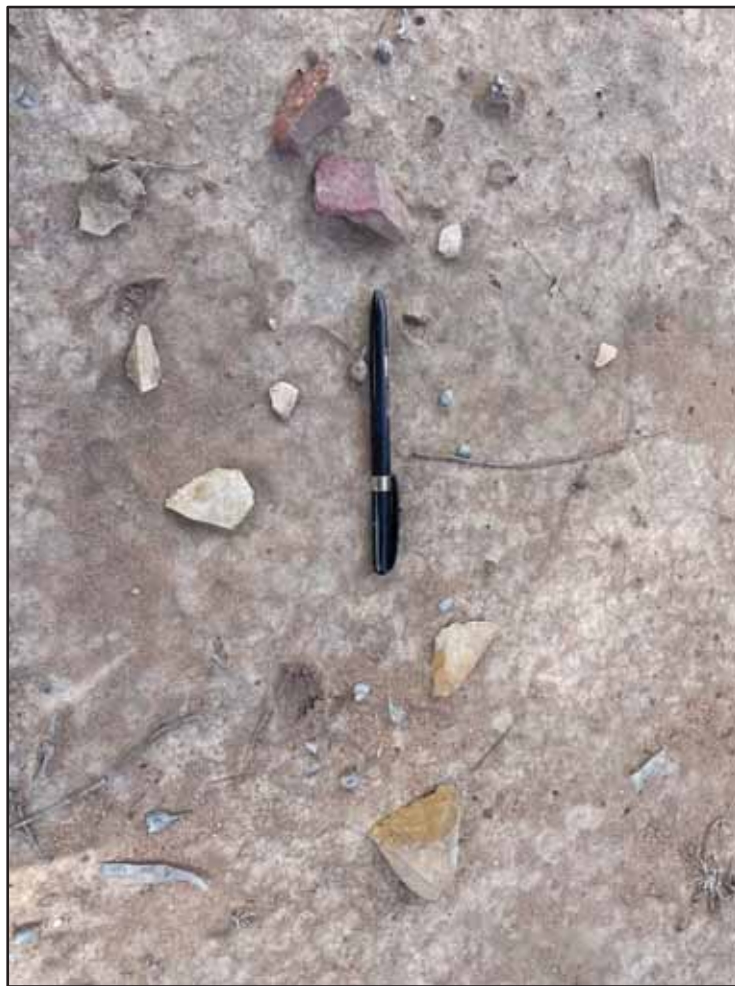
This site consists of c.10 flakes of silcrete located adjacent to an existing track under a tree. The site extends c.10x10m. Several artefact sites are located in the vicinity.

Examples of artefacts found at HVO-2140

9. The CM-CD1 area should continue to be targeted during HVO's vermin control program in order to reduce feral pig disturbance as much as possible.
10. Register the new ACH site HVO-2140 on the AHIMS database.

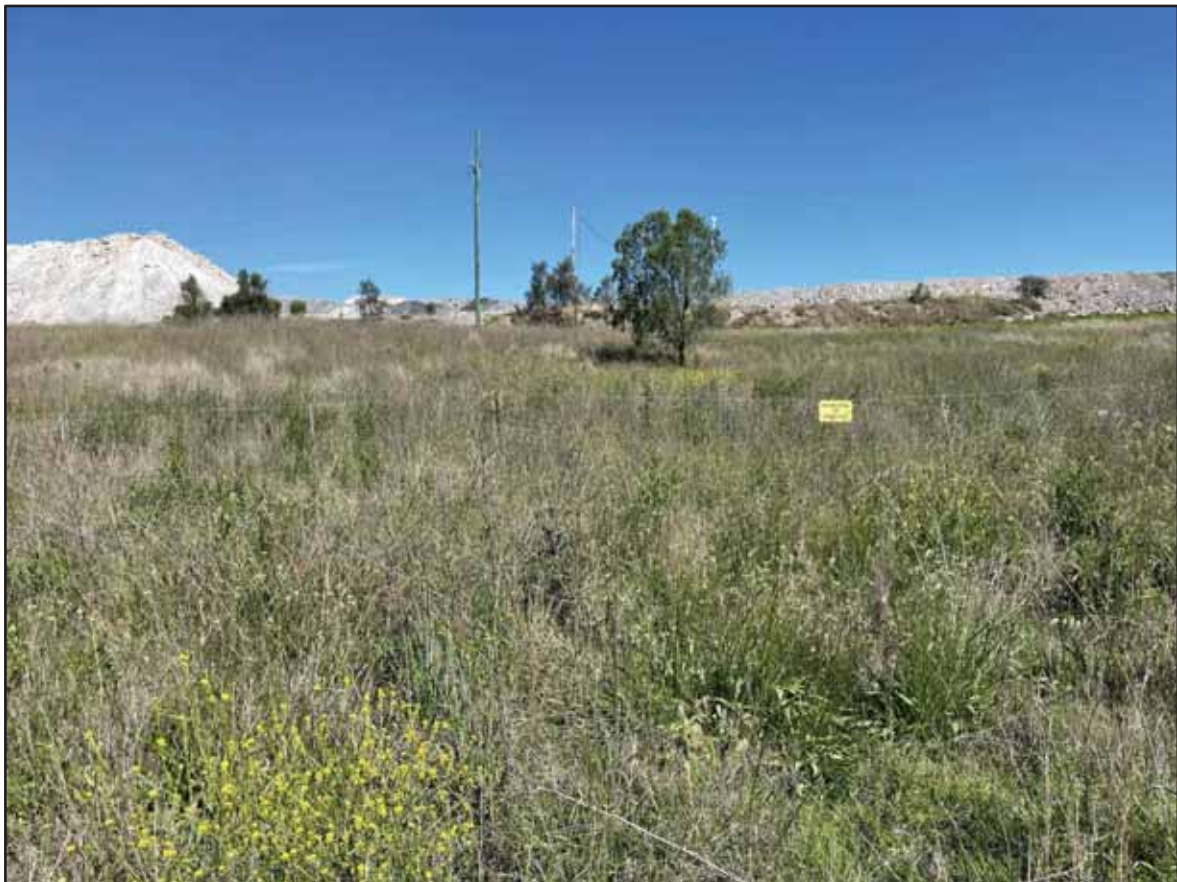
This site has been fenced but the area is currently infested by a thick covering of weeds and grasses. The site is an old recording and it is unclear whether the current fencing is arbitrary or accurately reflects the site's extent. It is recommended that the site is revisited with the report and site cards when vegetation levels are much lower so that better attempts can be made to relocate its contents.

View of vegetation cover across 37-6-0166
