Hunter Valley Operations South Aboriginal Heritage Management Plan April 2021 Compliance Audit Inspections

Report prepared for
Hunter Valley Operations

**HVO South April 2021
AHMP Compliance Inspection
Cheshunt ACH Sites**

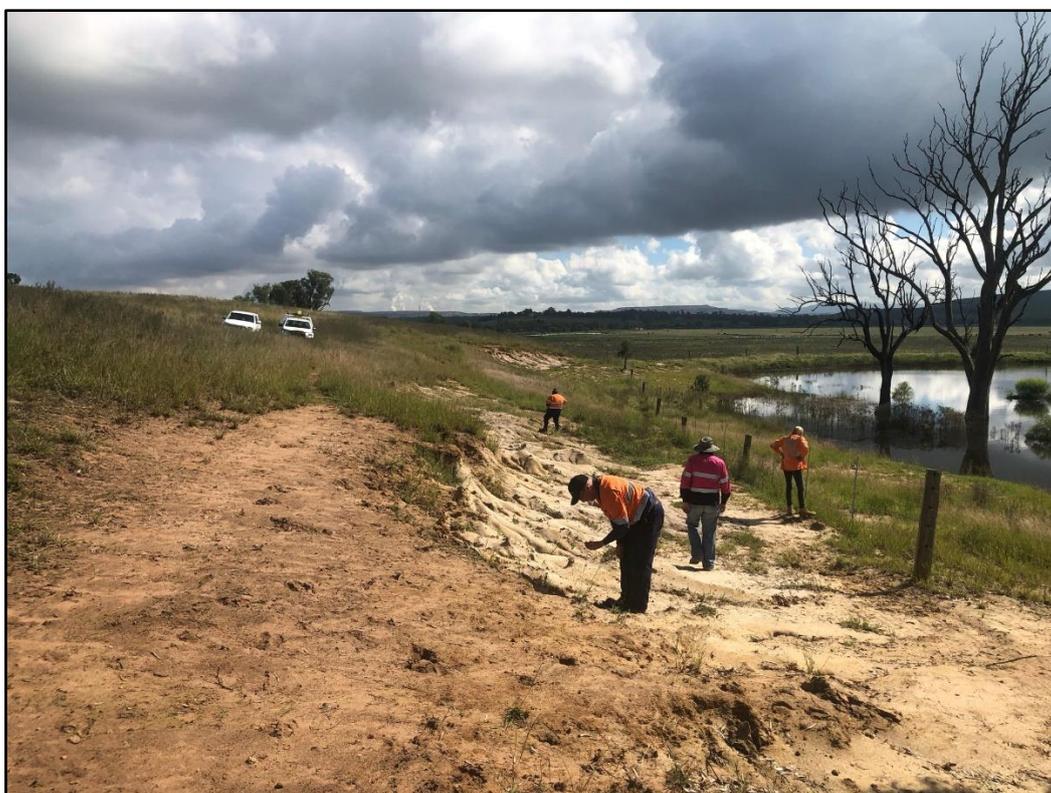
There are several ACH sites located around a dam where artefacts are at risk of being lost to erosion processes. Deep erosion on the slopes surrounding the dam is depositing sediment across the sites and posing the risk of washing artefacts into the dam. Rather than salvage the sites, the CHWG attendees agreed that the eroding areas containing these sites should be fenced off to exclude livestock. The fenced areas should then be seeded to promote the regeneration of stabilising ground cover. As a precaution, to prevent possible wash of artefacts into the dam sediment fencing should be installed on the downslope boundary.

Severe erosion in the vicinity of ACH sites HVO-1675, 76, 86, 87, 88

It should be noted that the new and upgraded ACH site fencing specification being trialled and installed at several ACH sites across HVO has been received positively by CHWG members and is considered the favoured option when site protection is warranted. In this instance, two fences should be installed – one around HVO-1685 and a more extensive fence surrounding the remaining sites.

- 1. Install hard fencing, including sediment fencing at ACH sites HVO-1675, 1676, 1685, 1686, 1687 and 1688; and**
- 2. ACH sites HVO-1653, 1654, 1655, 1682 and 1683 should be salvaged to prevent further inadvertent damage.**

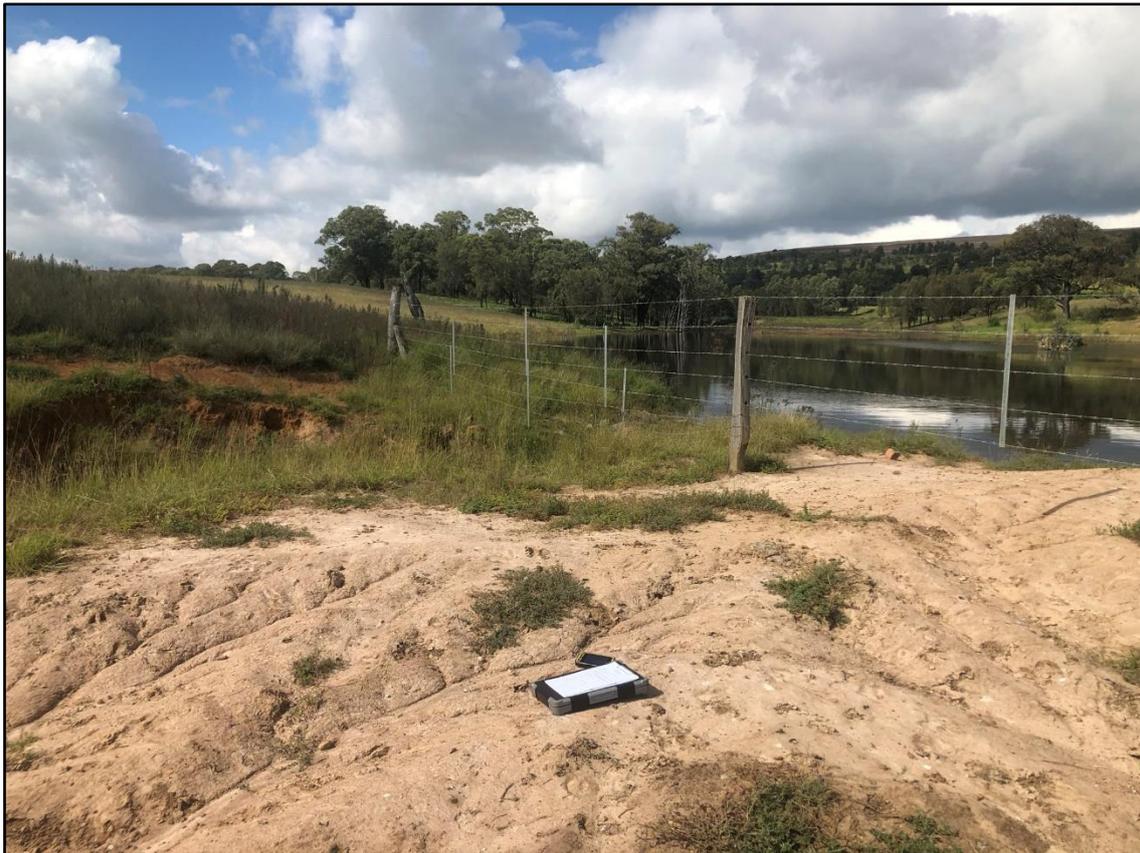
Erosion in the vicinity of ACH site HVO-1685

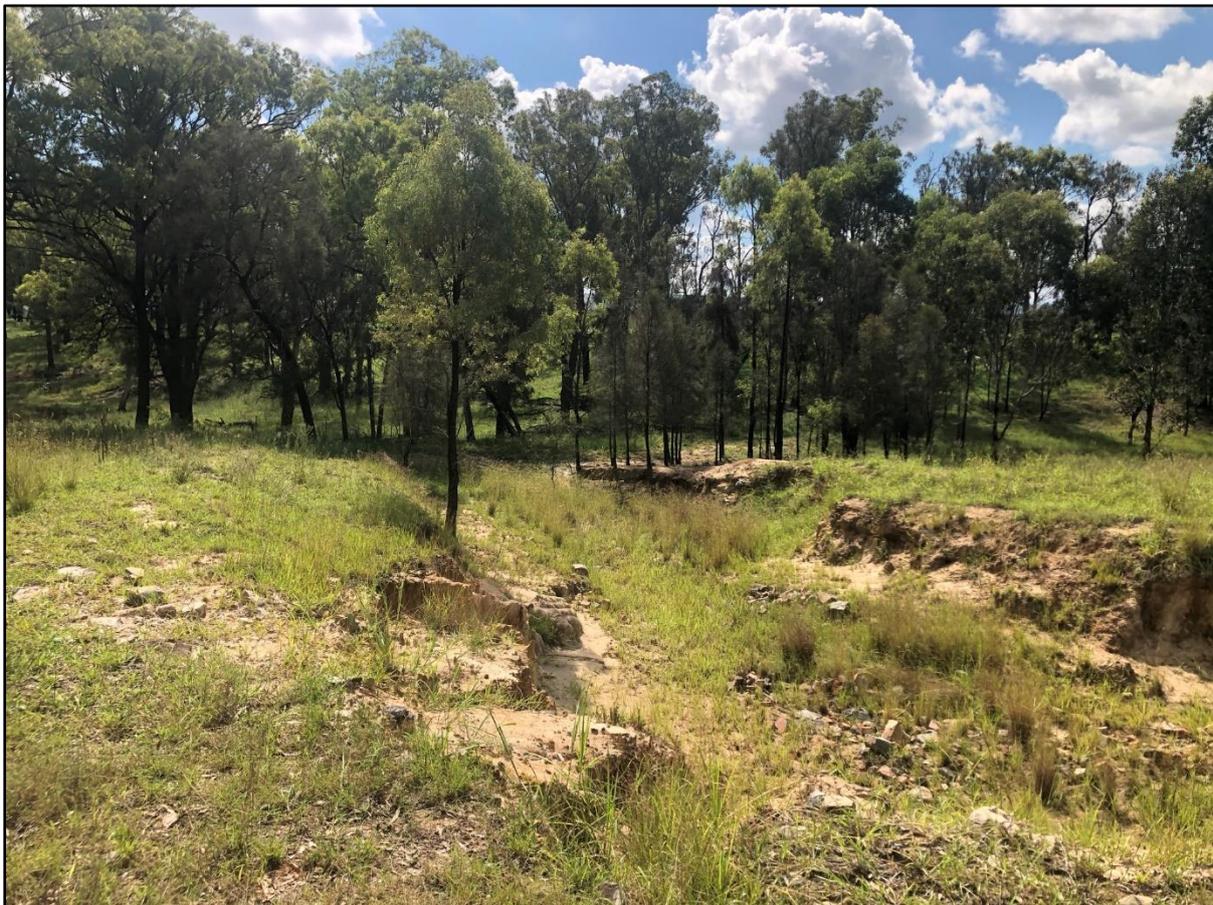
These five ACH sites are located in two discreet areas, both of which have been affected by severe fluvial action caused by dam wall or spillway failures. The damage to the dam in the vicinity of sites HVO-1653, 1654 and 1655 (all single isolated artefacts) is repairable, however, any repairs would not be possible without further disturbance to the artefacts present. Sites HVO-1682 and 1683 (both single isolated artefacts) are located on a severely eroded spillway where fencing is impractical and the risk of loss of artefacts in the deep erosion rills high.

Damaged spillway in the vicinity of ACH sites HVO-1653, 1654 and 1655

Due to the risk of further disturbance to these sites it was recommended by the CHWG representatives that they be salvaged. An AHIP is not required to implement this measure, as the salvage of these sites, with Aboriginal community participation, is authorised under the HVO South AHMP.

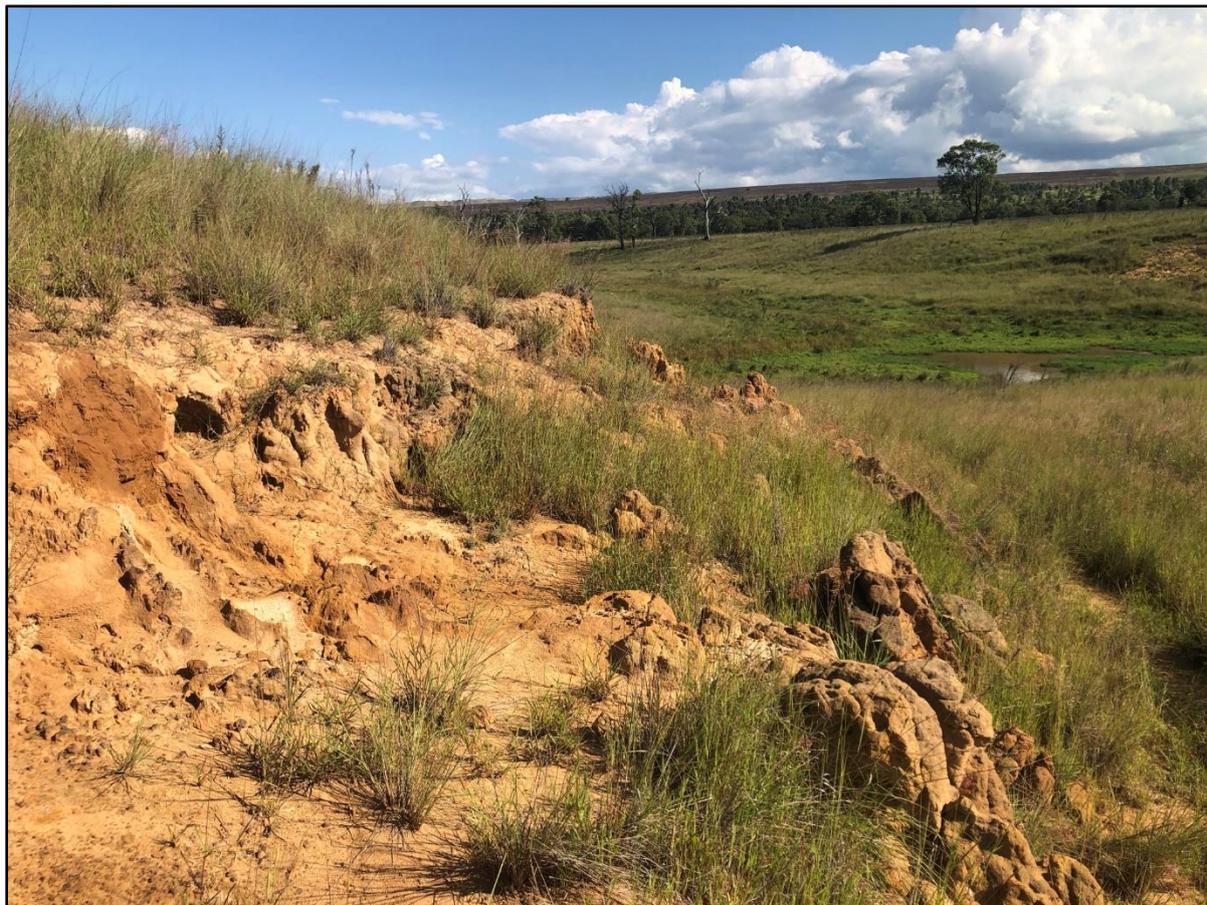
Severe erosion in the vicinity of ACH sites HVO-1682 and 1683
