HUNTER VALLEY OPERATIONS SOUTH MINE PROJECT

DOG LEG FENCE AND TIMBER BRIDGE SIGNIFICANCE ASSESSMENTS

20 NOVEMBER 2019
P0017219
PREPARED FOR HUNTER VALLEY OPERATIONS

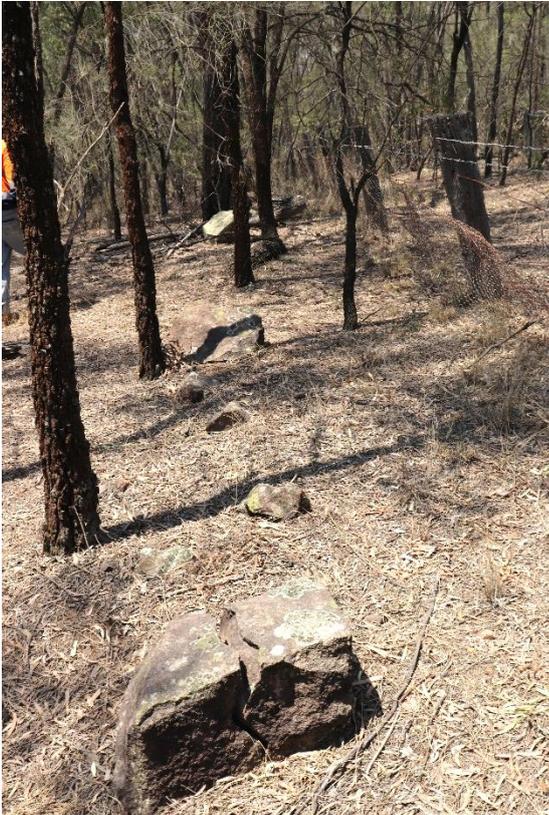
Sandstone blocks were used to support the lower log and the distances between the blocks varied greatly. At the eastern end of the surveyed area the blocks were the only fabric associated with the fence remaining (Picture 1). Generally the blocks were spaced between 3-4m apart, but in some locations as little as 1.8m.

Picture 1 – Stone blocks indicating former fence alignment

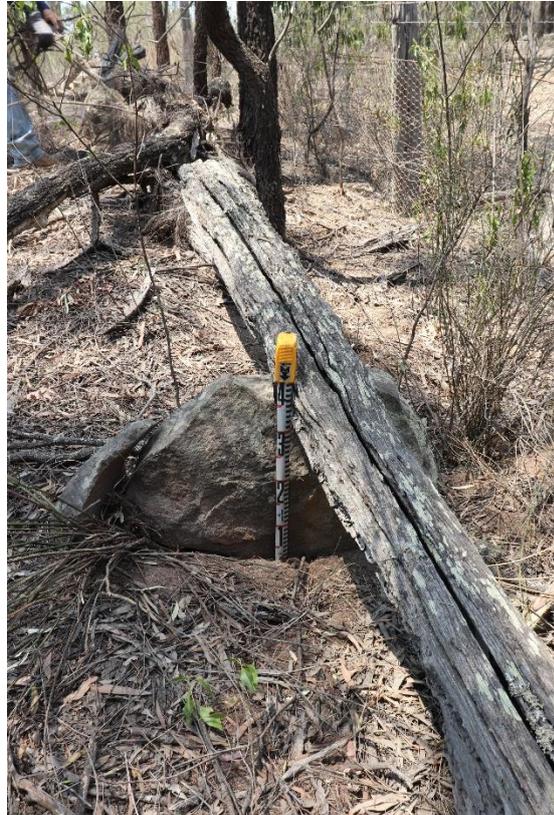
Blocks also varied in shape, but were generally 300-400mm in height and thickness (see Picture 2), and 500-800mm in length. Some blocks showed evidence of being carved (see Picture 3) to allow the lower log to be placed securely on top (Picture 4).

Picture 2 – General dimension of stone block

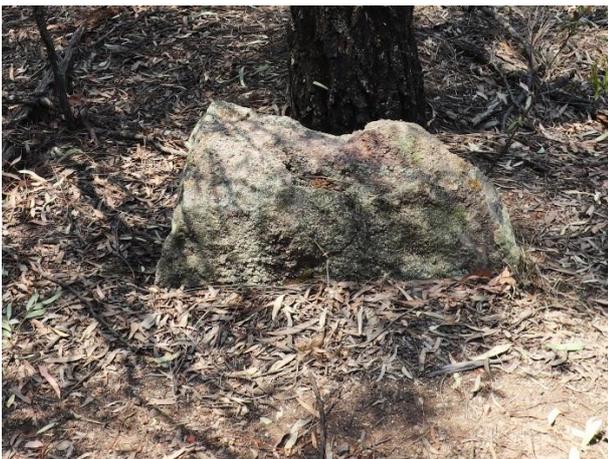
Picture 3 – Chiselled block

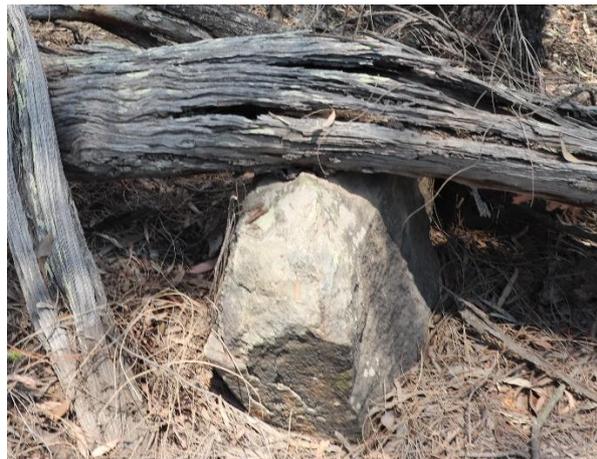
Picture 4 – Block with intact lower log

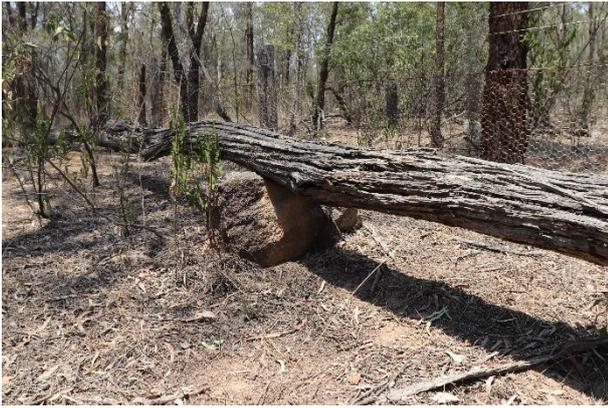
The blocks were used to support the lower log/bottom rail of the fence. While there are not many areas where both the upper and lower logs remain in-situ, the lower log remains among much of the fenceline (see Picture 5). Where both upper and lower logs remained the fence was on an angle (Picture 6). In a number of locations, length of Ironbark logs sit adjacent to sandstone blocks in the alignment of the former fence.

Picture 5 – Intact lower log/bottom rail

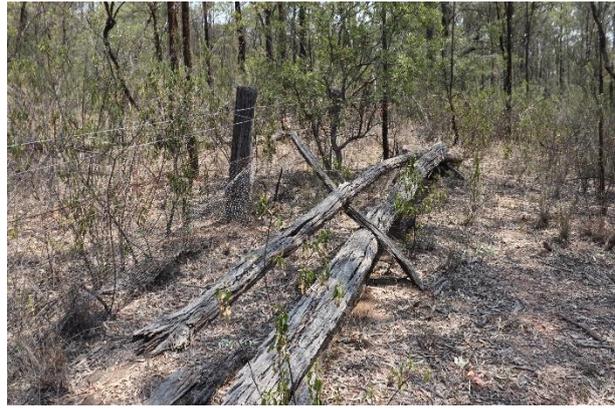
Picture 6 – Intact upper and lower logs

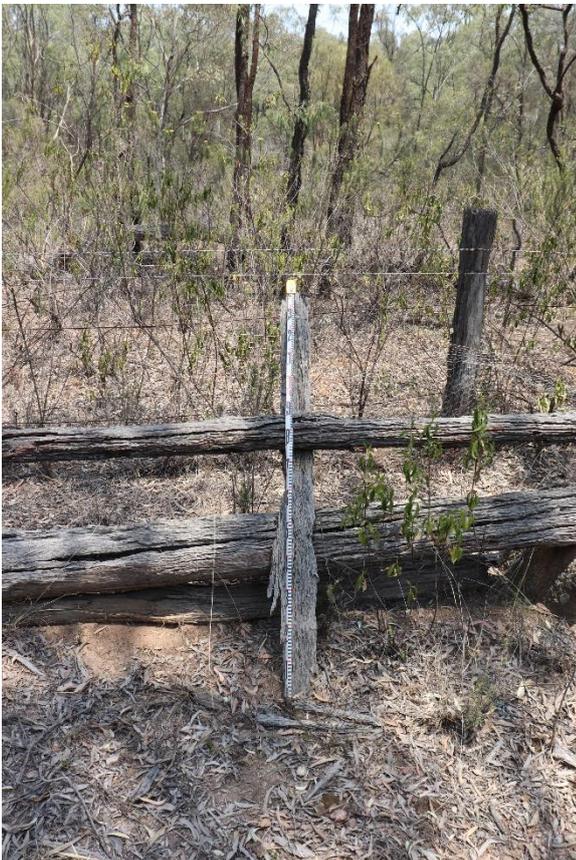
The posts of the fence are the “dog-legs” which are formed by pieces of split Ironbark. Remaining lengths were between 1.2-1.5m in length (see Picture 7), and in a number of locations the dog leg had failed leading to the collapse of the top rail/upper log (Picture 8).

Picture 7 – Remnant dog leg post

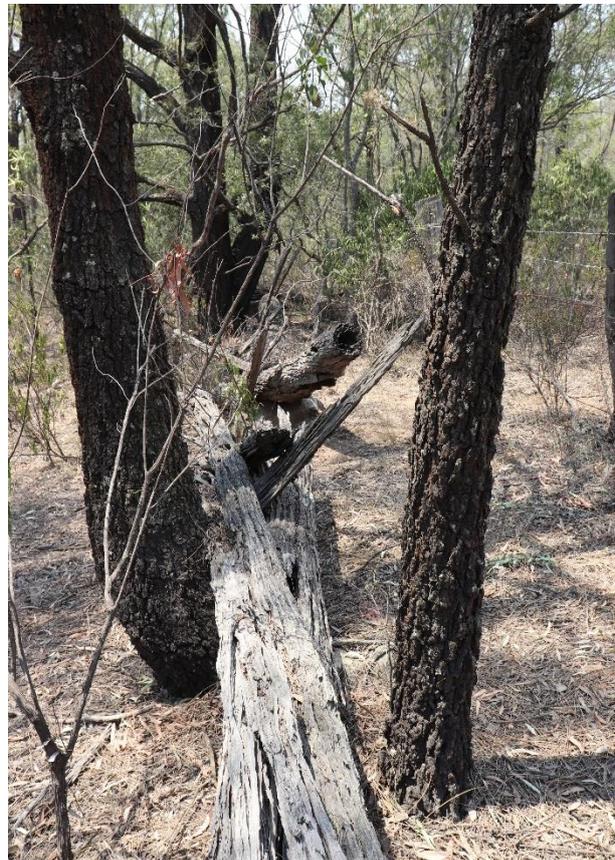
Picture 8 – Portion of fence with damaged dog-legs

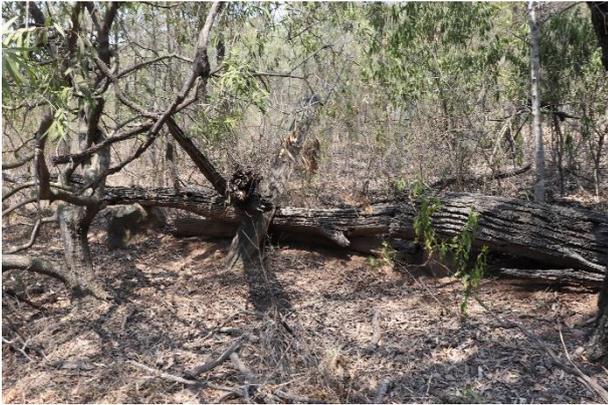
Picture 9 shows a section of fence with sandstone blocks, upper and lower logs and both dog legs remaining, but not in-situ. Picture 10 shows a section of fence with dislodged rail and sandstone blocks remaining.

Picture 9 – Fence impacted by vegetation

1. The fence and area adjacent should be cleared of vegetation and debris with assistance from an historical archaeologist to ensure all associated heritage fabric is retained.

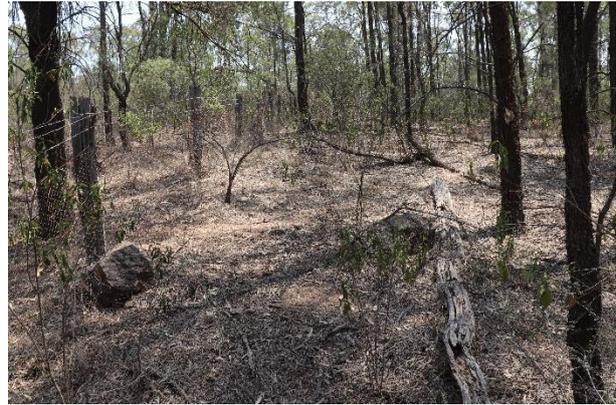
Picture 10 – Log lying adjacent to sandstone blocks

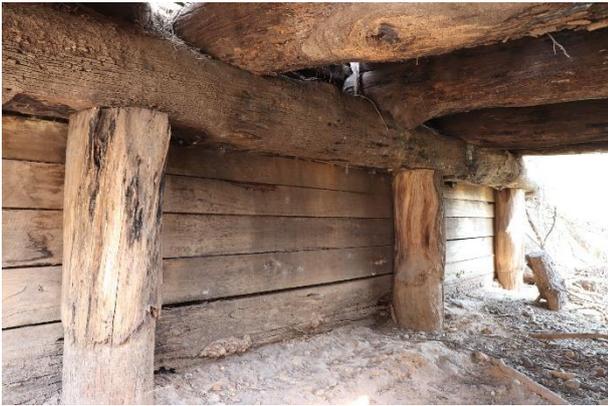
The substructure is constructed of timber pile abutments at roughly 2m centres (see Picture 13). Timber wing walls (Picture 14) are present at both ends, with rubble backfill.

Picture 13 – Timber piles
Source: Urbis 2019

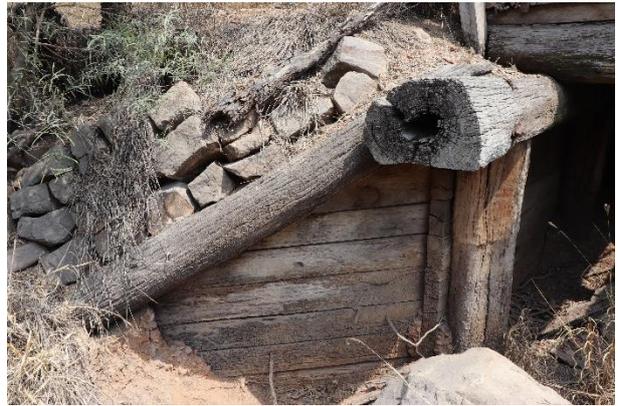
Picture 14 – Timber wing walls of abutments
Source: Urbis 2019

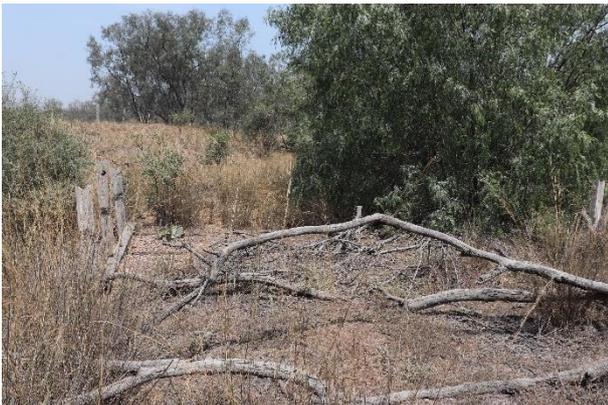
The decking comprises closely spaced transverse timber planks, 125mm deep and 200mm wide (see Picture 15). The planks have the remains of a flush seal surface (see Picture 16), commonly used to slow drying of timber and resultant splitting of timber.

Picture 15 – Decking of the structure looking south-west
Source: Urbis 2019

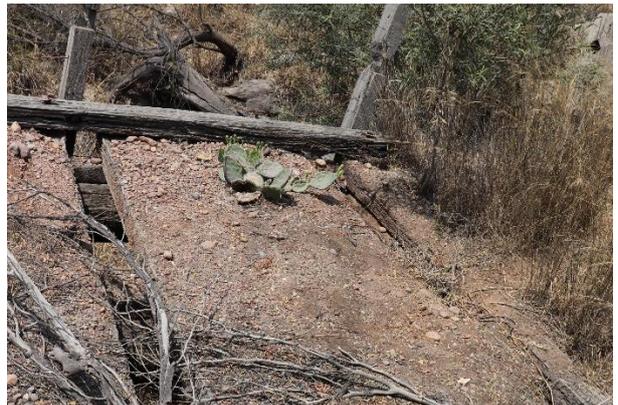
Picture 16 – Detail of deck surface
Source: Urbis 2019

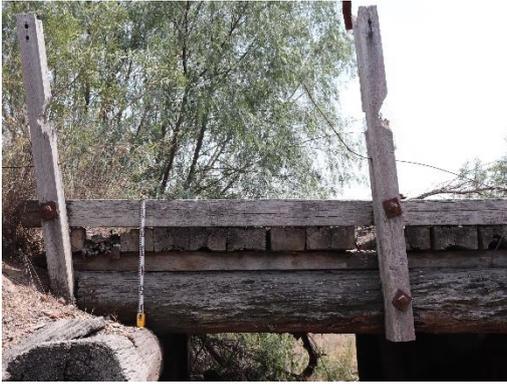
The decking is supported by log girders (sitting on log headstocks), and also comprises the remains of traffic barrier system in the form of kerbing and a post and rail system. None of the rails remain. Posts are bolted into the kerb and girders (see Picture 17), similar to standard timber bridge construction (see Picture 18).

Picture 17 – Remains of safety barrier

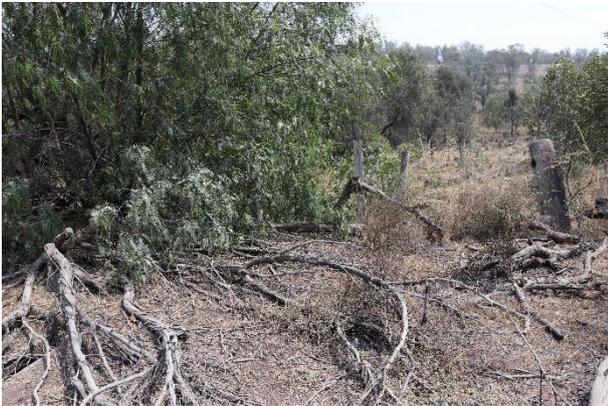
Overall the bridge is in poor condition, with vegetation growing against the structure (Picture 19), timber members showing signs of deterioration (Picture 20), corroded bolts, and missing timber decking and railing.

Picture 19 – Vegetation impacting on structure

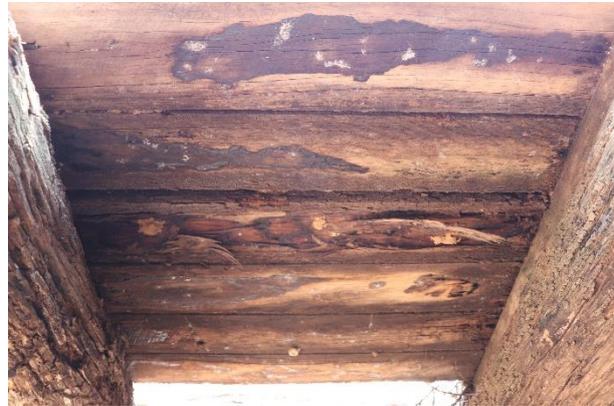
Picture 20 – Condition of underside of timber decking
