Hunter Valley Operations

2017 Annual Review

March 2018

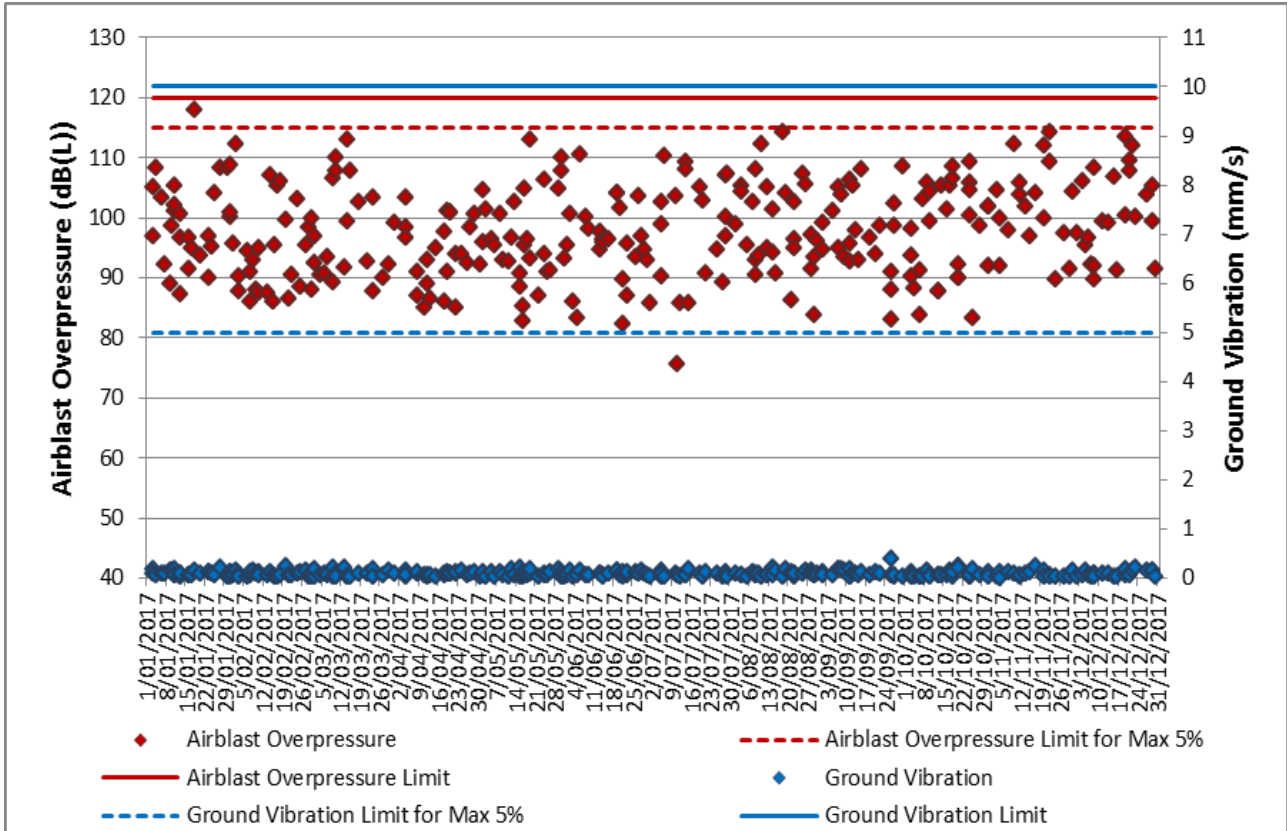
Figure 6: Jerrys Plains Blast Monitoring Results 2017

During the reporting period 288 blast events were initiated at HVO. HVO complied with all blasting related consent and licence conditions. Airblast Overpressure and Ground Vibration results for all blasts fired during the reporting period are displayed in Figure 6 to Figure 10.

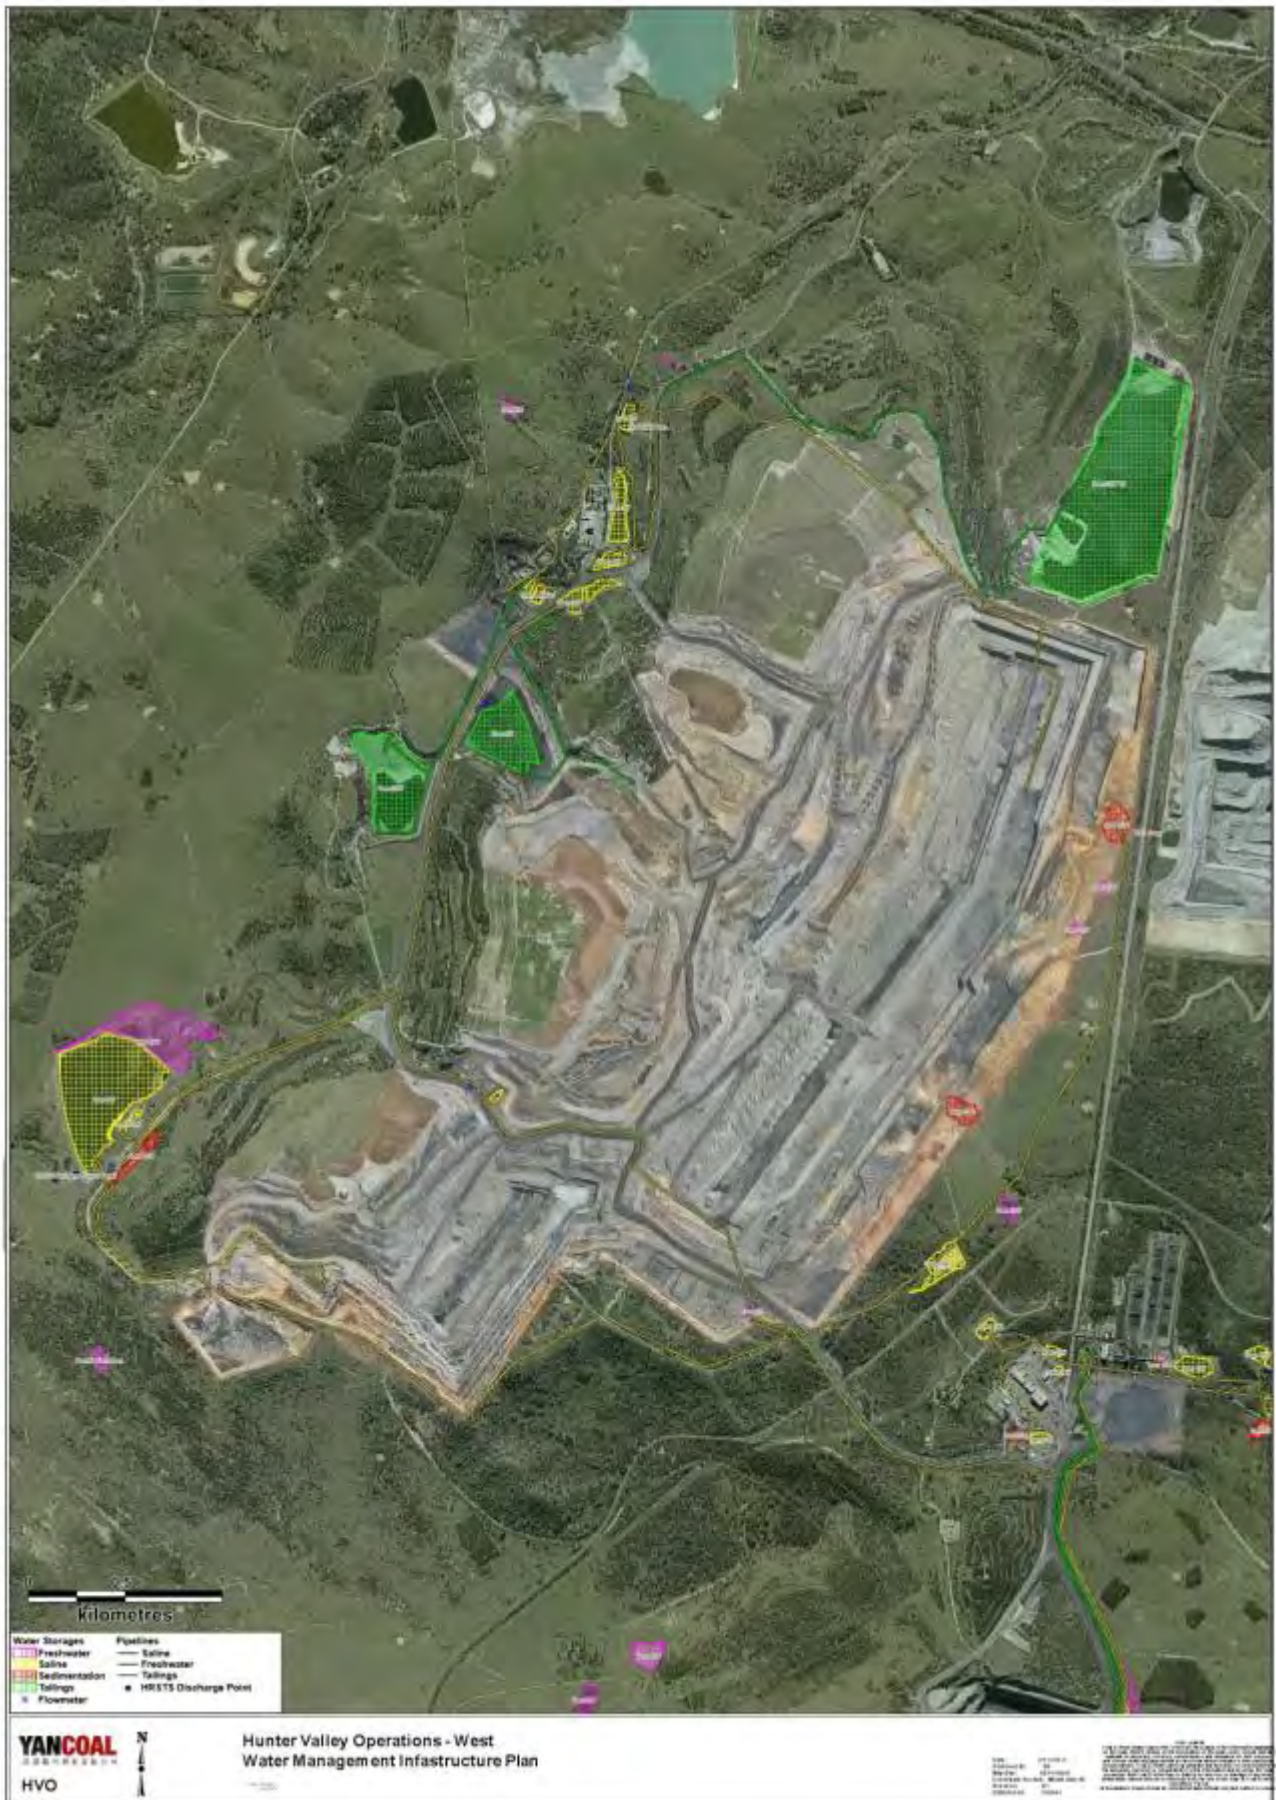
Figure 23: West Pit water management infrastructure

During the 2017 reporting period significant improvement works commenced at the Hunter Valley Load Point to improve the containment of runoff from the train loading facility. Installation of a secondary containment basin downstream of Parnell's Dam (dam 9W) also commenced during the reporting period.

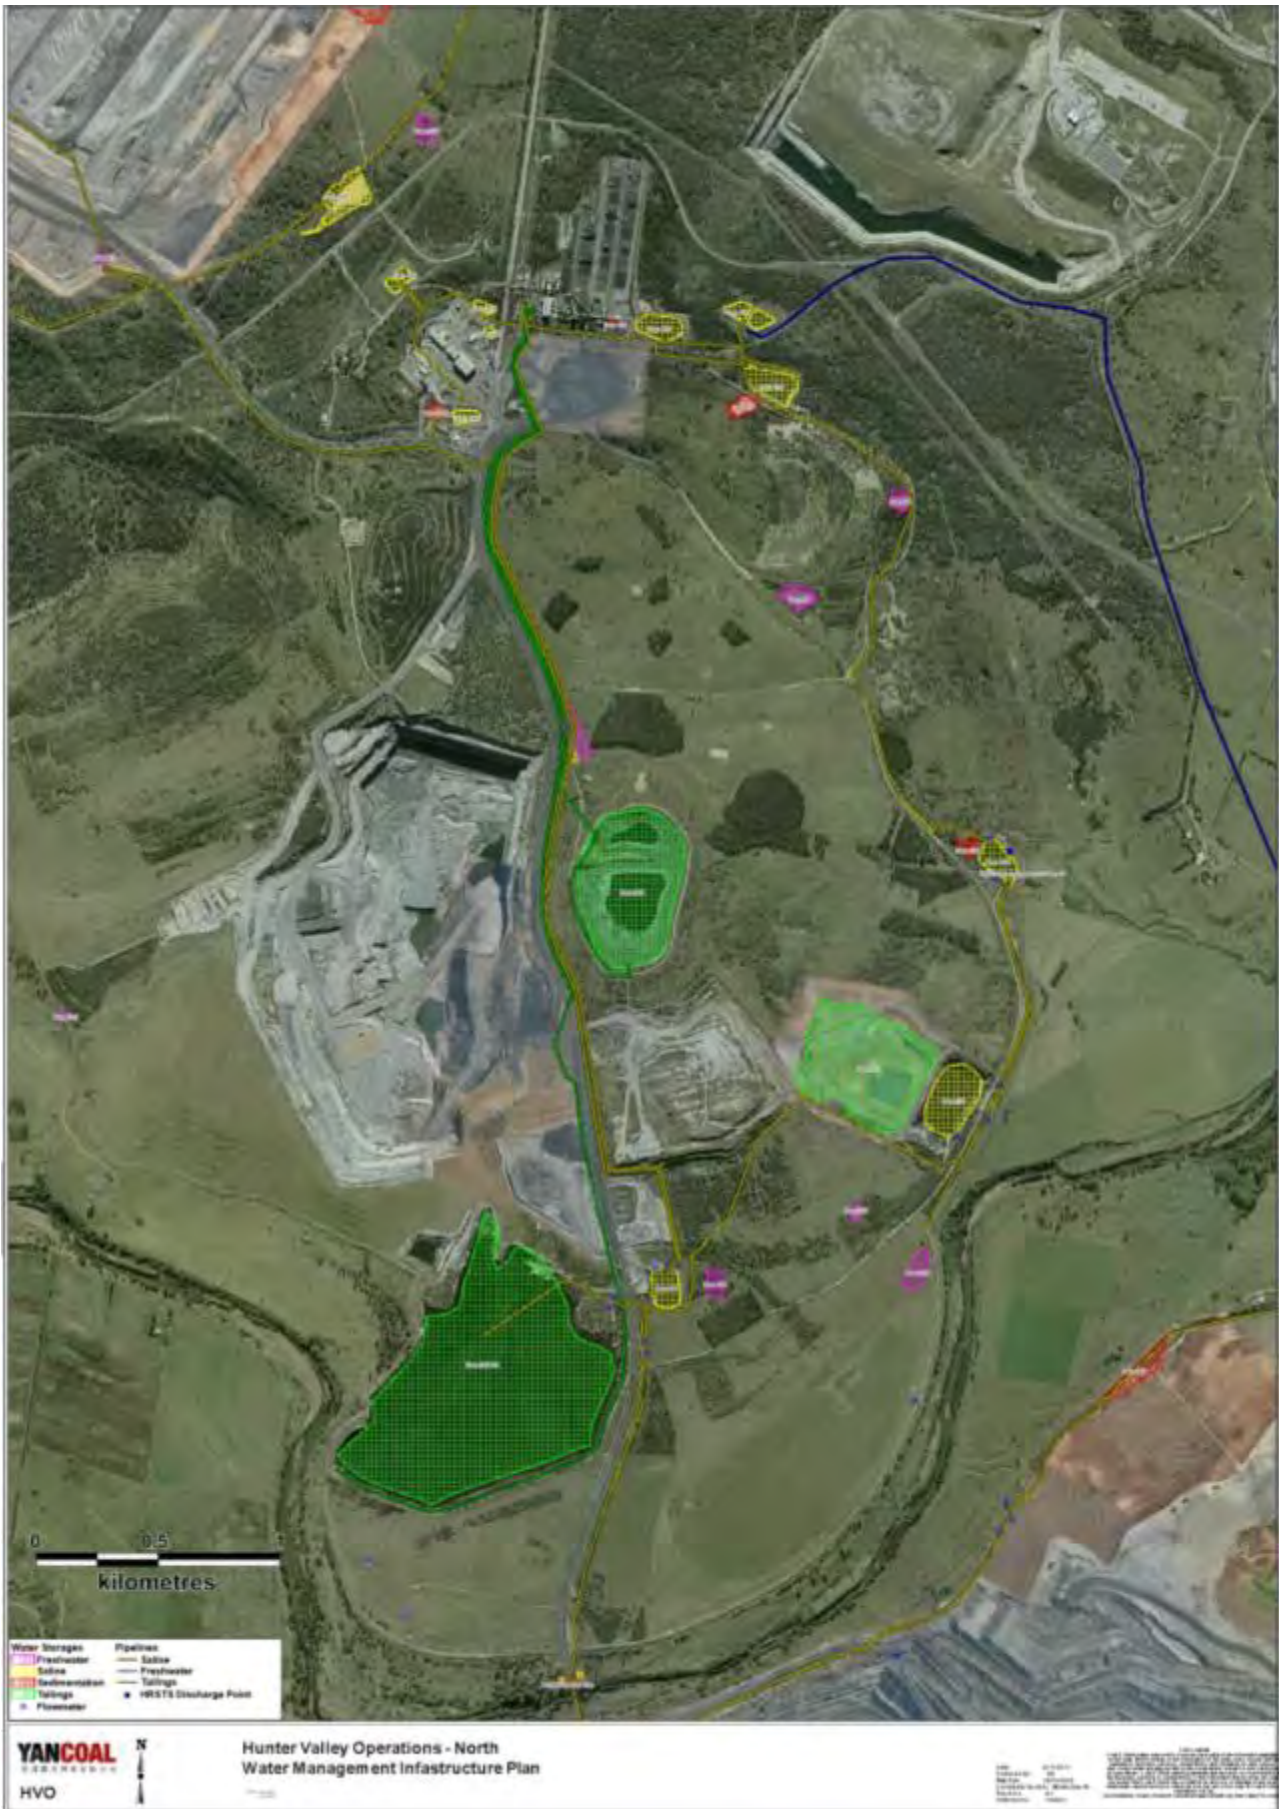
Figure 24: North Pit water management infrastructure

Plans showing the layout of all water management structures and key pipelines are shown in Figure 23 to Figure 25. The HVO Water Management Plan contains further detail on management practices and is available on Yancoal Australia's website.

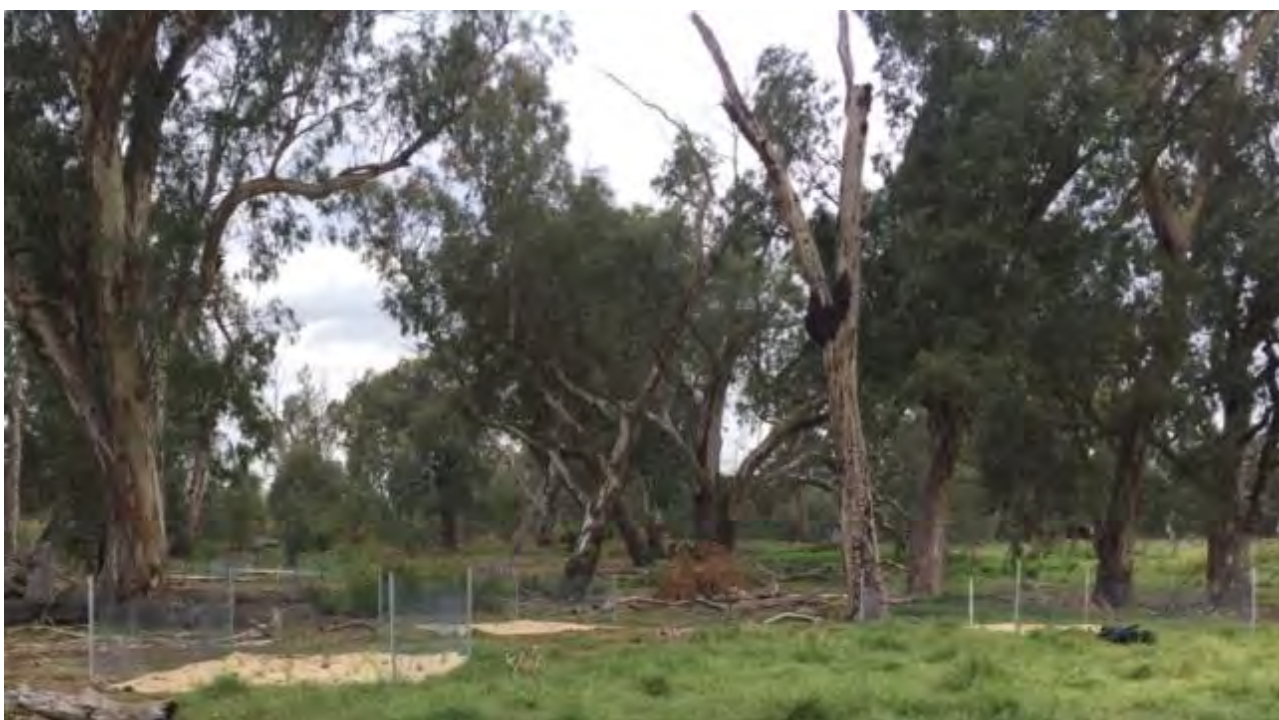
Figure 96: Native tube stock planting at Carrington Billabong

Planting programmes to increase the understory diversity of the Carrington Billabong have been undertaken in spring 2015 and autumn 2017. A total of 1,000 plants were planted during each programme and these were broken down into 500 grasses, 250 shrubs and 250 small trees. These were planted into weed mat islands that were fenced off for protection against rabbit and kangaroo browsing. River Red Gum tube stock were also planted into the area. An additional native understorey planting is scheduled to be undertaken in autumn 2018 to add to the diversity of the Carrington Billabong and other priority River Red Gum areas at HVO. Figure 96 shows the new weed mat islands at the Carrington Billabong.

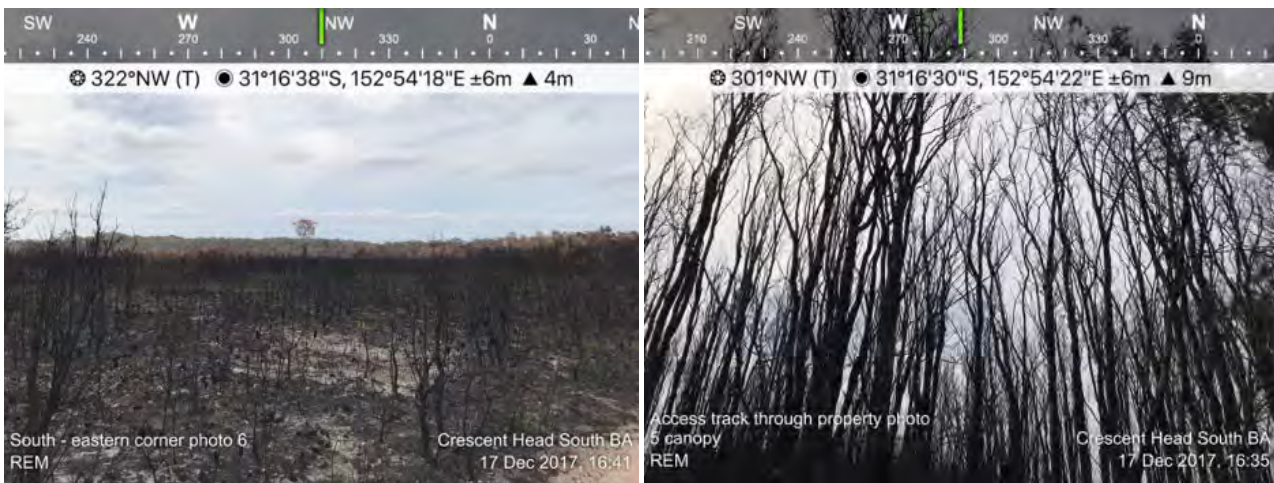
Figure 103: Damage to vegetation

The Regional Offset Bushfire Management Plan and the HVO Bushfire Management Plan were reviewed and updated. In December a bushfire that started in the neighbouring Limeburners Creek National Park, burnt through the Crescent Head South BA. A property inspection, undertaken two weeks after the fire, indicated that the vegetation was burnt to varying degrees across the Biodiversity Area. There was evidence of grasses already recovering from the bushfire and banksias and other heath species had released seeds. Figure 103 and Figure 104 show the Biodiversity Area after the fire.

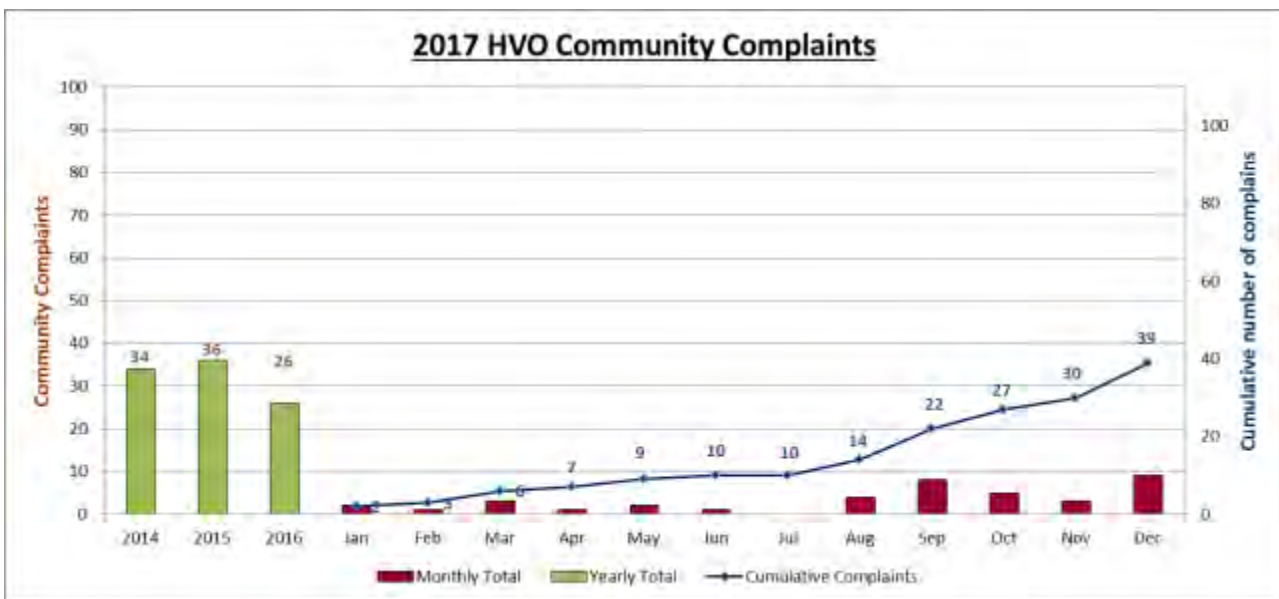
Figure 105 Community Complaints

A total of 39 complaints were received by HVO during 2017 (Figure 105). This represents an increase of 13 community complaints from the previous year but is consistent with historical trends. Complaints were received in relation to noise, dust and blasting and water quality.

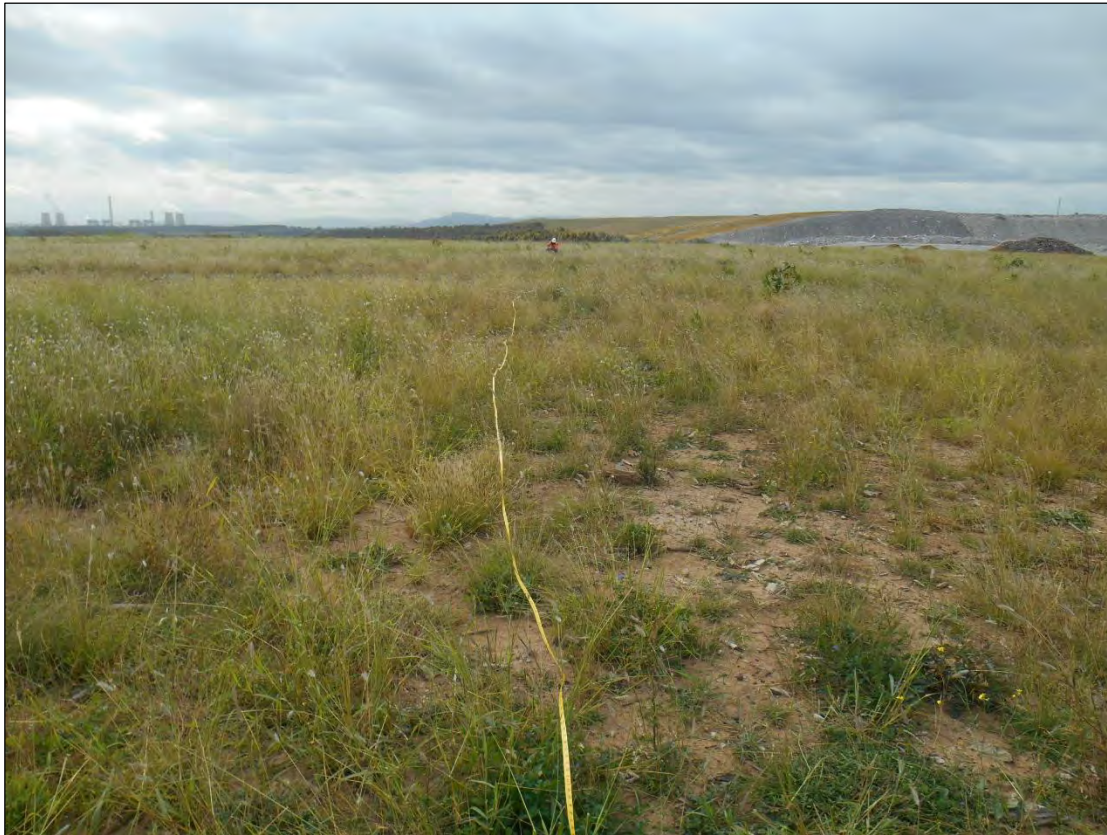
Start position 2017

Disturbance present at rehabilitation site HVOWES201604 consisted mainly of weeds, and grazing by macropods. No evidence of fire was observed in the rehabilitation area. No areas containing rubbish were observed.

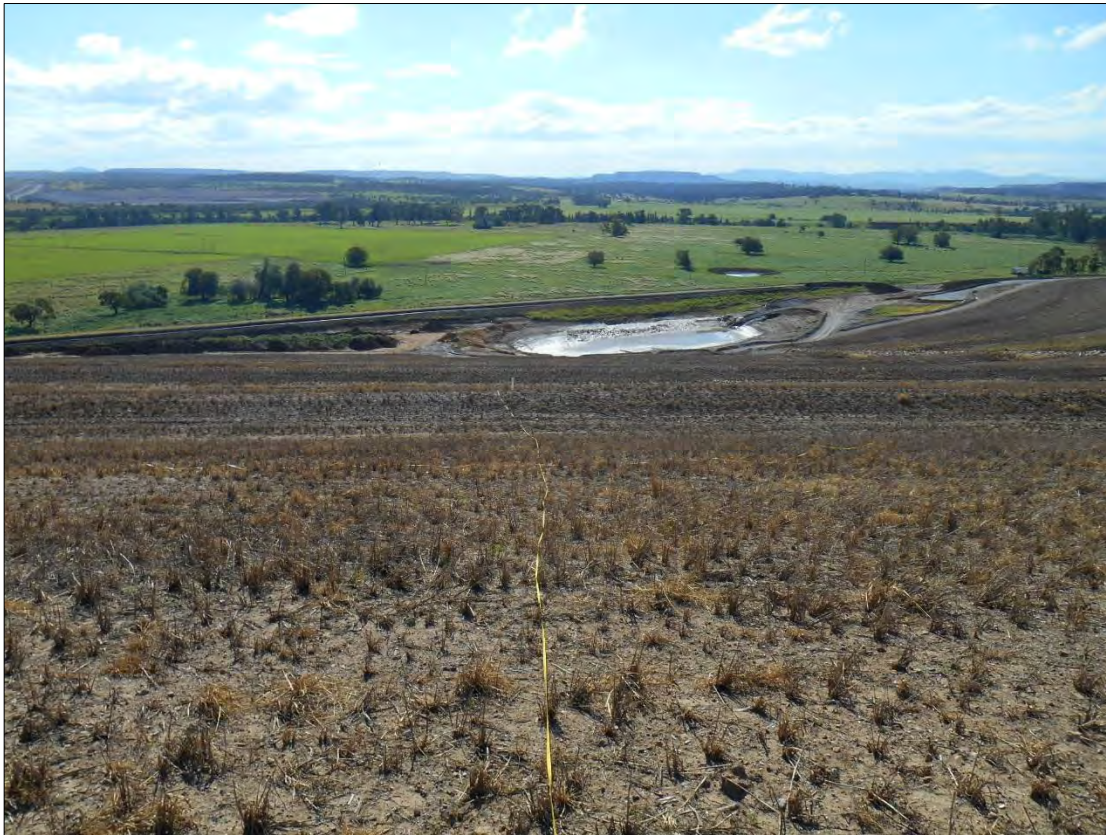
Start position 2017

Disturbance present at rehabilitation site HVOCHE201601 consisted mainly of weeds, and grazing by macropods. No evidence of fire was observed in the rehabilitation area. No areas containing rubbish were observed.

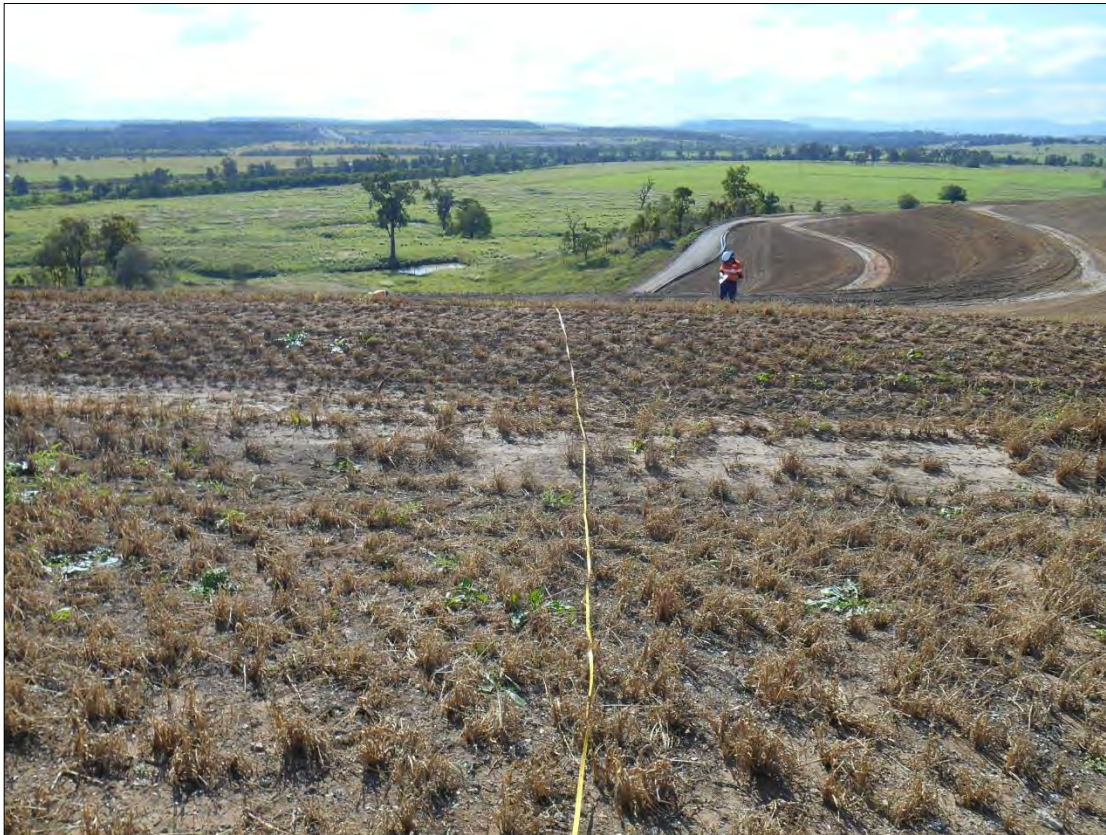
Start position 2017

Disturbance present at rehabilitation site HVOCHE201602 consisted mainly of weeds, and grazing by macropods. No evidence of fire was observed in the rehabilitation area. No areas containing rubbish were observed.

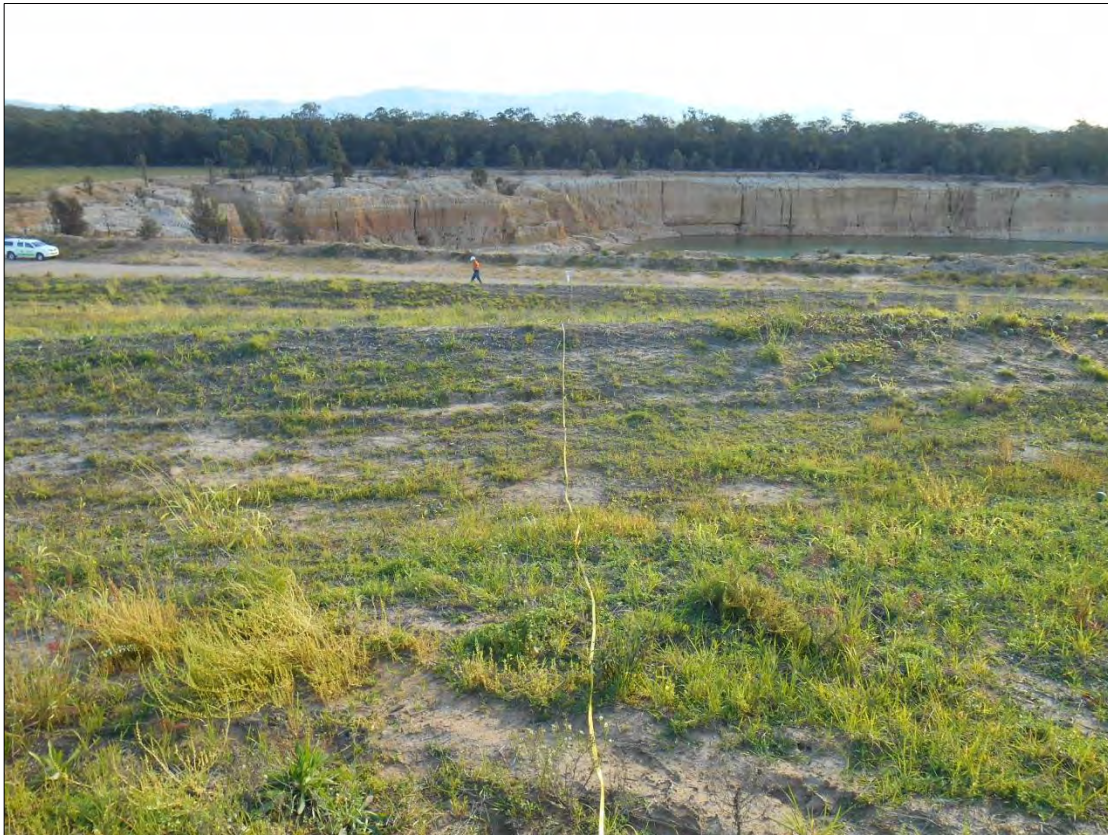
Start position 2017

Disturbance present at rehabilitation site HVOLEM201601 consisted mainly of weeds, and grazing by macropods. No evidence of fire was observed in the rehabilitation area. No areas containing rubbish were observed.

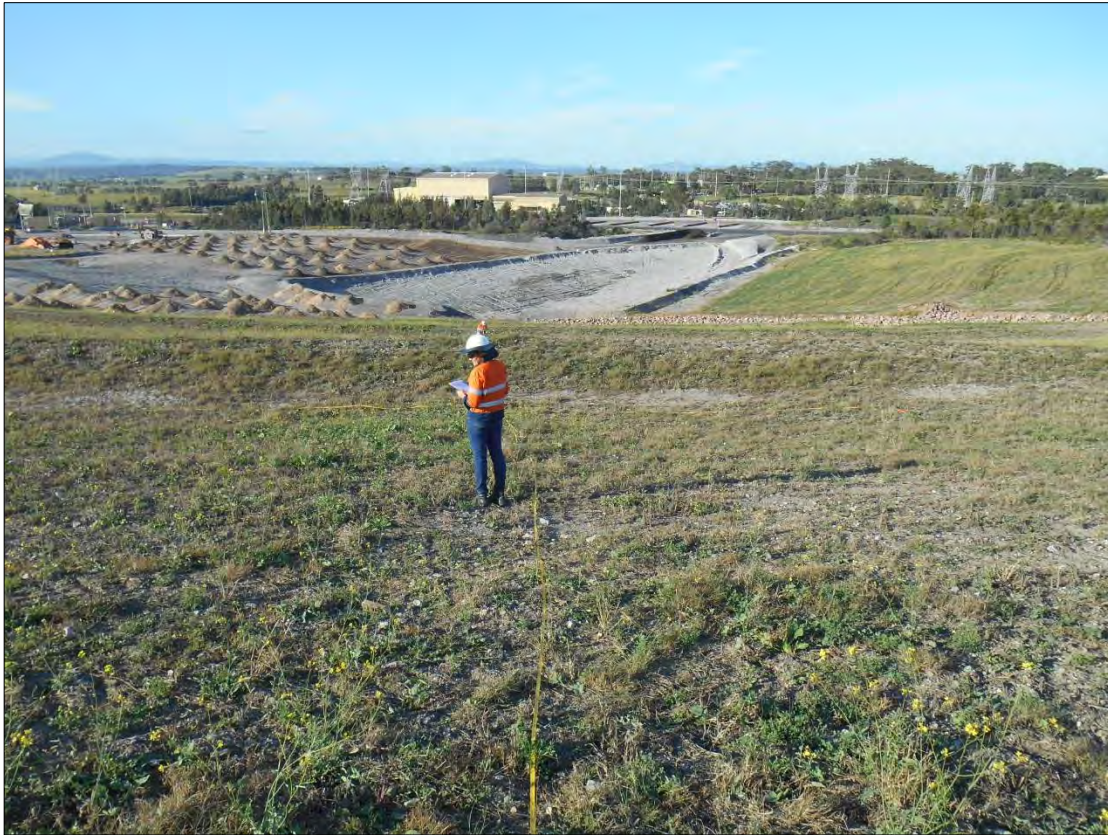
Start position 2017

Disturbance present at rehabilitation site MTWSPS201601 consisted mainly of weeds, and grazing by macropods. No evidence of fire was observed in the rehabilitation area. No areas containing rubbish were observed.

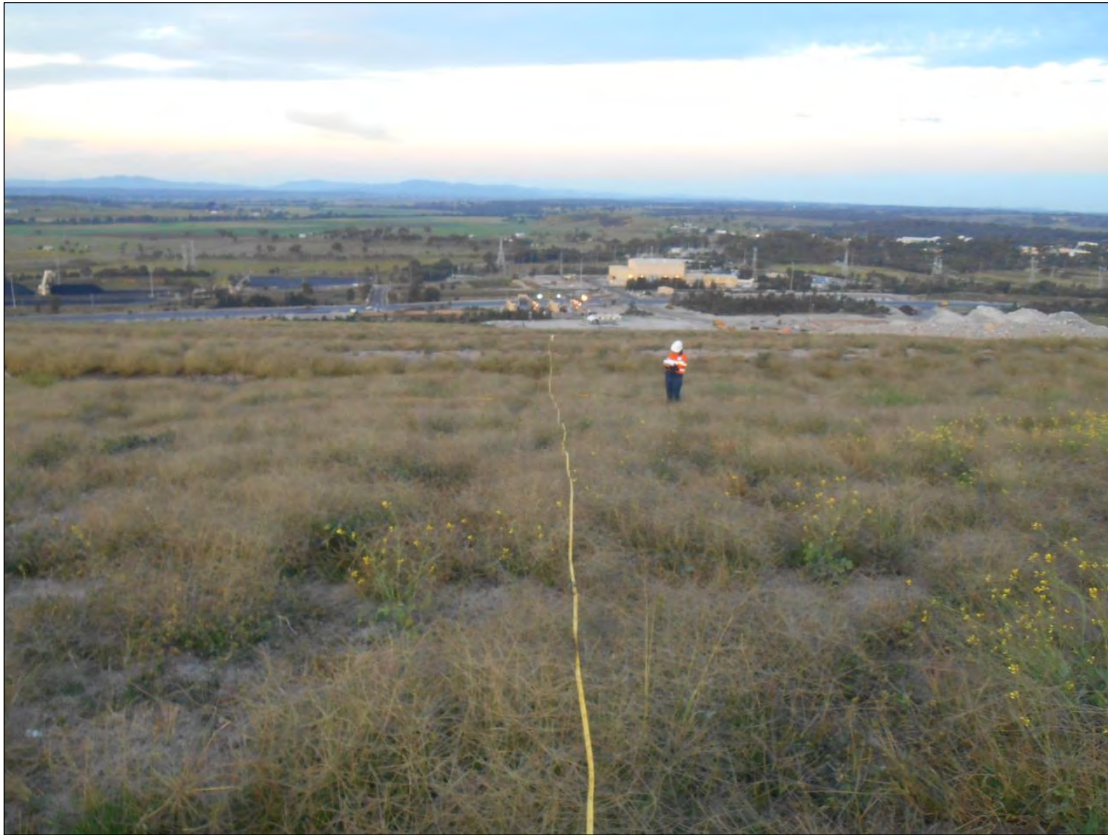
Start position 2017

Disturbance present at rehabilitation site MTWSPN201602 consisted mainly of weeds, and grazing by macropods. No evidence of fire was observed in the rehabilitation area. No areas containing rubbish were observed.

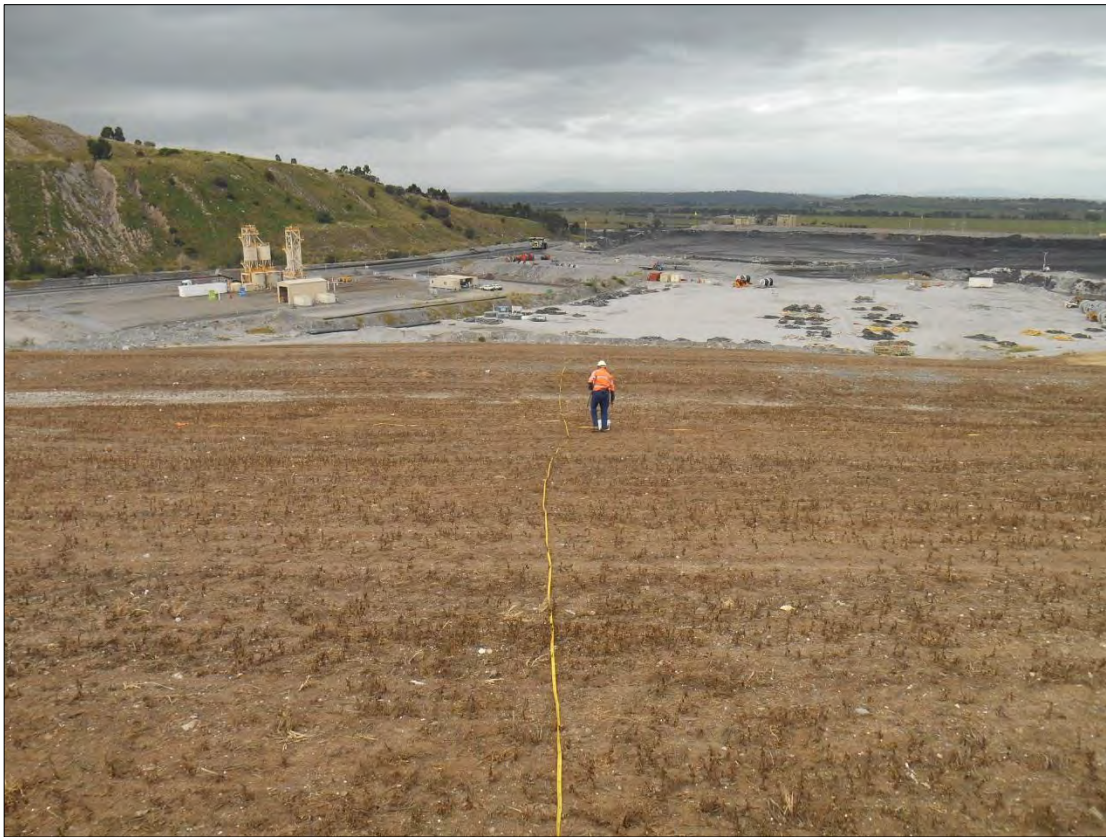
Start position 2017

It should be noted no natives or exotic species were recorded at MTWSPN201601.

Disturbance present at the rehabilitation site consisted mainly of weeds, and grazing by macropods. No evidence of fire was observed in the rehabilitation area. No areas containing rubbish were observed.

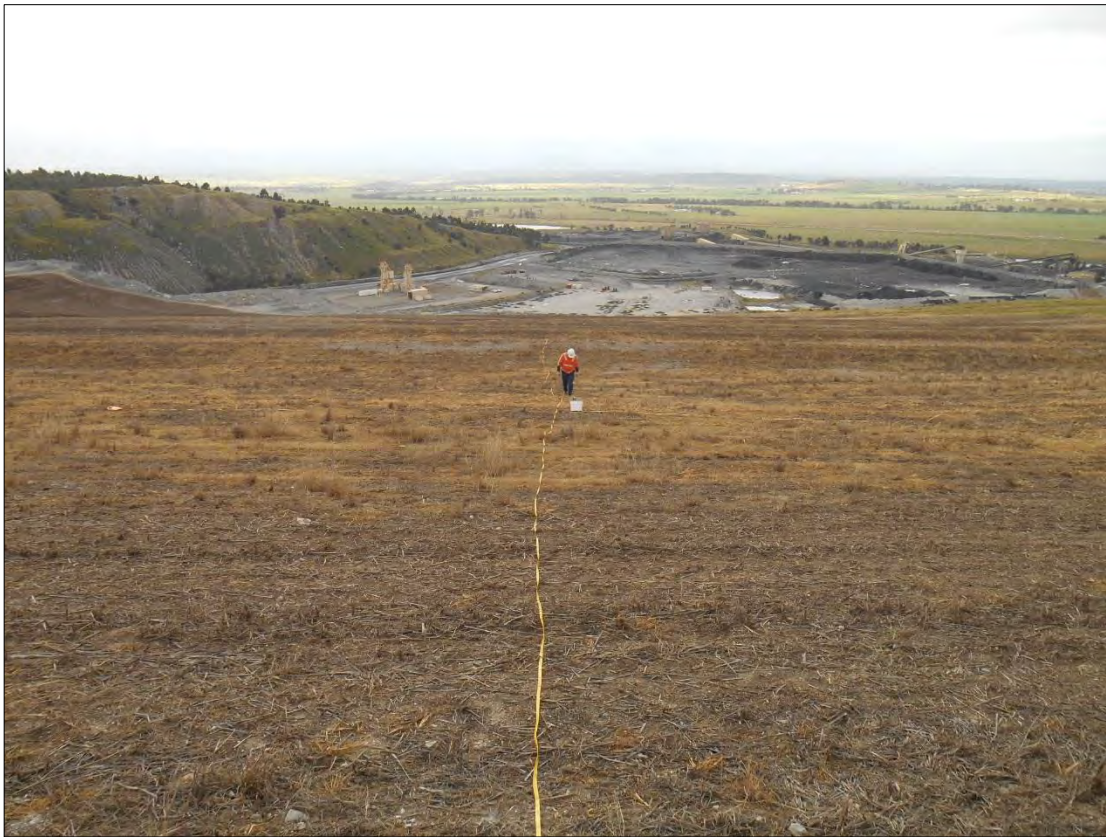
Start position 2017

It should be noted no native species were recorded at MTWSPN201501. One native species, *Chloris ventricosa*, was recorded which had been sprayed and was dead.

Disturbance present at the rehabilitation site consisted mainly of weeds, and grazing by macropods. No evidence of fire was observed in the rehabilitation area. No areas containing rubbish were observed.

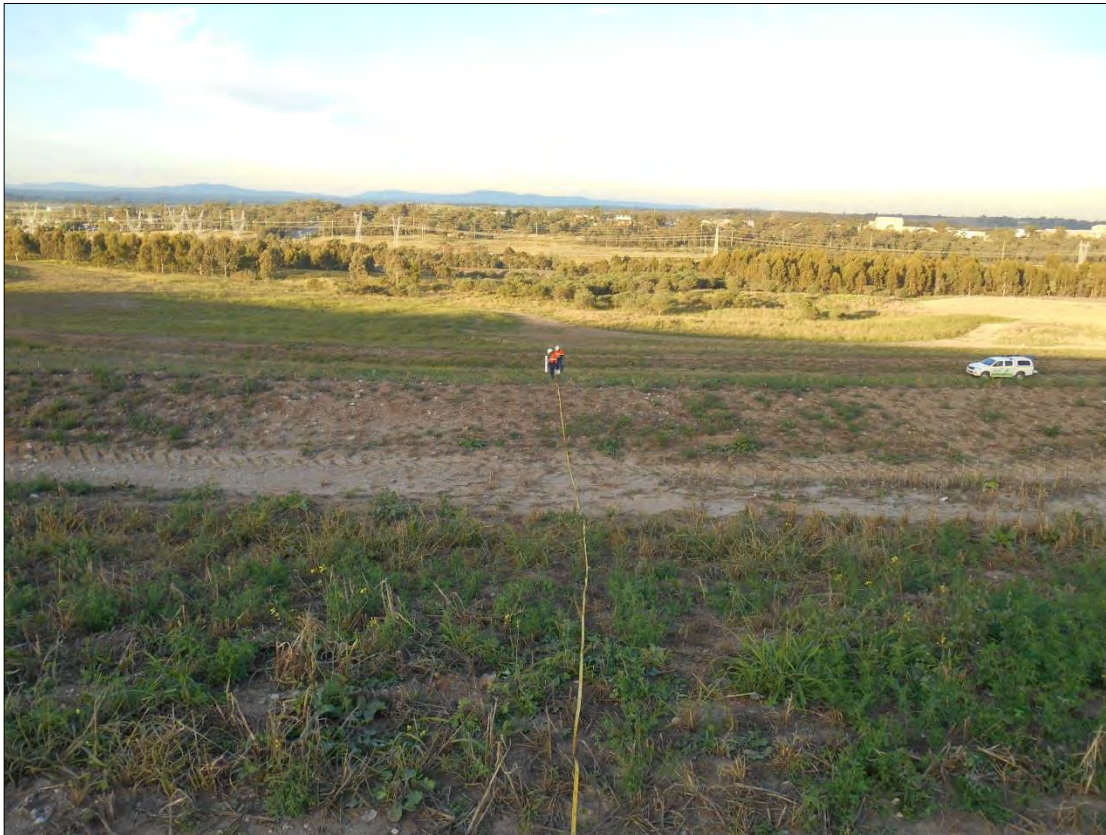
Start position 2017

Disturbance present at the site consisted mainly of weeds, and grazing by macropods. No evidence of fire was observed in the rehabilitation area. No areas containing rubbish were observed.

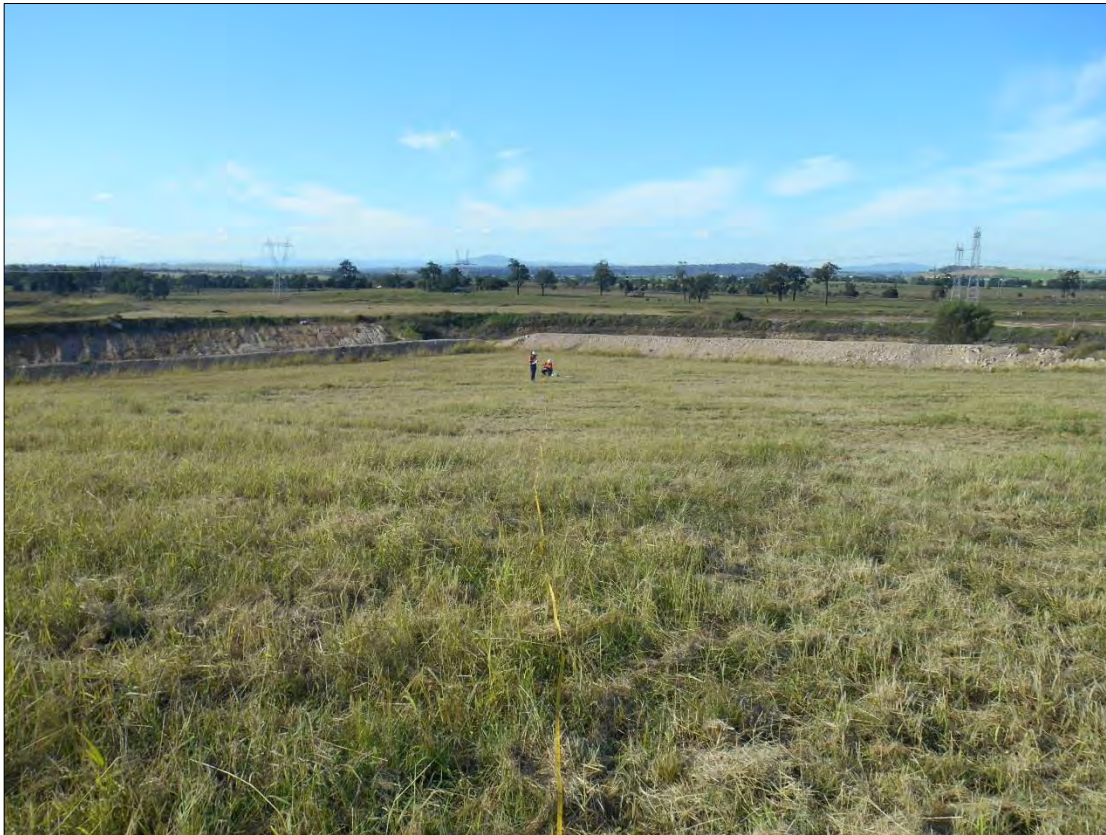
Start position 2016

Disturbance present at the rehabilitation site consisted mainly of weeds, and grazing by macropods. No evidence of fire was observed in the rehabilitation area. No areas containing rubbish were observed.

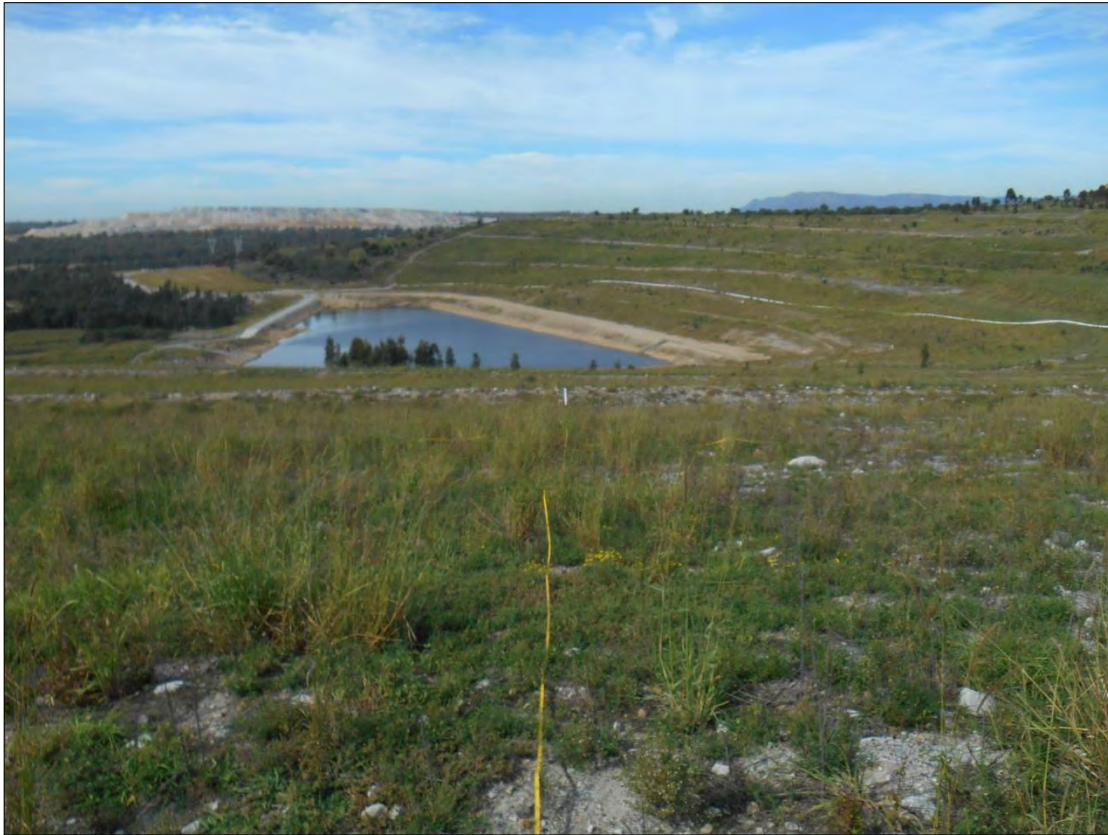
Start position 2017

Disturbance present at the site consisted mainly of weeds, and grazing by macropods. No evidence of fire was observed in the rehabilitation area. No areas containing rubbish were observed.

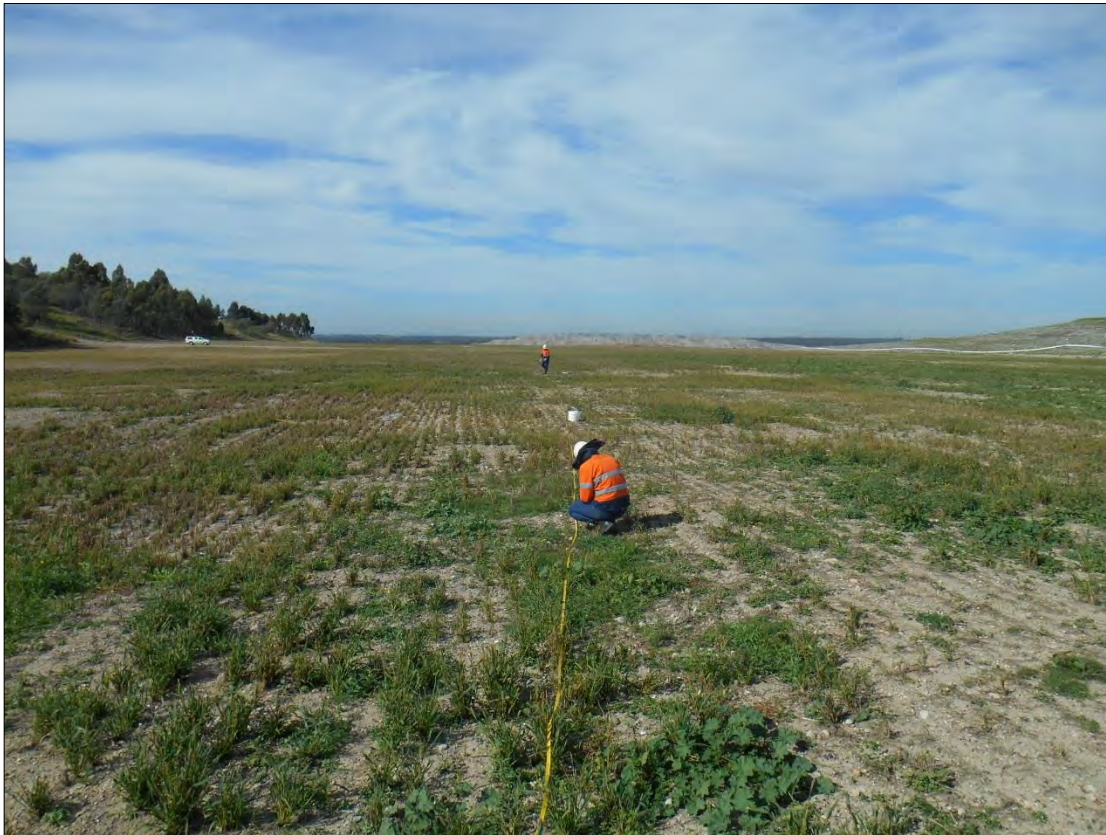
Start position 2017

Disturbance present at the site consisted mainly of weeds, and grazing by macropods. No evidence of fire was observed in the rehabilitation area. No areas containing rubbish were observed.
