**HUNTER VALLEY
OPERATIONS**

**MONTHLY
ENVIRONMENTAL
MONITORING REPORT
SEPTEMBER 2025**

DOCUMENT NUMBER
HVOOC-1797567310-5459

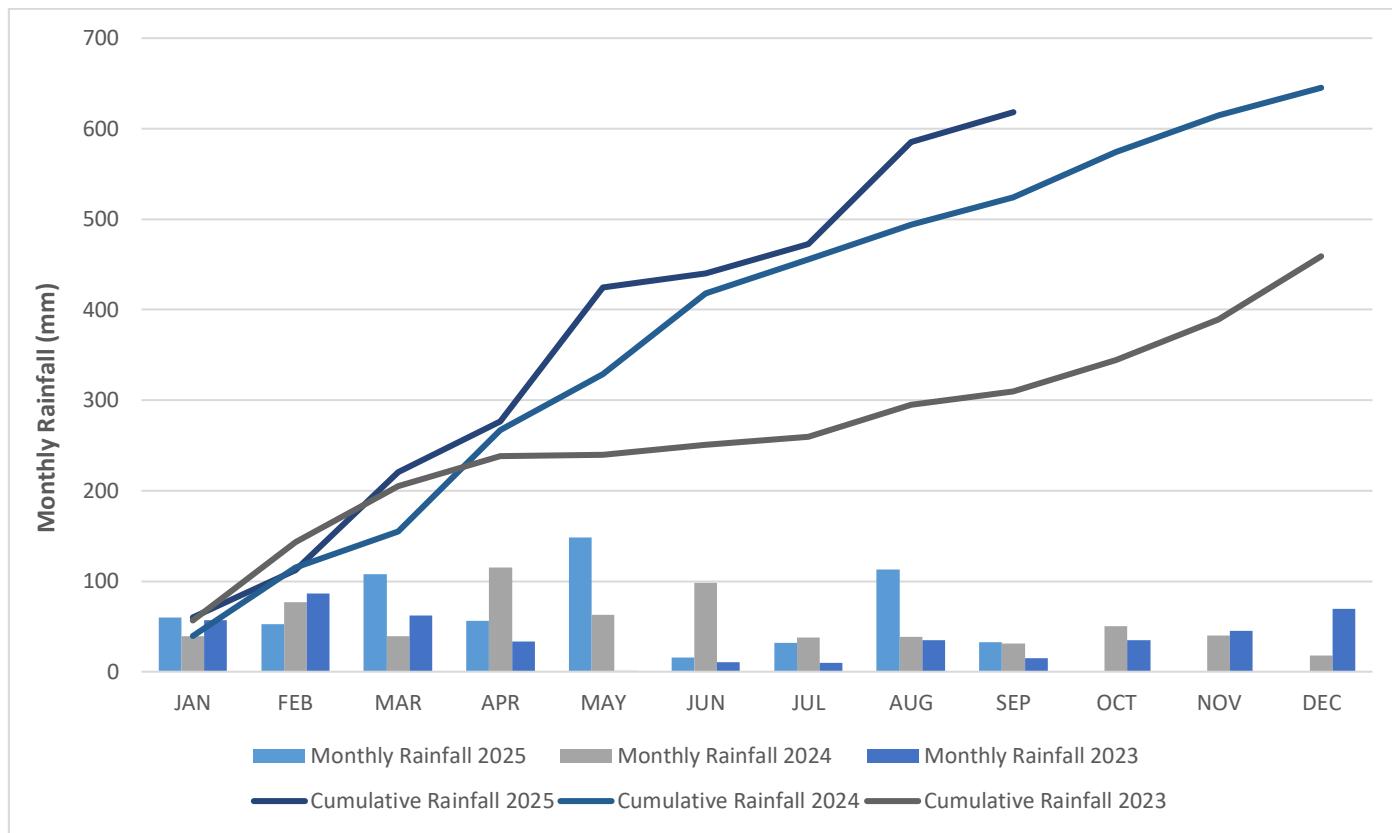
Figure 1 - Rainfall Summary 2023 – 2025

Rainfall recorded at the HVO Corporate weather station during the period is summarised in Table 1. The 2023, 2024 and 2025 trends are shown in Figure 1.

2025	Monthly Rainfall (mm)	Cumulative Rainfall (mm)
September	32.8	618.2

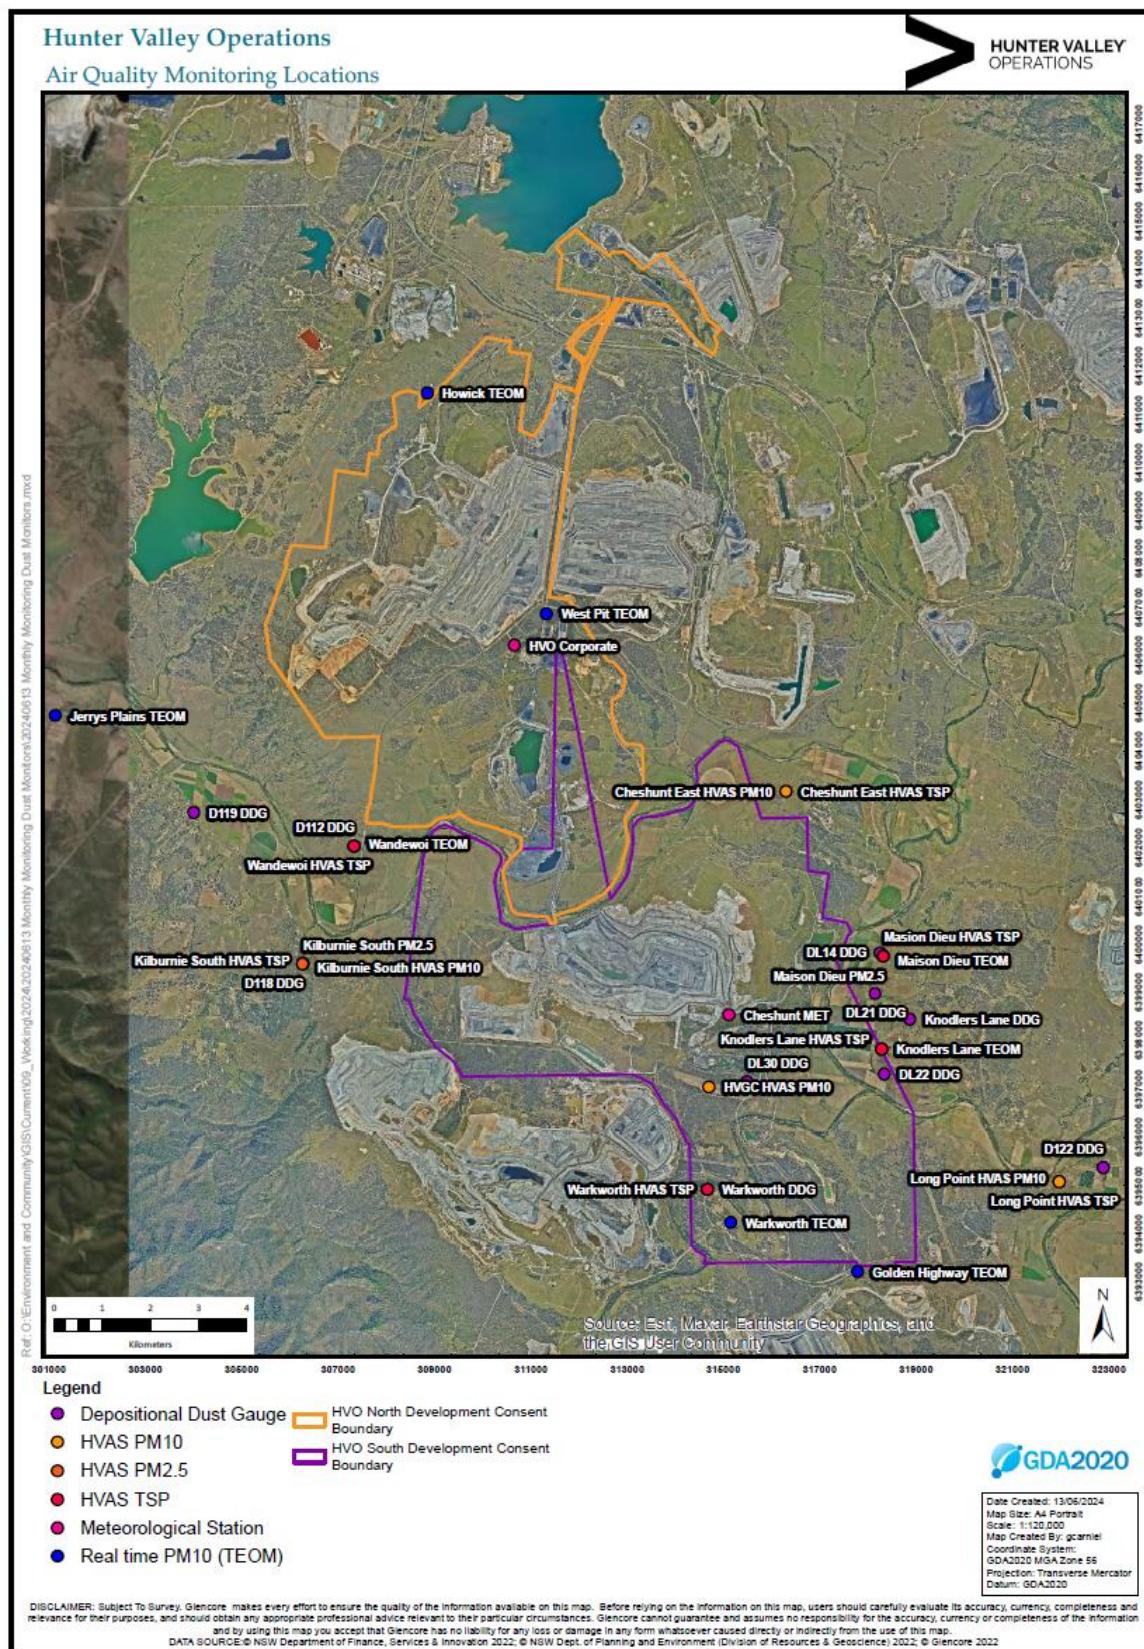
Figure 4 - Air Quality Monitoring Location Plan

HVO maintains two meteorological stations: ‘HVO Corporate’ and ‘Cheshunt’ (refer to Figure 4).

Suspended particles are measured by a network of High-Volume Air Samplers (HVAS) measuring Total Suspended Particulates (TSP) and Particulate Matter $<10\mu\text{m}$ (PM_{10}). The Kilburnie South (Moses Crossing) and Maison Dieu HVAS also monitor Particulate Matter $<2.5\mu\text{m}$ ($\text{PM}_{2.5}$). The location of these monitors is presented in **Figure 4**. Each HVAS runs for 24-hours on a six-day cycle.

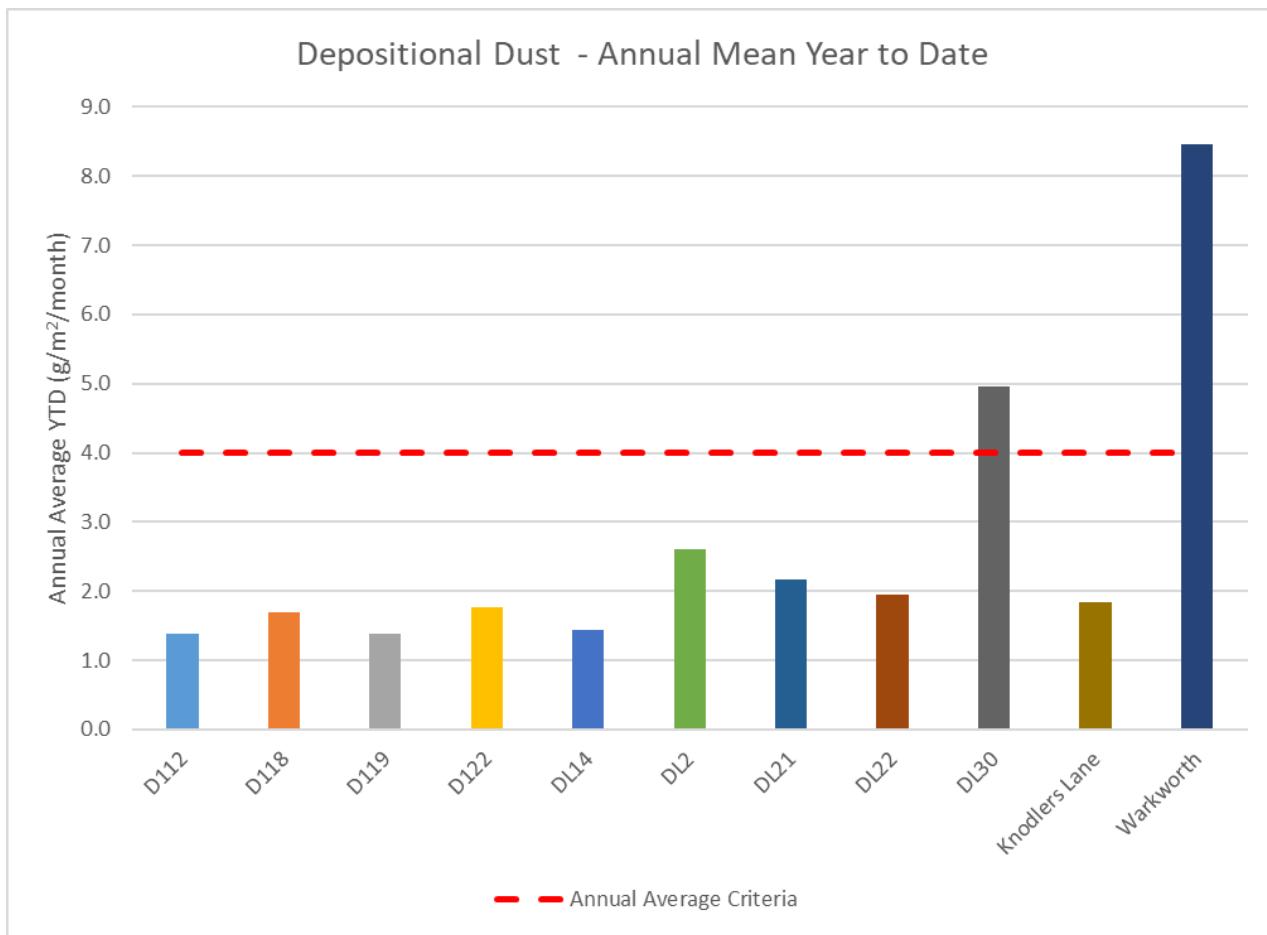
Figure 5 - Depositional Dust Results for the Reporting Period

Figure 5. displays insoluble solids results from depositional dust gauges during the reporting period compared against the annual impact assessment criteria. Any monthly results deemed to be contaminated (due to presence of bird droppings, insects, etc.) are not displayed. An assessment of HVO's contribution against the long-term impact assessment criteria will be provided in the 2025 Annual Review.

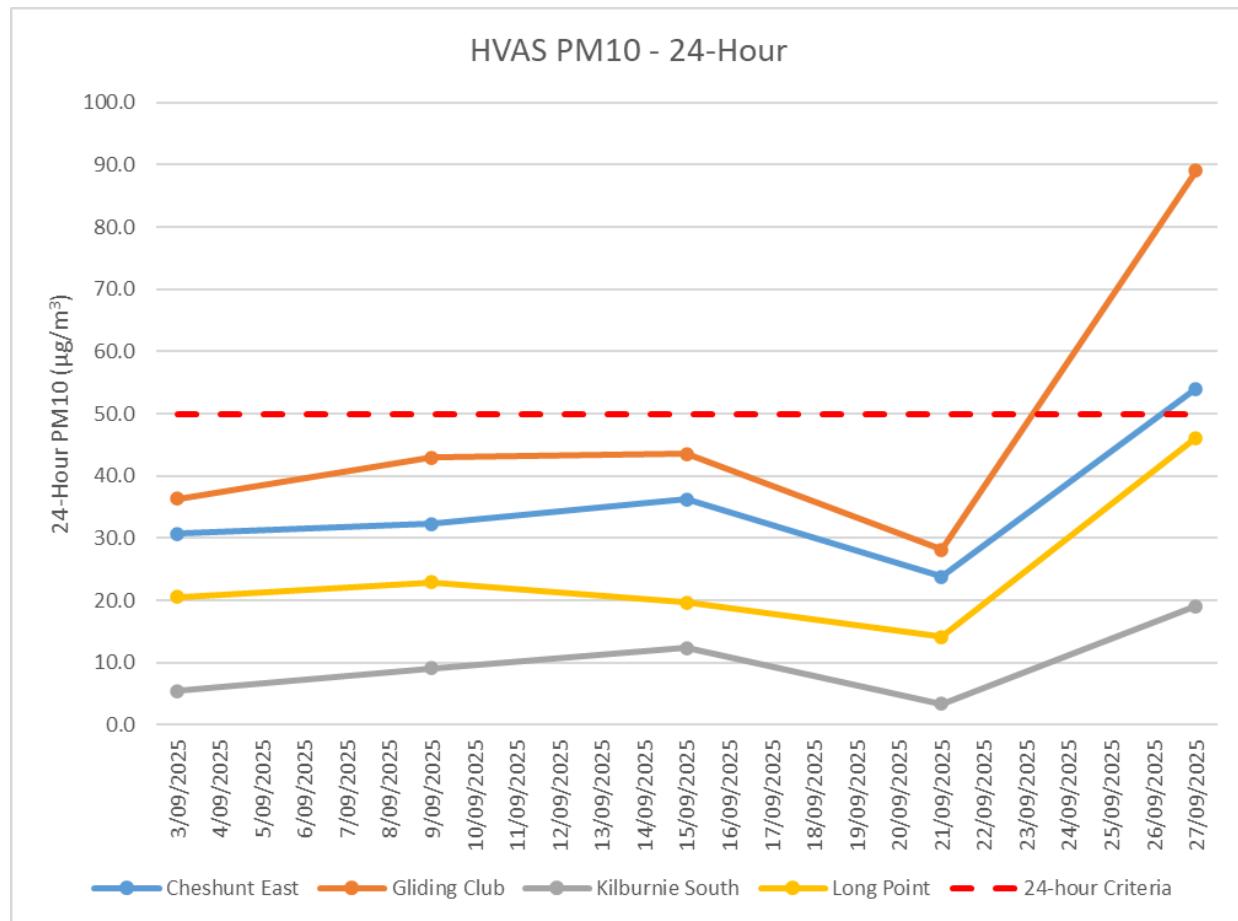
Figure 6 - Individual PM_{10} Results for the Reporting Period

Figure 6 shows individual PM_{10} results at each monitoring station against the short-term impact assessment criteria of $50\mu\text{g}/\text{m}^3$. All monitors were below the short-term impact assessment criteria during the reporting period, with the exception of Gliding Club and Cheshunt East on the 27th of September. These potential exceedances were investigated by a third party and found that the maximum calculated HVO contributions, where applicable, were below the compliance limits.

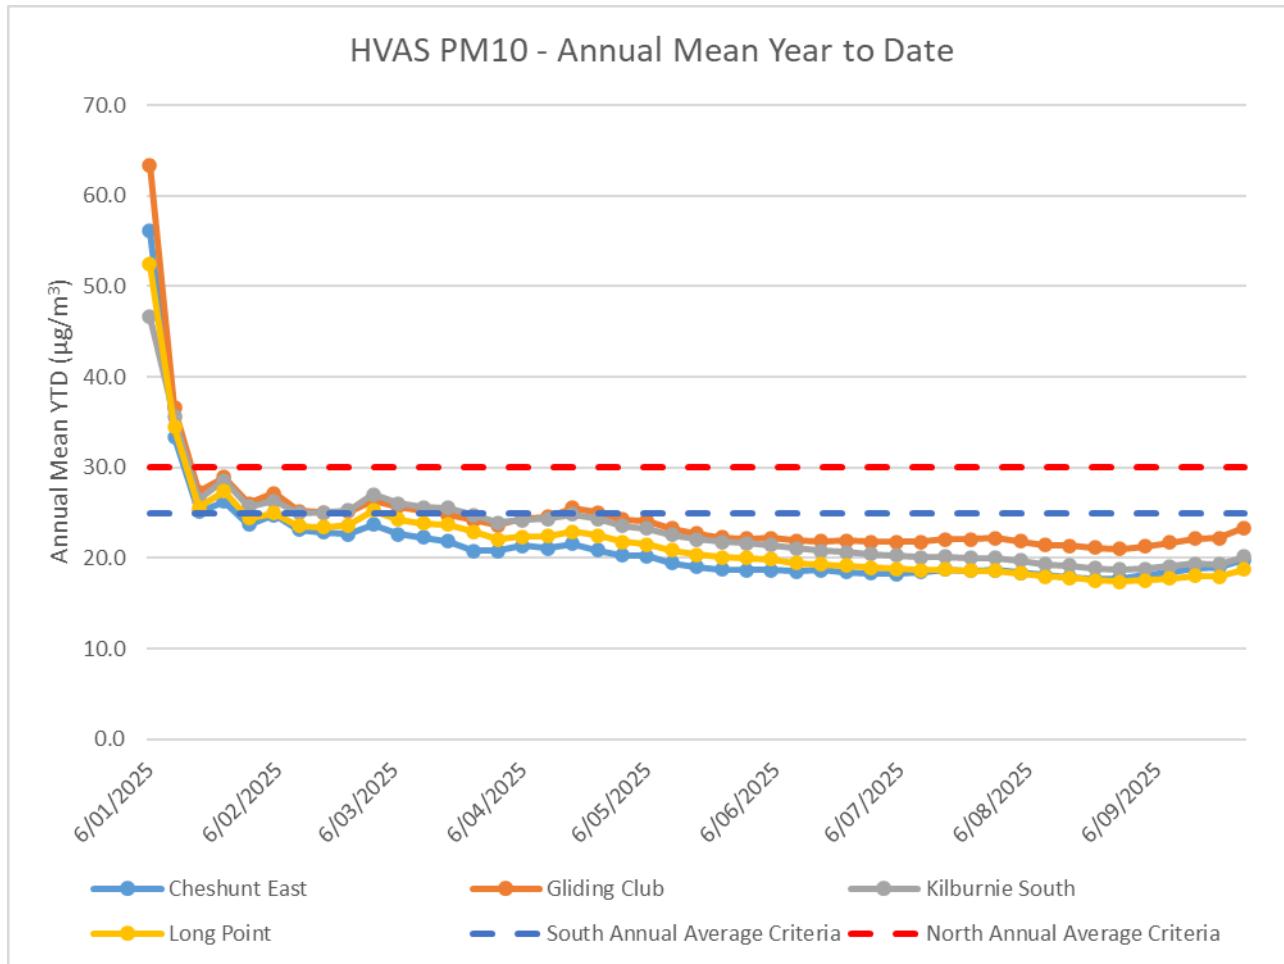
Figure 7 - Year to Date Average PM₁₀ as at end of the Reporting Period

Figure 7 shows the year-to-date annual average PM₁₀ results. All monitors were below the relevant long term impact assessment criteria during the reporting period.

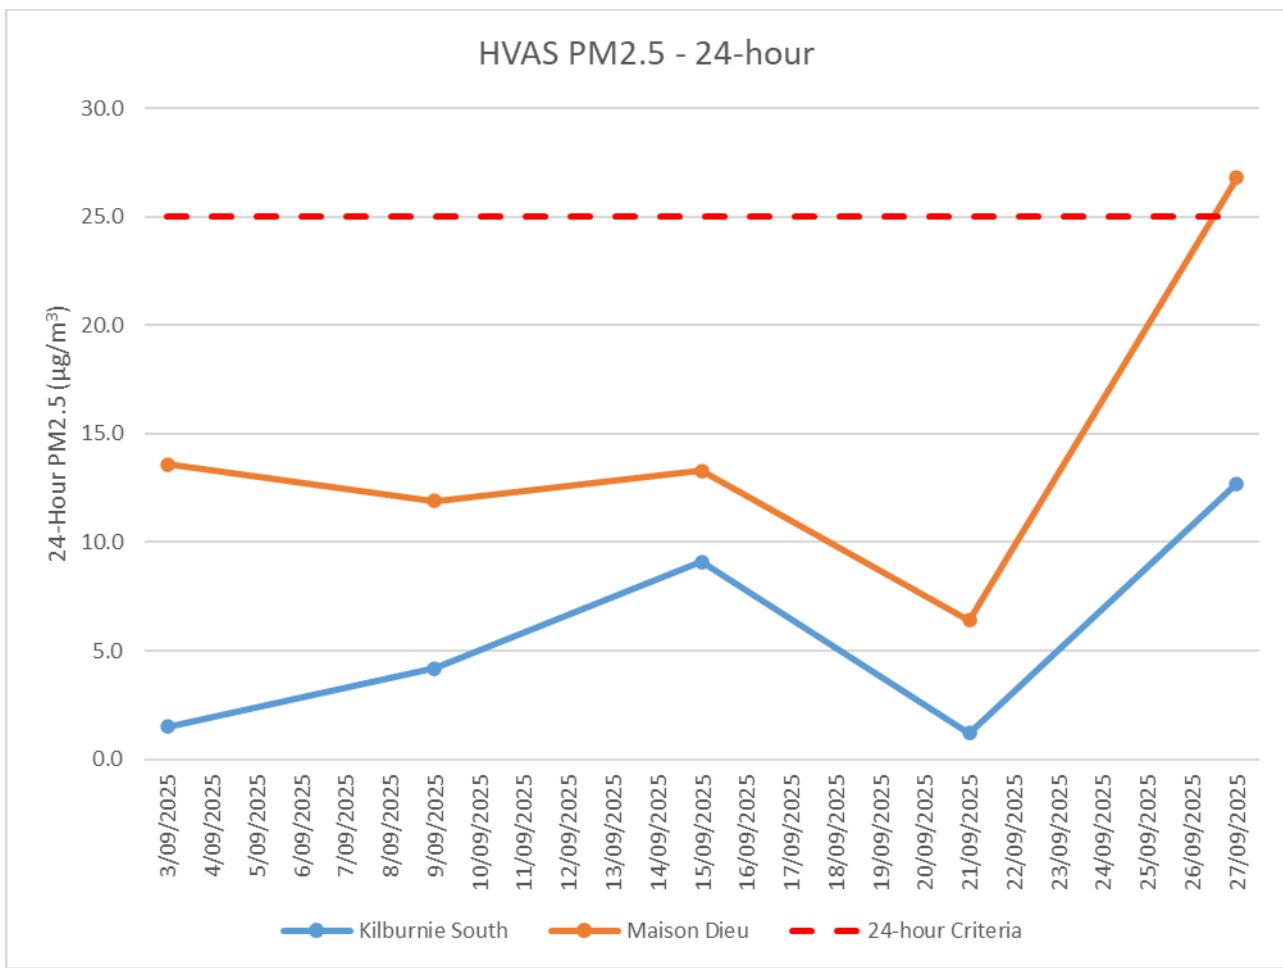
Figure 8 - Results for the Reporting Period

Figure 8 shows individual PM_{2.5} results at each monitoring station against the HVO South short-term impact assessment criteria of 25 $\mu\text{g}/\text{m}^3$. Both monitors were below the relevant short-term impact assessment criteria during the reporting period, with the exception of Maison Dieu on the 27th of September. This exceedance was investigated internally by HVO and it was found that the maximum calculated HVO contribution was below the compliance limit.

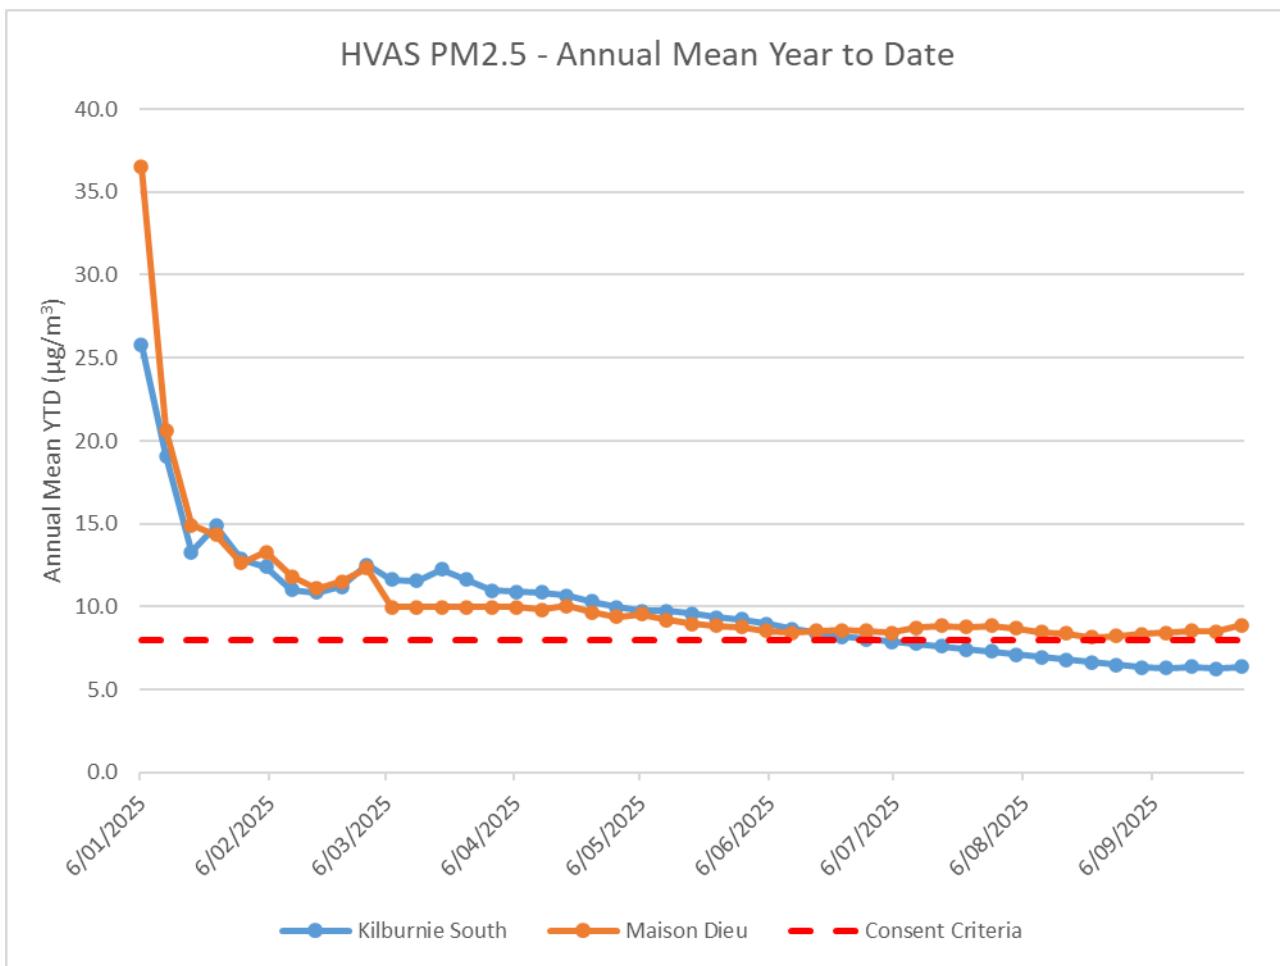
Figure 9 - Year to Date Average PM_{2.5} as at end of the Reporting Period

Figure 9 shows the year-to-date annual average PM_{2.5} results. During the reporting period, the annual average year to date results show Kilburnie South below the PM_{2.5} annual rolling mean and Maison Dieu above the PM_{2.5} annual rolling mean criteria of 8µg/m³.

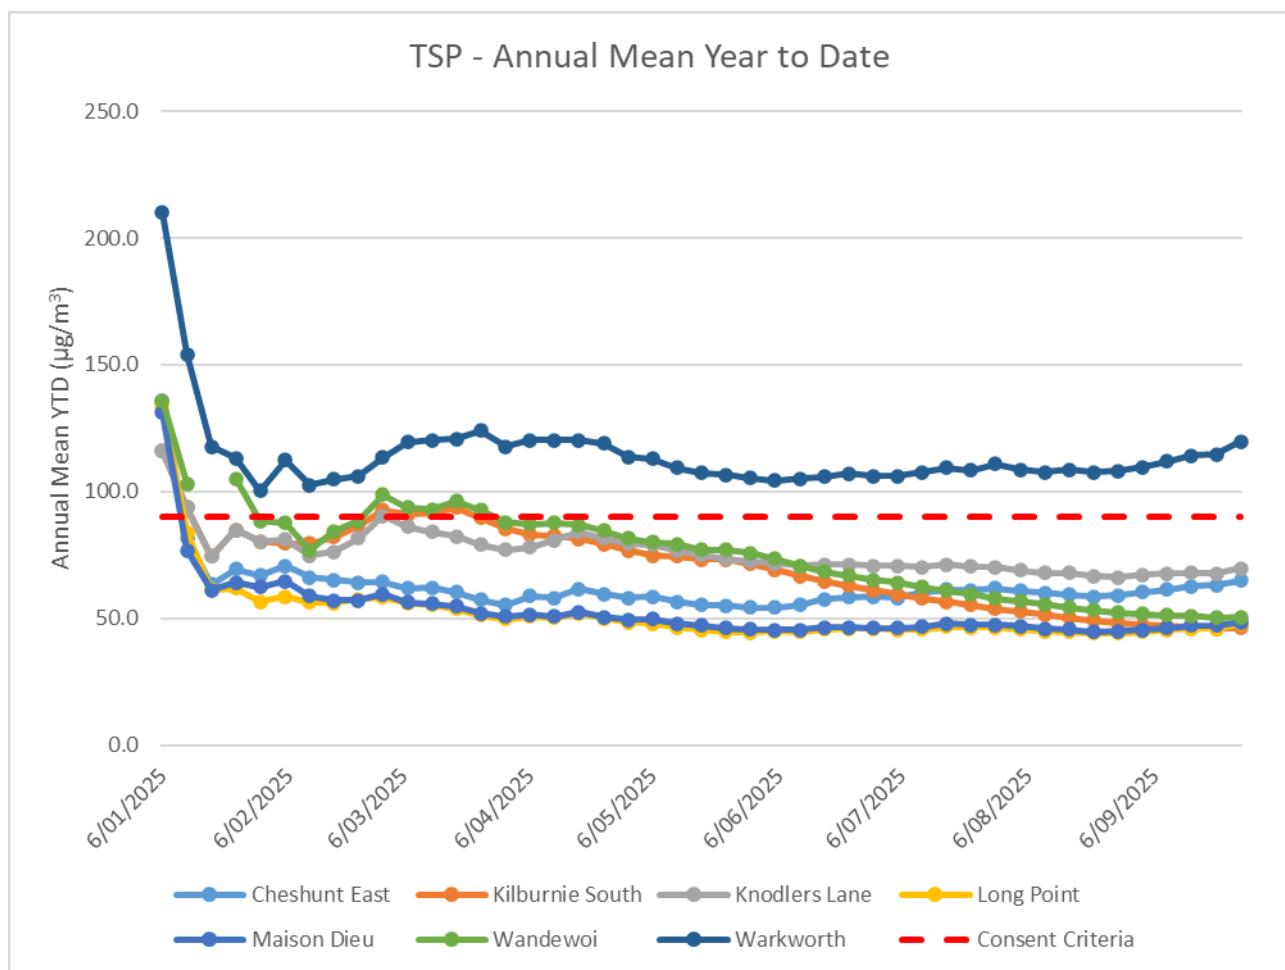
Figure 10 - Year to Date Average Total Suspended Particulates as at end of the Reporting Period

Figure 10 shows the annual average TSP results compared against the long-term impact assessment criteria of 90 $\mu\text{g}/\text{m}^3$.

Six of the seven monitors were below the relevant long-term impact assessment criteria during the reporting period. The Warkworth monitor was greater than the long-term impact assessment criteria during the reporting period.

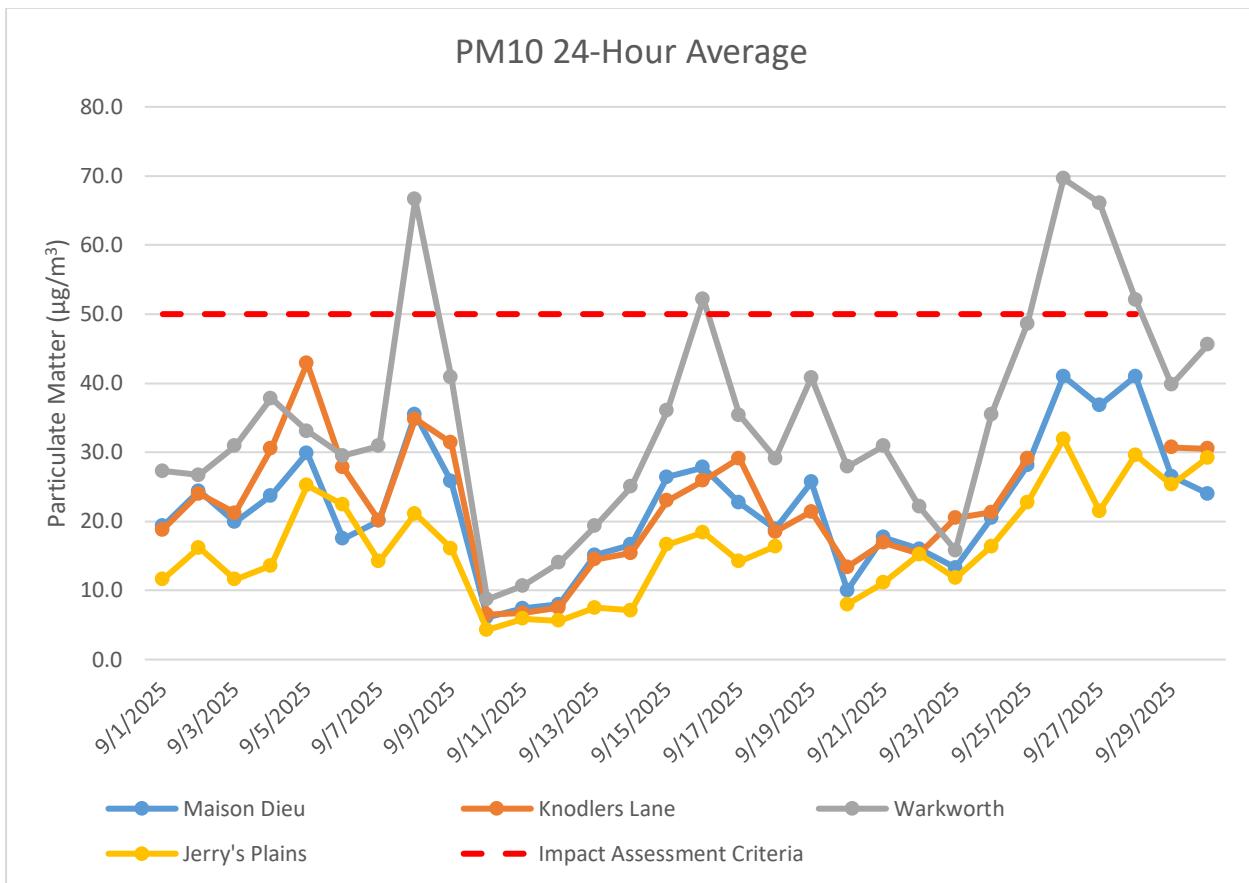
Figure 11 - Real Time PM₁₀ 24hr for the Reporting Period

Figure 11 shows the daily 24-hour average PM₁₀ result from the real time monitoring sites. During the reporting period, daily results were below the 24-hr average criteria of 50µg/m³ with the exception of:

- Warkworth on 8, 16, 26, 27 and 28 September

These exceedances were investigated internally by HVO and found that the maximum calculated HVO contribution was below the compliance limit.

The below listed monitors reported data capture rates of less than 75% on the respective dates, therefore these results are not displayed on Figure 11.

- Jerrys Plains on 19 September.
- Knodlers Lane on 26, 27 and 28 September.

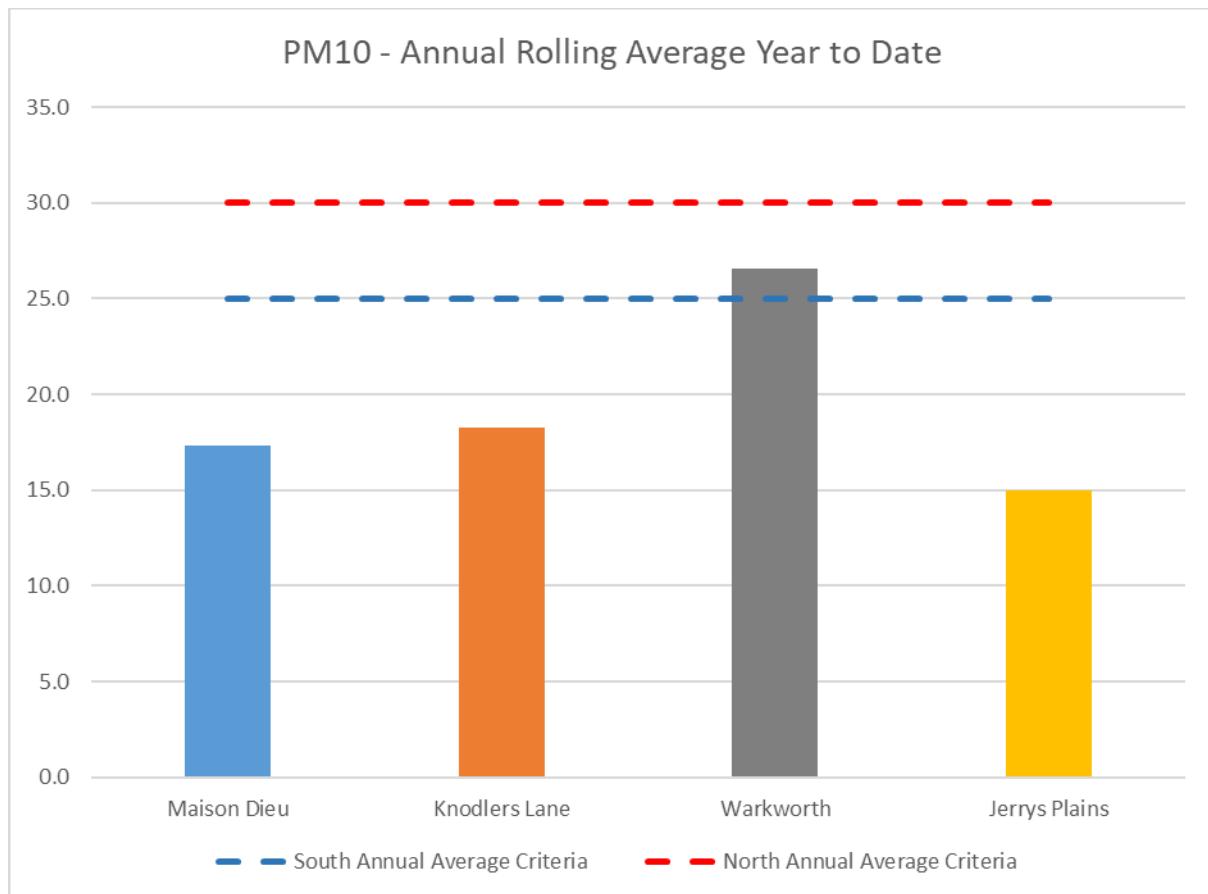
Figure 12 - Real Time PM₁₀ Annual Average for the Reporting Period

Figure 12 shows the annual rolling average PM₁₀ results from the real time monitoring sites. The annual average results for all monitors were below the relevant long-term impact assessment criterias for the reporting period, with the exception of Warkworth that is currently above the South annual rolling average but below the North annual rolling average.

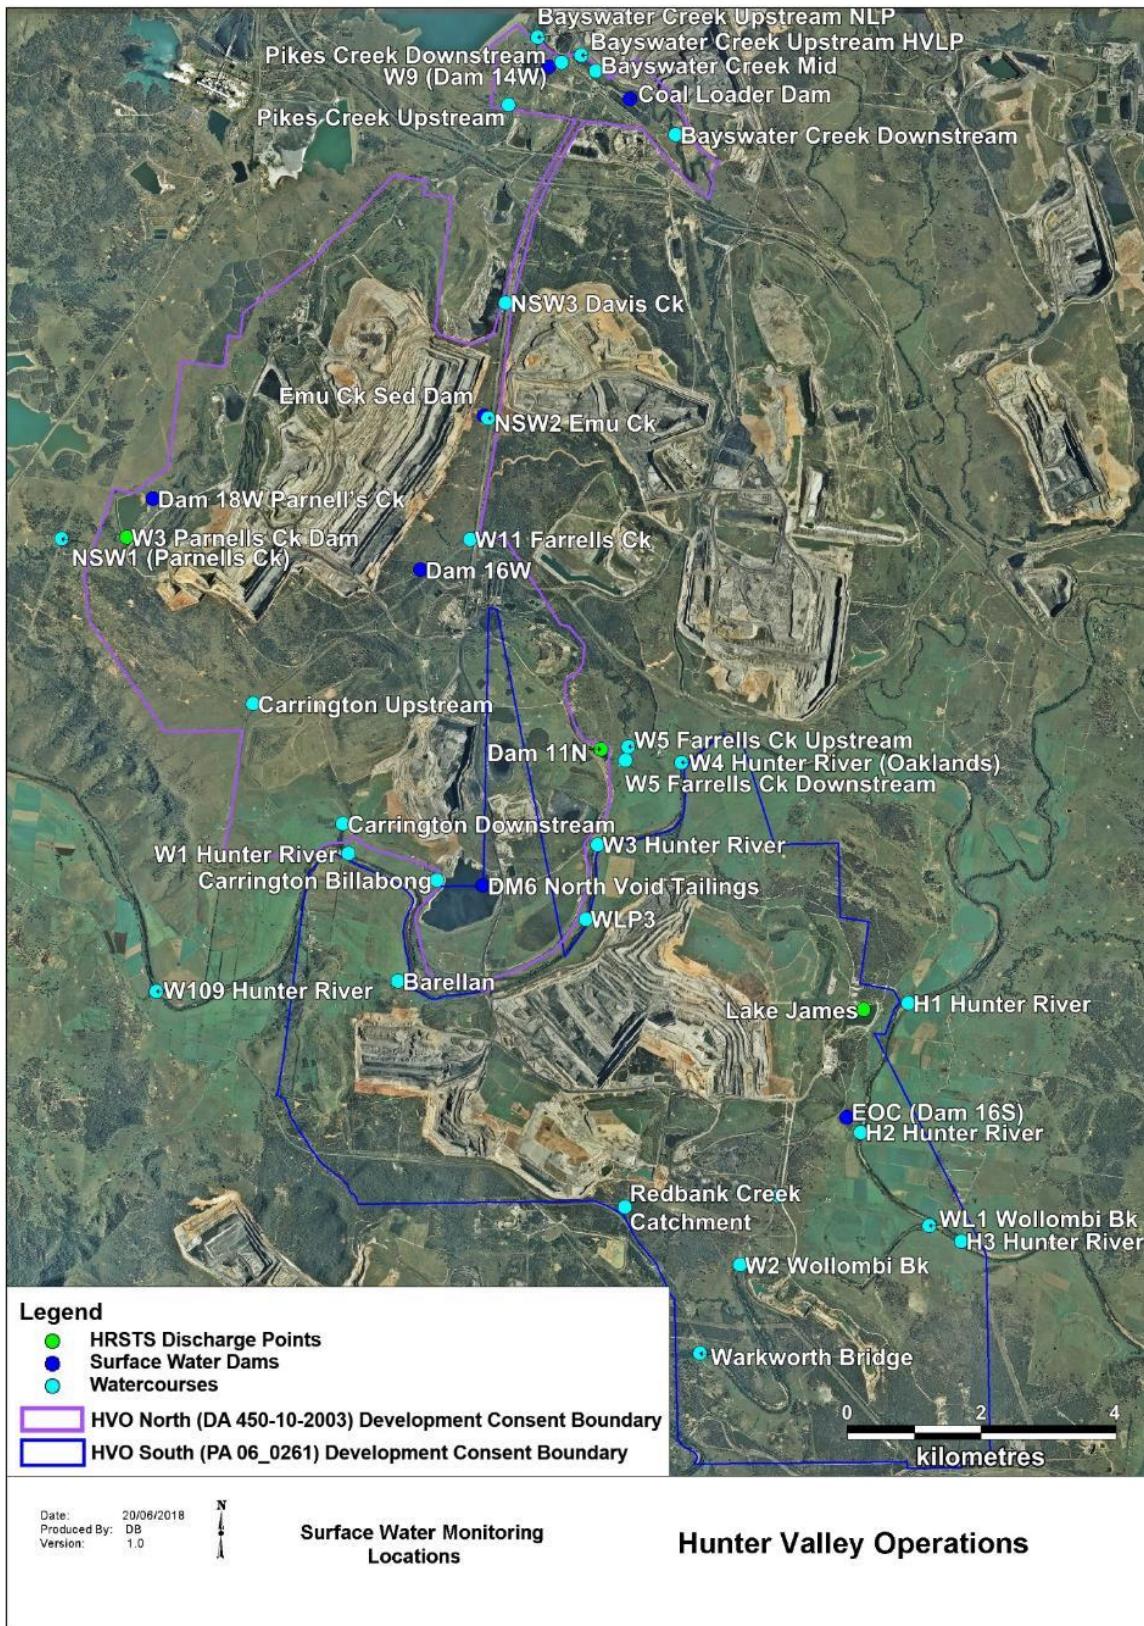
Figure 13 - HVO Surface Water Monitoring Locations

Surface watercourses are sampled on a quarterly sampling regime. Water quality is assessed through the parameters of pH, electrical conductivity (EC) and Total Suspended Solids (TSS). The location of surface water monitoring points across HVO is shown in **Figure 13**.

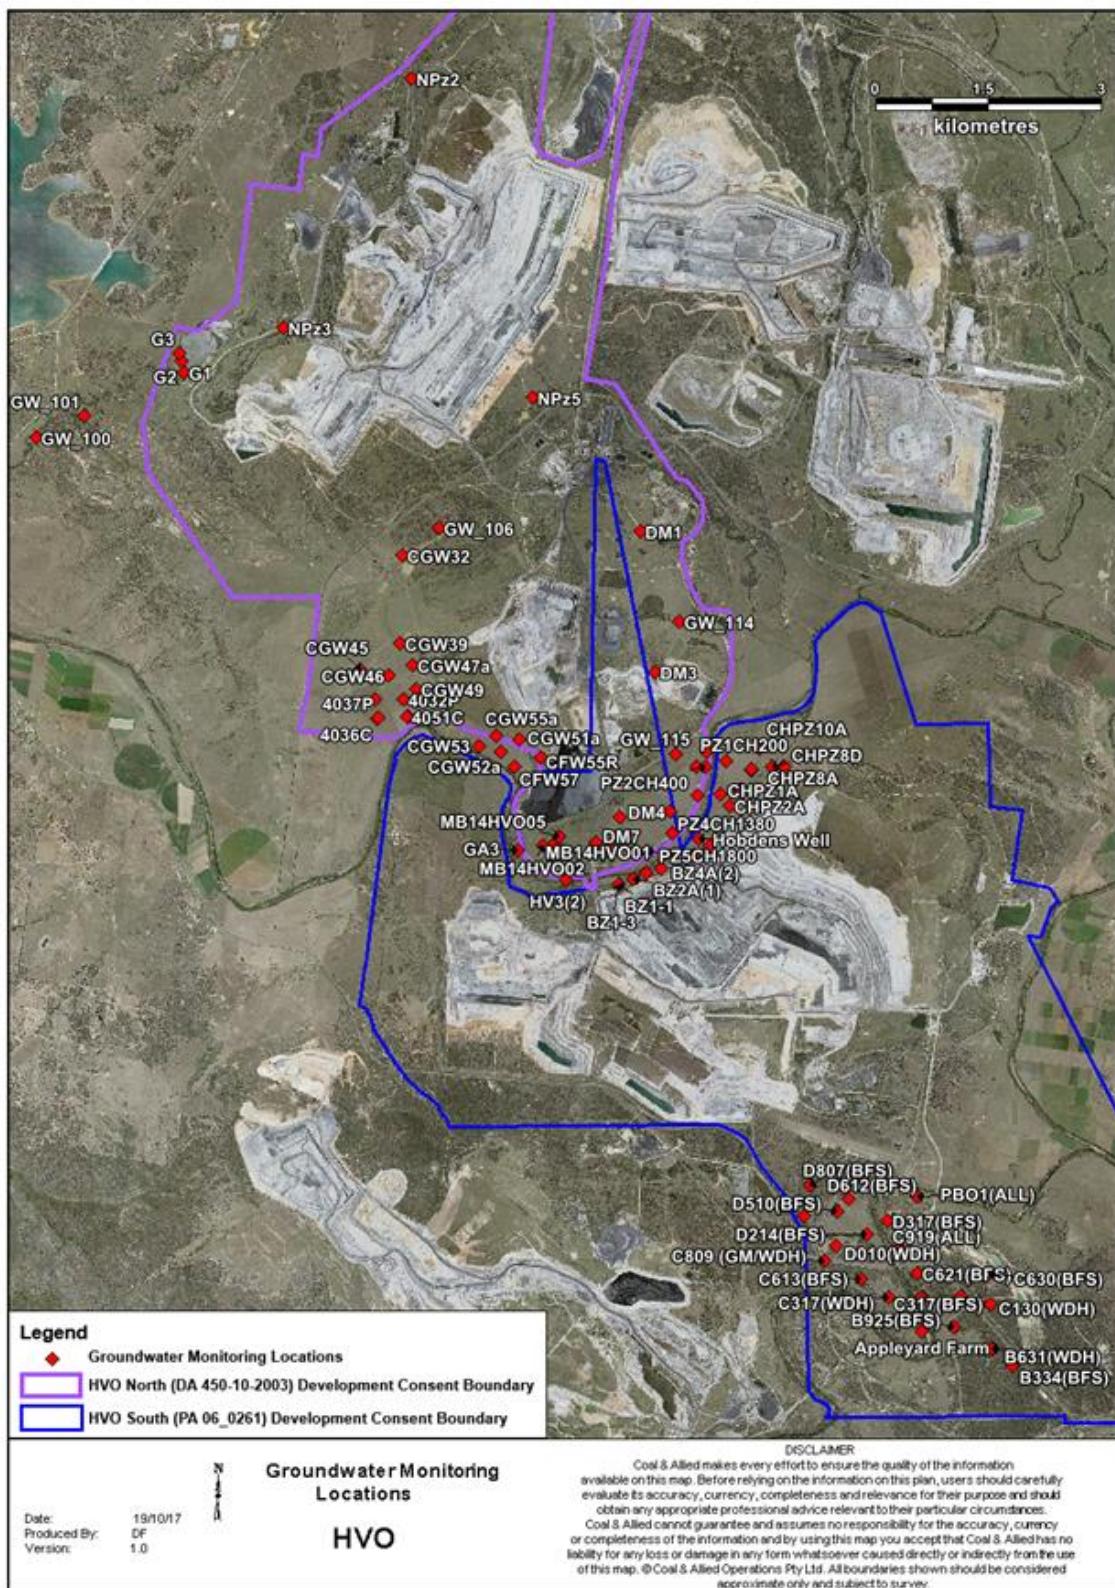
Figure 26 - Groundwater Monitoring Locations at HVO

Groundwater monitoring is undertaken on a quarterly basis in accordance with the HVO Water Management Plan and Groundwater Monitoring Programme. The location of groundwater monitoring points across HVO are show in **Figure 26**.

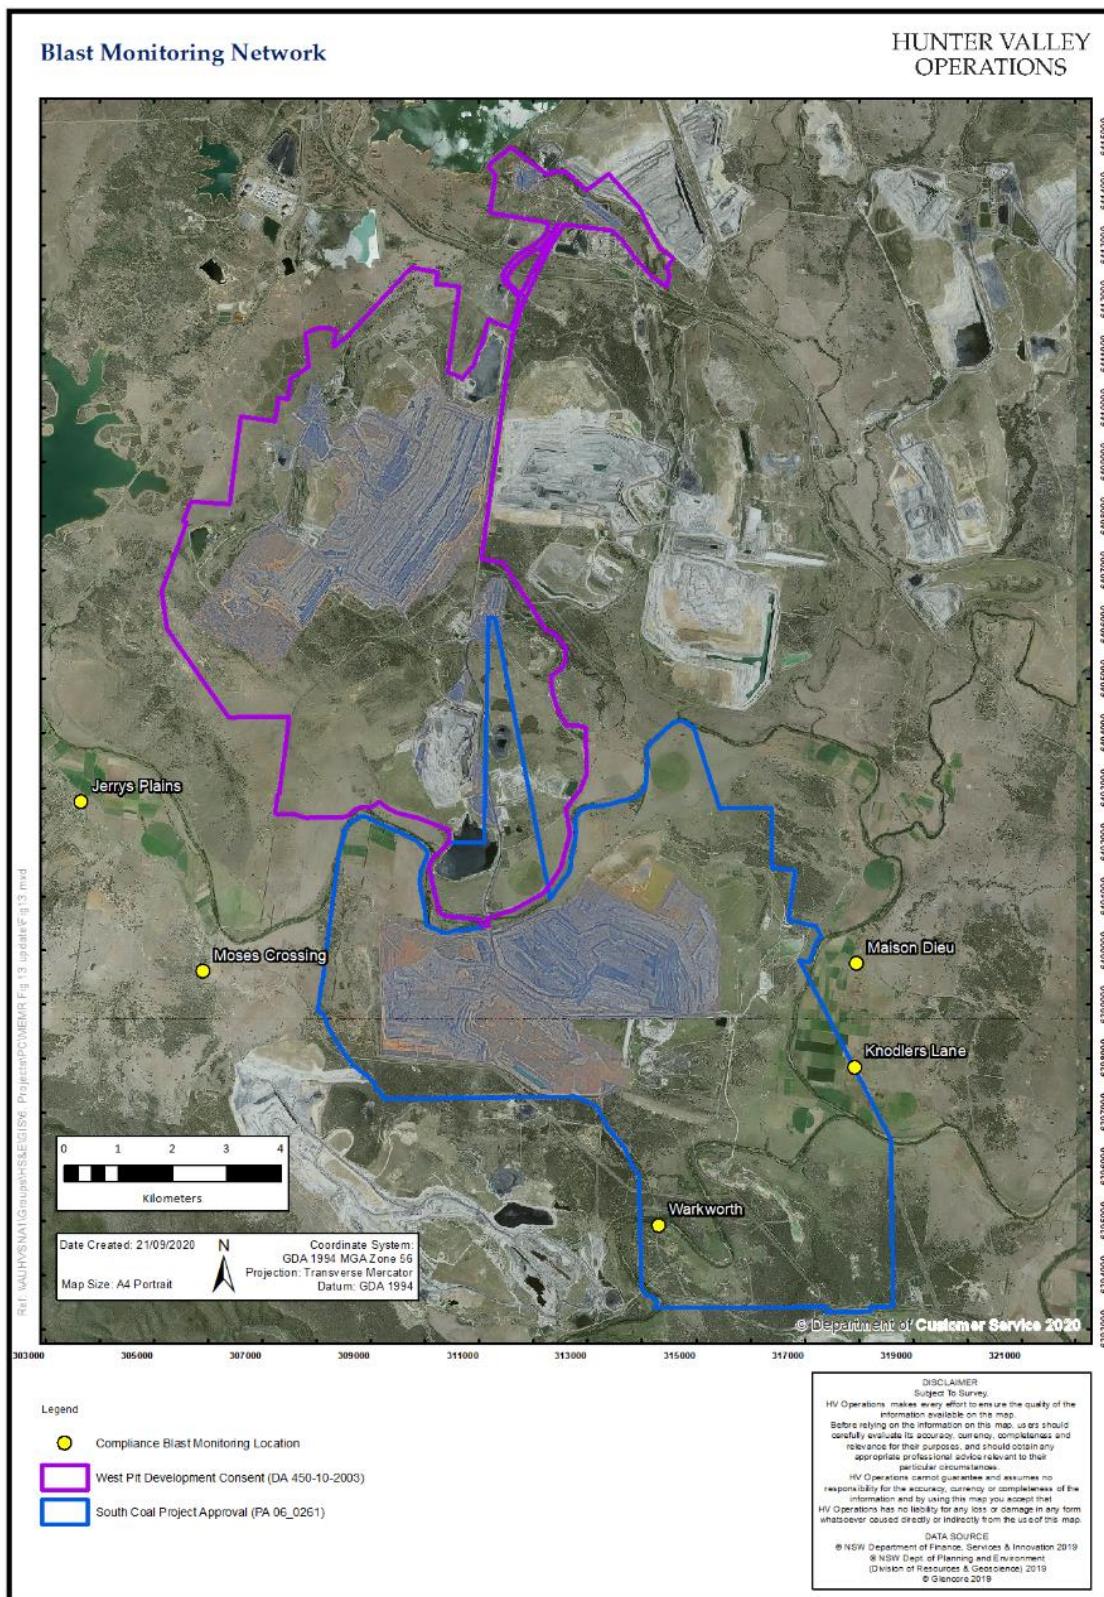
Figure 78 - Blast Monitoring Location Plan

HVO maintains a network of blast monitoring units located at nearby privately owned residences and function as regulatory compliance monitors. The location of these monitors can be found in **Figure 78**. Blasting criteria for HVO are summarised in **Table 4**.

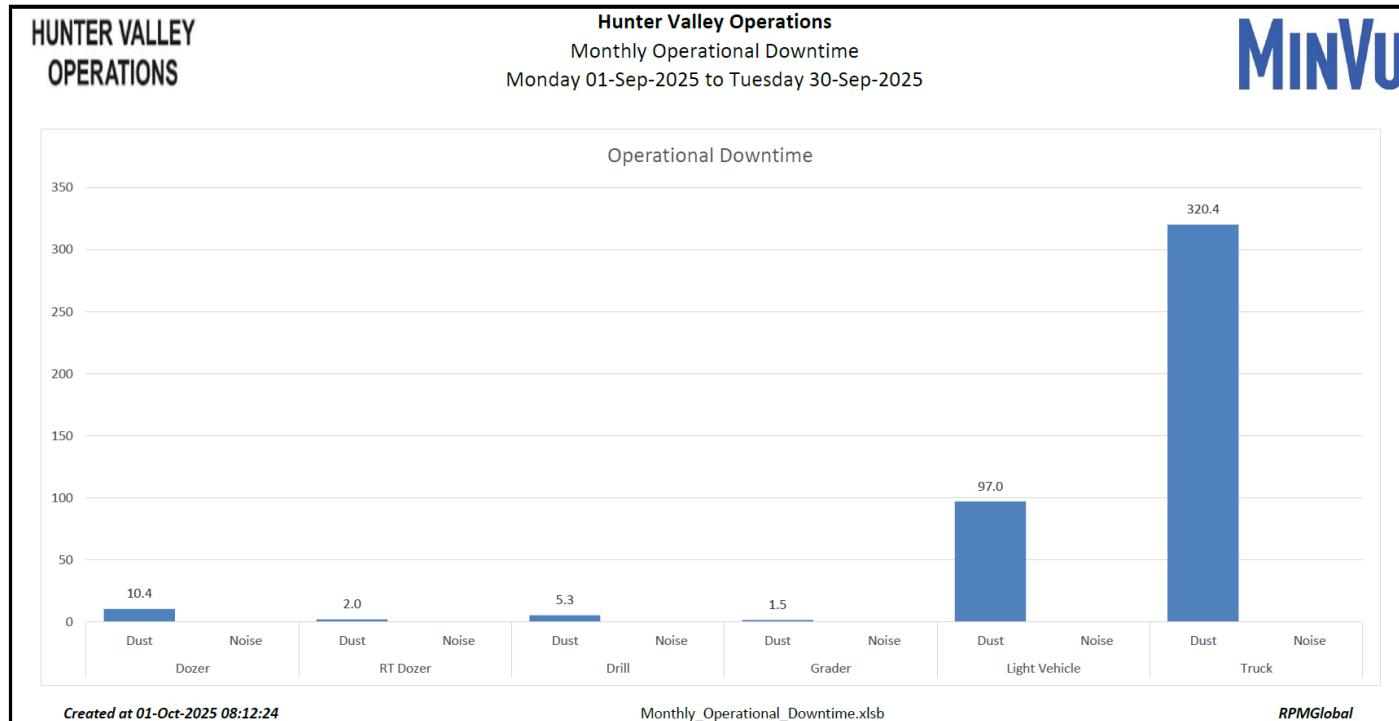
Figure 80 - Operational Downtime by Equipment Type for the Reporting Period

Operational downtime by equipment type is show in Figure 80. Note that these delays are instances where operations were completely stopped and does not include occasions where operations were changed/modified but not stopped (e.g. changed from exposed dump to in-pit dump).

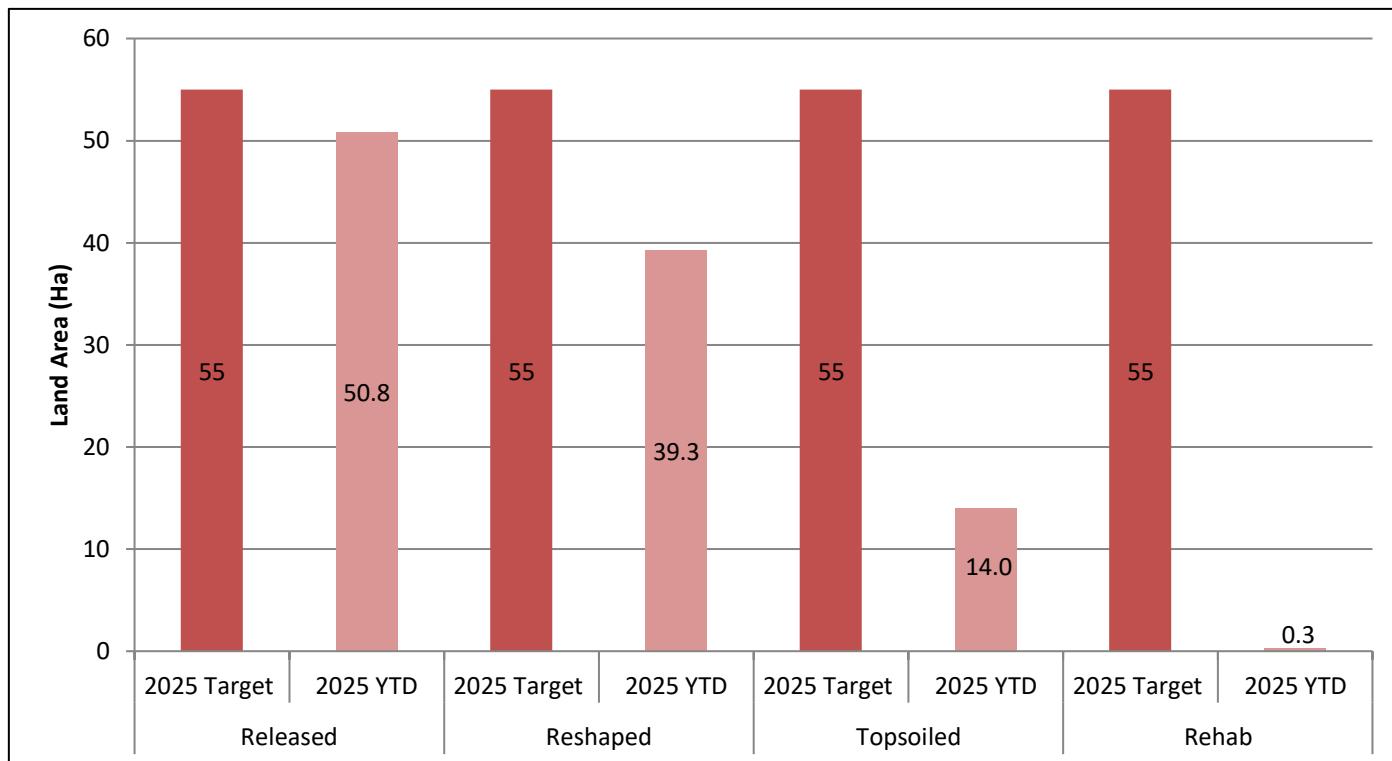
Figure 81 - Rehabilitation YTD September 2025

Year to date progress is shown in **Figure 81**.
