2014 Hunter Valley Operations Annual Environmental Review

March 2015

This Annual Environmental Review (Annual Review) reports on the environmental performance of Hunter Valley Operations (HVO) during the 2014 calendar year and satisfies the requirements of the Hunter Valley Operations (HVO) Development Consents and Mining Leases. The structure of the 2014 Annual Review intends to align with the NSW Department of Trade and Investment *EDG03 Guidelines to the Mining, Rehabilitation and Environmental Management Process* and the NSW Department of Planning and Infrastructure Draft *Guideline for Preparation of Annual Environmental Management Review (AEMR) December 2012*.

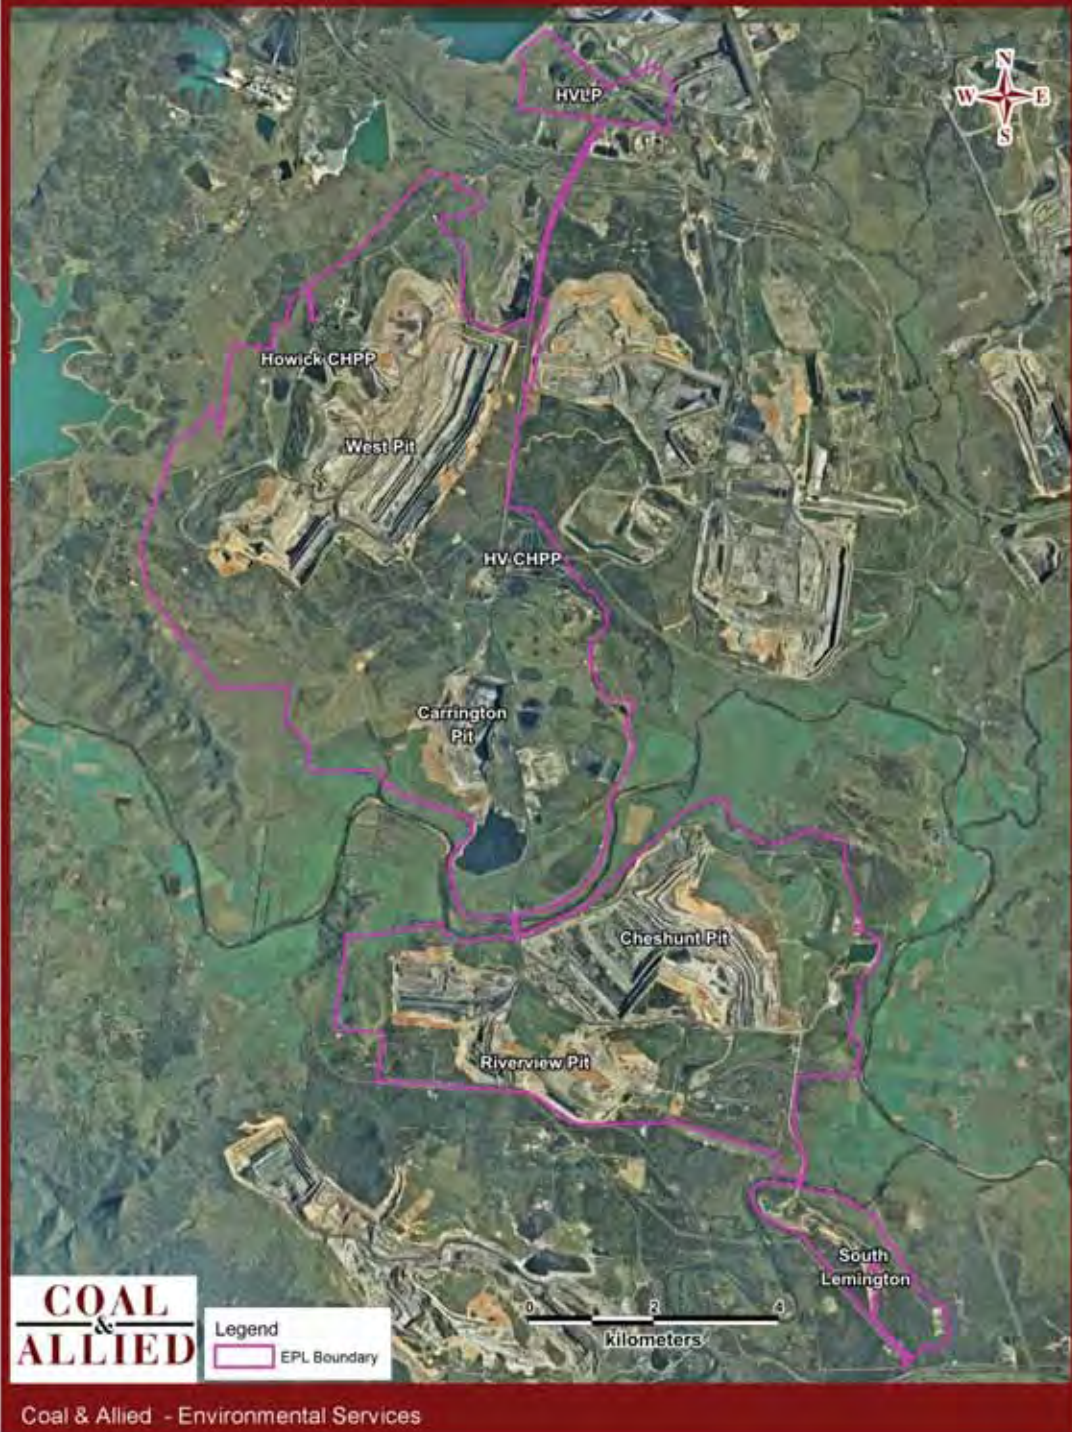
Figure 1: Site Layout

Carrington Pit		Carrington Pit is located on the western boundary of North Pit and commenced operations in November 2000. The seams mined are the Broonies and Bayswater. The pit has consent to mine up to 10 mtpa ROM coal, with all seams dipping at an average of three degrees to the south east. The overburden to product coal ratio averages 5.8:1.
South Pit (previously Lemington Pit and South Pit or Hunter Valley Number 2)	Incorporating the new Cheshunt Development and the former Lemington Pit, as well as the Riverview Pit	<p>Cheshunt Pit incorporates the former Lemington North Pit, where the new strip alignment commenced in November 2001. Seams mined in the Cheshunt Pit are Warkworth, Mt Arthur, Piercefield and Vaux seams and the pit has a combined consent with the Riverview Pit to mine up to 8 mtpa ROM coal. Seams predominantly dip at two degrees to the south east with an overburden to product coal ratio of around 9.3:1. Following the grant of the HVO South consent in 2009, the Deep Cheshunt development was commenced. This involves the extraction of Piercefield, Broonies and Bayswater seams with the first strip of Bayswater coal being extracted during the second half of 2011</p> <p>Riverview Pit commenced mining operations in 1991 and a modification to consent in 2001 allowed for the introduction of a dragline. Coal is extracted from the Glen Munro, Woodlands Hill, Arrowfield and Bowfield seams. The combined consent with Cheshunt Pit allows annual ROM coal production of up to eight mtpa. Predominantly, seams dip at three degrees to the south east and the current overburden to product coal strip ratio is approximately 7.3:1.</p>

Lemington South Pit.		Lemington South Pit is located on the southern side of the Wollombi Brook and is consented to produce up to 4.4 mtpa of product coal. Mining operations are currently suspended within the Lemington South Pit.

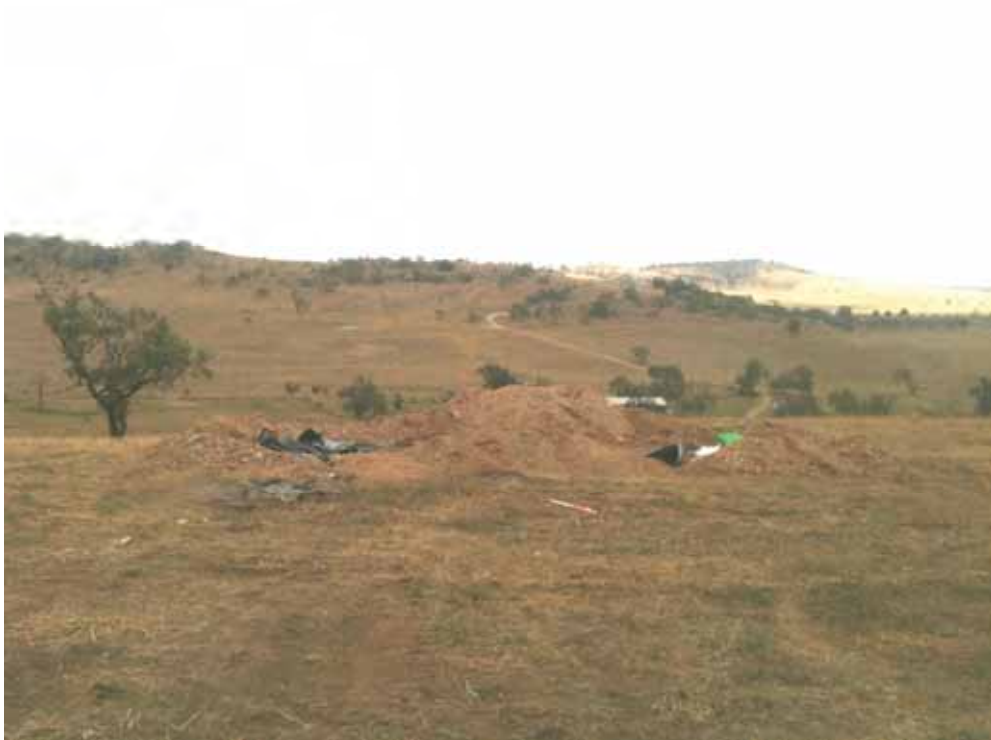
Figure 2: During Drilling

External MOP Area Rehabilitation (EMAR): After a borehole has been drilled and all sampling and testing has been completed, the borehole is grouted to surface. All equipment and gravel is then removed from site (excluding installed piezometers) and the pad area is re-contoured to its original shape. Stockpiled top soil is placed back on the pad and the area is reseeded with suitable seed. Saplings felled to provide space or access for the pad are placed back on the pad and access tracks.

Internal MOP Area Rehabilitation (IMAR): After a borehole has been drilled and all sampling and testing has been completed, the borehole is grouted to the surface unless the hole has been drilled in spoil where the borehole is grouted to the base of casing. Casing is removed where possible or cut or backed off below surface where not possible to maximise casing recovery. All equipment and gravel is then removed from site (excluding installed piezometers) and where applicable the pad is re-contoured to its original shape. Stockpiled top soil is placed back on the pad and reseeded with suitable seed. Saplings felled to provide space or access for the pad are placed back on the pad and access tracks. Rehabilitation progress of all exploration drill holes is tracked prior to internal sign off.

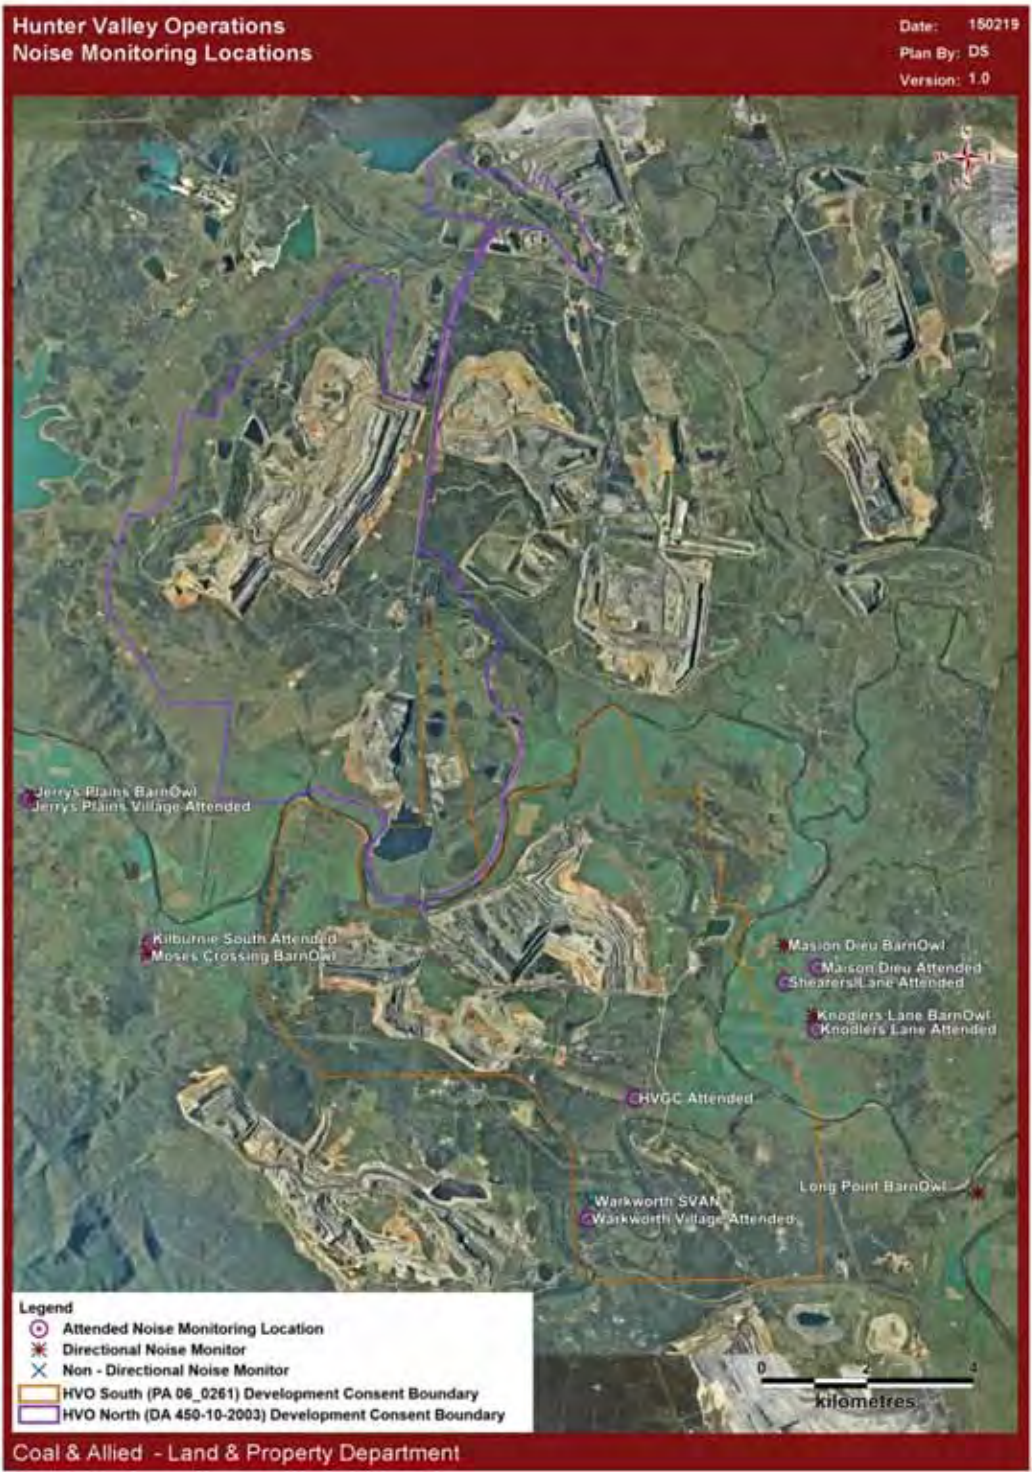
Figure 11: HVO Attended Noise Monitoring Network

To assess compliance with the relevant Project Approval noise criteria, HVO engages Global Acoustics to undertake routine compliance monitoring at nearby private residences (Figure 11), in accordance with the HVO Noise Monitoring Programme. Monitoring is undertaken at a frequency of one night per month so as to ensure that noise impacts are adequately assessed under a range of meteorological conditions throughout the year. Monitoring data is presented on a monthly basis in the Hunter Valley Operations Monthly Environmental Monitoring Report, published on the Rio Tinto website.

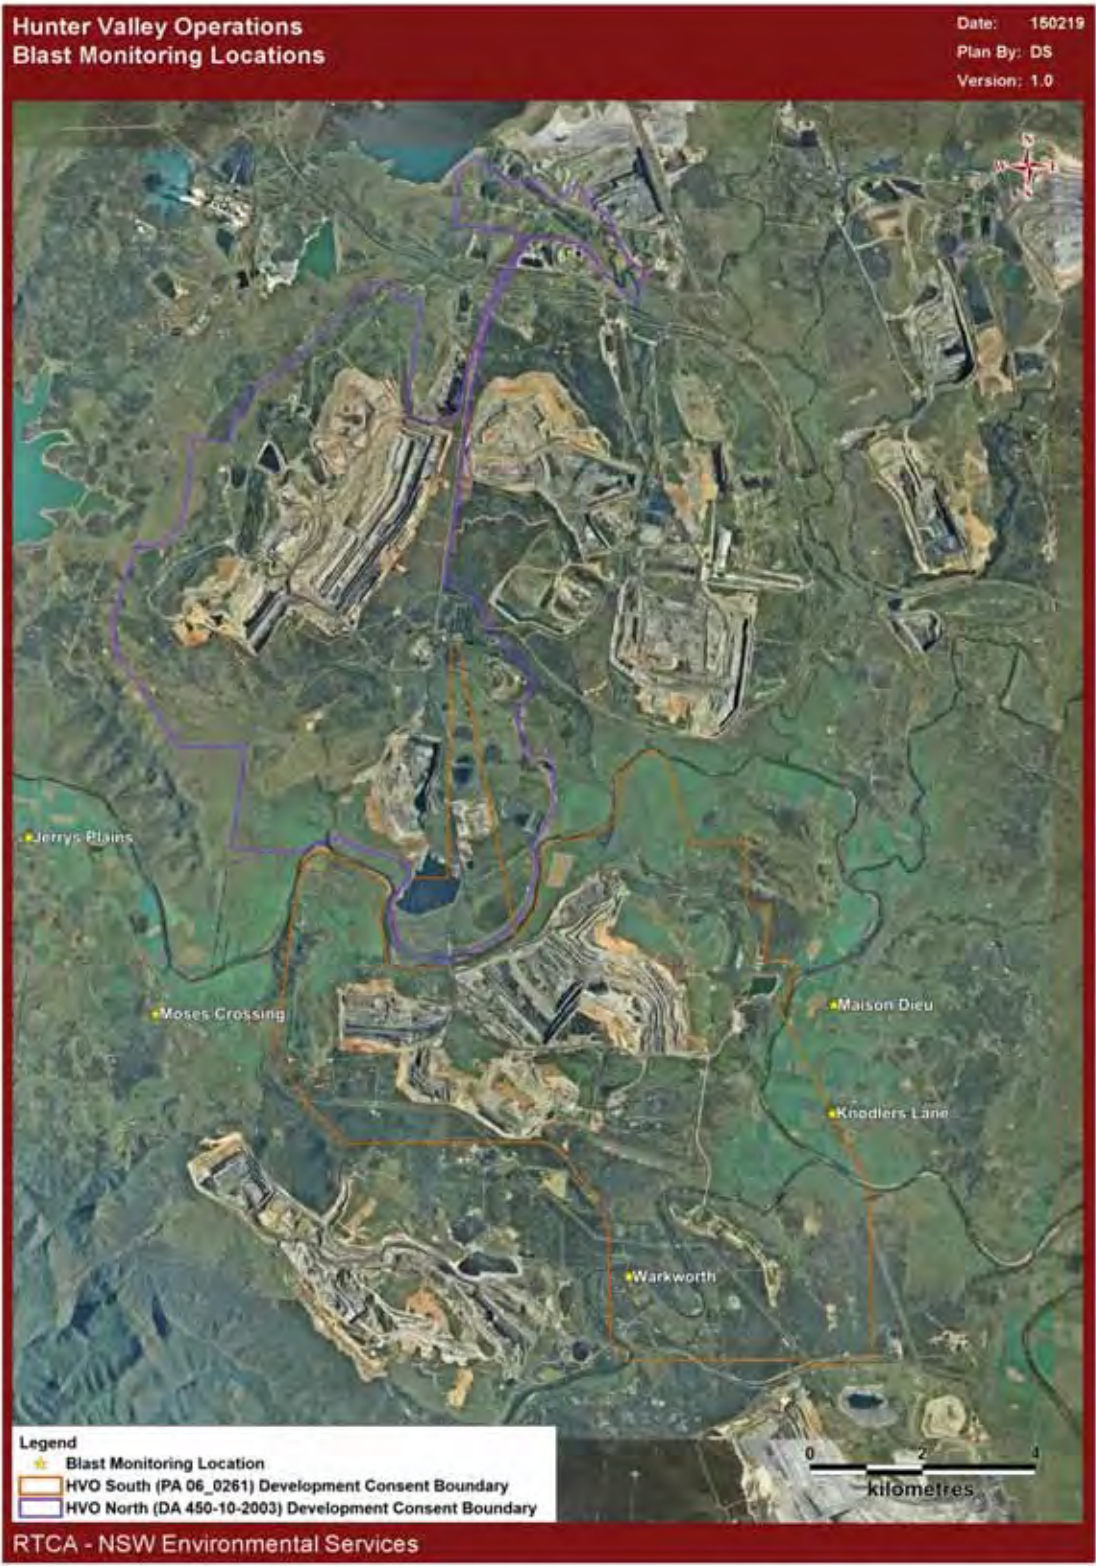
Figure 13: Blast Monitoring Network

HVO achieved 100% blast data capture during 2014. The increased data capture is the result of a monitor replacement project undertaken during 2012, and increased administrative oversight processes, ensuring capture and data integrity.

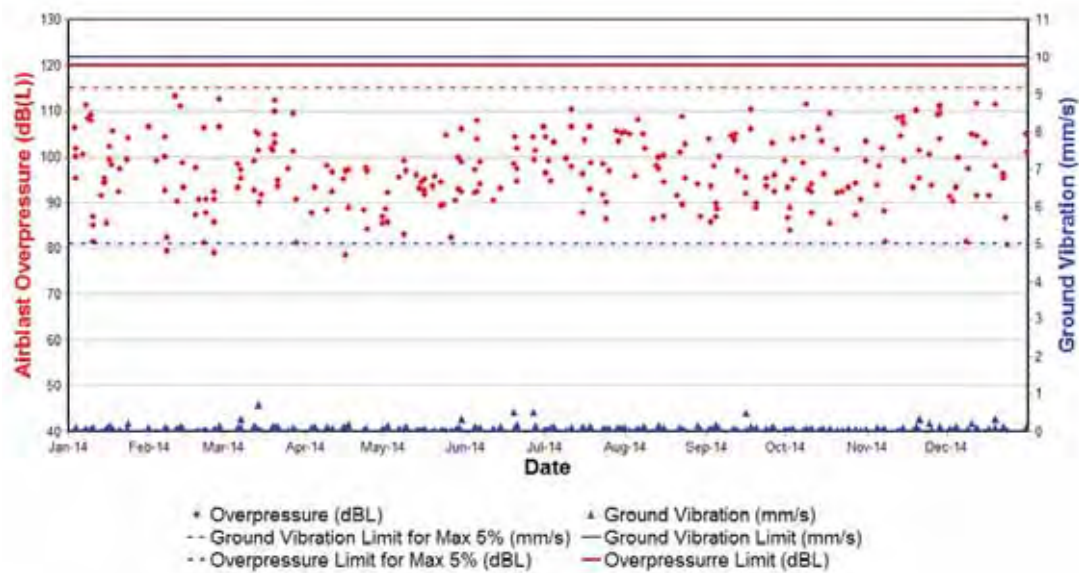
Figure 14: Jerrys Plains Blast Monitoring Results 2014

HVO received 24 complaints relating to blasting in 2014, the majority of which were regarding airblast overpressure or ground vibration from Jerrys Plains residents. The number of blast related complaints increased to 24 in 2014 compared to 10 in 2013. Of the 24 complaints, 16 were received from 2 households in Jerrys Plains. All blast measurements recorded in this area were below criteria in 2014 and no significant increase in overpressure or vibration is evident compared to 2013.

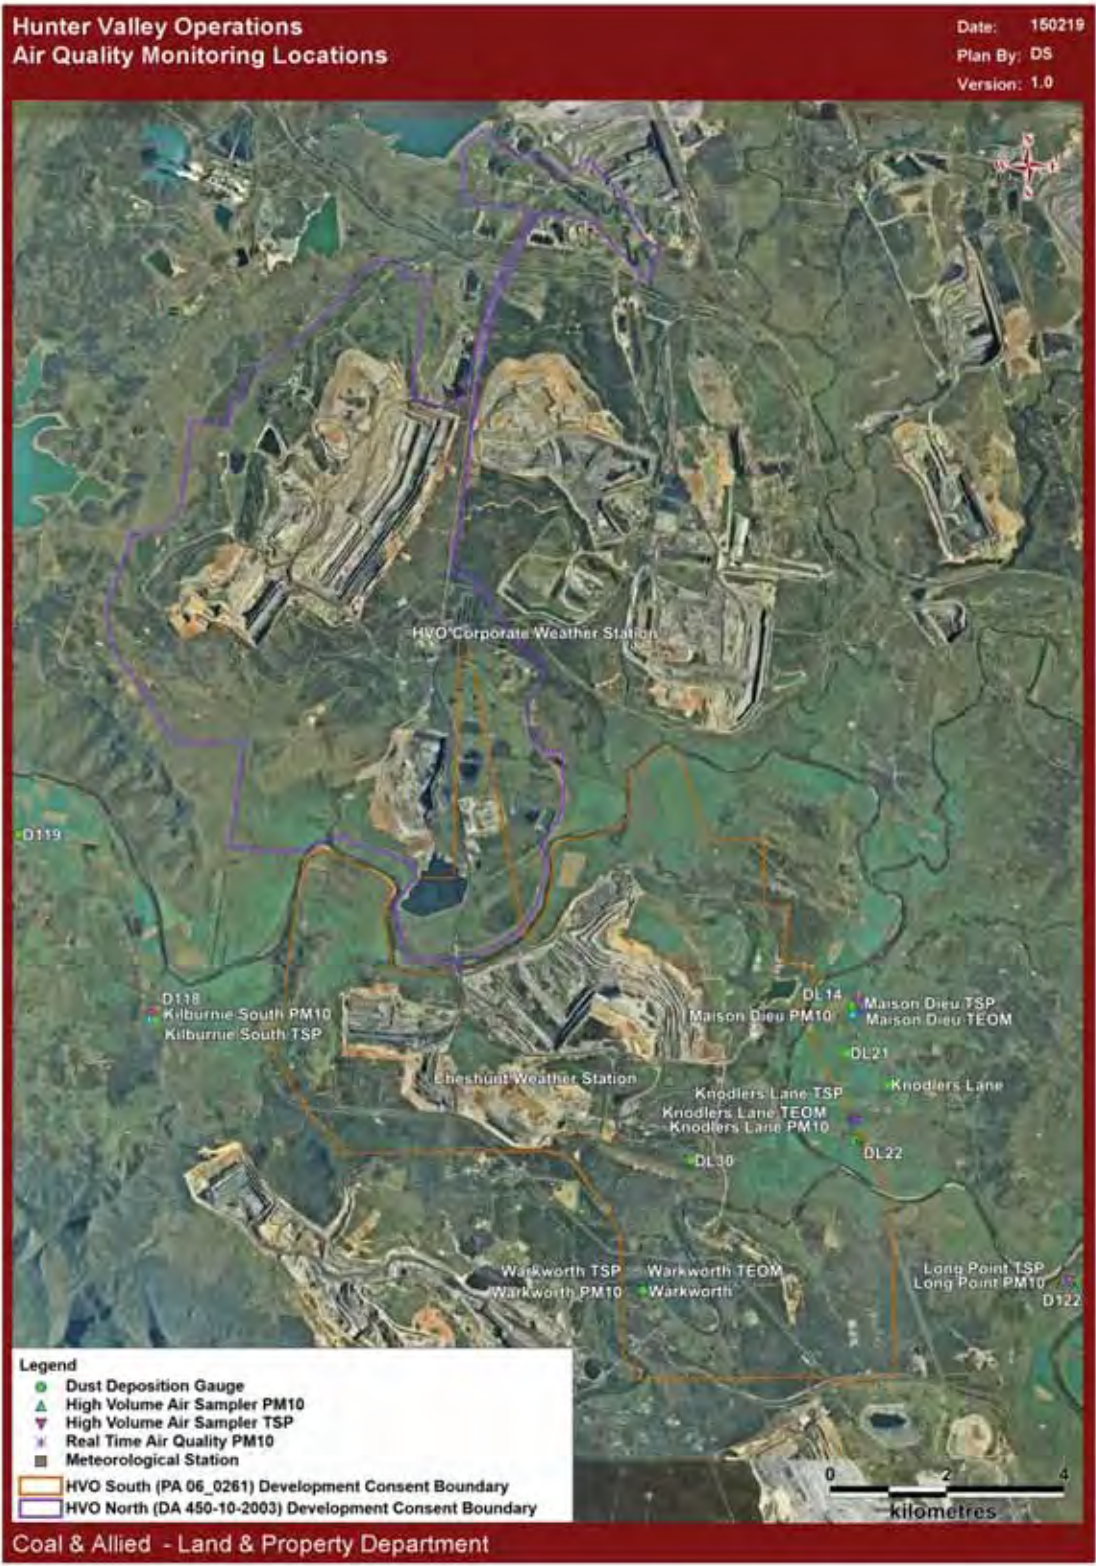
Figure 19: Air Quality Monitoring Network

Figure 19 shows the air quality monitoring network at HVO.

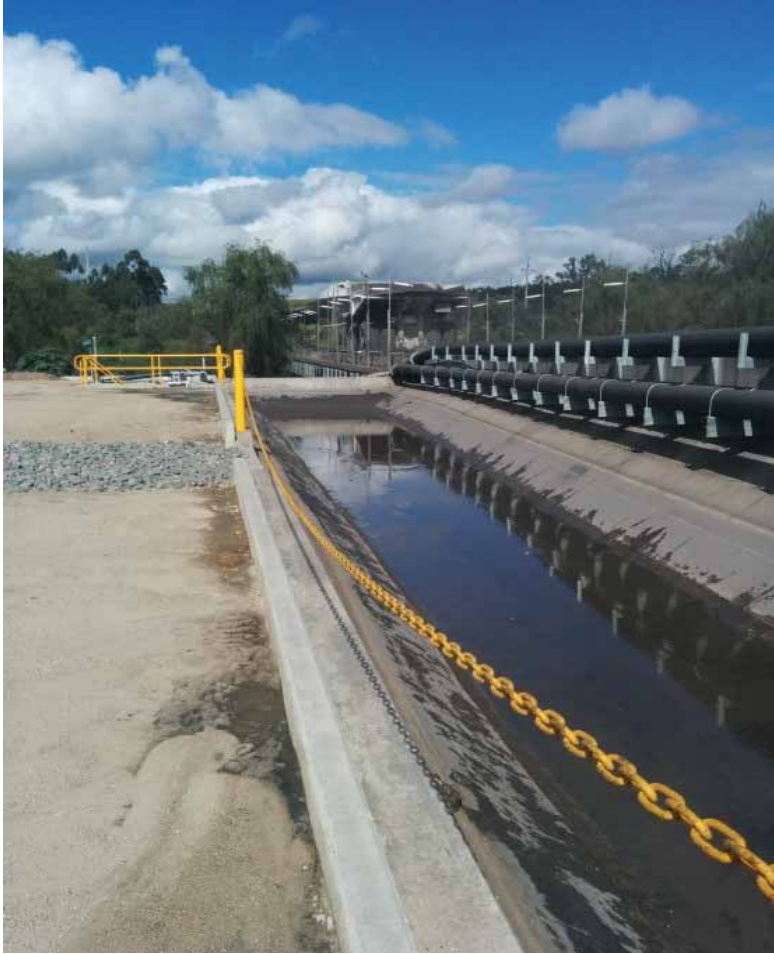
Stage 1 of the Hunter River bridge project was completed in 2014. Stage 1 focused on the north side of the bridge and included augmentation of the existing sediment basins to increase containment capacity and provide automated pump-out control. Figure 34 shows a completed sediment basin. Further detail regarding stage 2 of this project is included in section 6.6 of this report.

Figure 34: The completed sediment basin on the north-east side of the Hunter River Bridge

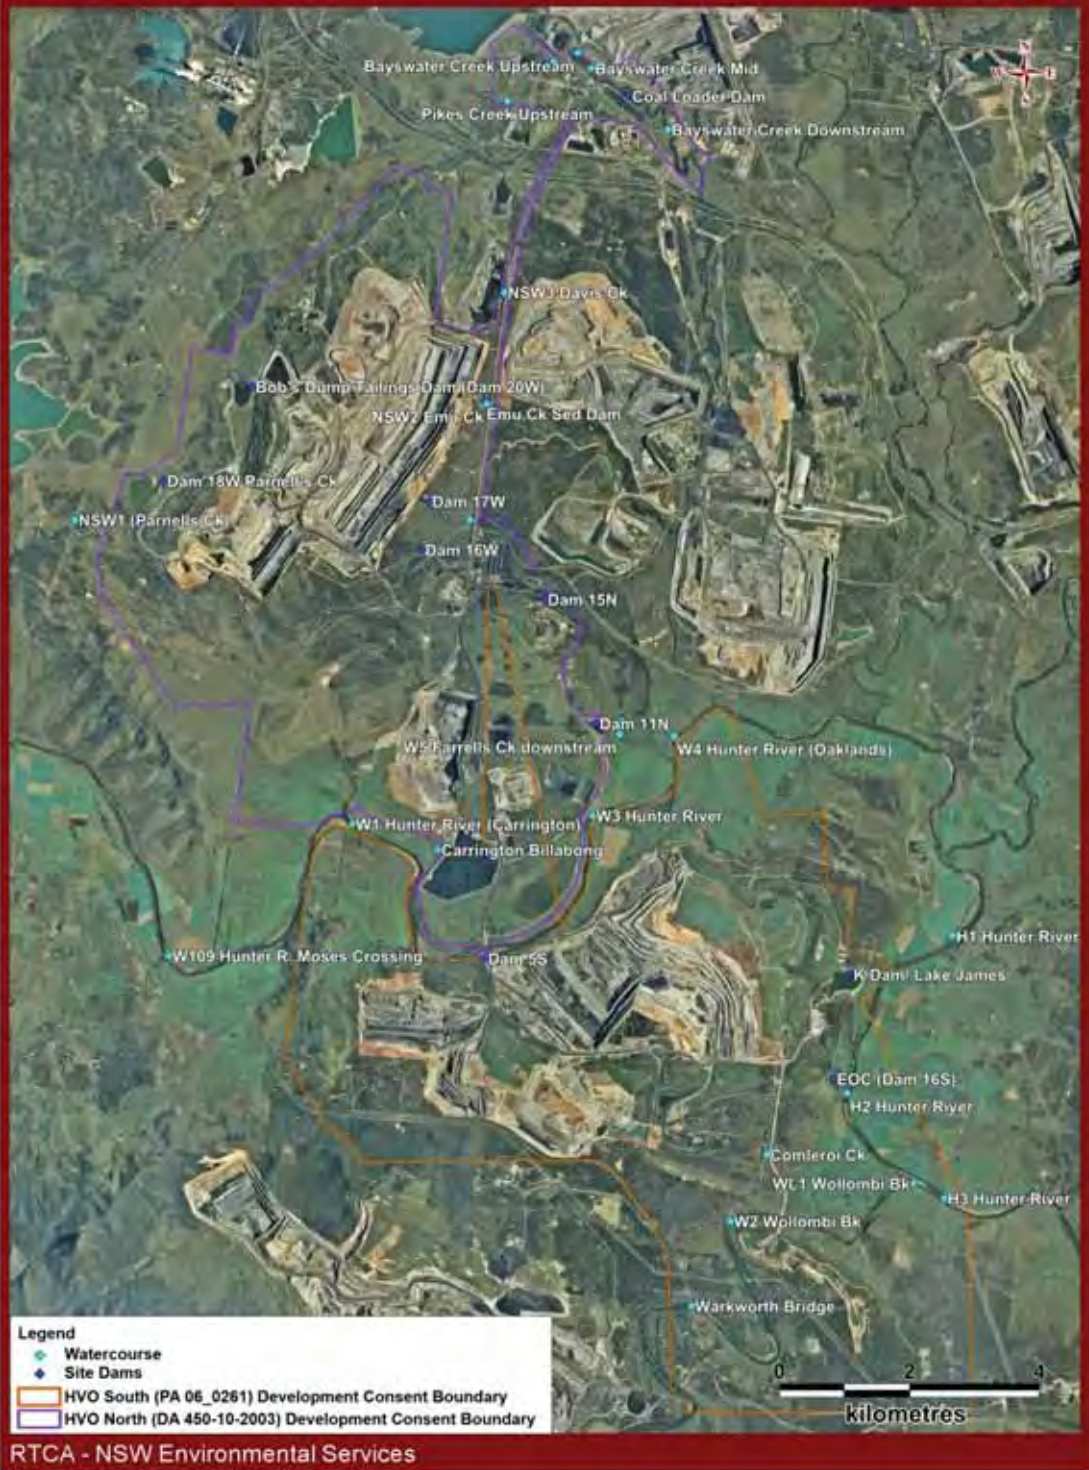
Figure 40: Surface Monitoring Locations

Surface water monitoring activities continued in 2014 in accordance with the HVO Water Management Plan and HVO Surface Water Monitoring Programme. HVO maintains a network of surface water monitoring sites located on mine site dams, discharge points and surrounding natural watercourses (Figure 40). Water quality monitoring is undertaken to verify the effectiveness of the water management system onsite, and to identify the emergence of potentially adverse effects on surrounding watercourses. Mine site dams are monitored routinely to verify the quality of mine water, used in coal processing, dust suppression, and other day to day activities around the mine.

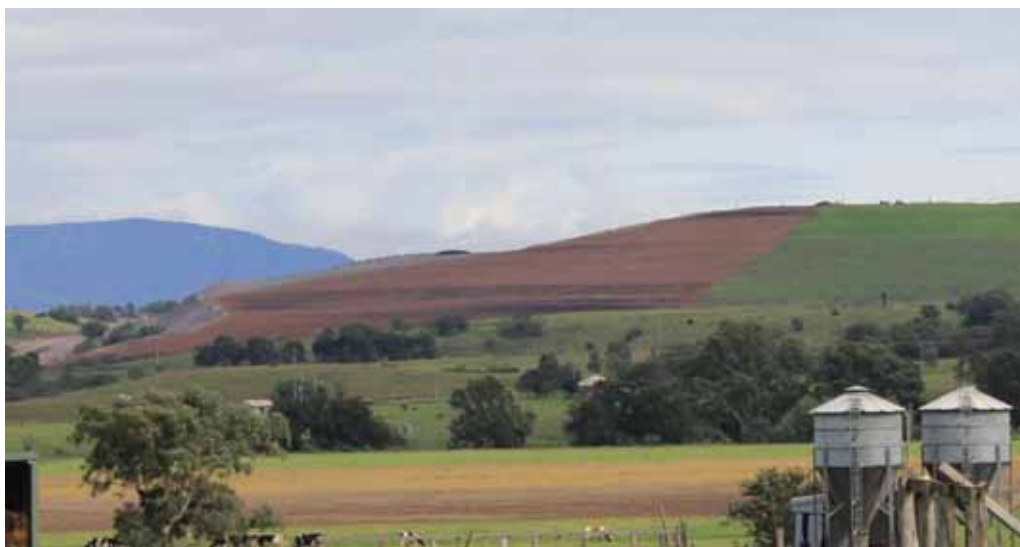
Rehabilitation of the Lemington No. 5 Tailings Storage Facility (TSF) was successfully completed during 2014 (Figure 110). Geotechnical investigations were conducted on the South East TSF during 2014 and Australian Tailings Consultants have been commissioned to design a Stage 1 Capping for this facility. Geotechnical investigations will be conducted on the Central TSF during 2015 to allow a capping design to be prepared for this facility. A Fine Rejects Management Strategy for HVO is being developed in accordance with Clause 28A of DA 450-10-2003 Mod 4. This strategy will be developed in consultation with DRE and NOW and will be submitted to DP&E by the 30 June 2015. The strategy will outline tailings management for the time horizon spanned by current approvals.

Figure 110: View from Maison Dieu Road showing the topsoiled landform that has been built over the Lemington No. 5 Tailings storage Facility.

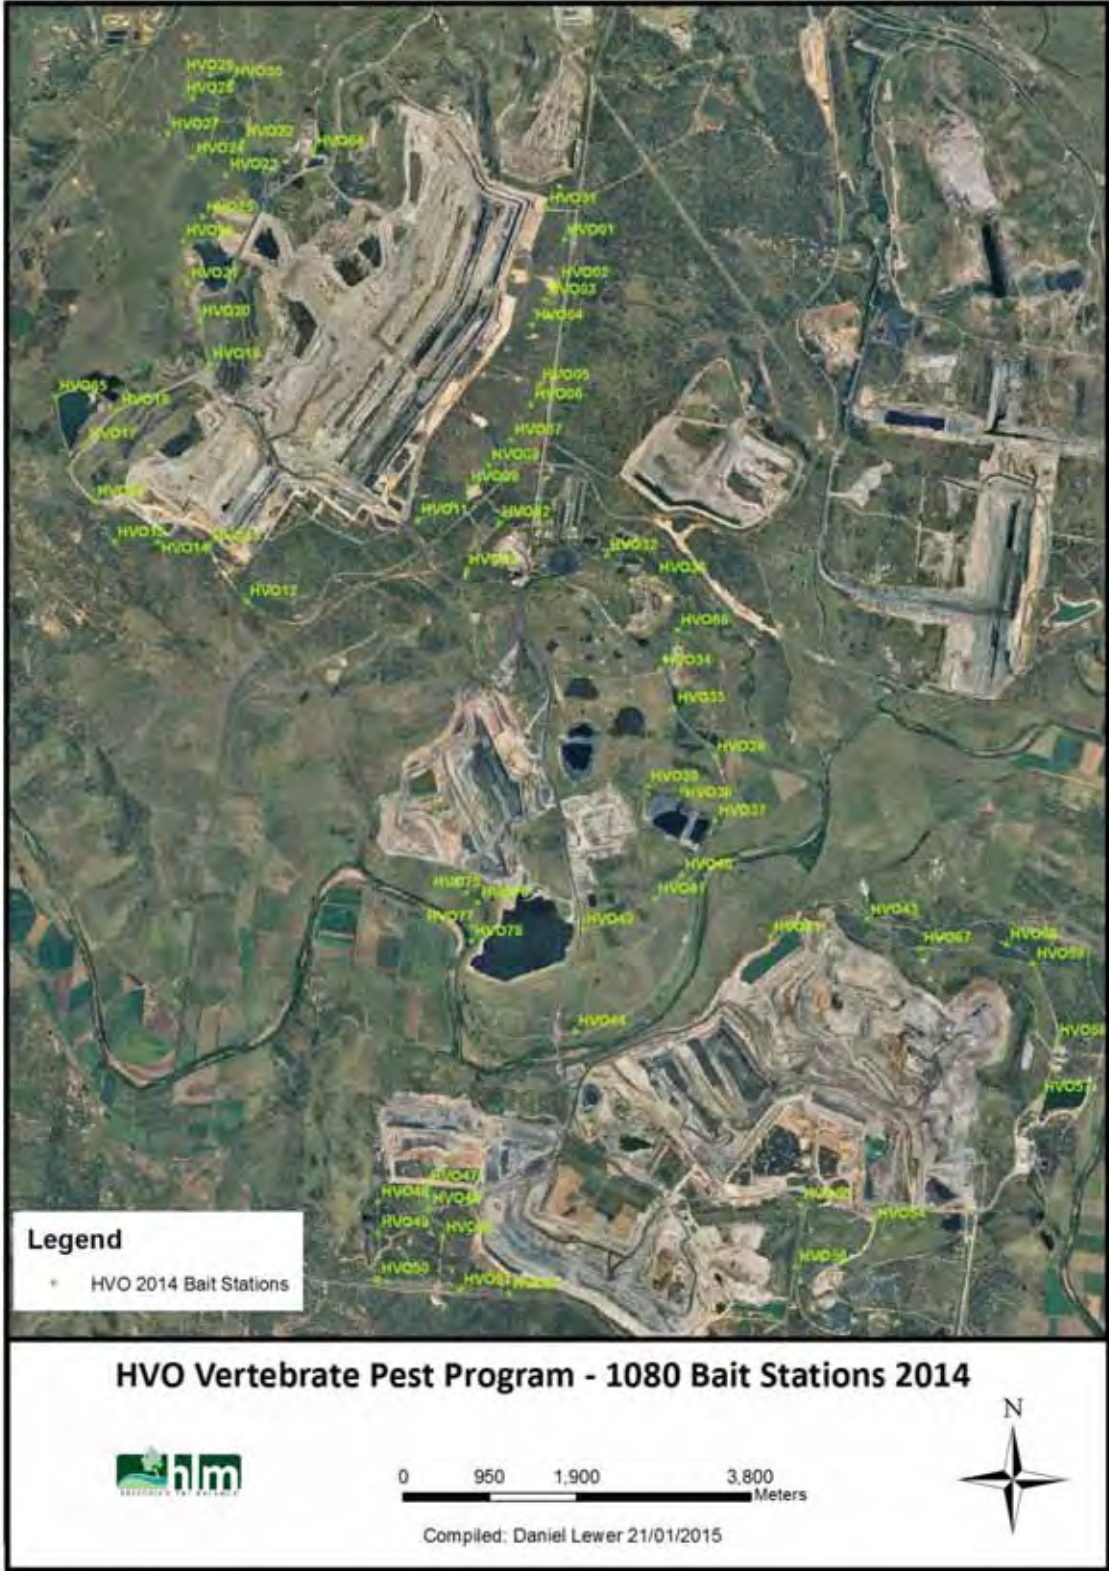
Figure 114: HVO Vertebrate Pest Management Bait Locations 2014

As part of HVO's Vertebrate Pest Action Plan, a control programme is carried out quarterly and on a seasonal basis. The results from each programme are considered when planning the next baiting programme. The 2014 vertebrate pest control targeted wild dogs and foxes using meat baits injected with *sodium monofluoroacetate* (commonly known as 1080). Table 59 summarises the vertebrate pest control undertaken at HVO during 2014, with baiting locations shown in Figure 114.

Winter and spring baiting in the 2014 programmes were extended from a 2 week to a 4 week period to increase exposure times to the target species. In late 2013 and early 2014 there was a spike in wild dog sightings in the area. To address this, the amount of bait laid was increased by 47% which is mostly accounted for in the addition of the winter programme which included 234 baits. This resulted in a significant increase of wild dog takes (from 12 takes in 2013 to 33 takes in 2014). The amount of fox takes remained high. Overall there was a 16% increase in total feral animal takes for 2014 compared to 2013.

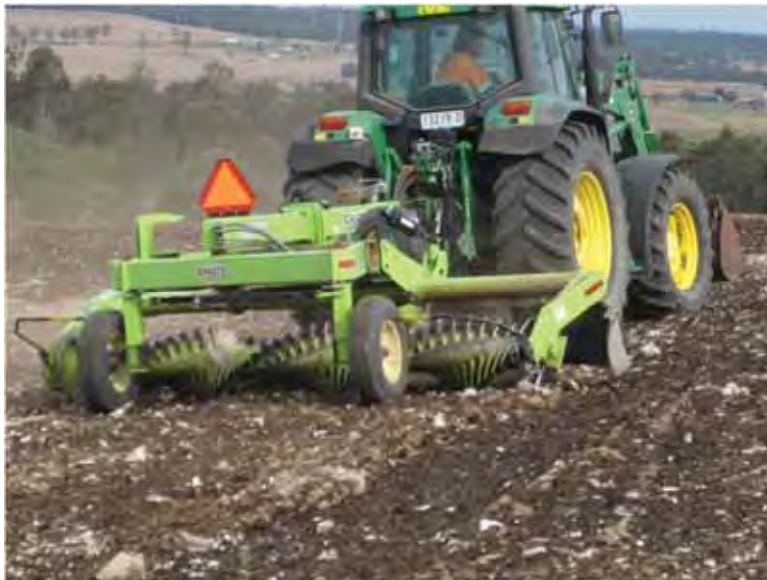
Two agricultural implements have been used to incorporate the compost through the top layer of growth medium. The first of these is a rock windrower which is typically used to sweep rocks into a windrow for removal from cropping paddocks (Figure 115). A rock picker is then used to pick up the windrowed rocks. The benefit of using the rock windrower and rock picker is that the soil surface is then free of rocks that would cause difficulties for the direct-drill that is used for sowing. Rock picking and aerating was completed on an as-needs basis during 2014, depending on ground conditions.

Figure 115: Rock windrower incorporating compost in rehabilitation, Cheshunt Pit

The outcome of trialling these two implements is that they were both beneficial for incorporating the compost and are used depending on the situation. The rock windrower and rock picker are used in areas containing surface rock that will cause problems for the direct-drill but it was found that the smooth surface left by the rock windrower was not suited to slopes. On slopes, the aerator is used after the rock windrower to leave a surface pattern that slows surface runoff and improves water harvesting. In areas without surface rock the aerator alone provides suitable incorporation of the compost.

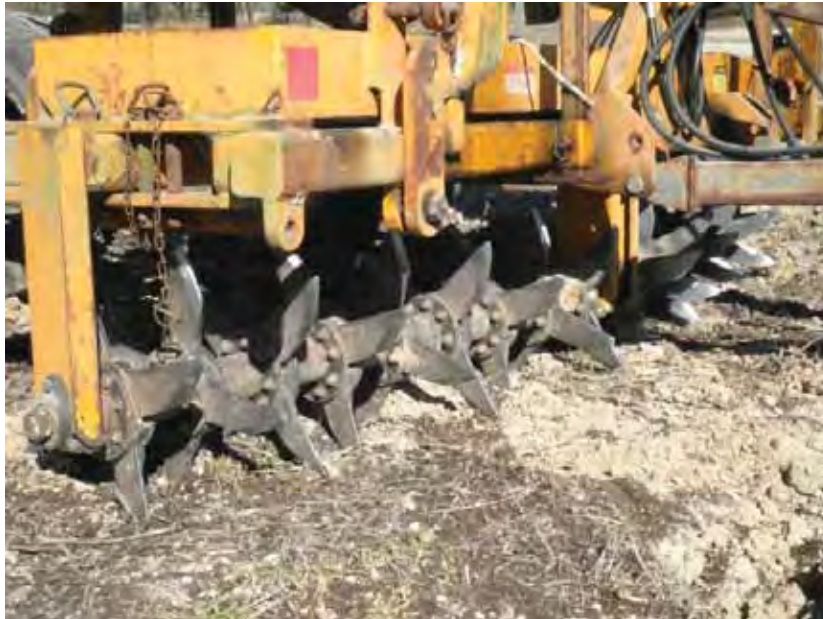
Figure 116: Aerator showing tyne arrangement

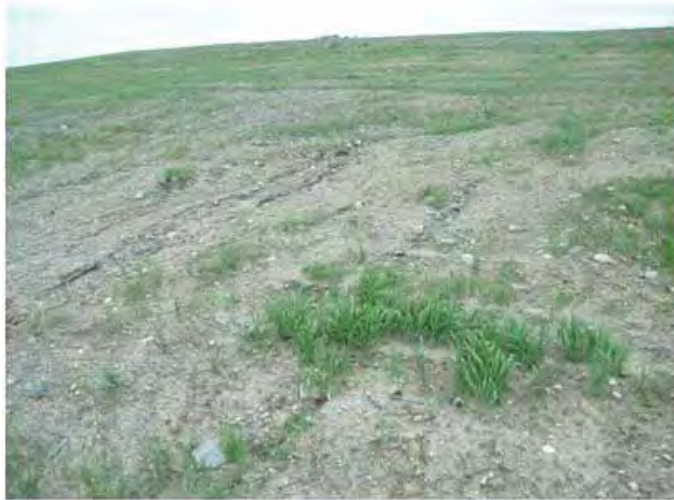
Figure 117: An area which has been harrowed, demonstrating poorer crop establishment and rill erosion

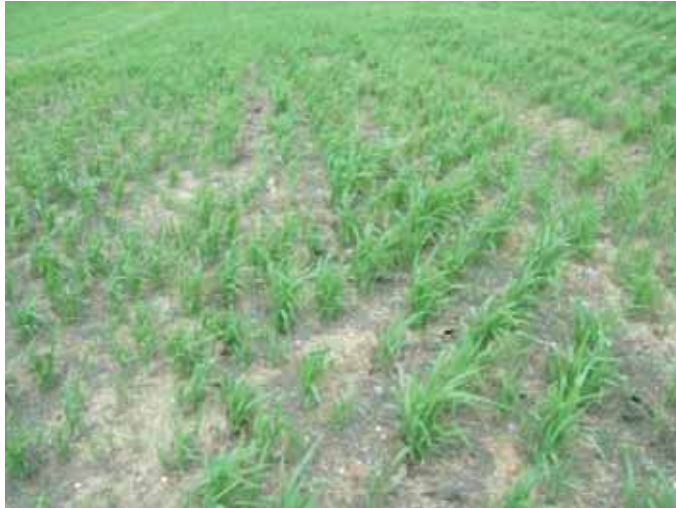
Broadcast spreading of cover crop seed onto a freshly-prepared aerated surface has been found to be most effective in establishing initial cover on slopes. Seedlings that establish in the holes left by the aerator can survive dry conditions because of the improved water harvesting ability of the aerator pattern (Figure 117 and Figure 118). Harrows are not used to provide soil coverage after sowing because the seed that falls in the aerator holes is sufficiently buried by the movement of the fresh topsoil by rain and wind. Avoiding the use of harrows is important because they have been found to smooth out the aerator pattern and produce a slick surface less able to harvest water and more prone to erosion.

Figure 118: An area which has been aerated (not harrowed), showing healthy cover crop establishment in the aerator pattern

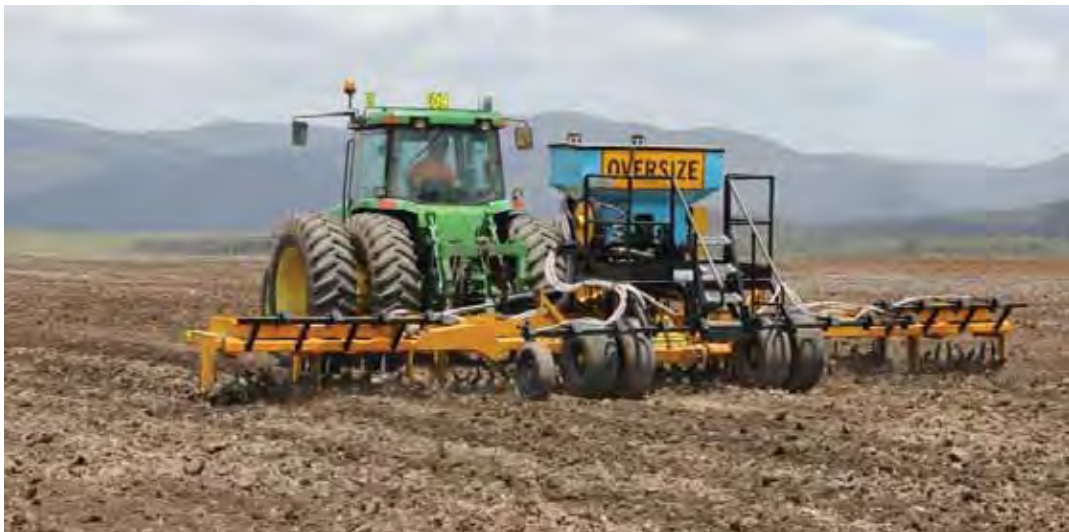
A new piece of machinery, employed during 2014, was an aerator fitted with an air seeder (Figure 119). This allows seed to be broadcast directly into the aerator pattern with the following benefits:

Figure 119: Aerator implement fitted with an air seeder used in 2014 to allow soil preparation and seeding to be undertaken in a single pass.

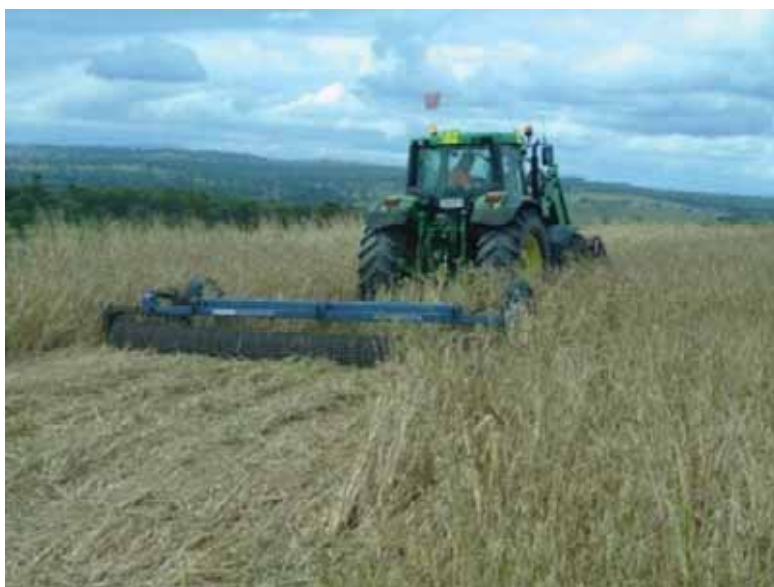
Rolling the crop onto the surface rather than slashing/mulching the stubble was preferred because it leaves a more stable “attached” mulch (i.e. mulch still attached to roots) rather than small pieces of stubble which would be more prone to being washed or blown off the soil surface. Rehabilitation areas with the rolled cover crop on the surface have been found to be very stable and resistant to the effects of both wind and water erosion.

Figure 120: Crop rolling the millet cover crop on to the surface

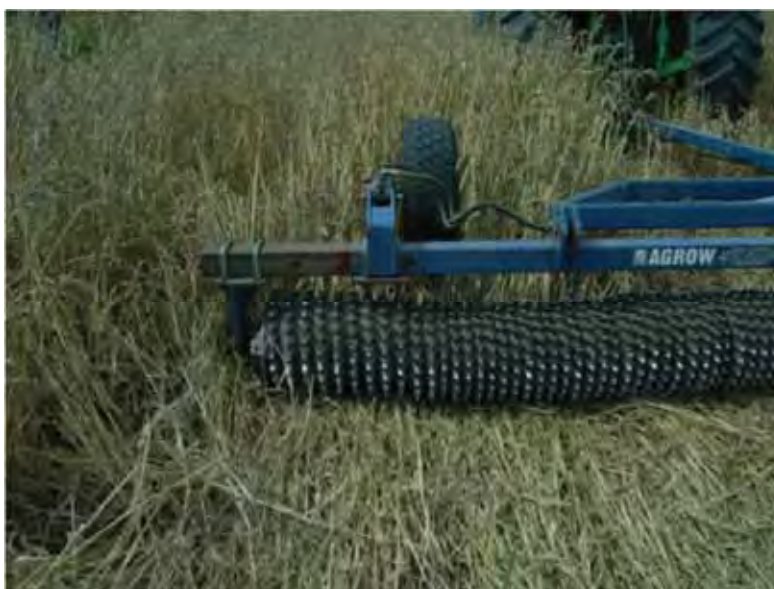
The solution that was adopted was the use of a flexiroller to flatten the cover crop on the surface and allow the weeds to poke up through the flattened stubble (Figure 120 and Figure 121). The weeds are then exposed for effective herbicide spraying with a boom spray.

Figure 121: The flexiroller is made up of individual rings which allow it to conform to the surface contours

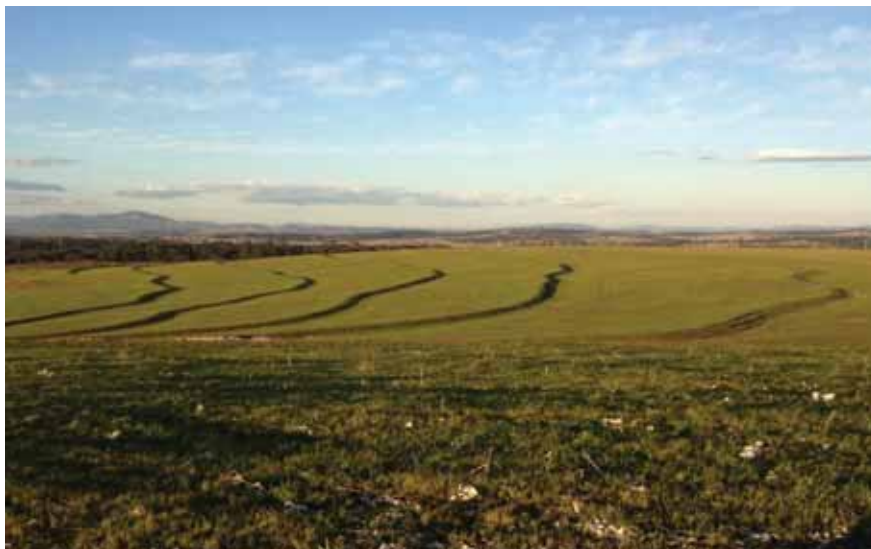
The native grass seed box on the direct-drill is equipped with agitators to keep the seed mix from bridging and pick-wheels to help pull seed down into metering points. Despite this the initial trials showed the native grass seed was still causing some blockages during seeding. Further processing of the native grass seed mix, by putting it through a garden style mulcher, was needed to reduce blockages. A commercial thresher was used for processing seed in 2014. This machine uses stiff brushes and sieves to process the seed in order to improve the flowability of the seed mix through the direct-drill. The use of the thresher rather than the garden mulcher reduces potential damage to seed caused by spinning mulcher blades. Figure 122 shows an area in Cheshunt that has been sown to native seed mix using the methods described above.

Figure 122: Rehabilitation area in Cheshunt that has been sown to native seed mixes in 2013 after initial cover crop.

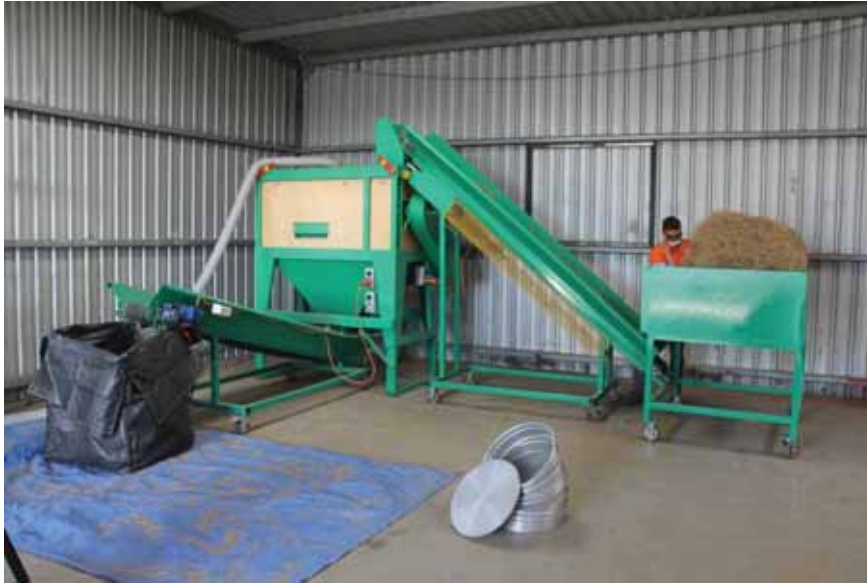
Trials have been undertaken in 2014 by native grass seed contractors using custom-designed machinery to improve the flowability of the native seed through the direct-drill seeder. These trials have used a combination of threshers, sieves and shaker tables to separate the seed from the awn and floret appendages, and remove stalk (Figure 123). Further refinement of these processes will be undertaken during 2015 to produce native seed mixes that are more suitable for direct-drilling and potentially suitable for broadcast seeding through air seeding equipment.

Figure 123: Native grass seed thresher used to process harvested seed into a form suitable for the direct-drill seeder.

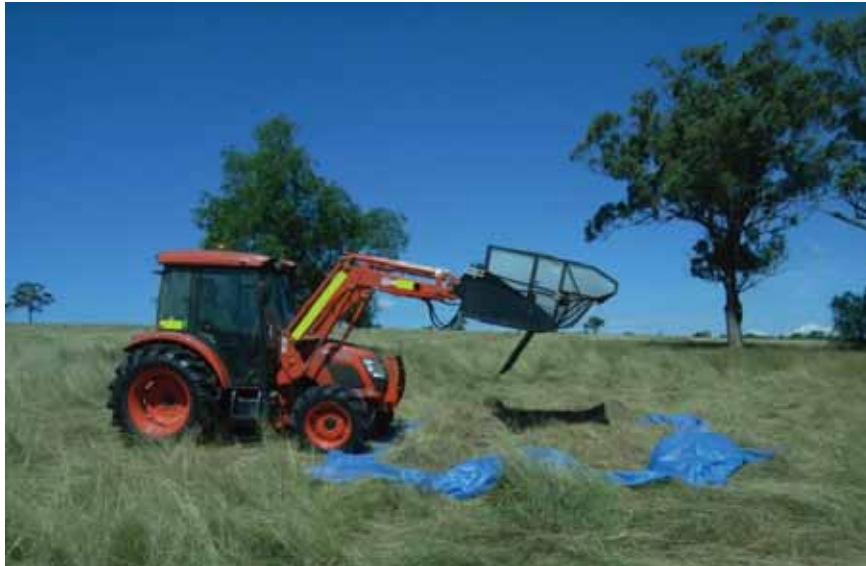
Figure 124 shows the Native grass seed harvesting implement used on Coal & Allied Properties and Figure 125 shows the harvested seed being dried prior to going into storage.

Figure 124: Native grass seed harvesting at a Coal & Allied owned property near Muswellbrook.

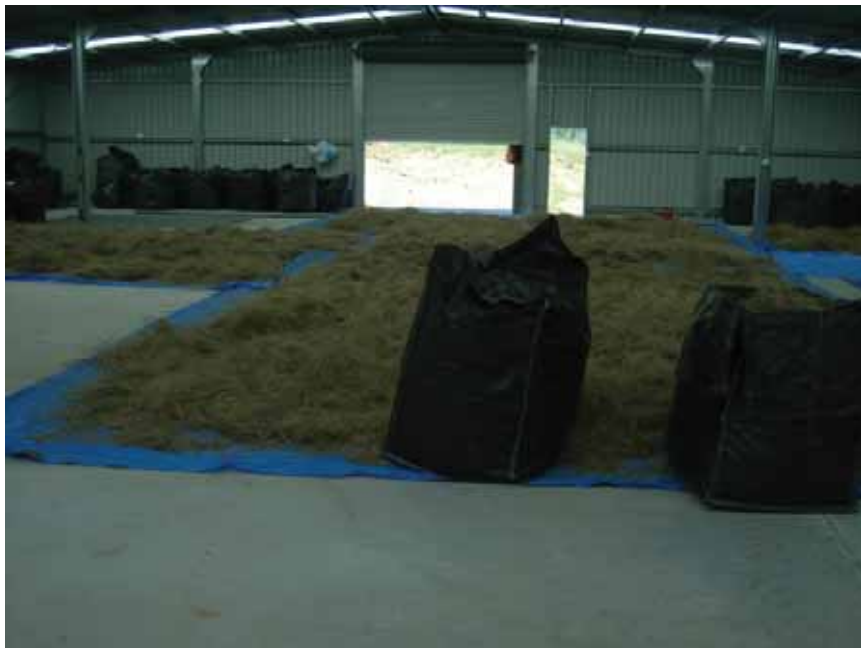
Figure 125: Harvested native grass seed material being dried before storage.
