2014 Hunter Valley Operations Annual Environmental Review

March 2015

This Annual Environmental Review (Annual Review) reports on the environmental performance of Hunter Valley Operations (HVO) during the 2014 calendar year and satisfies the requirements of the Hunter Valley Operations (HVO) Development Consents and Mining Leases. The structure of the 2014 Annual Review intends to align with the NSW Department of Trade and Investment *EDG03 Guidelines to the Mining, Rehabilitation and Environmental Management Process* and the NSW Department of Planning and Infrastructure Draft *Guideline for Preparation of Annual Environmental Management Review (AEMR) December 2012*.

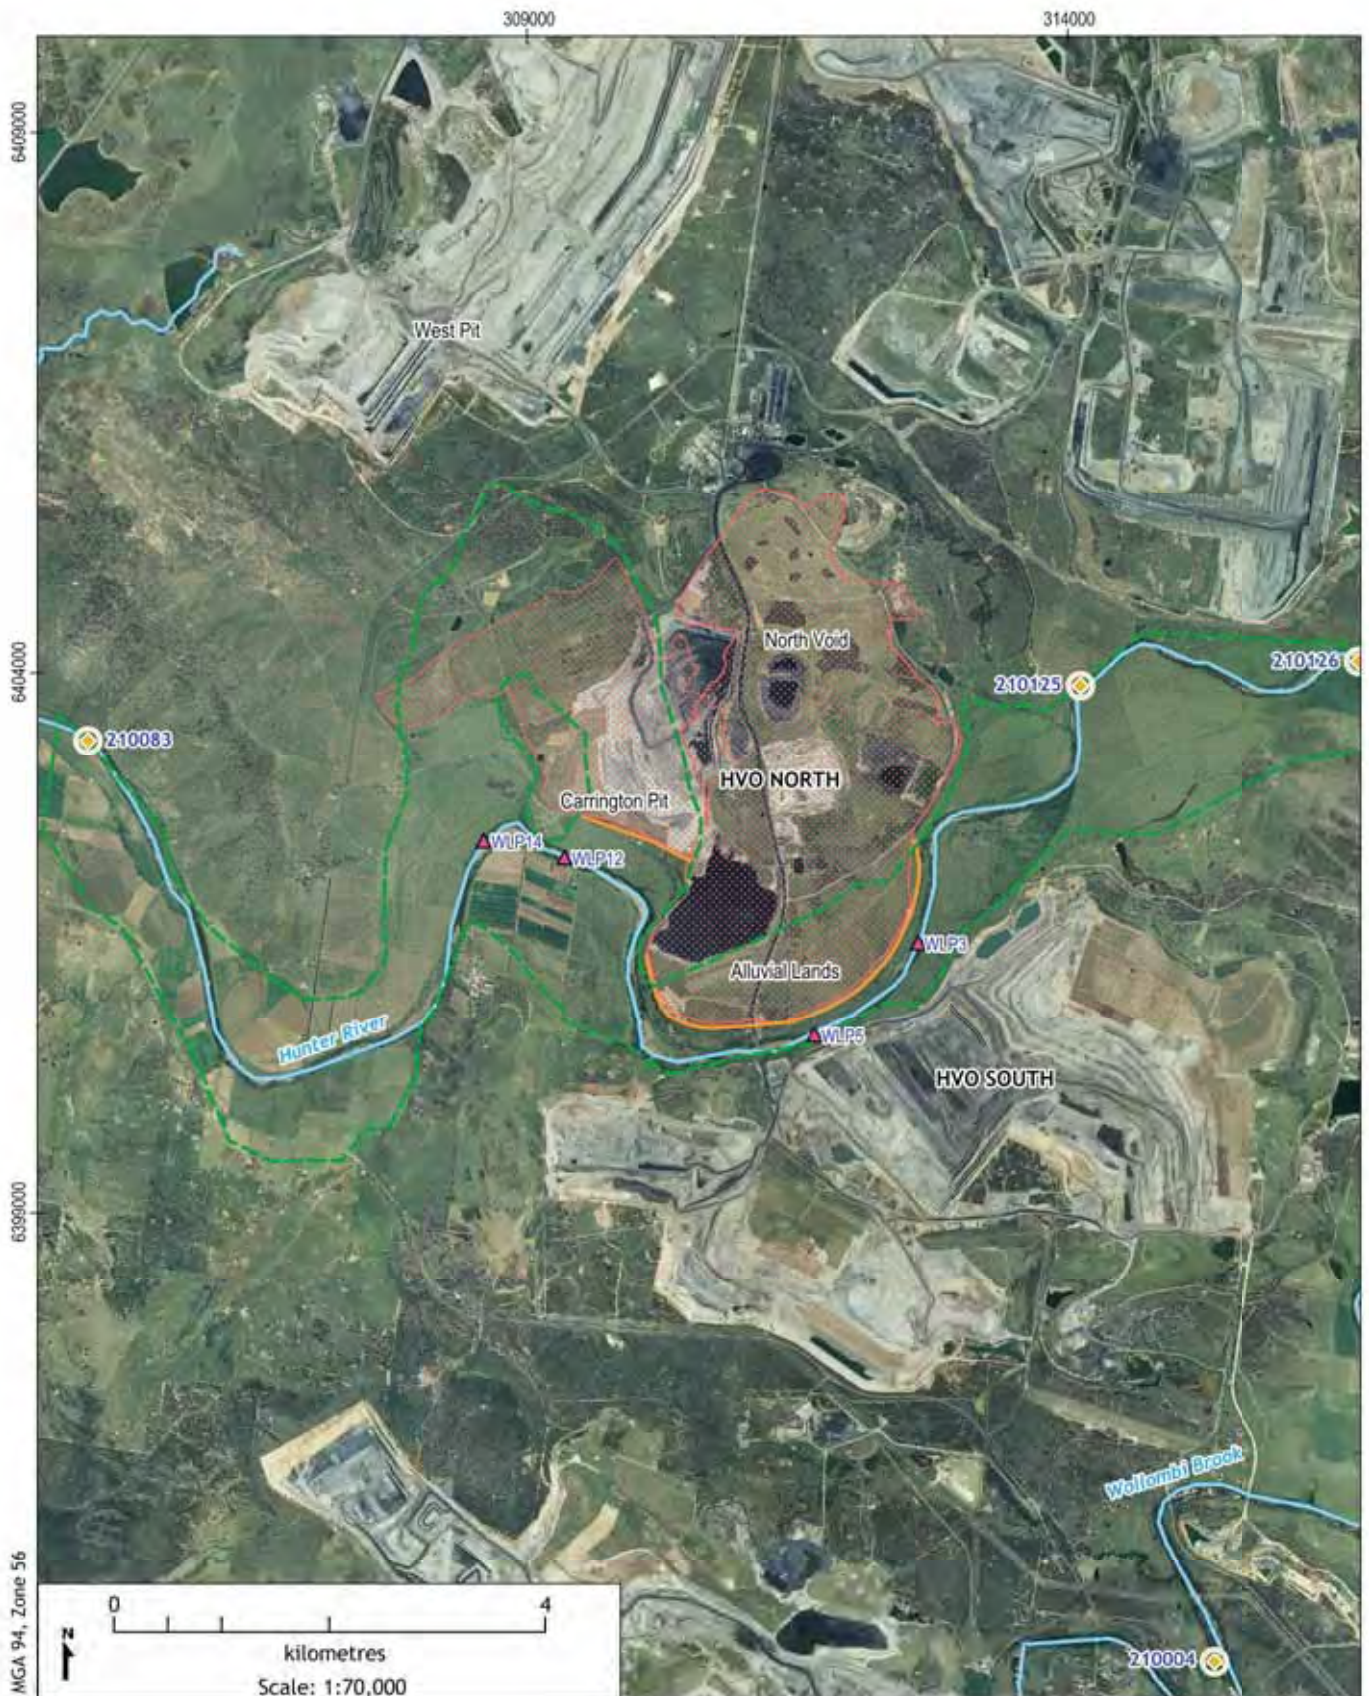
The barrier wall was constructed as a compacted clay buttress wall, against an existing levee that extended across the eastern limb of a Tertiary palaeochannel. The wall was constructed to the base of the Vaux Seam. The extent of the barrier wall and the location of the Carrington Billabong are shown in Figure 1.

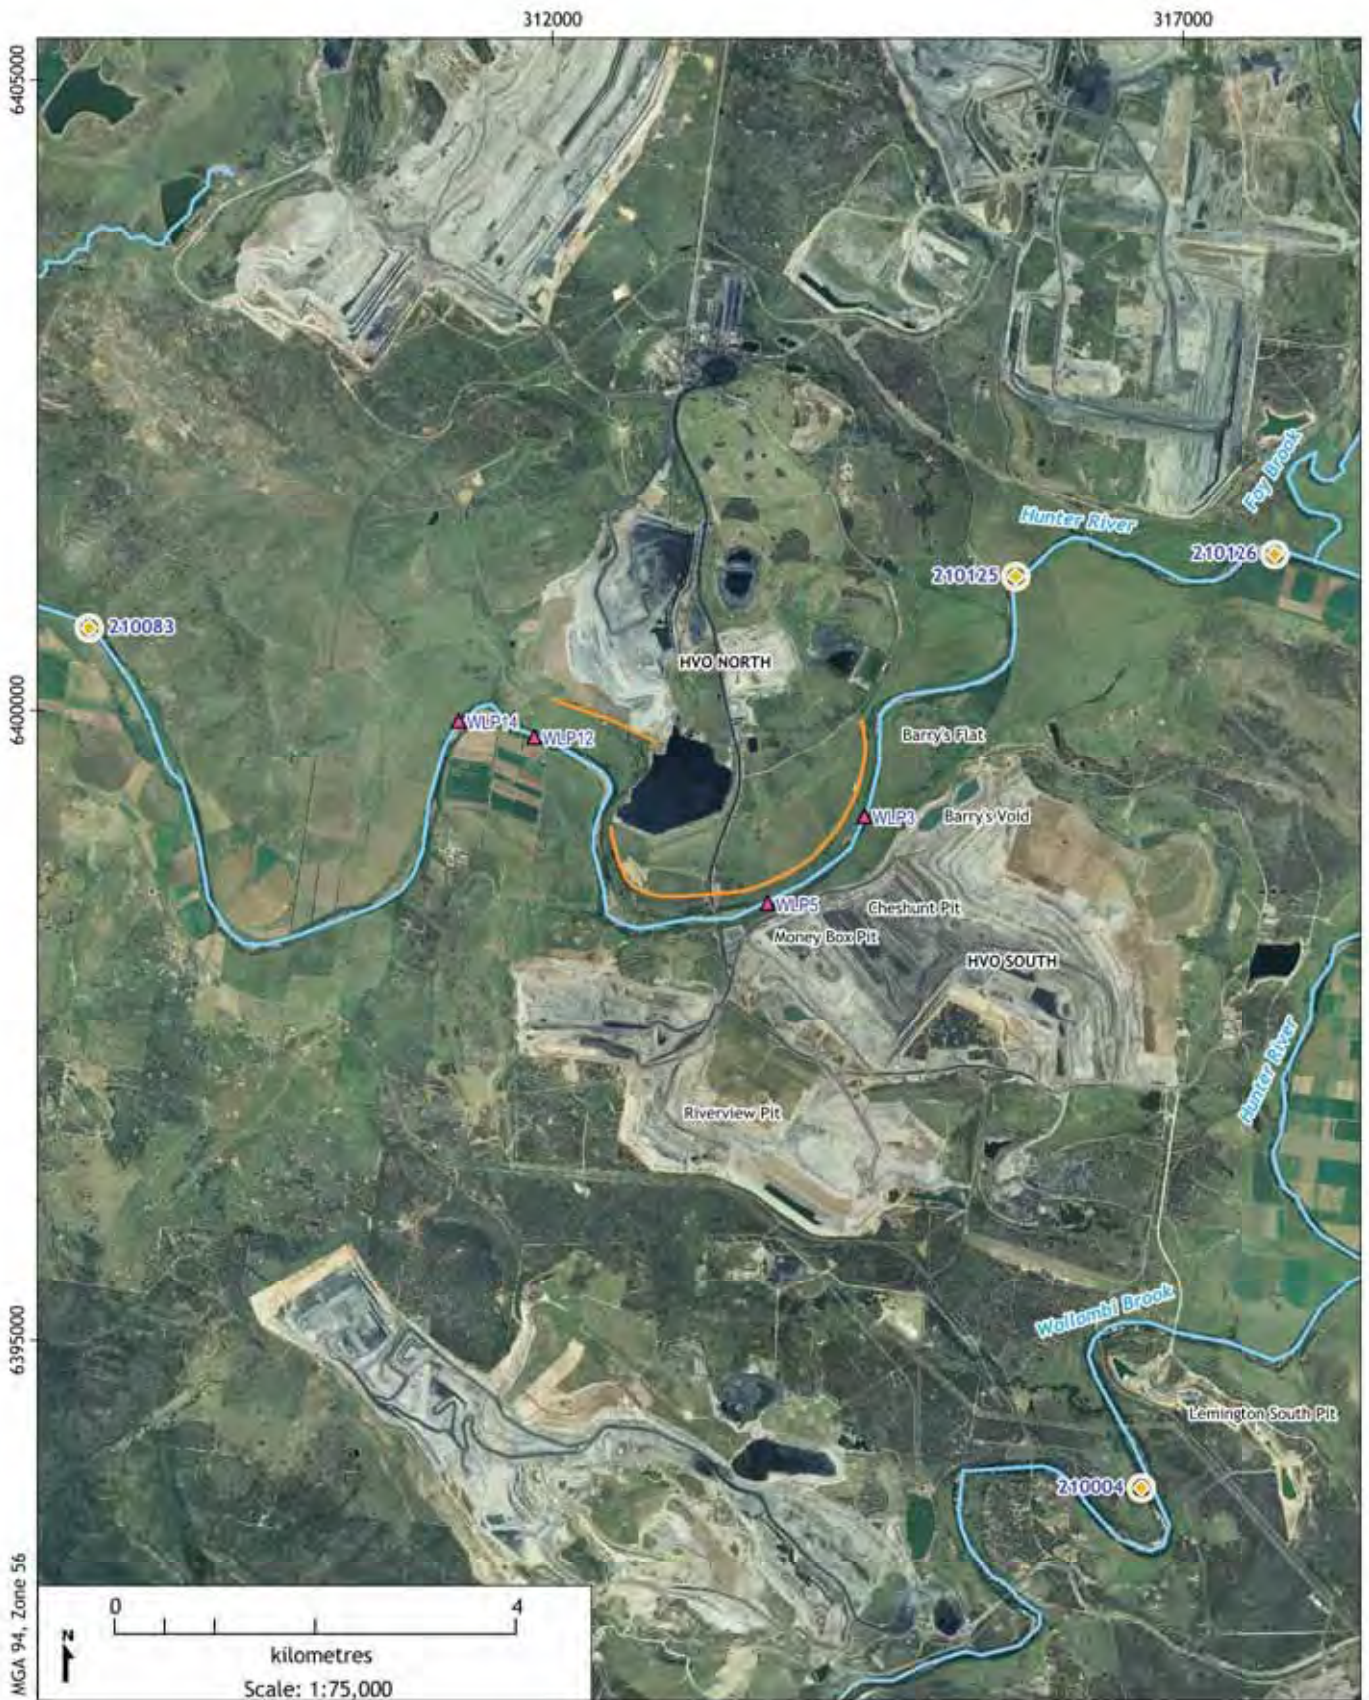
This report focuses on HVO South, which is located to the south of the Hunter River and comprises of the Cheshunt and Lemington South Pit areas. HVO South is bound by the Golden Highway to the west, and the New England Highway to the east. Several mines are located around HVO South, including Warkworth Mine and Wambo Mine, which are located within 2 km of Lemington South Pit 1. Refer to Figure 1.

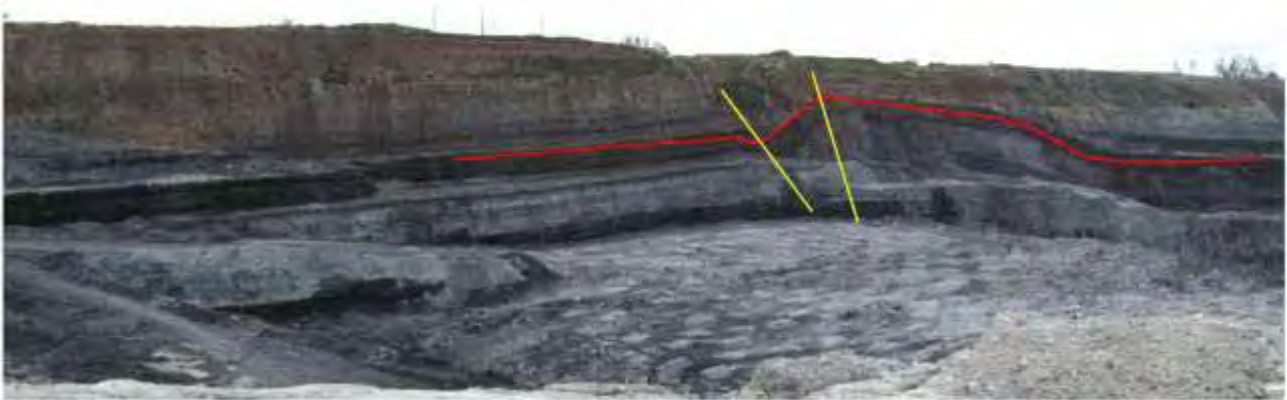
Figure 5 Cheshunt Pit anticline

An anticline structure is also present within the northern highwall of Cheshunt Pit. Figure 5 highlights the anticline structure (in red), and shows minor displacement of the coal measures along minor faults (in yellow). Along the crest of the anticline, the MTA appears to sub-crop beneath the alluvium (Appendix B).

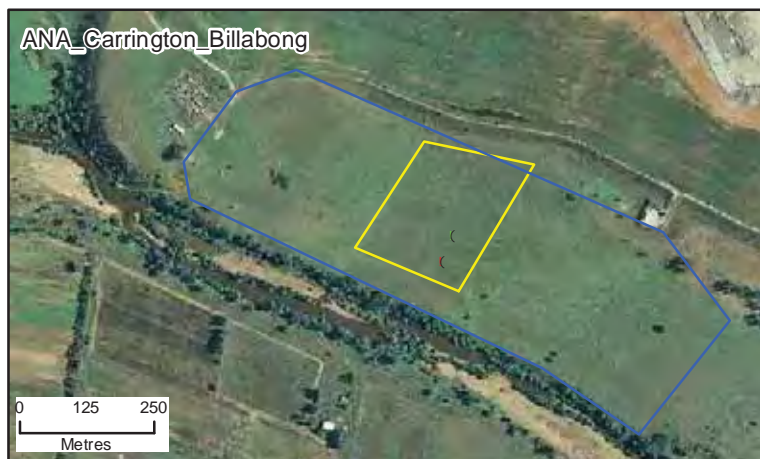
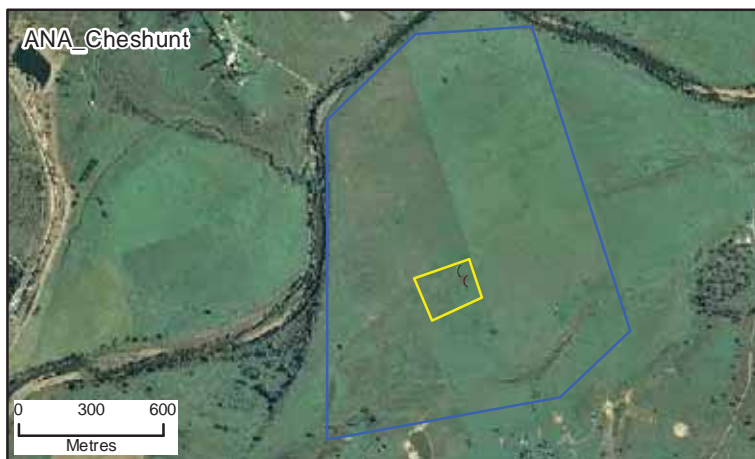
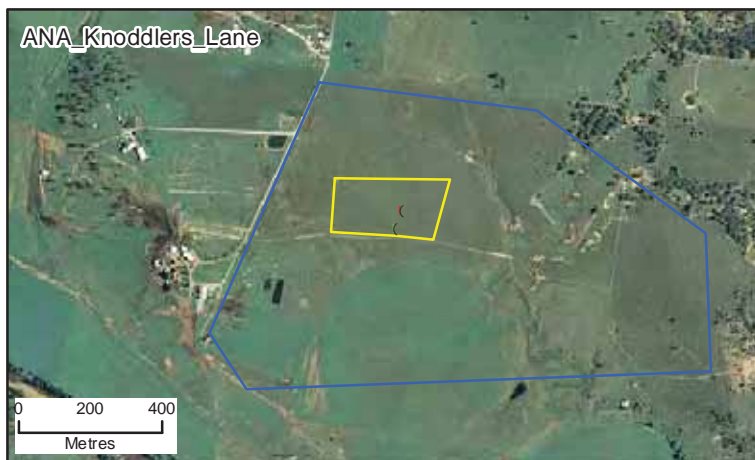
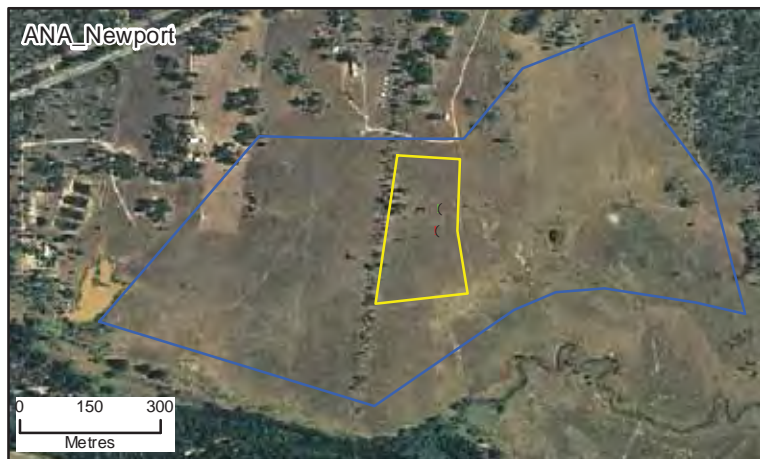
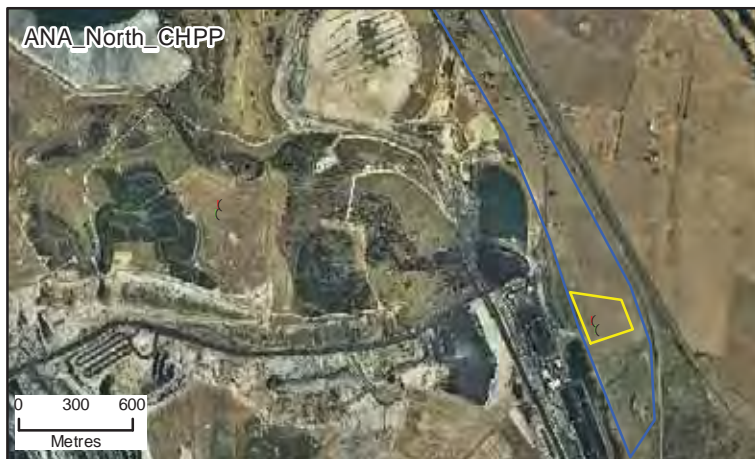
**Analogue monitoring sites:
LFA transects and Botanal study area location**
Rehabilitation Monitoring Programme 2015
Source: RTCA (2014), AECOM (2015)

- Analogue Polygon (approx) ⌋ LFA Transect End
- Botanal Study Area ⌋ LFA Transect Start

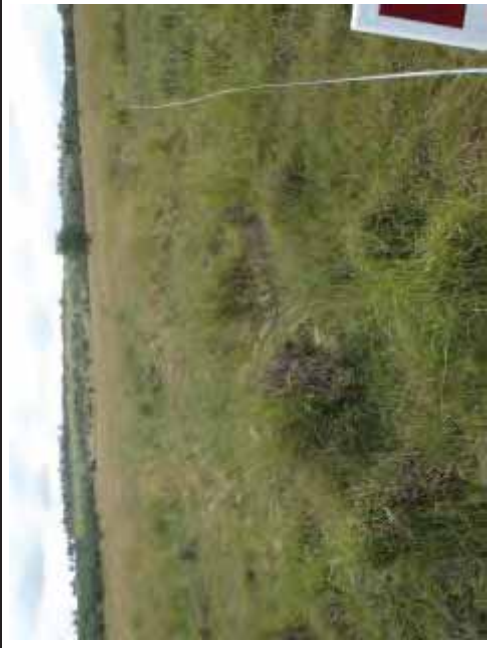
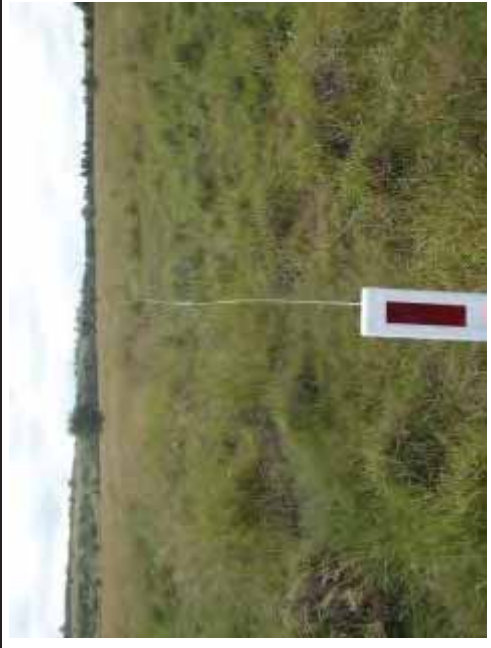
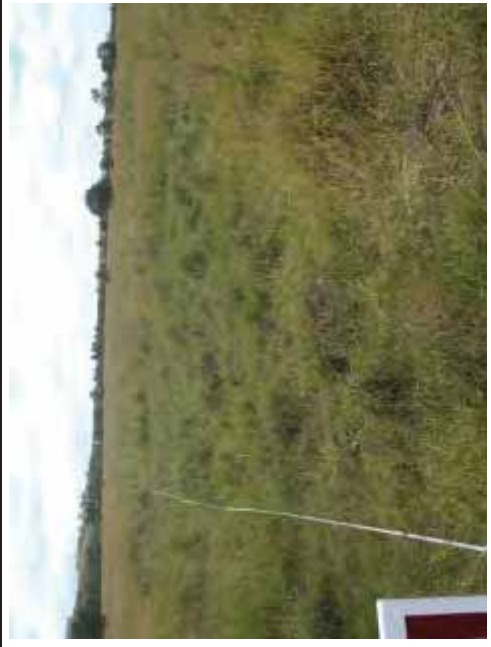
Monitoring site: RHB_HVON_Carrington			
View from start of transect

Infiltration indices were comprised between 28.0% and 39.8%. Soil infiltration potential was lowest at 'RHB_HVON_Carrington' and 'RHB_HVOS_Riverview' (yet still with index scores within the 'satisfactory' range of values, refer to Table 9), and highest at 'RHB_HVOW_Wilton' ('excellent' index score), with all other sites returning 'good' infiltration index scores (refer to Table 9). As with stability, the infiltration potential of the soils was greatly influenced by the dense grass vegetation cover across the sites. Indeed, the high vegetative ground cover present at all sites reduces water surface runoff velocities (thereby providing more time for water to infiltrate within the soil profile), and enhances infiltration processes by increasing the soil organic matter content, which in turns enhance soil aggregation and pore space within the soil profile (USDA 2008).

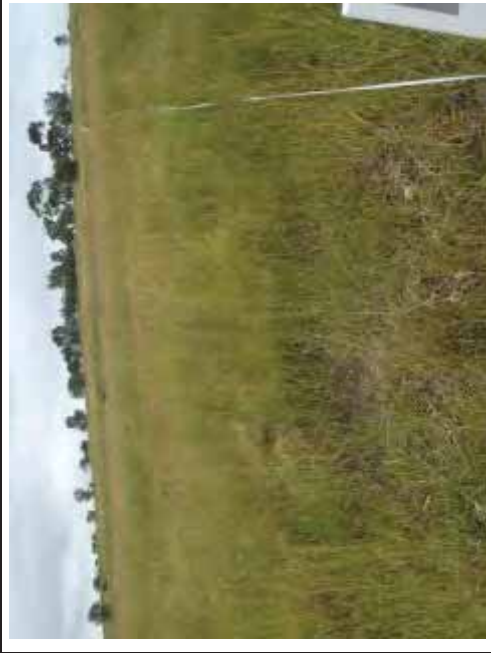
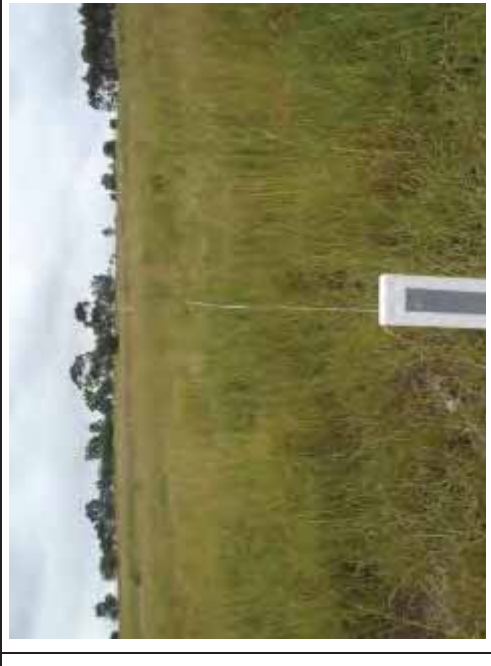
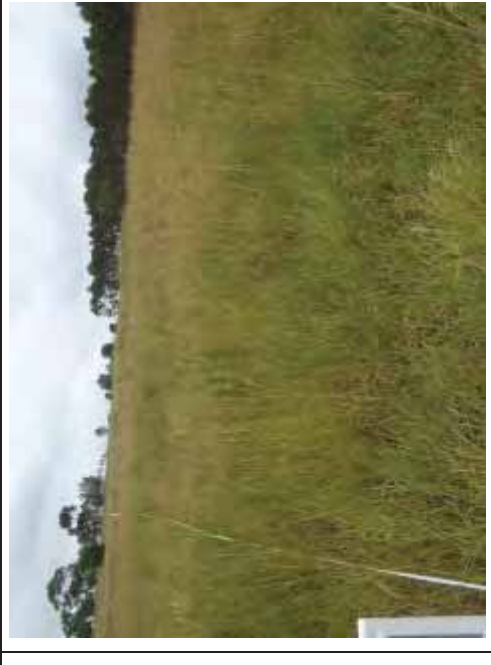
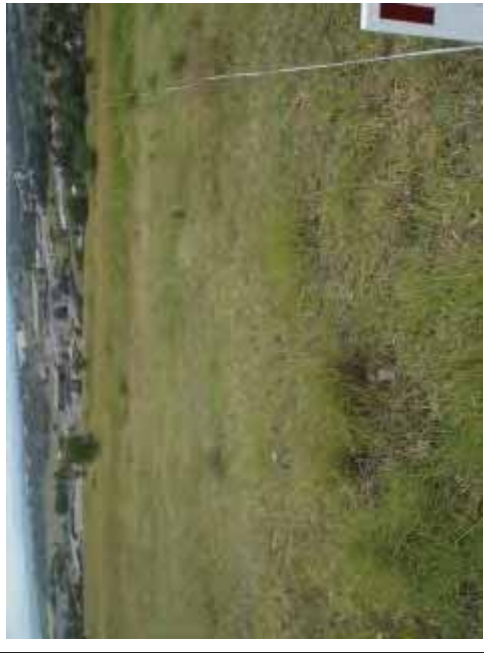
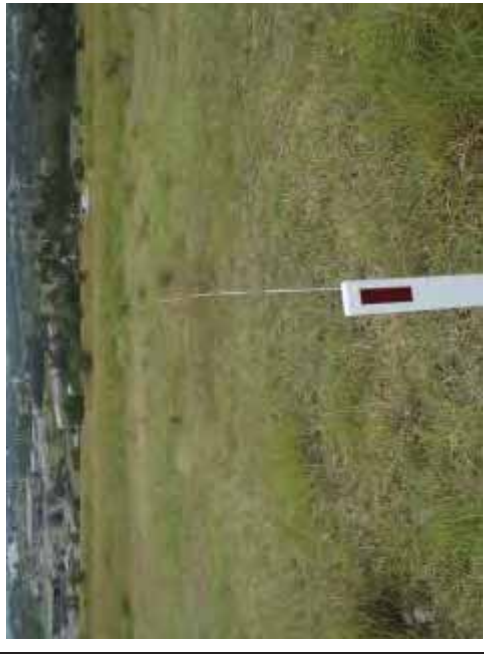
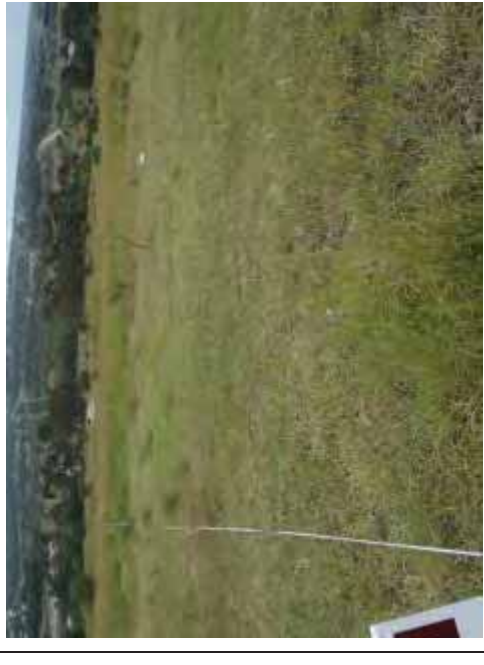
Monitoring site: RHB_MTO_North_Dump			
View from start of transect

at most rehabilitation sites were within the 'excellent' range of values (i.e. $\geq 65\%$, refer to Table 9), with only 'RHB_MTO_North_Dump' and 'RHB_WML_Swanlake' returning indices falling within the 'good' range of values (i.e. 60-65%), which correlates well with these two sites also having the lowest ground cover percentage as discussed above. Overall, all rehabilitation sites were stable with no signs of active erosion observed during the field survey.

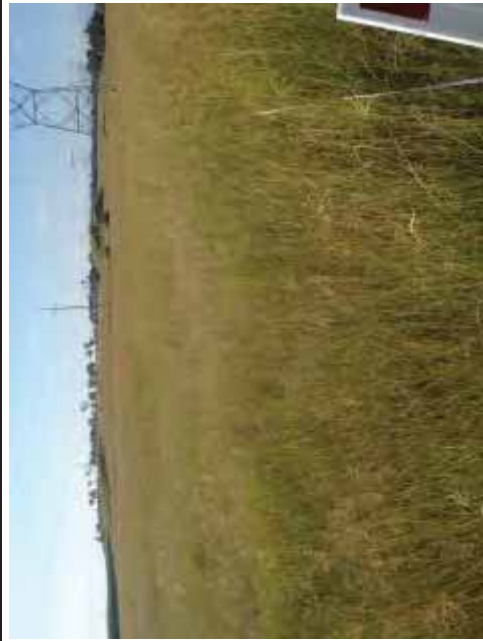
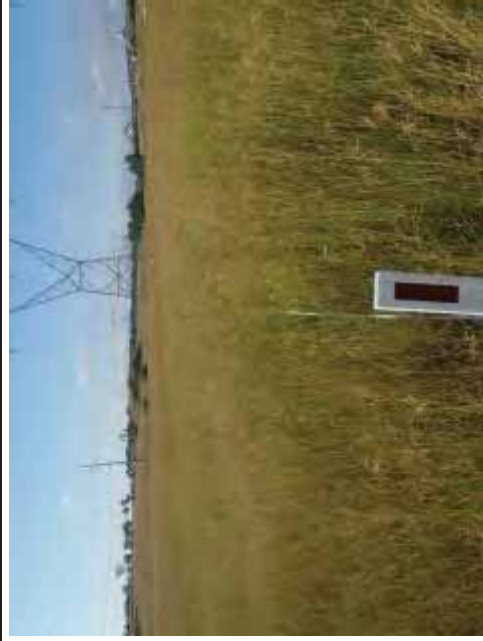
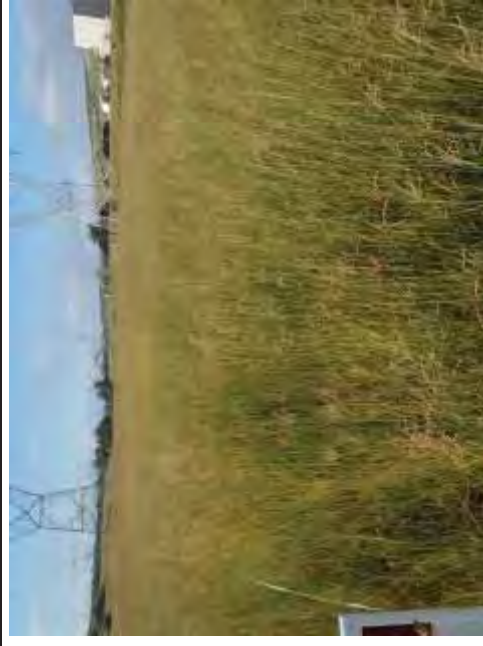
Monitoring site: ANA_North_CHPP

View from start of transect

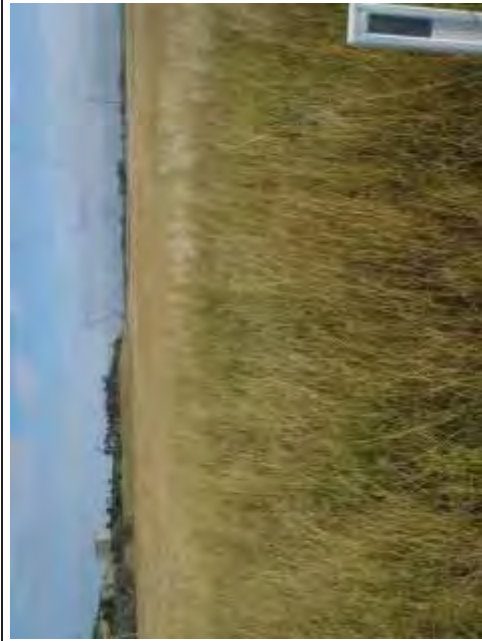
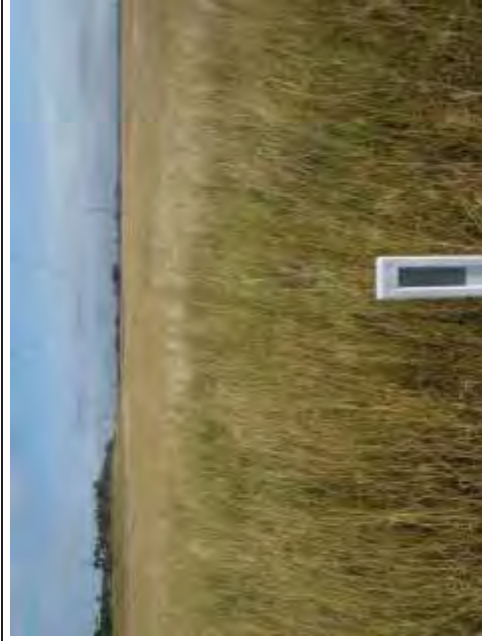
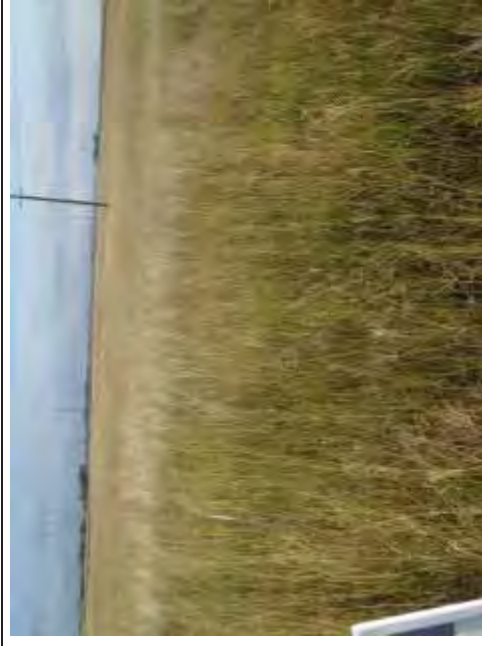
View from start of transect
