Hunter Valley Operations

2016 Annual Environmental Review

March 2017

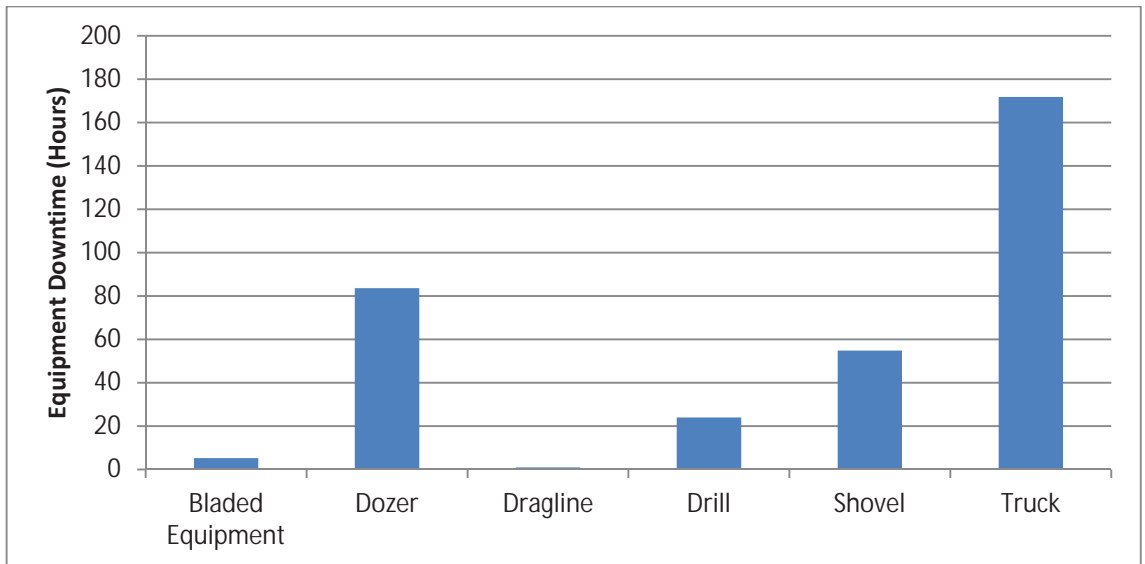
**Figure 3: Environmental delays due to noise 2016**

HVO manages noise to ensure compliance with permissible noise limits at nearby private residences. During the reporting period there were no non-compliances recorded against HVO's development consent limits. An additional two Komatsu 830E-DC haul trucks were fitted with sound attenuating equipment to reduce noise output. A total of 340.4 hours of equipment downtime was recorded due to proactive and reactive measures to minimise noise.

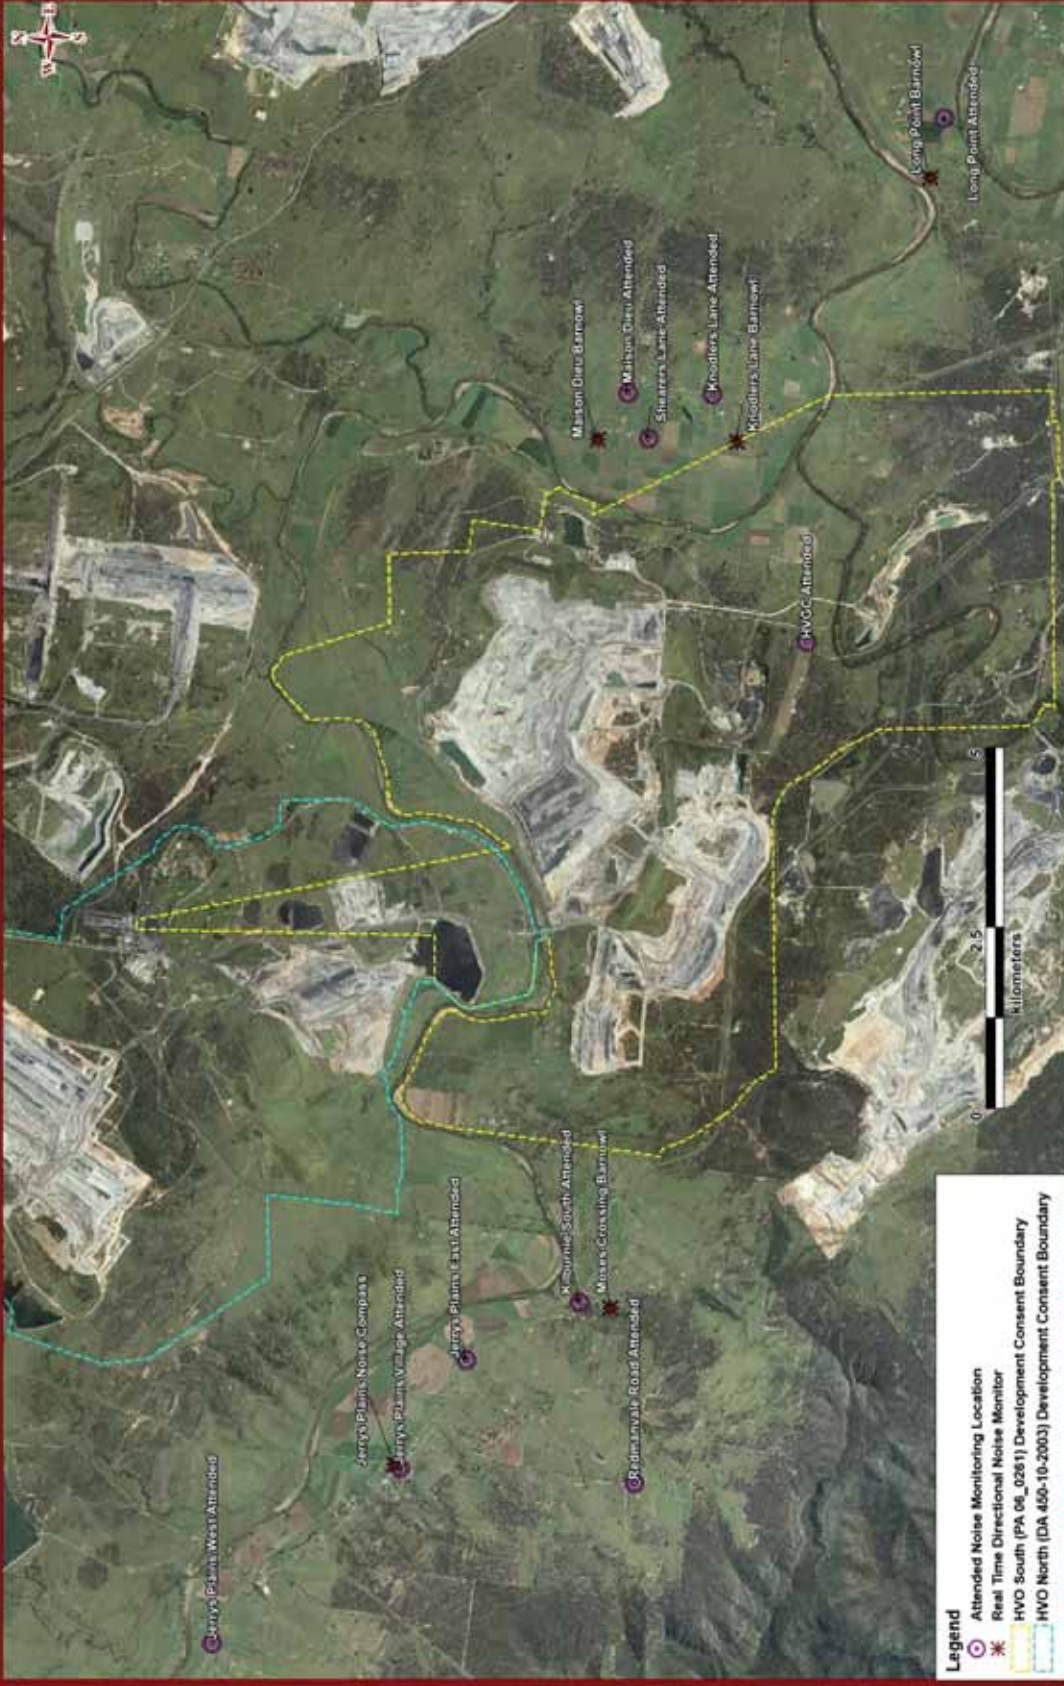
**Hunter Valley Operations  
 Noise Monitoring Locations**

The noise monitoring network was improved following the commissioning of an Environmental Noise Compass (ENC) in July 2016. The ENC utilises a 26 microphone array and conventional beamforming techniques (borrowed from military / submarine applications) to resolve the source direction of measured noise in real-time. The ENC replaced the Jerrys Plains BarnOwl monitor.

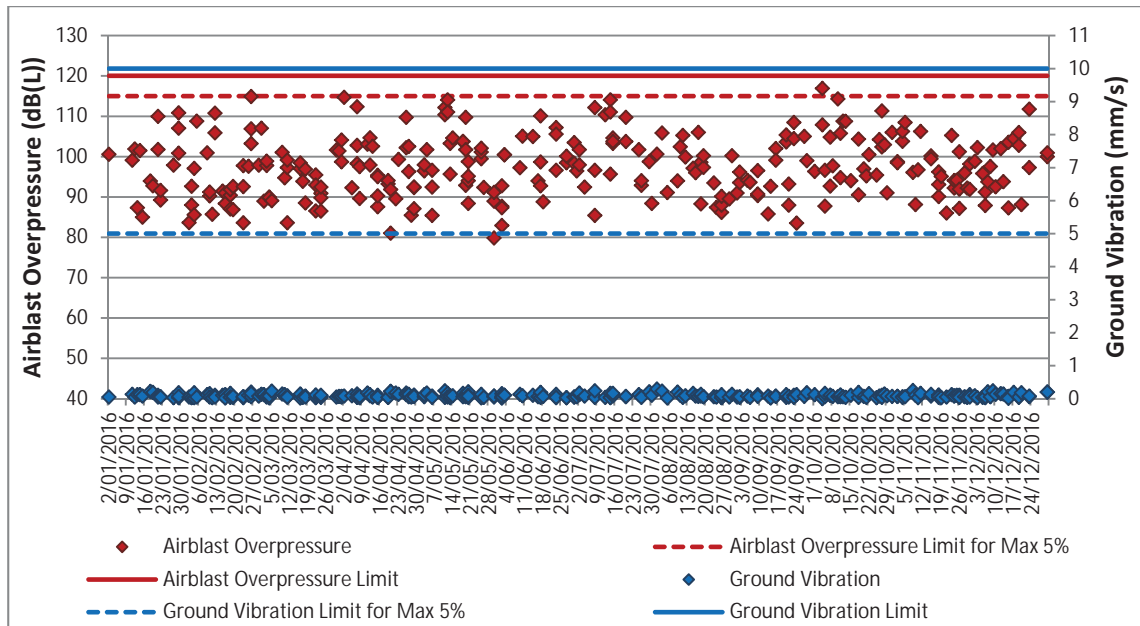
Figure 6: Jerrys Plains Blast Monitoring Results 2016

During the reporting period 289 blast events were initiated at HVO. One blast event on 25th February 2016 recorded an airblast overpressure result of 125.78dB(L), exceeding the Airblast Overpressure criterion of 120.0 dB(L). HVO complied with all other blasting related consent and licence conditions during the reporting period. Airblast Overpressure and Ground Vibration results for all blasts fired during the reporting period are displayed in Figure 6 to Figure 10.

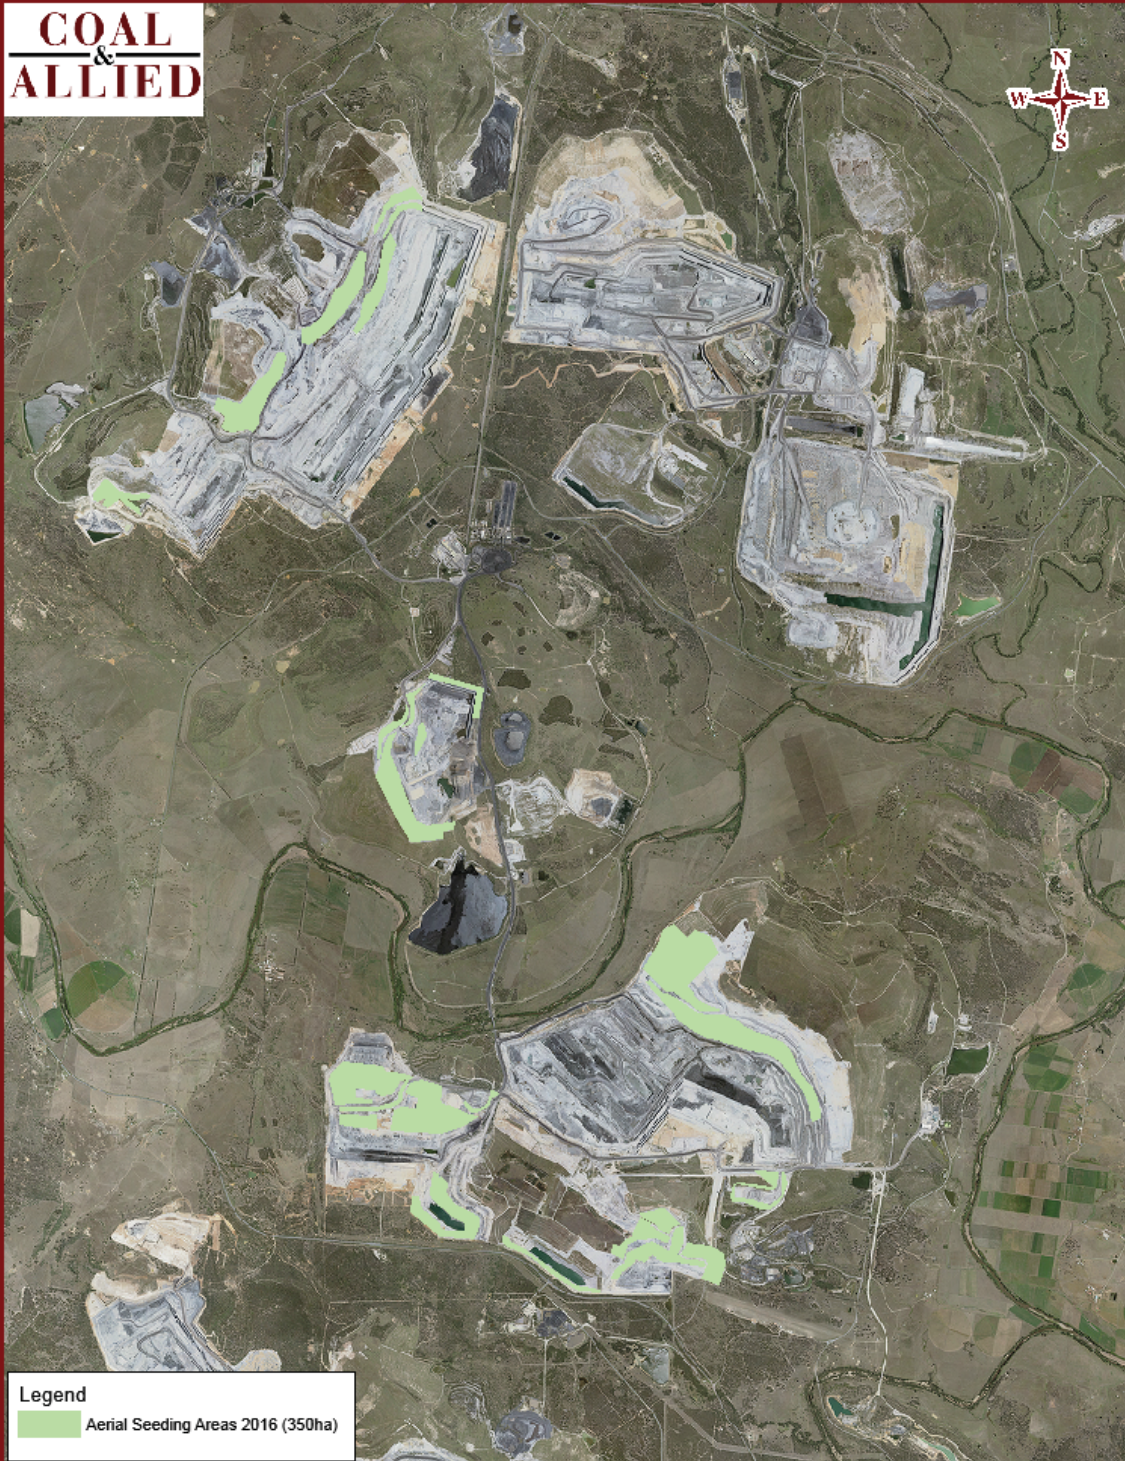
# 2016 Aerial Seeding Areas

**Legend**  
Aerial Seeding Areas 2016 (350ha)

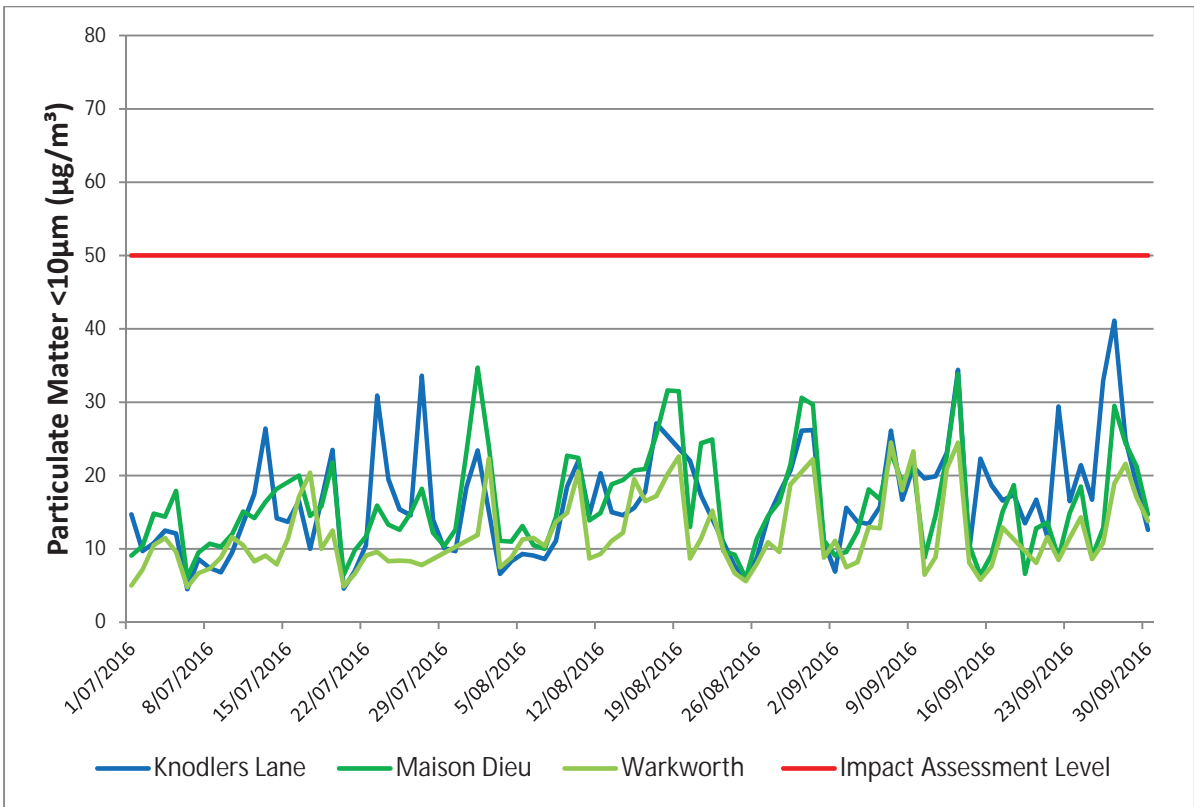
Monitoring results for 2016 PM<sub>10</sub> (24 hour) collected through the High Volume Air Sampler monitoring regime compared against the short term impact assessment criteria are shown in Figure 17. All 24hr average results recorded by HVO's surrounding network of TEOM monitors are presented on a quarterly basis in Figure 18 to Figure 21.

**Figure 18: 24hr average PM<sub>10</sub> (real time monitors) - Quarter One 2016**

**Figure 19: 24hr average PM<sub>10</sub> (real time monitors) - Quarter Two 2016**

**Figure 20: 24hr average PM<sub>10</sub> (real time monitors) - Quarter Three 2016**

**Figure 21: 24hr average PM<sub>10</sub> (real time monitors) - Quarter Four 2016**

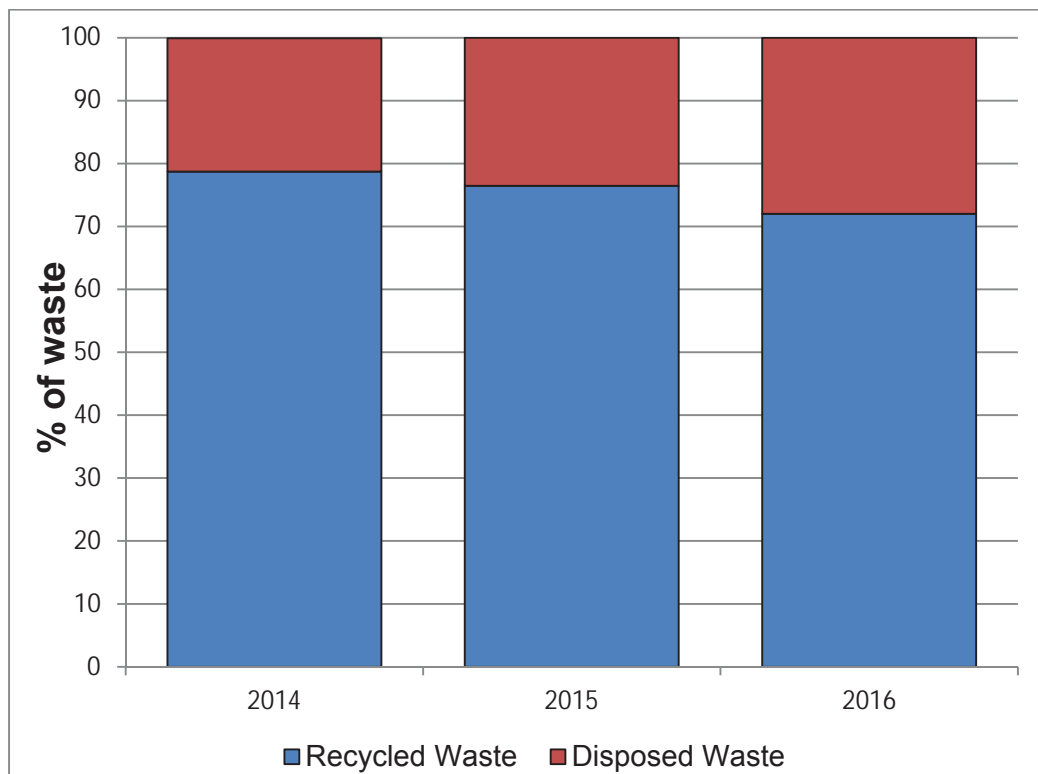
All wastes leaving the site are tracked and recorded; Regulated wastes are tracked and reported in accordance with regulatory requirements. Figure 23 and Figure 24 depict the waste statistics at HVO. This information is used by HVO personnel to identify areas of improvements and track performance against targets.

Figure 23: HVO waste streams trend 2014- 2016

**Figure 24: Waste disposed off-site from HVO activities from 2014 to 2016**

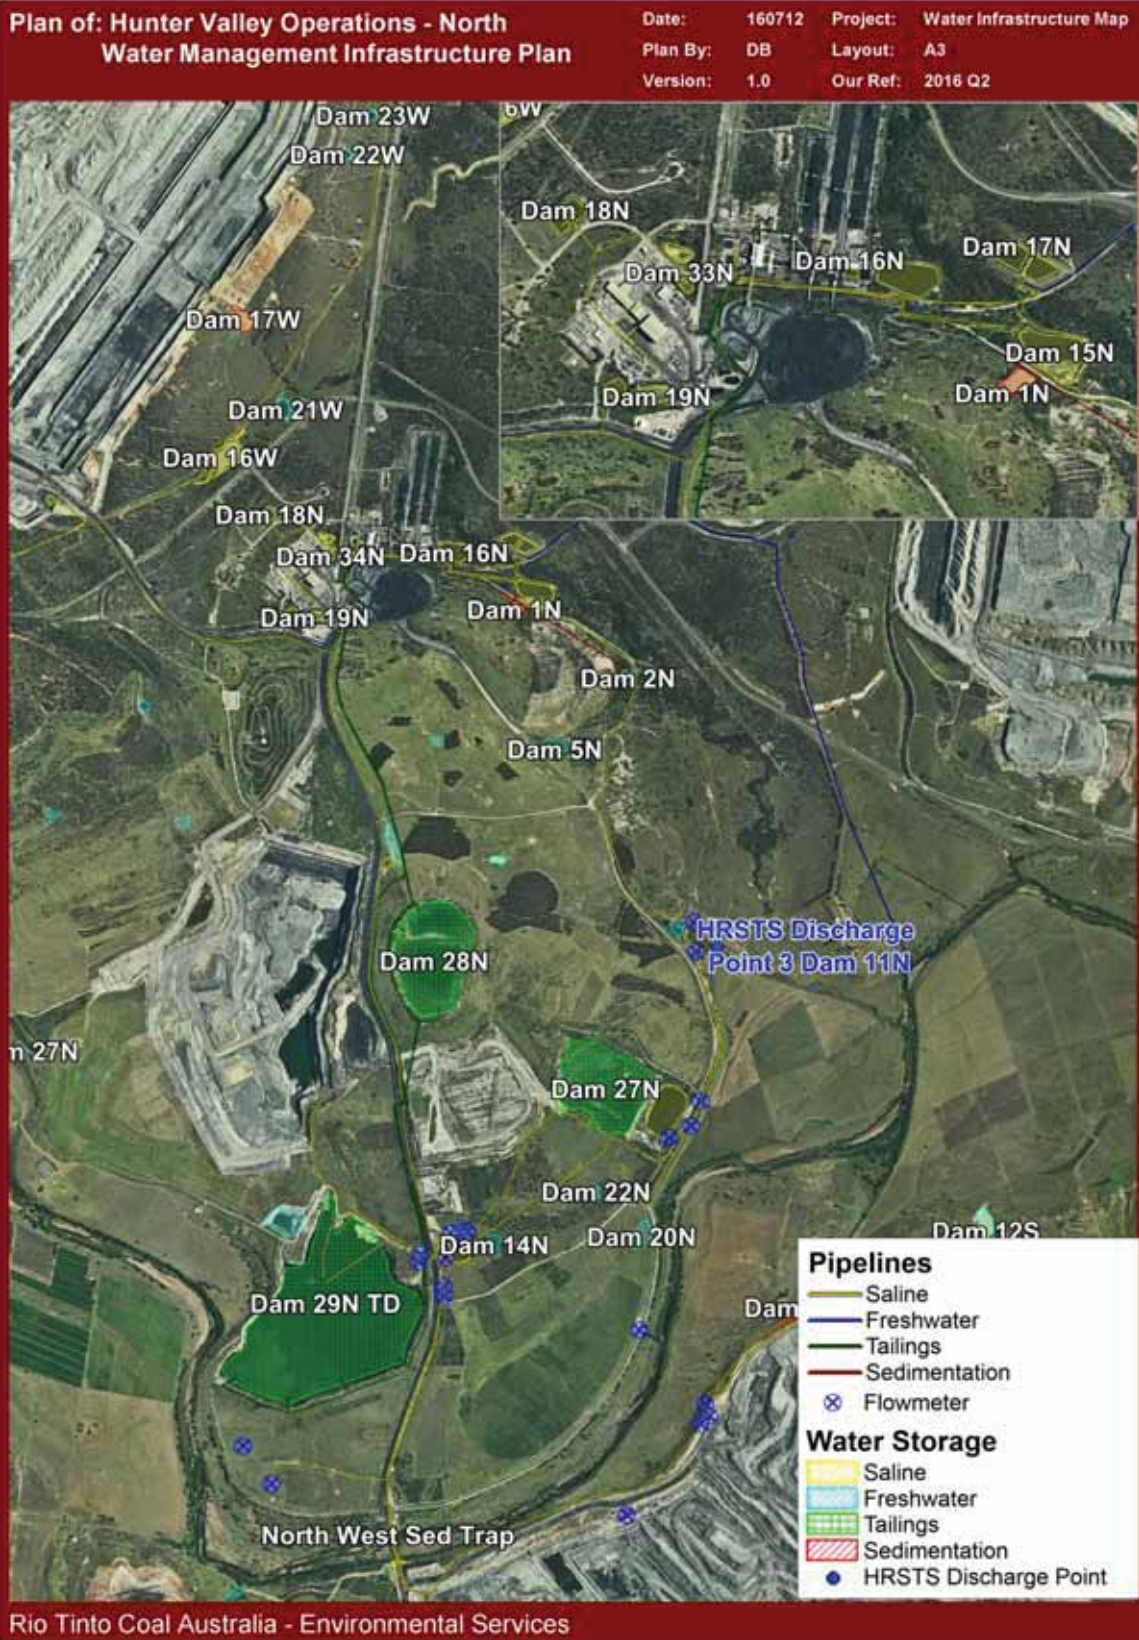
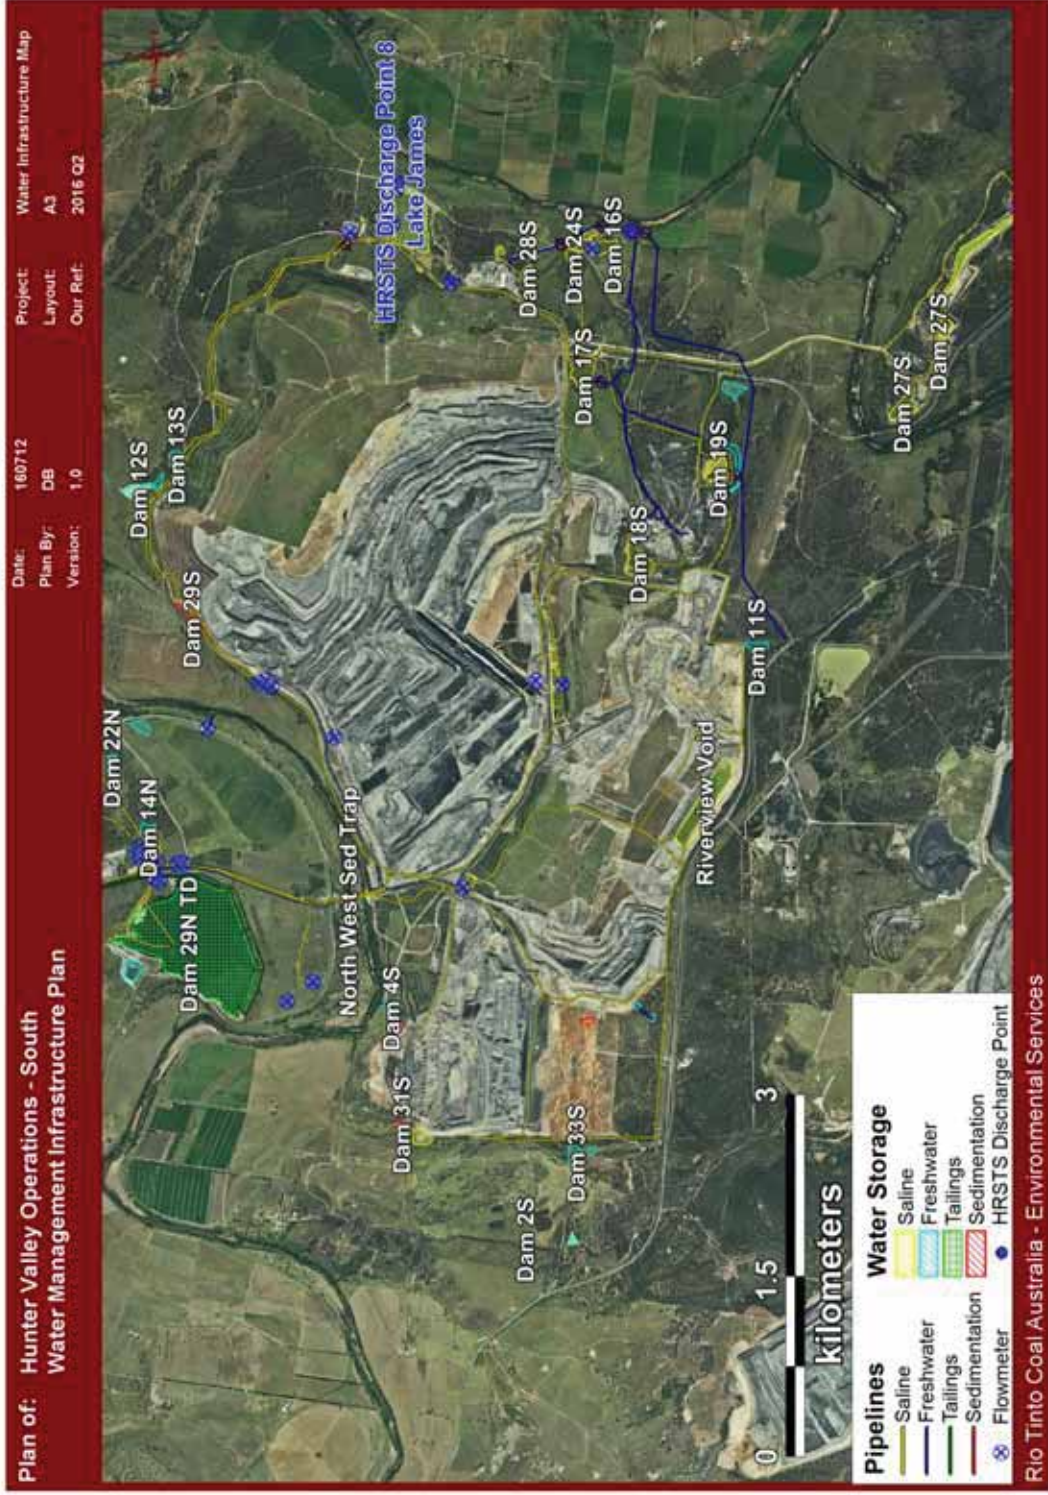
Plans showing the layout of all water management structures and key pipelines are shown in Figure 25 to Figure 27. The HVO Water Management Plan contains further detail on management practices and is available on Rio Tinto Coal Australia's website.

Figure 25: West Pit water management infrastructure

Figure 26: North Pit water management infrastructure

**Figure 27: South Pit water management infrastructure**

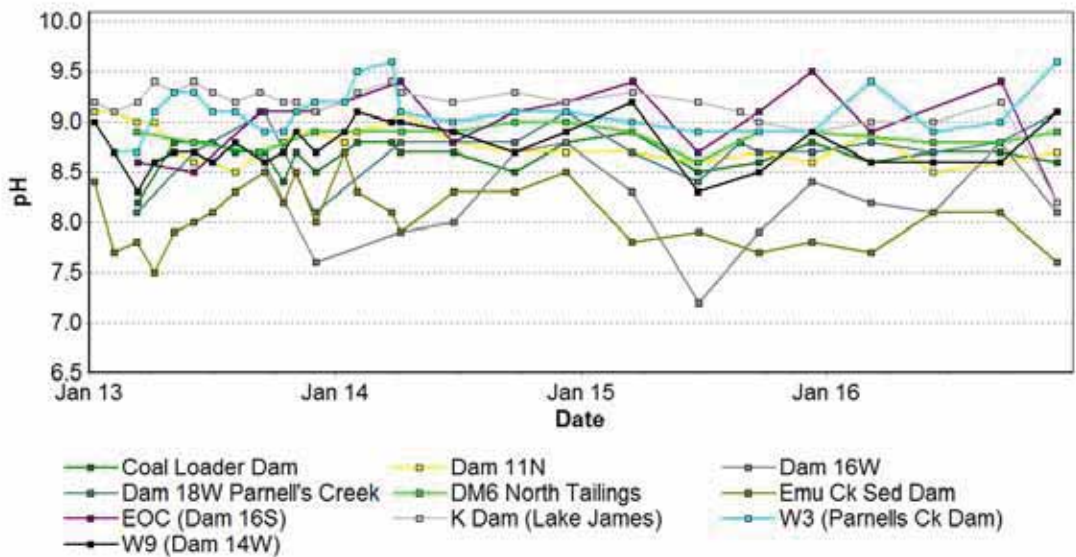
Figure 40: HVO Site Dams pH Trends 2013 – 2016

40 samples were collected across 10 dams during 2016; long term trends for pH, EC and TSS are shown in Figure 40 to Figure 42. EC results show a slight increasing trend during the reporting period, as a result of drier weather conditions reducing rainfall runoff inflows to the mine water management system. Emu Creek Sed Dam continues to record elevated TSS concentrations, associated with the advancement of mining around the dam; noting the dam is operated to spill back into the pit and will not flow offsite.

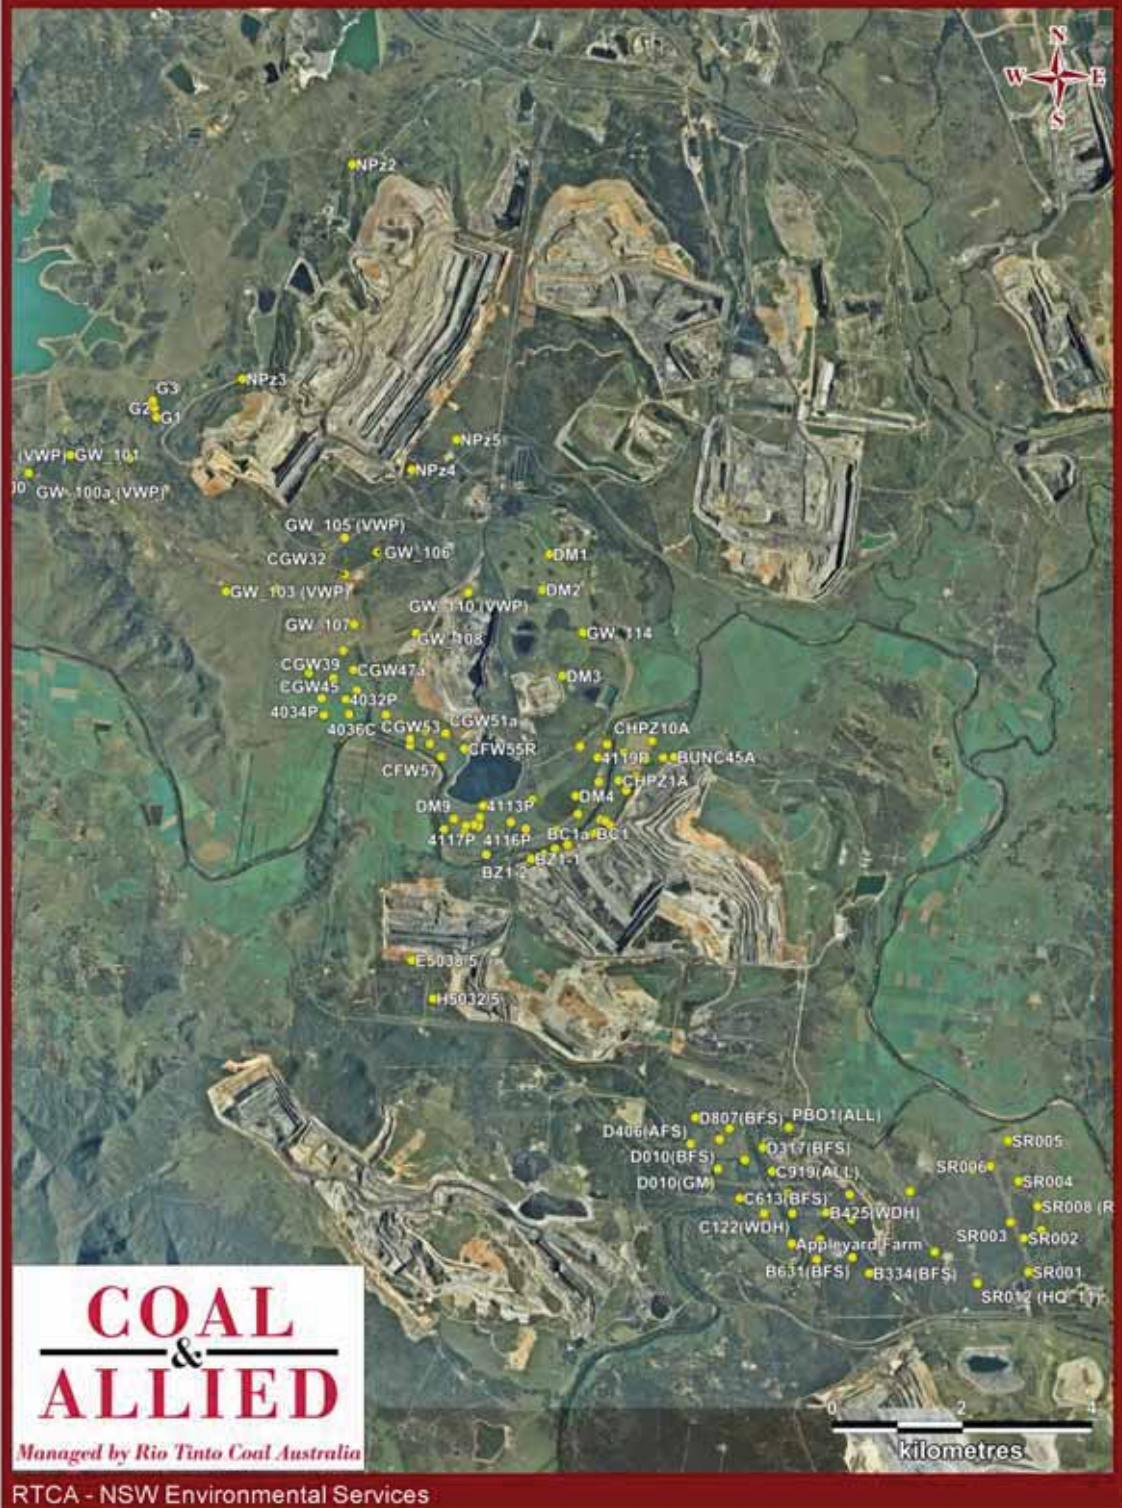
Figure 43: Groundwater Monitoring Network at HVO - 2016

Location	Data Recovery (%)	Comments
4051C	50%	Bore unable to be sampled in September and December due to obstruction (potential bore collapse) – investigation underway.
4036C	25%	Insufficient water during June, September and December monitoring events.
DM7	75%	No safe access to site during December monitoring event.
4113P	25%	Bore unable to be sampled in June, September and December due to obstruction (potential bore collapse) – investigation underway.
4119P	75%	No safe access to site during September monitoring event.
CGW47a	75%	Insufficient water during June monitoring event.

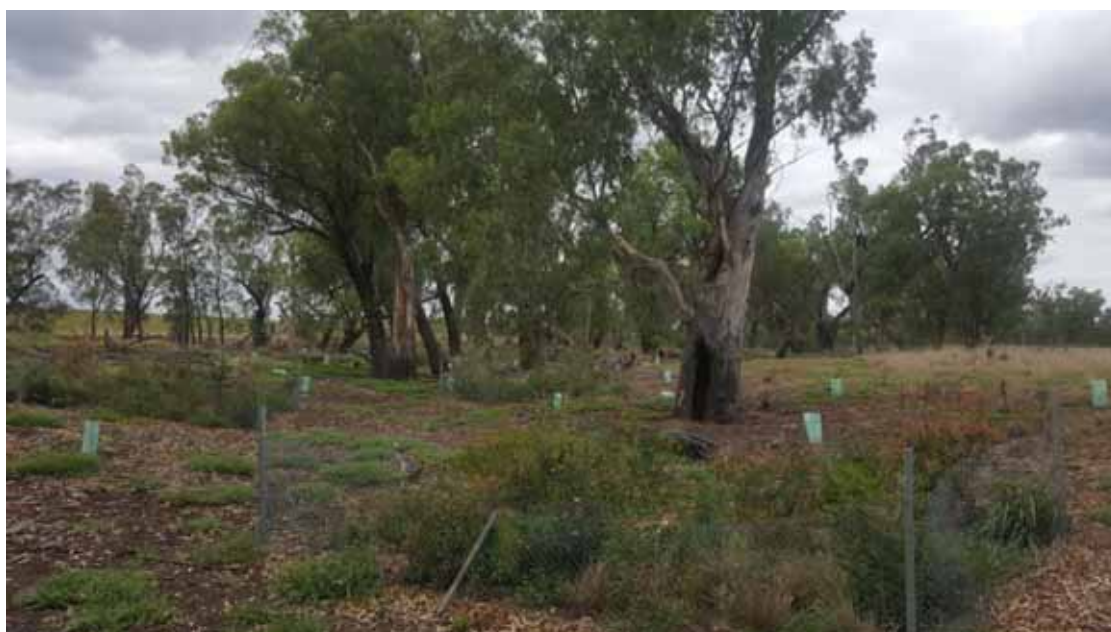
**Figure 97: Native tube stock planting at Carrington Billabong**

Cattle grazing has been excluded from the Carrington Billabong since 2007 to reduce the impact on native vegetation. During spring 2015 a native tube stock planting programme was undertaken in the Carrington Billabong including grasses, shrubs and small trees making up a total of 1000 plants. These were broken down into 500 grasses, 250 shrubs and 250 small trees. The tube stock was planted into weed mat islands that were fenced off for protection against rabbit and kangaroo browsing. In addition to these tube stock 300 River Red Gum tube stock were planted into the area during early December. Plants were watered in at the time of planting and have received ongoing watering over the summer period. An additional native understorey planting is scheduled to be undertaken in autumn 2017 to increase the overall diversity of the Carrington Billabong. Figure 97 shows the mature weed mat islands at the Carrington Billabong.

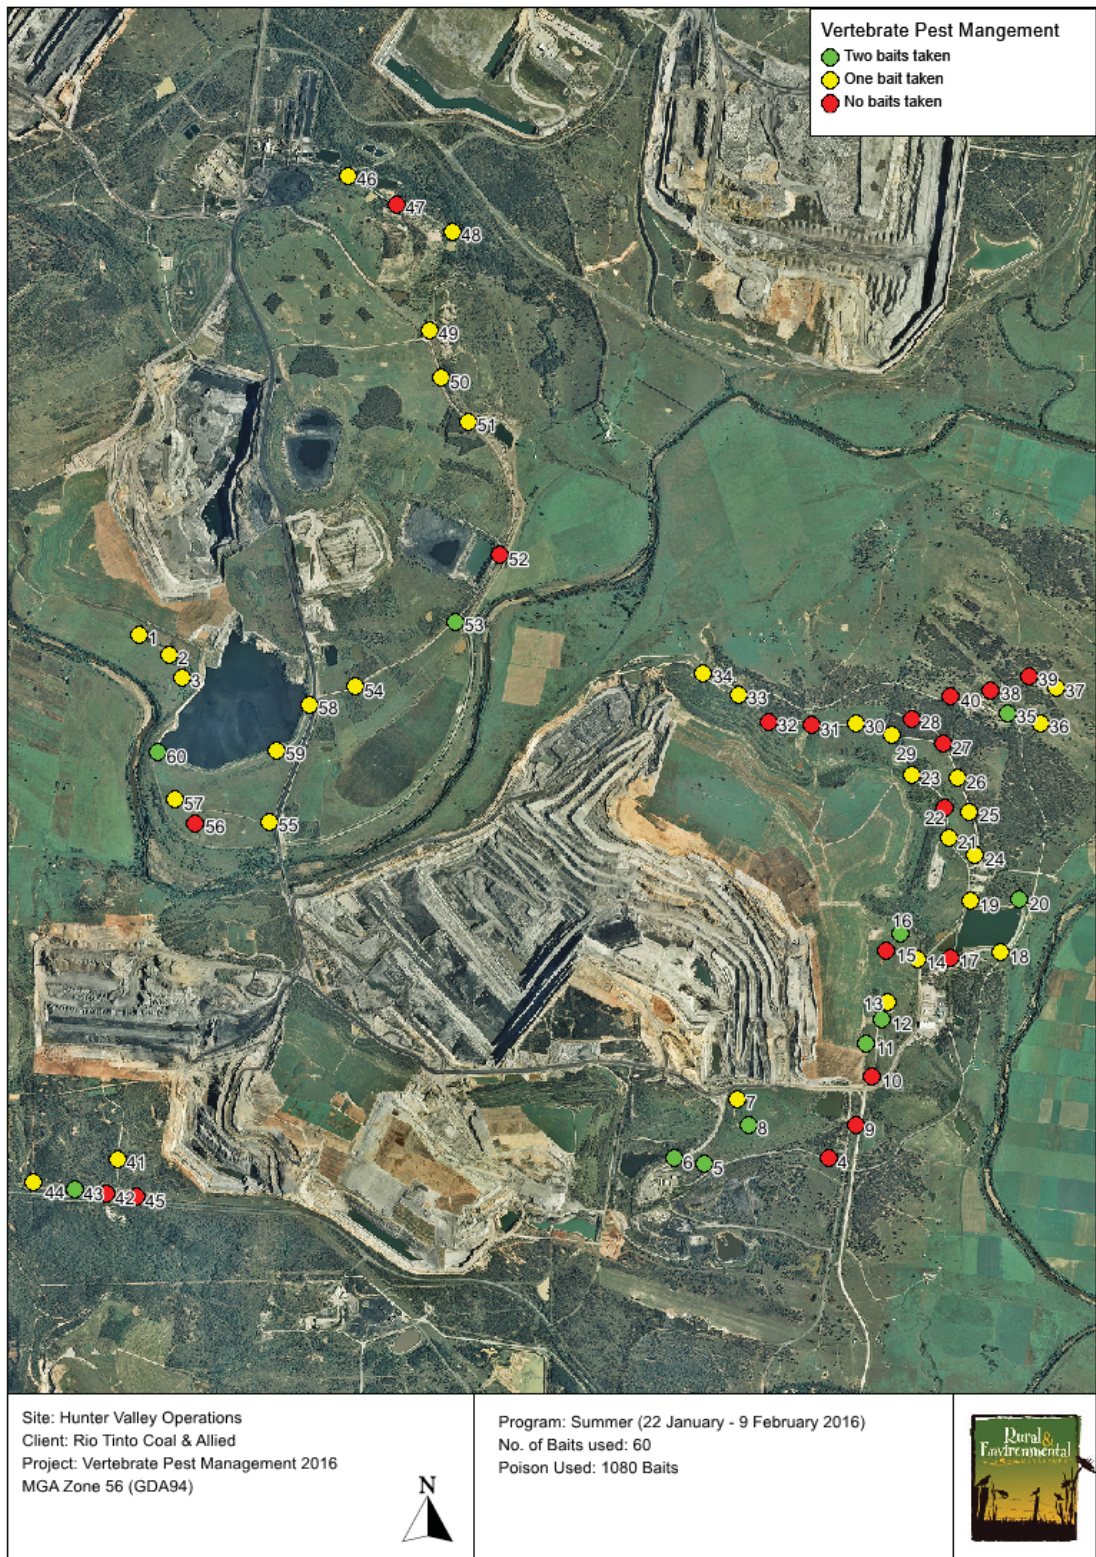
**Figure 101: HVO Vertebrate Pest Management Bait Locations – Summer 2016**

As part of HVO's Vertebrate Pest Action Plan a control programme is carried out on a seasonal basis within HVO. Three 1080 ground baiting programmes consisting of 60 bait sites utilising meat baits and ejector baits were undertaken during summer, winter and spring to target wild dogs and foxes. Baits were checked over a two to four week period and replaced each week when taken. Table 45 summarises the results from the programmes carried out at HVO during 2016 with baiting locations and results for the programs illustrated in Figure 101, Figure 102 and Figure 103.
