COMPLIANCE AUDIT REPORT

HUNTER VALLEY OPERATIONS SOUTH – TOPSOIL MANAGEMENT

Hunter Valley Operations Pty Ltd

As part of the compliance audit program, an audit of the topsoil management activities associated with the mining operations at Hunter Valley Operations South (HVO South) was undertaken on 5 June 2019.

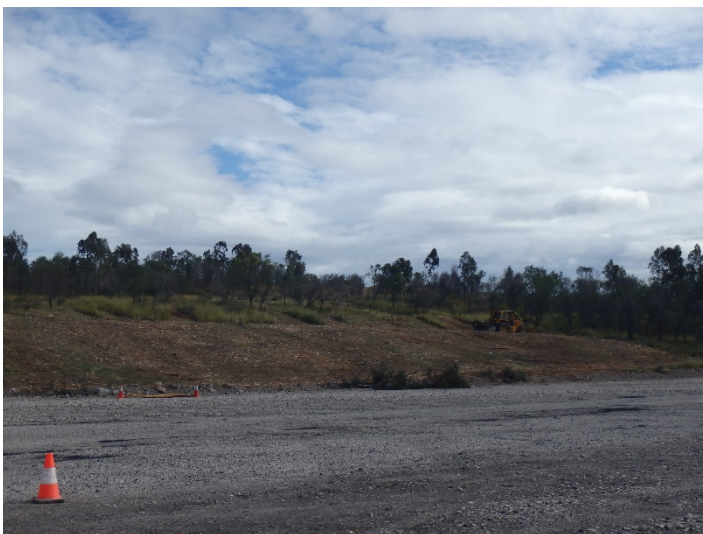
It was observed that grubbing of the area had been completed to remove large trees and shrubs from the site (Figure 1). A mulcher was in operation on the groundcover along the strip for incorporation into the topsoil when stripped. This process was observed to be consistent with the process described in section 2.4.2.3 of the MOP.

Figure 1 Mulcher on Cheshunt strip 24 before topsoil removal

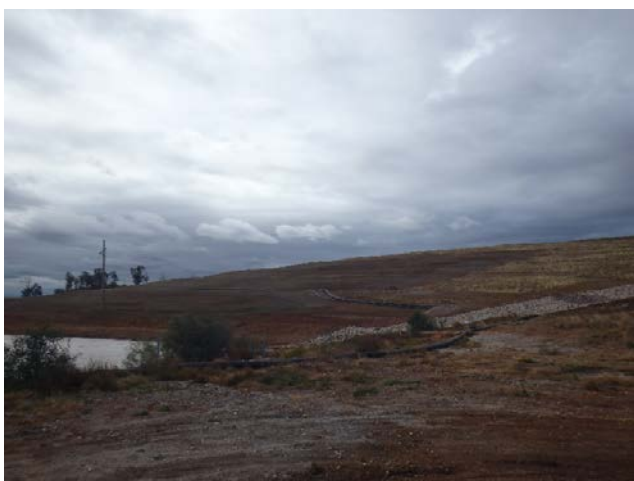
HVO has identified that direct placement of topsoil was the preferred option when undertaking topsoil stripping operations and the site inspection identified several areas of rehabilitation have had direct placement of topsoil, for example, topsoil stripped from Riverview South was direct placed on Riverview North (Figure 2).

Figure 2 An area of Riverview North where topsoil was direct placed

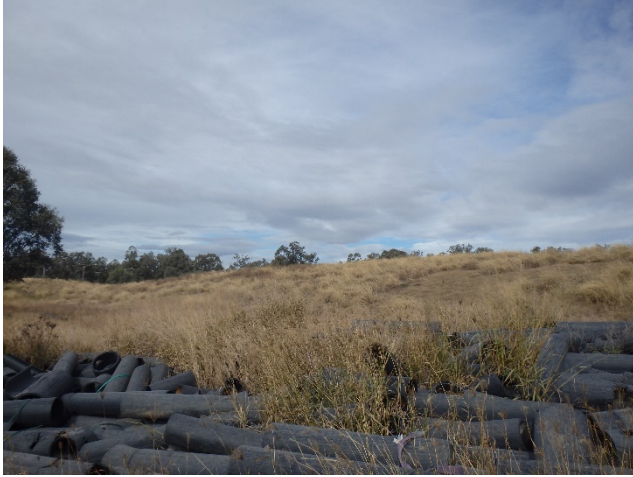
However, one older stockpile (possibly 15+ years old) was observed next to a laydown area for high density polyethylene pipe (HDPE pipe) (Figure 3). Although the stockpile was well vegetated and signposted, there was a risk that vehicles could inadvertently impact the stockpile during placement or retrieval of the pipe sections. The location of the laydown area for the HDPE pipe would not appear to be consistent with the location principles for topsoil stockpiles specified in the MOP. It is acknowledged that this stockpile was established before the existing guidelines for topsoil management, however, the placement of HDPE pipe has occurred after stockpile establishment and the pipes could be moved to a more suitable location. This is raised as **observation of concern no. 2**.

Figure 3 An older topsoil stockpile immediately adjacent to a pipe laydown area

OBSERVATION OF CONCERN NO.	DESCRIPTION OF ISSUE	RECOMMENDATION
1	Generally, the descriptions in the MOP relating to topsoil management are very brief and quite generic using language such as ‘where possible’ or ‘if required’. Using a risk-based approach to topsoil management, it would be expected that some form of trigger action response plan (TARP) would be available to provide the triggers for ‘when’ a particular control might be required.	This should be addressed during the development of the topsoil management plan being prepared in response to the Section 240 direction issued in October 2018.
2	One older stockpile (possibly 15+ years old) was observed to be located next to a laydown area for high density polyethylene pipe (HDPE pipe). Although the stockpile was well vegetated and signposted, there was a risk that vehicles could inadvertently impact the stockpile during placement or retrieval of the pipe sections. The location of the laydown area for the HDPE pipe would not appear to be consistent with the location principles for topsoil stockpiles specified in the MOP.	HVO should review the risks associated with the pipe laydown area adjacent to the topsoil stockpile and implement controls as required.

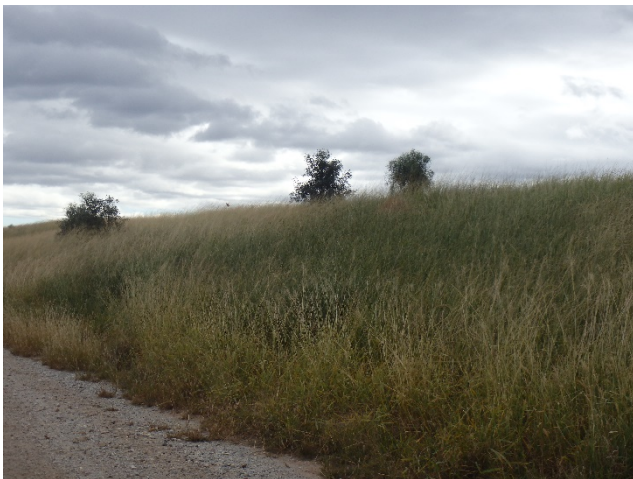
The MOP states that stockpiles will generally be sown with a multi-species cover crop, and generally the stockpiles inspected had been sown similar to stockpile 53 (Figure 4). However, the procedure for sowing of stockpiles does not appear to be consistently implemented as stockpile 47 did not appear to have a cover crop sown (Figure 5).

Figure 4 Topsoil stockpile 53, sown and well vegetated

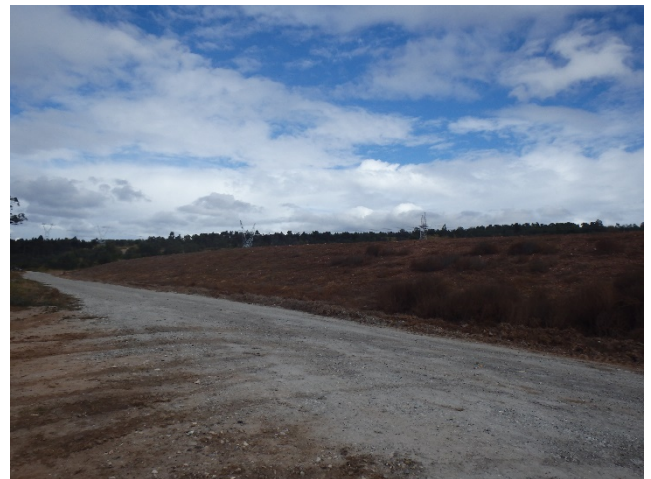
Figure 5 Topsoil stockpile 47, not sown, little vegetation
