Hunter Valley Operations

Business Papers – November 2017

Environmental Monitoring Report – June 2017

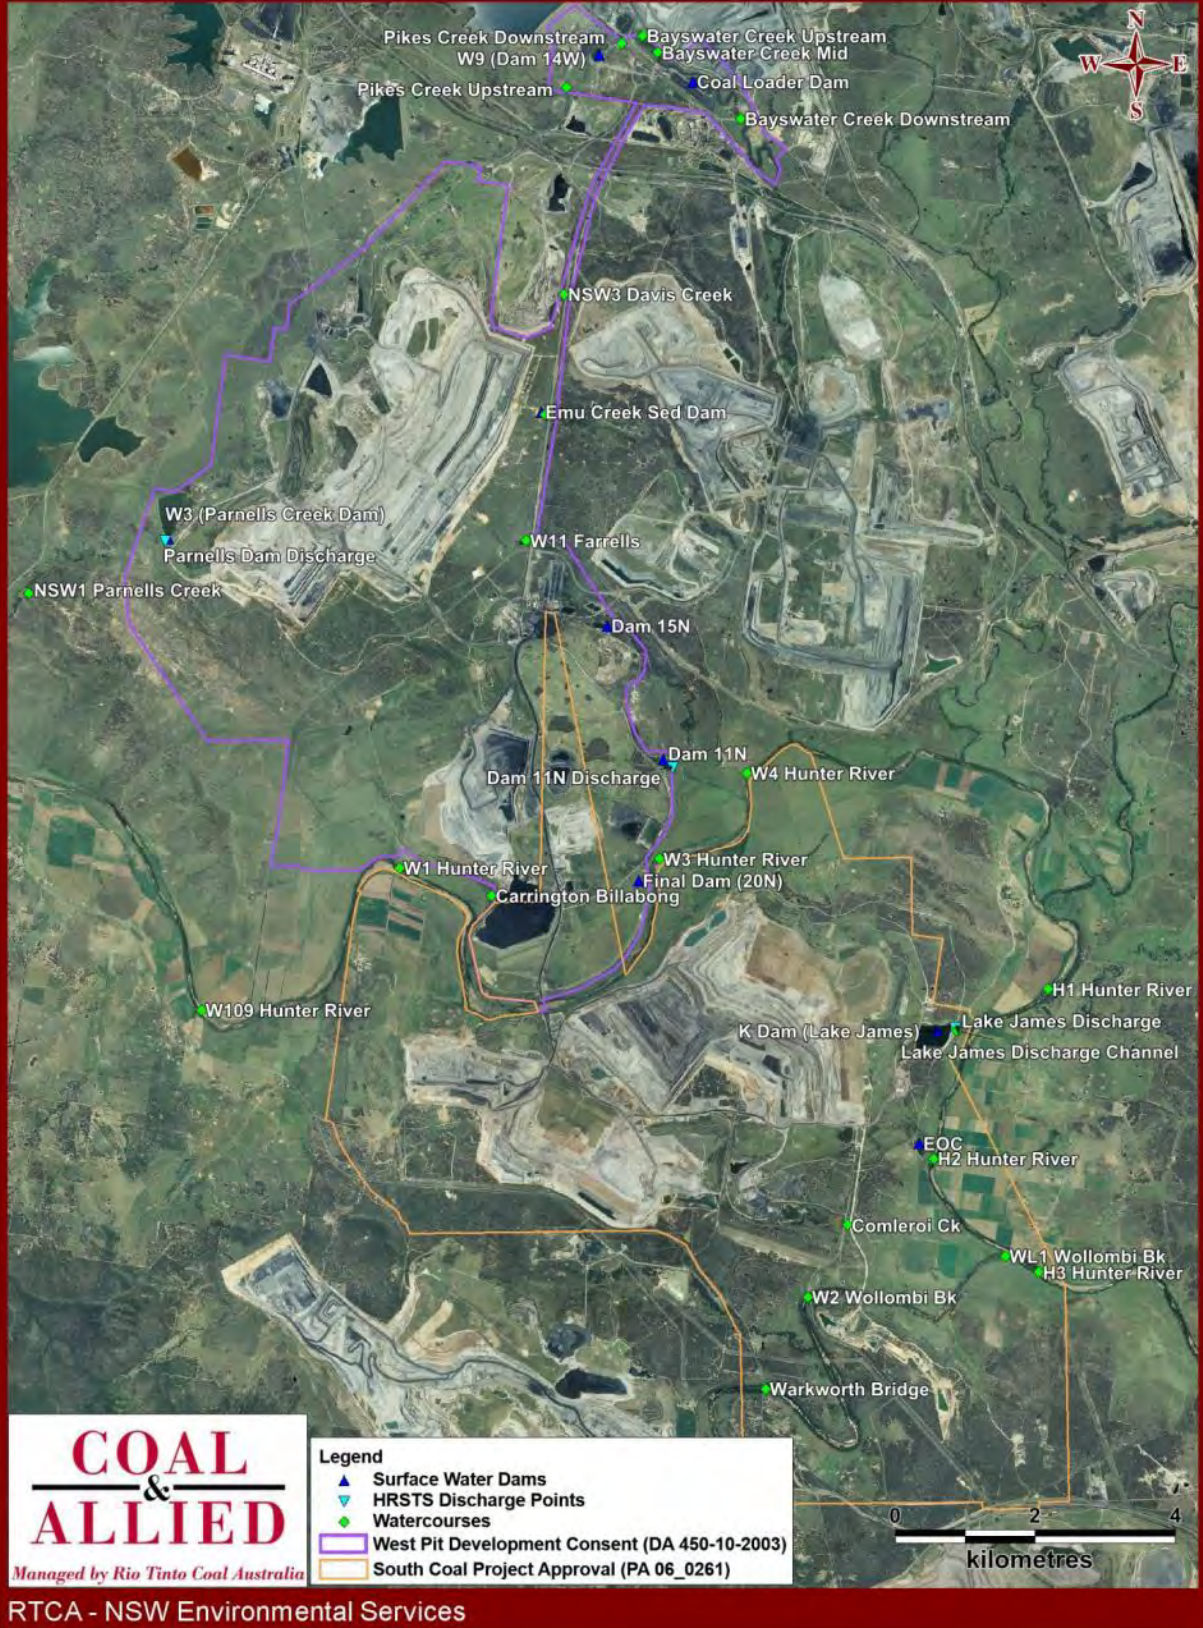
Figure 22: Surface Water Monitoring Location Plan

**Hunter Valley Operations
Surface Water Monitoring Locations**

The location of Surface Water monitoring locations is shown in **Figure 22**.

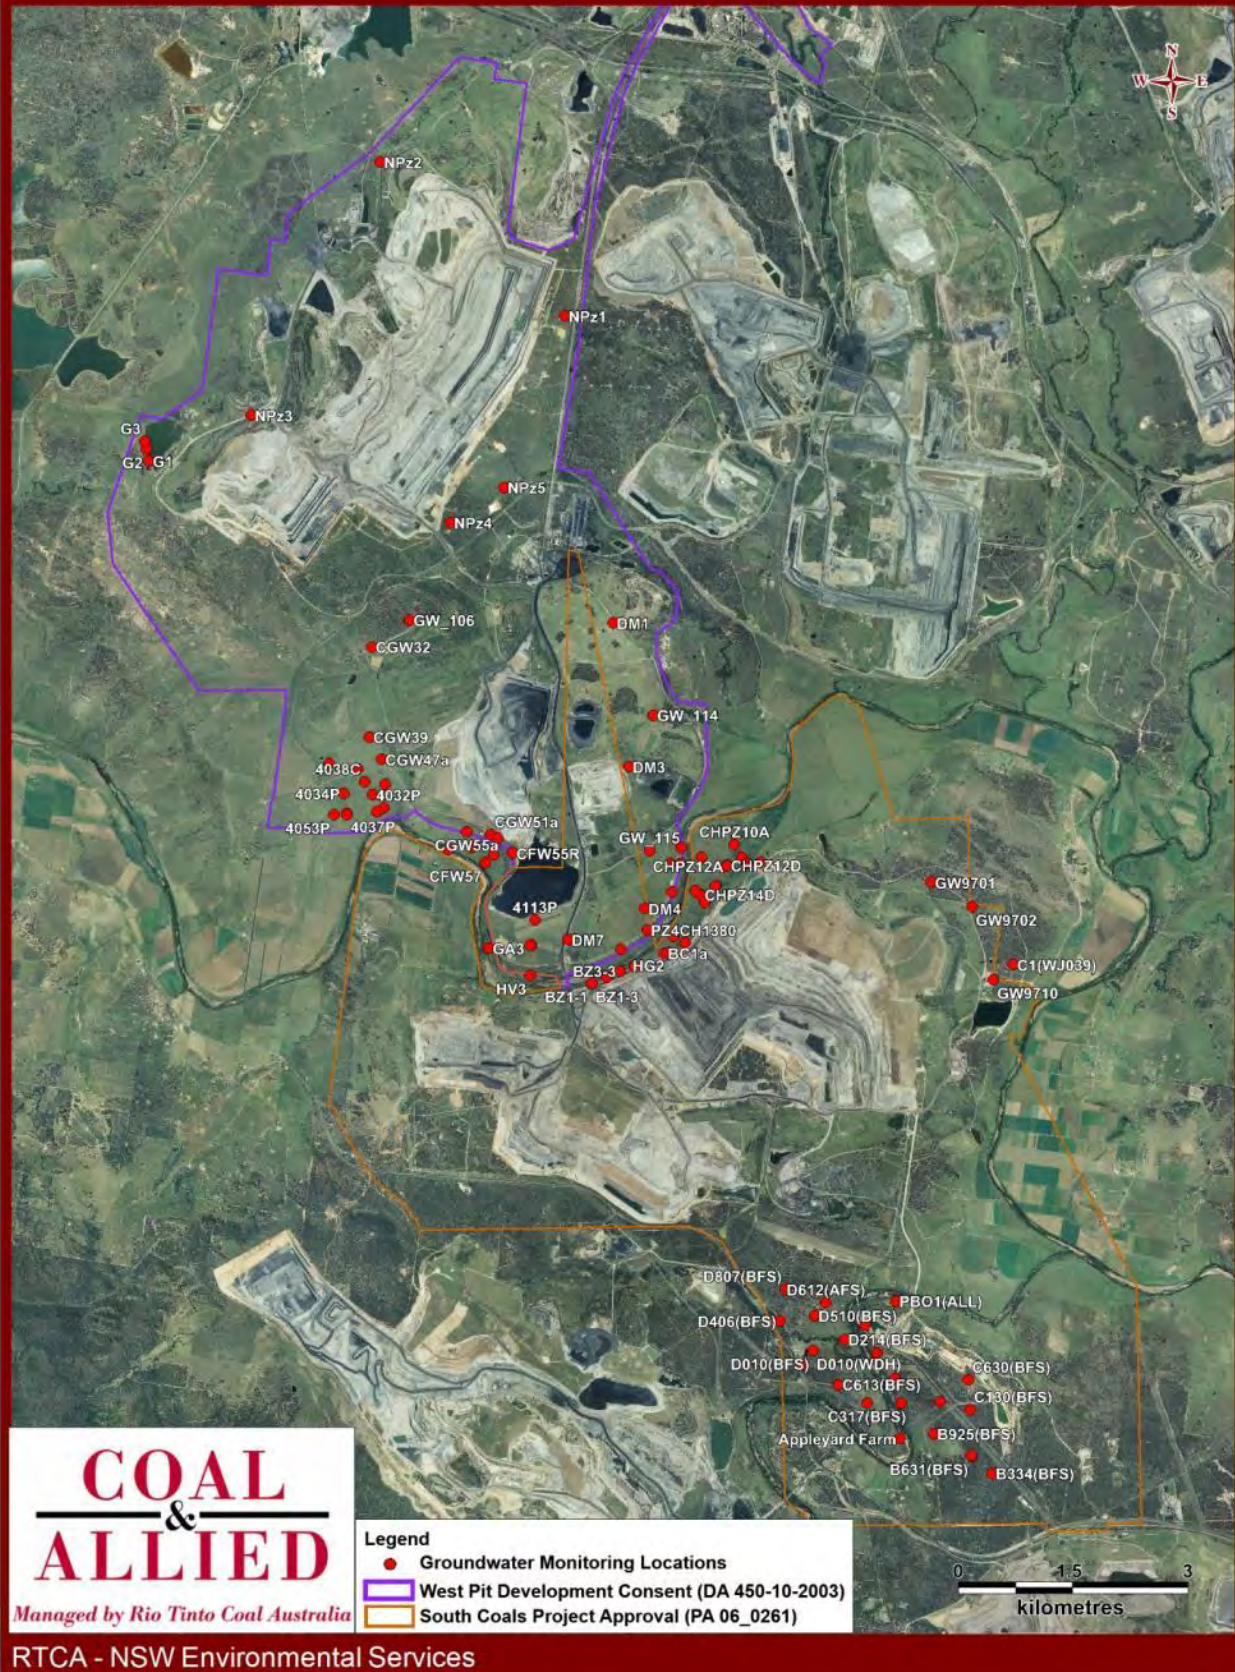
Figure 77: Groundwater Monitoring Location Plan

**Hunter Valley Operations
Groundwater Monitoring Locations**

Groundwater monitoring is undertaken on a quarterly basis in accordance with the HVO Water Management Plan and Ground Water Monitoring Programme. Monitoring sites are shown in **Figure 77**.

Internal trigger limits have been developed to assess monitoring data on an on-going basis, and to highlight potentially adverse groundwater impacts. The process for evaluating monitoring results against the internal triggers and subsequent responses are outlined in the HVO Water Management Plan. Locations of groundwater bores are shown in Figure 77.

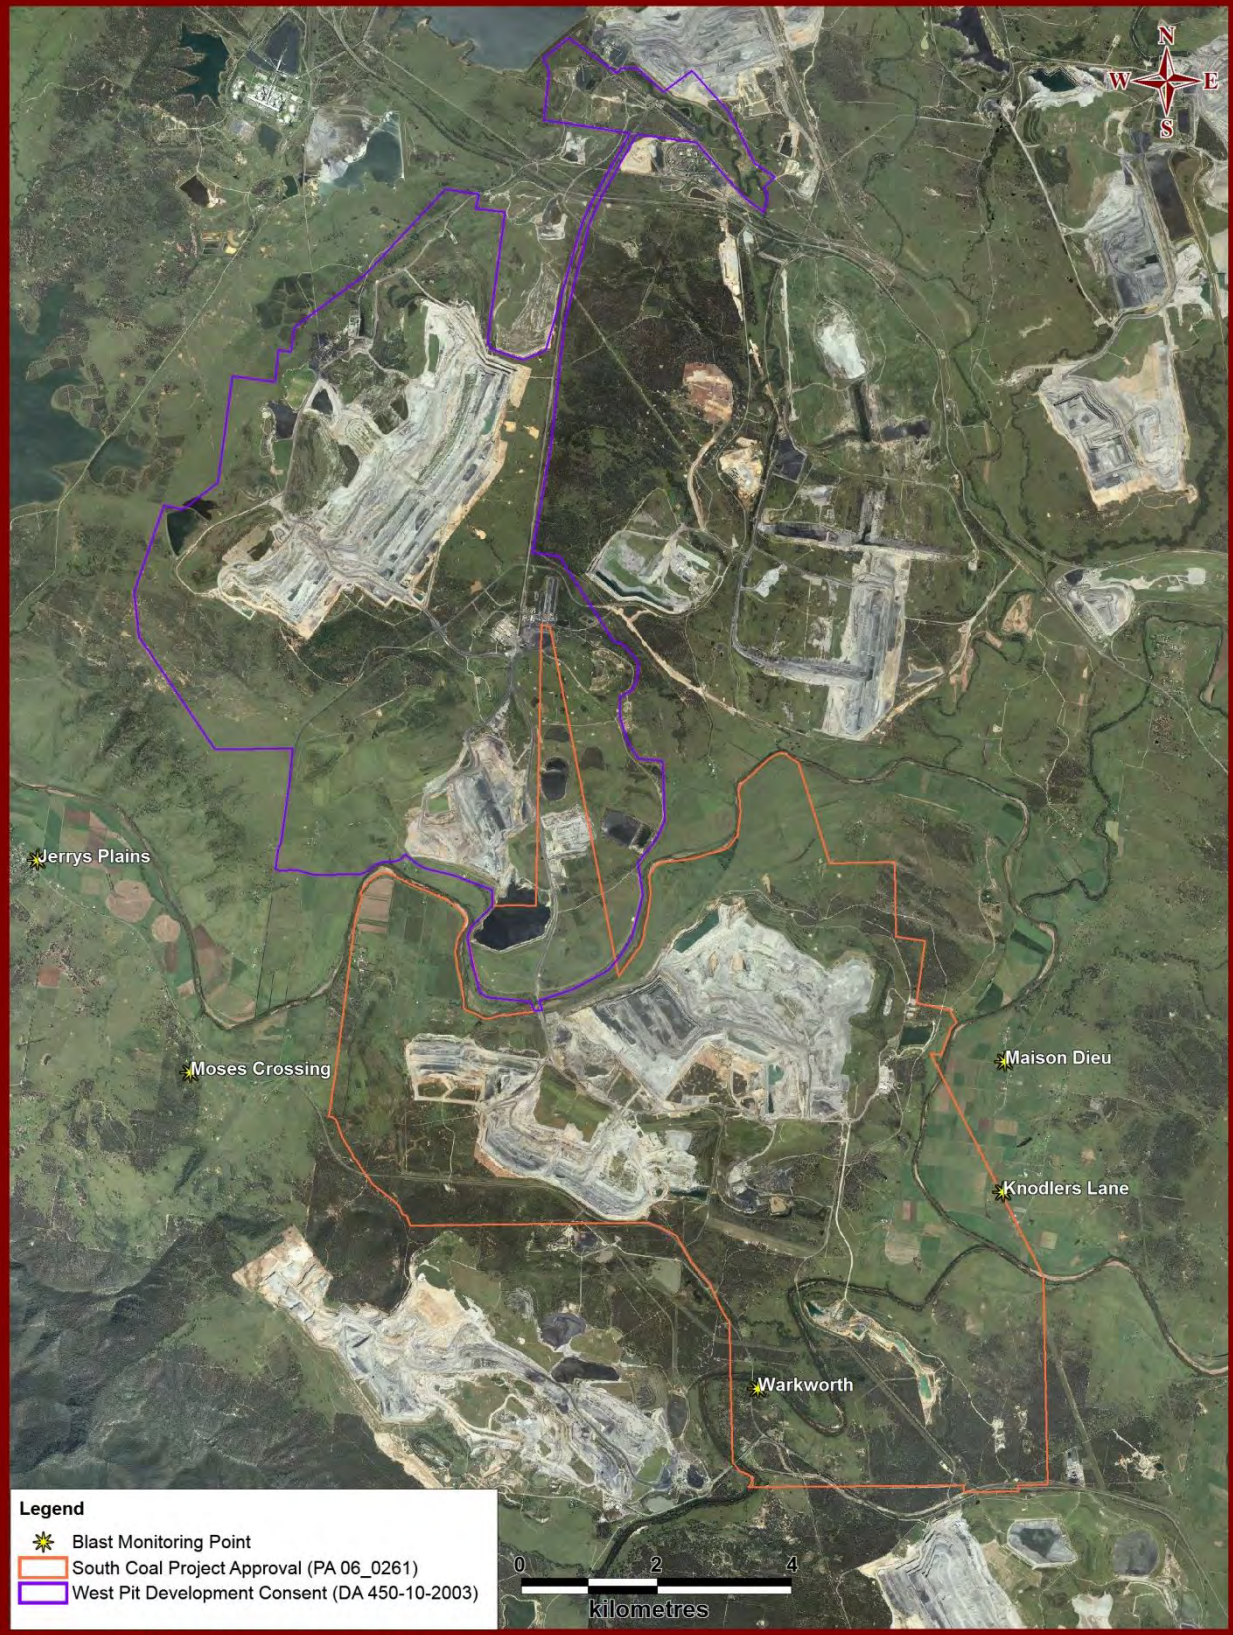
Figure 83: Blast Monitoring Location Plan

HVO have a network of five blast monitoring units. These are located at nearby privately owned residences and function as regulatory compliance monitors. The location of these monitors can be found in **Figure 83**.

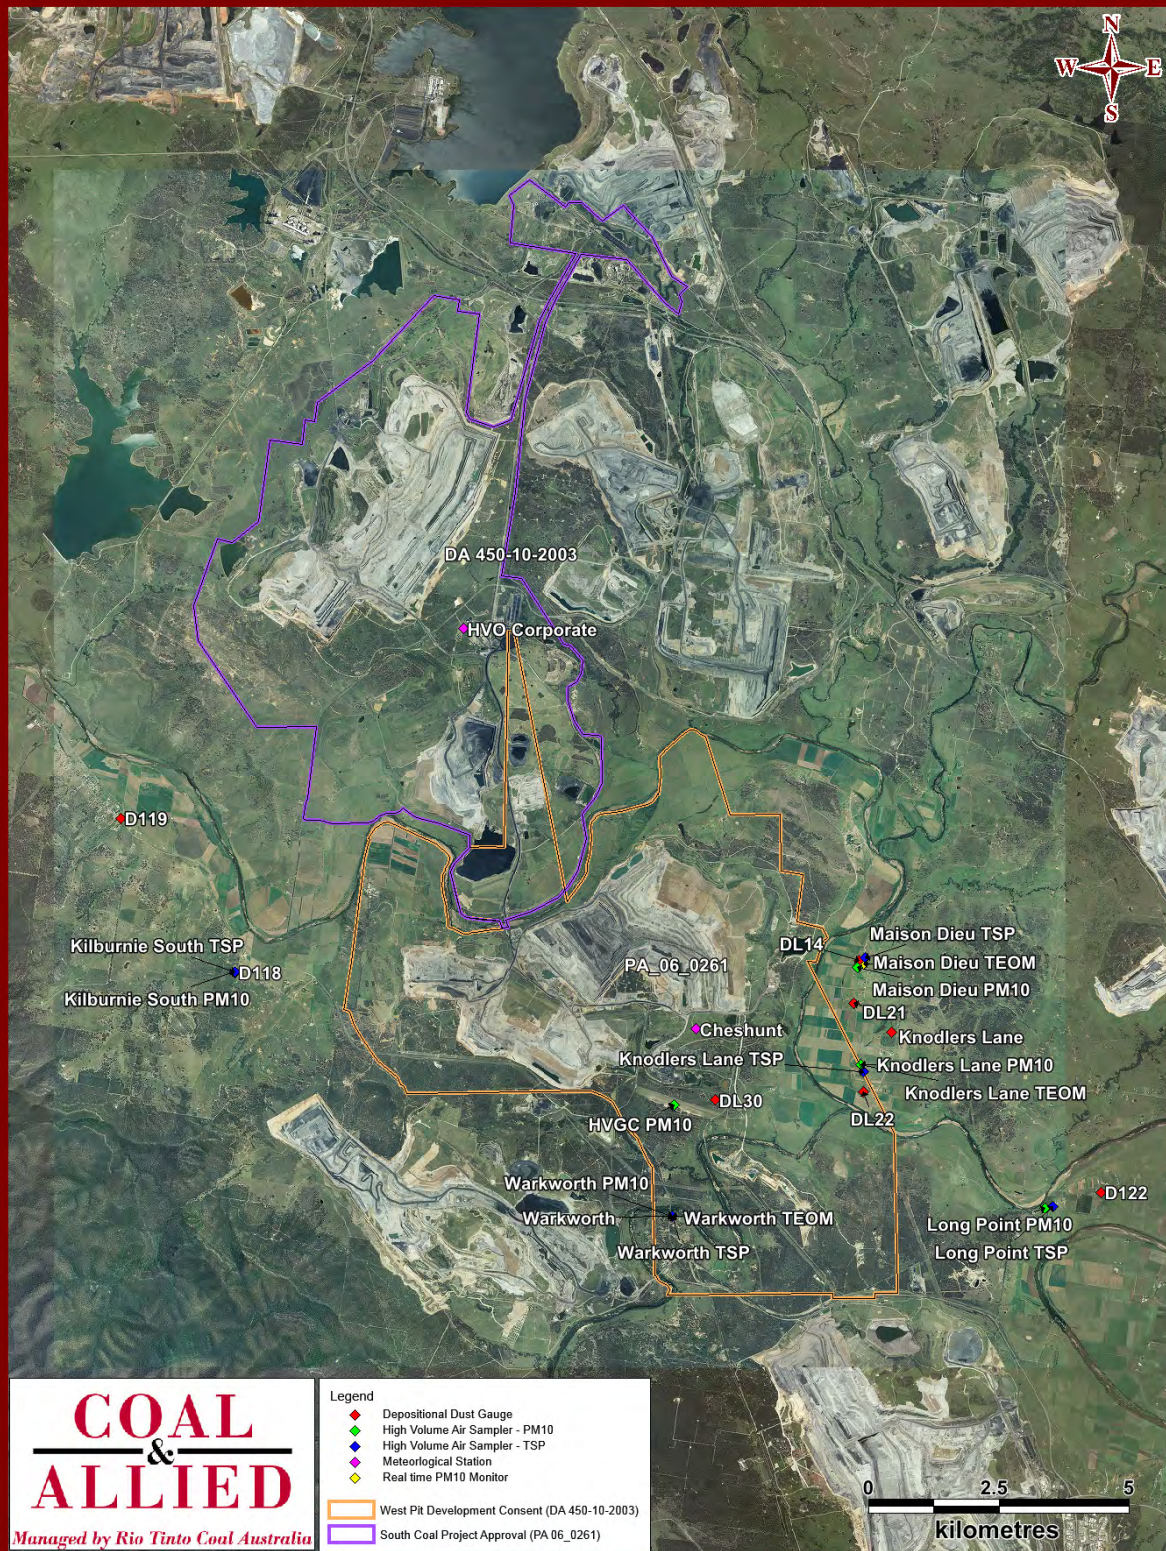
Figure 4: Air Quality Monitoring Location Plan

Suspended particulates are measured by a network of High Volume Air Samplers (HVAS) measuring Total Suspended Particulates (TSP) and Particulate Matter <10µm (PM₁₀). The location of these monitors can be found in Figure 4. Each HVAS was run for 24 hours on a

six-day cycle in accordance with EPA requirements with the exception of the Warkworth HVAS, which failed to run on 5 July due to an instrument fault..

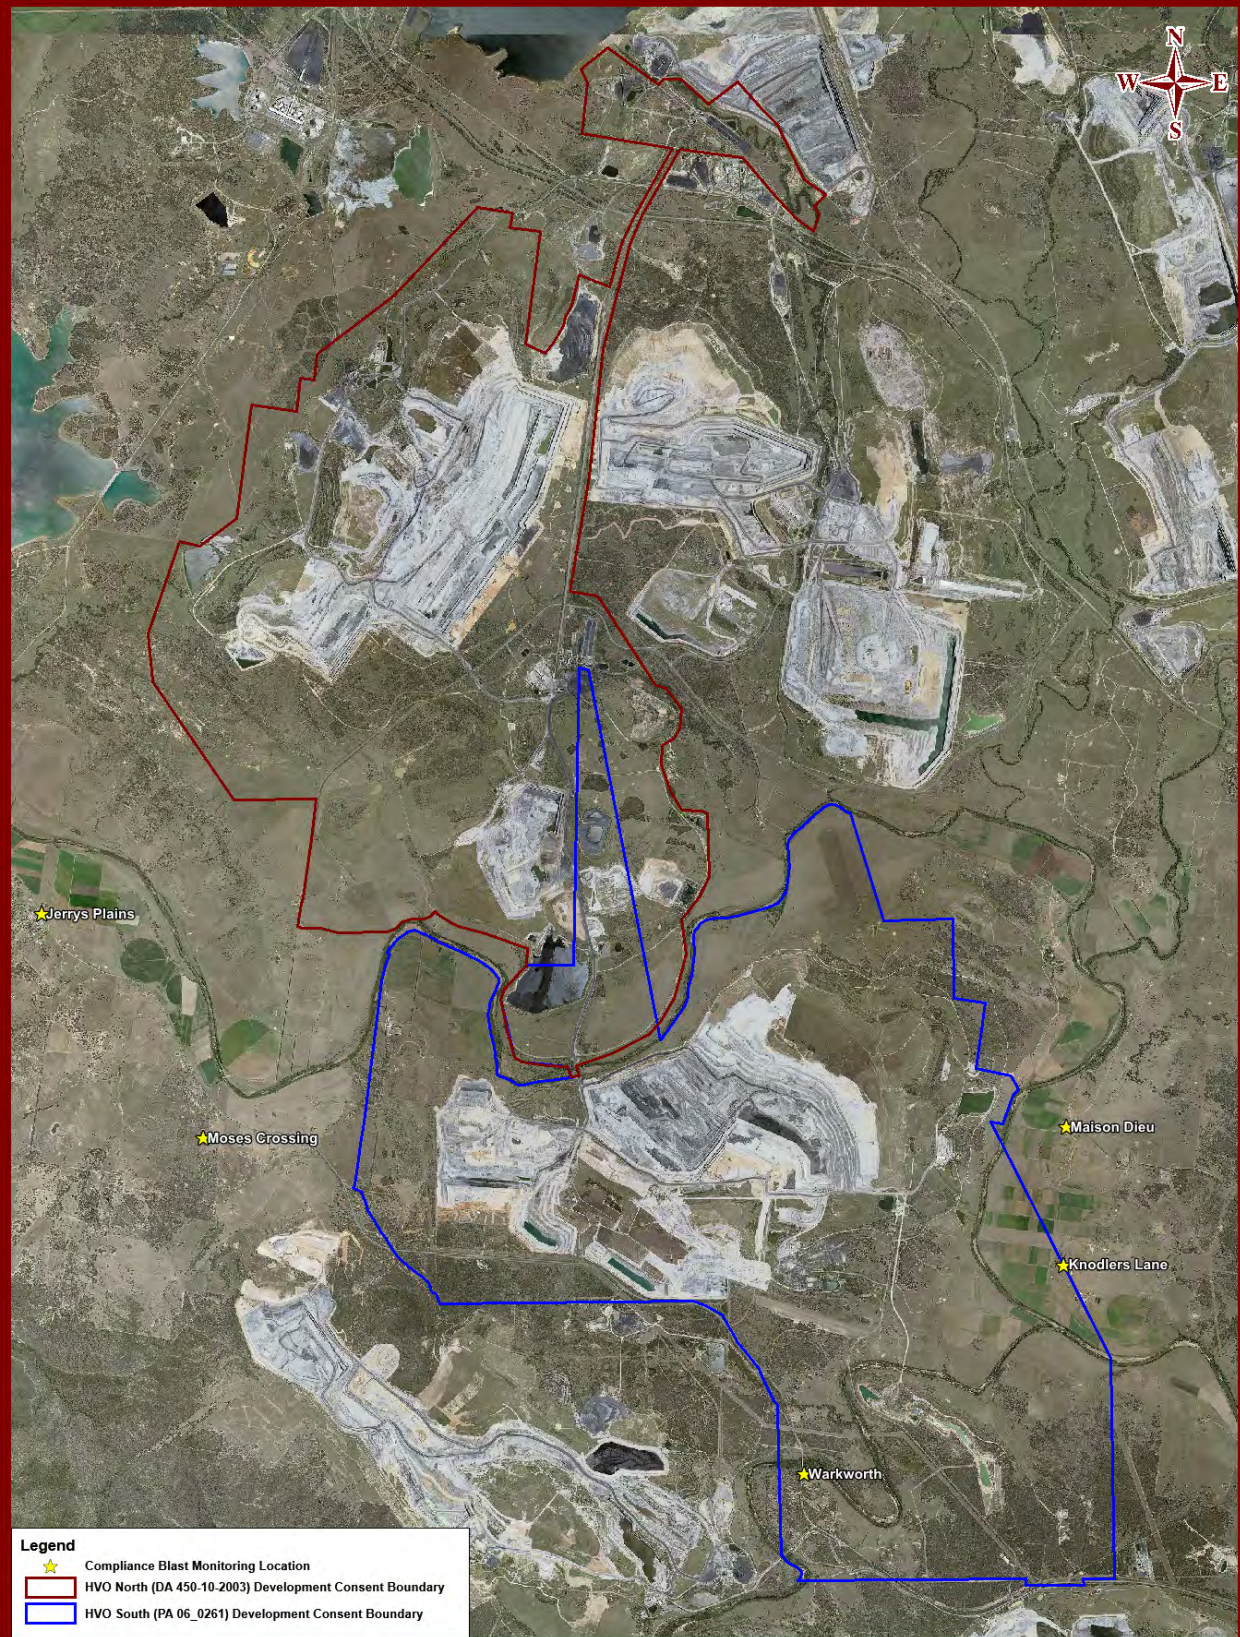
Figure 15: Blast Monitoring Location Plan

HVO have a network of five blast monitoring units. These are located at nearby privately owned residences and function as regulatory compliance monitors. The location of these monitors can be found in Figure 15.

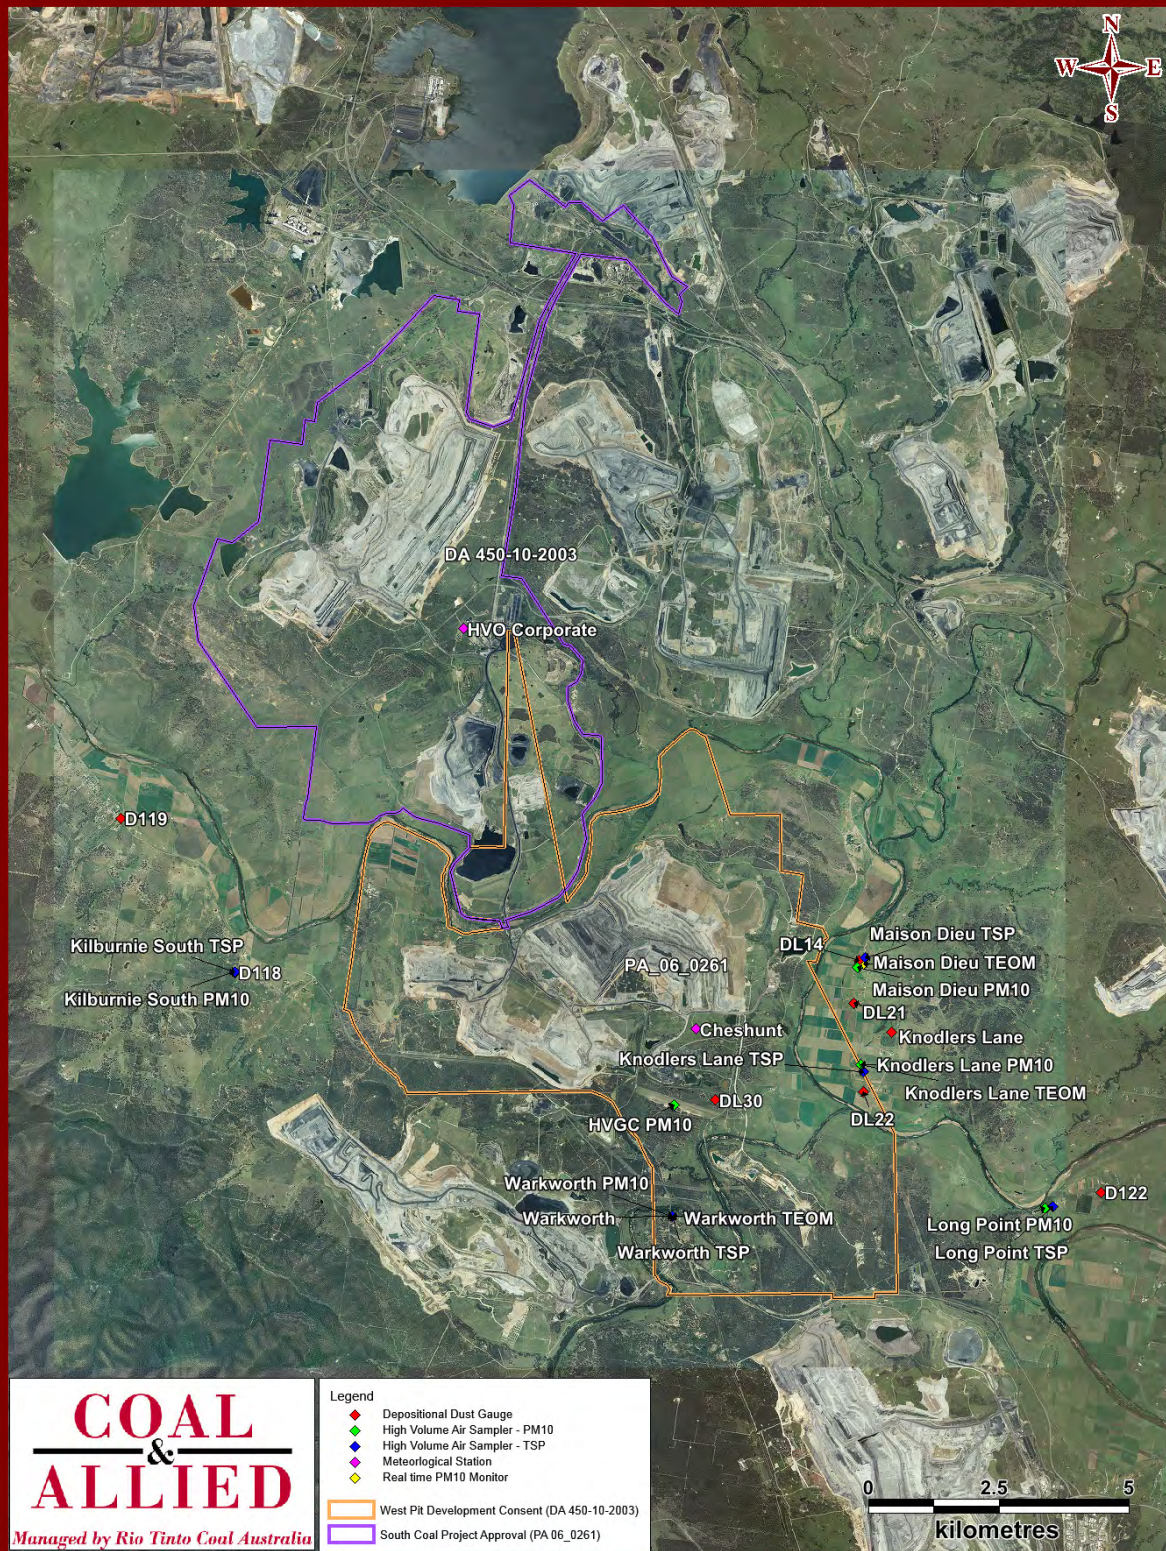
Figure 4: Air Quality Monitoring Location Plan

Suspended particulates are measured by a network of High Volume Air Samplers (HVAS) measuring Total Suspended Particulates (TSP) and Particulate Matter <10µm (PM₁₀). The location of these monitors can be found in Figure 4. Each HVAS was run for 24 hours on a six-day cycle.
