Hunter Valley Operations

Community Consultative Committee

Business Papers – July 2017

Materials ahead of meeting of the committee on 13 July 2017

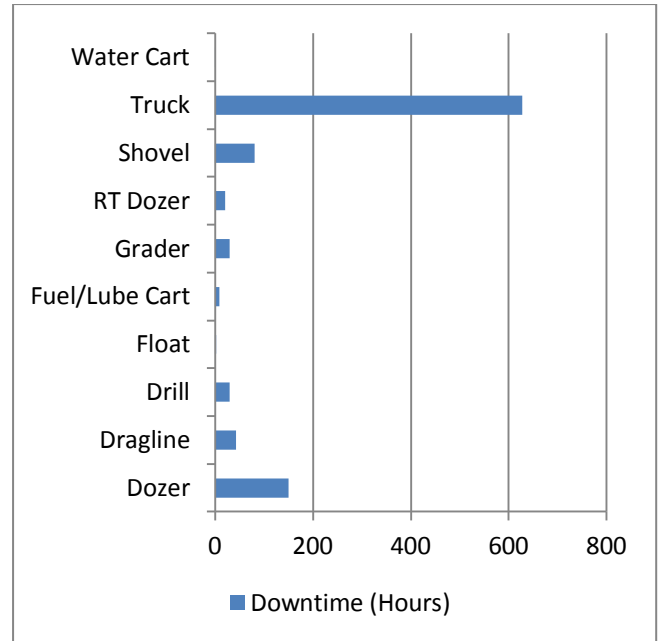
Figure 17: Operational Downtime by Equipment Type – February 2017

During February, a total of 991.3 hours of equipment downtime was logged in response to real time monitoring and visual inspections for environmental reasons such as dust, noise and meteorological conditions. Operational downtime by equipment type is shown in Figure 17.

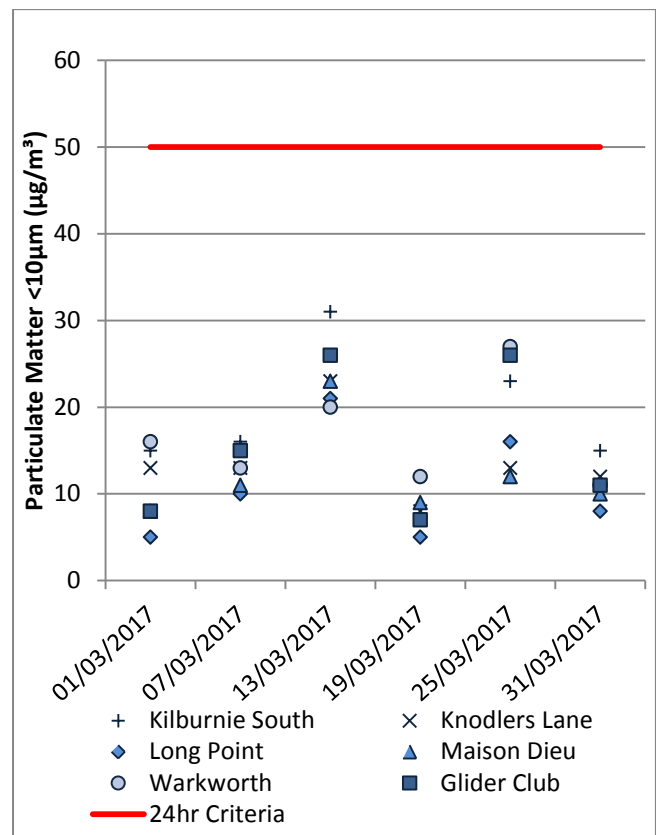
Figure 6: Individual PM₁₀ Results – March 2017

Figure 6 shows individual PM₁₀ results at each monitoring station against the short term impact assessment criteria of 50µg/m³.

The Kilburnie South HVAS monitor failed to collect a valid sample on the 19th of March due to a power outage.

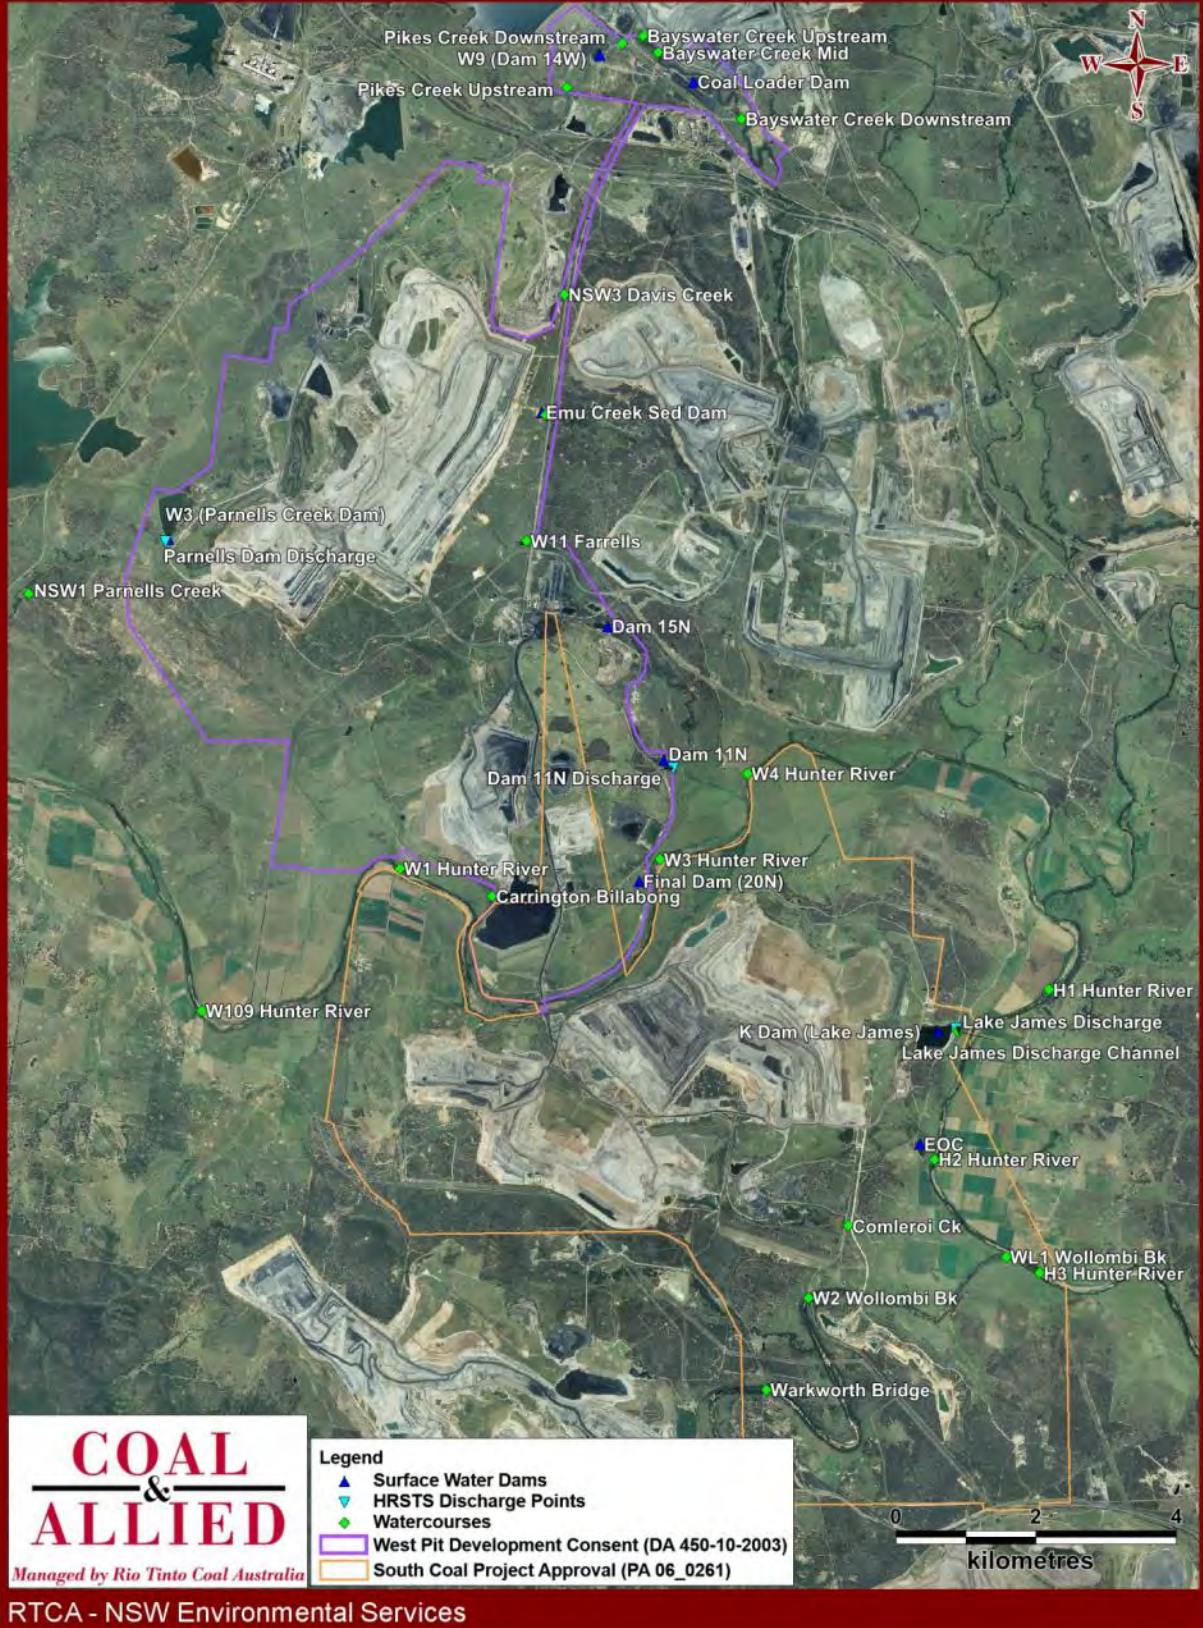
Figure 22: Surface Water Monitoring Location Plan

**Hunter Valley Operations
Surface Water Monitoring Locations**

The location of Surface Water monitoring locations is shown in Figure 22.

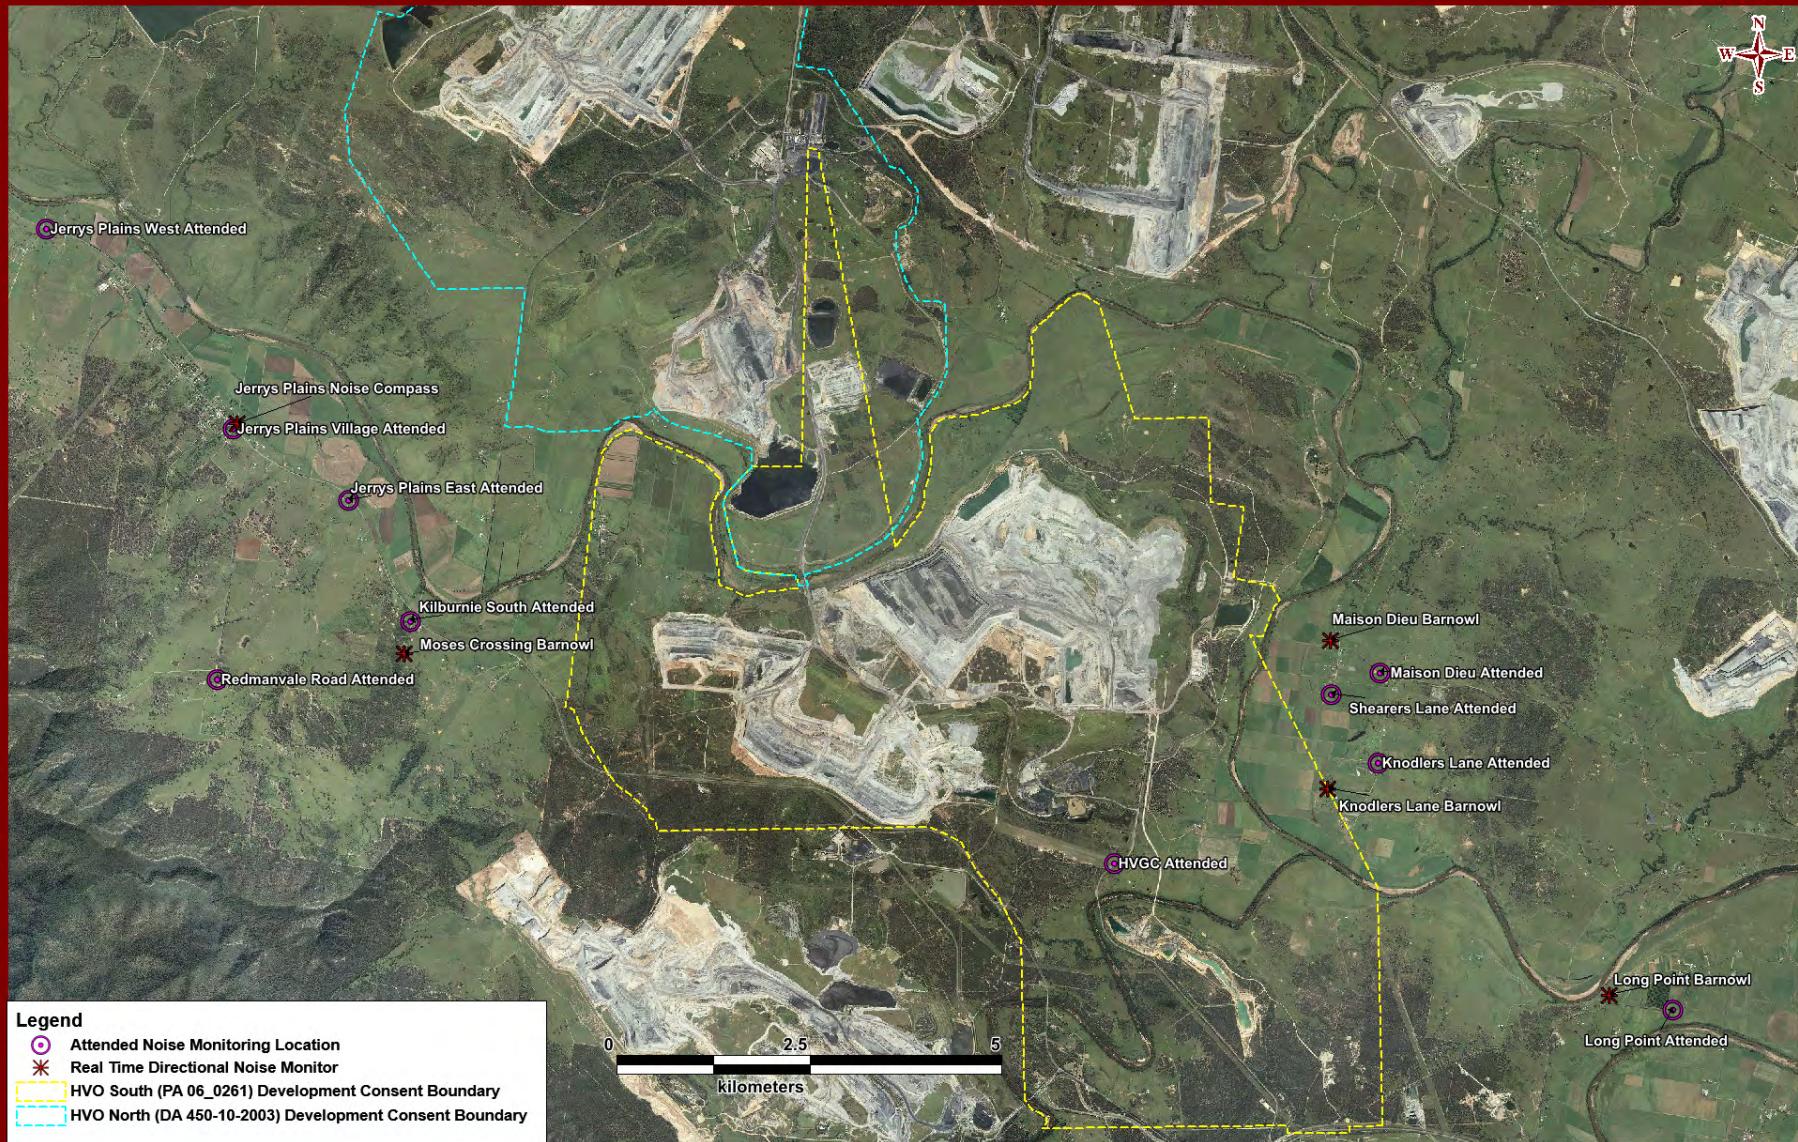
Figure 16: Noise Monitoring Location Plan

Hunter Valley Operations Noise Monitoring Locations
