# Hunter Valley Operations

## Community Consultative Committee

### **Business Papers – March 2017**

Materials ahead of meeting of the committee on 23 March 2017

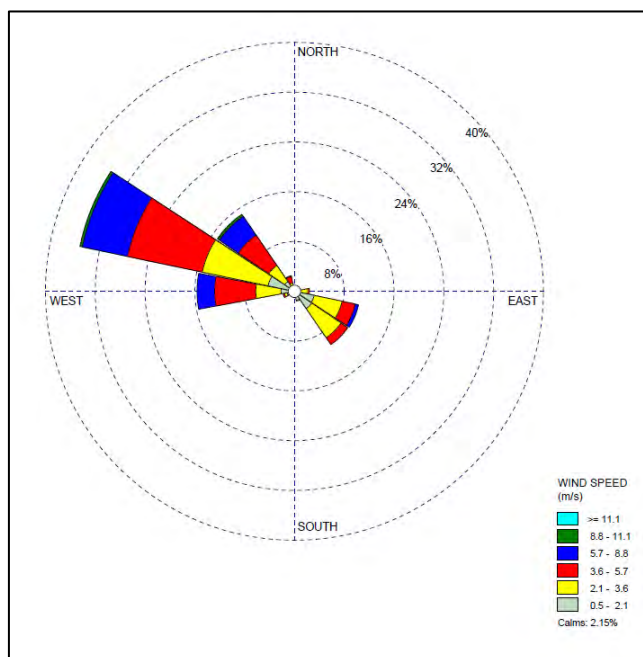
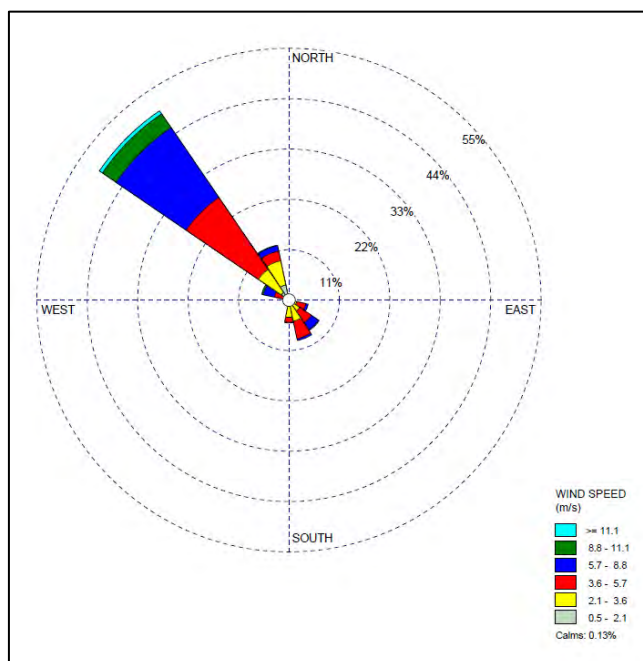
North-westerly winds were dominant during October as shown in Figure 2 (HVO Corporate) and Figure 3 (HVO Cheshunt).

**Figure 2: HVO Corporate Wind Rose – October 2016**

**Figure 3: HVO Cheshunt Wind Rose – October 2016**

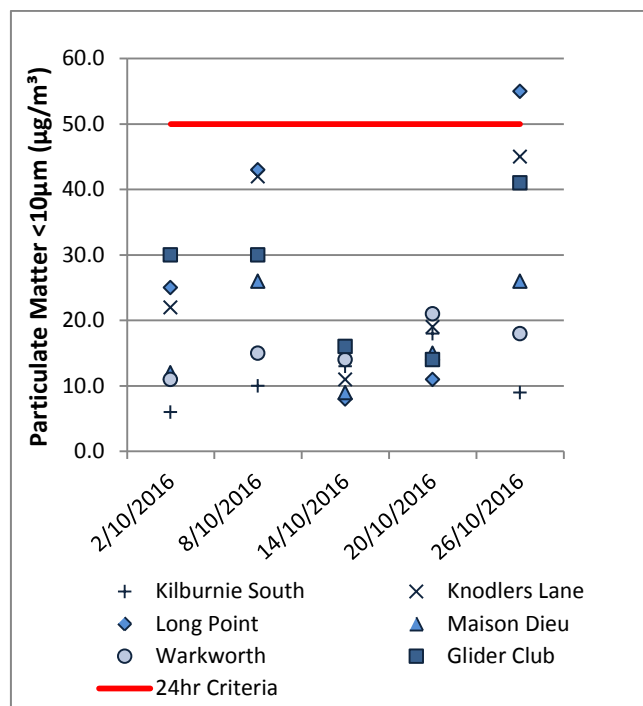
On 26/10/2016 one HVAS PM<sub>10</sub> unit recorded a result greater than the short term (24hr) PM<sub>10</sub> impact assessment criteria; Long Point (55 µg/m<sup>3</sup>). At the time of preparation of this report, the result is under investigation. Preliminary advice has been provided to the Department of Planning & Environment.

Figure 6: Individual PM<sub>10</sub> Results – October 2016

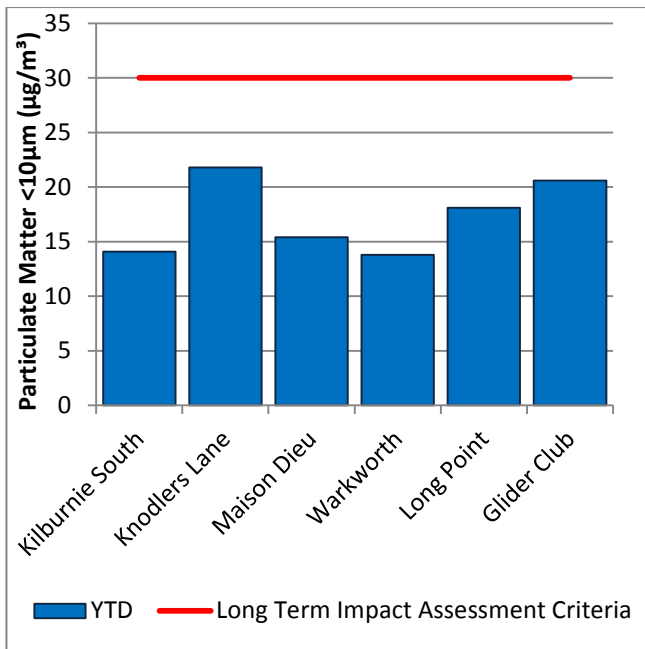
Figure 7 shows the annual average PM<sub>10</sub> results. During the reporting period, all PM<sub>10</sub> results were below the long term impact assessment criteria.

**Figure 7: Year To Date Average PM<sub>10</sub> – October 2016**

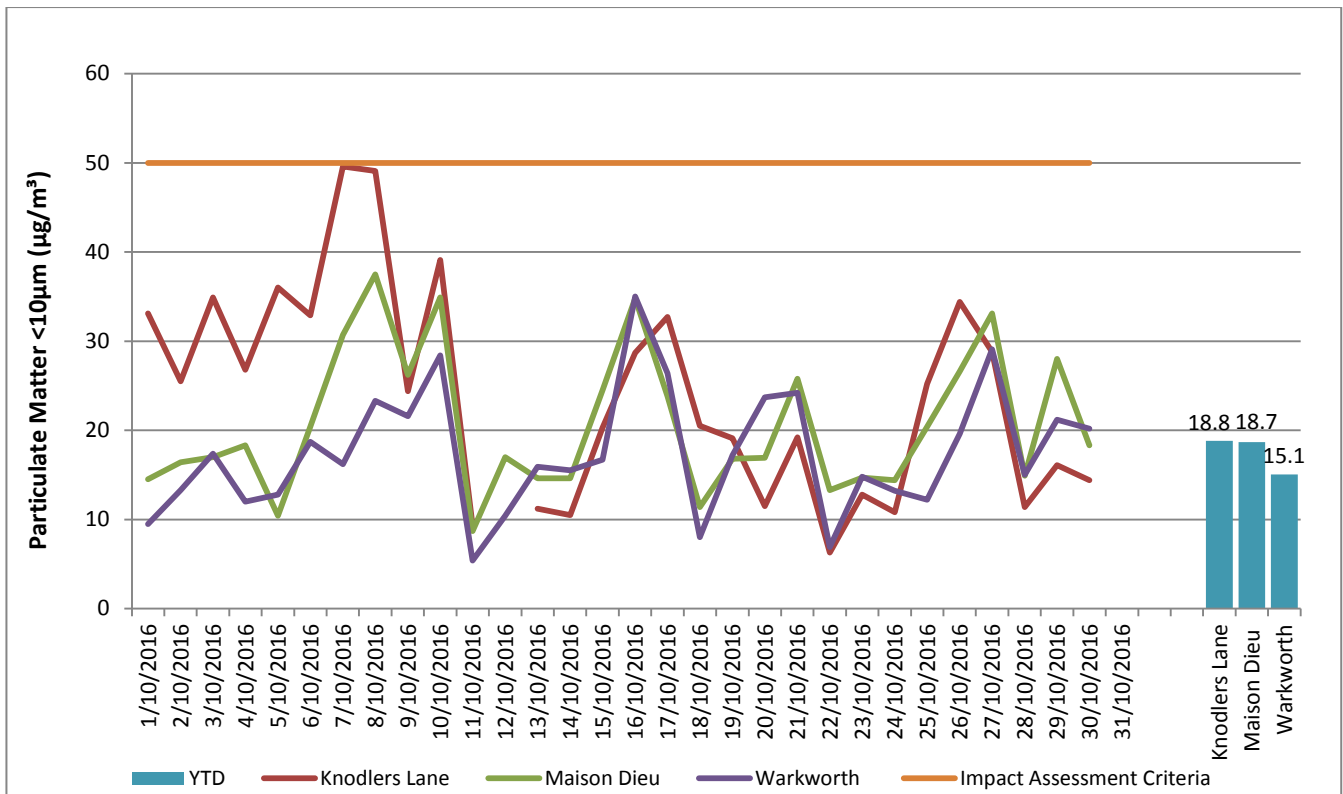
During October, the real time monitoring system generated 87 automated air quality related alarms. 53 alarms were related to adverse weather conditions and 34 alarms related to PM<sub>10</sub>.

**Figure 9: Real Time PM<sub>10</sub> 24hr average and YTD Average – October 2016**

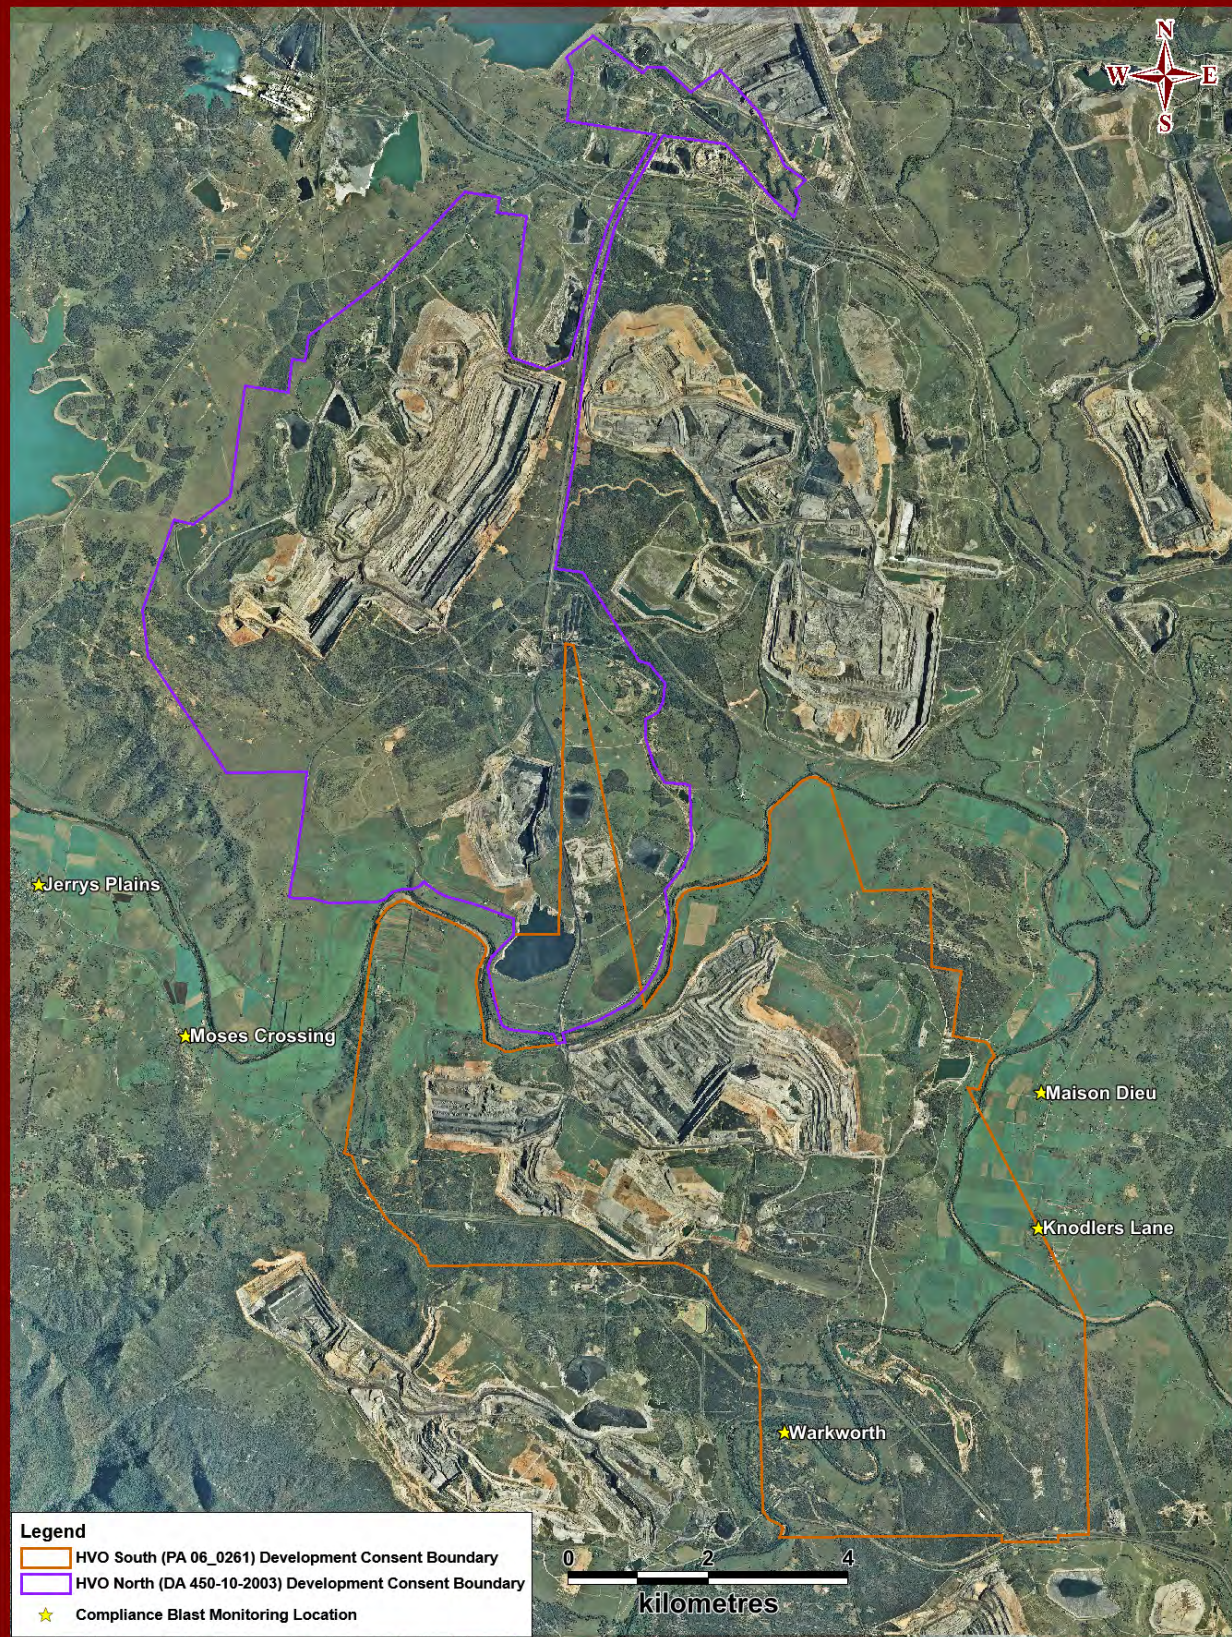
Figure 15: Blast Monitoring Location Plan

HVO have a network of five blast monitoring units. These are located at nearby privately owned residences and function as regulatory compliance monitors. The location of these monitors can be found in Figure 15.

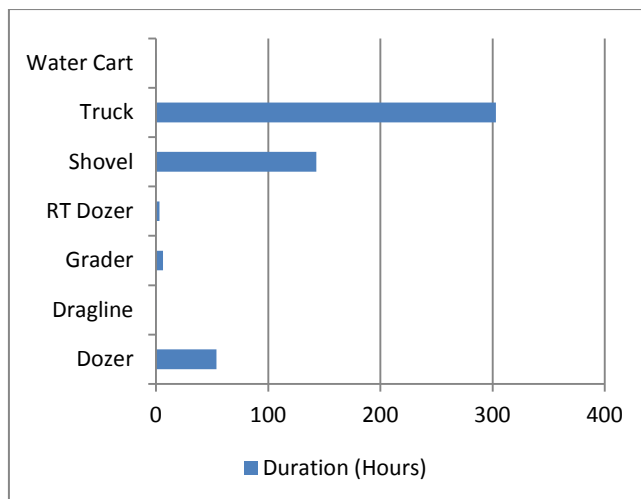
During October, a total of 509.7 hours of equipment downtime was logged in response to real time monitoring and visual inspections for environmental reasons such as dust, noise and meteorological conditions. Operational downtime by equipment type is shown in Figure 17.

**Figure 17: Operational Downtime by Equipment Type – October 2016**

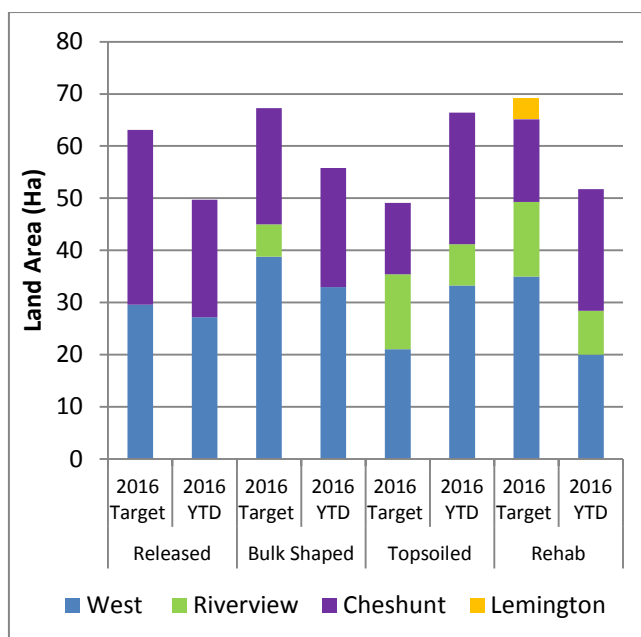
During October, 2.8 Ha of land was released, 8.7 Ha of land was bulk shaped, 3.4 Ha of land was topsoiled, 3.4 Ha of land was composted and 9.9 Ha of land was rehabilitated. Year to date progress can be viewed in Figure 18.

**Figure 18: Rehabilitation YTD - October 2016**

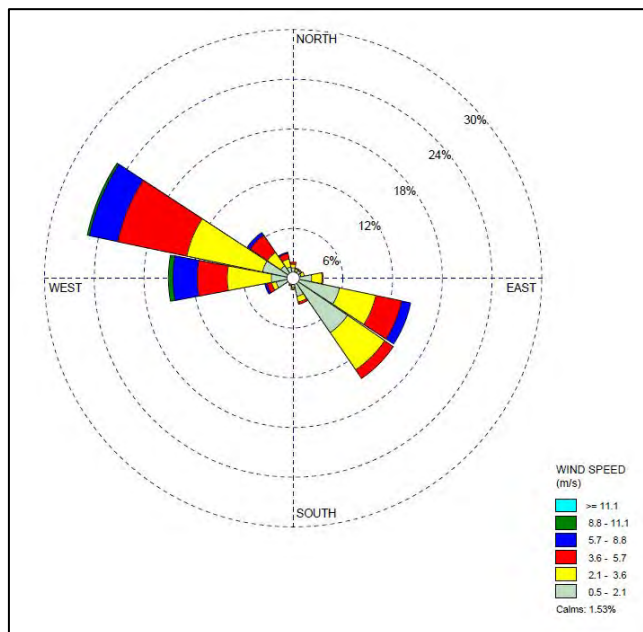
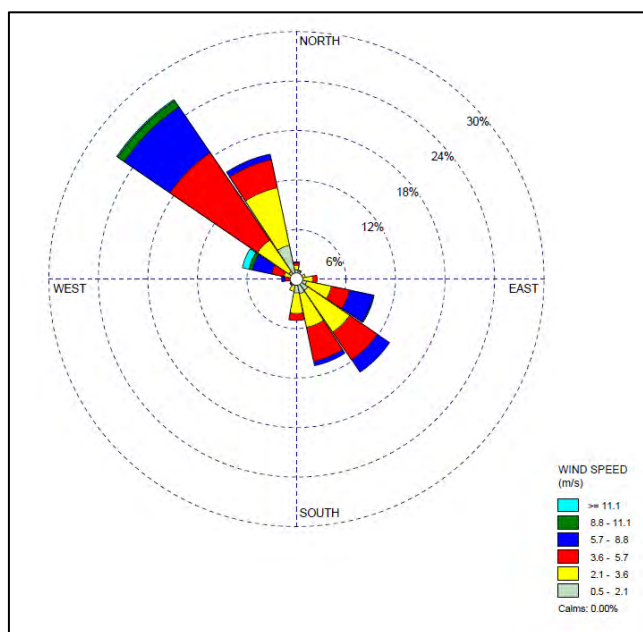
North-westerly winds were dominant during November as shown in Figure 2 (HVO Corporate) and Figure 3 (HVO Cheshunt).

**Figure 2: HVO Corporate Wind Rose – November 2016**

**Figure 3: HVO Cheshunt Wind Rose – November 2016**

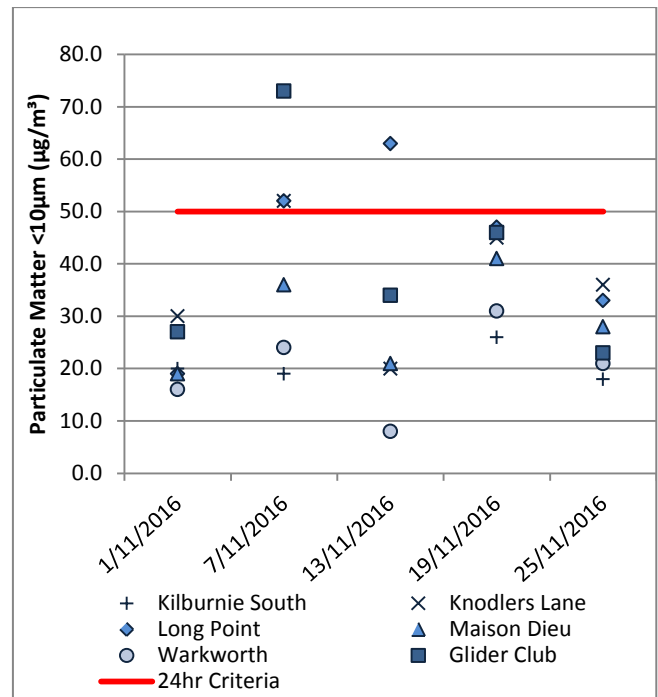
Preliminary investigation indicates that the measurement is likely influenced by a local source. All downwind monitors located closer to HVO including the monitor located at the Gliding Club returned measurements below criterion on the day.

**Figure 6: Individual PM<sub>10</sub> Results – November 2016**

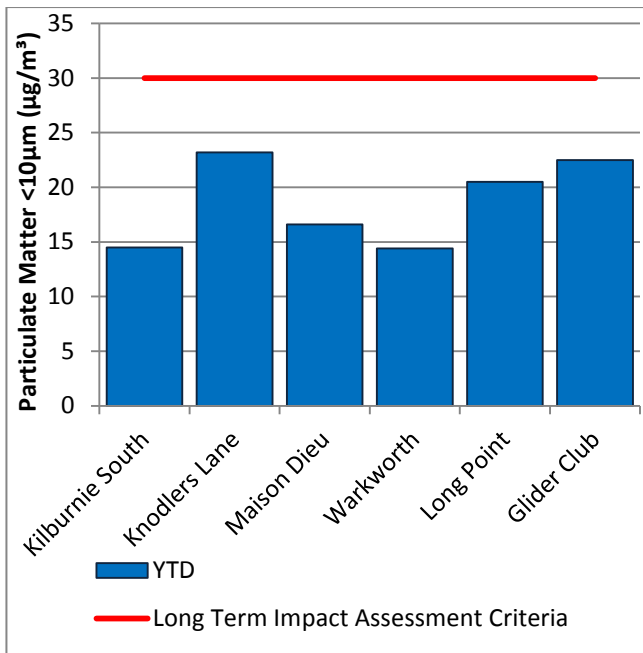
Figure 7 shows the annual average PM<sub>10</sub> results. During the reporting period, all PM<sub>10</sub> results were below the long term impact assessment criteria.

**Figure 7: Year To Date Average PM<sub>10</sub> – November 2016**

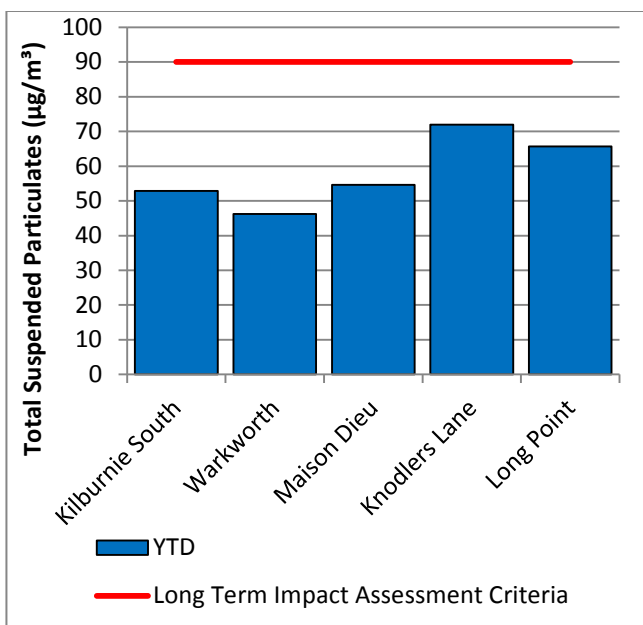
Figure 8 shows the annual average TSP results compared against the long term impact assessment criteria of 90µg/m<sup>3</sup>.

**Figure 8: Year To Date Average Total Suspended Particulates - November 2016**

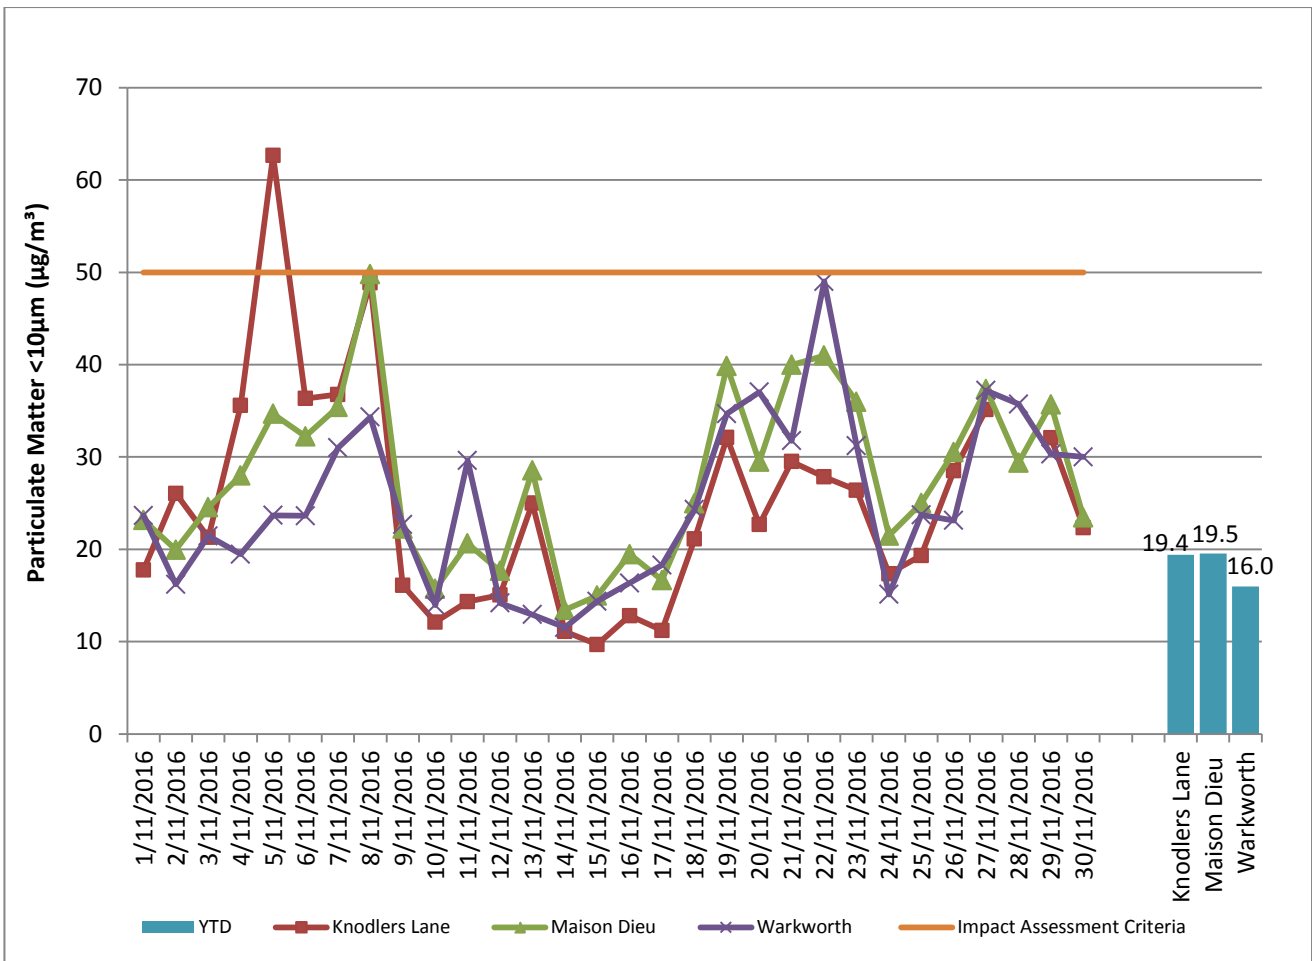
During November, the real time monitoring system generated 64 automated air quality related alarms. 20 alarms were related to adverse weather conditions and 44 alarms related to PM<sub>10</sub>.

**Figure 9: Real Time PM<sub>10</sub> 24hr average and YTD Average – November 2016**

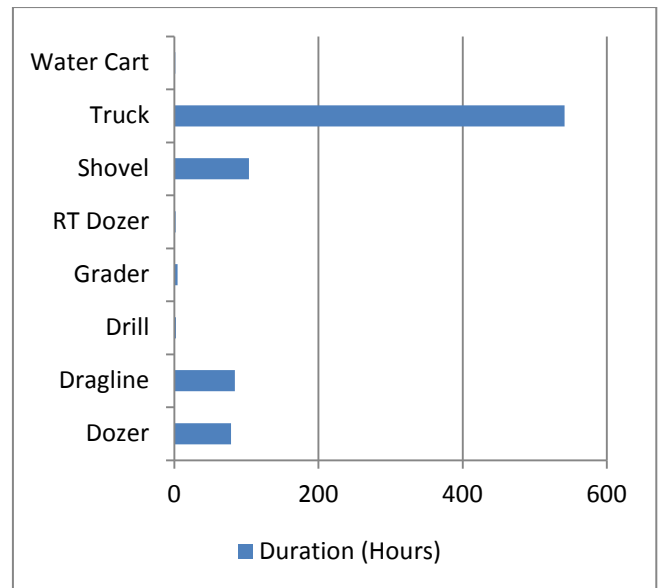
During November, a total of 817 hours of equipment downtime was logged in response to real time monitoring and visual inspections for environmental reasons such as dust, noise and meteorological conditions. Operational downtime by equipment type is shown in Figure 17.

**Figure 17: Operational Downtime by Equipment Type – November 2016**

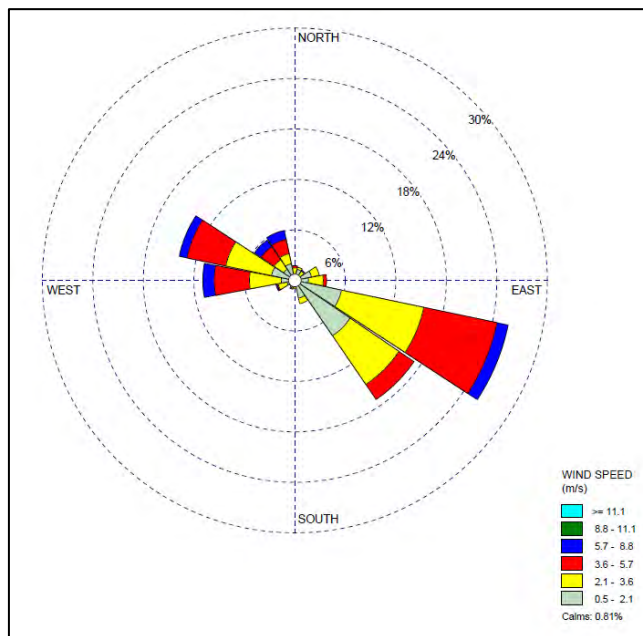
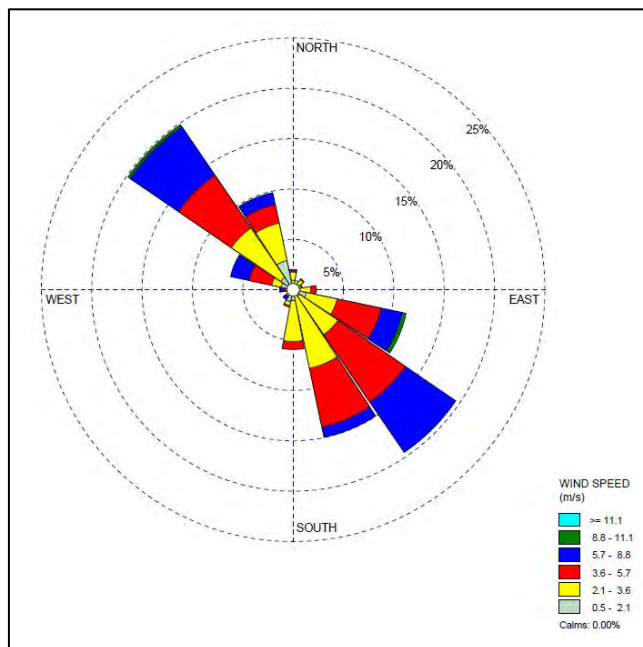
South Easterly and North Westerly component winds were dominant during December as shown in Figure 2 (HVO Corporate) and Figure 3 (HVO Cheshunt).

**Figure 2: HVO Corporate Wind Rose - December 2016**

**Figure 3: HVO Cheshunt Wind Rose - December 2016**

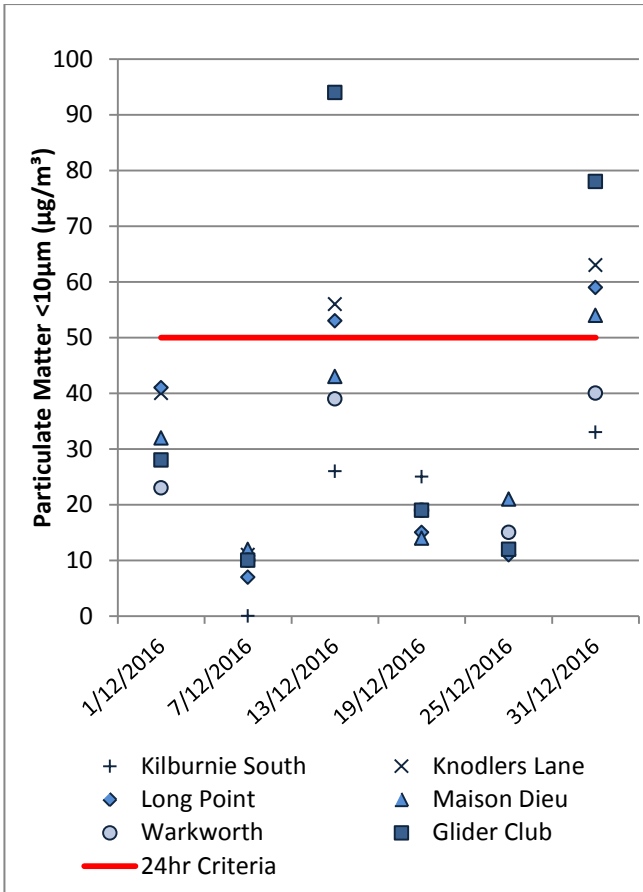
Preliminary investigation indicates that HVO was outside of the main arc of influence for all locations on the 31st December. Accordingly, no further action is required.

**Figure 6: Individual PM<sub>10</sub> Results – December 2016**

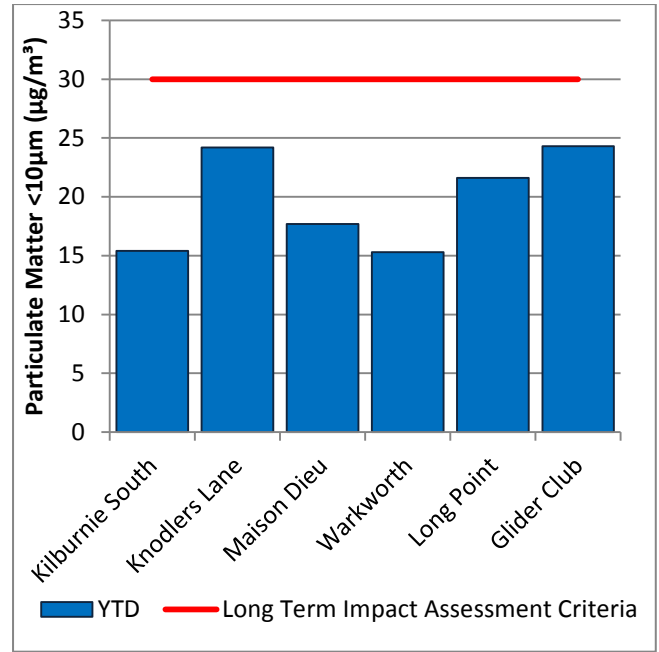
Figure 7 shows the annual average PM<sub>10</sub> results. During the reporting period, all PM<sub>10</sub> results were below the long term impact assessment criteria.

**Figure 7: Year to Date Average PM<sub>10</sub> – December 2016**

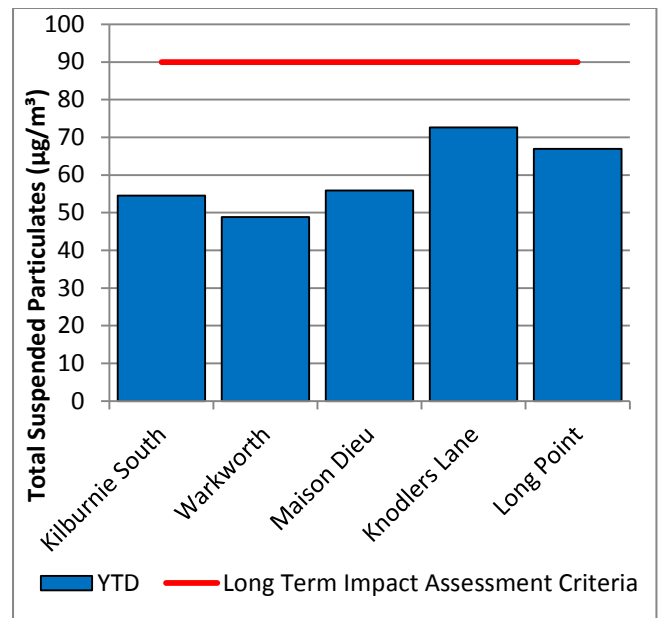
Figure 8 shows the annual average TSP results compared against the long term impact assessment criteria of 90µg/m<sup>3</sup>.

**Figure 8: Annual Average Total Suspended Particulates – December 2016**

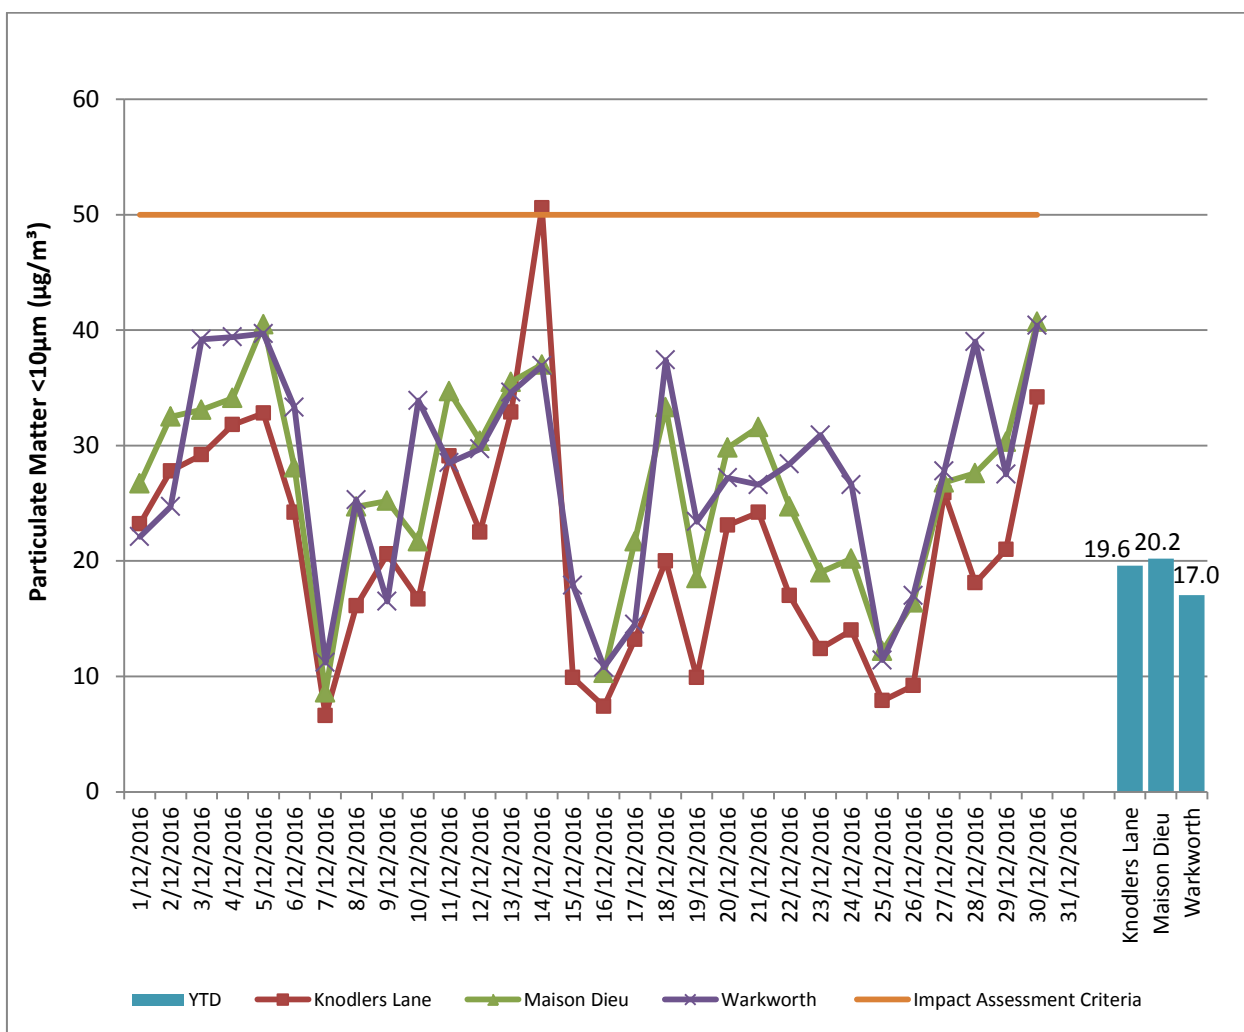
During December, the real time monitoring system generated 65 automated air quality related alarms. 29 alarms were related to adverse weather conditions and 36 alarms related to PM<sub>10</sub>.

Figure 9: Real Time PM<sub>10</sub> 24hr average and YTD average – December 2016

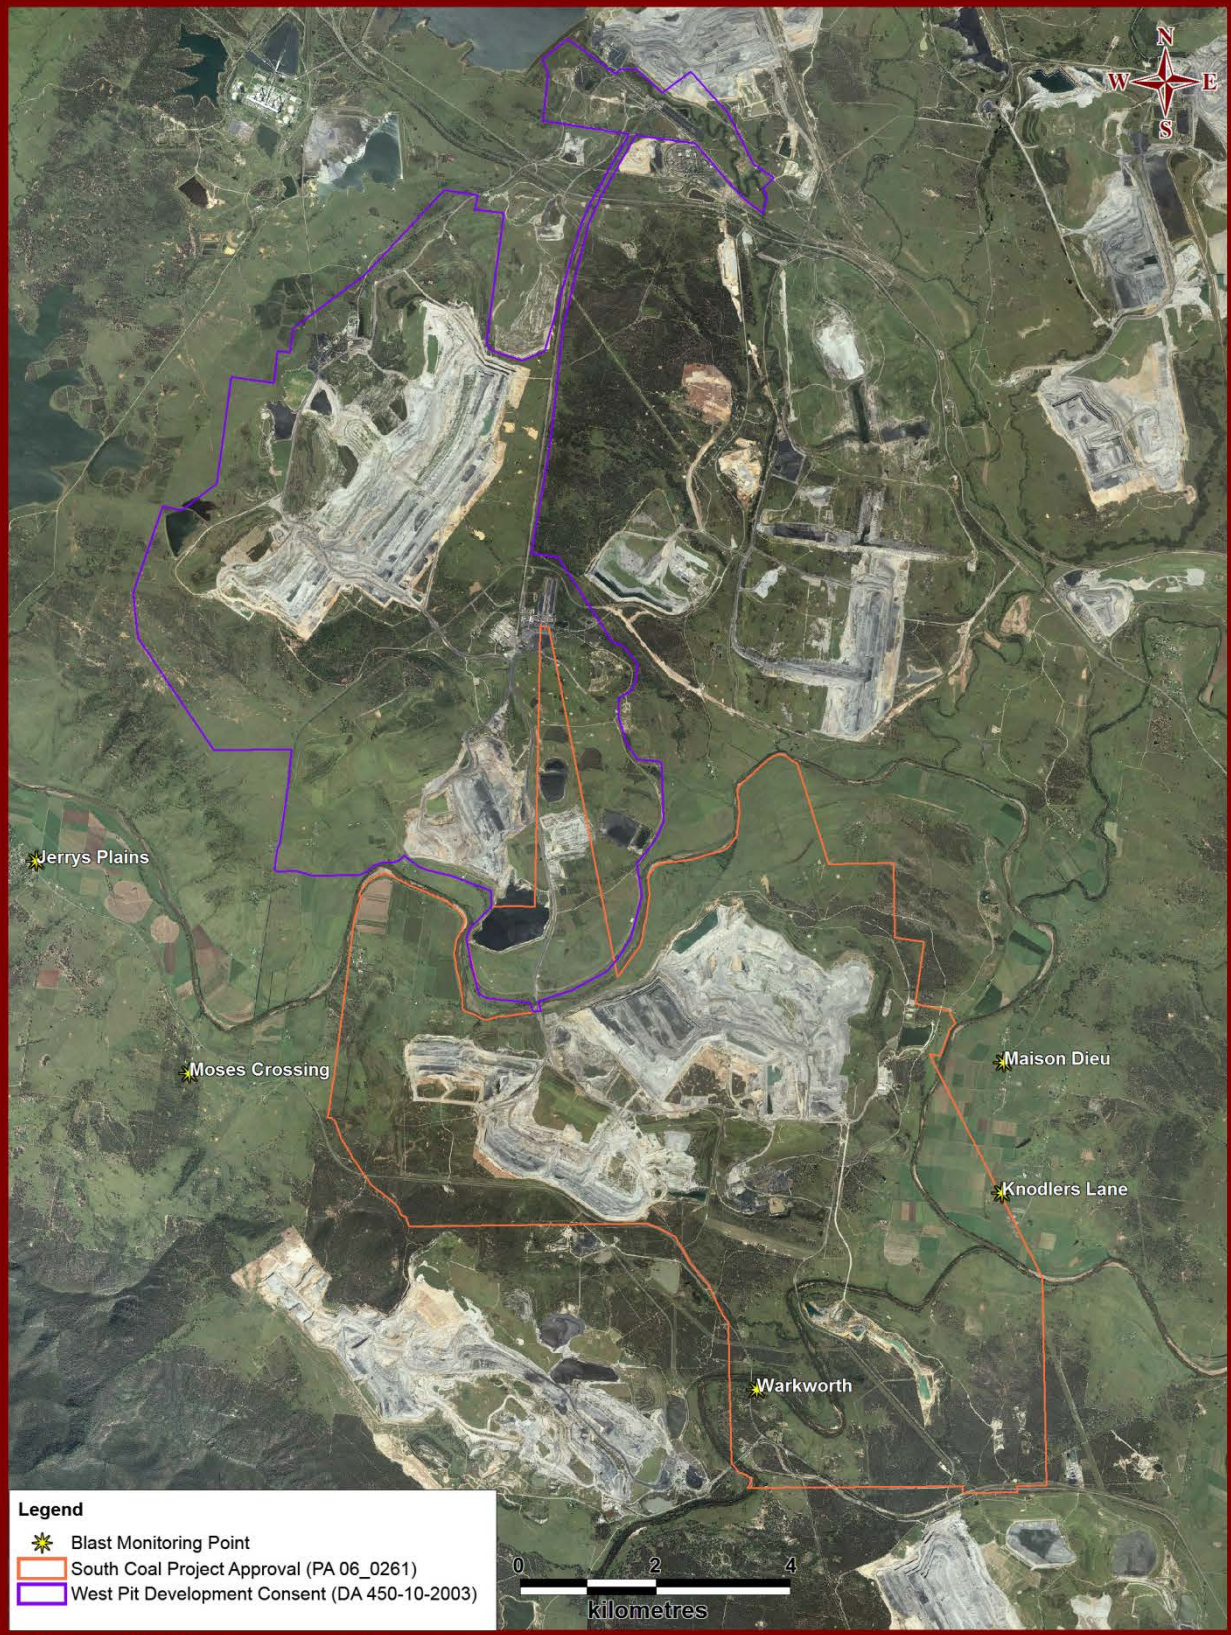
**Figure 83: Blast Monitoring Location Plan**

HVO have a network of five blast monitoring units. These are located at nearby privately owned residences and function as regulatory compliance monitors. The location of these monitors can be found in Figure 83.

**Hunter Valley Operations  
Blast Monitoring Locations**

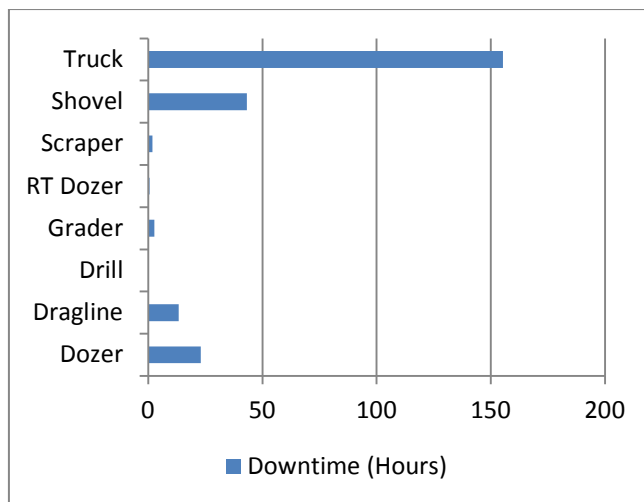
During December, a total of 240.3 hours of equipment downtime was logged in response to real time monitoring and visual inspections for environmental reasons such as dust, noise and meteorological conditions. Operational downtime by equipment type is shown in Figure 85.

**Figure 85: Operational Downtime by Equipment Type –December 2016**

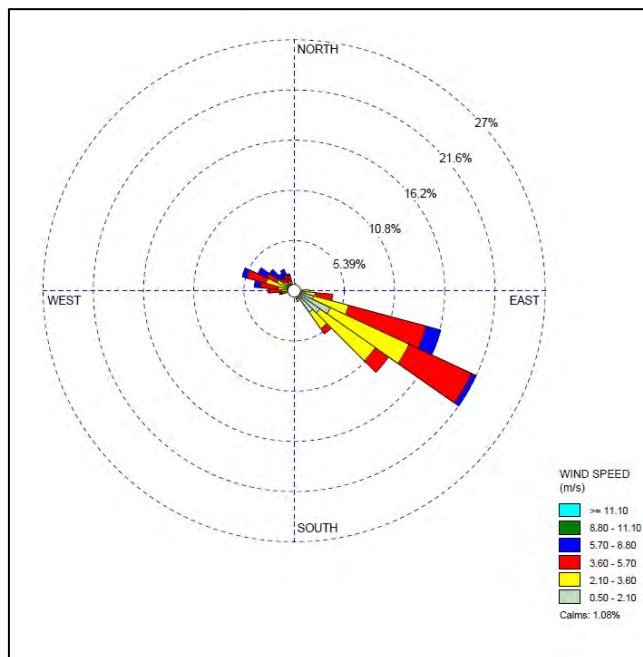
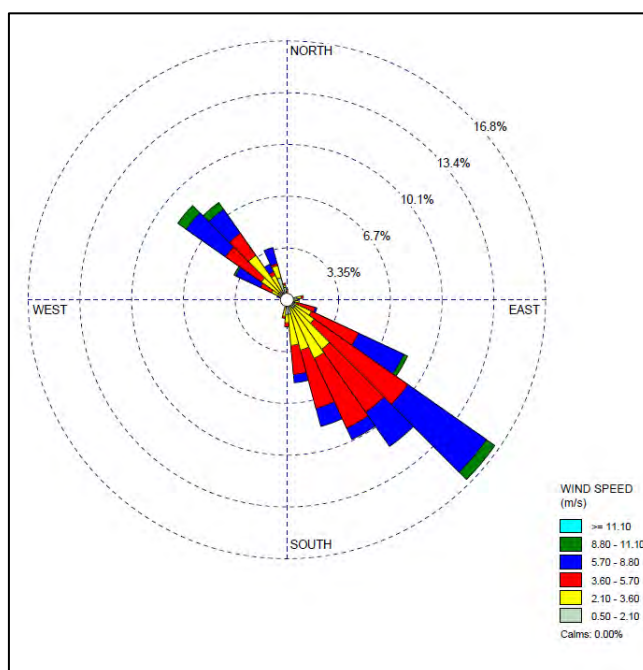
South-Easterly winds were dominant during January as shown in Figure 2 (HVO Corporate) and Figure 3 (HVO Cheshunt).

**Figure 2: HVO Corporate Wind Rose – January 2017**

**Figure 3: HVO Cheshunt Wind Rose – January 2017**

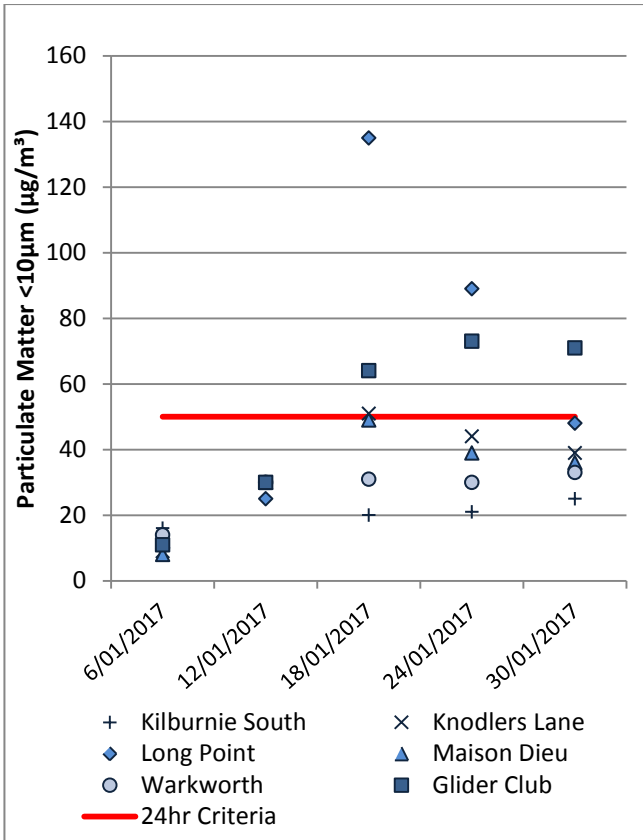
Investigation indicates that that the likely HVO contribution to the results at Cheshunt East and Gliding Club on the 30<sup>th</sup> January is less than 75%. Accordingly, no further action is required.

**Figure 6: Individual PM<sub>10</sub> Results – January 2017**

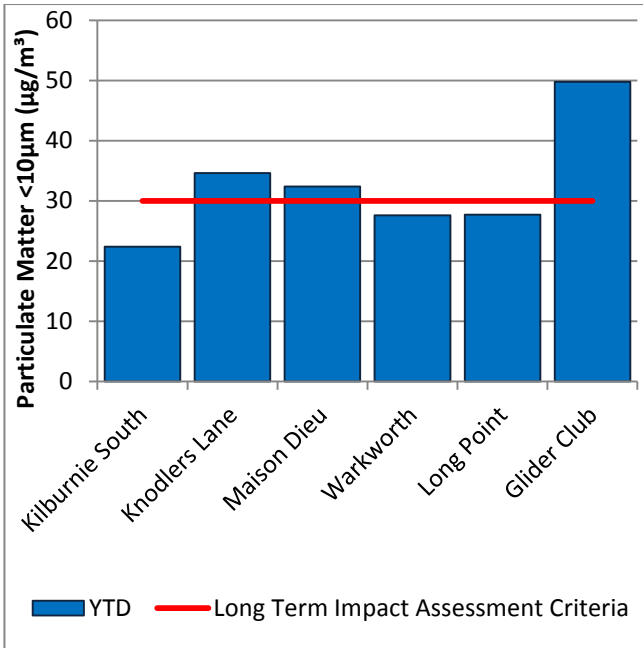
Figure 7 shows the annual average PM<sub>10</sub> results. During the reporting period, all PM<sub>10</sub> results were below the long term impact assessment criteria.

**Figure 7: Year To Date Average PM<sub>10</sub> – January 2017**

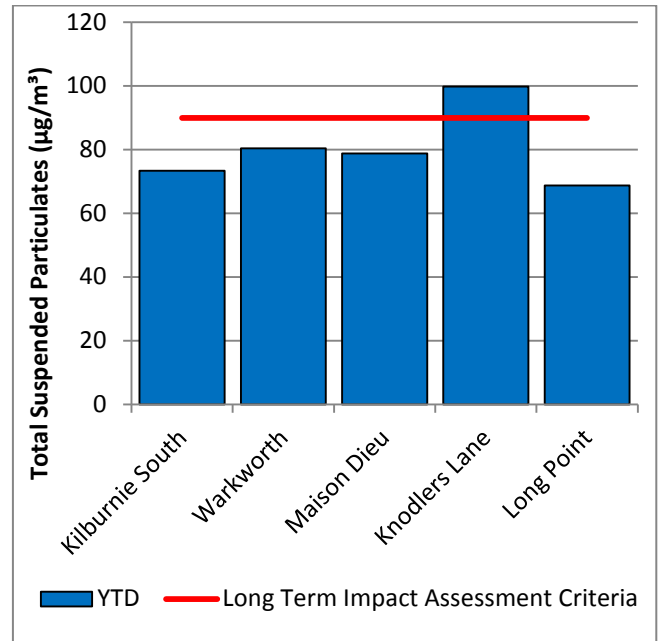
Figure 8 shows the annual average TSP results compared against the long term impact assessment criteria of 90µg/m<sup>3</sup>.

**Figure 8: Year To Date Average Total Suspended Particulates - January 2017**

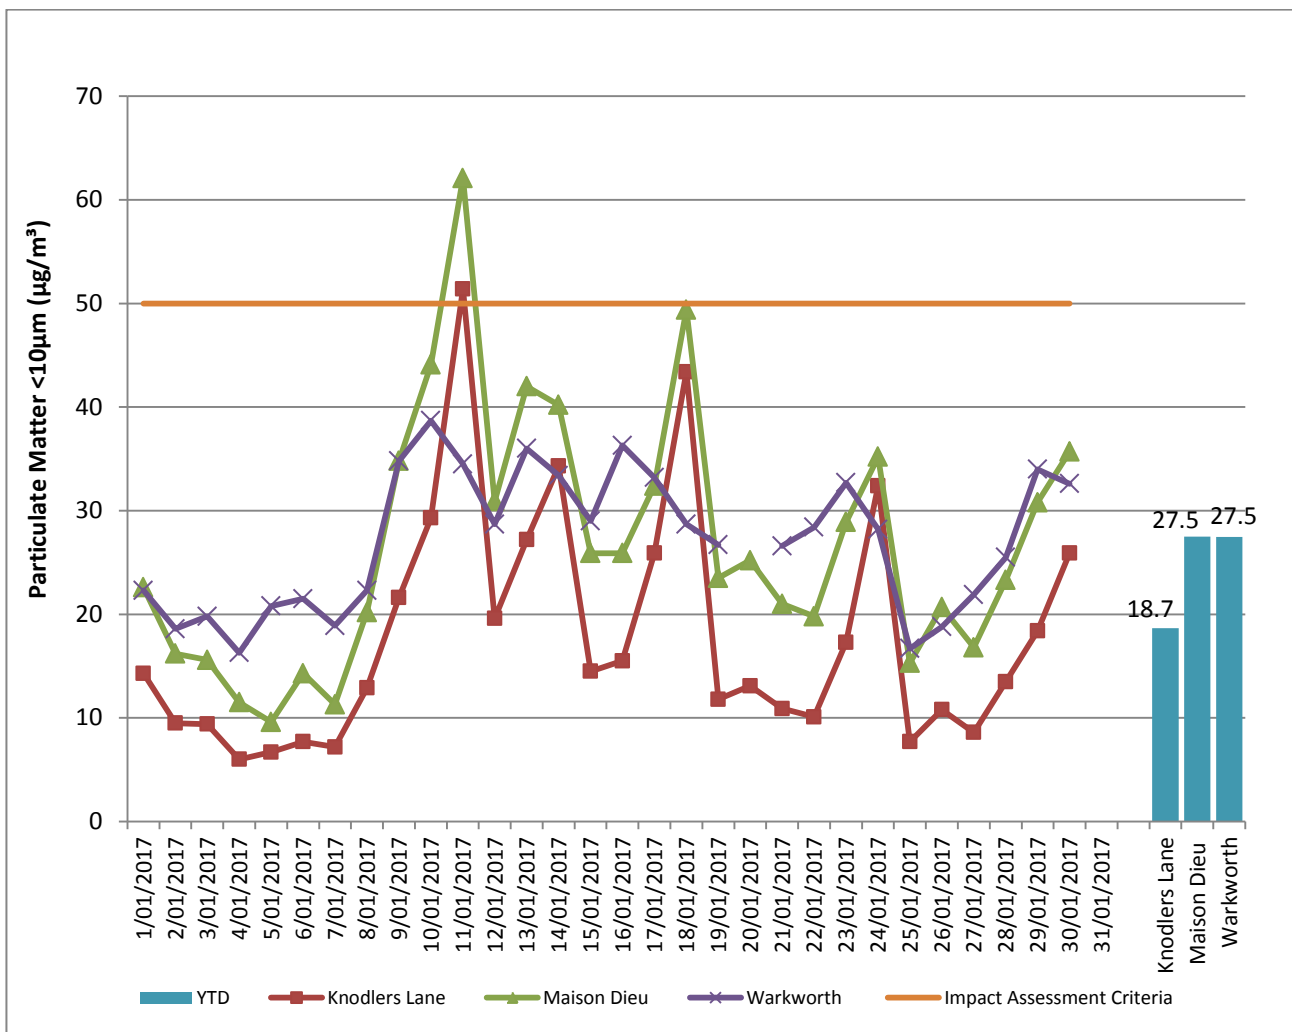
During January, the real time monitoring system generated 75 automated air quality related alarms. 26 alarms were related to adverse weather conditions and 49 alarms related to PM<sub>10</sub>.

Figure 9: Real Time PM<sub>10</sub> 24hr average and YTD Average – January 2017

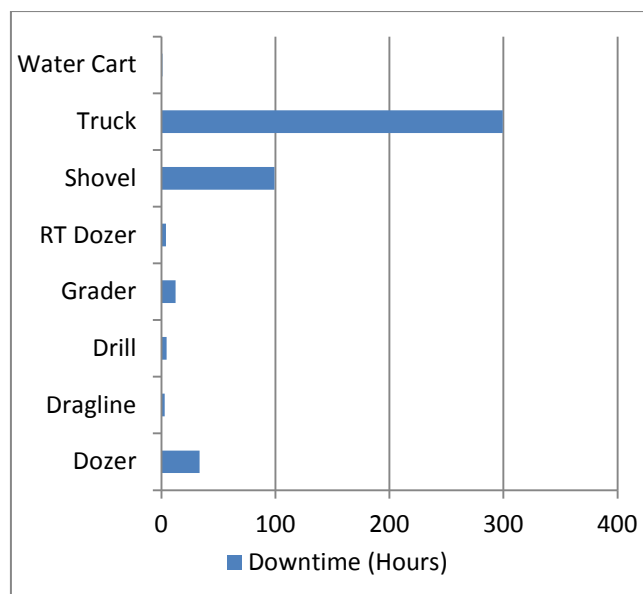
During January, a total of 456.7 hours of equipment downtime was logged in response to real time monitoring and visual inspections for environmental reasons such as dust, noise and meteorological conditions. Operational downtime by equipment type is shown in Figure 17.

**Figure 17: Operational Downtime by Equipment Type – January 2017**
