Hunter Valley Operations

Community Consultative Committee

Business Papers – February 2018

Environmental Monitoring Report – September 2017

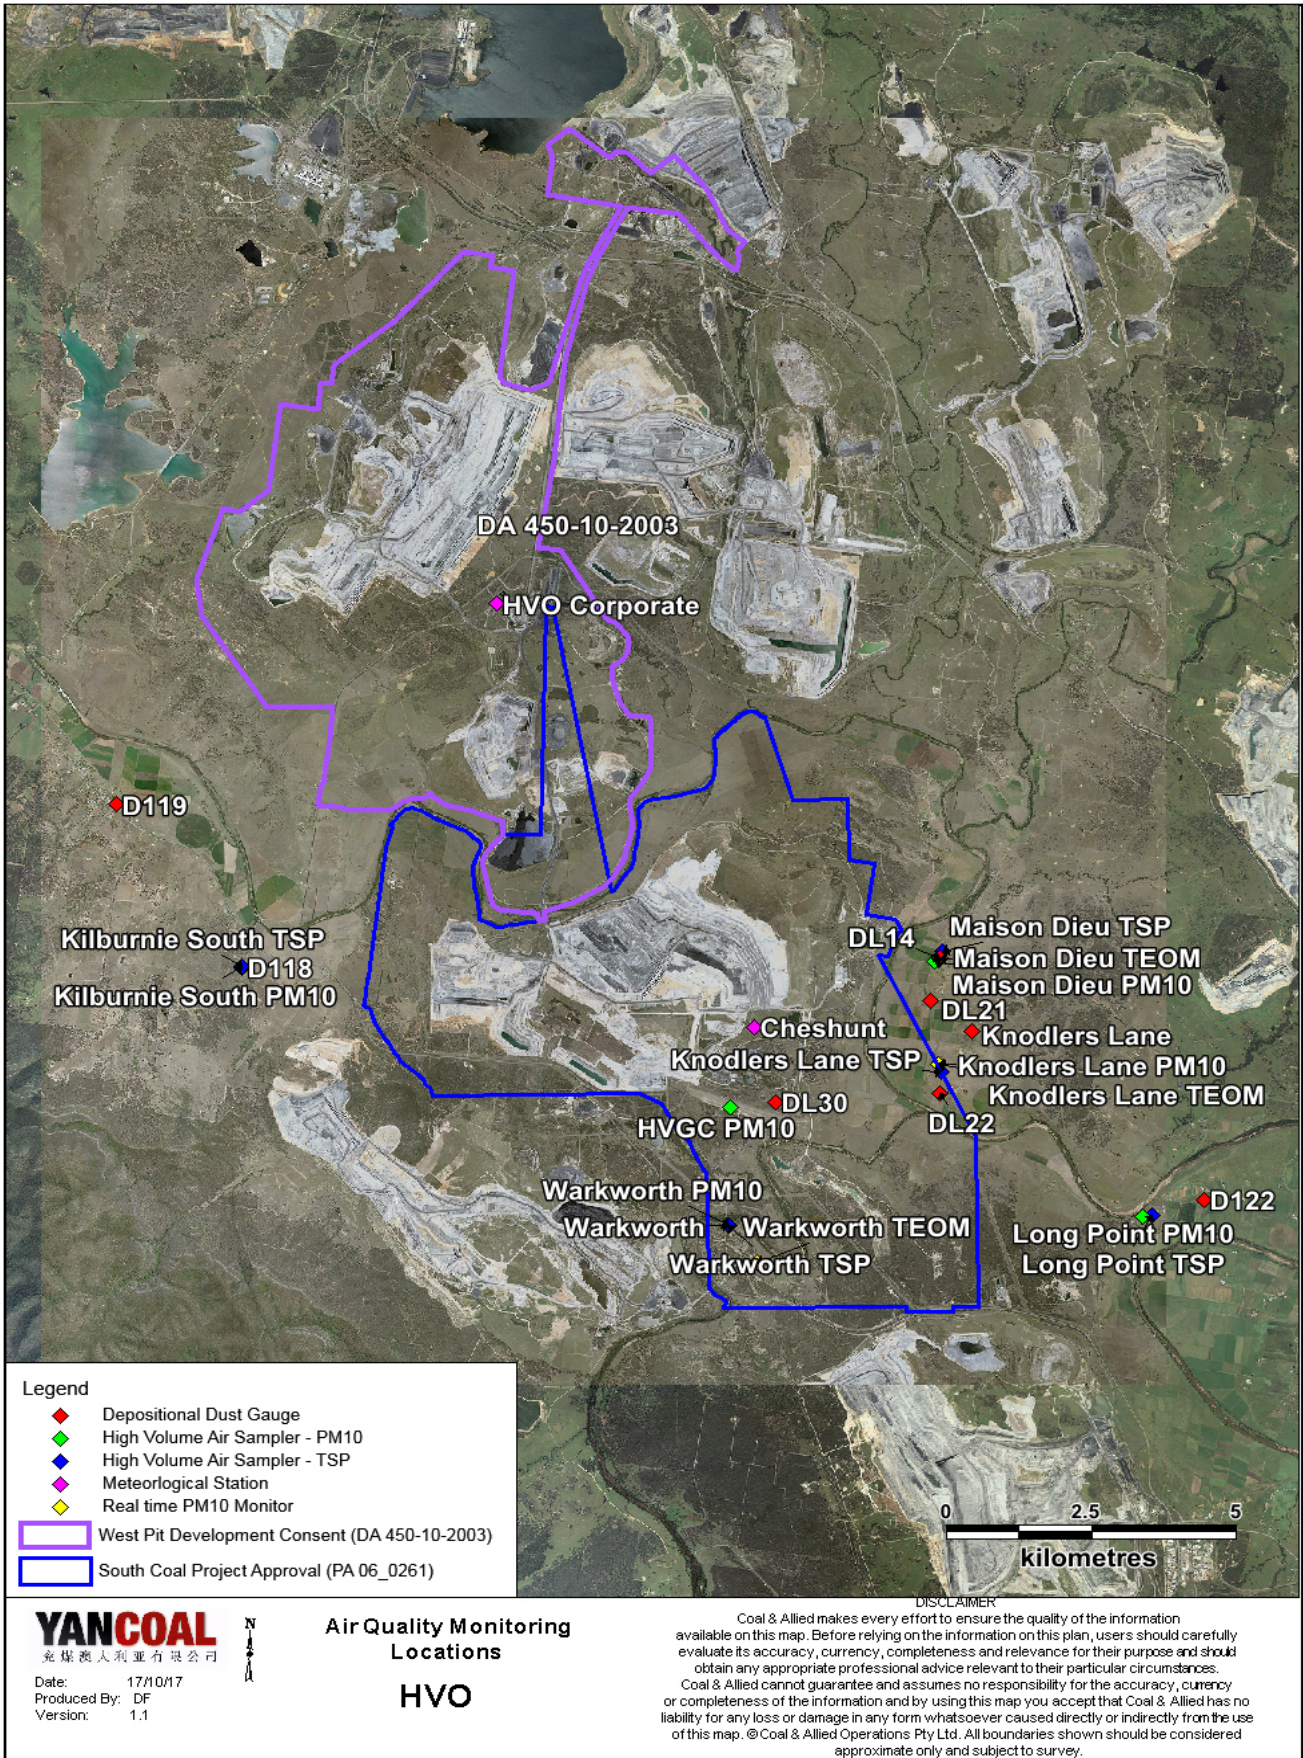
Figure 4: Air Quality Monitoring Location Plan

Suspended particulates are measured by a network of High Volume Air Samplers (HVAS) measuring Total Suspended Particulates (TSP) and Particulate Matter <10µm (PM₁₀). The location of these monitors can be found in Figure 4. Each HVAS was run for 24 hours on a six-day cycle.

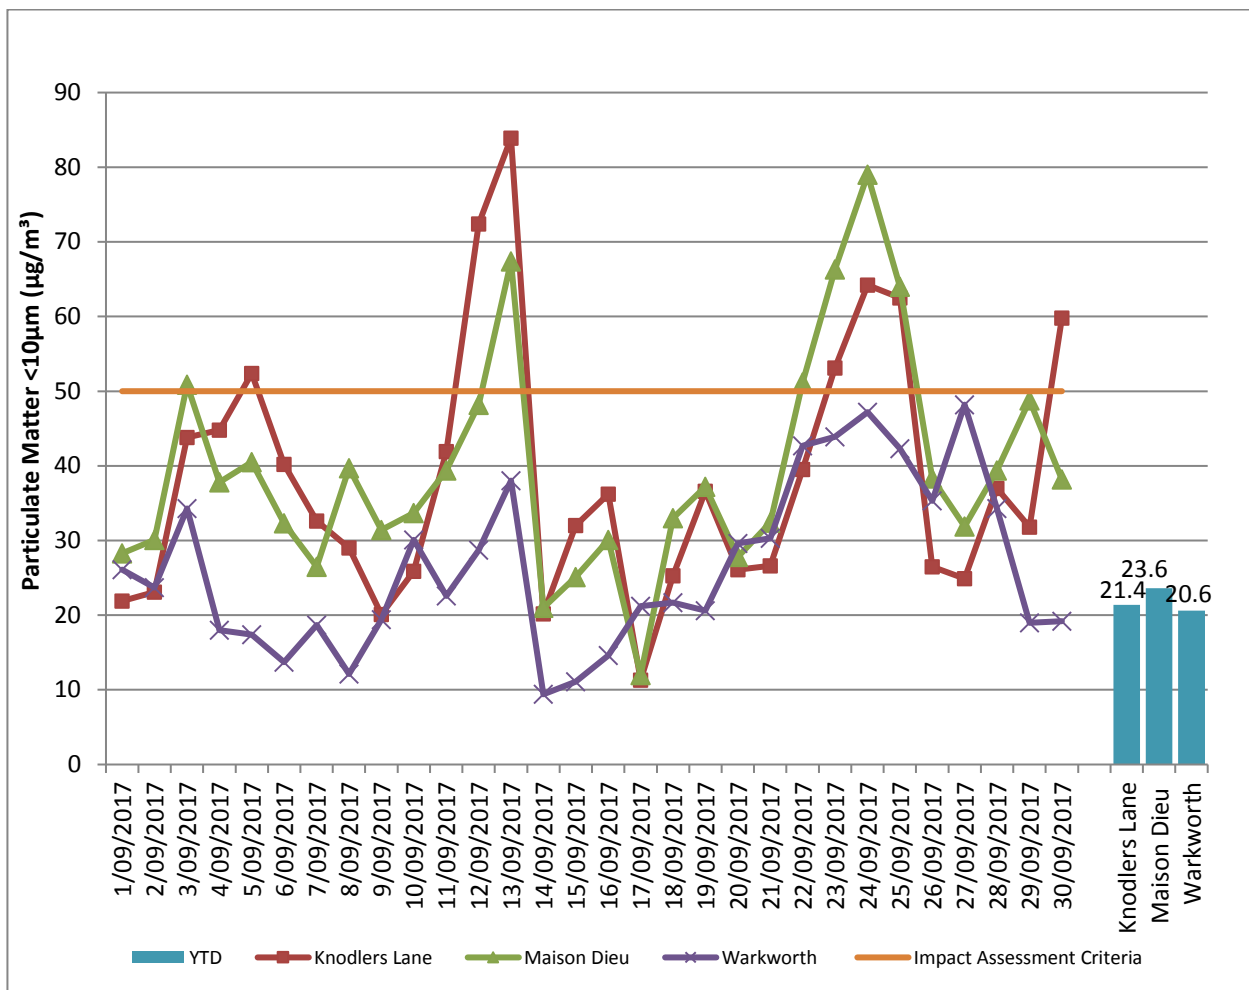
During September the real time monitoring system generated 176 automated air quality related alarms. 42 were related to adverse weather conditions and 134 alarms relating to PM_{10} .

Figure 9: Real Time PM_{10} 24hr average and YTD average – September 2017

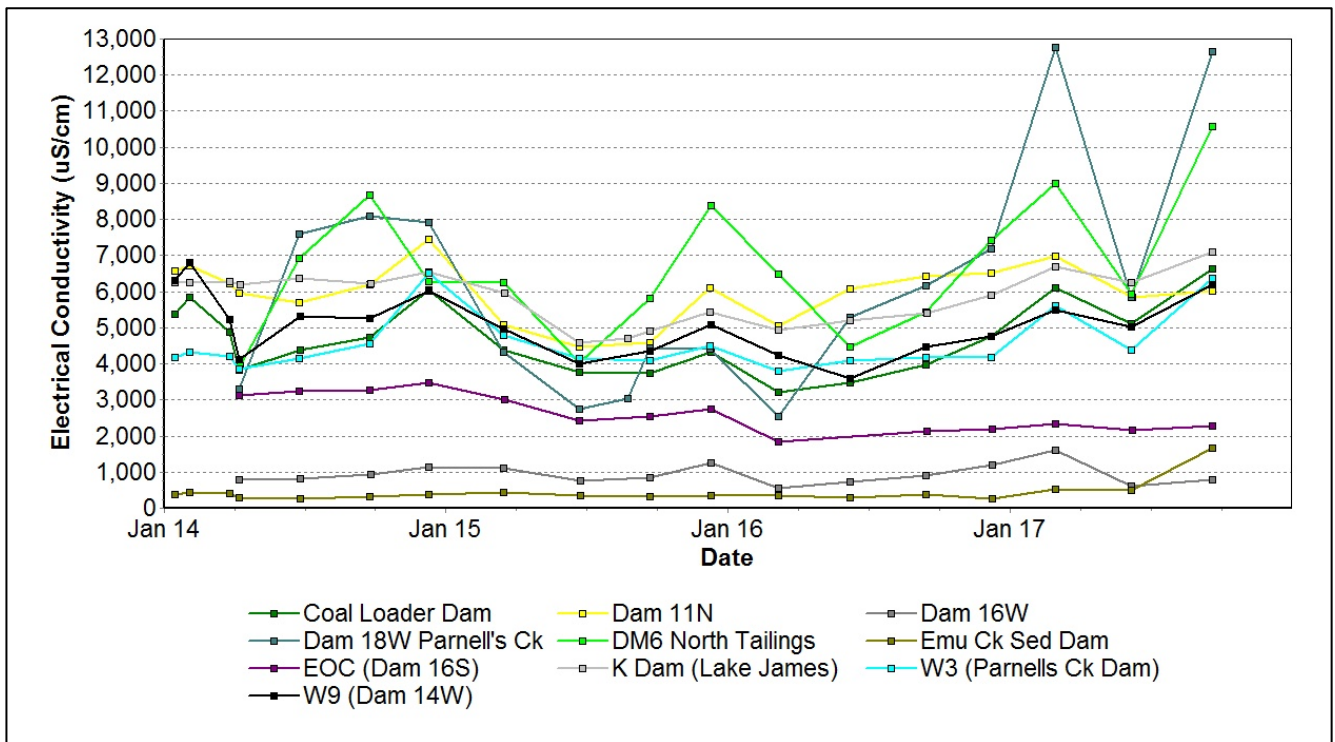
Figure 10 to Figure 12 show the long term surface water trend (2014 – current) within HVO mine dams. Figure 13 to Figure 21 show the long term surface water trend (2014 – current) in surrounding watercourses.

Figure 10: Site Dams Electrical Conductivity Trend – September 2017

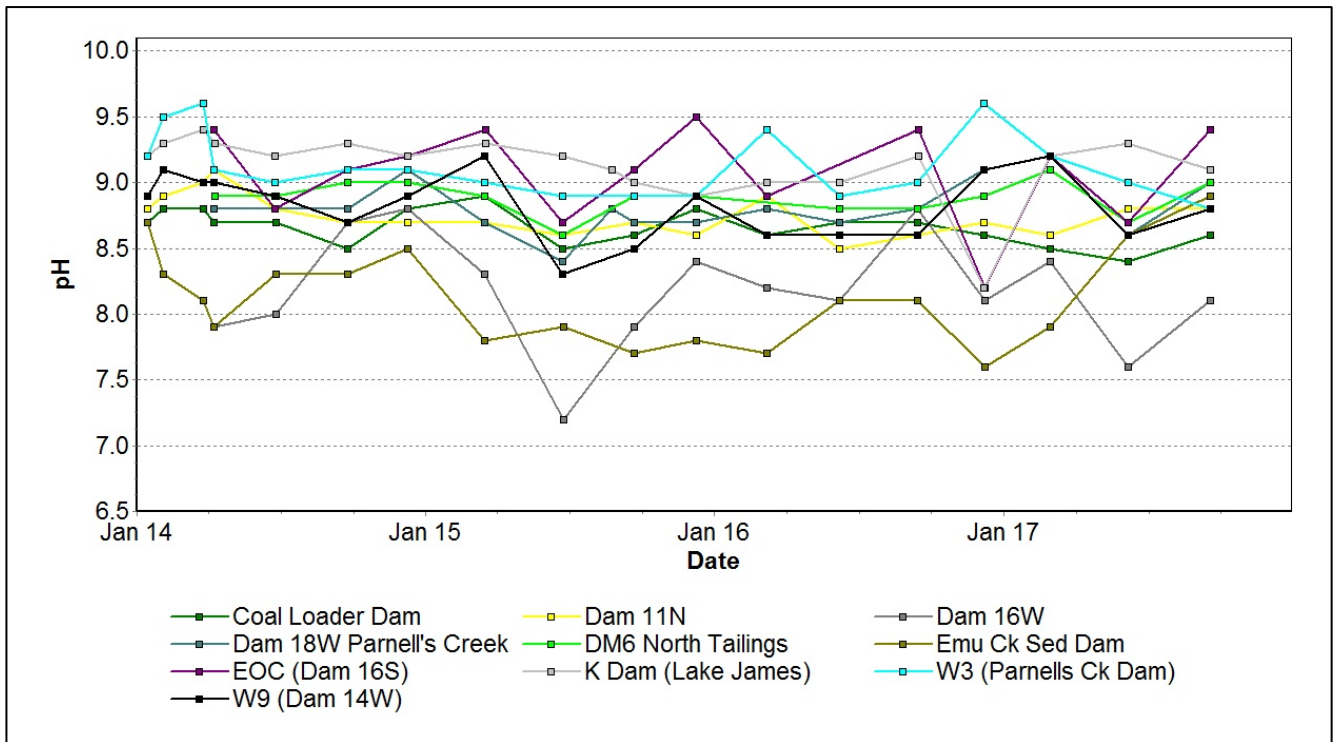
Figure 11: Site Dams pH Trend – September 2017

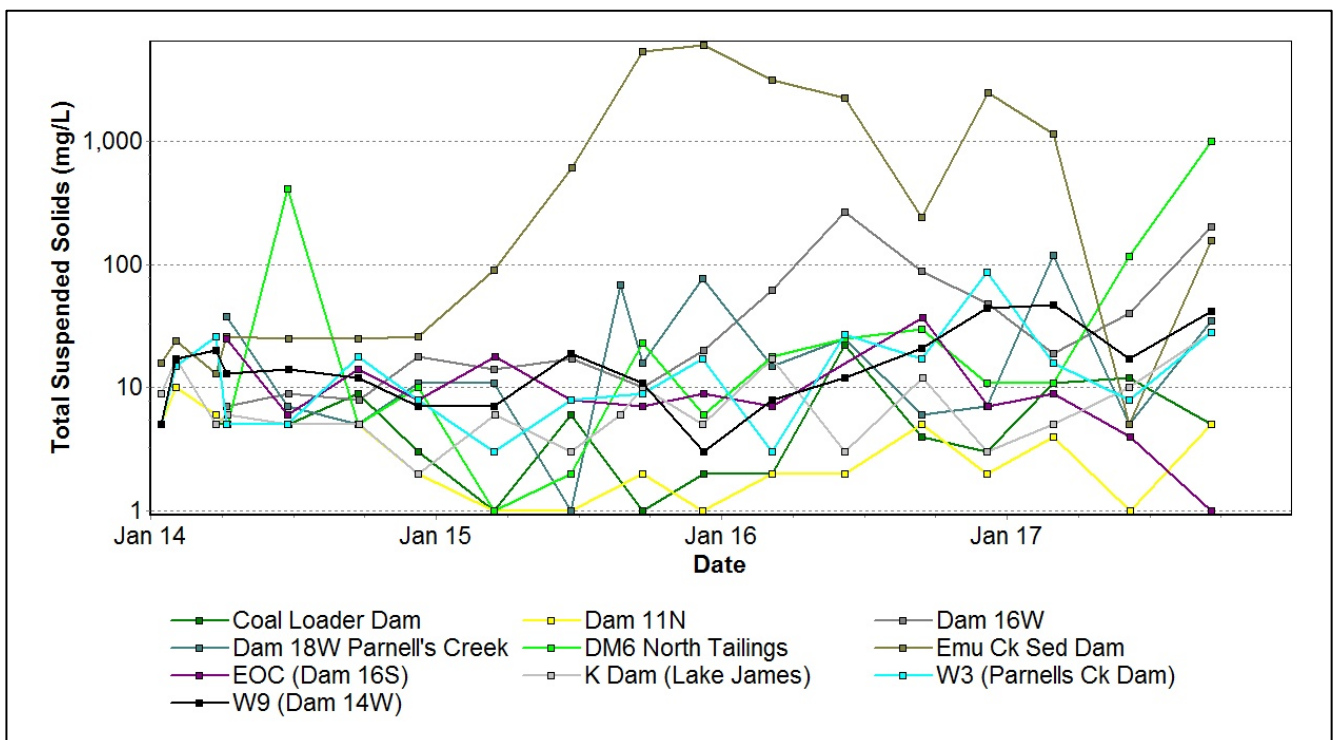
Figure 12: Site Dams Total Suspended Solids Trend – September 2017

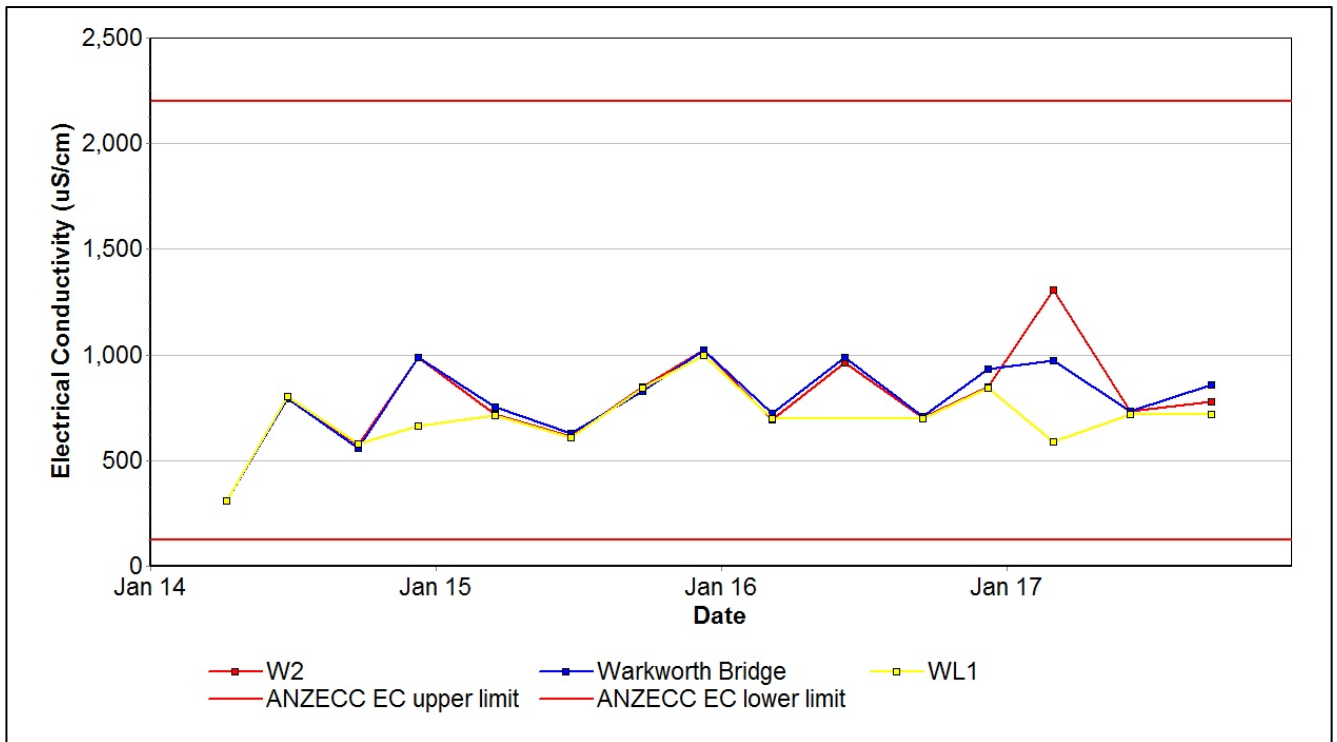
Figure 13: Wollombi Brook Electrical Conductivity Trend - September 2017

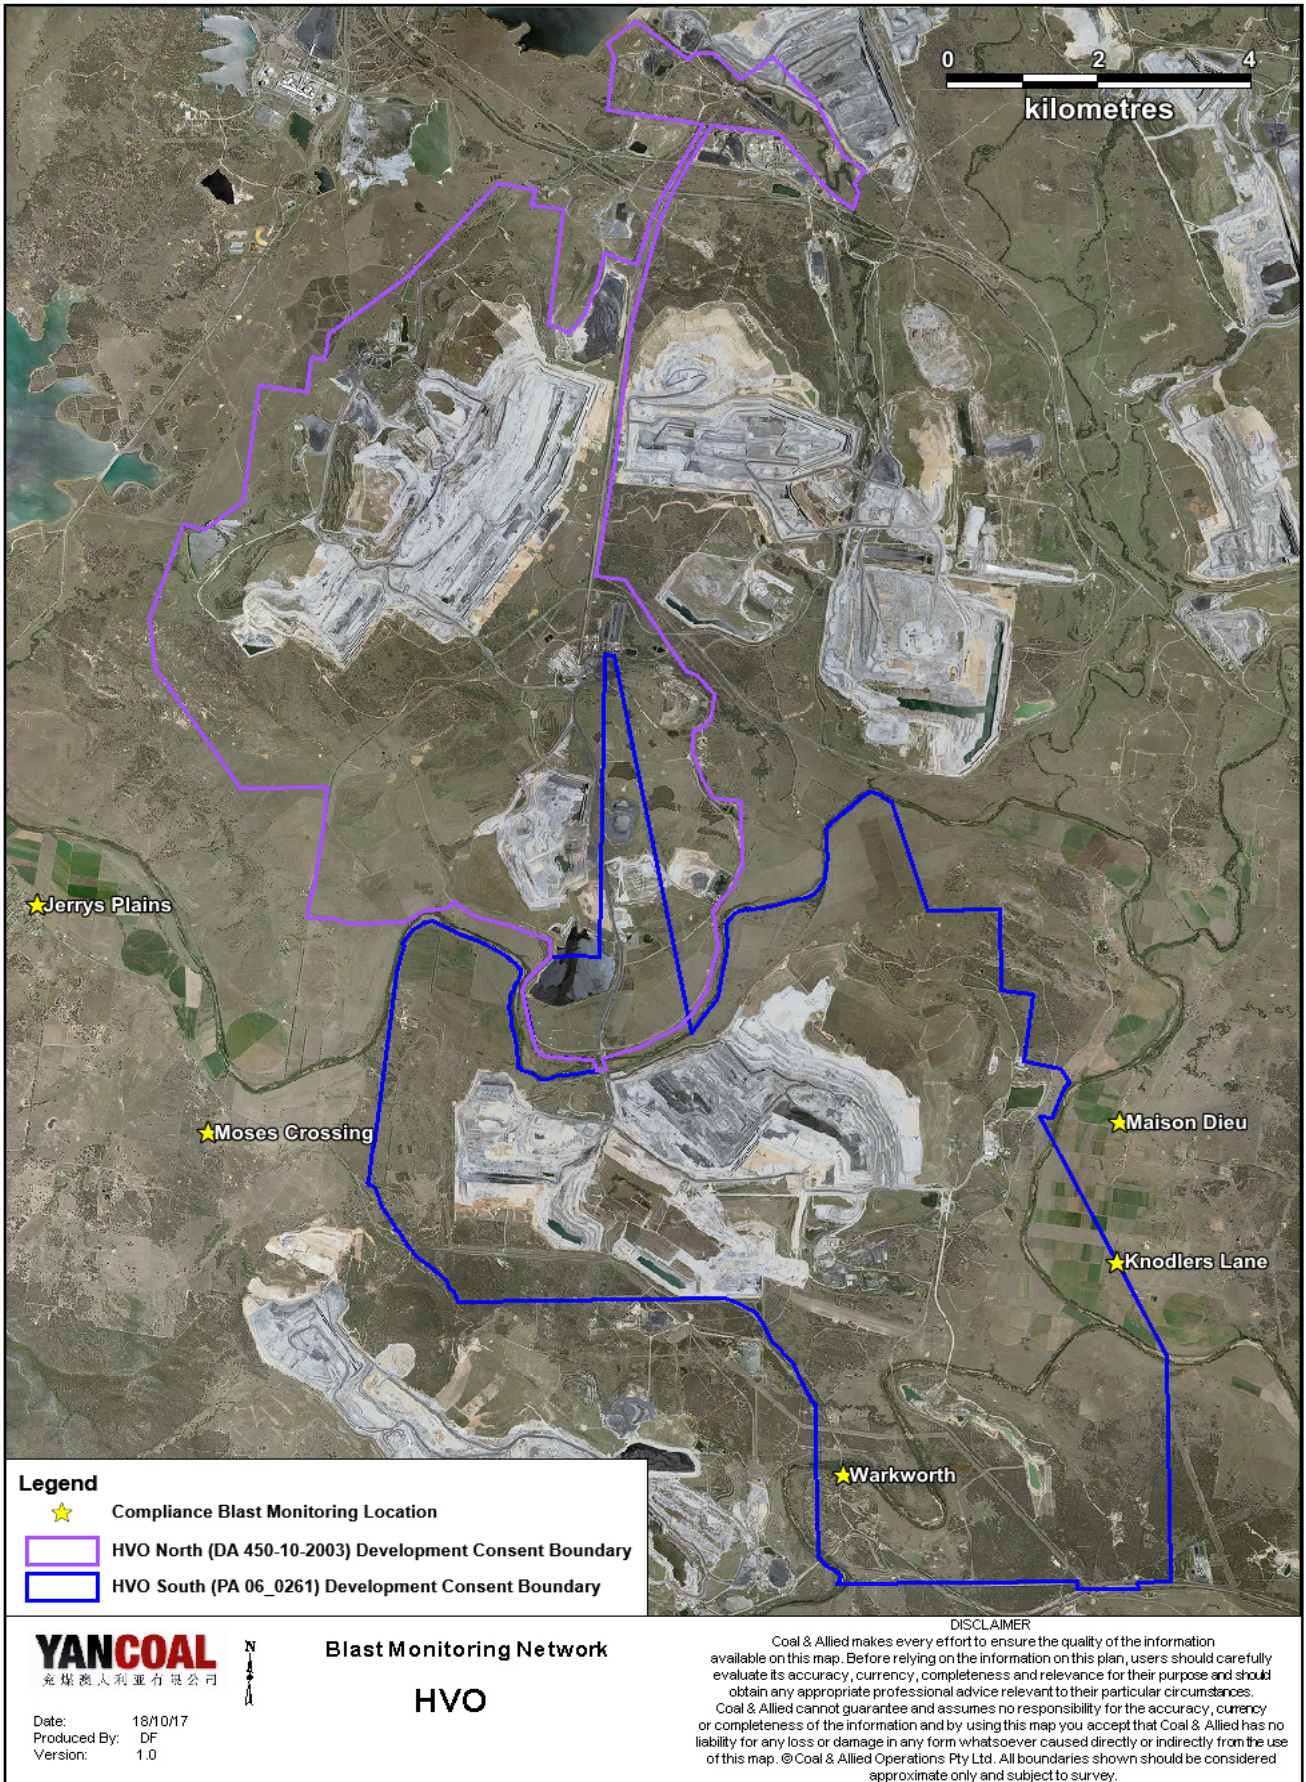
Figure 83: Blast Monitoring Location Plan

HVO have a network of five blast monitoring units. These are located at nearby privately owned residences and function as regulatory compliance monitors. The location of these monitors can be found in Figure 83.

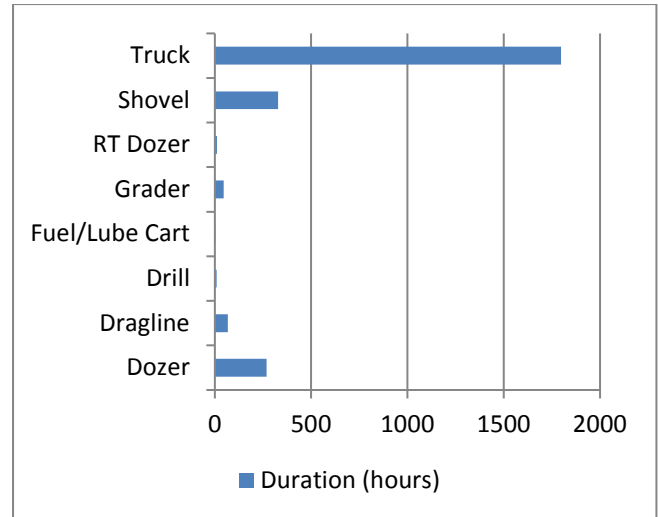
During September, a total of 2531.5 hours of equipment downtime was logged in response to real time monitoring and visual inspections for environmental reasons such as dust, noise and meteorological conditions. Operational downtime by equipment type is shown in Figure 85.

Figure 85: Operational Downtime by Equipment Type – September 2017

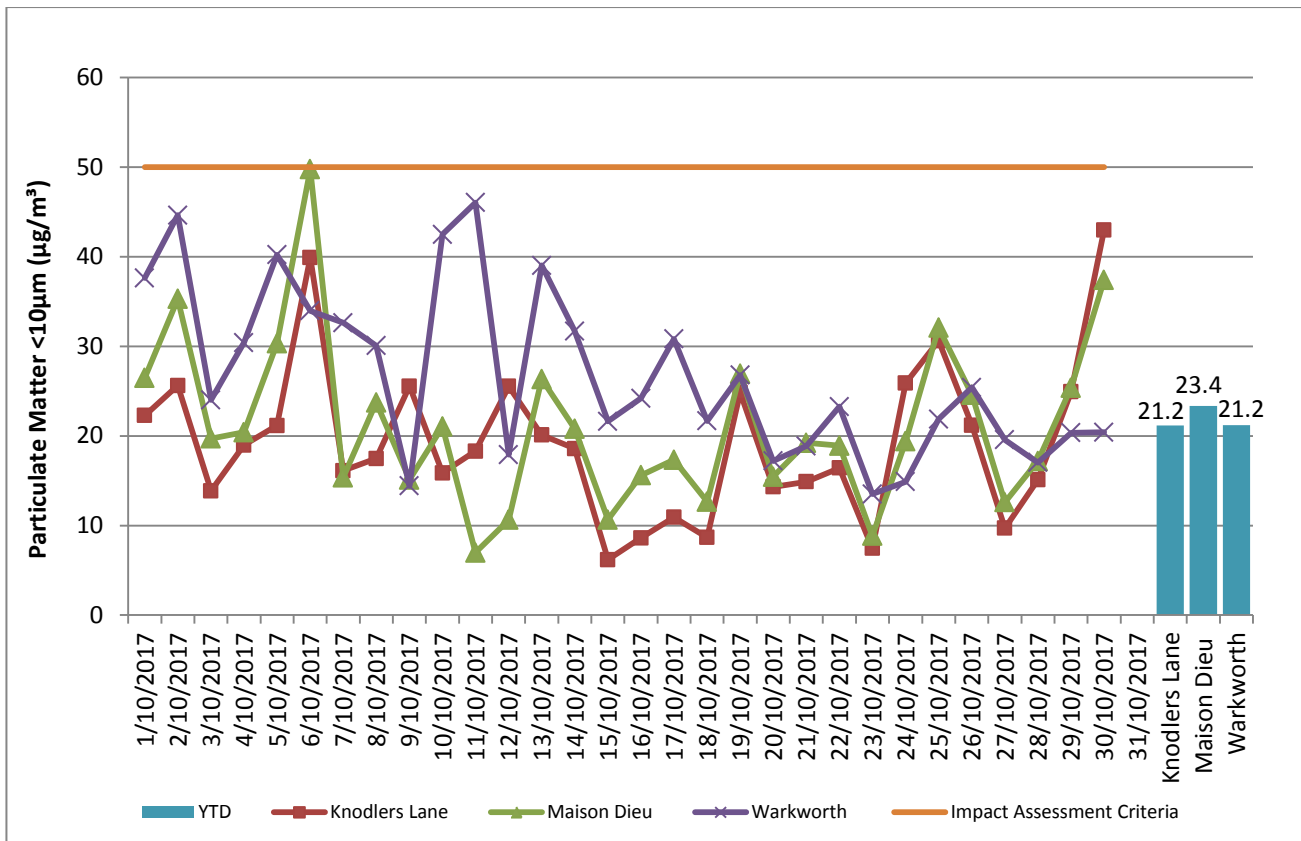
During October the real time monitoring system generated 44 automated air quality related alarms. 4 were related to adverse weather conditions and 40 alarms relating to PM₁₀.

Figure 9: Real Time PM₁₀ 24hr average and YTD average – October 2017

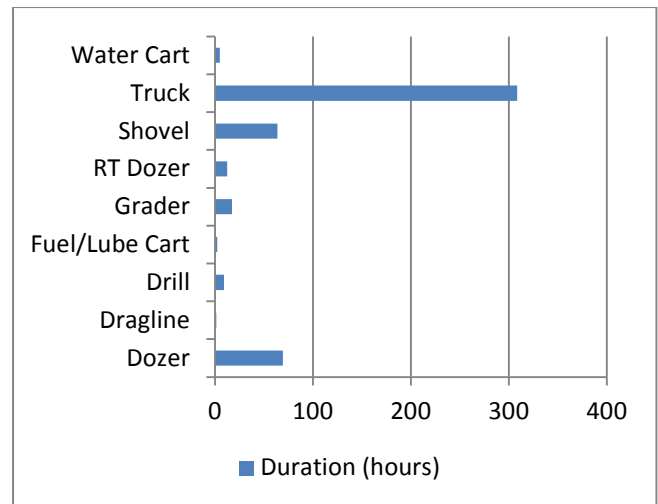
During October, a total of 490.4 hours of equipment downtime was logged in response to real time monitoring and visual inspections for environmental reasons such as dust, noise and meteorological conditions. Operational downtime by equipment type is shown in Figure 17.

Figure 17: Operational Downtime by Equipment Type – October 2017

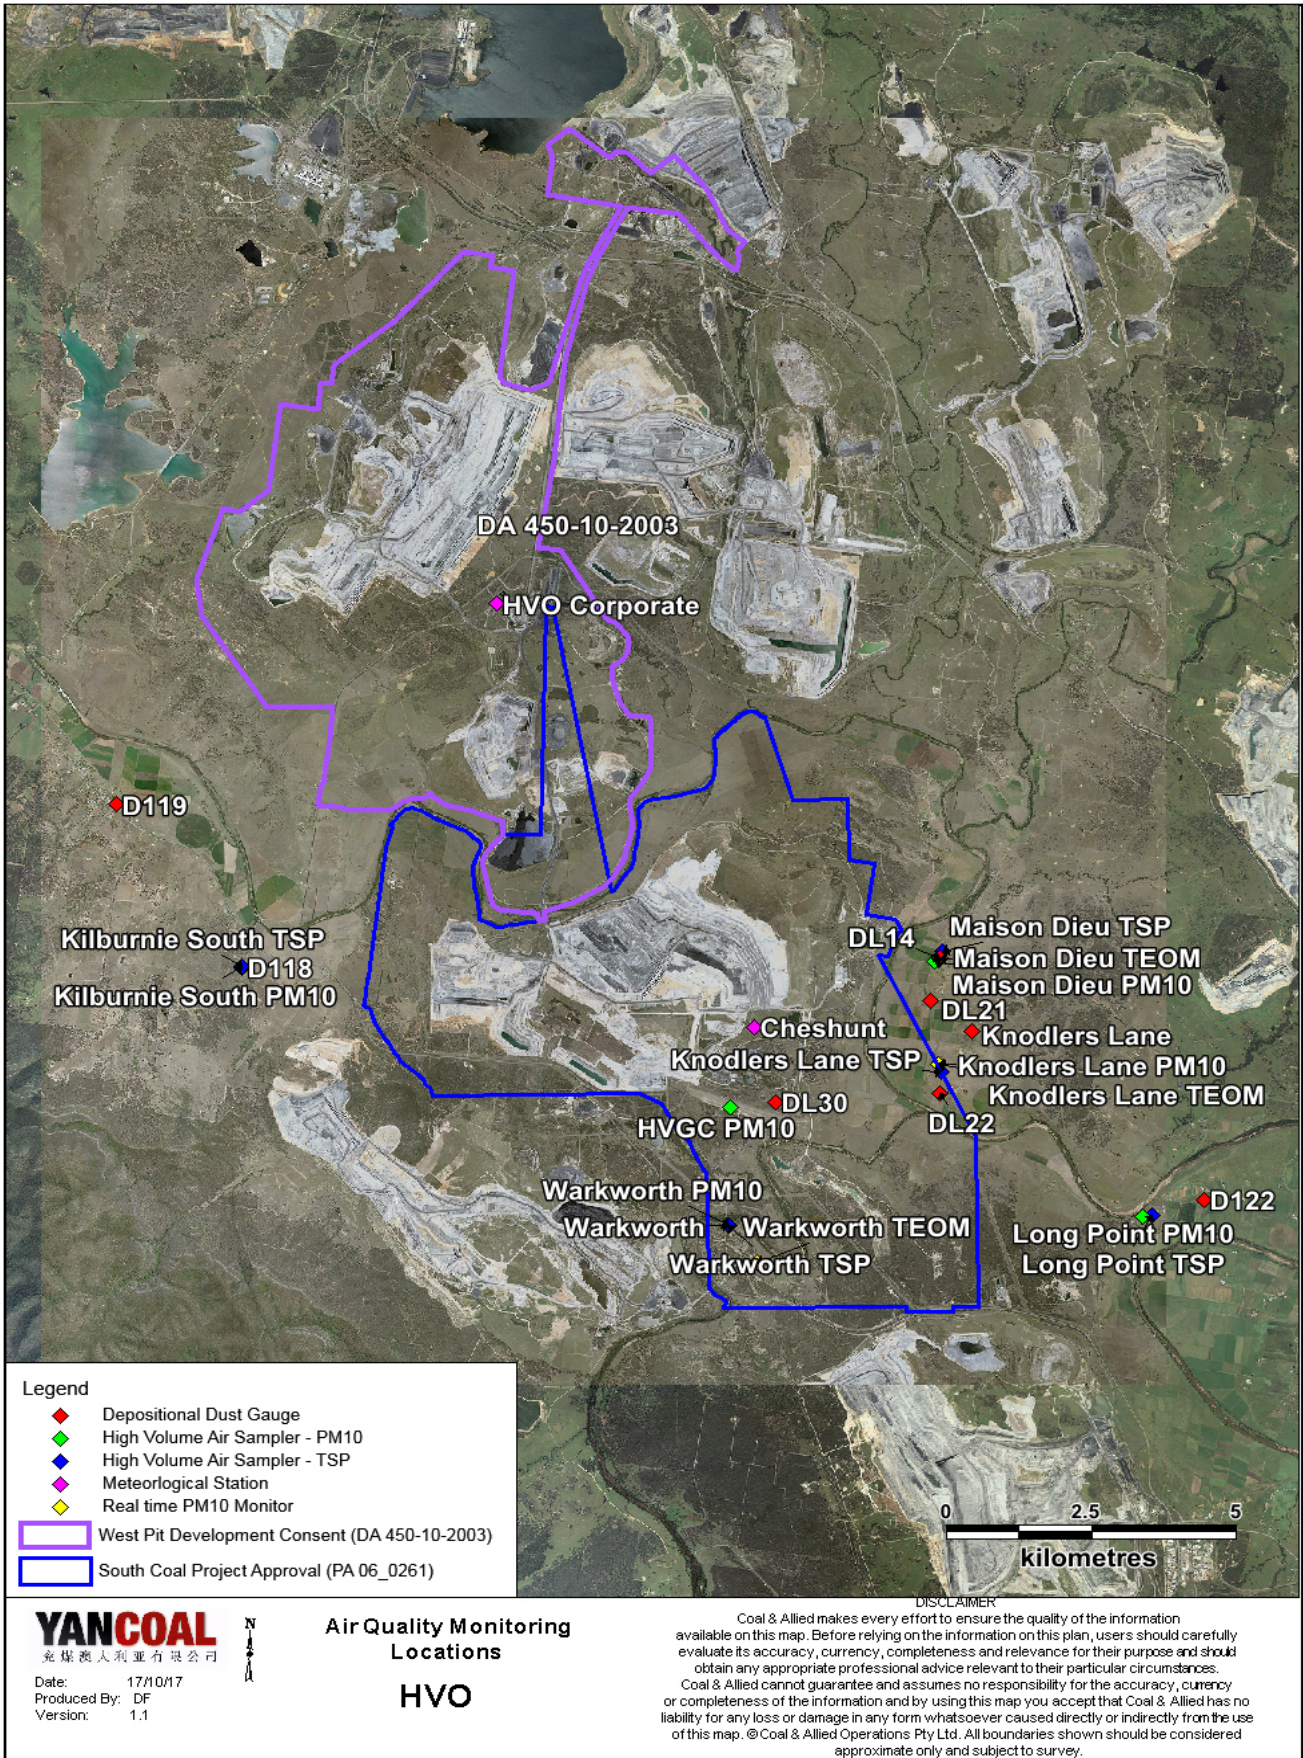
Figure 4: Air Quality Monitoring Location Plan

Suspended particulates are measured by a network of High Volume Air Samplers (HVAS) measuring Total Suspended Particulates (TSP) and Particulate Matter <10µm (PM₁₀). The location of these monitors can be found in Figure 4. Each HVAS was run for 24 hours on a six-day cycle.

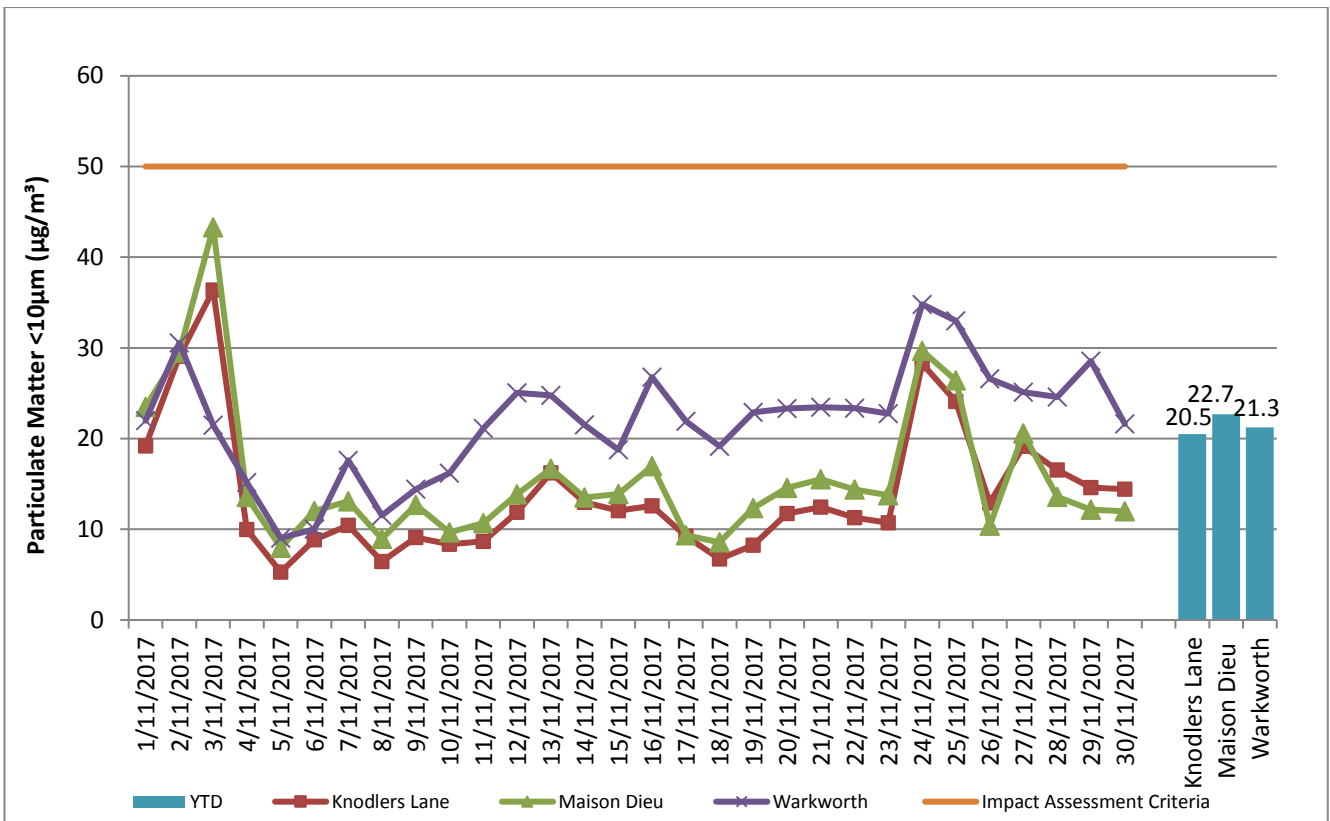
During November the real time monitoring system generated 49 automated air quality related alarms. 32 were related to adverse weather conditions and 17 alarms relating to PM₁₀.

Figure 9: Real Time PM₁₀ 24hr average and YTD average – November 2017

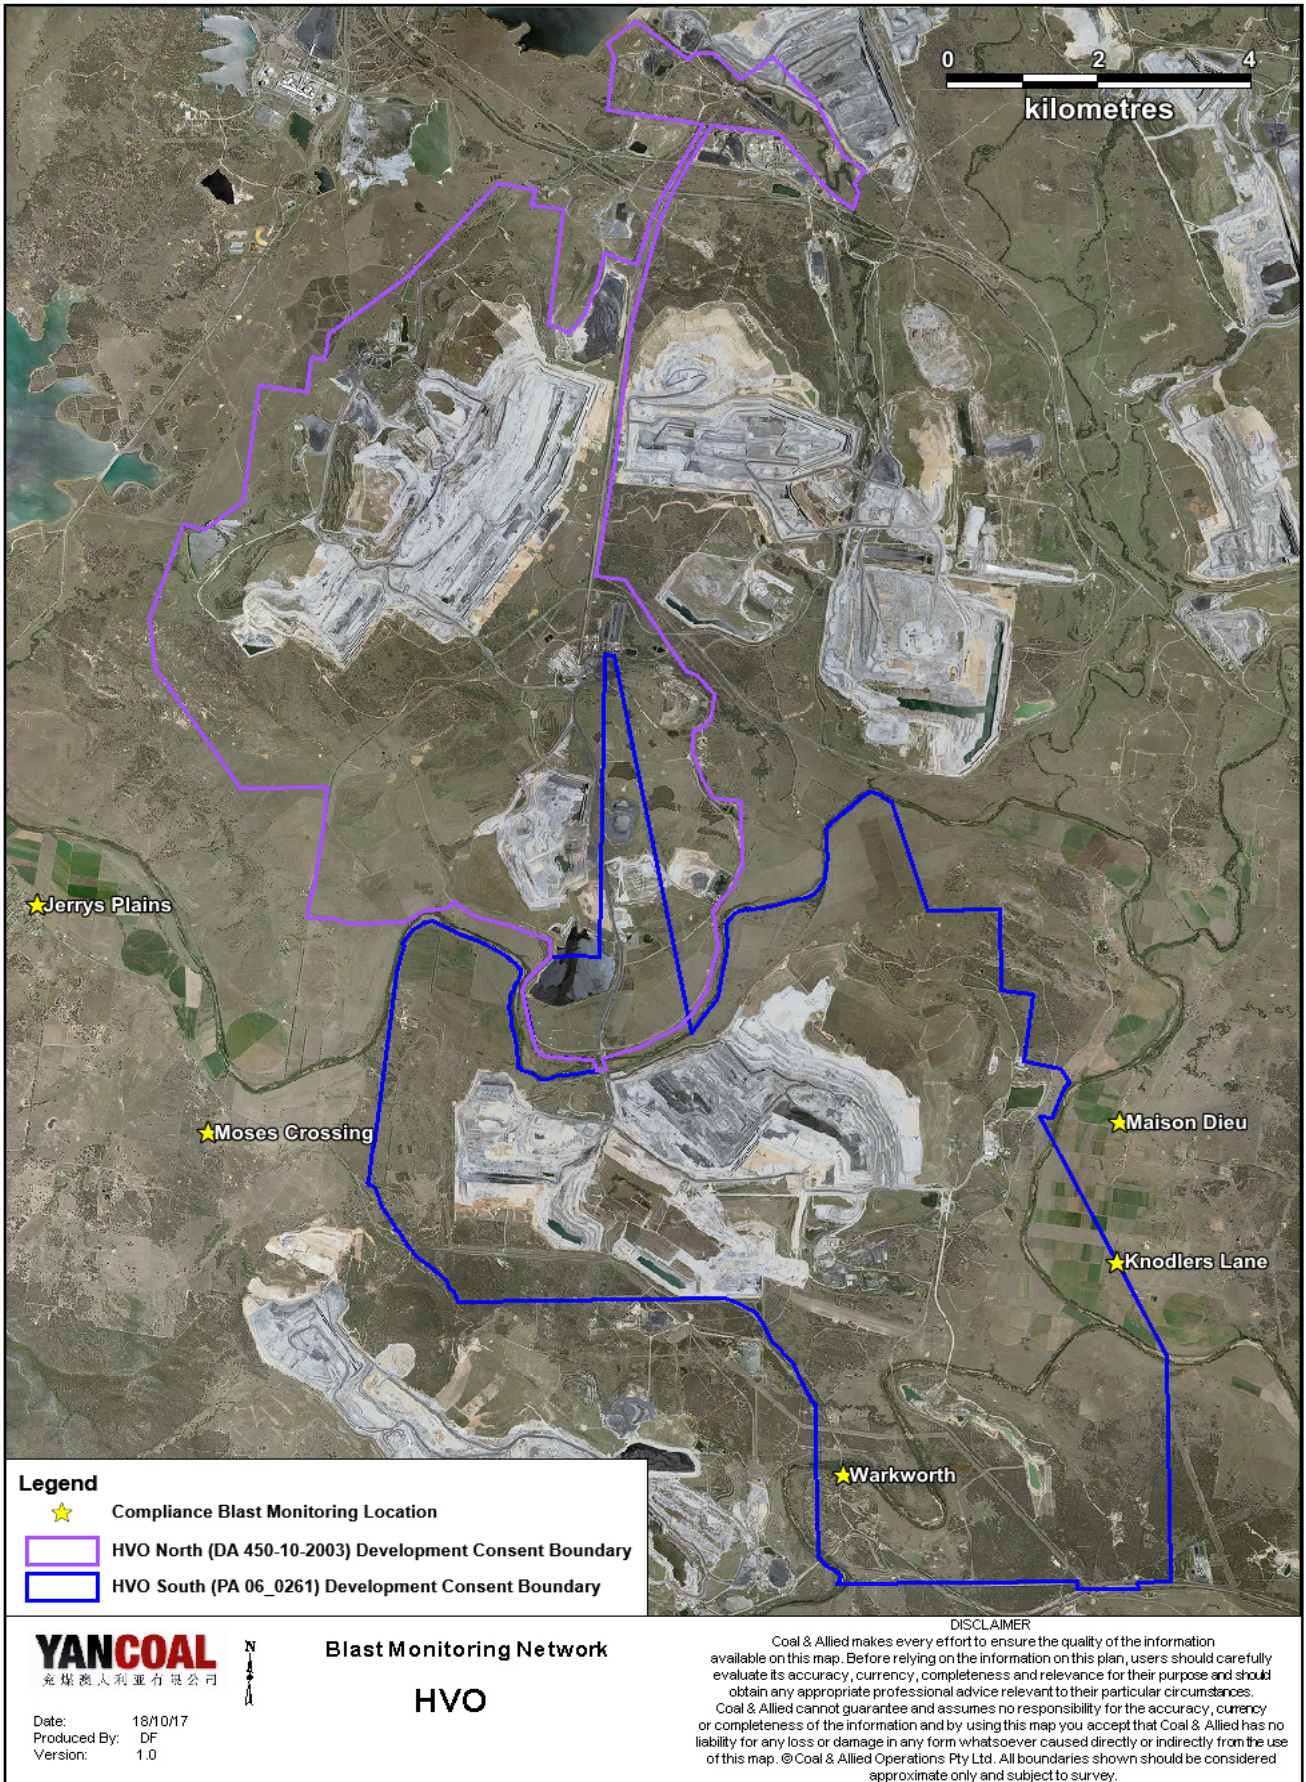
Figure 15: Blast Monitoring Location Plan

HVO have a network of five blast monitoring units. These are located at nearby privately owned residences and function as regulatory compliance monitors. The location of these monitors can be found in Figure 15.

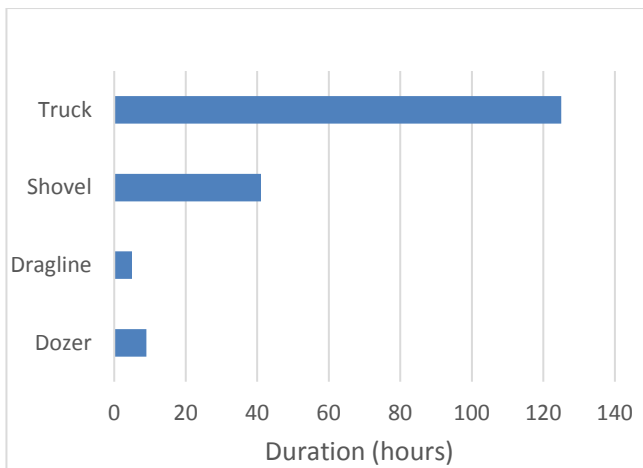
During November, a total of 180 hours of equipment downtime was logged in response to real time monitoring and visual inspections for environmental reasons such as dust, noise and meteorological conditions. Operational downtime by equipment type is shown in Figure 17.

Figure 17: Operational Downtime by Equipment Type – November 2017
