Hunter Valley Operations

Monthly Environmental Report

February 2017

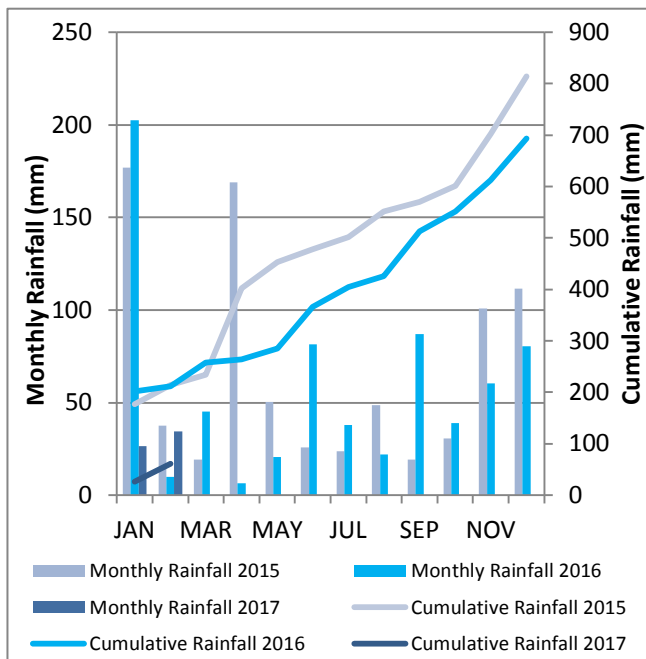
Figure 1: Year to Date Rainfall Summary 2017

Rainfall for the period is summarised in Table 1, the 2017 trend and historical trend are shown in Figure 1.

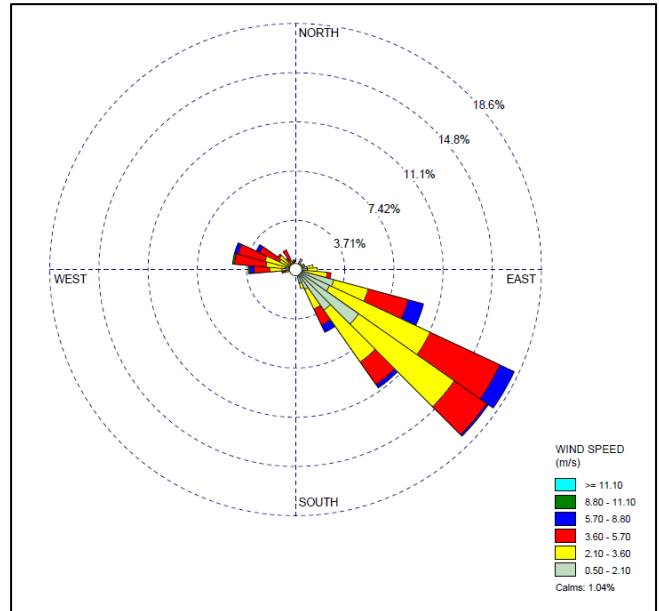
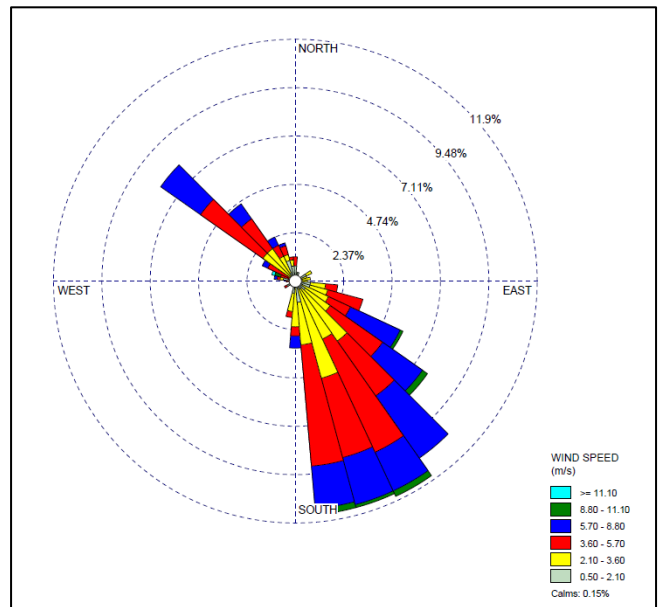
Figure 2: HVO Corporate Wind Rose – February 2017

South-Easterly winds were dominant during February as shown in Figure 2 (HVO Corporate) and Figure 3 (HVO Cheshunt).

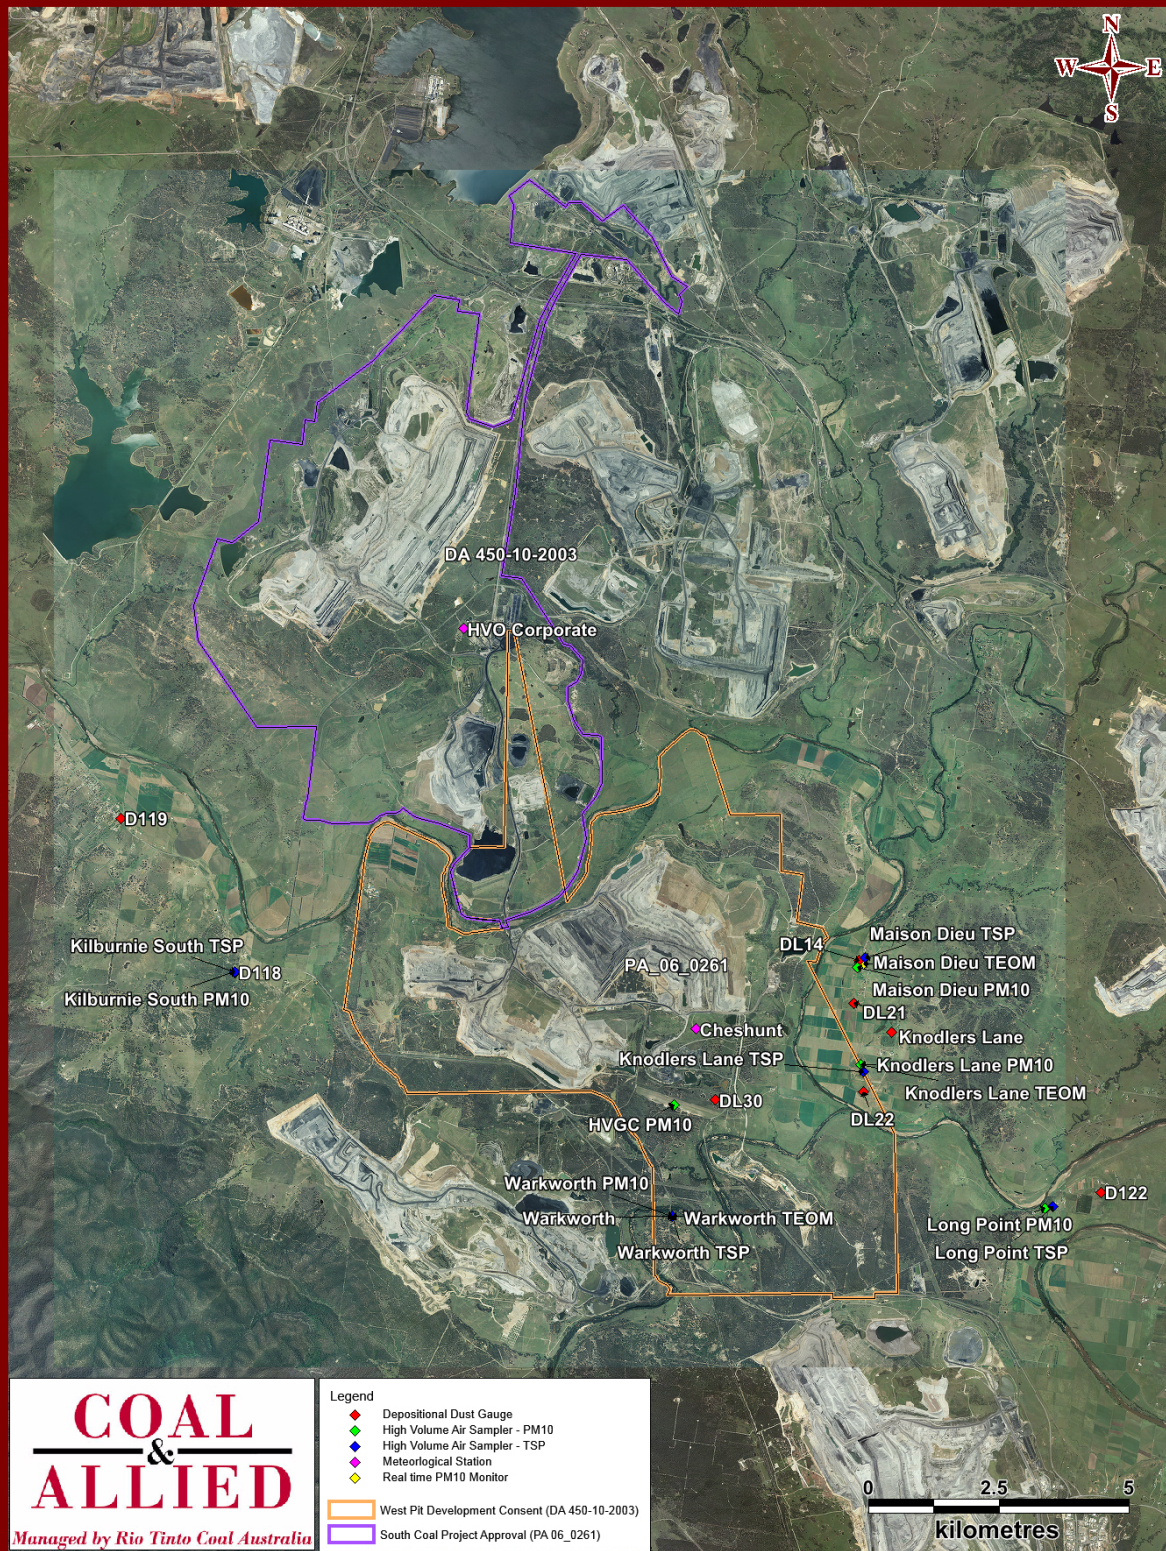
Figure 4: Air Quality Monitoring Location Plan

HVO maintains two meteorological stations; 'Corporate' and 'Cheshunt' (Refer to Figure 4: Air Quality Monitoring Location Plan).

Suspended particulates are measured by a network of High Volume Air Samplers (HVAS) measuring Total Suspended Particulates (TSP) and Particulate Matter <10µm (PM₁₀). The location of these monitors can be found in Figure 4. Each HVAS was run for 24 hours on a six-day cycle in accordance with EPA requirements.

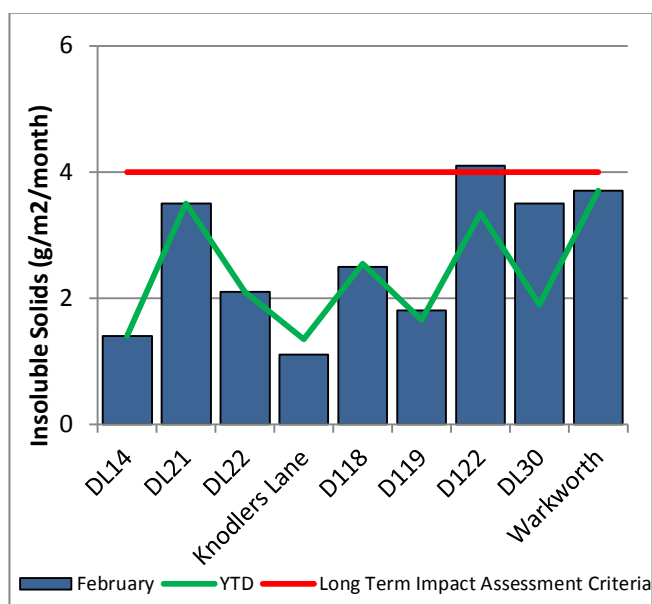
Figure 5: Depositional Dust Results – February 2017

Figure 5 displays insoluble solids results from depositional dust gauges during the reporting period compared against the year-to-date average and the annual impact assessment criteria.

During the reporting period the D122 monitor recorded a monthly result above the long term impact assessment criteria of 4.0 g/m² per month. There is no evidence to suggest that the D122 result is contaminated. Accordingly, this result will be included in the annual average calculation.

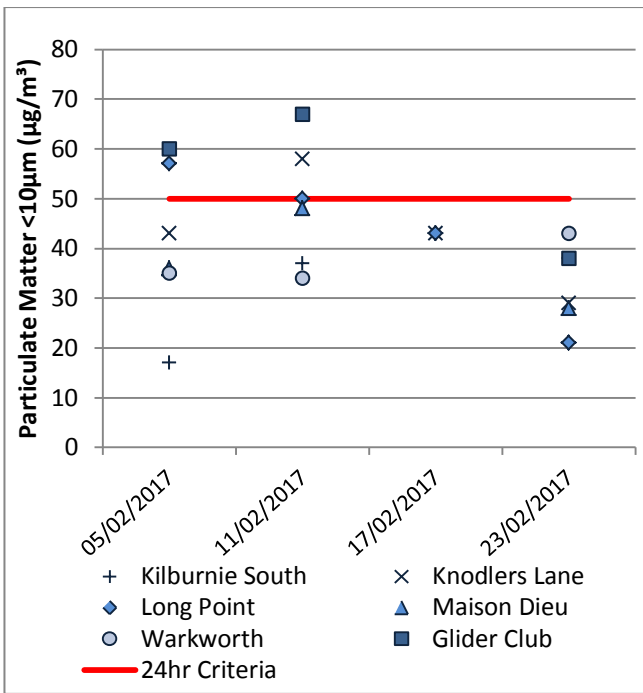
Figure 6: Individual PM₁₀ Results – February 2017

Figure 6 shows individual PM₁₀ results at each monitoring station against the short term impact assessment criteria of 50µg/m³.

The Kilburnie South, Maison Dieu, Warkworth and Gliding Club HVAS monitors failed to collect valid samples on the 17th of February due to a power outage (likely related to storm activity).

On 05/02/2017 two HVAS PM₁₀ units recorded results greater than the short term (24hr) PM₁₀ impact assessment criteria; Long Point (57 µg/m³) and Gliding Club (60 µg/m³).

On 11/02/2017 two HVAS PM₁₀ units recorded results greater than the short term (24hr) PM₁₀ impact assessment criteria; Knodlers Lane (58 µg/m³) and Gliding Club (67 µg/m³).

Investigation indicates that that the likely HVO contribution to the results at Long Point and Gliding Club on the 5th February is less than 75%. Accordingly, no further action is required (as per approved Air Quality Monitoring Programme).

Investigation indicates that that the likely HVO contribution to the results at Knodlers Lane and Gliding Club on the 11th February is less than 75%. Accordingly, no further action is required.

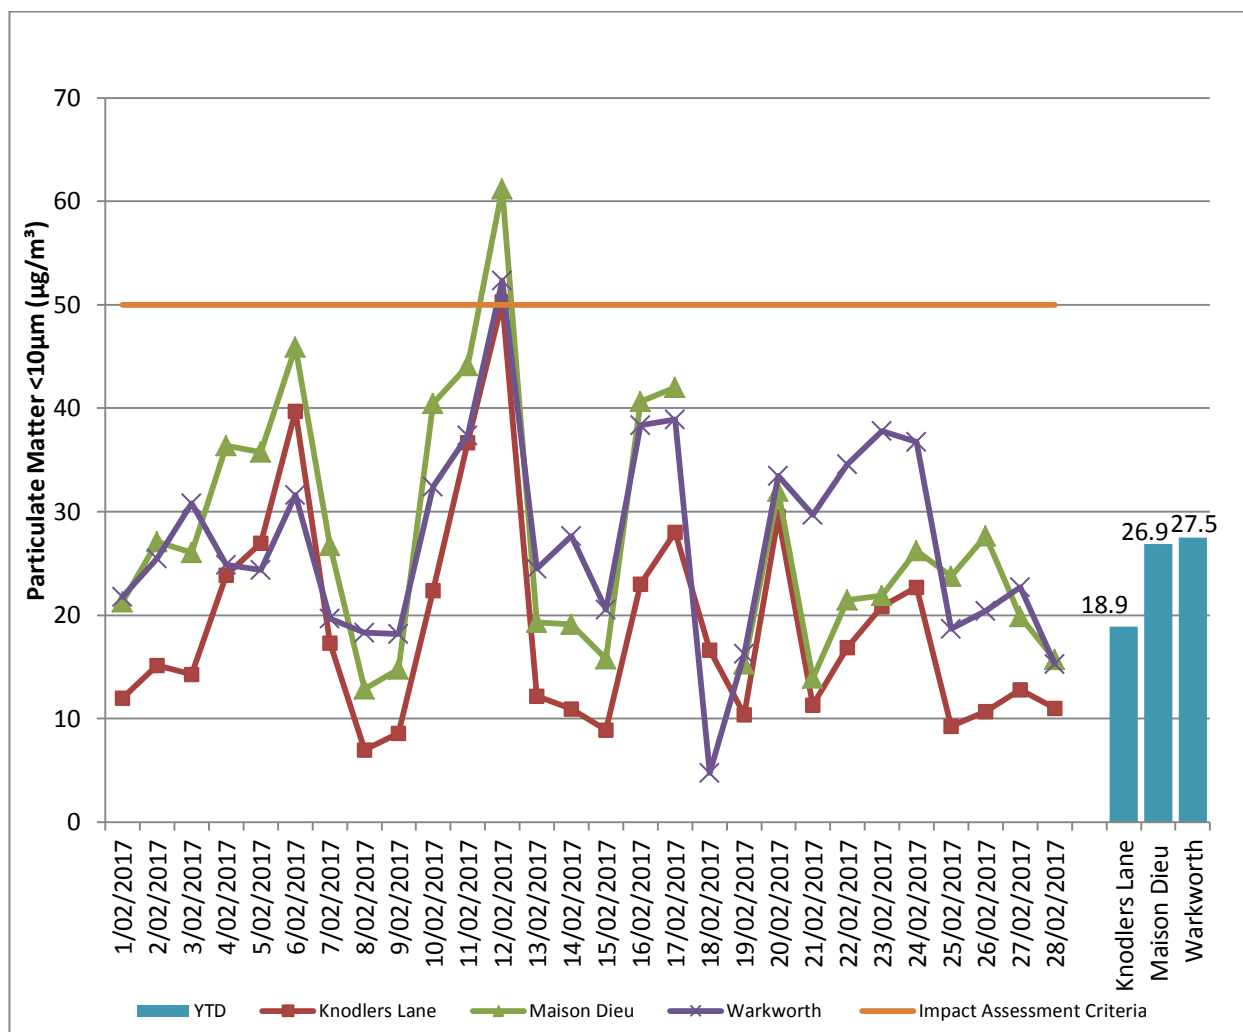
Figure 9: Real Time PM₁₀ 24hr average and YTD Average – February 2017

Results for real time dust sampling are shown in Figure 9, including the daily 24 hour average PM₁₀ result and the 24 hour YTD PM₁₀ average. There were three results recorded which exceeded the short term (24hr) criteria in the approvals. A measurement of 50.3µg/m³ was recorded at the Knodlers Lane TEOM location, a measurement of 61.2 µg/m³ was recorded at the Maison Dieu TEOM and a measurement of 52.3µg/m³ was recorded at Warkworth TEOM location on the 12th February.

Data was not available on the 18th February (Maison Dieu) due to technical issues.

An investigation was undertaken to assess air quality and meteorological conditions on the day, and to assess the maximum potential HVO contribution to the measured result. The investigation determined that HVO's maximum potential contribution to measured levels at Knodlers Lane, Maison Dieu and Warkworth is estimated at less than 75%. Accordingly, no further action is required (as per approved Air Quality Monitoring Programme).

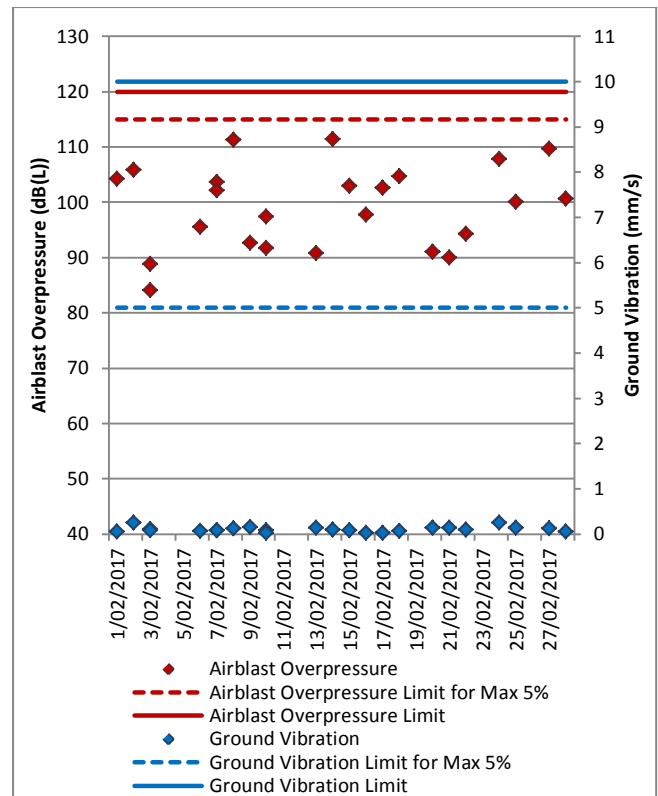
Figure 10: Moses Crossing Blast Monitoring Results – February 2017

During February, 24 blasts were initiated at HVO. Figure 10 through to Figure 14 show the blast monitoring results for the reporting period against the impact assessment criteria. The criteria are summarised in Table 2.

During the reporting period one blast exceeded the 115 dB(L) threshold for airblast overpressure. A blast recorded on the 25th February at 12:37pm, recorded an elevated airblast overpressure reading of 115.19dB(L) at the Knodlers Lane blast monitoring location. No blasts exceeded the 5mm/s criterion for ground vibration.

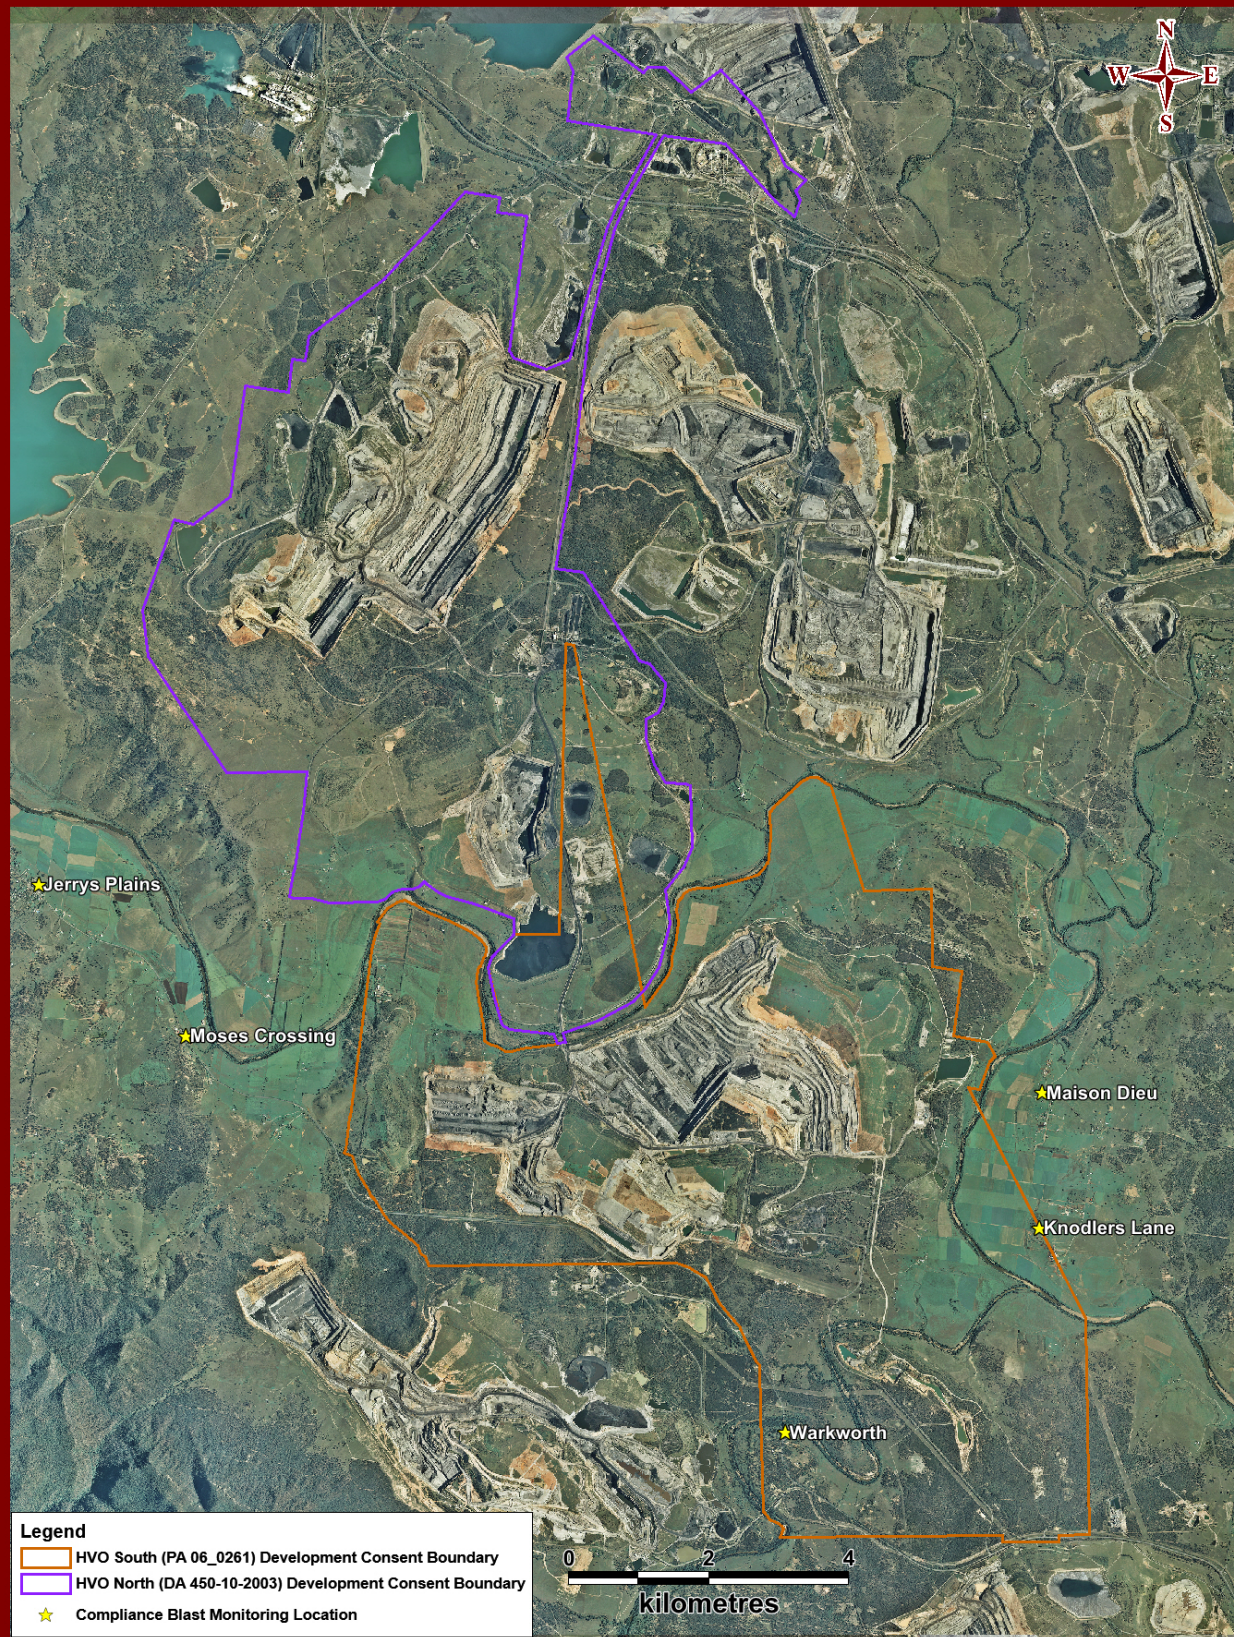
Figure 15: Blast Monitoring Location Plan

HVO have a network of five blast monitoring units. These are located at nearby privately owned residences and function as regulatory compliance monitors. The location of these monitors can be found in Figure 15.

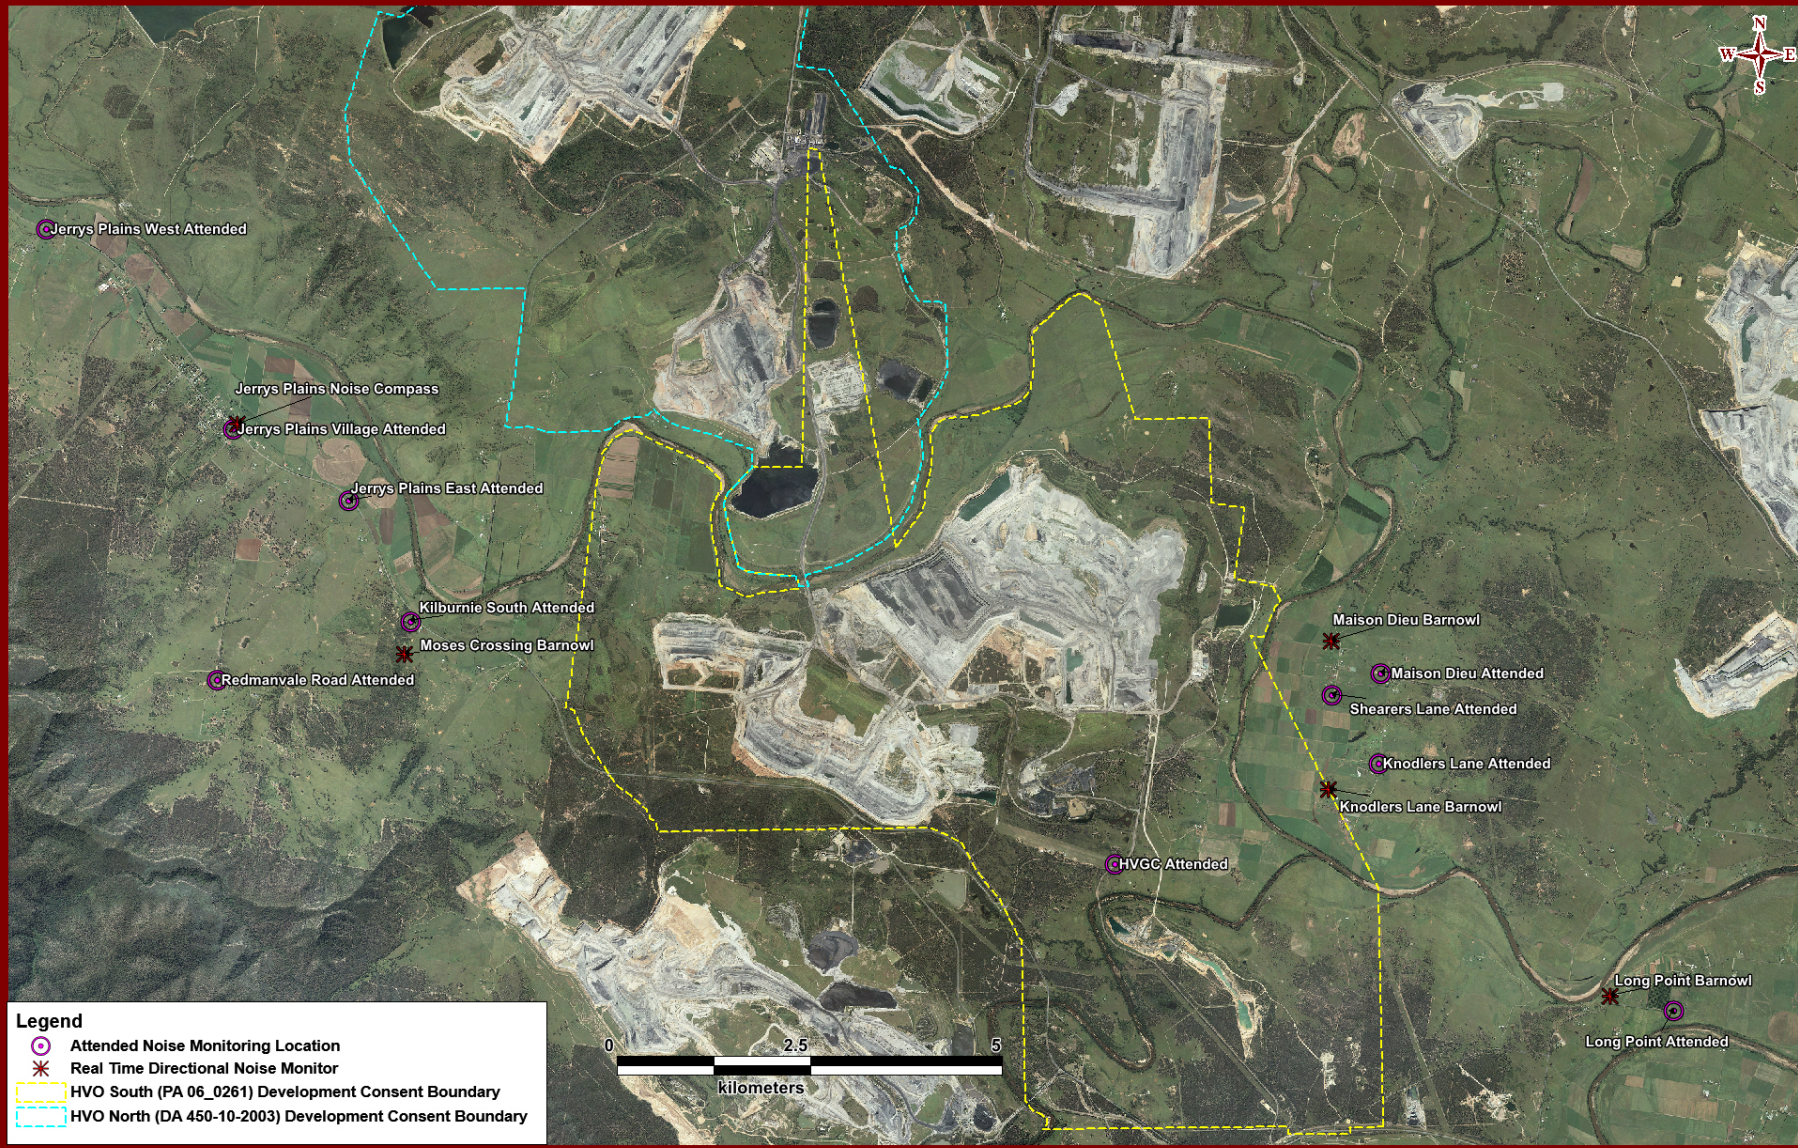
Figure 16: Noise Monitoring Location Plan

Routine attended noise monitoring is carried out at defined locations around HVO as described in the HVO Noise Monitoring Programme. The purpose of the noise surveys is to quantify and describe the acoustic environment around the site and compare results with specified limits. Unattended monitoring (real time noise monitoring) also occurs at five sites surrounding HVO. The attended noise monitoring locations are displayed in Figure 16.

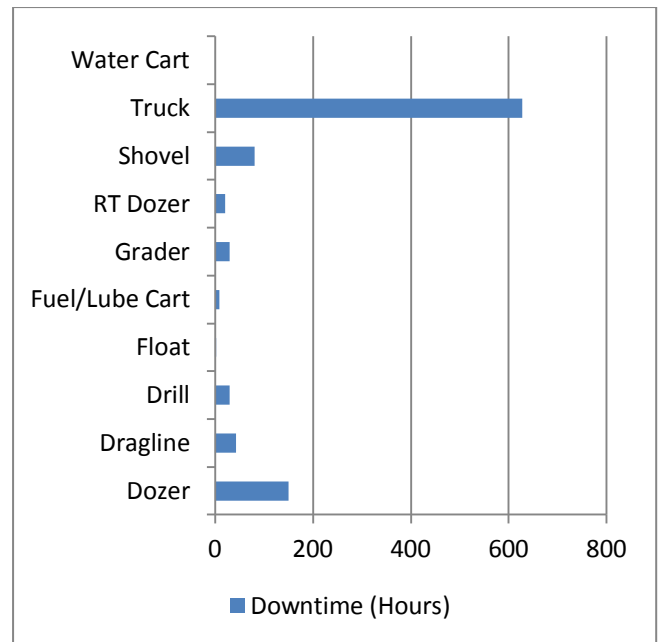
Figure 17: Operational Downtime by Equipment Type – February 2017

During February, a total of 991.3 hours of equipment downtime was logged in response to real time monitoring and visual inspections for environmental reasons such as dust, noise and meteorological conditions. Operational downtime by equipment type is shown in Figure 17.

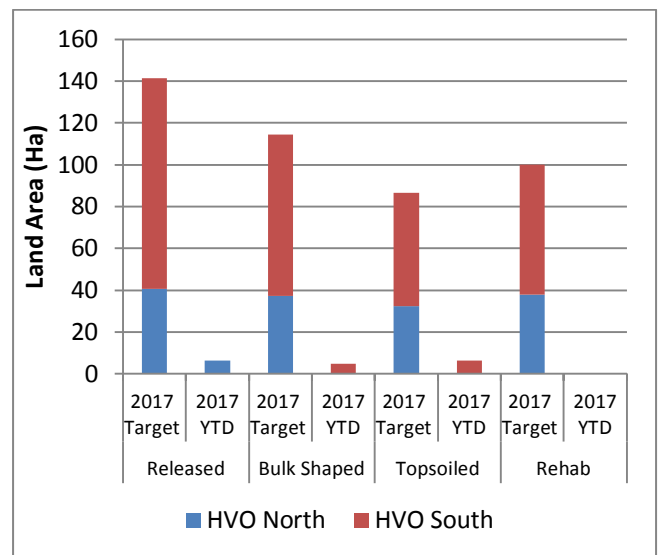
Figure 18: Rehabilitation YTD - February 2017

During February, 35.8 Ha of land was released, 15.8 Ha of land was bulk shaped, 5.1 Ha of land was topsoiled and 5.1 Ha of land was composted. Year to date progress can be viewed in Figure 86.

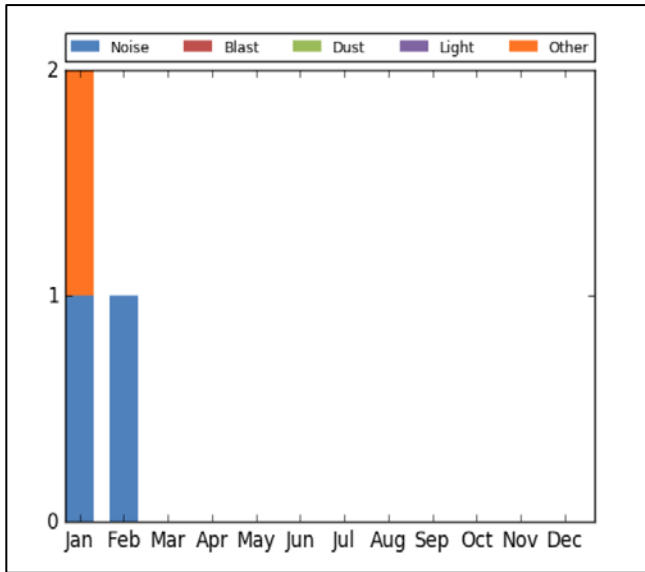
Figure 19: Complaints Graph – February 2017

One complaint was received during the reporting period. Details of complaints received YTD are shown in Figure 19 below.
