**HUNTER VALLEY  
OPERATIONS**

**Monthly Environmental  
Monitoring Report**

**June 2019**

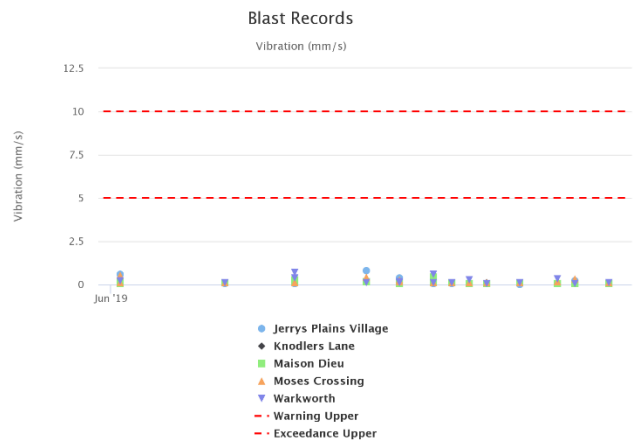
**Figure 81: Overpressure Blast Monitoring Results – June 2019**

During June, 19 blasts were initiated at HVO. Figure 81 and Figure 82 show the blast monitoring results for the reporting period against the impact assessment criteria. The criteria are summarised in Table 5.

During the reporting period there were no exceedances of the airblast overpressure or ground vibration criteria.
