**HUNTER VALLEY
OPERATIONS**

**Monthly Environmental
Monitoring Report**

March 2019

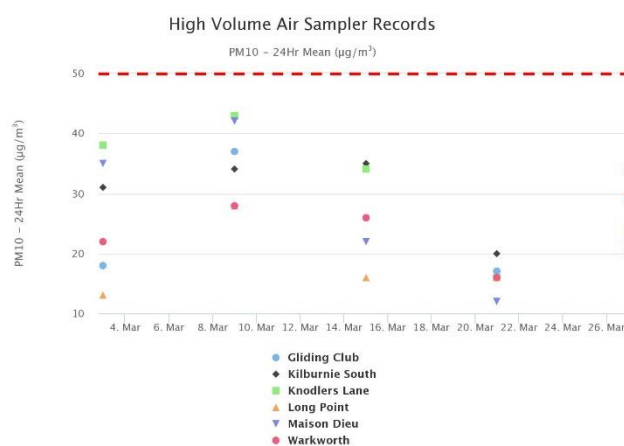
Figure 6: Individual PM₁₀ Results – March 2019

Figure 6 shows individual PM₁₀ results at each monitoring station against the short term impact assessment criteria of 50 µg/m³.

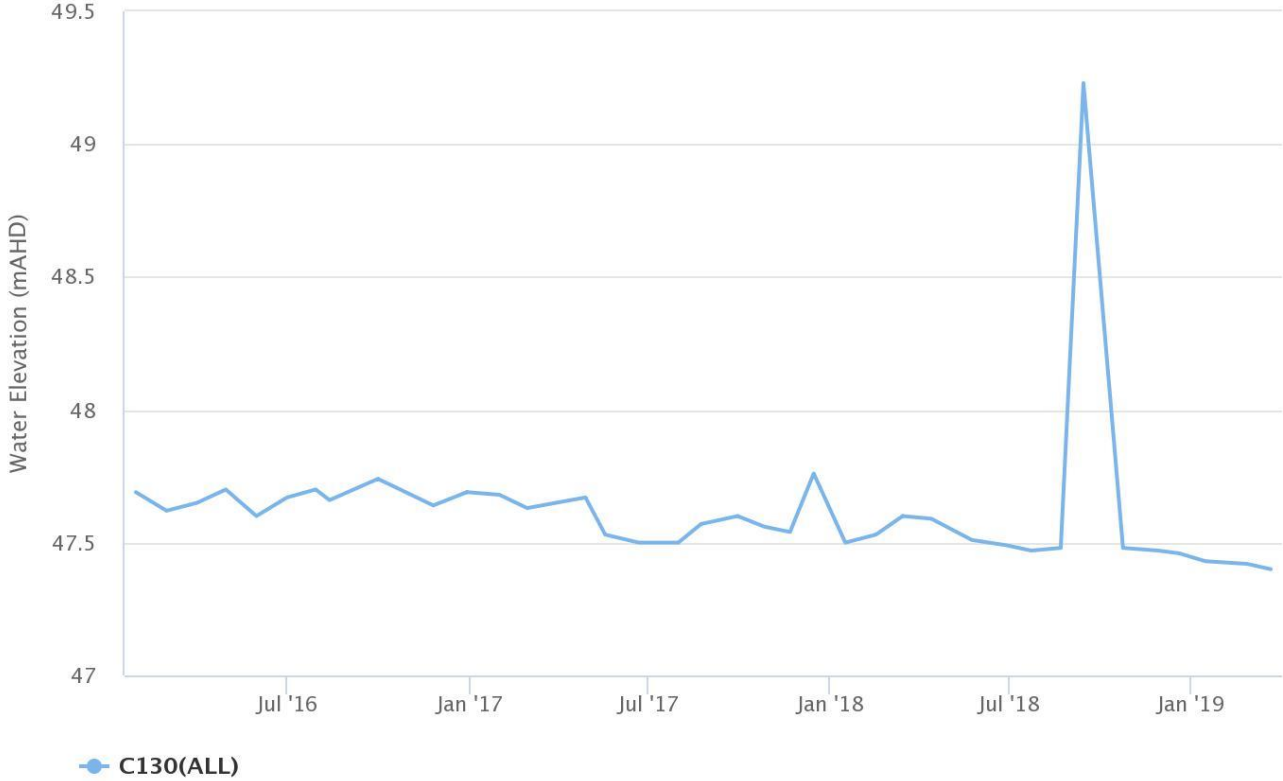
Figure 61: Lemington South Interburden Standing Water Level – March 2019

Water Elevation (mAHD)

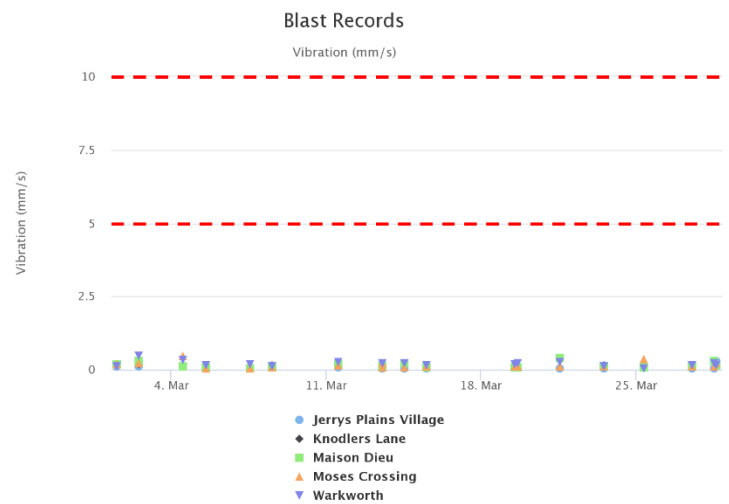
Figure 82: Ground Vibration Blast Monitoring Results – February 2019

During March, 19 blasts were initiated at HVO. Figure 81 and Figure 82 show the blast monitoring results for the reporting period against the impact assessment criteria. The criteria are summarised in Table 5.

During the reporting period there were no exceedances of the airblast overpressure or ground vibration criteria.
