HUNTER VALLEY OPERATIONS

Quarterly Environmental Monitoring Report

June 2020

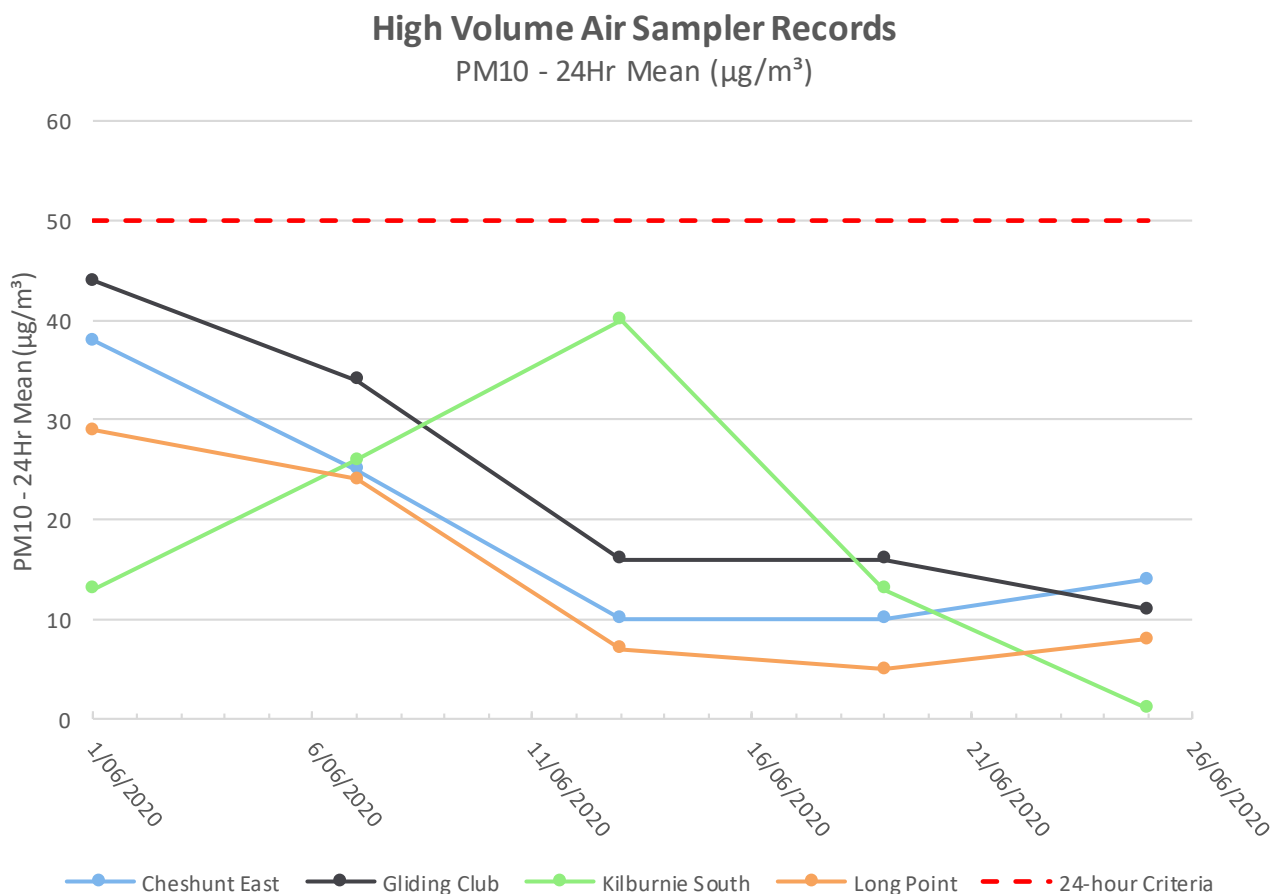
Figure 6: Individual PM₁₀ Results – June 2020

Figure 6 shows individual PM₁₀ results at each monitoring station against the short term impact assessment criteria of 50 µg/m³. During the reporting period, no monitors recorded an exceedance above the short term impact assessment criteria of 50 µg/m³.

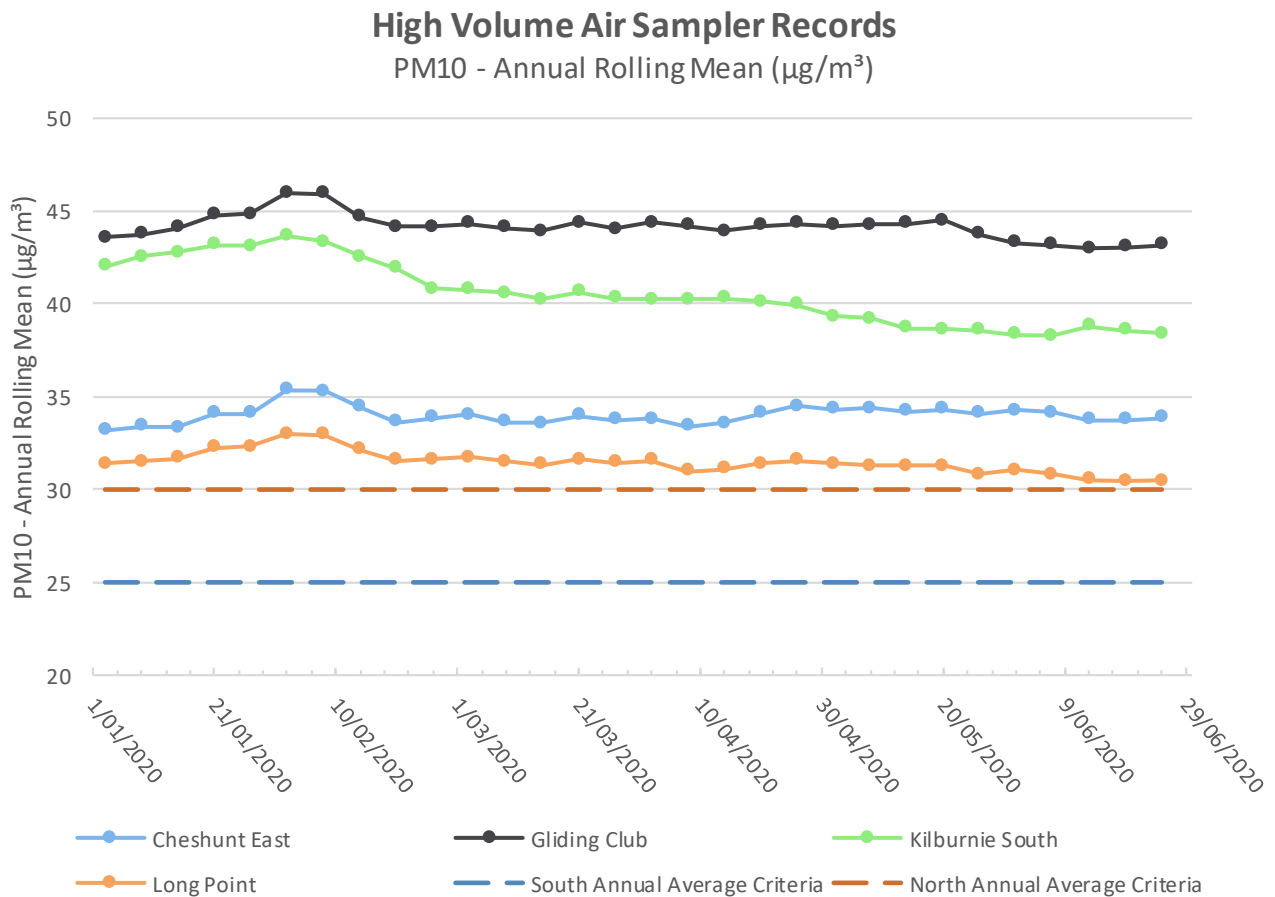
Figure 7: Year to Date Average PM₁₀ – as at end of June 2020

Figure 7 shows the year to date annual average PM₁₀ results. During the reporting period all monitors recorded an annual average above the PM₁₀ Annual Rolling Mean of 30µg/m³.

This is likely to be due to the bushfires experienced earlier in 2020, and is expected to decrease over the remainder of the reporting period. However, an assessment of HVO’s contribution against the long term impact assessment criteria will be provided in the 2020 Annual Review.

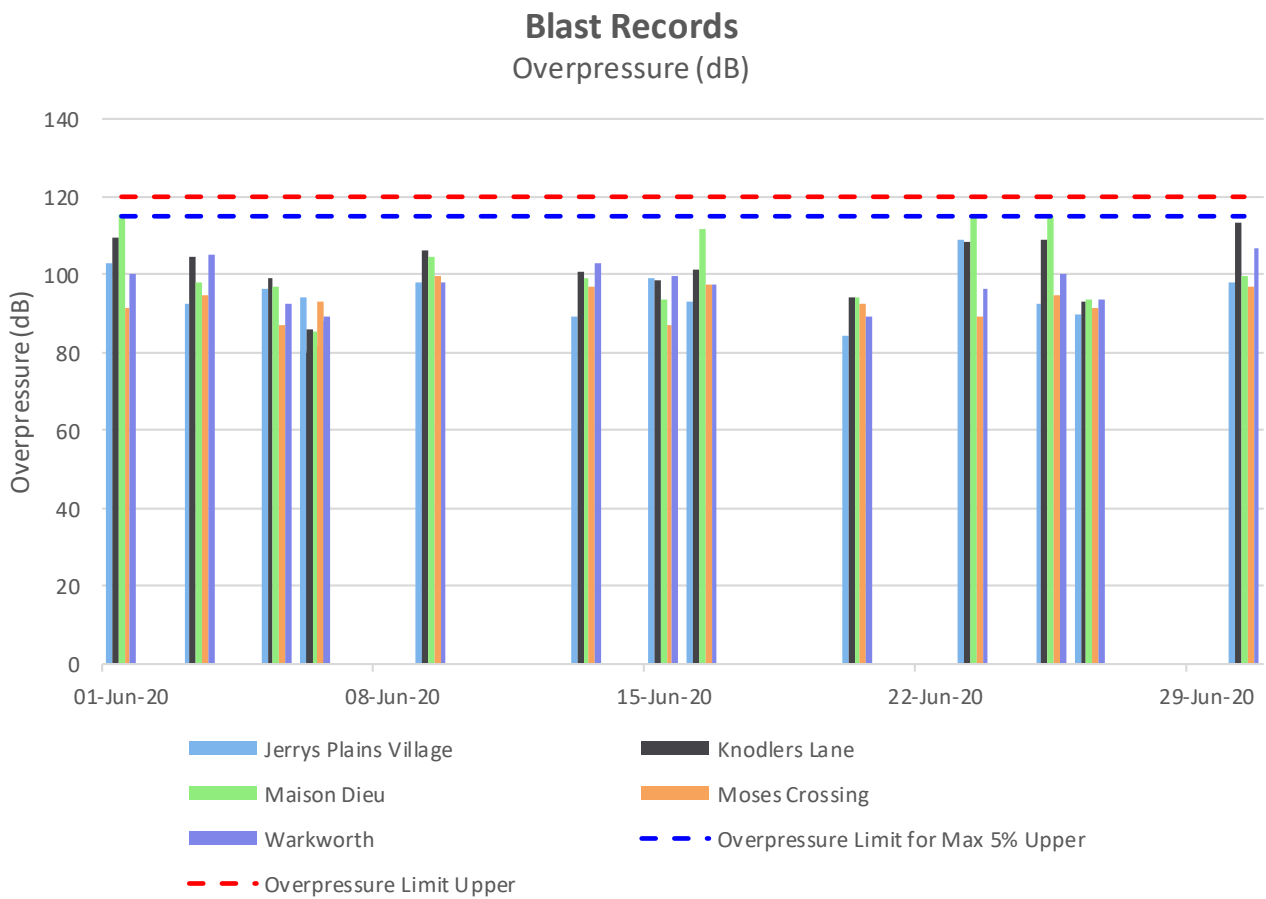
Figure 84: Overpressure Blast Monitoring Results – June 2020

During June, 14 blasts were initiated at HVO. Figure 84 and Figure 85 show the blast monitoring results for the reporting period against the impact assessment criteria.

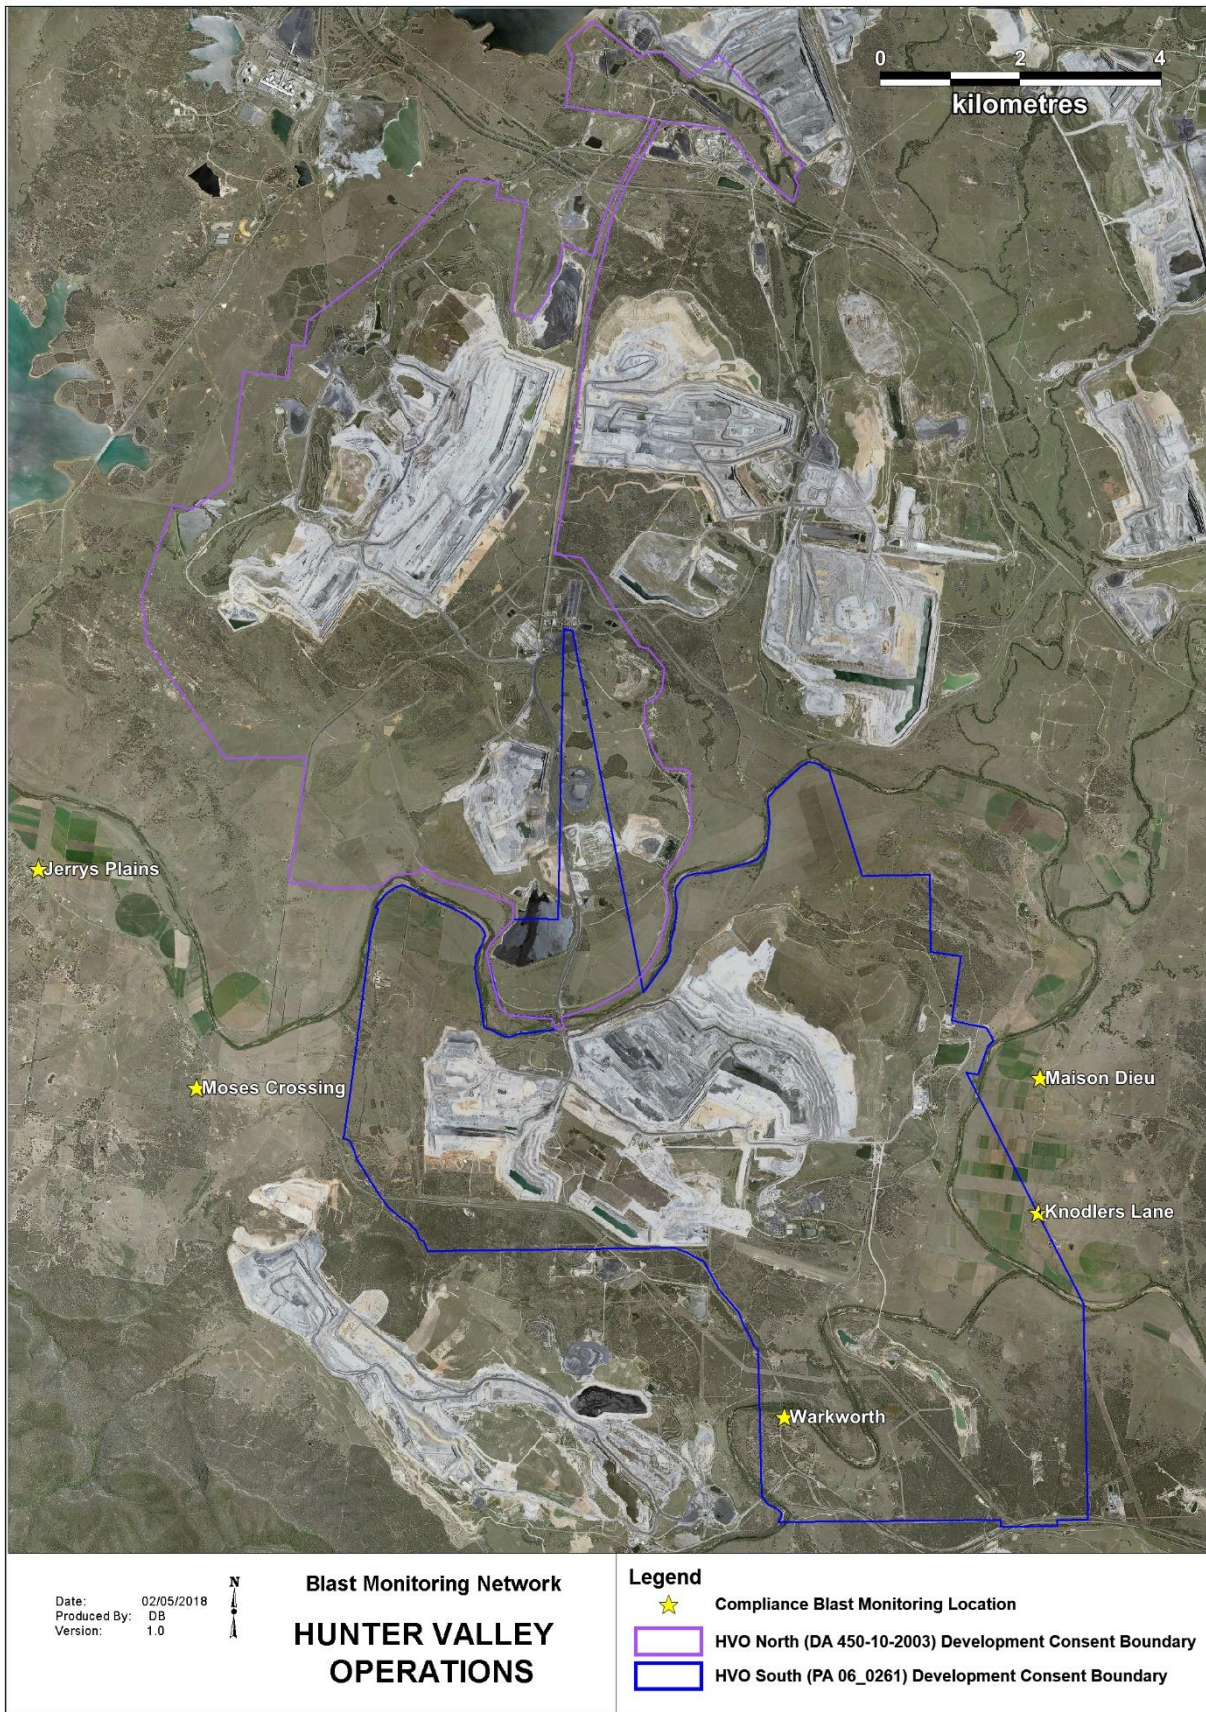
Figure 86: Blast Monitoring Location Plan

HVO have a network of five blast monitoring units. These are located at nearby privately owned residences and function as regulatory compliance monitors. The location of these monitors can be found in Figure 86. Blasting criteria are summarised in Table 4.

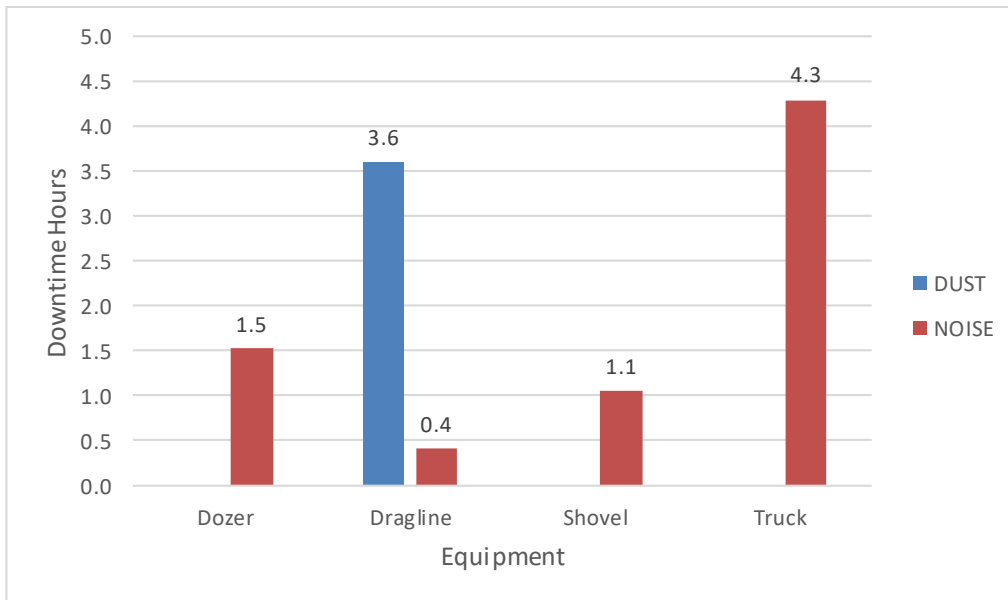
Figure 88: Operational Downtime by Equipment Type – June 2020

During June, a total of 10.9 hours of equipment downtime was logged in response to real time monitoring and visual inspections for environmental reasons such as dust, noise and meteorological conditions. Operational downtime by equipment type and reason is shown in Figure 88.
