HUNTER VALLEY OPERATIONS

Quarterly Environmental Monitoring Report

March 2020

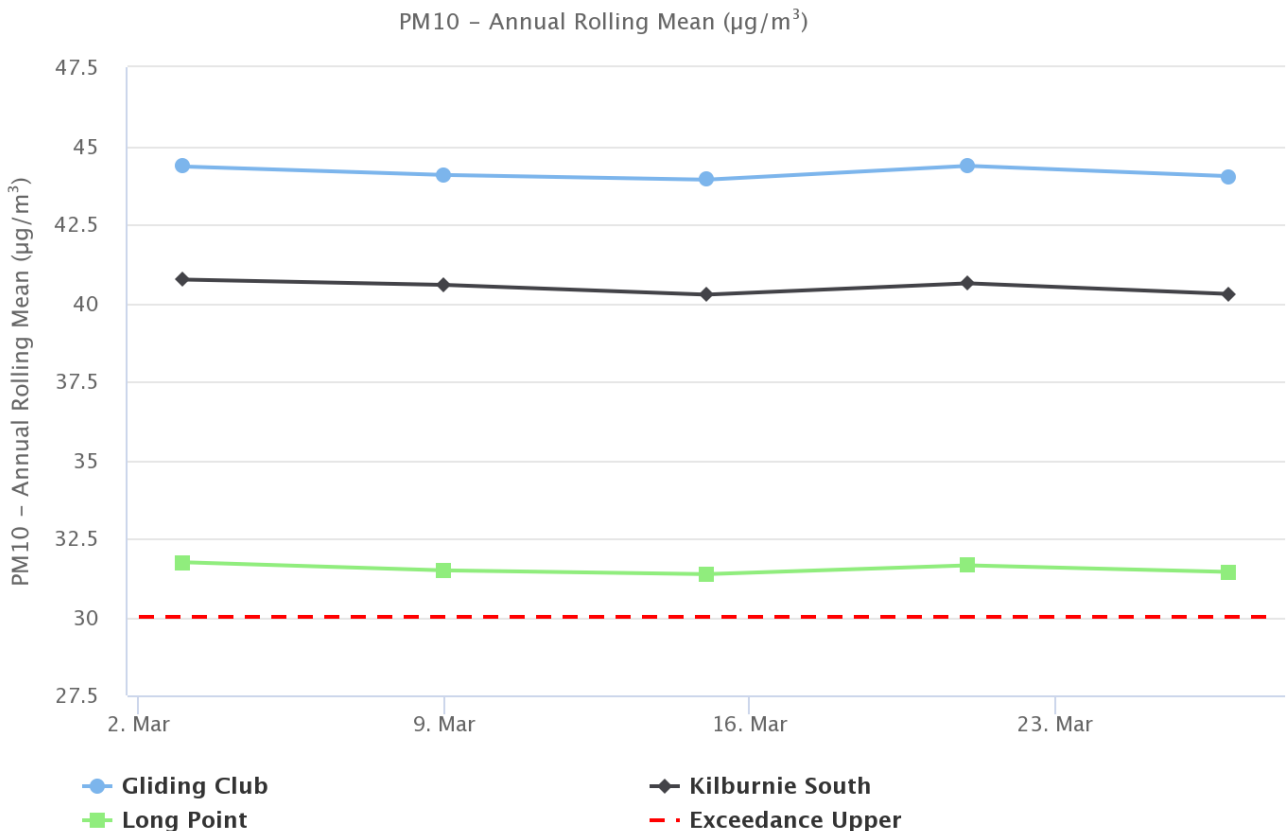
Figure 7: Year to Date Average PM₁₀ – as at end of March 2020

Figure 7 shows the year to date annual average PM₁₀ results. During the reporting period all monitors recorded an annual average above the PM₁₀ Annual Rolling Mean of 30µg/m³.

This is likely to be due to the result being an average of the January - March period which historically has higher ambient dust levels, and will decrease over the remainder of the reporting period. However, an assessment of HVO's contribution against the long term impact assessment criteria will be provided in the 2020 Annual Review.

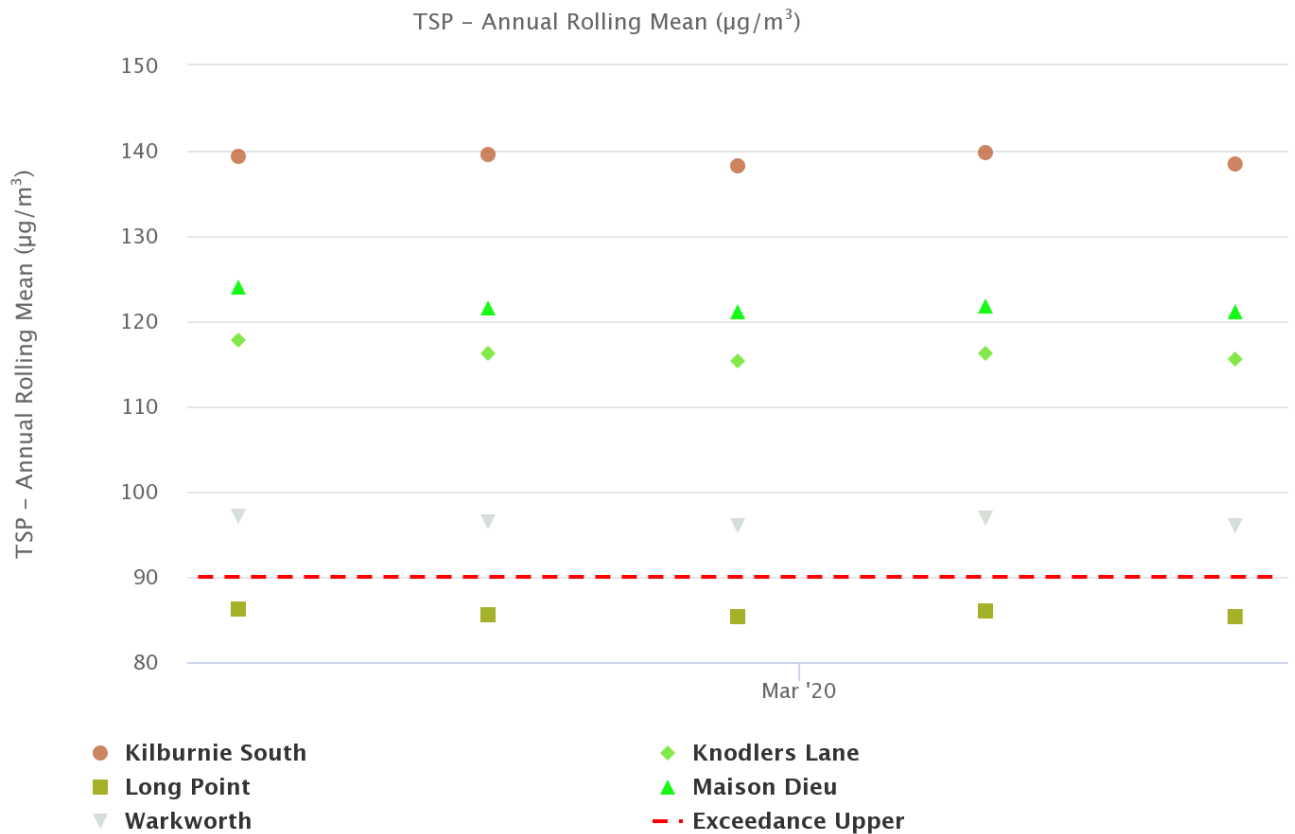
Figure 10: Year to Date Average Total Suspended Particulates – as at end of March 2020

Figure 10 shows the annual average TSP results compared against the long term impact assessment criteria of 90µg/m³.

During the reporting period, the Kilburnie South, Warkworth, Knodlers Lane and Maison Dieu monitors' annual average was above the long term impact assessment criteria of 90µg/m³.

This is likely to be due to the result being an average of the January - March period which historically has higher ambient dust levels, and will decrease over the remainder of the reporting period. However, an assessment of HVO's contribution against the long term impact assessment criteria will be provided in the 2020 Annual Review.

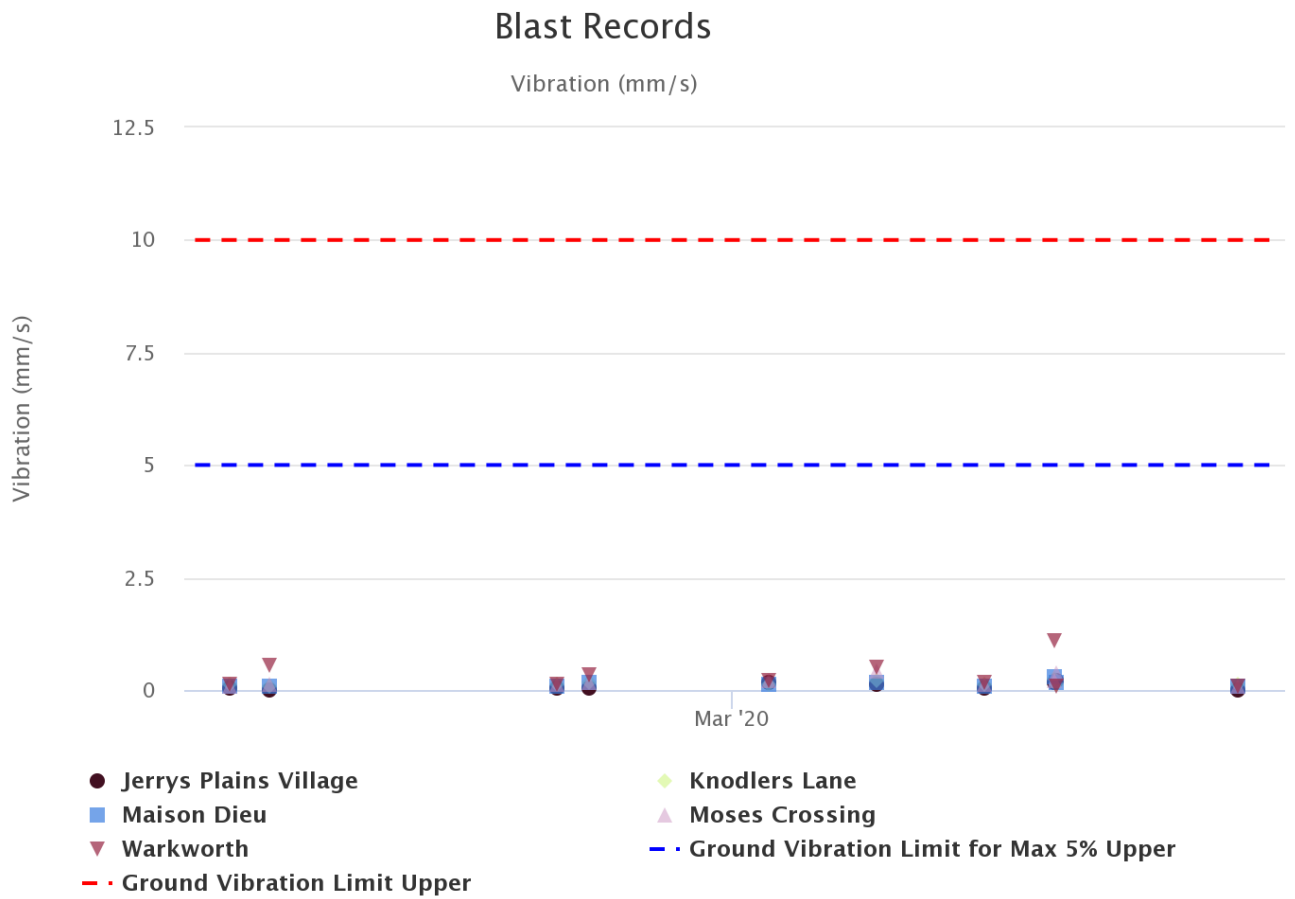
Figure 84: Ground Vibration Blast Monitoring Results – March 2020

During March, 10 blasts were initiated at HVO. Figure 83 and Figure 84 show the blast monitoring results for the reporting period against the impact assessment criteria.

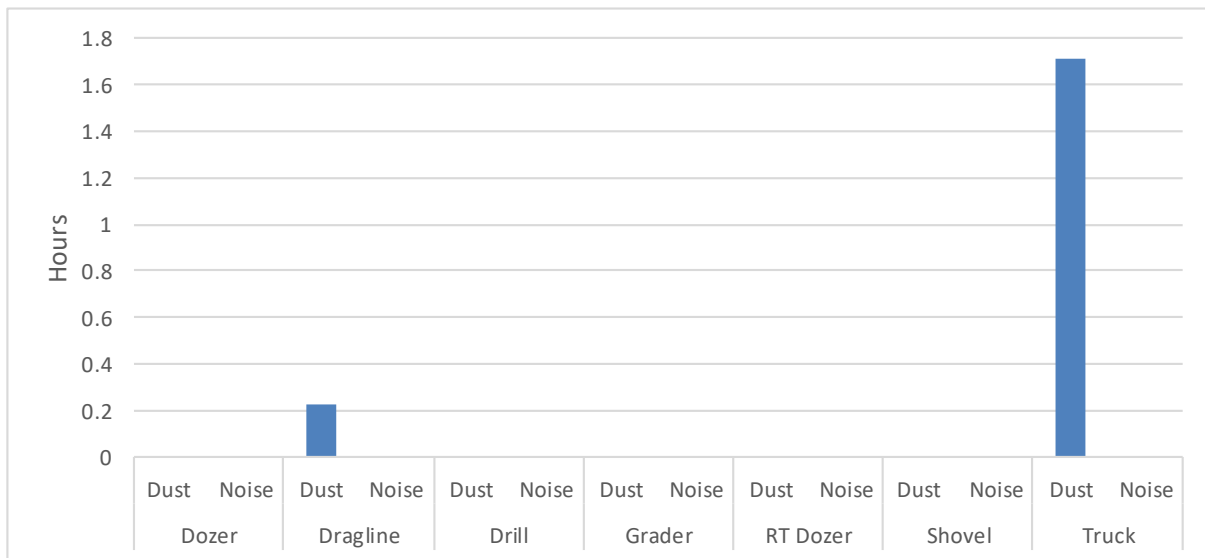
Figure 87: Operational Downtime by Equipment Type – March 2020

During March, a total of 1.94 hours of equipment downtime was logged in response to real time monitoring and visual inspections for environmental reasons such as dust, noise and meteorological conditions. Operational downtime by equipment type is shown in Figure 87. Note that these delays are instances where operations were completely stopped, and does not include occasions where operations were changed / modified but not stopped (e.g. changed from exposed dump to in-pit dump).
