# HUNTER VALLEY OPERATIONS

## Monthly Environmental Monitoring Report December 2020

**Document Number:** HVOOC-1797567310-3609

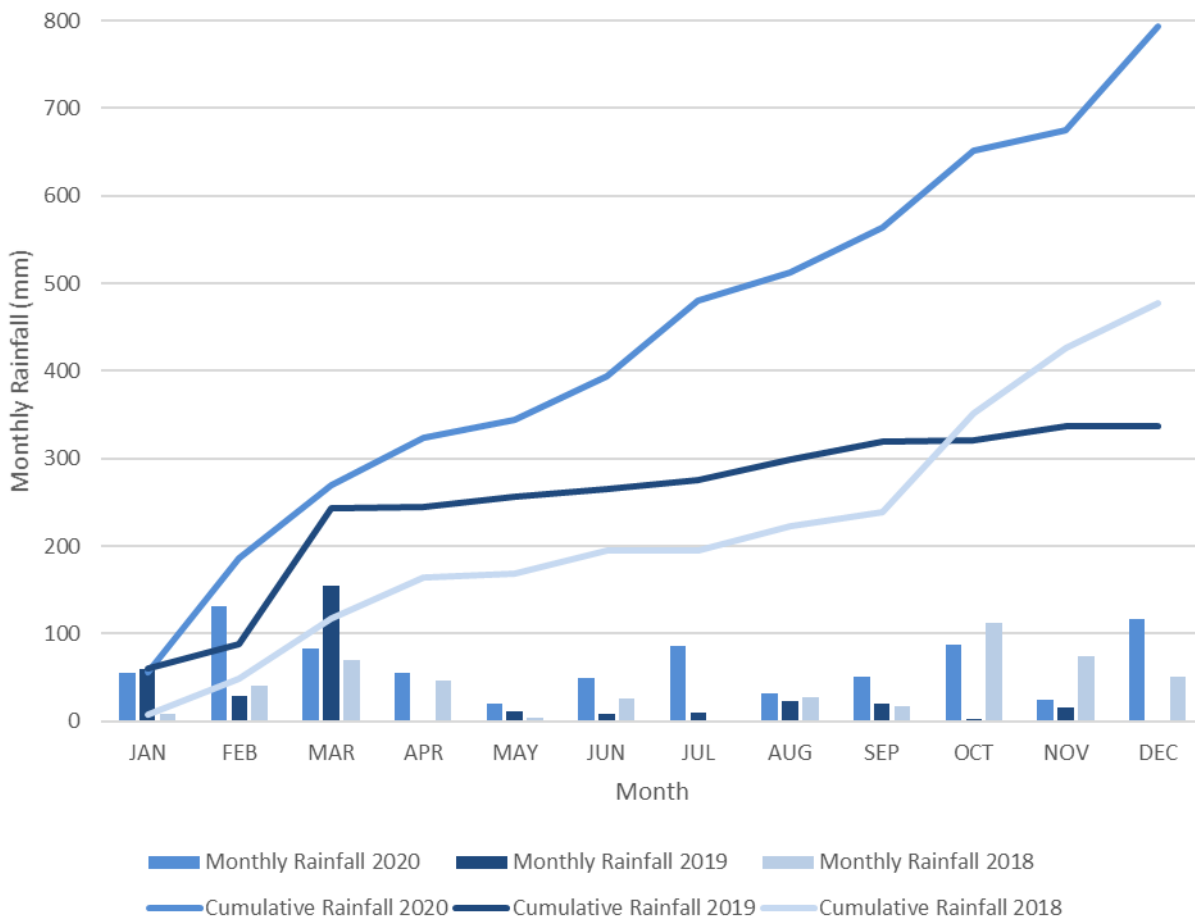
**Figure 1 - Rainfall Summary 2020**

Rainfall for the period is summarised in **Table 1**. The 2020 trend and historical trends are shown in **Figure 1**.

2020	Monthly Rainfall (mm)	Cumulative Rainfall (mm)
December	117.4	793

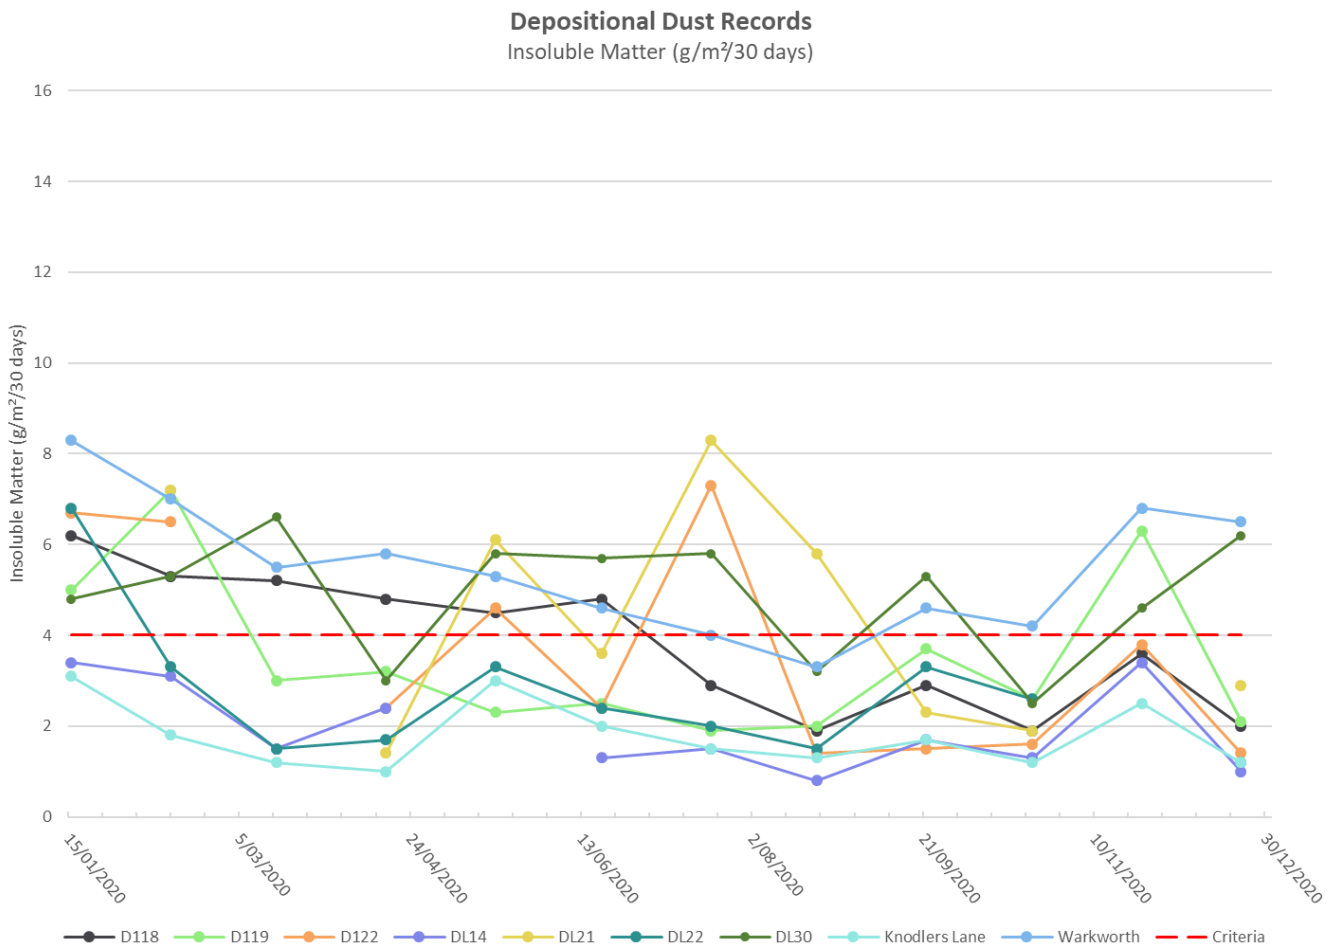
**Figure 5 - Depositional Dust Results December 2020**

**Figure 5** displays insoluble solids results from depositional dust gauges during the reporting period compared against the annual impact assessment criteria. Any monthly results deemed to be contaminated (due to presence of bird droppings, insects, etc.) are not displayed. During December, no results were deemed contaminated.

During the reporting period, the Warkworth and DL30 monitors recorded a monthly result above the long-term impact assessment criteria of 4.0 g/m<sup>2</sup> per month.

An assessment of HVO's contribution against the long-term impact assessment criteria will be provided in the 2020 Annual Review.

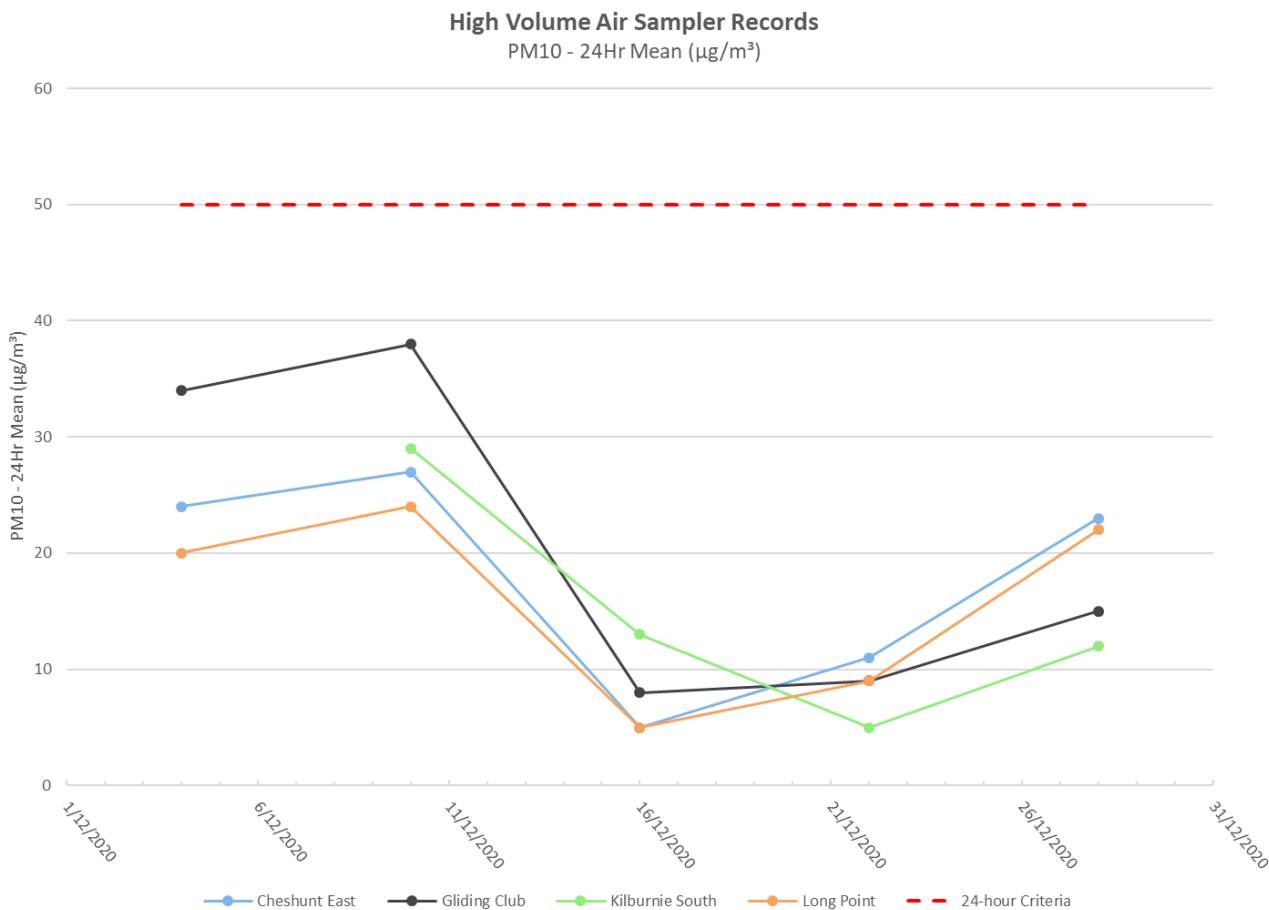
Figure 6 - Individual PM<sub>10</sub> Results December 2020

Figure 6 shows individual PM<sub>10</sub> results at each monitoring station against the short-term impact assessment criteria of 50µg/m<sup>3</sup>. During the reporting period, no monitors recorded an exceedance above the short-term impact assessment criteria of 50µg/m<sup>3</sup>.

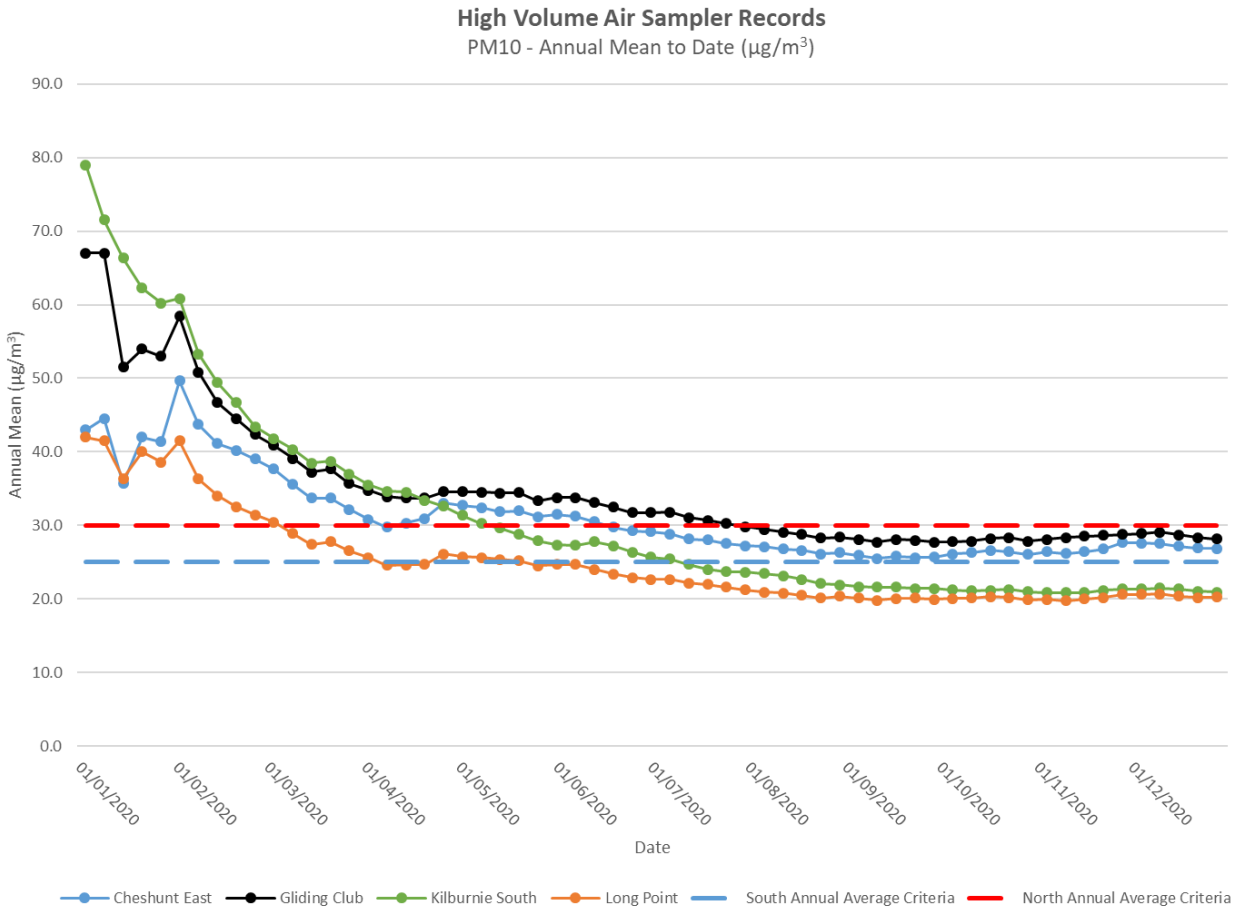
Figure 7 - Year to Date Average PM<sub>10</sub> as at end of December 2020

Figure 7 shows the year to date annual average PM<sub>10</sub> results. During the reporting period, the Gliding Club monitor recorded an annual average above the PM<sub>10</sub> Annual Rolling Mean criteria of 25µg/m<sup>3</sup> for HVO South. All monitors recorded an annual average below the 30µg/m<sup>3</sup> criteria for HVO North.

An assessment of HVO’s contribution against the long-term impact assessment criteria will be provided in the 2020 Annual Review.

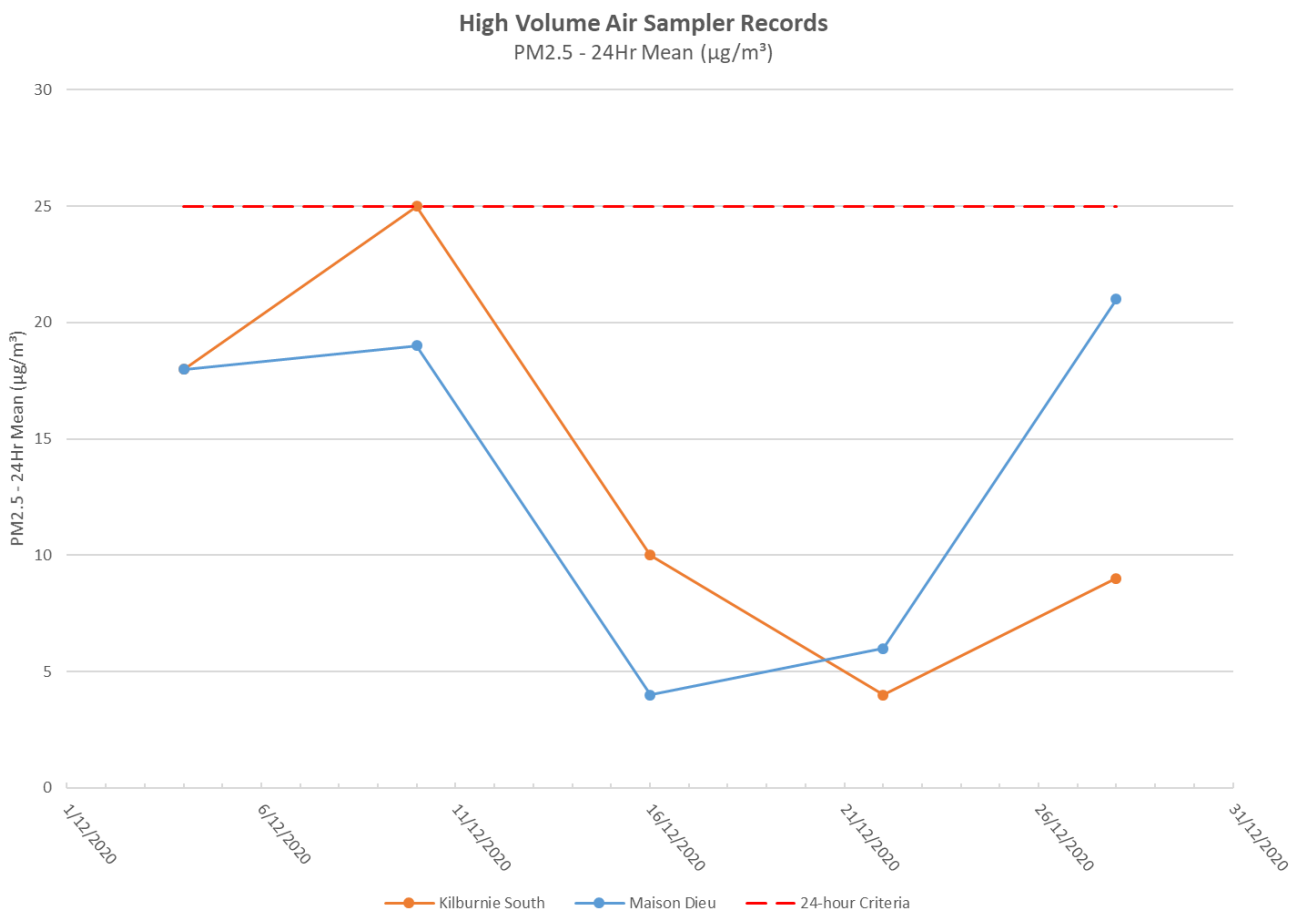
Figure 8 - Individual PM<sub>2.5</sub> Results December 2020

Figure 8 shows individual PM<sub>2.5</sub> results at each monitoring station against the HVO South short-term impact assessment criteria of 25µg/m<sup>3</sup>.

During the reporting period neither monitor recorded an exceedance of the short-term impact assessment criteria of 25µg/m<sup>3</sup>

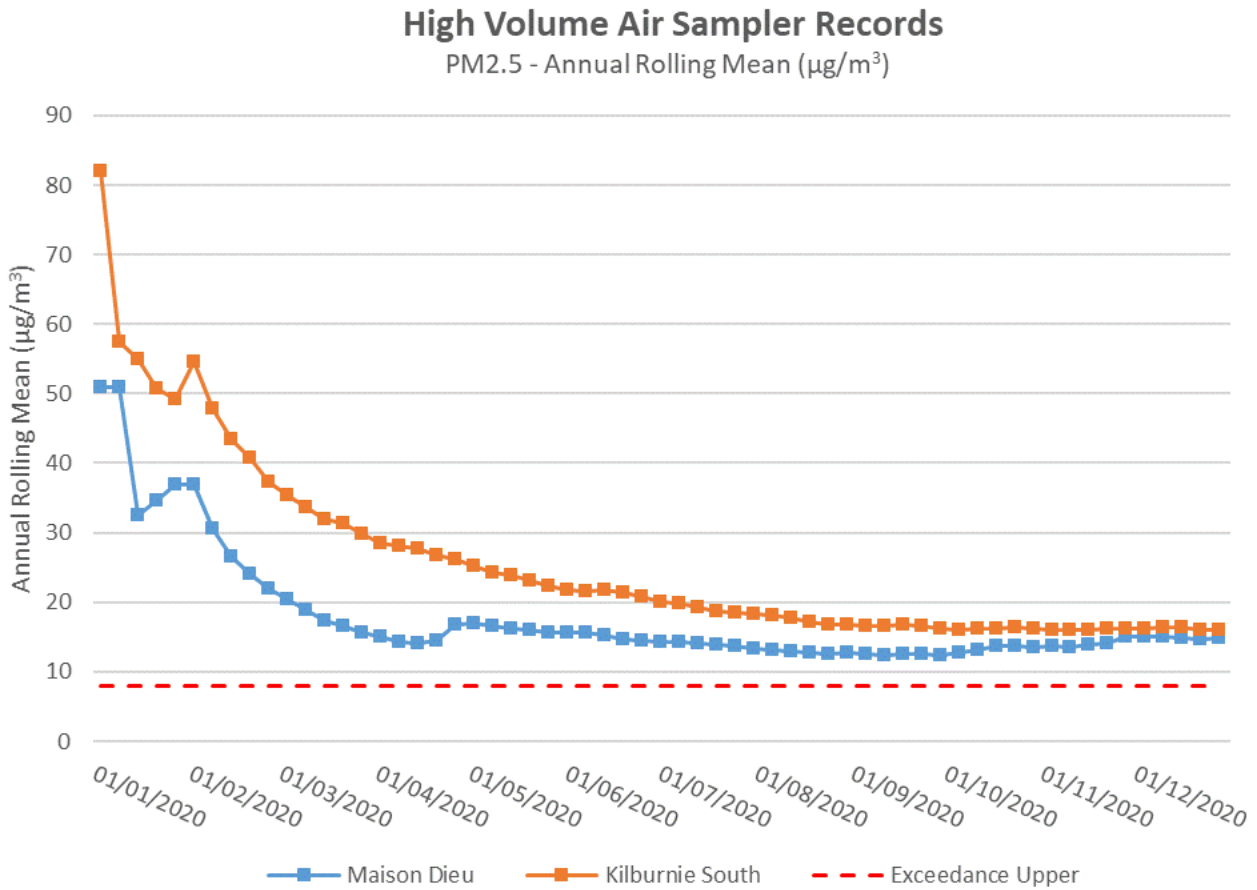
**Figure 9 - Year to Date Average PM<sub>2.5</sub> as at end of December 2020**

**Figure 9** shows the year to date annual average PM<sub>2.5</sub> results. During the reporting period, both monitors recorded an annual average above the PM<sub>2.5</sub> Annual Rolling Mean criteria of 8µg/m<sup>3</sup>.

This is likely due to the impact of bushfire smoke and regional air quality in the first months of the year. An assessment of HVO's contribution against the long term impact assessment criteria will be provided in the 2020 Annual Review.

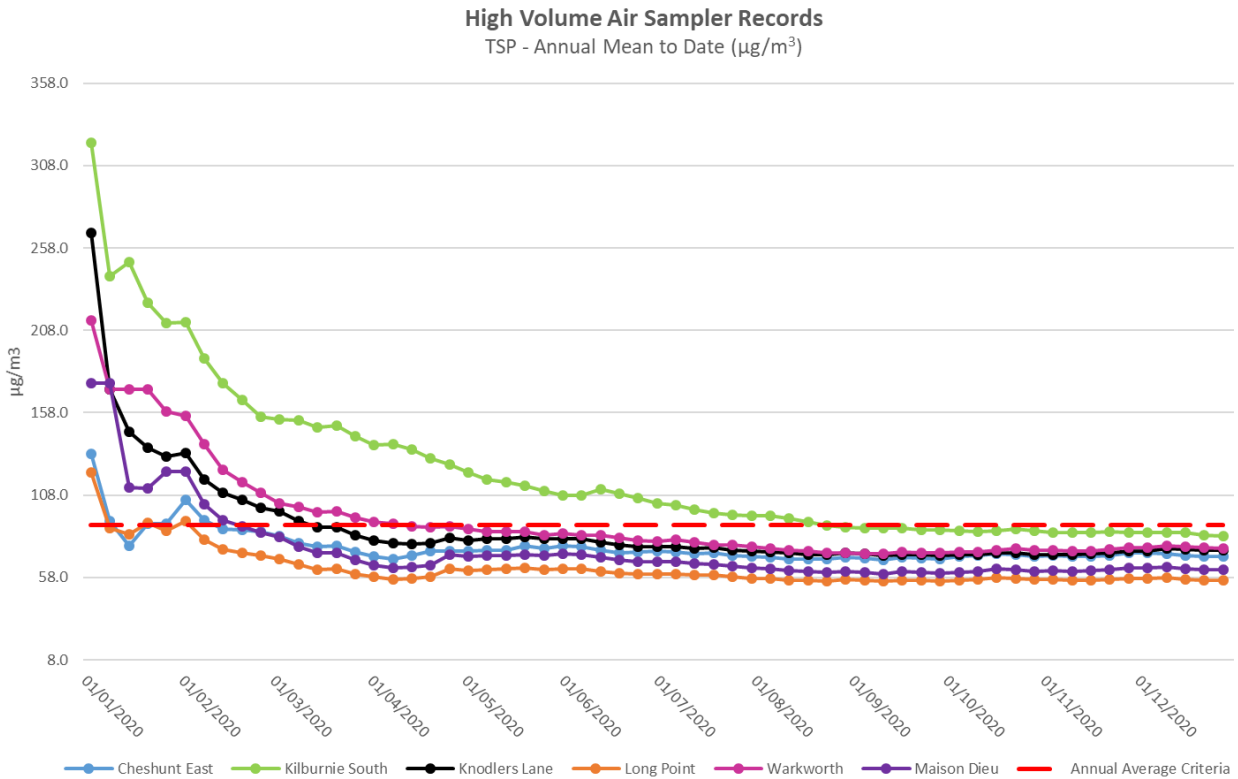
Figure 10 - Year to Date Average Total Suspended Particulates at end of December 2020

Figure 10 shows the annual average TSP results compared against the long-term impact assessment criteria of 90µg/m<sup>3</sup>.

No monitors recorded an annual average above the long-term impact assessment criteria of 90µg/m<sup>3</sup> during the reporting period.

An assessment of HVO’s contribution against the long-term impact assessment criteria will be provided in the 2020 Annual Review.

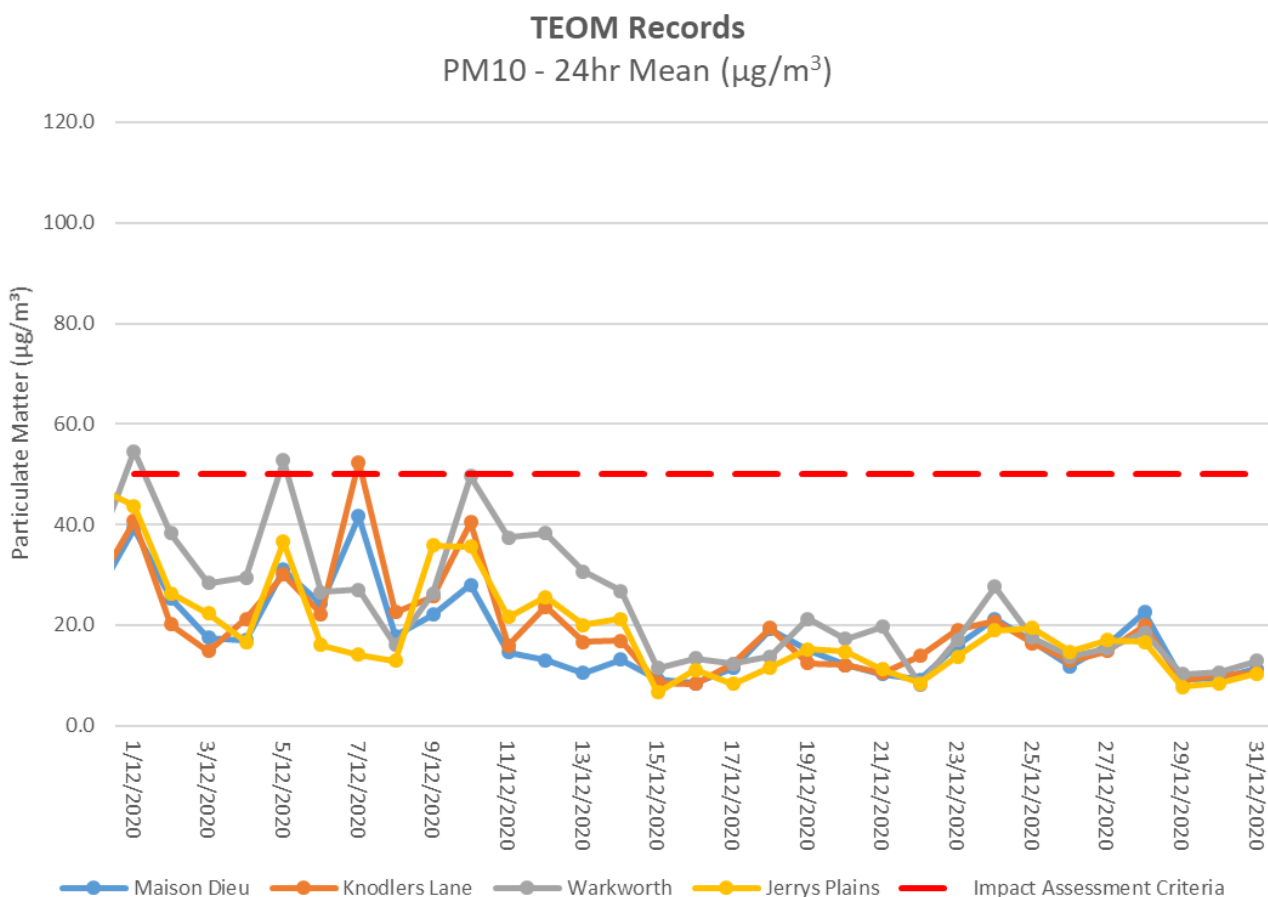
**Figure 11 - Real Time PM<sub>10</sub> 24hr average and YTD average December 2020**

**Figure 11** shows the daily 24-hour average PM<sub>10</sub> result from the real time monitoring sites. The year to date annual averages for each monitoring site are shown in **Figure 12**.

On the 1<sup>st</sup> and 5<sup>th</sup> December the Warkworth monitor exceeded the 24-hour average PM<sub>10</sub> result limit, investigations determined HVO's contributions to be below the criteria value on each day.

On the 7<sup>th</sup> December the Knodlers Lane monitor exceeded the 24-hour average PM<sub>10</sub> result limit, an investigation determined HVO's contribution to be below the criteria value.

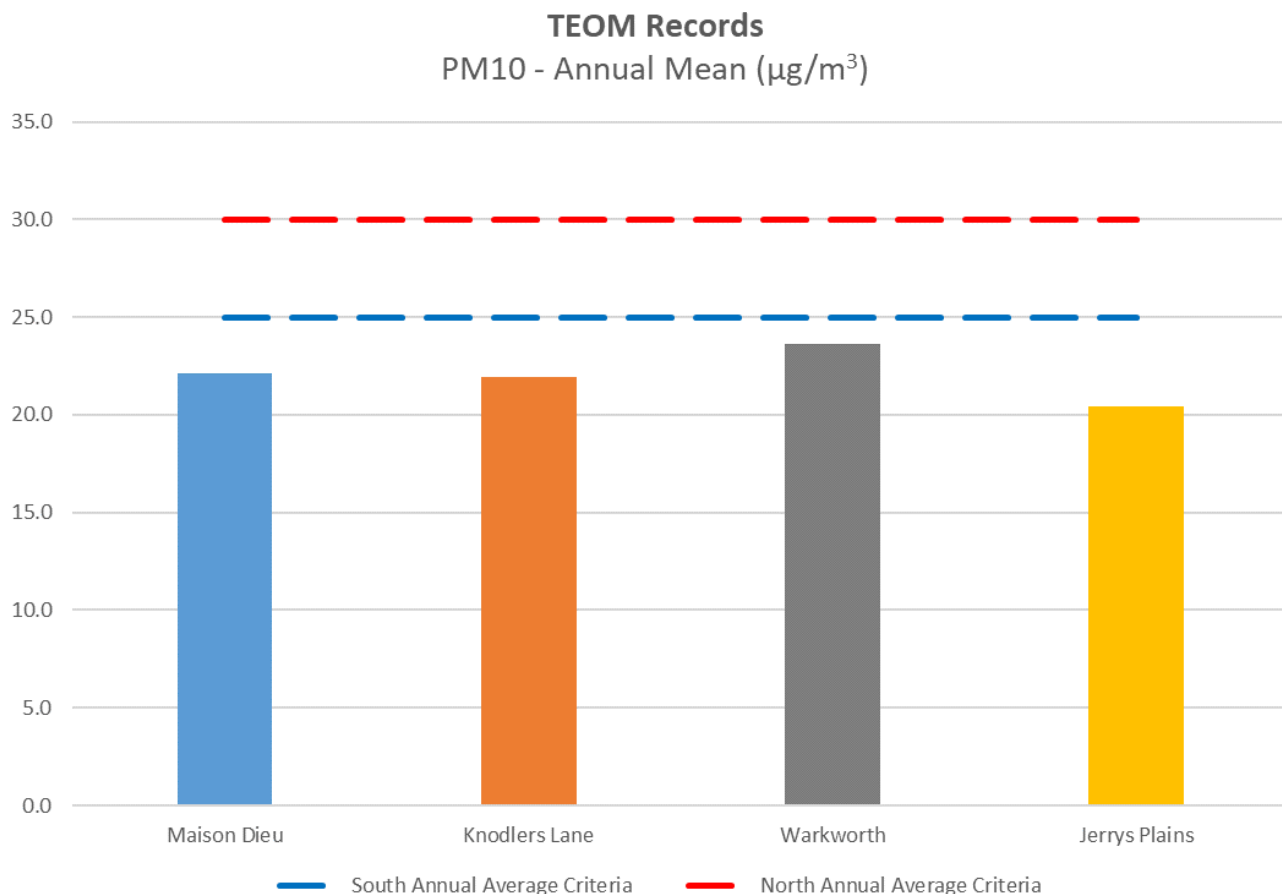
Figure 12 - Real Time PM<sub>10</sub> Annual Average December 2020

No monitors recorded an annual average above the long-term impact criteria.

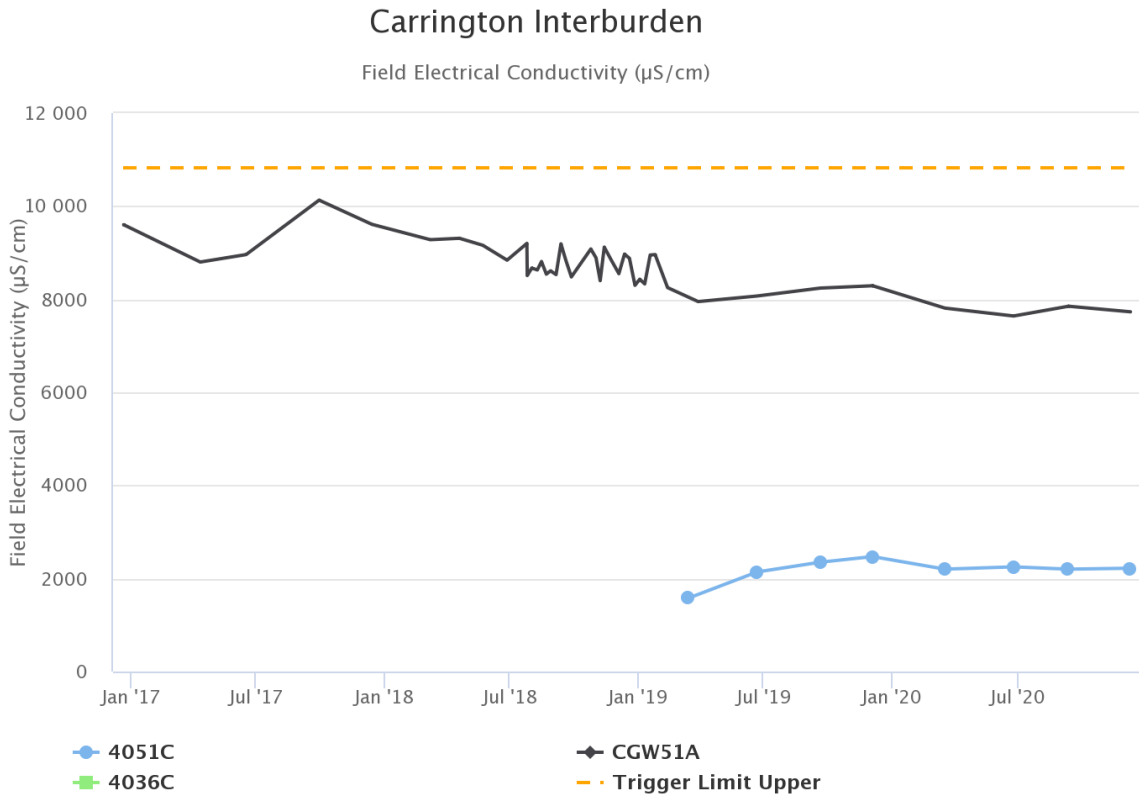
Figure 30 - Carrington Interburden Field Electrical conductivity Trend - December 2020

Note: 4036C produced insufficient water for a sample

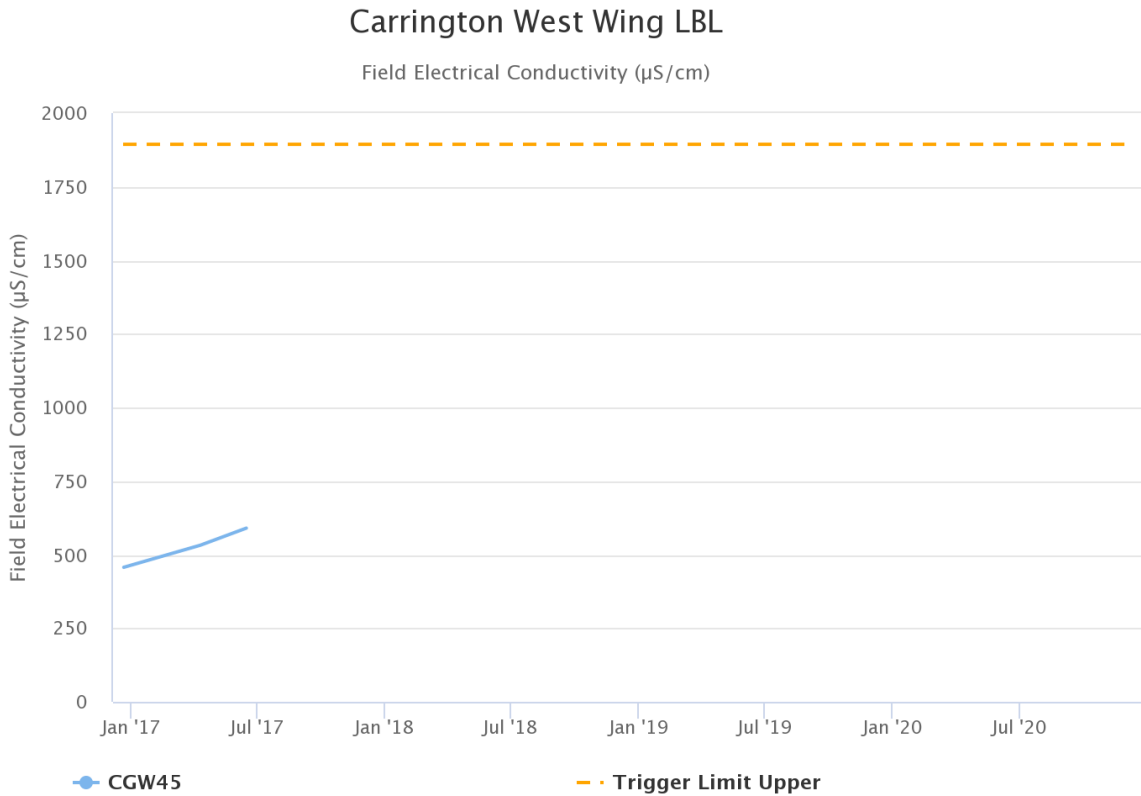
**Figure 48 - Carrington West Wing LBL Field Electrical Conductivity Trend - December 2020**

Note: CGW45 has been blocked since July 2017

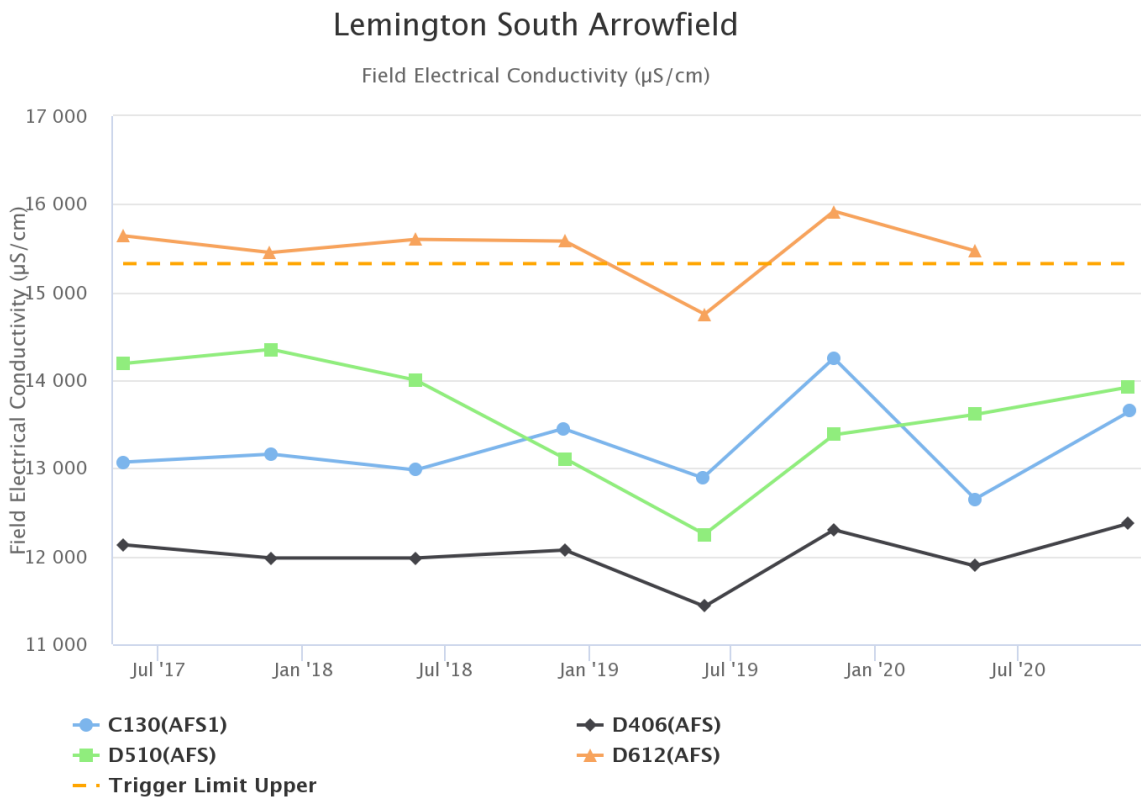
**Figure 54 - Lemington South Arrowfield Field Electrical Conductivity Trend - December 2020**

Note: D612(AFS) produced insufficient water for a sample.

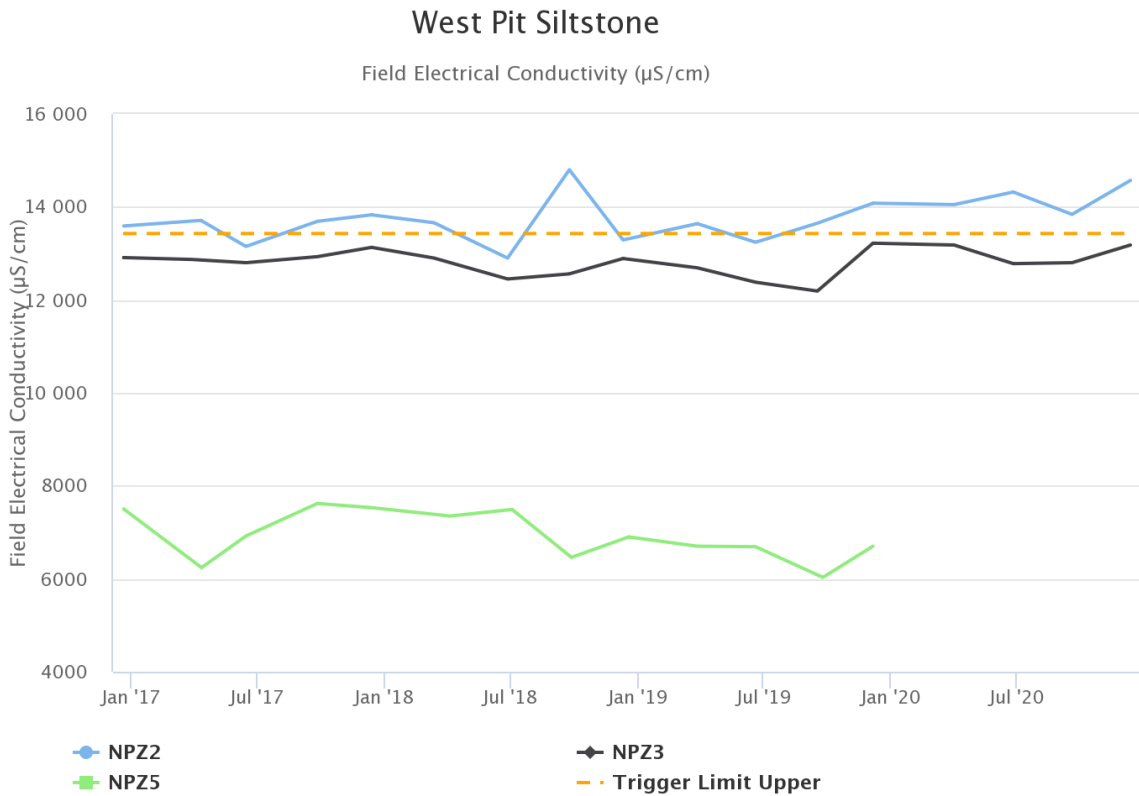
**Figure 69 - West Pit Siltstone Field Electrical Conductivity Trend - December 2020**

Note: NPZ5 could not be sampled due to unsafe access.

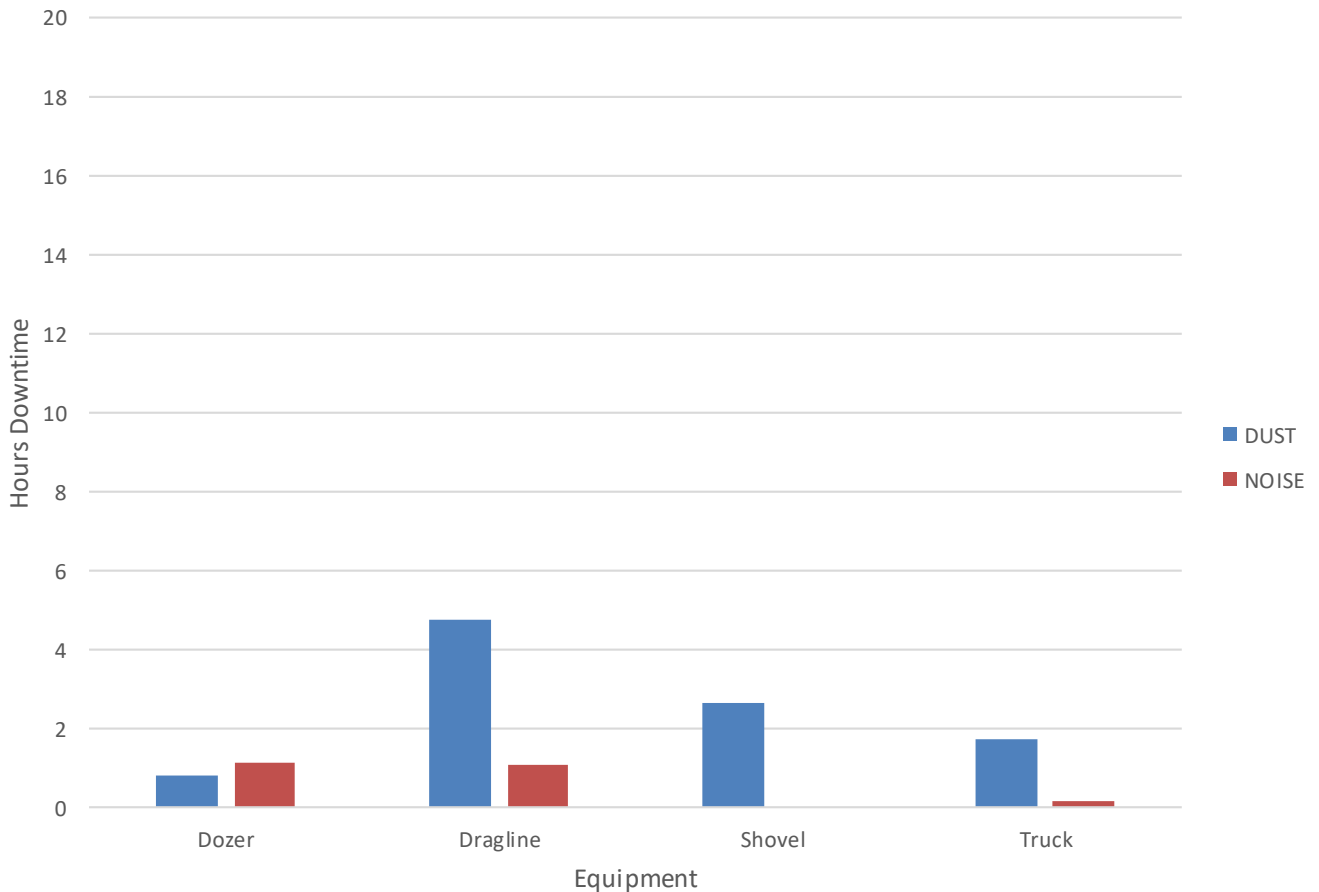
**Figure 86 - Operational Downtime by Equipment Type December 2020**

During December a total of 12 hours of equipment downtime were logged in response to real time monitoring and inspections for environmental factors such as noise and dust. Operational downtime by equipment type is show in **Figure 86**. Note that these delays are instances where operations were completely stopped and does not include occasions where operations were changed/modified but not stopped (e.g. changed from exposed dump to in-pit dump).

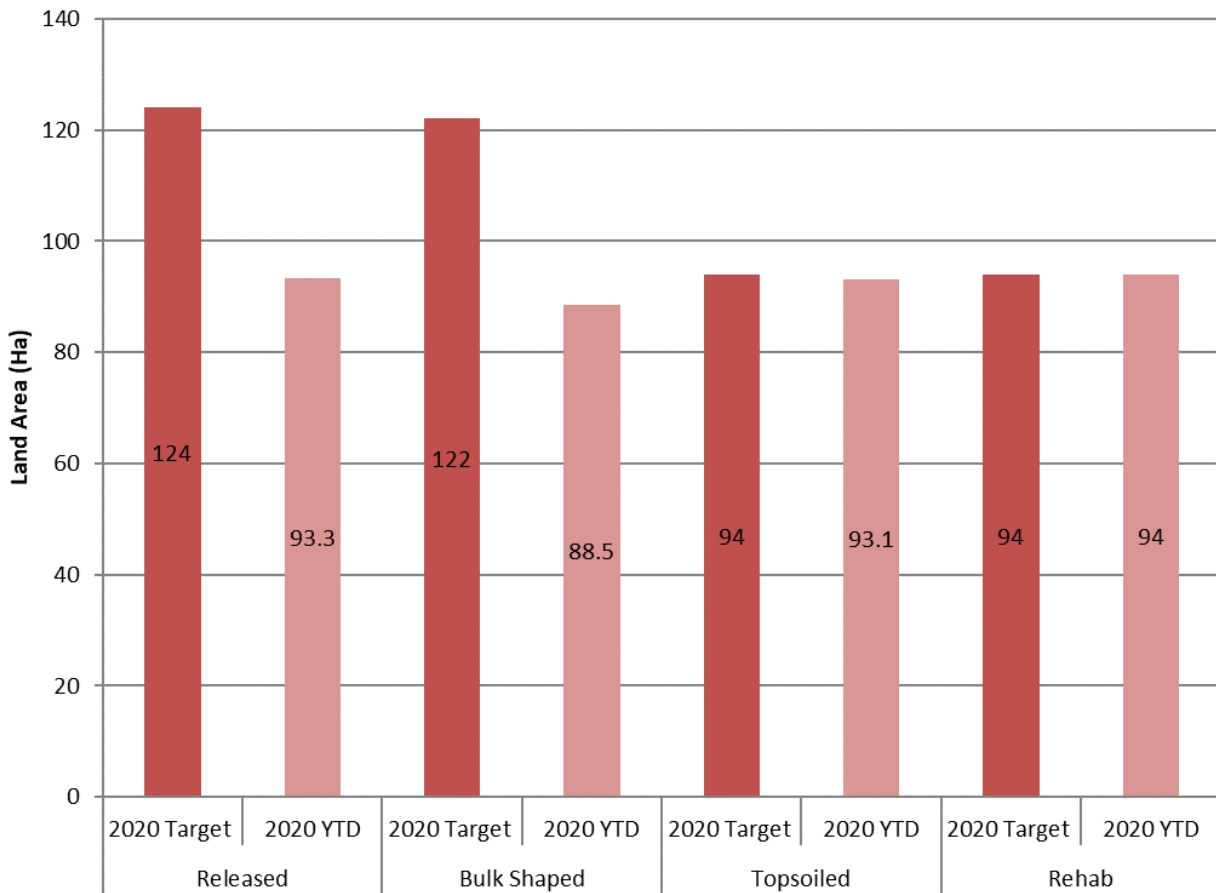
**Figure 87 - Rehabilitation YTD December 2020**

During December, 0.03 Ha of land was bulk shaped, 0.03 Ha of land was released, 5.49 Ha of land was topsoiled, and 7.68 Ha was rehabilitated. Year to date progress can be viewed in **Figure 87**.
