Hunter Valley Operations

Community Consultative Committee

**Business Papers – May 2019**

Materials ahead of meeting of the committee on **29 May 2019**

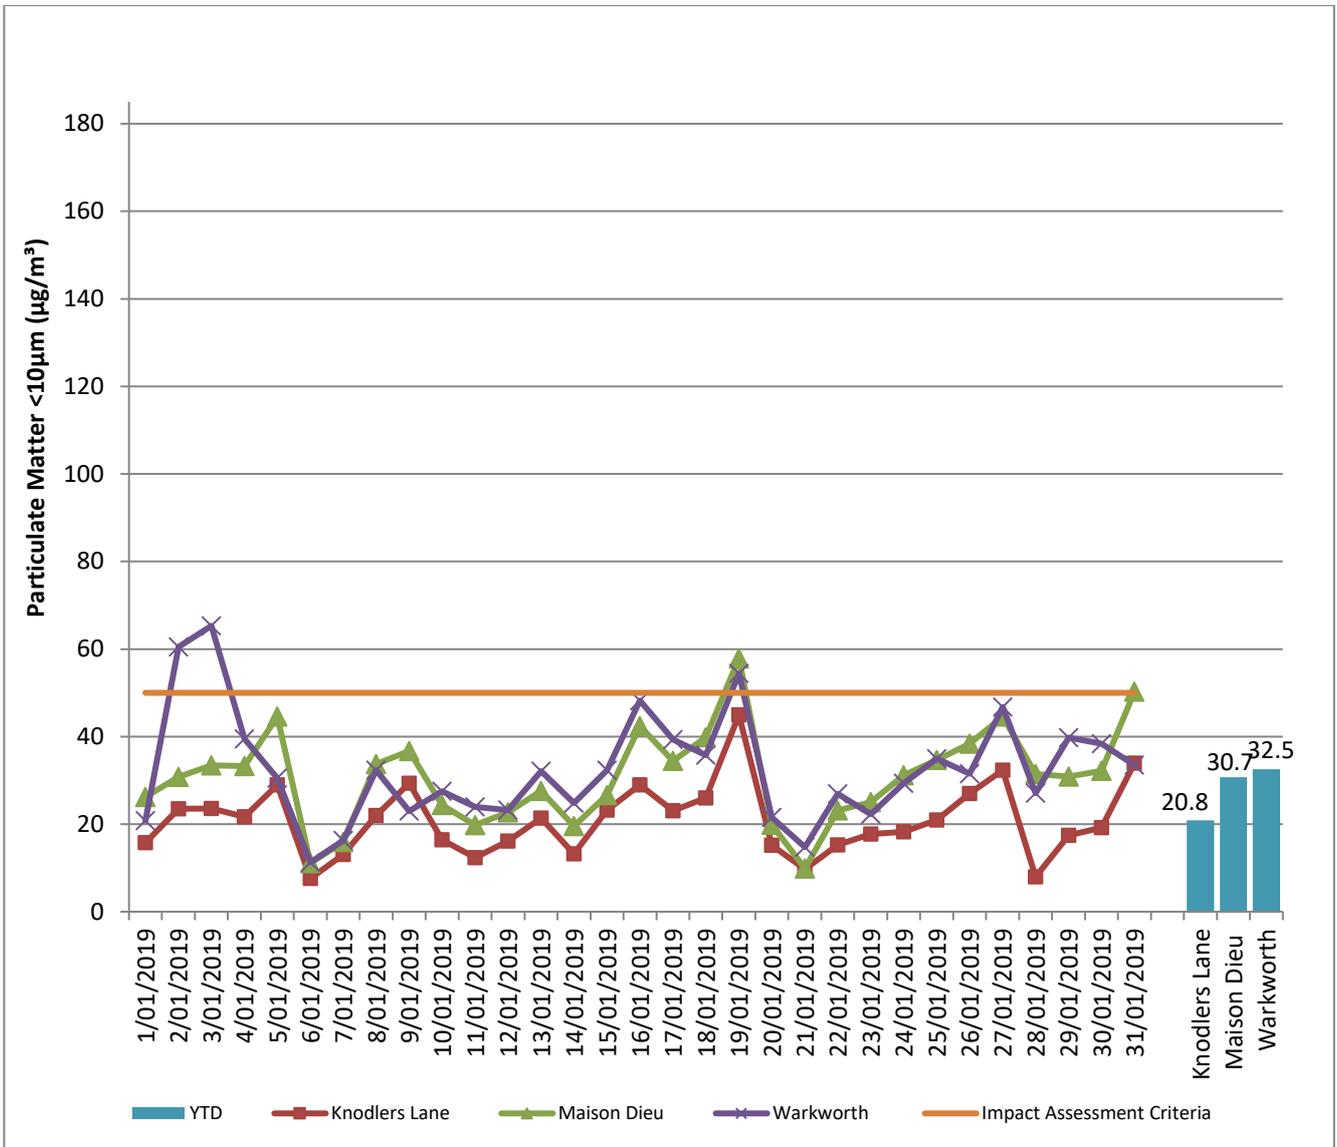
During January the real time monitoring system generated 214 automated air quality related alarms. 75 were related to adverse weather conditions and 141 alarms relating to PM<sub>10</sub>.

Figure 9: Real Time  $\text{PM}_{10}$  24hr average and YTD average – January 2019

<b>Date</b>	<b>Site</b>	<b>Total Measured Result (µg/m3)</b>	<b>Estimated contribution from HVO (µg/m3 / %)</b>	<b>Discussion</b>
2/1/2019	Warkworth TEOM	60.5	30.8 µg/m3 Or 50.8%	An internal investigation determined HVO maximum potential contribution to be in the order of 30.8 ug/m3 or 50.8% of the total measured based on prevailing wind conditions and upwind TEOM monitoring results.
3/1/2019	Warkworth TEOM	65.3	27.3 µg/m3 Or 41.8%	An internal investigation determined HVO maximum potential contribution to be in the order of 27.3 ug/m3 or 41.8% of the total measured based on prevailing wind conditions and upwind TEOM monitoring results.
16/1/2019	Jerrys Plains TEOM	53.7	8.6 µg/m3 Or 15.9%	An internal investigation determined HVO maximum potential contribution to be in the order of 8.6 ug/m3 or 15.9% of the total measured based on prevailing wind conditions and upwind TEOM monitoring results.
17/1/2019	Jerrys Plains TEOM	57.3	20.2 µg/m3 Or 35.3%	An internal investigation determined HVO maximum potential contribution to be in the order of 20.2 ug/m3 or 35.3% of the total measured based on prevailing wind conditions and upwind TEOM monitoring results.

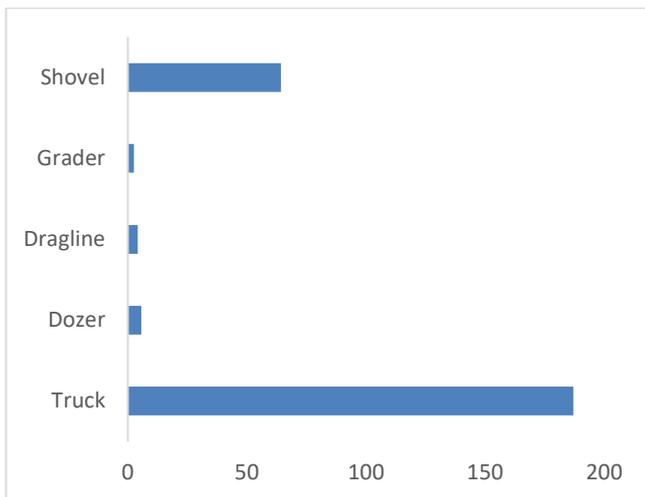
During January, a total of 263 hours of equipment downtime was logged in response to real time monitoring and visual inspections for environmental reasons such as dust, noise and meteorological conditions. Operational downtime by equipment type is shown in Figure 14.

**Figure 14: Operational Downtime by Equipment Type – January 2019**

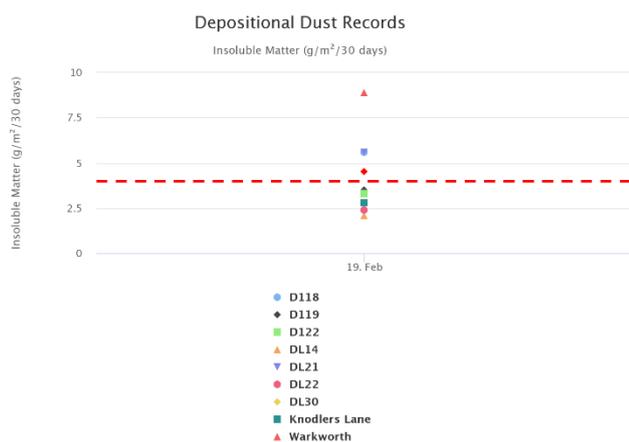
During the reporting period the DL21, DL30, D118 and Warkworth monitors recorded a monthly result above the long term impact assessment criteria of 4.0 g/m<sup>2</sup> per month. The sample from DL30 was found to be contaminated with vegetation and insects.

Figure 5: Depositional Dust Results – February 2019

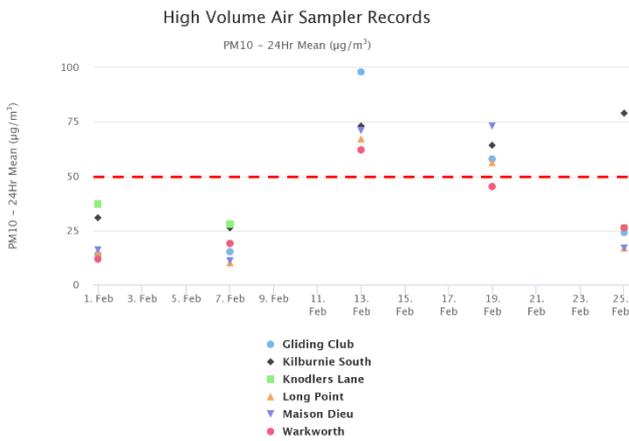
On 25 February 2019, the Kilburnie South HVA5 unit recorded an elevated 24 hour average ( $79 \mu\text{g}/\text{m}^3$ ), upon investigation HVO's contribution was deemed to minimal due to prevailing wind conditions.

Figure 6: Individual PM<sub>10</sub> Results – February 2019

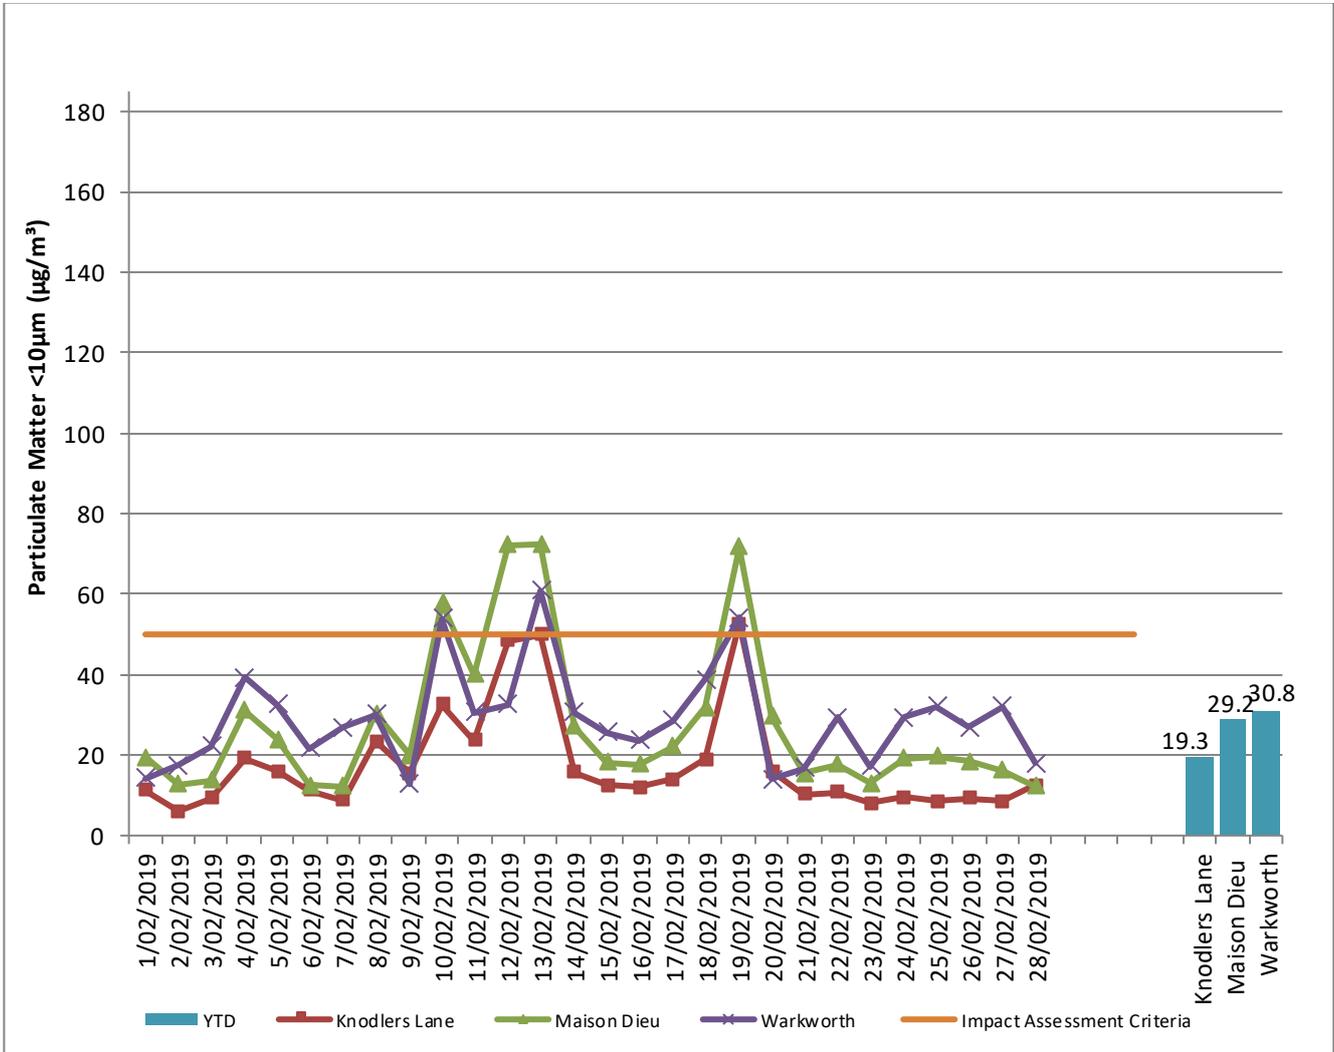
During February the real time monitoring system generated 145 automated air quality related alarms. 68 alarms were related to adverse weather conditions and 77 alarms relating to PM<sub>10</sub>.

Figure 9: Real Time PM<sub>10</sub> 24hr average and YTD average – February 2019

<b>Date</b>	<b>Site</b>	<b>Total Measured Result (µg/m3)</b>	<b>Estimated contribution from HVO (µg/m3 / %)</b>	<b>Discussion</b>
10/2/2019	Maison Dieu TEOM	57.8	14.6 µg/m3 Or 25.1%	An internal investigation determined HVO maximum potential contribution to be in the order of 14.6 ug/m3 or 25.1% of the total measured based on prevailing wind conditions and upwind TEOM monitoring results.
10/2/2019	Warkworth TEOM	53.9	NA	An internal investigation determined HVO contribution to be minimal due to prevailing wind conditions and high Background levels.
12/2/2019	Maison Dieu TEOM	72.8	26.9 µg/m3 Or 37.2%	An internal investigation determined HVO maximum potential contribution to be in the order of 26.9 ug/m3 or 37.2% of the total measured based on prevailing wind conditions and upwind TEOM monitoring results.
13/2/2019	Maison Dieu TEOM	72.4	7.5 µg/m3 Or 10.3%	Monitoring results on this day were considered to have been effected by a regional dust event which travelled from the States west.  An internal investigation determined HVO maximum potential contribution to be in the order of 7.5 ug/m3 or 10.3% of the total measured based on prevailing wind conditions and upwind TEOM monitoring results.

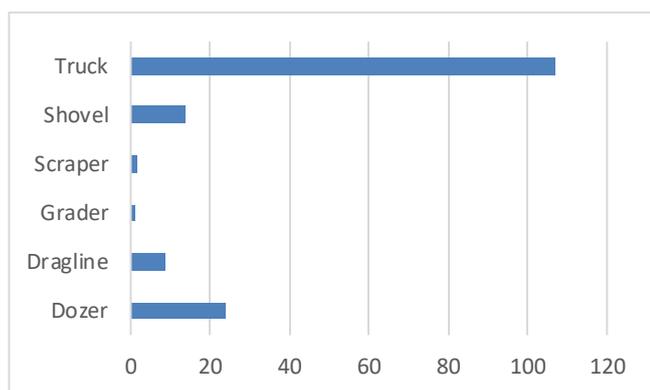
During February, a total of 157 hours of equipment downtime was logged in response to real time monitoring and visual inspections for environmental reasons such as dust, noise and meteorological conditions. Operational downtime by equipment type is shown in Figure 14.

**Figure 14: Operational Downtime by Equipment Type – February 2019**

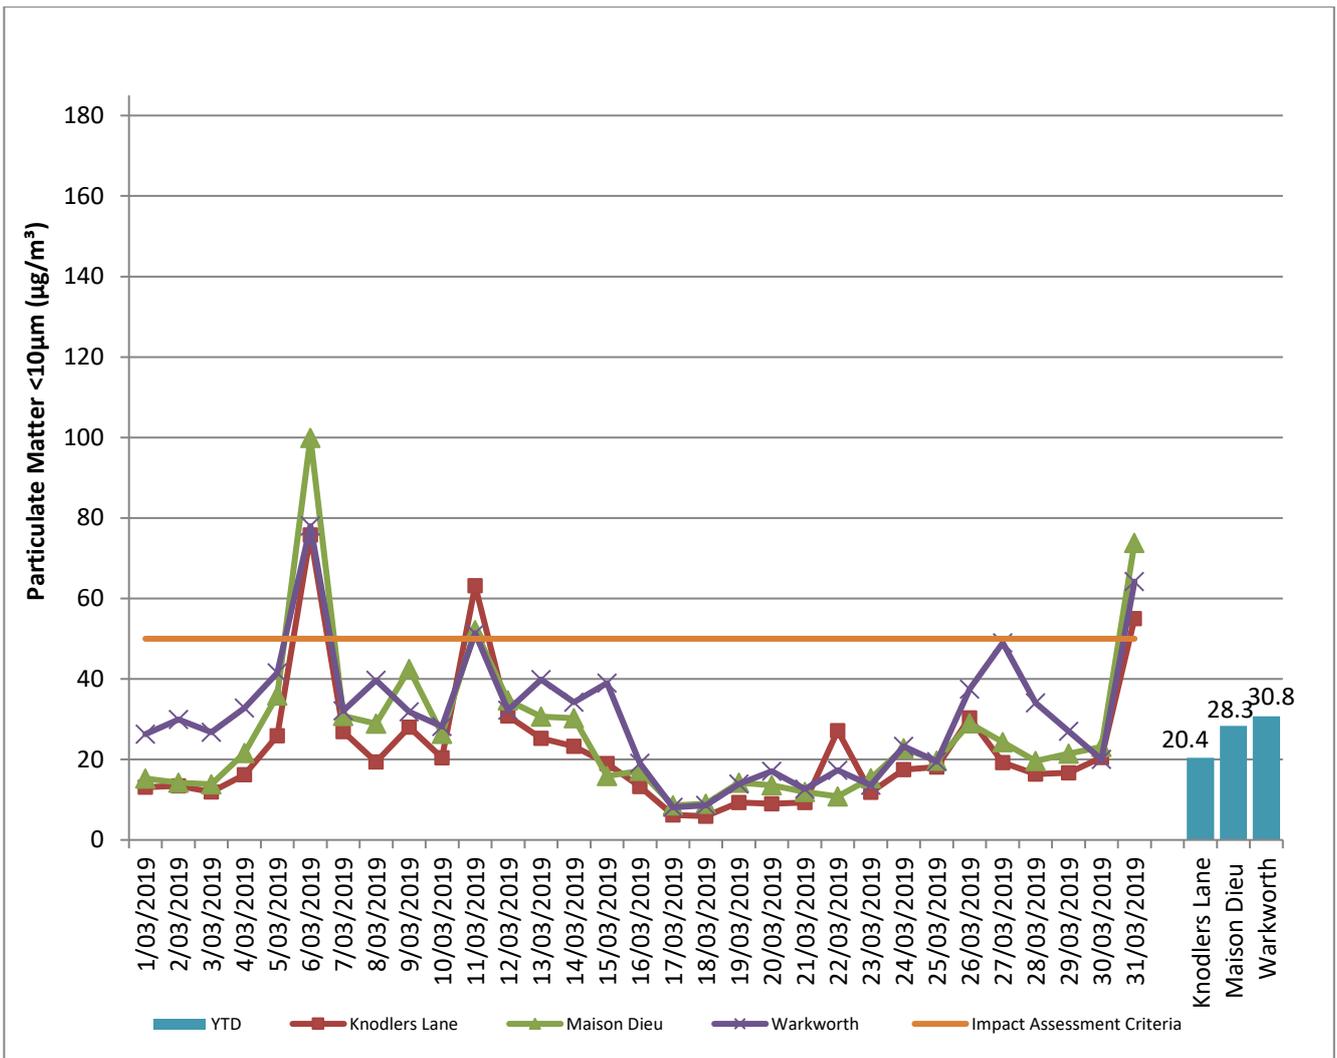
During March the real time monitoring system generated 140 automated air quality related alarms. 24 were related to adverse weather conditions and 116 alarms relating to PM<sub>10</sub>.

Figure 9: Real Time  $PM_{10}$  24hr average and YTD average – March 2019

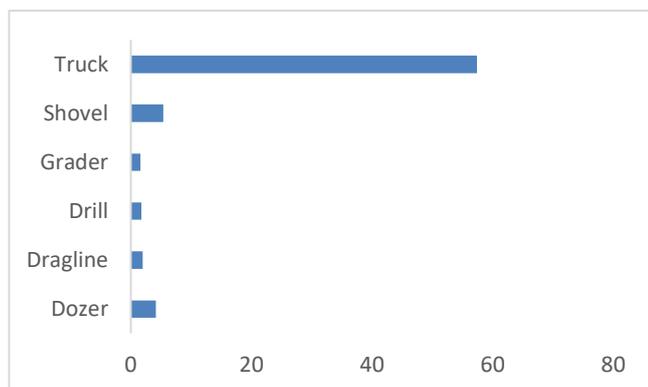
During March, a total of 72 hours of equipment downtime was logged in response to real time monitoring and visual inspections for environmental reasons such as dust, noise and meteorological conditions. Operational downtime by equipment type is shown in Figure 85.

**Figure 85: Operational Downtime by Equipment Type – March 2019**
