Hunter Valley Operations

Community Consultative Committee

Business Papers – August 2019

Materials ahead of meeting of the committee on **21 August 2019**

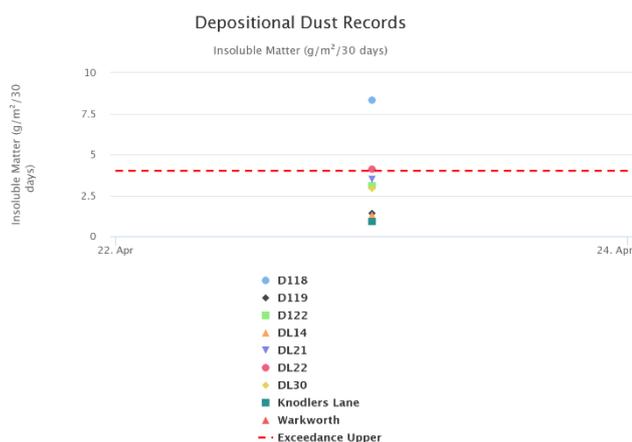
Figure 5: Depositional Dust Results – April 2019

During the reporting period, D118 and DL22 monitors recorded a monthly result above the long term impact assessment criteria of 4.0 g/m² per month. No sample was collected for the Warkworth monitor due to a broken sample jar.

An assessment of HVO's contribution against the long term impact assessment criteria will be provided in the 2019 Annual Review.

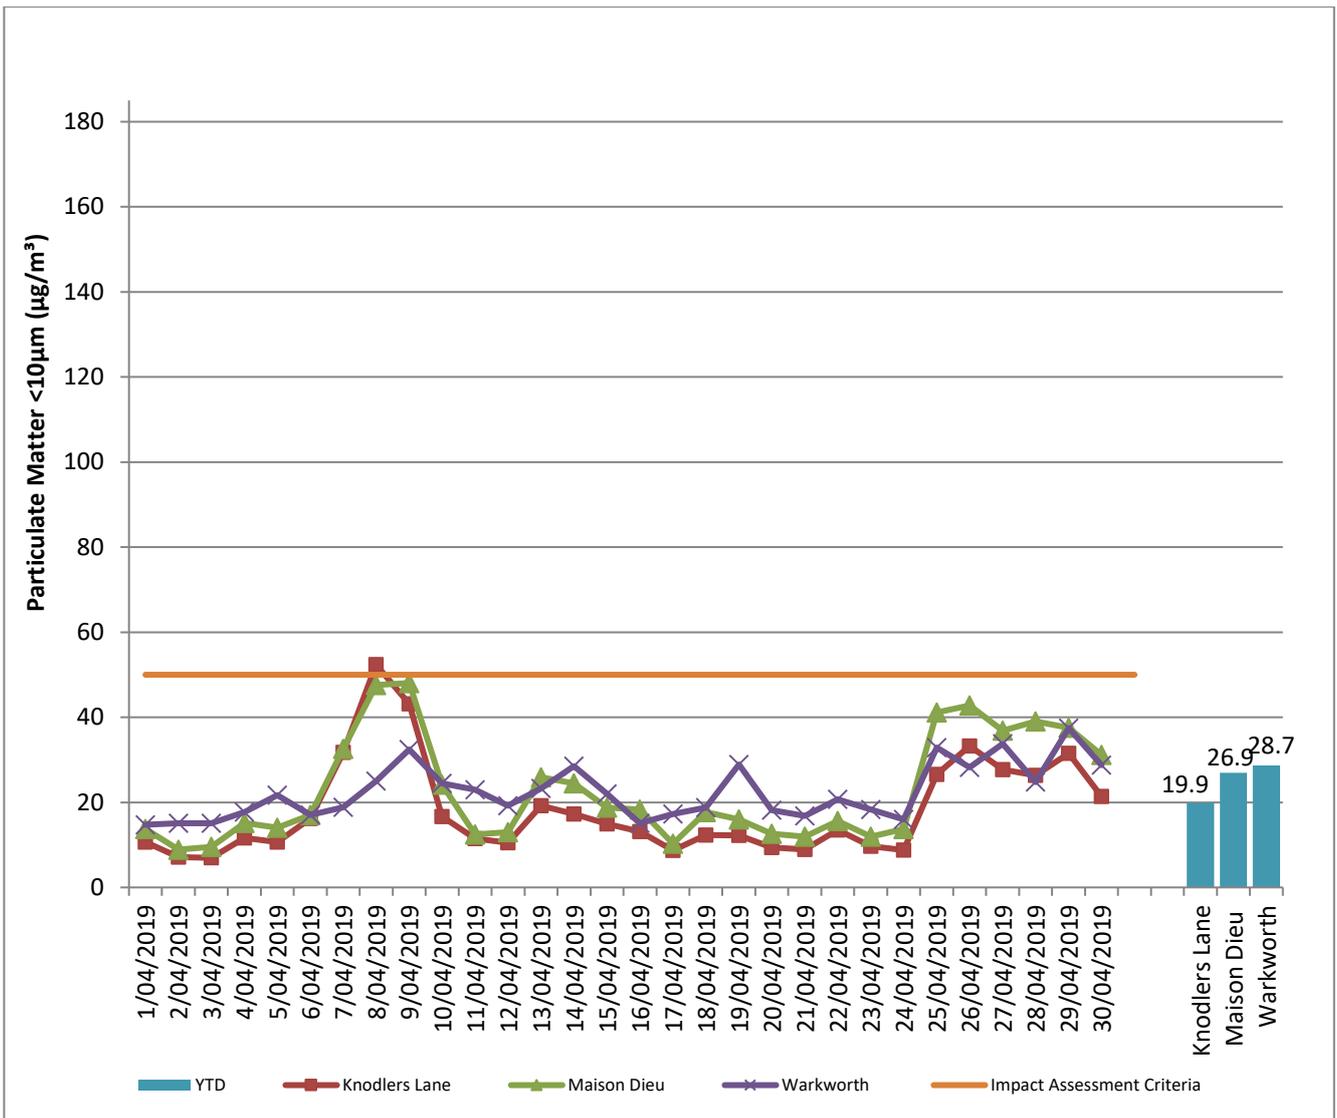
Figure 9: Real Time PM₁₀ 24hr average and YTD average – April 2019

During April the real time monitoring system generated 223 automated air quality related alarms. 90 alarms were related to adverse weather conditions and 133 alarms relating to PM₁₀.

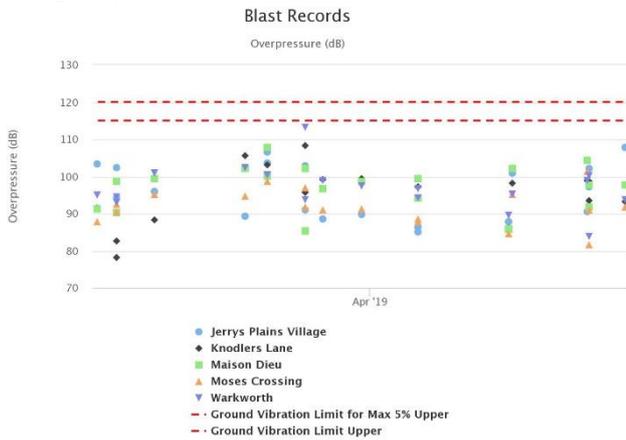
Figure 10: Overpressure Blast Monitoring Results – April 2019

Figure 10 and 11 show the blast monitoring results for the reporting period against the impact assessment criteria. The criteria are summarised in Table 3.

During April, 12 blasts were initiated at HVO

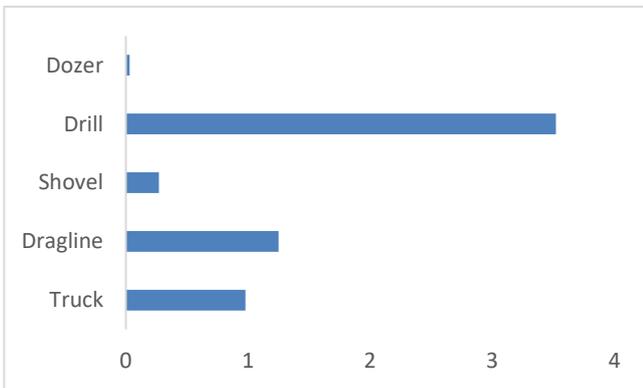
Figure 14: Operational Downtime by Equipment Type – April 2019

During April, a total of 6.05 hours of equipment downtime was logged in response to real time monitoring and visual inspections for environmental reasons such as dust, noise and meteorological conditions. Operational downtime by equipment type is shown in Figure 14.

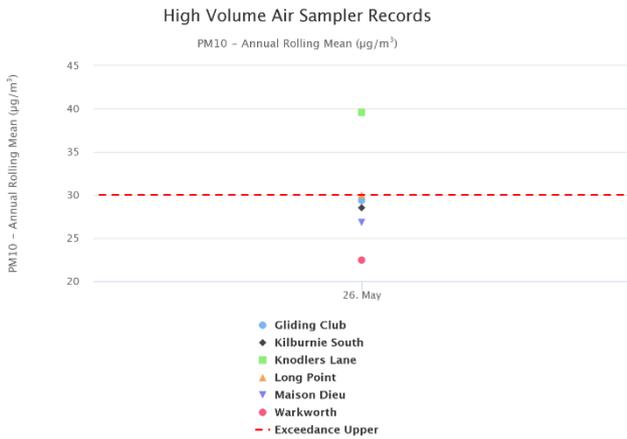
Figure 7: Year to Date Average PM₁₀ – as at end of May 2019

Figure 7 shows the year to date annual average PM₁₀ results.

An assessment of HVO's contribution against the long term impact assessment criteria will be provided in the 2019 Annual Review.

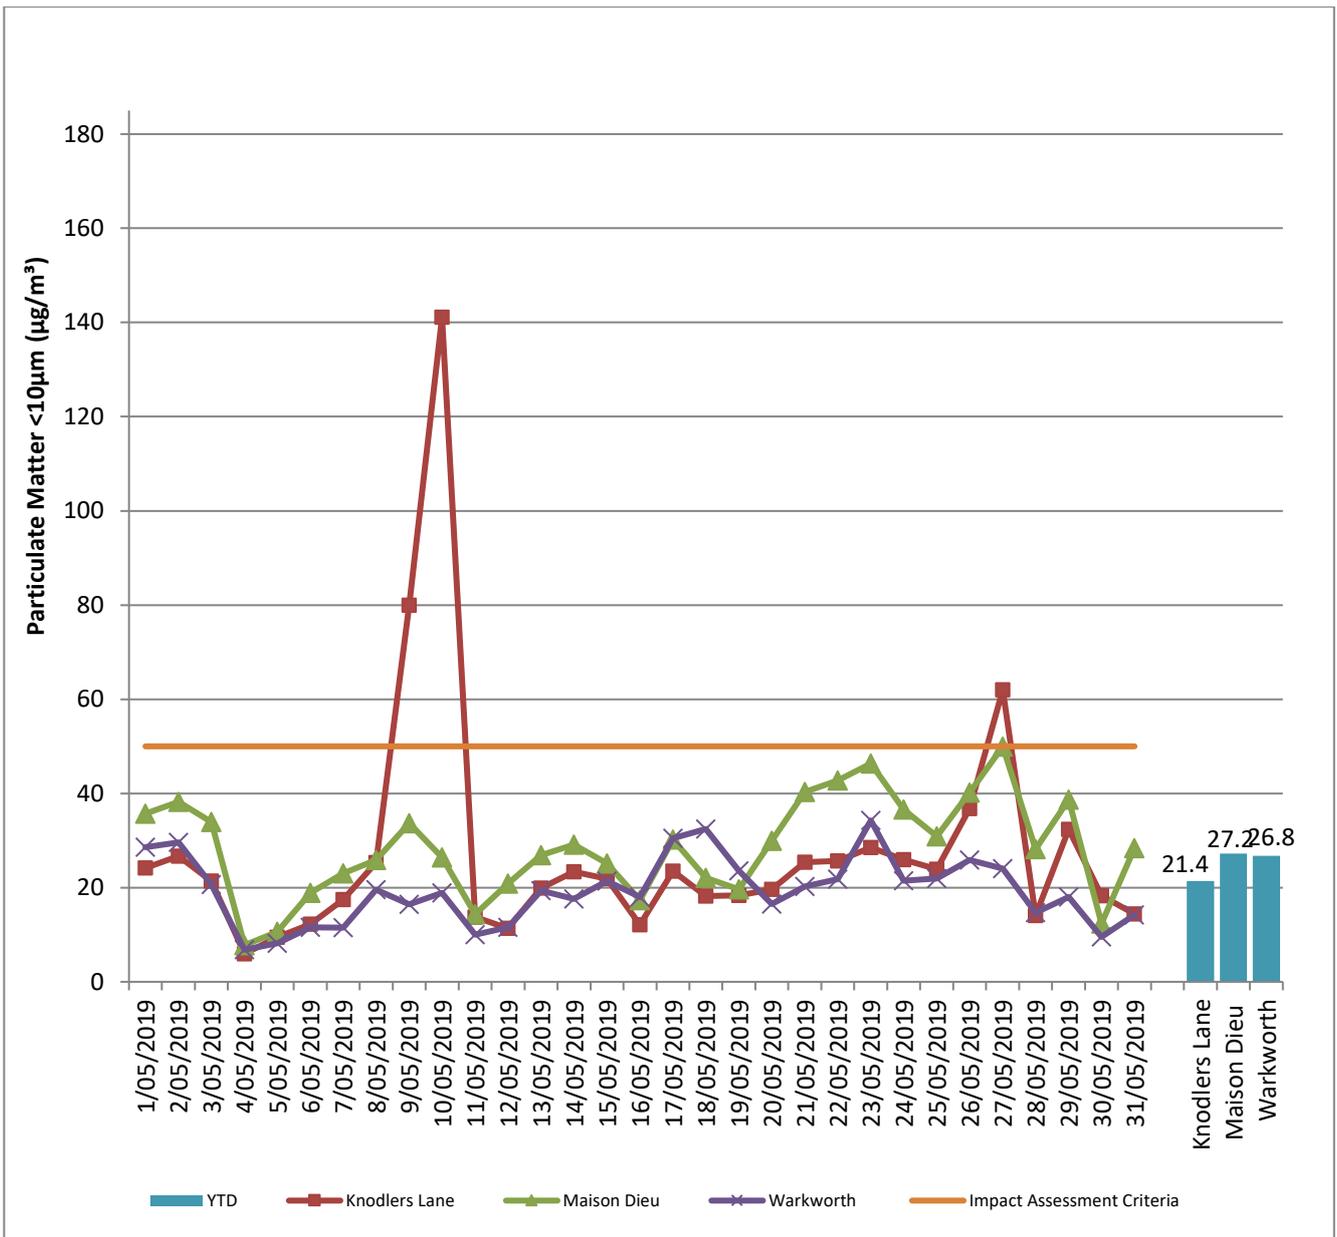
Figure 9: Real Time PM₁₀ 24hr average and YTD average – May 2019

During May the real time monitoring system generated 231 automated air quality related alarms. 131 alarms were related to adverse weather conditions and 100 alarms relating to PM₁₀.

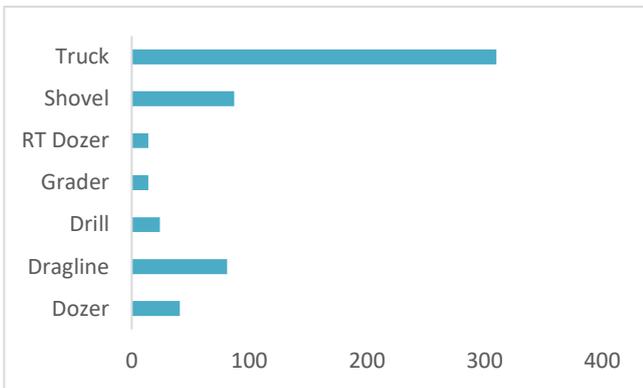
Figure 14: Operational Downtime by Equipment Type – May 2019

During May, a total of 571 hours of equipment downtime was logged in response to real time monitoring and visual inspections for environmental reasons such as dust, noise and meteorological conditions. Operational downtime by equipment type is shown in Figure 14.

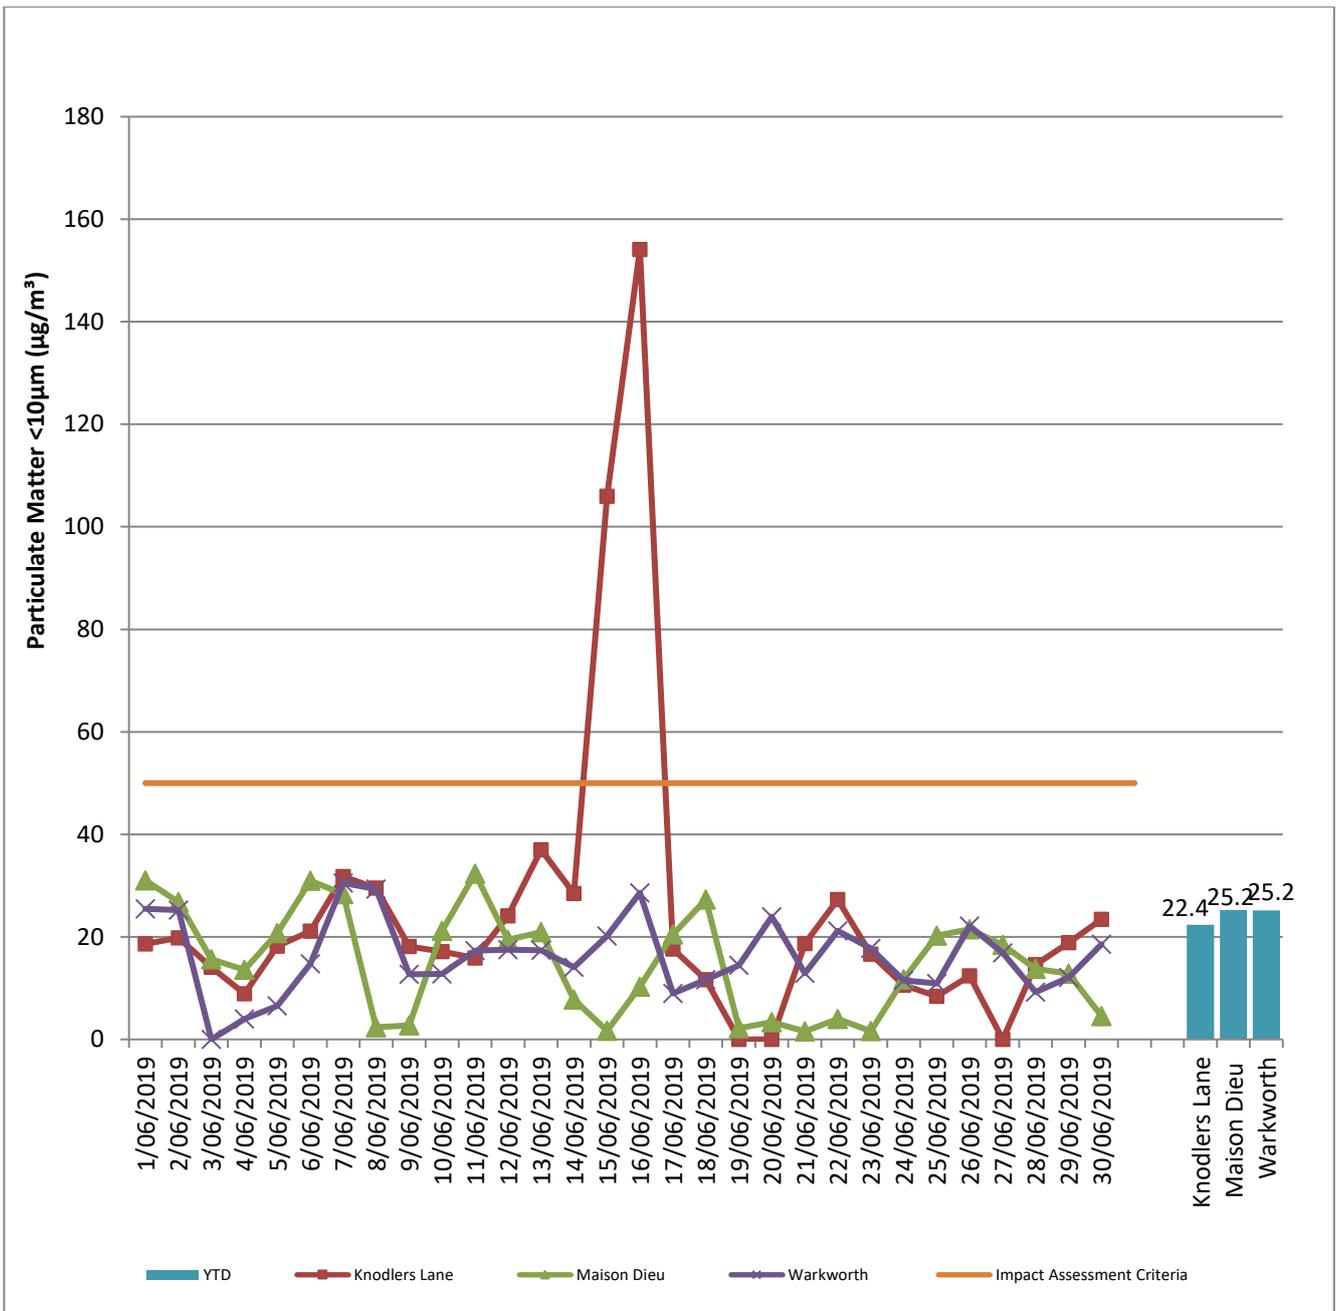
Figure 9: Real Time PM_{10} 24hr average and YTD average – June 2019

During June the real time monitoring system generated 154 automated air quality related alarms. 10 were related to adverse weather conditions and 144 alarms relating to PM₁₀.

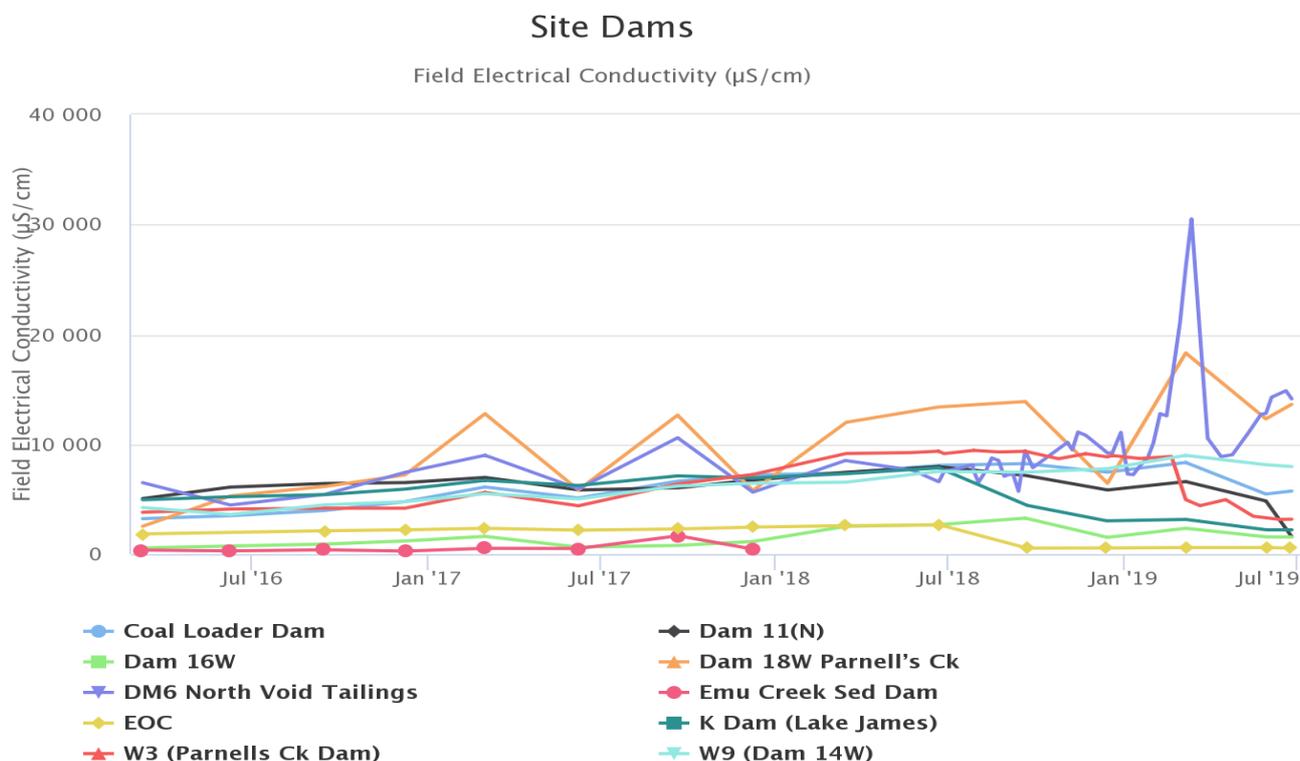
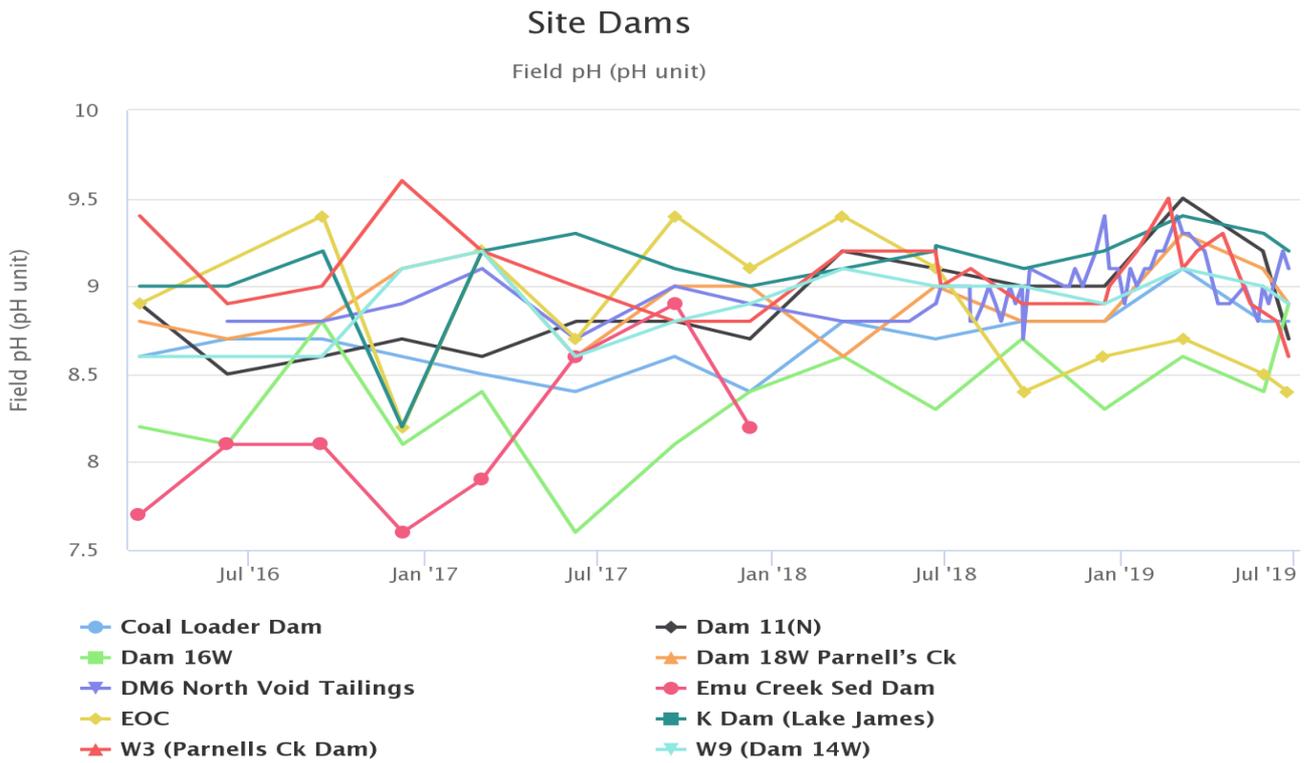
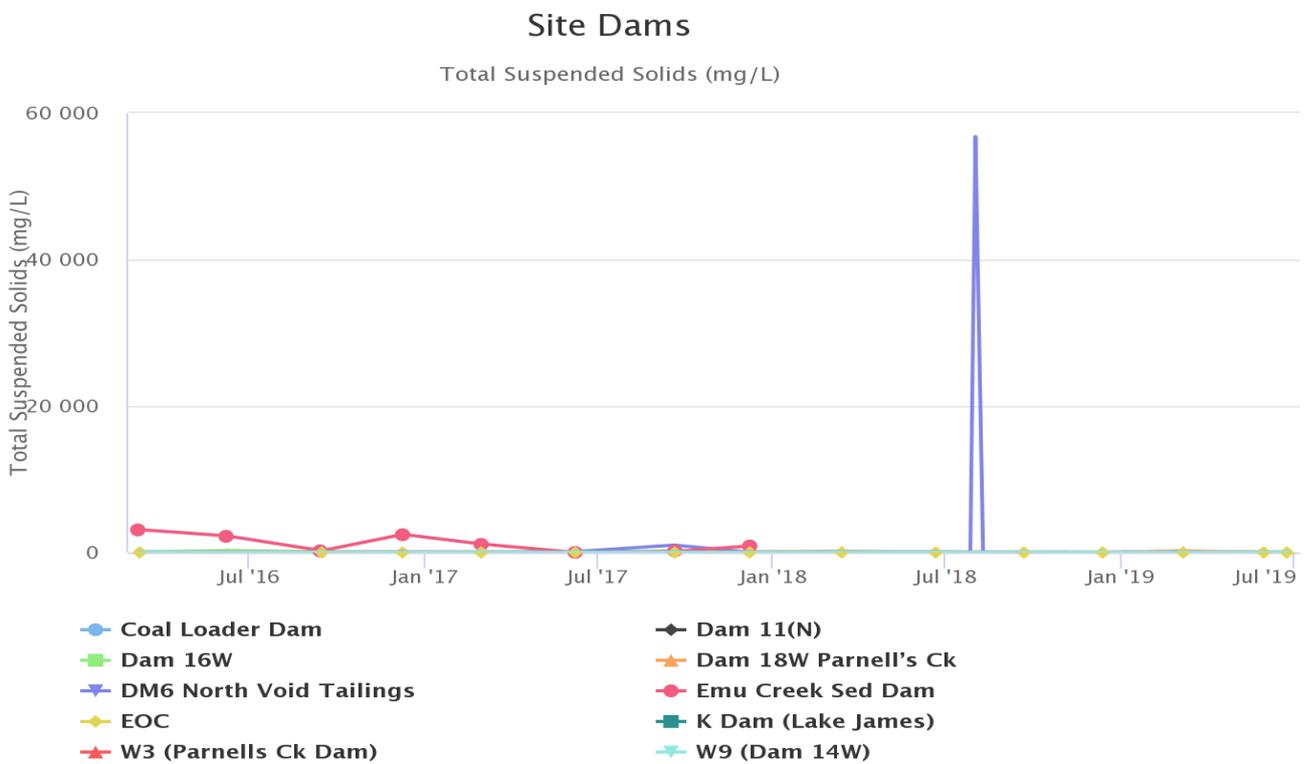
Figure 10 to Figure 12 show the long term surface water trend (2016- current) within HVO mine dams.

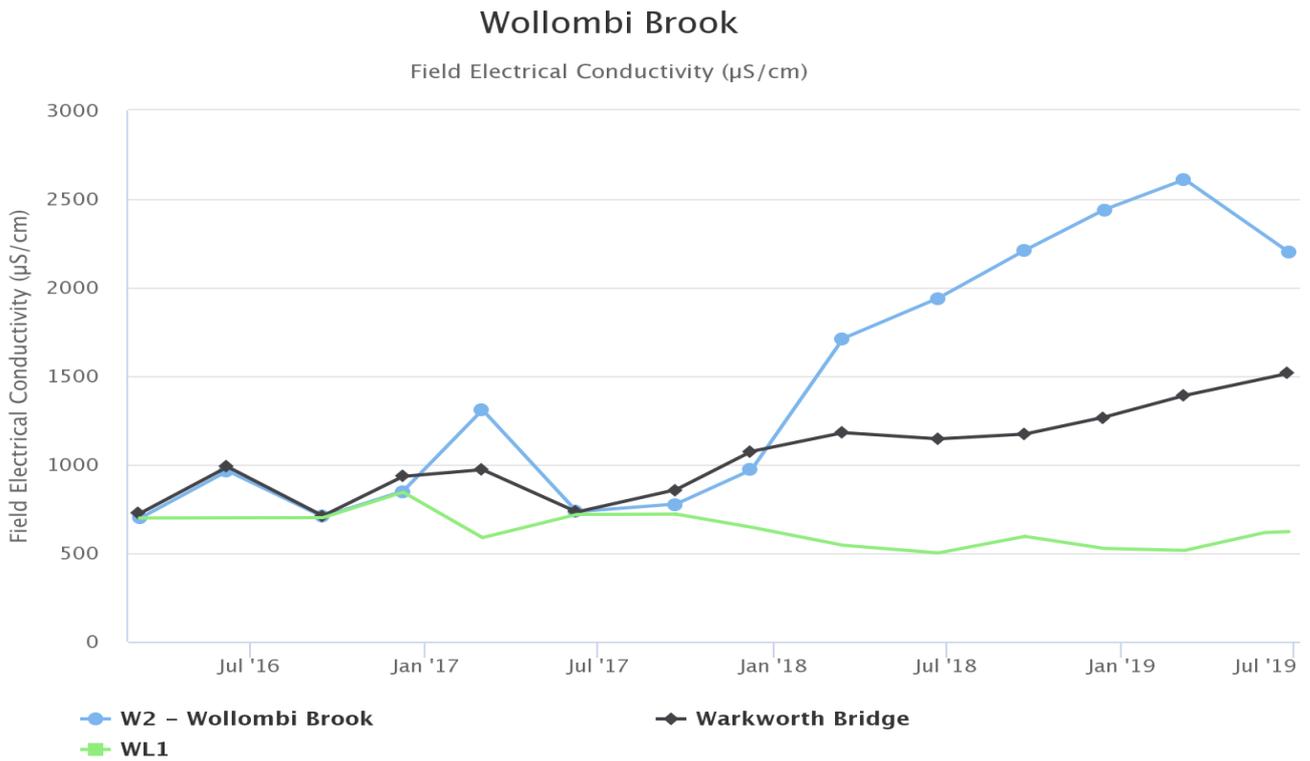
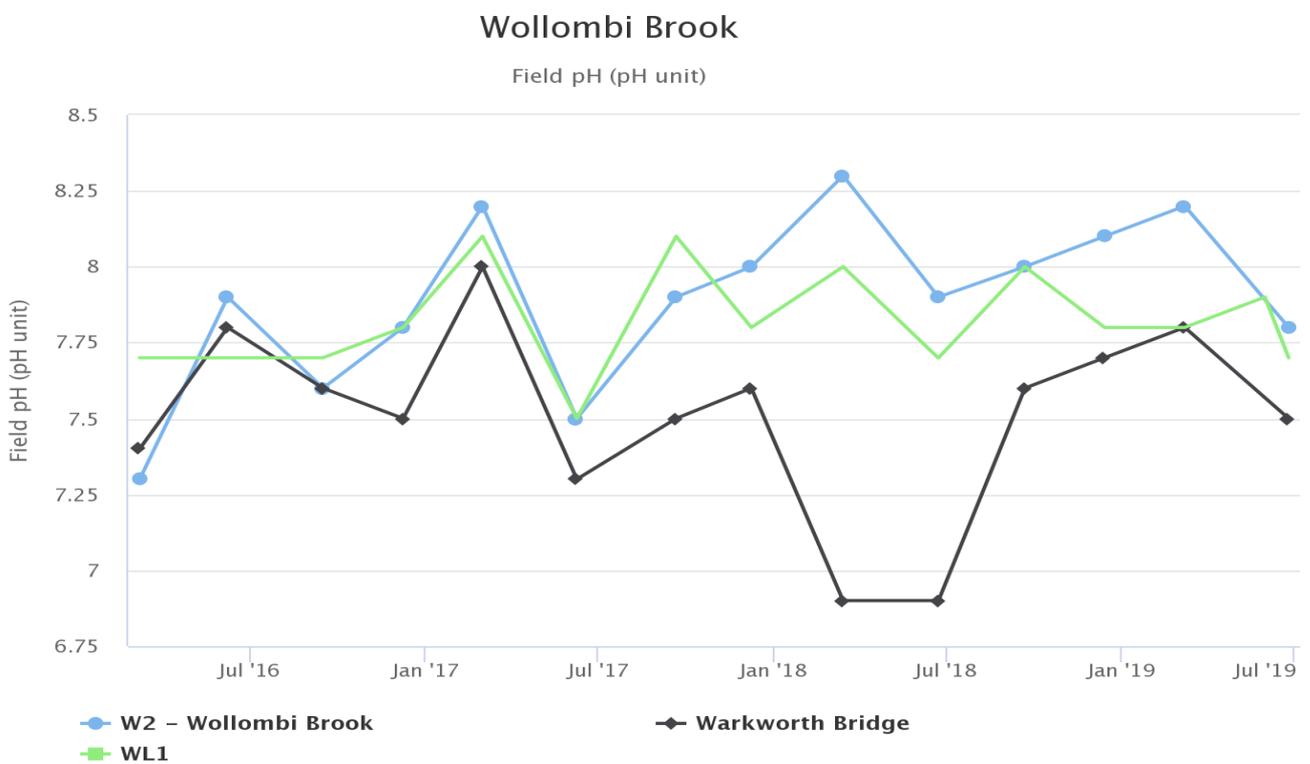
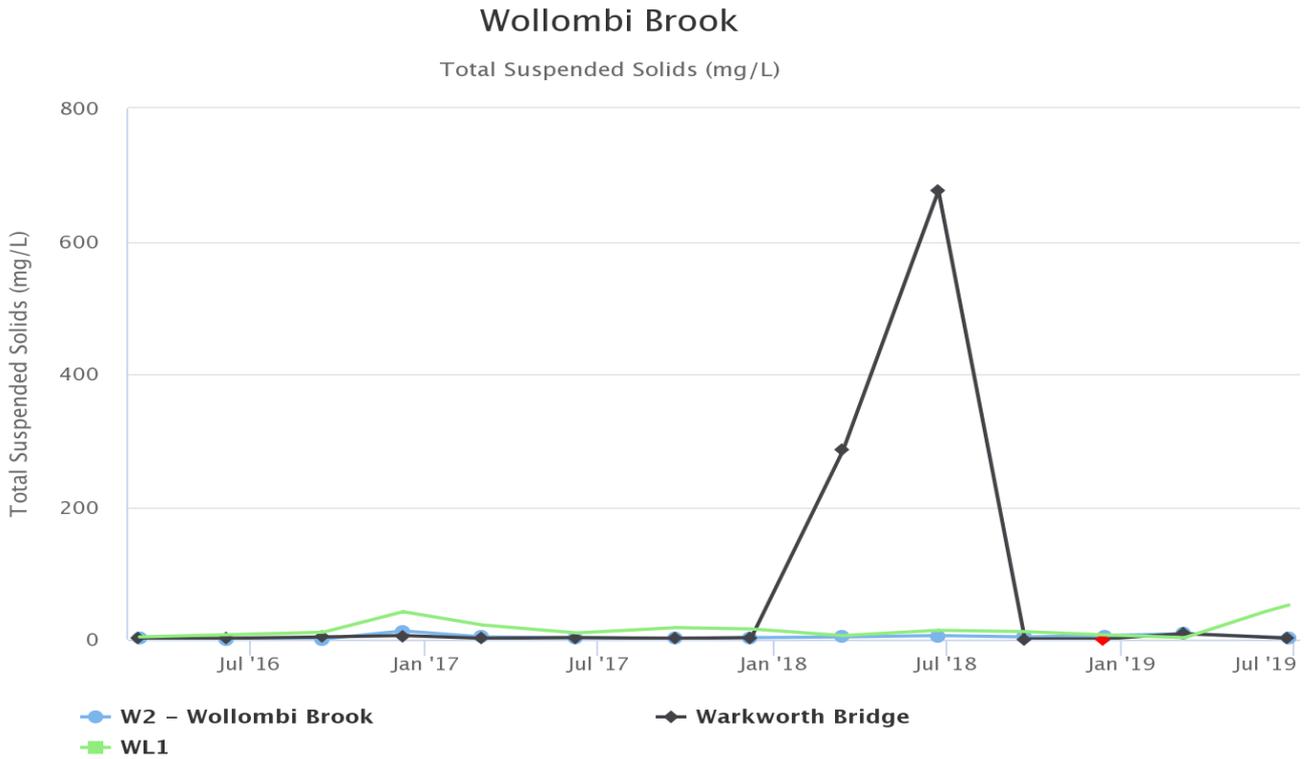
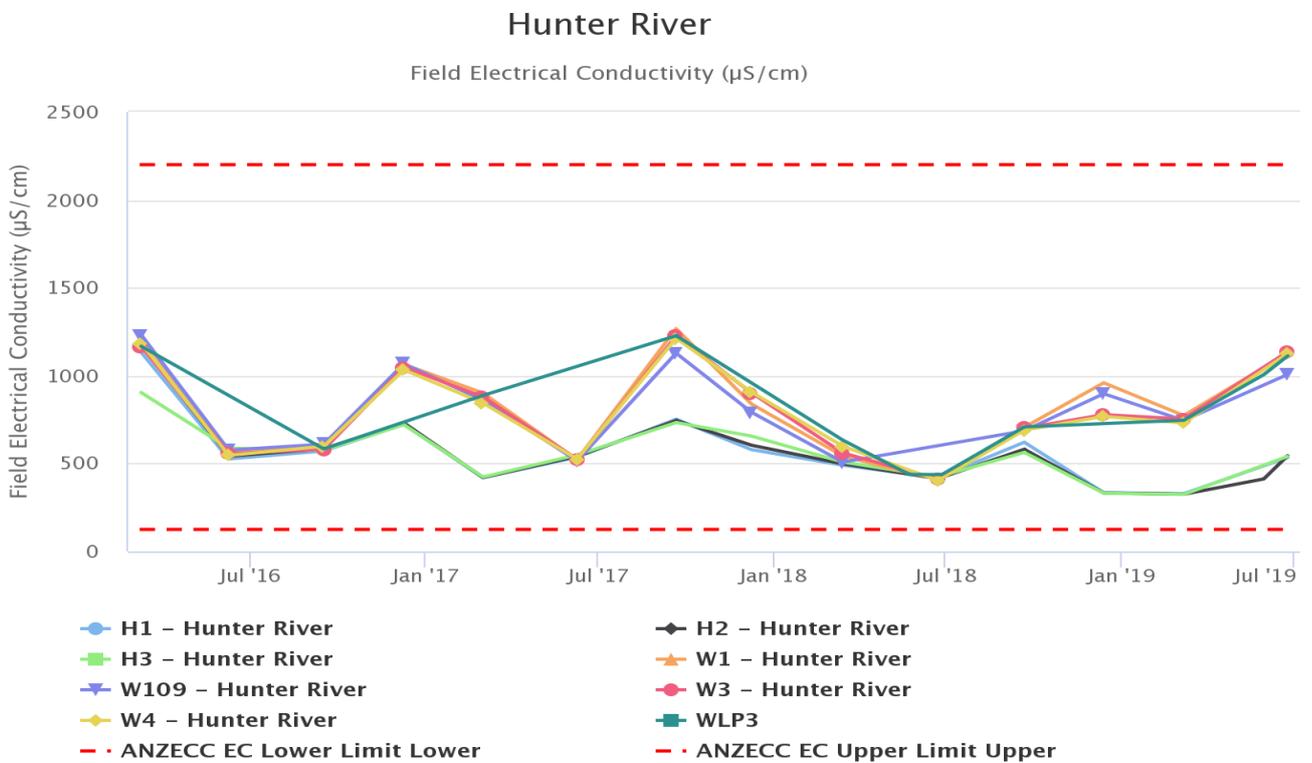
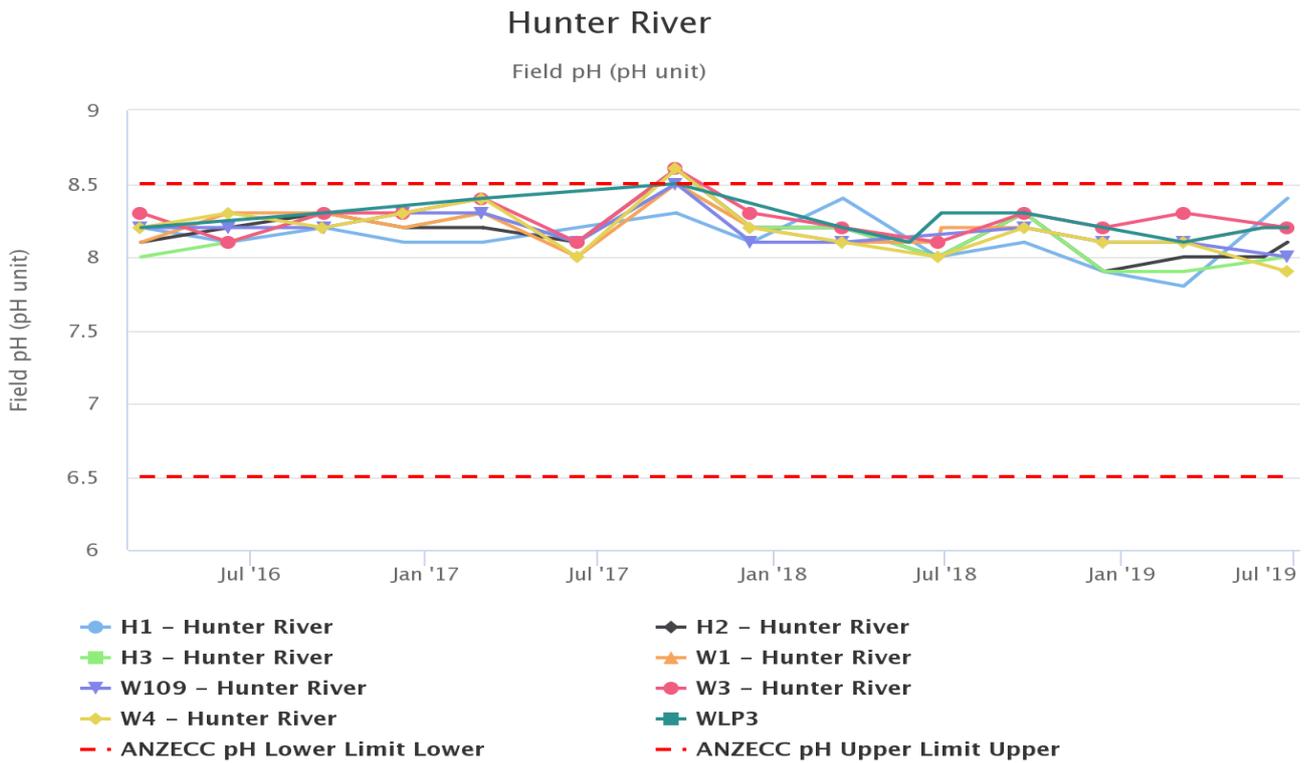
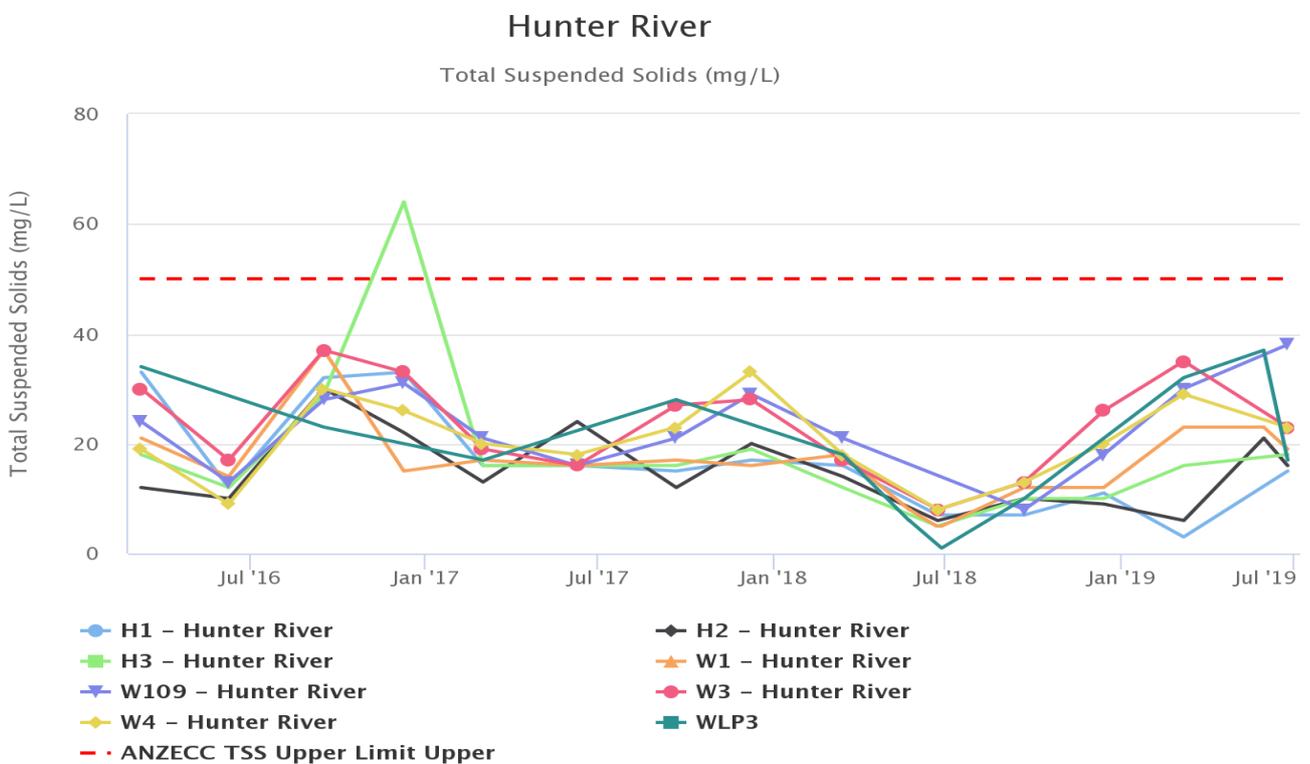
Figures 13 to 21 show the long term surface water trend (2016 – current) in surrounding watercourses

W2 Wollombi Brook	24/06/2019	EC 95 th Percentile	First Breach of TSS. Downstream results at monitoring location H3 in the Hunter indicate better water quality than that measured at WL1 indicating that the TSS results may be isolated to a local source to the sampling location and not from a broader impact. Watching Brief*
WL1	24/06/2019	TSS

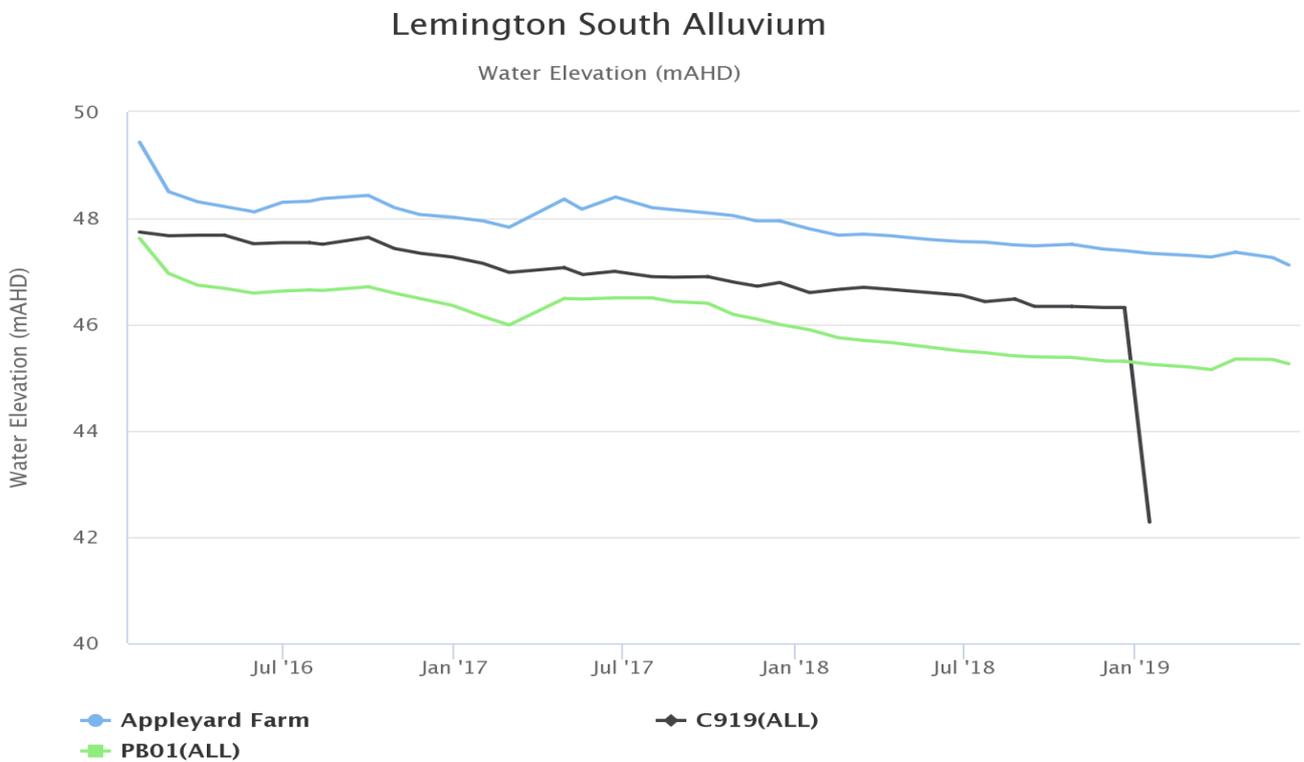
Figure 49: Lemington South Alluvium Standing Water Level Trend – June 2019*

*C919(ALL) has been dry from February to June 2019

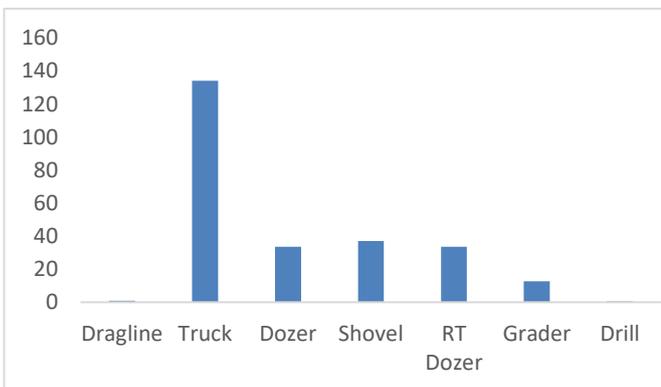
Figure 85: Operational Downtime by Equipment Type – June 2019

During June, a total of 252.3 hours of equipment downtime was logged in response to real time monitoring and visual inspections for environmental reasons such as dust, noise and meteorological conditions. Operational downtime by equipment type is shown in Figure 85.
