HUNTER VALLEY OPERATIONS

Monthly Environmental Monitoring Report

September 2019

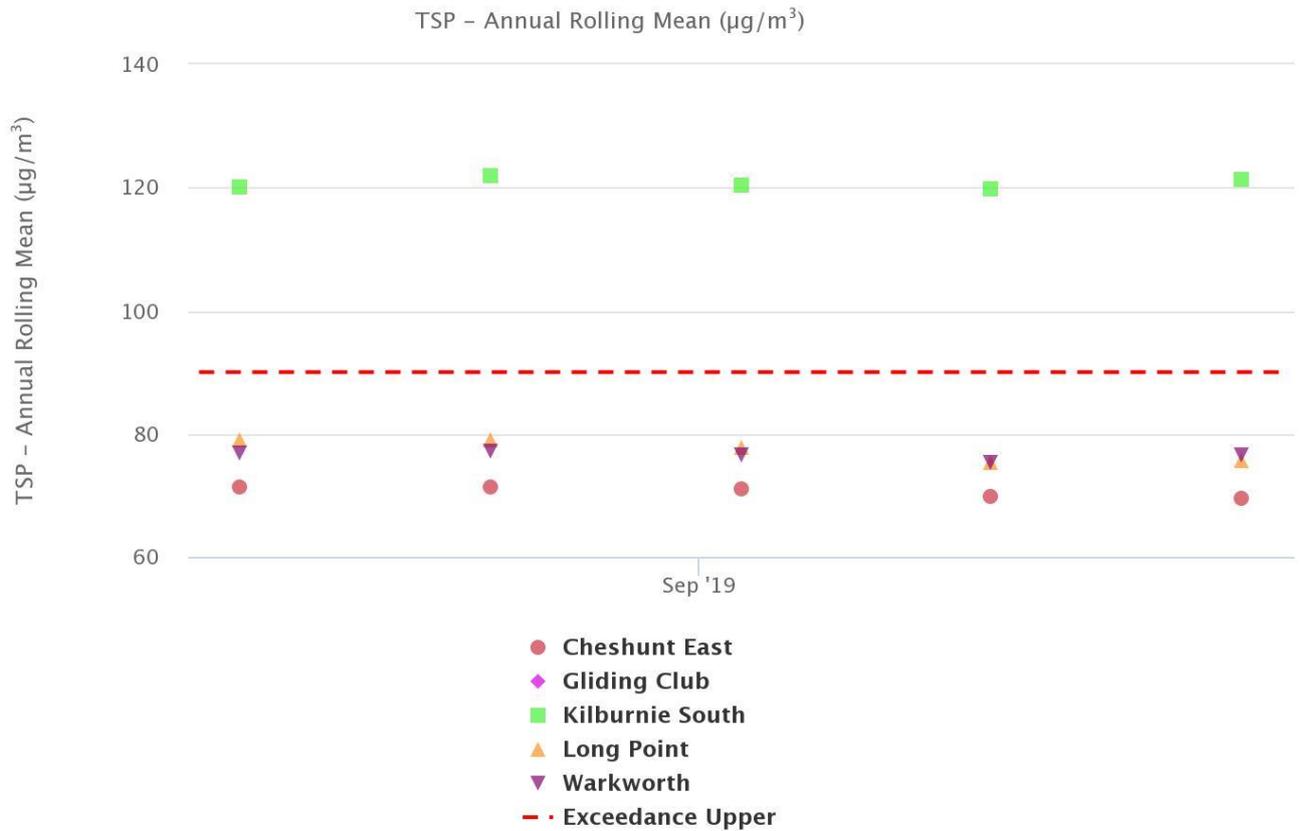
Figure 8: Year to Date Average Total Suspended Particulates – as at end of September 2019

Figure 8 shows the annual average TSP results compared against the long term impact assessment criteria of $90\mu\text{g}/\text{m}^3$. During the reporting period, the Kilburnie South monitor recorded exceedances above the long term impact assessment criteria of $90\mu\text{g}/\text{m}^3$.

An assessment of HVO's contribution against the long term impact assessment criteria will be provided in the 2019 Annual Review.

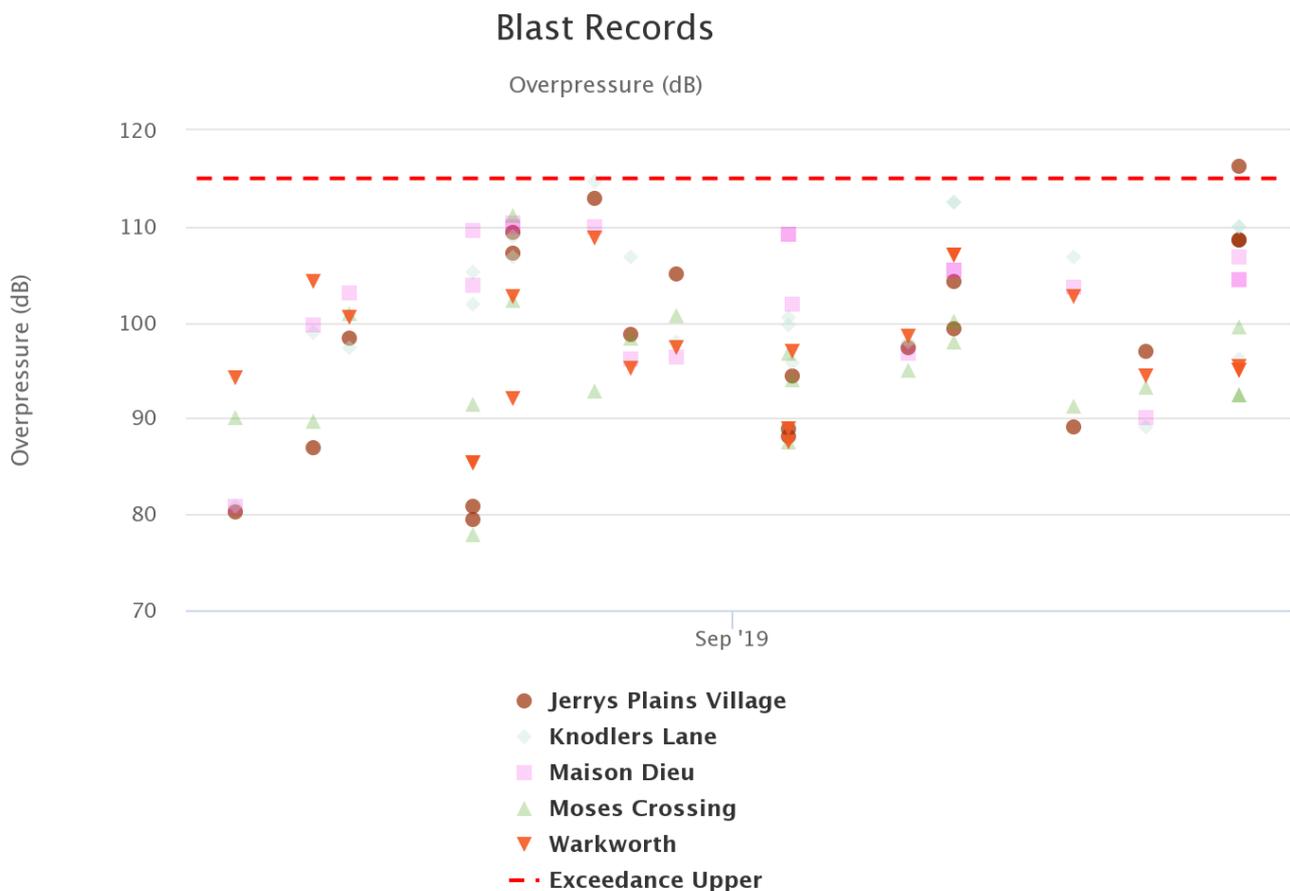
Figure 81: Overpressure Blast Monitoring Results – September 2019

During September, 21 blasts were initiated at HVO. Figure 81 and Figure 82 show the blast monitoring results for the reporting period against the impact assessment criteria.

*Note that the Jerrys Plain Village exceedance recorded on 28th September is currently being investigated at the time of writing of this report.

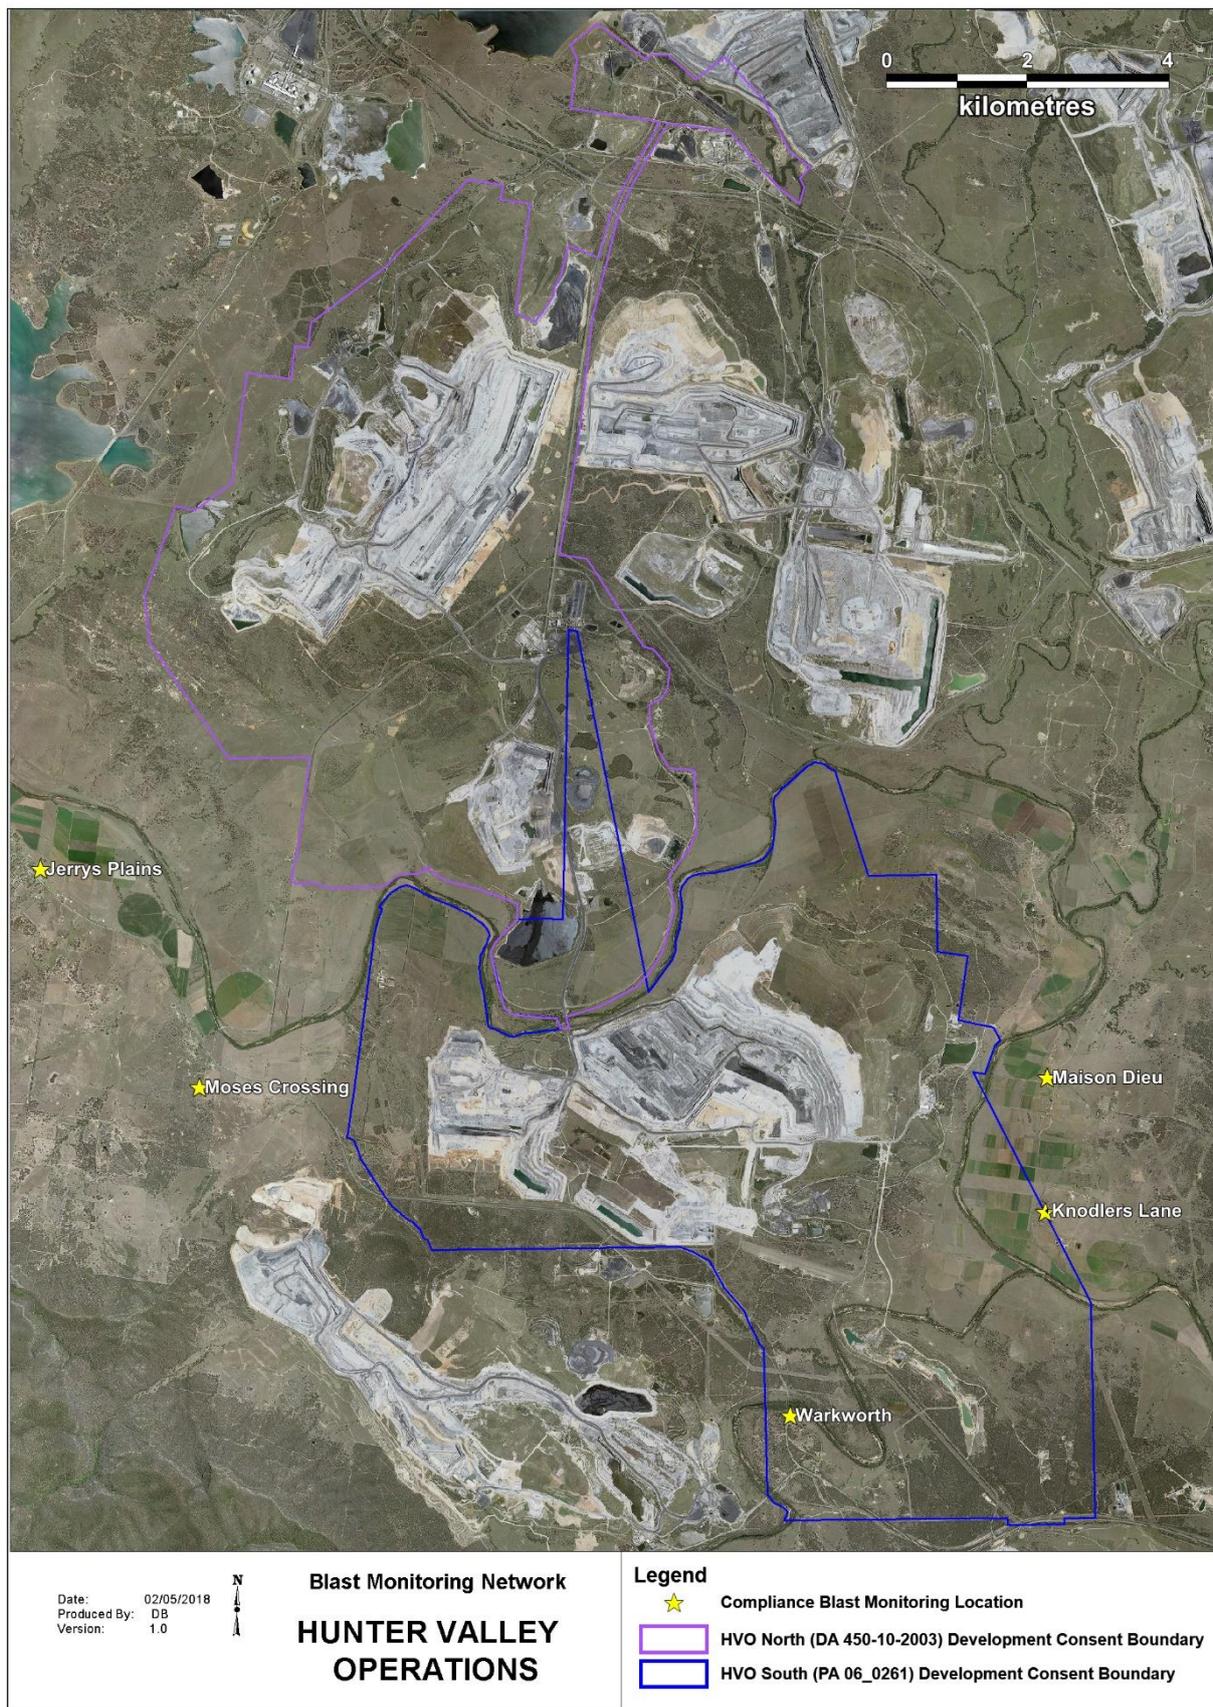
Figure 83: Blast Monitoring Location Plan

HVO have a network of five blast monitoring units. These are located at nearby privately owned residences and function as regulatory compliance monitors. The location of these monitors can be found in Figure 83. Blasting criteria are summarised in Table 5.
