# HUNTER VALLEY OPERATIONS

## Monthly Environmental Monitoring Report December 2021

**Document Number:** HVOOC-1797567310-4062

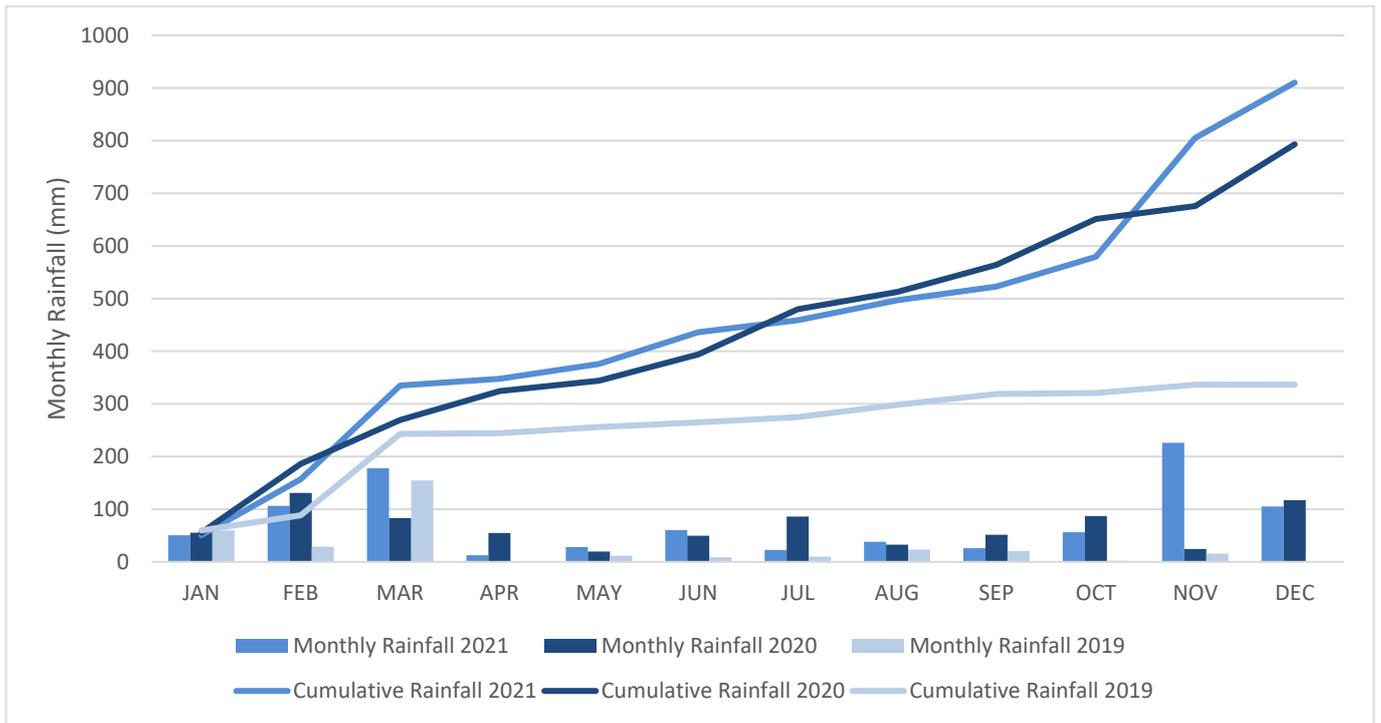
Figure 1 - Rainfall Summary 2021

Rainfall for the period is summarised in **Table 1**. The 2019, 2020 and 2021 trends are shown in **Figure 1**.

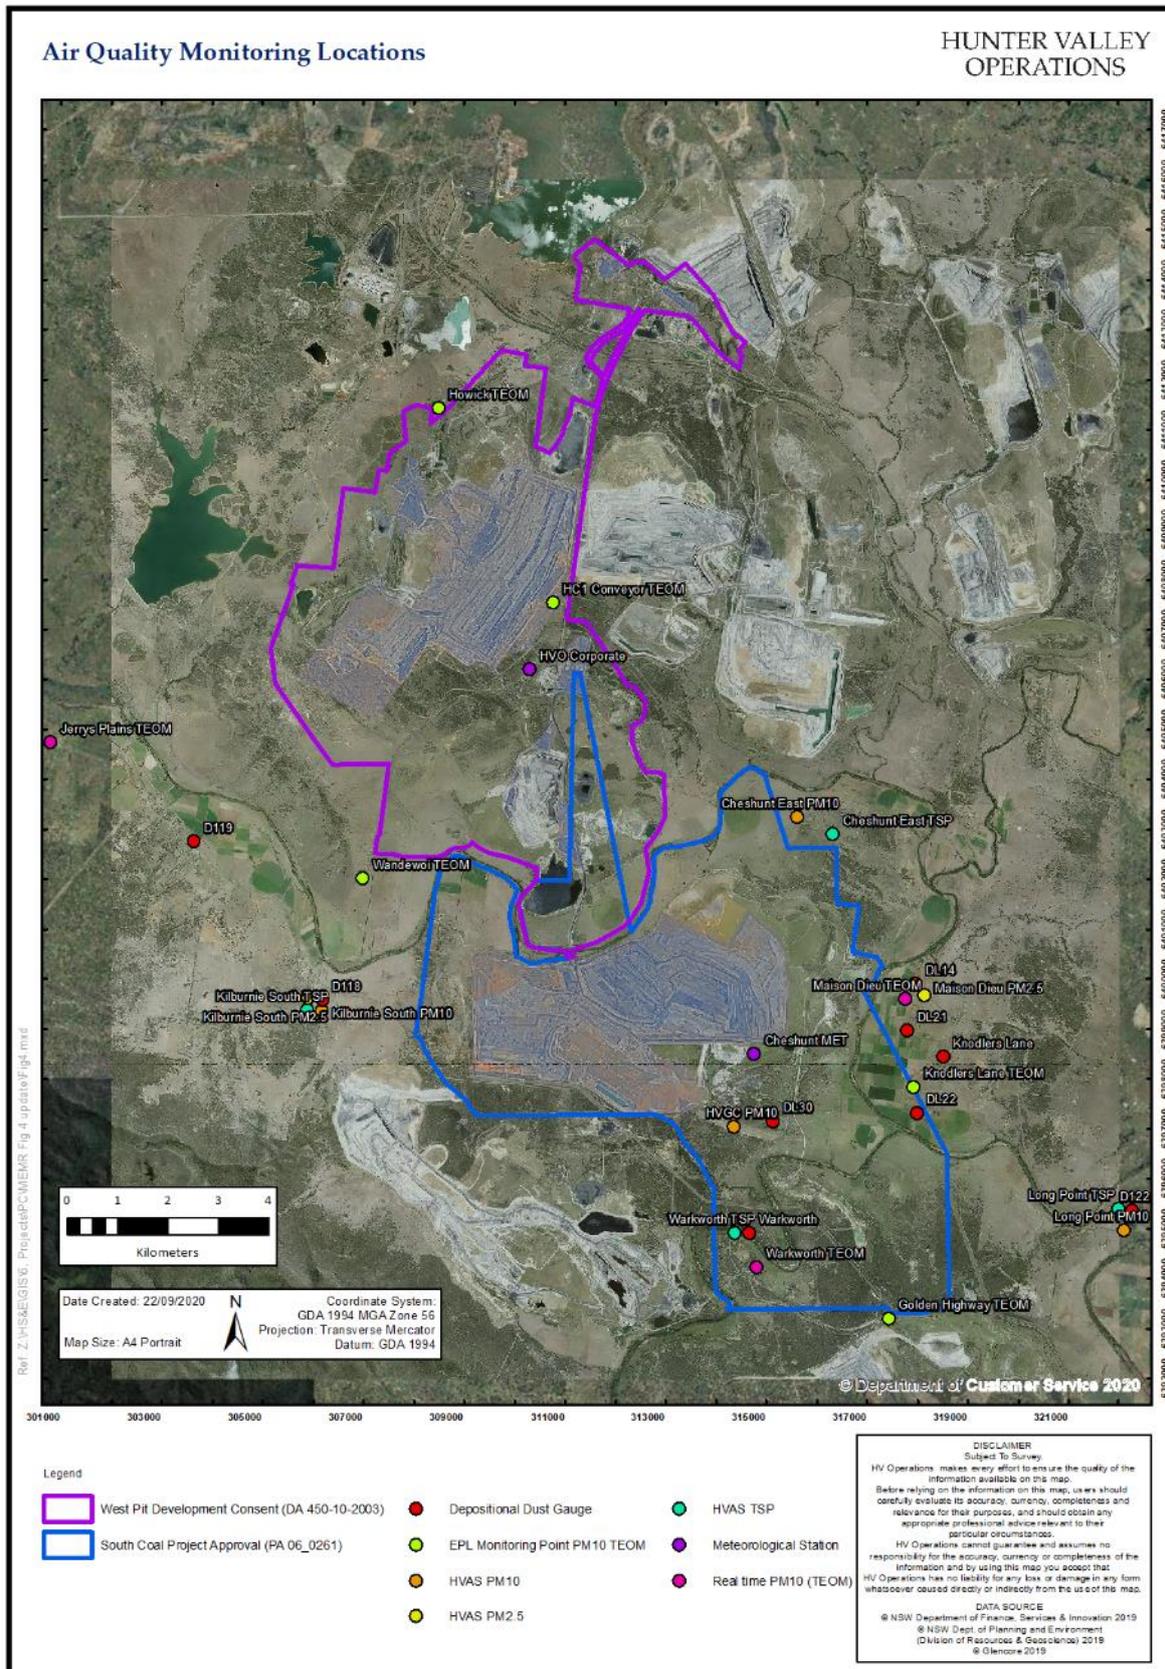
Figure 4 - Air Quality Monitoring Location Plan

HVO maintains two meteorological stations: 'HVO Corporate' and 'Cheshunt' (refer to **Figure 4**)

Suspended particles are measured by a network of High Volume Air Samplers (HVAS) measuring Total Suspended Particulates (TSP) and Particulate Matter <10µm (PM<sub>10</sub>). The Kilburnie South and Maison Dieu HVAS also monitor Particulate Matter <2.5µm (PM<sub>2.5</sub>). The location of these monitors can be seen in Figure 4. Each HVAS runs for 24-hours on a six-day cycle.

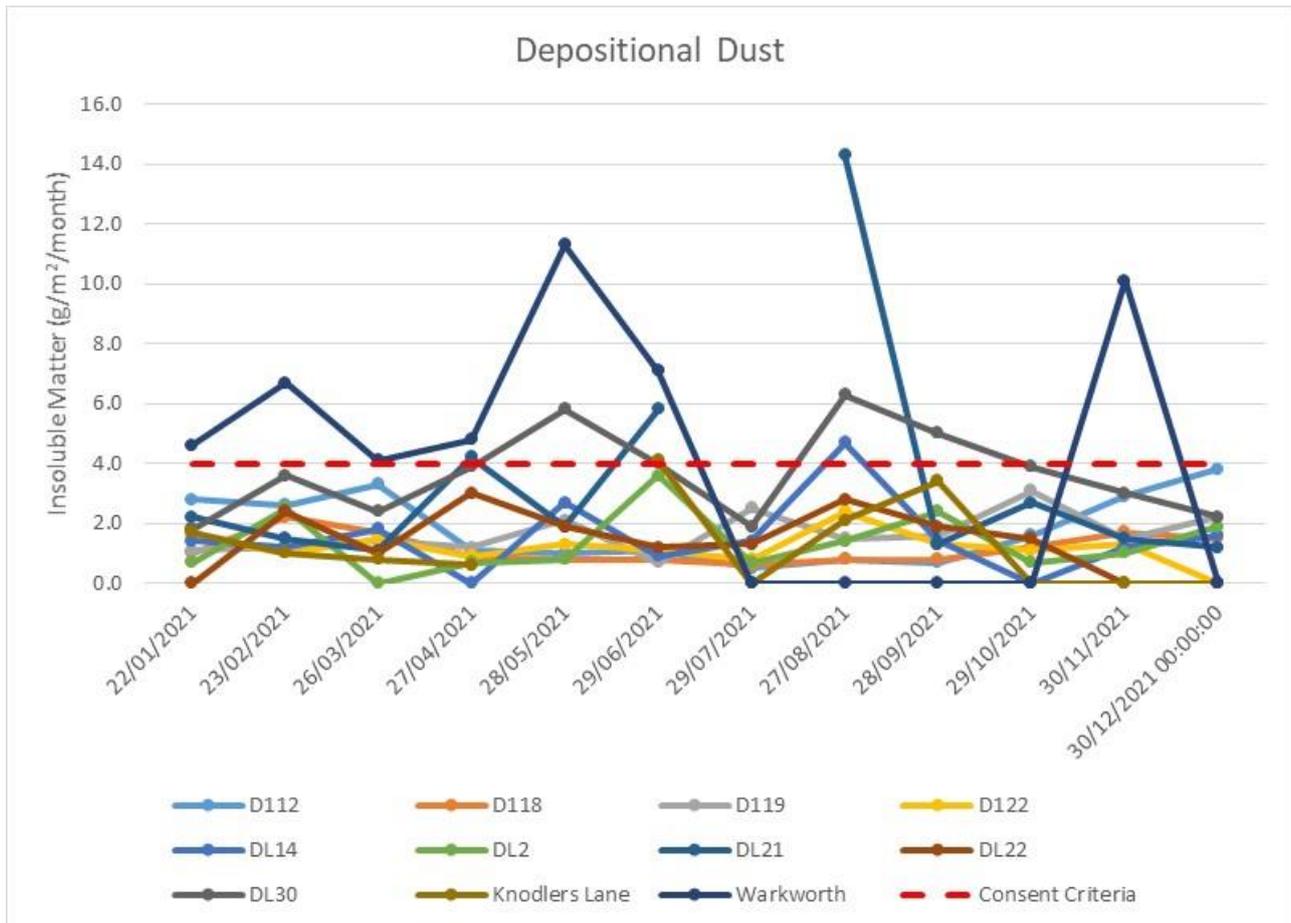
Figure 5 - Depositional Dust Results for the Reporting Period

**Figure 5** displays insoluble solids results from depositional dust gauges during the reporting period compared against the annual impact assessment criteria. Any monthly results deemed to be contaminated (due to presence of bird droppings, insects, etc.) are not displayed. An assessment of HVO’s contribution against the long-term impact assessment criteria will be provided in the 2021 Annual Review.

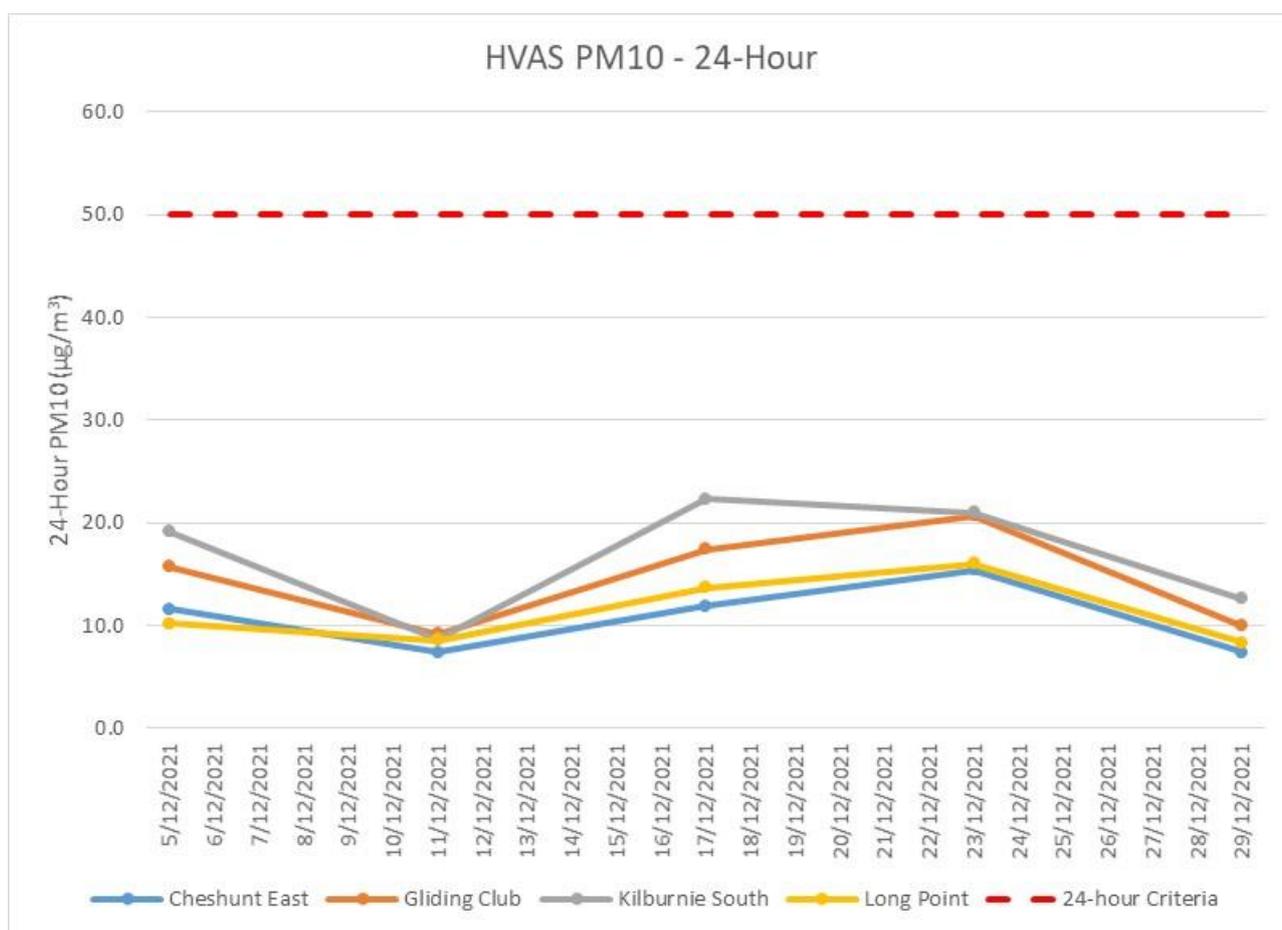
Figure 6 - Individual PM<sub>10</sub> Results for the Reporting Period

Figure 6 shows individual PM<sub>10</sub> results at each monitoring station against the short-term impact assessment criteria of 50µg/m<sup>3</sup>. No exceedances were recorded.

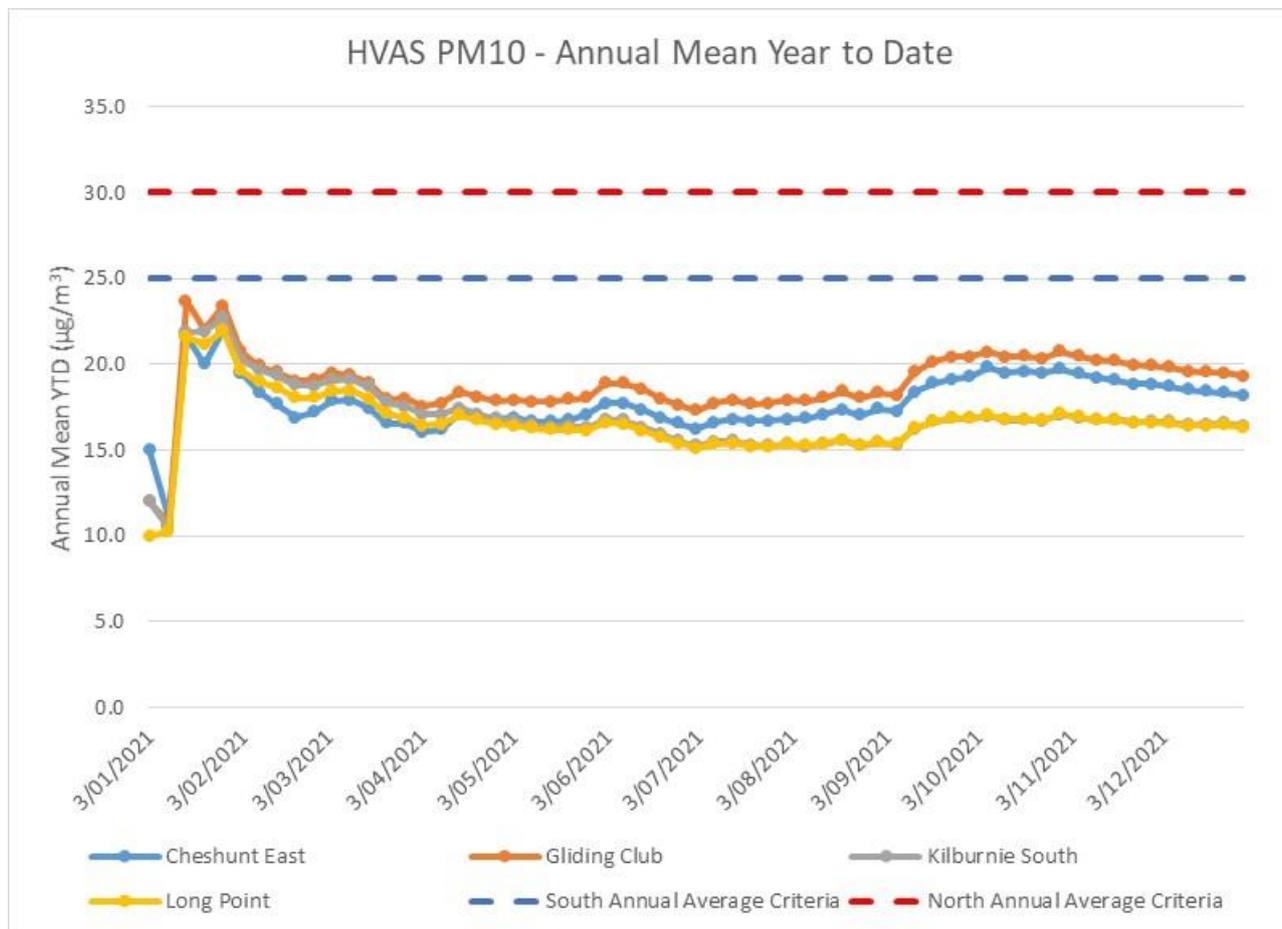
Figure 7 - Year to Date Average PM<sub>10</sub> as at end of the Reporting Period

Figure 7 shows the year to date annual average PM<sub>10</sub> results. All monitors were below the relevant long term impact assessment criteria during the reporting period. An assessment of HVO’s contribution against the long-term impact assessment criteria will be provided in the 2021 Annual Review.

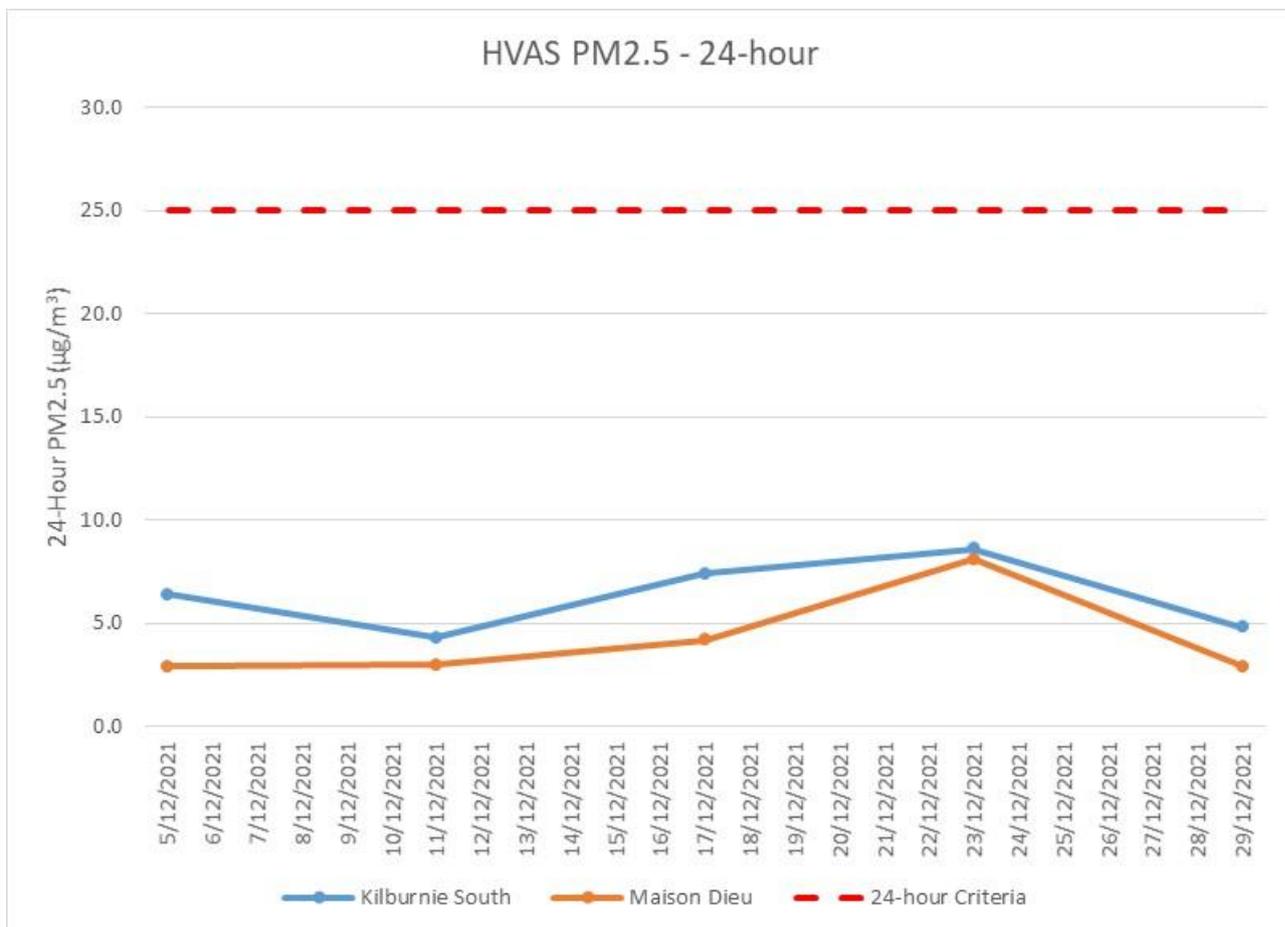
Figure 8 - Individual PM<sub>2.5</sub> Results for the Reporting Period

Figure 8 shows individual PM<sub>2.5</sub> results at each monitoring station against the HVO South short-term impact assessment criteria of 25µg/m<sup>3</sup>. No exceedances were recorded.

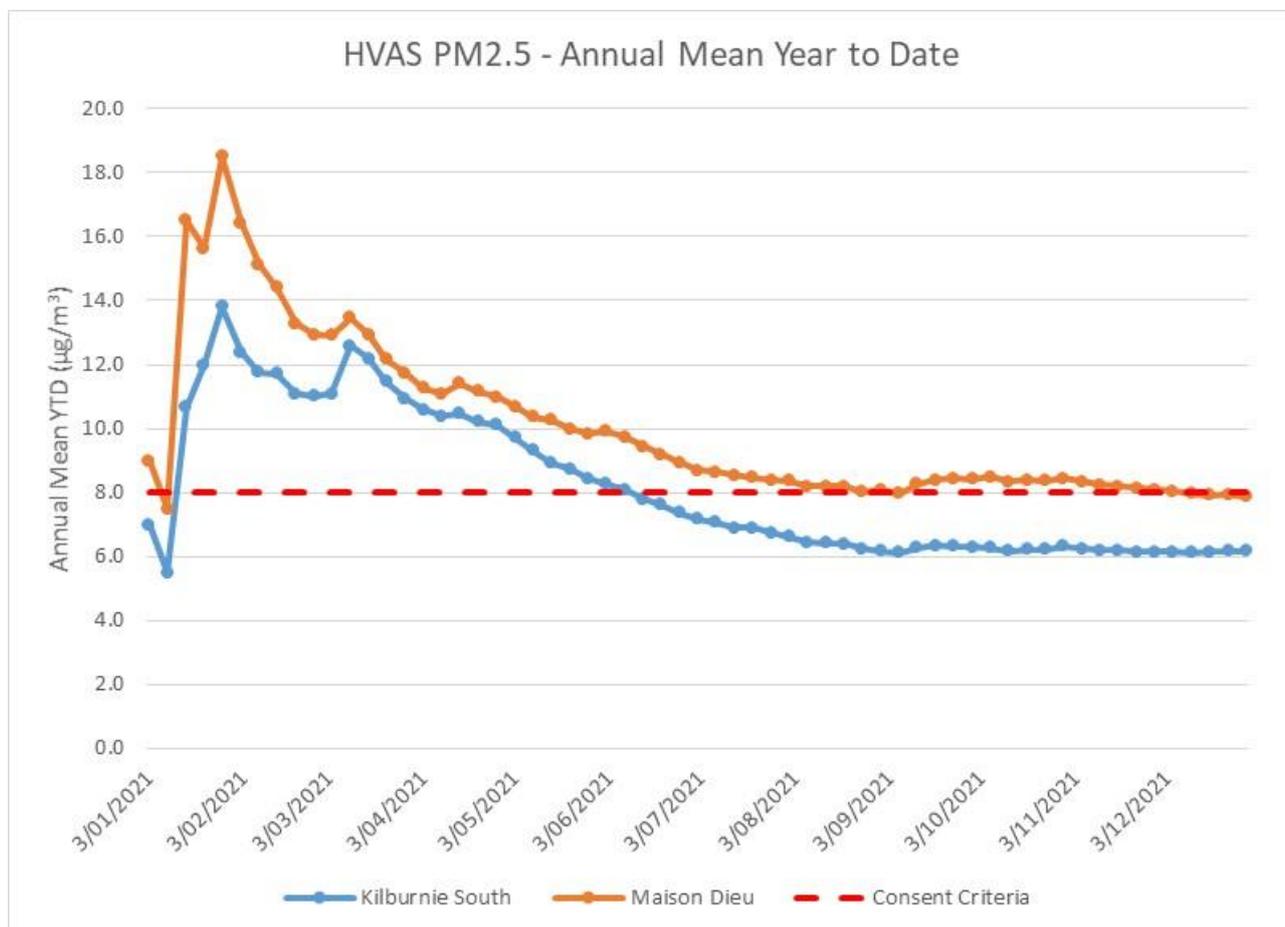
Figure 9 - Year to Date Average PM<sub>2.5</sub> as at end of the Reporting Period

Figure 9 shows the year to date annual average PM<sub>2.5</sub> results. Maison Dieu recorded an annual average exceedance above the PM<sub>2.5</sub> Annual Rolling Mean criteria of 8µg/m<sup>3</sup>.

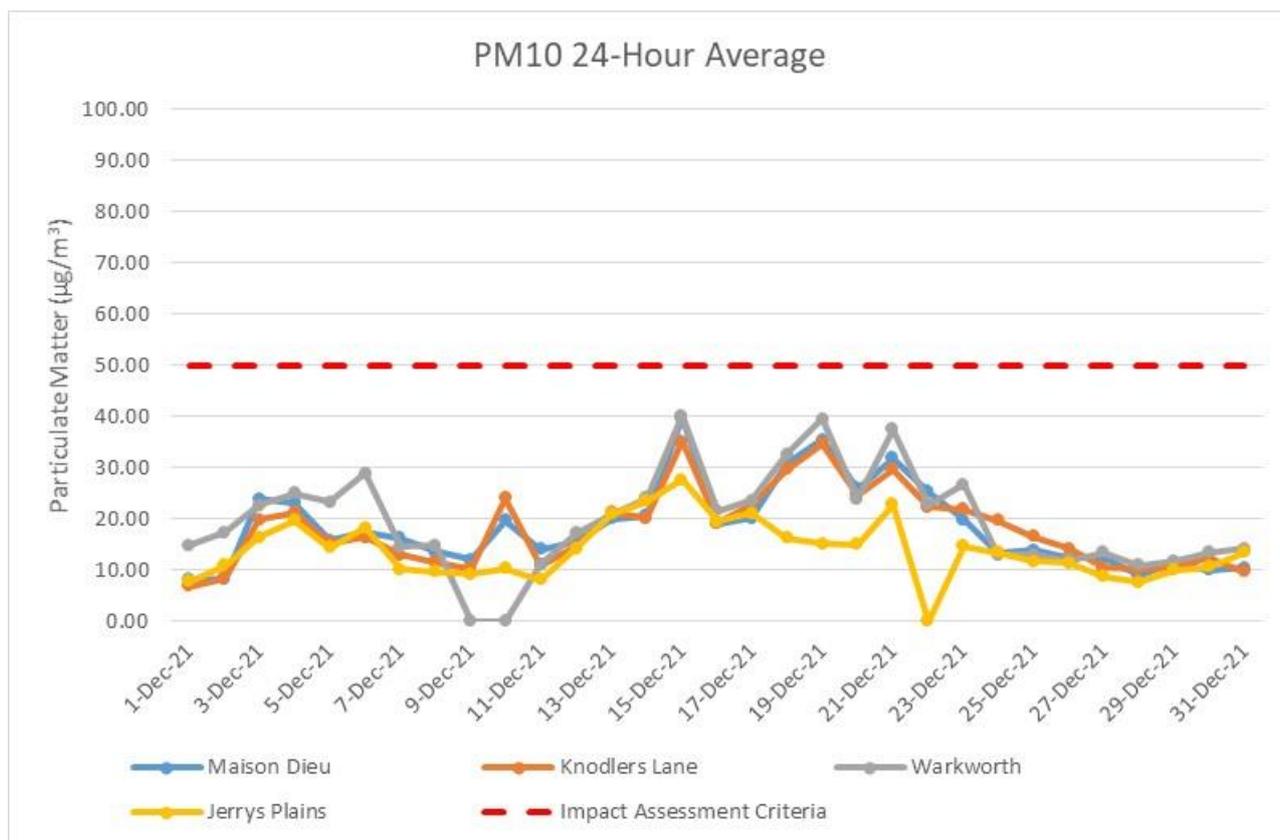
**Figure 11 - Real Time PM<sub>10</sub> 24hr for the Reporting Period**

**Figure 11** shows the daily 24-hour average PM<sub>10</sub> result from the real time monitoring sites which shows no exceedances for the reporting period. The year to date annual averages for each monitoring site are shown in **Figure 12**.

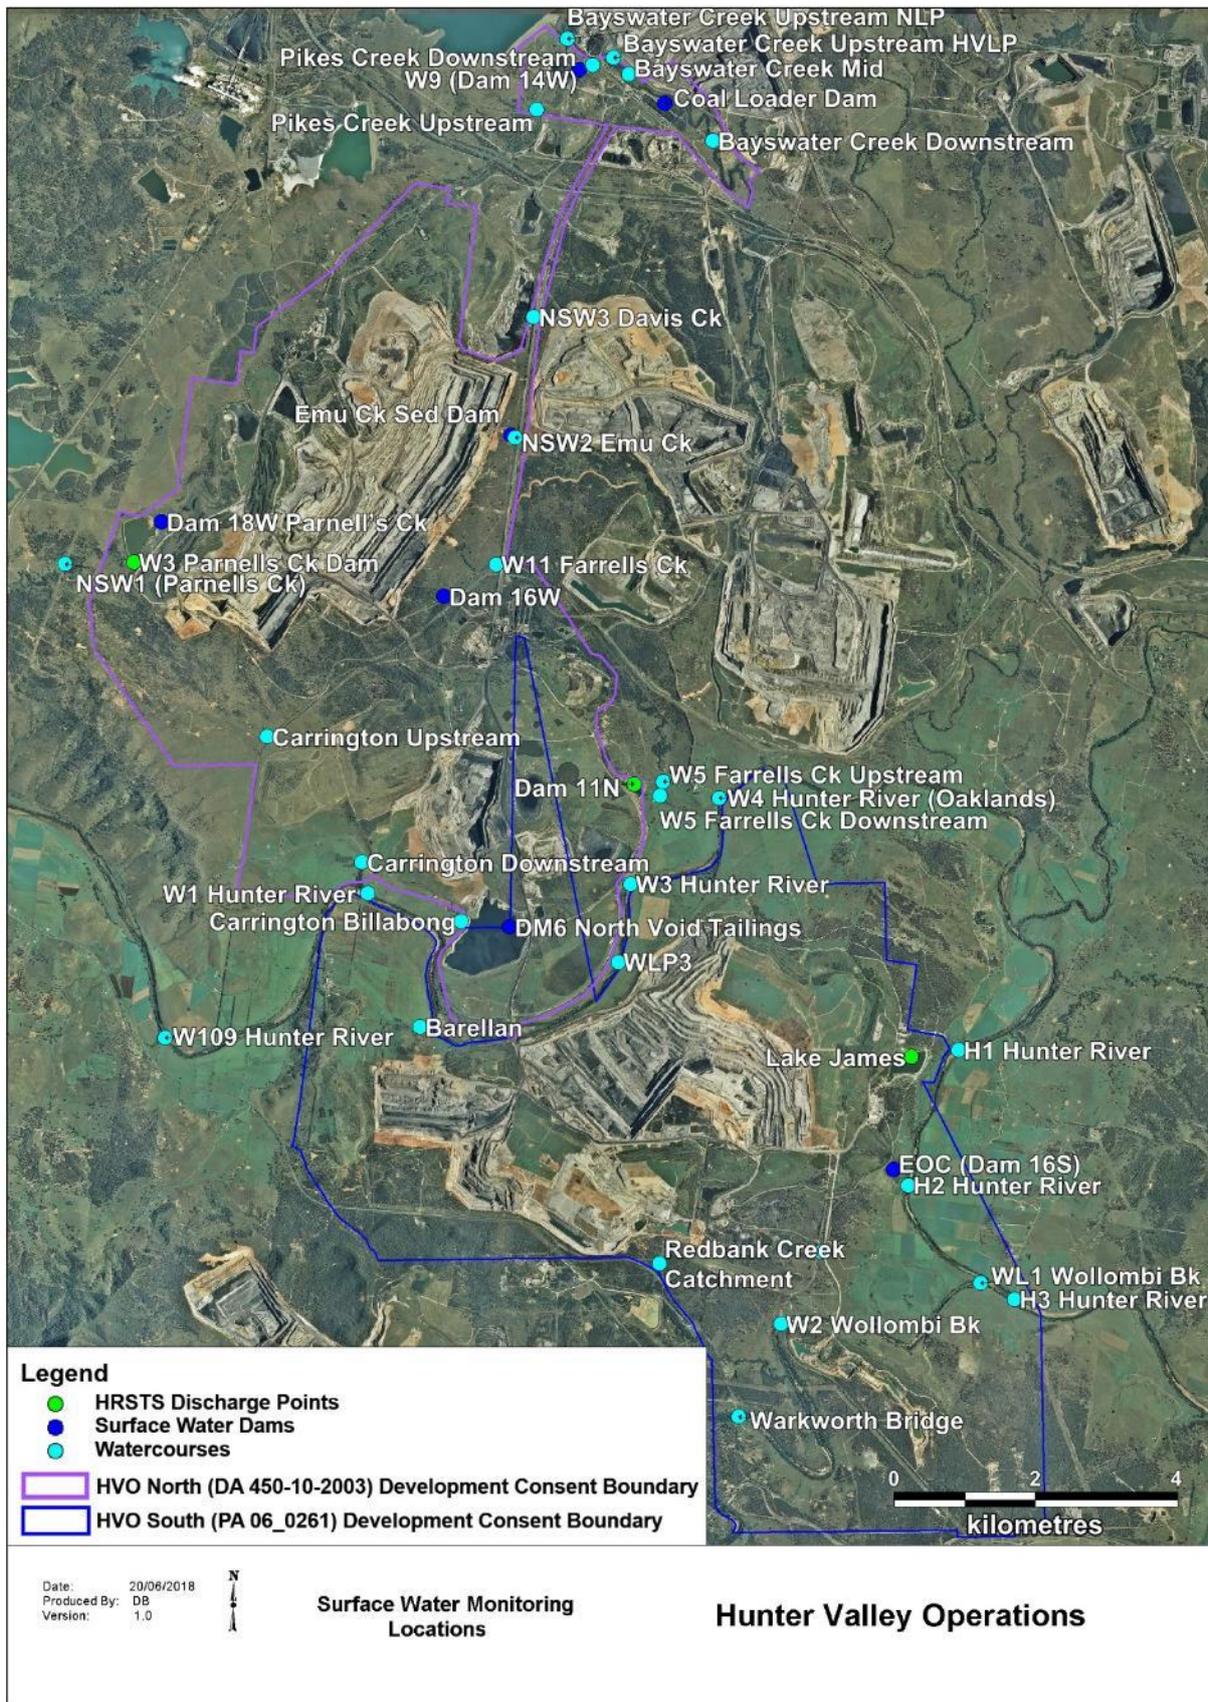
Figure 13 - HVO Surface Water Monitoring Locations

Surface watercourses are sampled on a quarterly sampling regime. Water quality is assessed through the parameters of pH, electrical conductivity (EC) and Total Suspended Solids (TSS). The location of surface water monitoring points across HVO are shown in **Figure 13**.

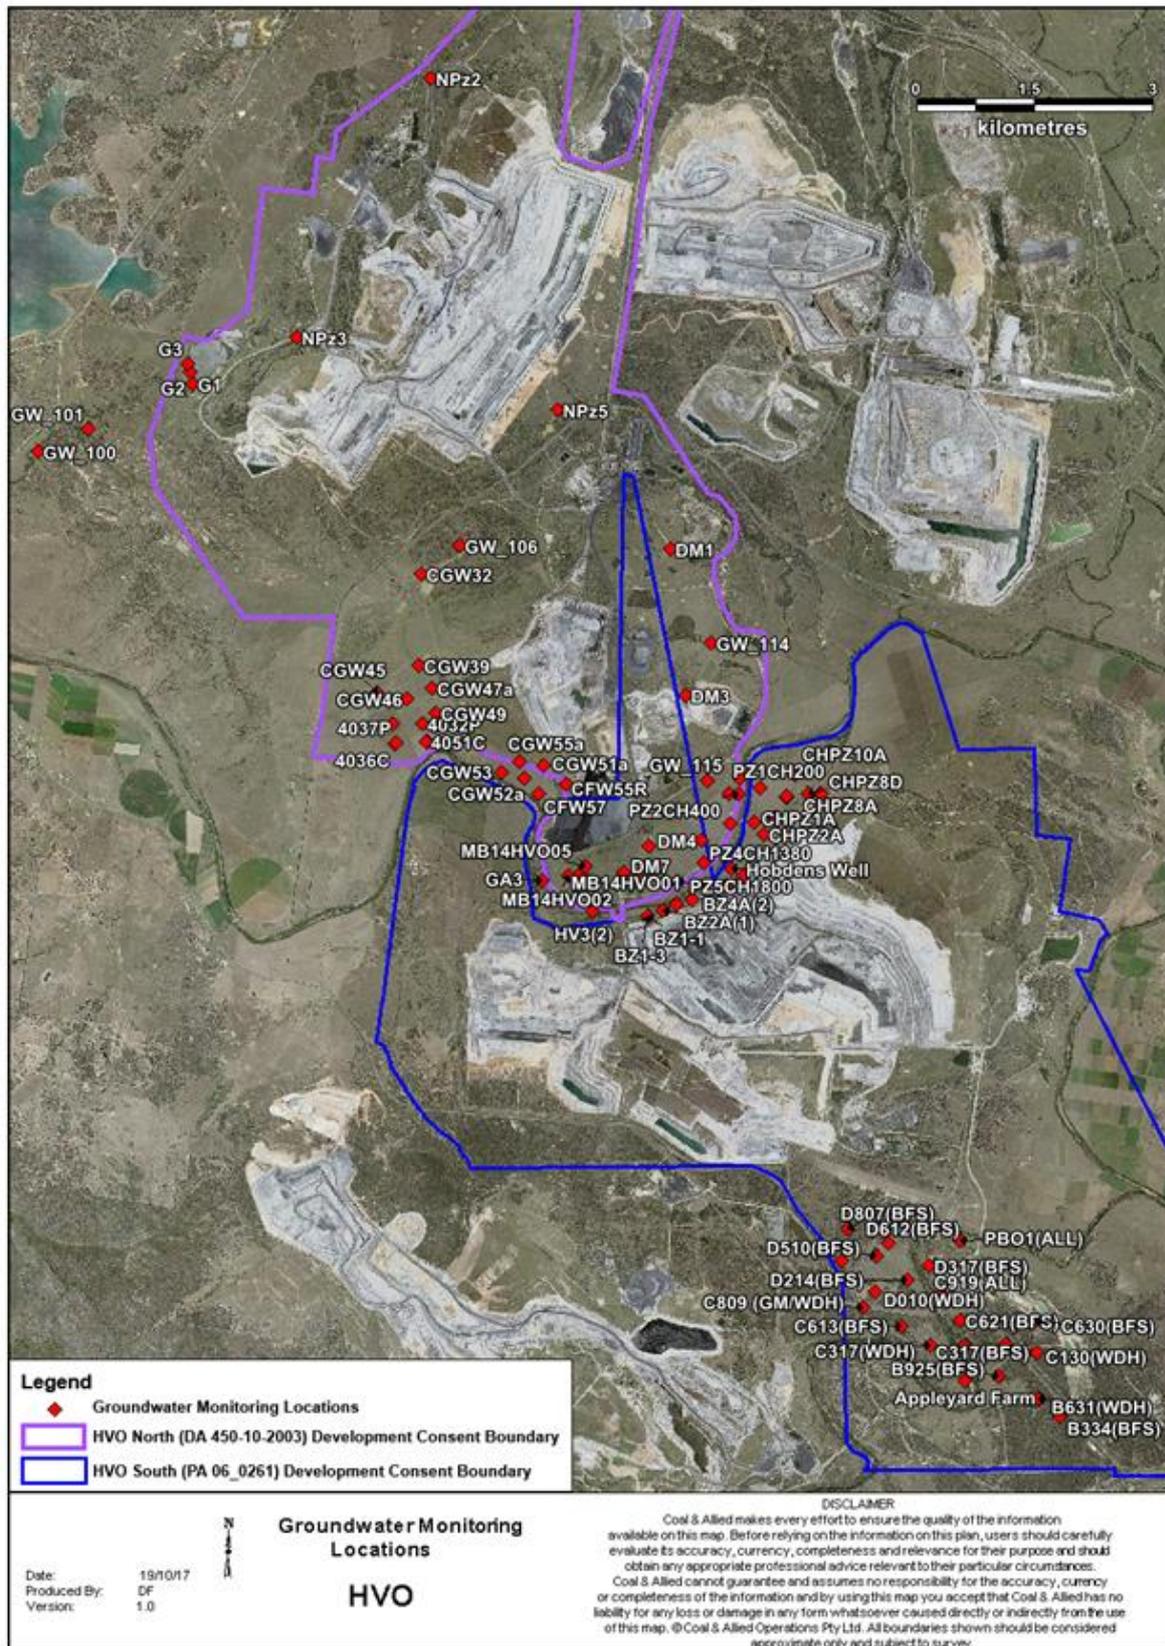
Figure 26 Groundwater monitoring Locations at HVO

Groundwater monitoring is undertaken on a quarterly basis in accordance with the HVO Water Management Plan and Groundwater Monitoring Program. The location of groundwater monitoring points across HVO are show in **Figure 26**.

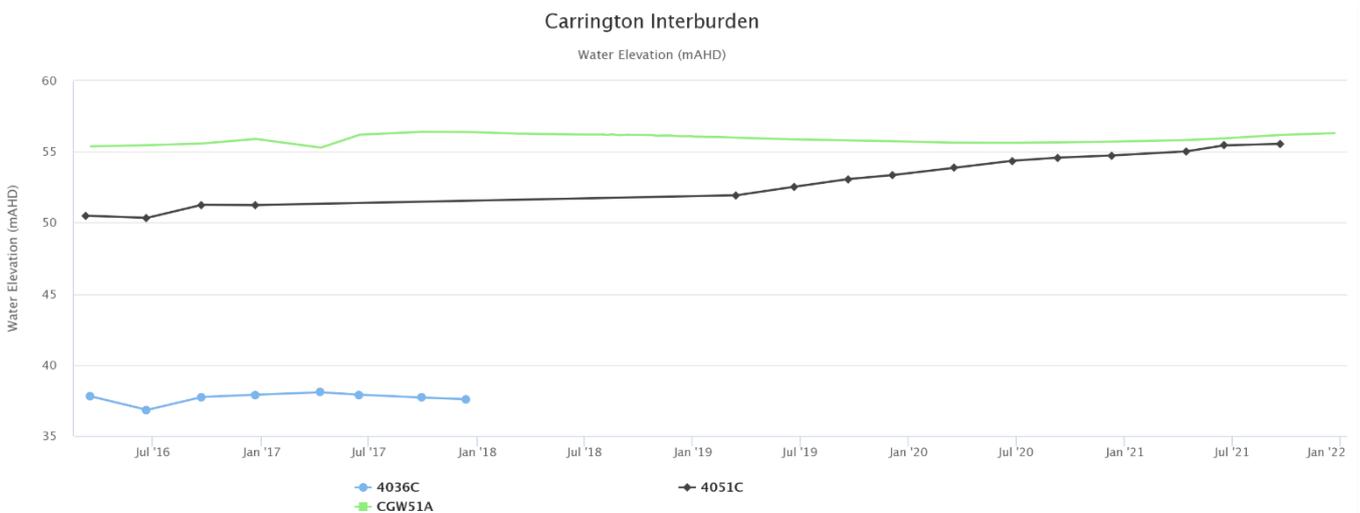
**Figure 32 - Carrington Interburden Water Elevation Trend – Q4 2021**

\* 4036C had insufficient water for sampling

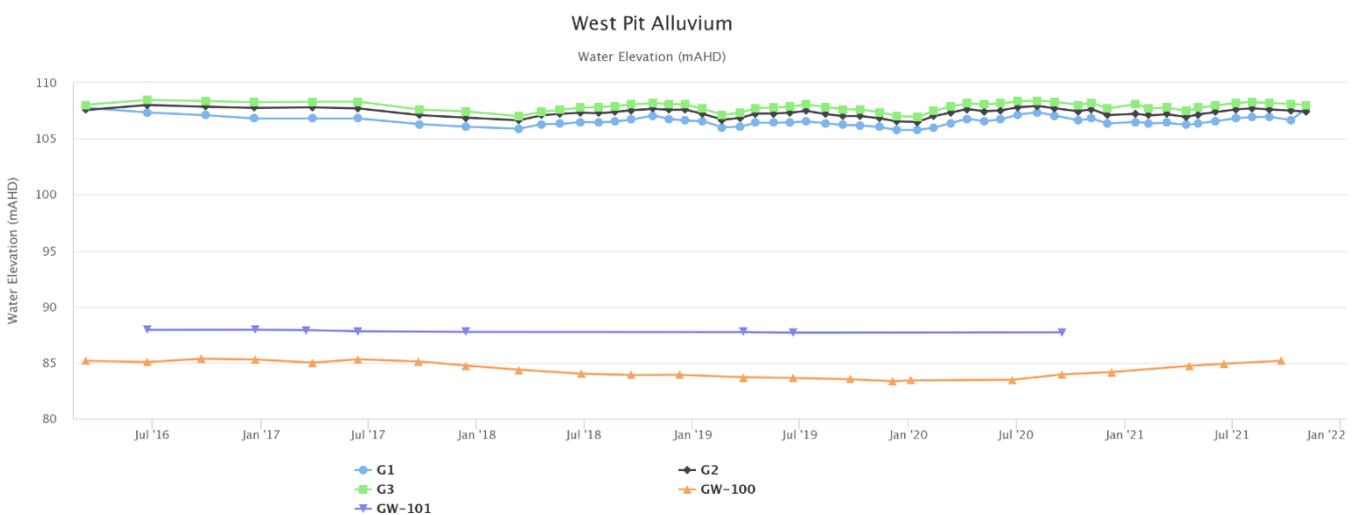
Figure 65 - West Pit Alluvium Water Elevation Trend - Q4 2021

\* GW -101 had insufficient water for sampling

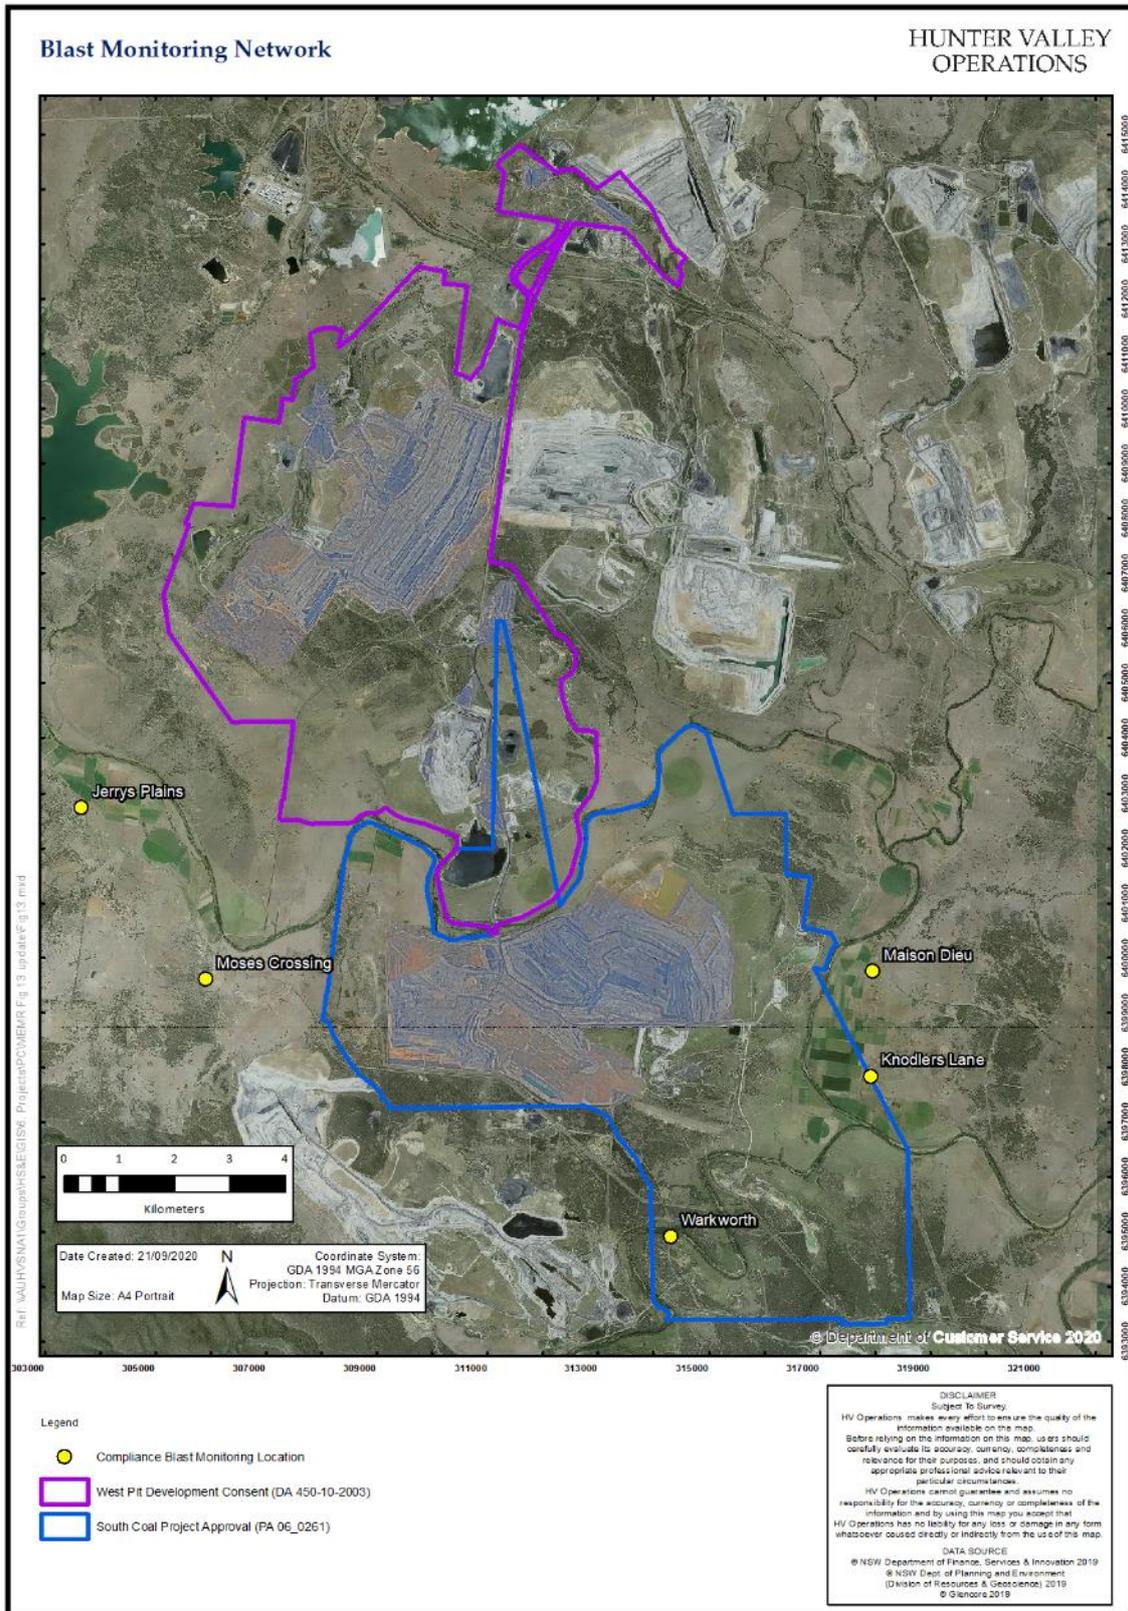
Figure 81 - Blast Monitoring Location Plan

HVO maintains a network of blast monitoring units located at nearby privately owned residences and function as regulatory compliance monitors. The location of these monitors can be found in **Figure 81**. Blasting criteria for HVO are summarised in **Table 4**.

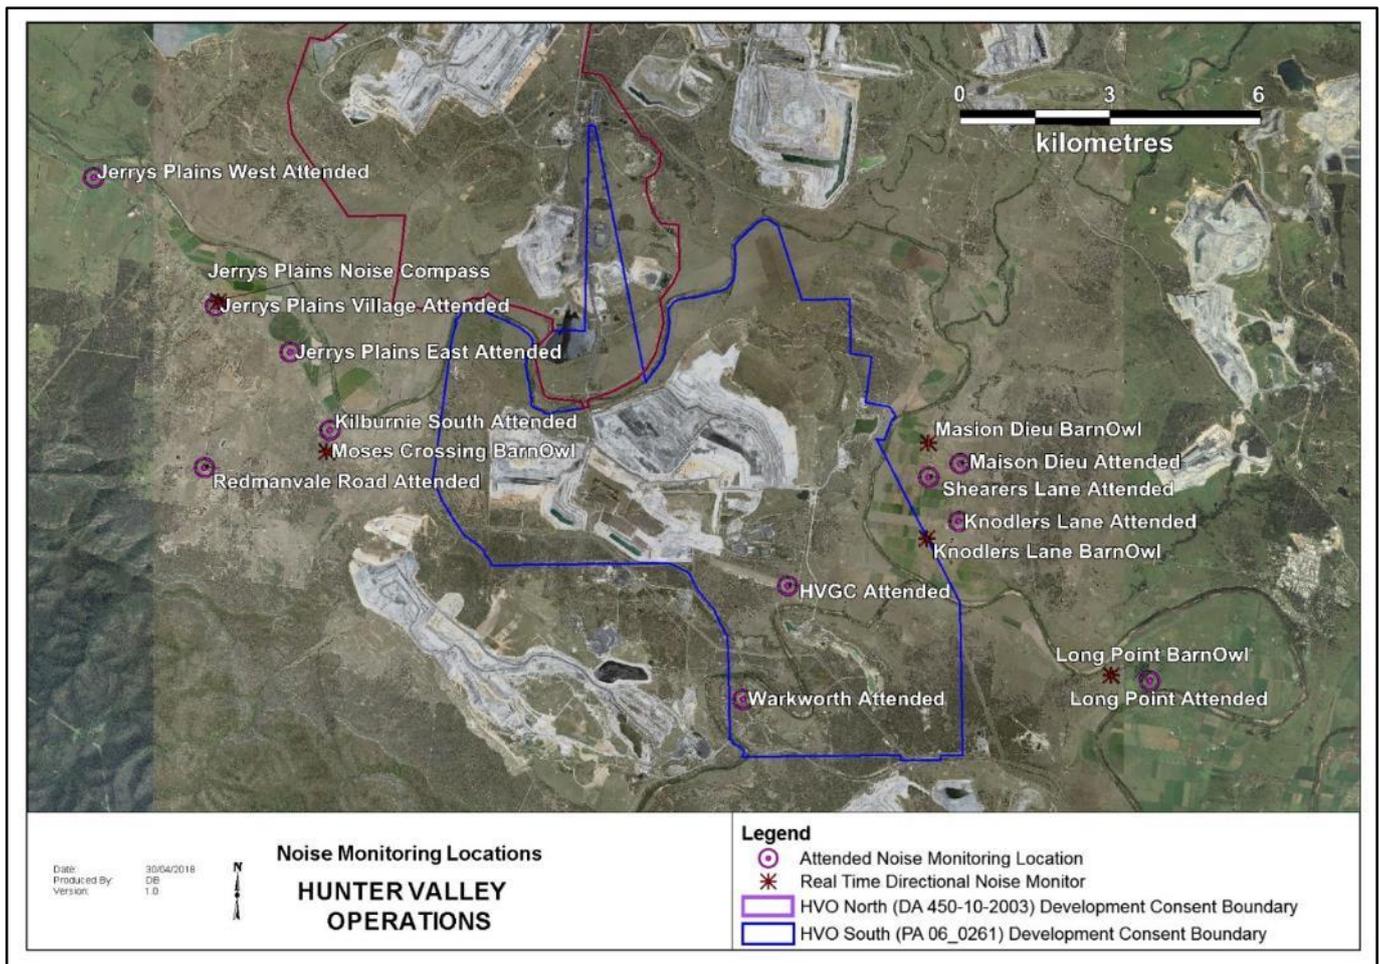
Figure 82 - Noise Monitoring Location Plan

HVO utilises a network of real-time directional noise monitors to manage noise impacts on a continuous basis, shown in **Figure 82**. Noise alarms are in place at five monitoring locations (Knodlers Lane, Maison Dieu, Jerrys Plains, Moses Crossing, and Long Point) which alert HVO staff to elevated noise levels that require investigation.

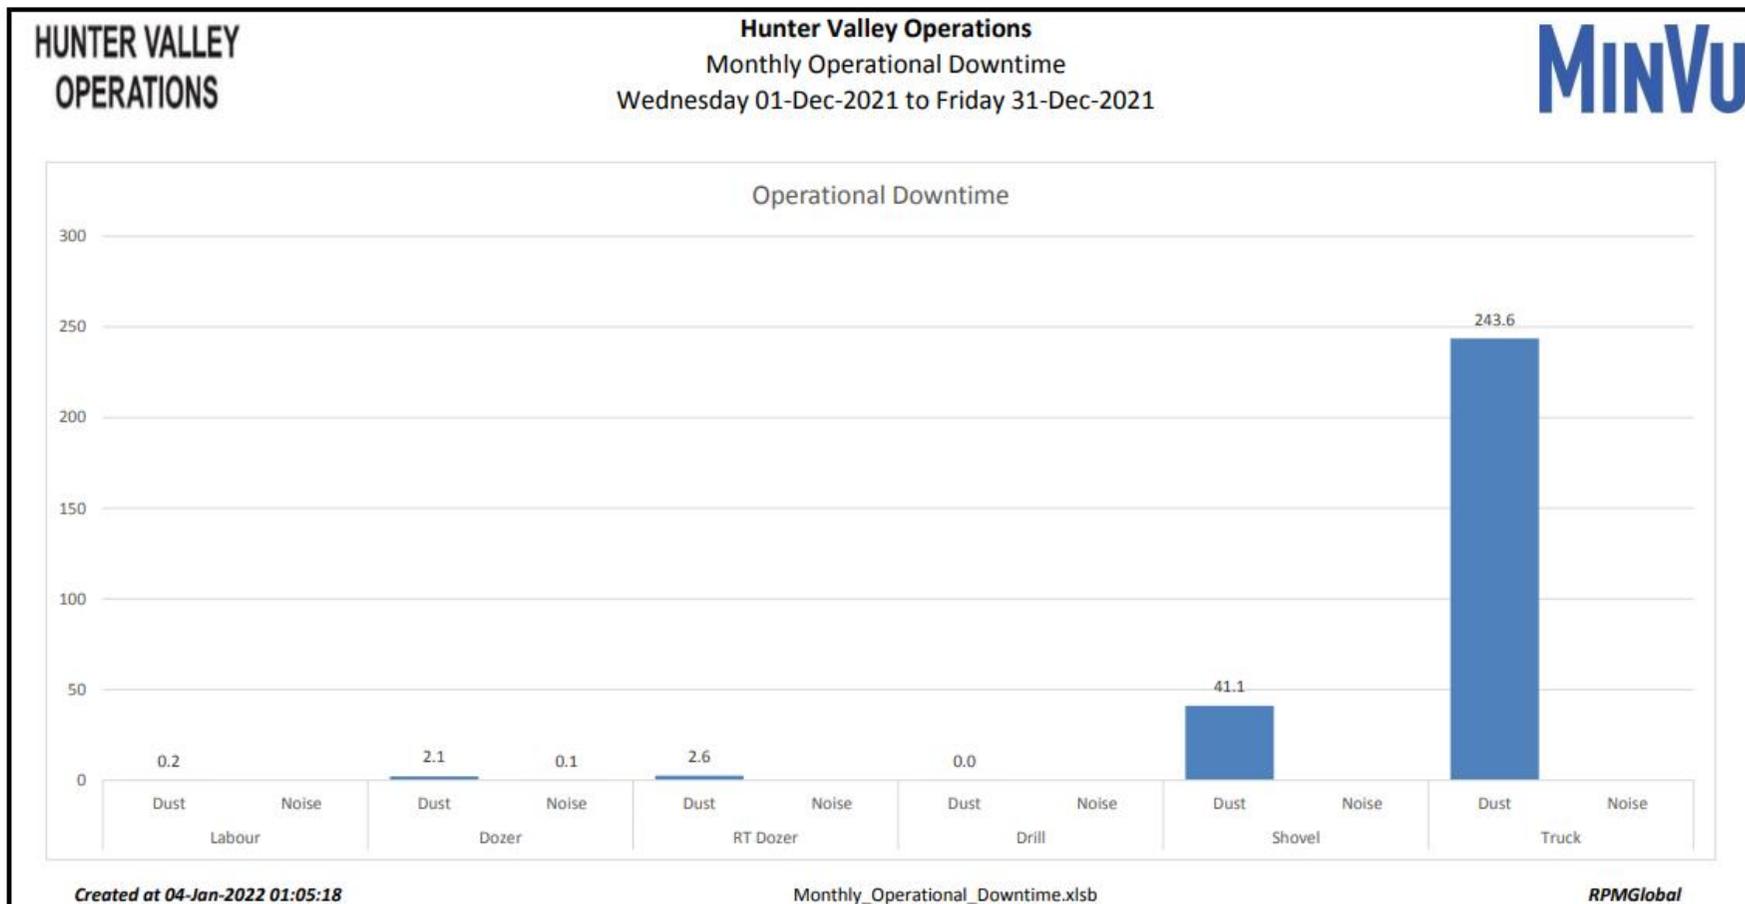
Figure 83 - Operational Downtime by Equipment Type for the reporting period

A total of 289.4 hours of equipment downtime were logged in response to real time monitoring and inspections for environmental factors such as noise and dust during the reporting period. Operational downtime by equipment type is show in **Figure 83**. Note that these delays are instances where operations were completely stopped and does not include occasions where operations were changed/modified but not stopped (e.g. changed from exposed dump to in-pit dump).

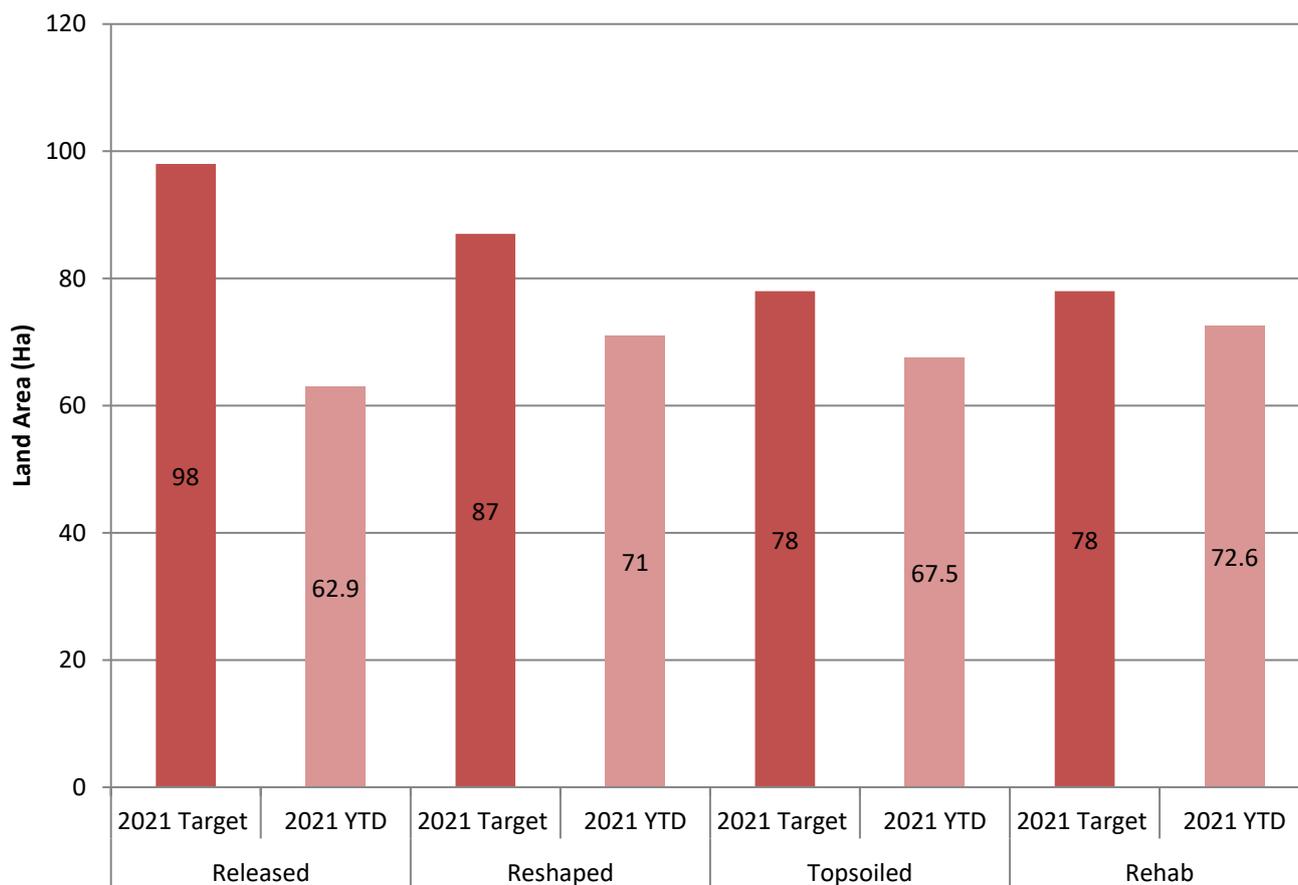
**Figure 84 - Rehabilitation YTD December 2021**

- 1.57 Ha of land was reshaped
- 1.57 Ha of land was released (became available for the application of topsoil)
- 20.56 Ha of land was topsoiled
- 21.97 Ha of land was rehabilitated

Year to date progress is shown in **Figure 84**.
