HUNTER VALLEY OPERATIONS

2019 Annual Environmental Review

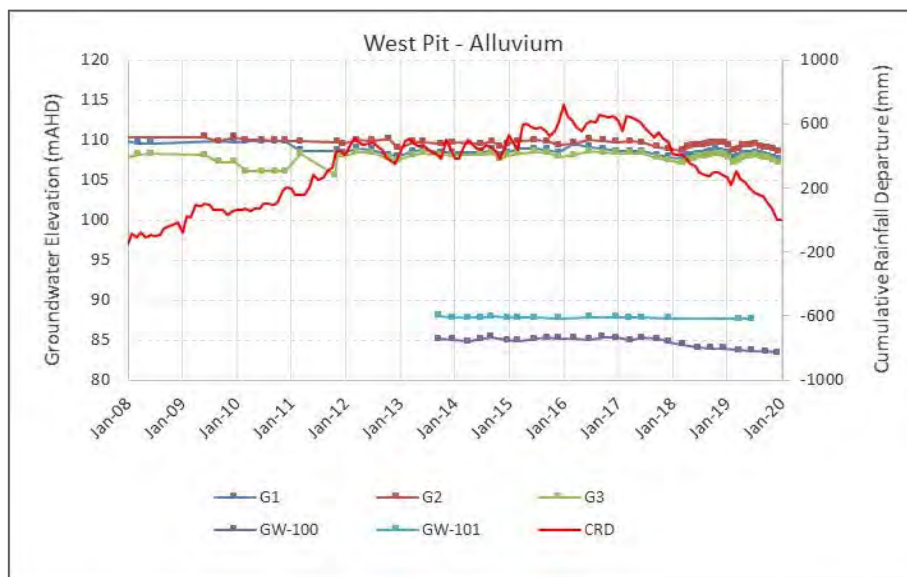
Figure 5-1 Hydrograph of Alluvial Bores – West Pit

Time series groundwater levels for the five alluvial/regolith bores north and north-west of West Pit are presented in Figure 5-1. Over 2019 groundwater elevations within the three bores (G1, G2 and G3) on the south-western side of Parnell’s Creek Dam (18W) ranged between 107.12 mAHD and 109.52 mAHD (2.42 m and 0.46 m depth). Groundwater levels decreased slightly over 2019, consistent with rainfall trends.

Bores GW-100 and GW-101 are located along Parnell’s Creek, downslope of the dam (18W). Comparison between groundwater levels and screened depths indicates the bores are likely dry and readings may relate to water within the sump at the base of the bore. Review of the bore construction log indicates GW-100 extends to 6 m depth and has screen from 4 m to 6 m within gravels (colluvial deposit). Bore GW-101 extends to 12 m depth and has a screen from 9 m to 12 m depth within clay. Groundwater levels within bore GW-100 show a general decline since 2017 from 4.2 m below top of casing (TOC) to 6.2 m mTOC near the base of the bore. This decline in groundwater levels appears to correspond with a general declining trend in CRD since 2017 and is likely related to reduced rainfall recharge. Bore GW-101 has recorded groundwater levels over 12 mTOC and noted as dry or having insufficient water to sample since 2013. This may relate to the construction of the bore screen across low permeability clay.

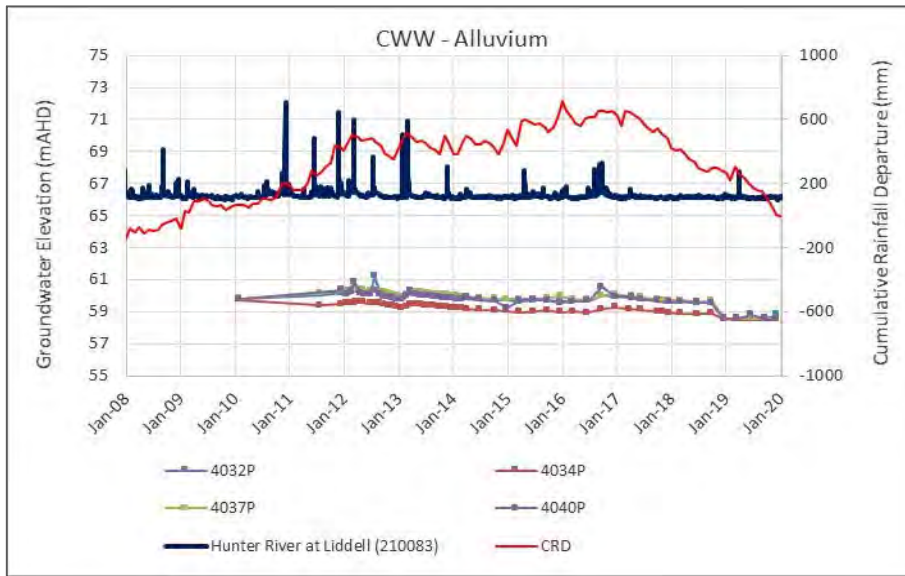
Figure 5-2 Hydrograph of Alluvial Bores – Carrington (Western Limb)

Time series groundwater levels for bores within the alluvium on the western limb of the paleochannel near Carrington and Carrington West Wing are shown in Figure 5-2. Over 2019 groundwater elevations within the four bores (4032P, 4034P, 4037P and 4040P) in this area ranged between 58.79 mAHD and 59.77 mAHD (10.36 m and 12.67 m depth). Groundwater levels declined in three of the bores by 0.02 m up to 0.05 m over 2019, which appears to correlate with climate and stream flow trends. The groundwater level of 4032P increased by 0.28 m over 2019. The cause for this trend is unclear as no other bores recorded this rise and there are no known changes in land use near the bore. The bore is located outside of the mine area on land used for cattle grazing and is located near a small stand of trees. It is recommended that the condition of the bore and local land use be reviewed to determine the cause of the increase.

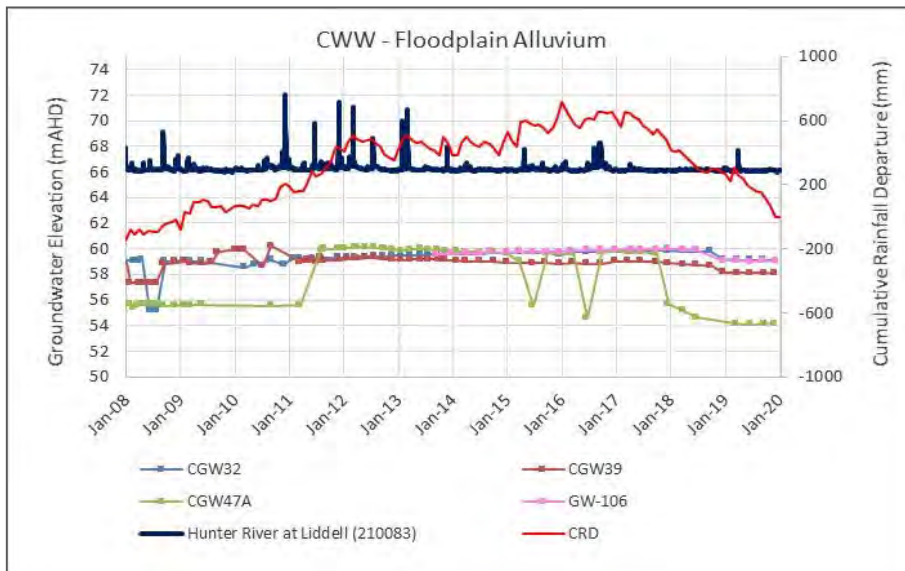
Figure 5-3 Hydrograph of Floodplain Alluvial Bores – Carrington (Western Limb)

Time series groundwater levels for bores within the floodplain alluvium on the northern end of the paleochannel (CGW32 and GW-106) and the two bores on the western limb of the paleochannel (CGW39 and CGW47a) near Carrington and Carrington West Wing are shown in Figure 5-3. Over 2019 groundwater elevations within the four bores in this area ranged between 54.55 mAHD and 59.88 mAHD (12.18 m and 23.30 m depth). However, bore CGW47a was recorded as dry throughout 2019. Groundwater levels declined by 0.05 m within the bores over 2019, which appears to correlate with climate and stream flow trends and may also relate to localised drawdown towards the Carrington Pit final void.

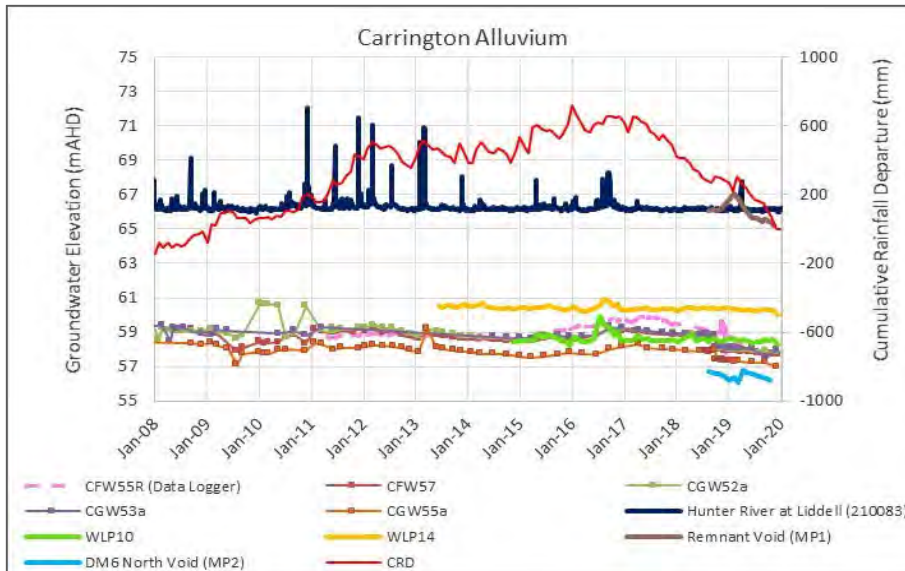
Figure 5-4 Hydrograph of Alluvial Bores – Carrington

Time series groundwater levels for bores within the alluvium on the five bores on the eastern limb of the paleochannel near Carrington and Carrington West Wing are shown in Figure 5-4. The groundwater levels in all five bores, CFW55R, CGW53a, CFW57, CGW55a, and CGW52a, remained relatively stable throughout 2019. Groundwater levels ranged between 57.44 mAHd (13.60 m depth – CGW55a) and 58.63 mAHd (11.65 m depth – CFW55R).

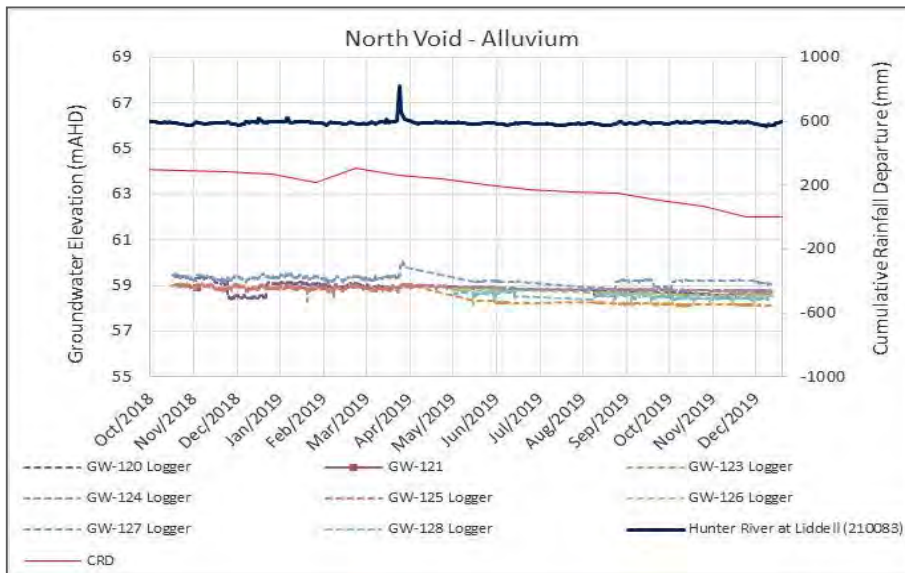
Figure 5-10 Hydrograph of Alluvial Bores – Carrington/North Void

Time series groundwater levels for the newly installed bores within the alluvium along the western edge of the North Void and south of Carrington Pit are shown in Figure 5-10. Monitoring began in the eight bores in October 2018. Over 2019 groundwater elevations within the eight alluvium bores in this area ranged between 58.44 mAHD and 58.91 mAHD (10.21 m and 12.30 m depth). Bore GW-121 was recorded as dry throughout 2019. Groundwater levels declined by 0.04 m to 0.12 within the bores over 2019. The purpose of the monitoring is to ensure no additional seepage into the alluvium at this location. The observed decline in groundwater levels over 2019 indicates a decline in seepage and corresponds with a general trend of below average rainfall.

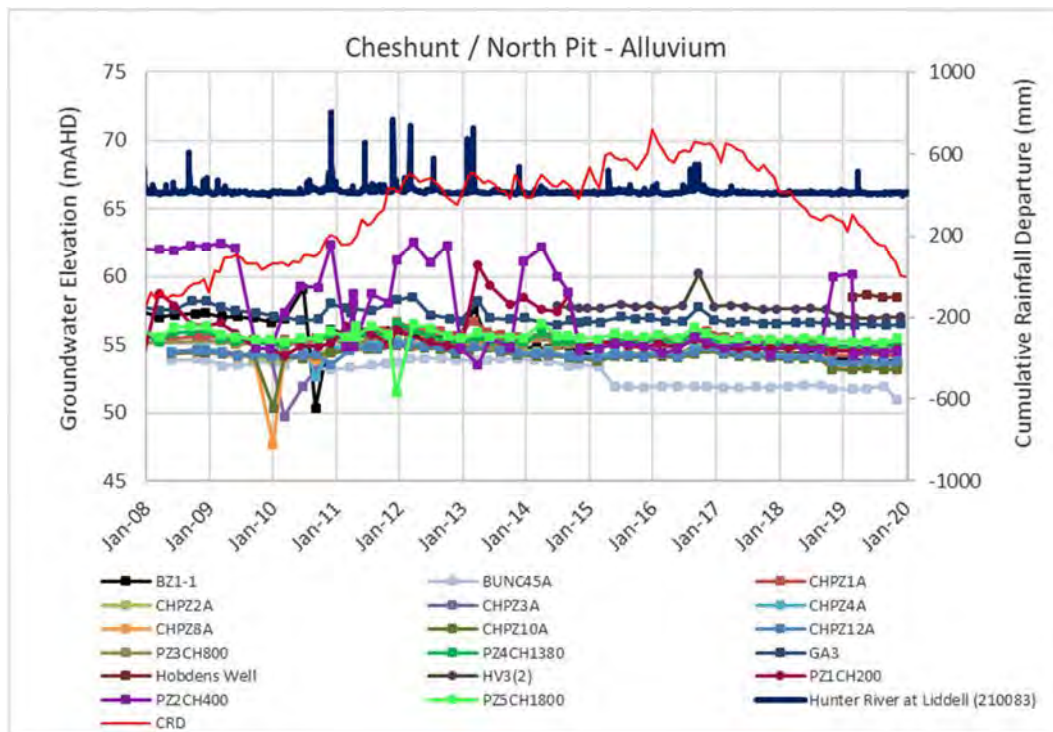
Figure 5-11 Hydrograph of Alluvial Bores – Cheshunt/North Pit

Time series groundwater levels for bores within the alluvium north and south of the Hunter River, between North Pit and Cheshunt Pit are shown in Figure 5-11. Two bores (CHPZ8A and BUNC45A) recorded groundwater levels at or below the base of the screen and are believed to be dry. Bore BZ1-1 was recorded as dry in Q2 and bore CHPZ2A was recorded as blocked in Q2. Where the alluvium is saturated, groundwater levels ranged between 53.94 mAHD and 60.27 mAHD (2.36 m and 17.68 m depth). With the exception of PZ2CH400, groundwater levels generally stable and increased slightly by up to 0.24 m within the alluvial bores over 2019.

Over 2019 groundwater levels in PZ2CH400 ranged from 2.36 m (60.27 mAHD) in Q1 to 8.02 m (54.61 mAHD) in Q4, but remained higher than upstream bore PZ3CH800, by 5.24 m by the end of the year. Bore PZ2CH400 is located immediately east of the North Pit barrier wall and around 180 m east of spoil bore 4119P. Bore 4119P recorded spoil water elevations between 53.56 mAHD and 53.85 mAHD over 2019, lower than alluvial levels at bore PZ2CH400. It was recommended that the bore construction and condition be reviewed in the 2018 Annual Review. It is noted that this is planned to be undertaken during 2020.

It is also noted that bore BZ1-1 is included in the WMP as being within the alluvium, however as identified in prior annual reviews (AGE, 2013a) the bore likely intersects interburden material. It is recommended that this bore be updated in the WMP as intersecting interburden.

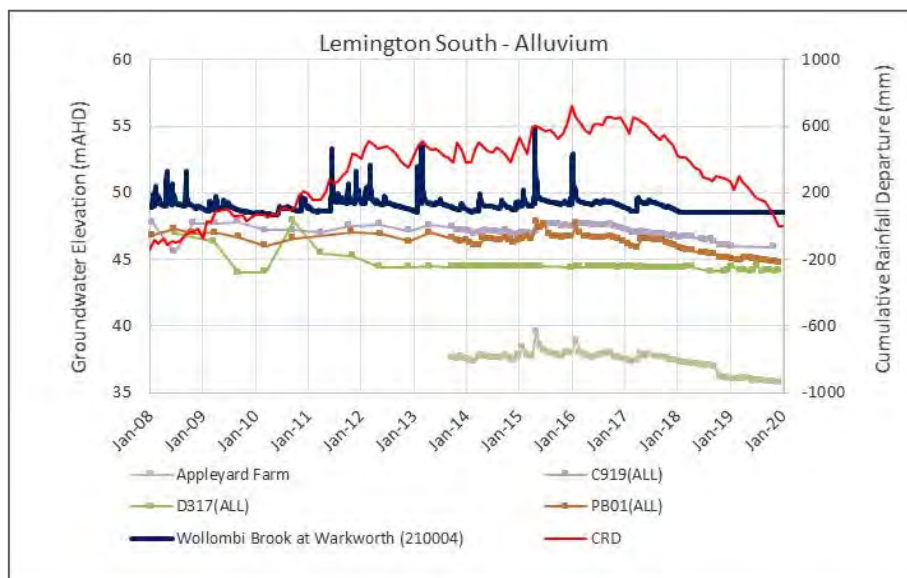
Figure 5-12 Hydrograph of Alluvial Bores – Lemington South

Time series groundwater levels for four bores within the alluvium at Lemington South, along the Wollombi Brook, are shown in Figure 5-12. As shown in Figure 5-12, groundwater levels fairly stable throughout 2019 with the a decline in groundwater levels of 0.36 m recorded within Appleyard Farm bore, which is located over 1.2 km upstream of Lemington South Pit and within 50 m of Wollombi Brook. Stream gauge Wollombi Brook at Warkworth is located approximately 350 m upstream of the bore. The groundwater level trends show a close correlation with declining stream flow levels and discharge for Wollombi Brook, with no discharge recorded since 2017.

Bore PB01(ALL) is located approximately 150 m from Wollombi Brook and shows a more muted response to stream flow with a decline in groundwater levels of 0.26 m. Bore C919(ALL) was recorded as dry in Q2, Q3 and Q4 of 2019. Bore D317(ALL) is located adjacent to the Lemington South Pit, approximately 190 m from Wollombi Brook.

Over 2019 groundwater elevations within the alluvial bores Appleyard Farm and PB01(ALL) ranged between 36.48 mAHD and 45.35 mAHD. Groundwater levels remained fairly stable over 2019, but showed a decline of up to 0.36 m in line with stream flow and rainfall.

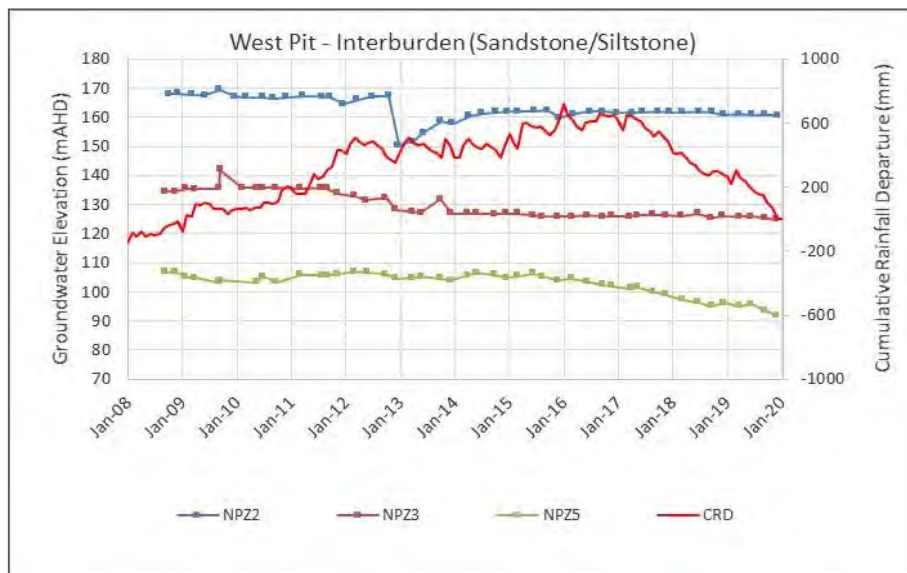
Figure 5-13 Hydrograph of Permian Coal Measures Bores – West Pit Bores

Groundwater elevations for the bores at West Pit are presented in Figure 5-13. Over 2019 groundwater levels within bore NPz2 declined by 0.48 m over 2019, while bore NPz3 groundwater levels declined 0.91 m over 2019. These two bores are located upslope, on the northwest side of West Pit. The cause for the groundwater trends at NPz2 and NPz3 is unclear and would require further information regarding historical land use activities in the region. However, based on available information, the cause for the changes in groundwater levels do not appear to correlate to mine activities conducted at West Pit. As part of a network review it was recommended that NPz2 and NPz3 be removed from the compliance network within the WMP, as the location and construction of the bores precludes them from providing an indication of potential impacts. However, it is recommended these bores remain in the monitoring program to assist with future assessments and assessment of post closure groundwater conditions.

Bore NPz5 is located down-slope (south) of the West Pit highwall and recorded a 3.28 m decline in groundwater levels over 2019. This decline is likely a response to mining at West Pit, and consistent with groundwater drawdown predictions for the approved operations (see Section 2.2). With the removal of bores NPz4 and NPz5, ongoing monitoring of groundwater trends in the coal measures can be captured at VWP GW-103 to GW-105.

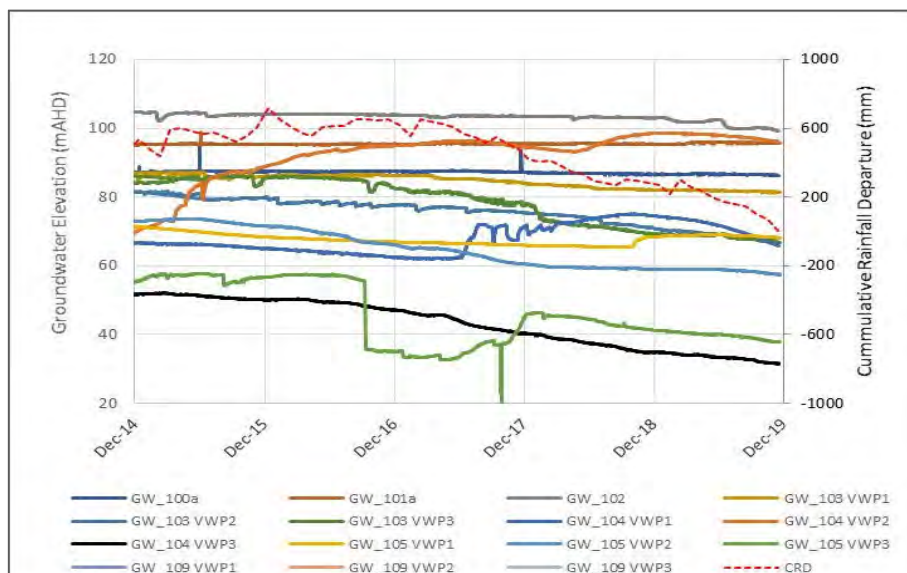
Figure 5-14 Hydrograph of Permian Coal Measures Bores – West Pit VWPs

Eight vibrating wire piezometers (VWPs) were installed in the West Pit area (GW-100a, GW-101a, GW-102, GW-103, GW-104, GW-105, GW-109, and GW-110) in 2012, intersecting the Permian coal measures. Bores GW-103, GW-104 and GW-105 are located to the south of West Pit. Bore GW-109 is located to the west of Carrington Pit, and bore GW-110 is located north of Carrington Pit. Groundwater level trends for the VWPs are presented in Figure 5-14. Review of the data identified that some sensors have previously failed, including VWP1 (interburden) in GW-101a and VWP3 (coal seam) in GW-109. The units these sensors monitor are also monitored by nearby bores/VWPs. It is recommended that these sensors be removed from the revised WMP. In addition, calibration details for GW-110 were not available at the time of reporting, therefore data could not be converted and graphed. However, VWP GW-110 is located near the highwall within Carrington Pit void and may be decommissioned. Ongoing monitoring of groundwater level recovery in spoil material near Carrington Pit void can continue to be conducted at bores GW-107 and GW-108.

VWP GW-103, VWP GW-104 and VWP GW-105 are located south of West Pit. GW-103 recorded relatively stable levels, while GW-105 shows a gradual decline in levels over time. GW-104 VWP1 (Lower Pikes Gully Seam), VWP2 (interburden material) and VWP3 (in sandstone above the Barrett Seam) all declined over time due to depressurisation from coal mining at West Pit.

VWP GW-109 is located within the west of the Carrington Pit and the sensor within weathered coal (GW-109 VWP1) recorded a slight rise in water levels over 2019, while the deeper sensor within tuffaceous coal (GW-109 VWP2) recorded a relatively stable groundwater levels at a lower elevation. The difference in the two sensors may relate to instrument drift or an additional source of recharge to the shallow stratigraphy. The area generally experienced below average rainfall and no water storage is known of at the site or upgradient of the VWP. Groundwater levels within the spoil in Carrington Pit 1.3 km to the north are also lower at around 24 mAHD (GW-109) and predicted to remain low due to the presence of the Carrington Pit void (AGE, 2016). It is recommended that local site conditions and the condition of the VWP GW-109 be reviewed, and groundwater conditions within the spoil in Carrington Pit continue to be monitored.

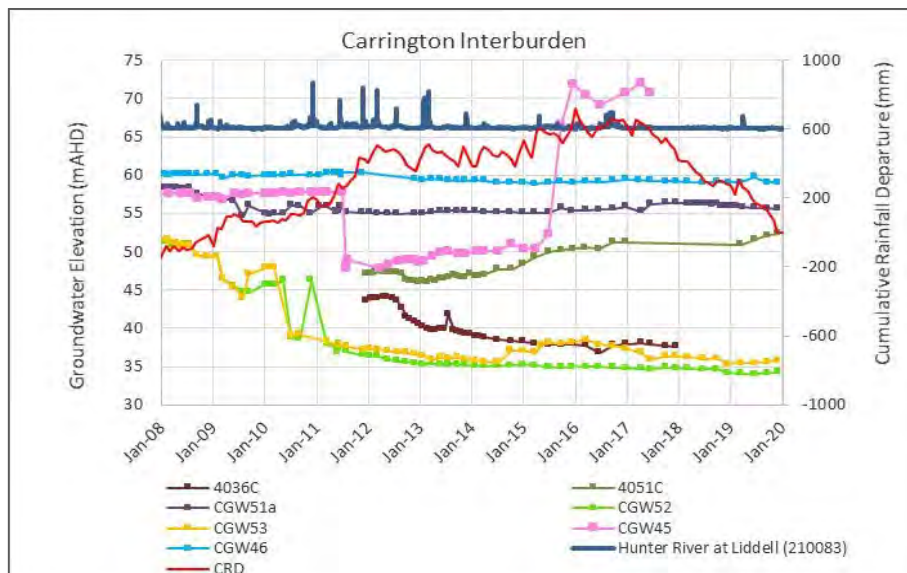
Figure 5-15 Hydrograph of Permian Coal Measures Bores – Carrington

The WMP includes seven monitoring bores with screens that intersect the Permian coal measures at Carrington and Carrington West Wing. This includes two bores within the Bayswater Seam (CGW45 and CGW46), two within the Broonie Seam (CGW52, CGW53) and three within the interburden material (4036C, 4051C and CGW51a). One of the bores (CGW45) were reported as blocked in 2019, and one was recorded as dry (4036C). Time series groundwater elevations for the seven bores are presented in Figure 5-15.

Review of available bore details indicates bore CGW51a is actually screened within alluvium comprising fine to medium grained gravel and sand immediately overlying coal. As a result, groundwater within the bore is representative of alluvial groundwater and groundwater within the weathered coal measures. Over 2019 the bore recorded a general decline in groundwater levels following climate trends. Due to the construction of the bore, it is recommended that it be decommissioned to minimise potential mixing and groundwater levels within the backfilled Carrington Pit be monitored to ensure the void continues to act as a groundwater sink. It is recommended that a new bore be installed within the spoil material to replace CGW51a.

Bore 4051C is located in the western limb of the paleochannel, screened within interburden. Groundwater levels in bore 4051C increased by 1.42 m over 2019. Nearby, bore 4040P, screened in alluvium, remained stable over 2019. Previous records indicated an obstruction within bore 4051C, it is recommended that the total depth of the bore be checked and a downhole camera survey conducted to verify if 4051C is providing representative groundwater data.

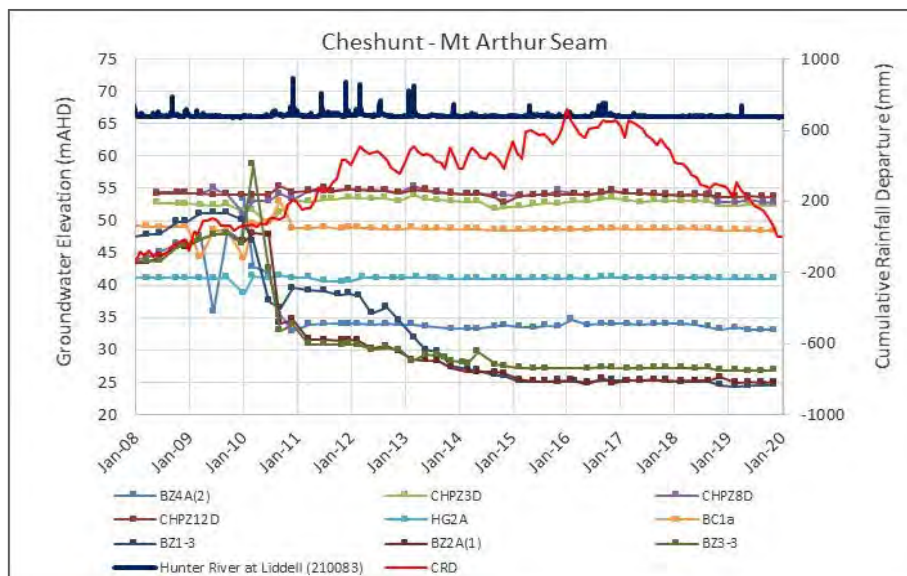
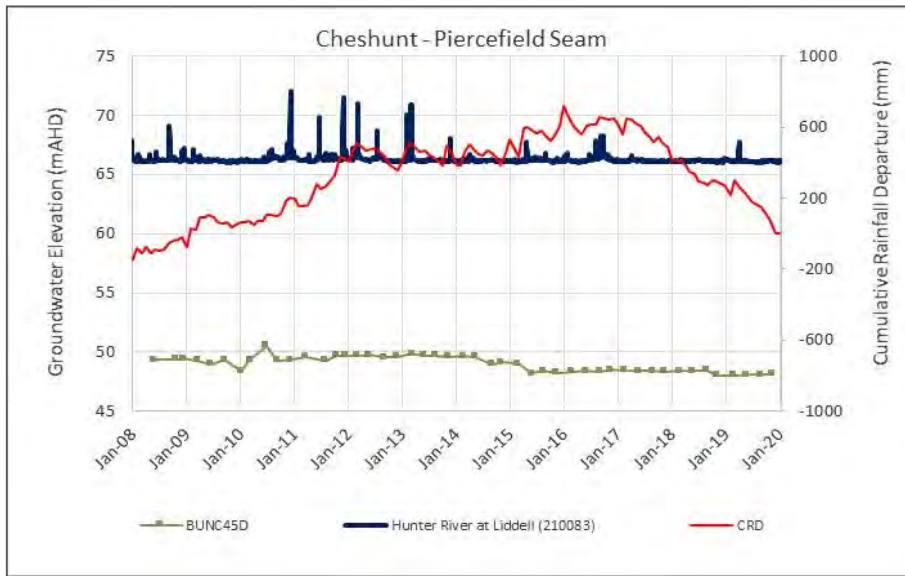
Time series groundwater elevations for the bores are presented in Figure 5-16 to Figure 5-18. Sustained groundwater level drawdown in response to the approved mining is visible within two of the bores intersecting the Mt Arthur seam (BZ1-3 and BZ4A(2)). Bores BZ2A(1), BZ3-3, which also intersect the Mt Arthur seam, had stable groundwater level trends over 2019. Bore BC1a also intersects the Mt Arthur Seam and showed drawdown from 2011 to 2014 (48.78 mAHD), followed by a gradual recovery in groundwater levels (49.08 mAHD) in 2017. A decline was recorded in November 2018 of 0.3m (48.78 mAHD). Over 2019 groundwater levels in BC1a remained fairly stable with a groundwater elevation of 48.75 mAHD in Q4. The adjacent Mt Arthur Seam bore HG2a shows relatively stable groundwater elevations of around 41.15 mAHD since 2012. Due to the proximity of BC1a and HG2a it is recommended that the bore construction and condition is reviewed to understand the difference in groundwater elevations between the two bores.

Groundwater levels in bore BZ3-1, which intersects the Cheshunt Interburden, declined 0.83 m over 2019. The remaining Mt Arthur seam bores (CHPZ3D, CHPZ8D and CHPZ12D) and Piercefield seam bore (BUNC45D) are located over 1 km north-east of Cheshunt Pit, north of the rehabilitated Barry's Pit. All four bores show relatively stable groundwater levels over 2019.

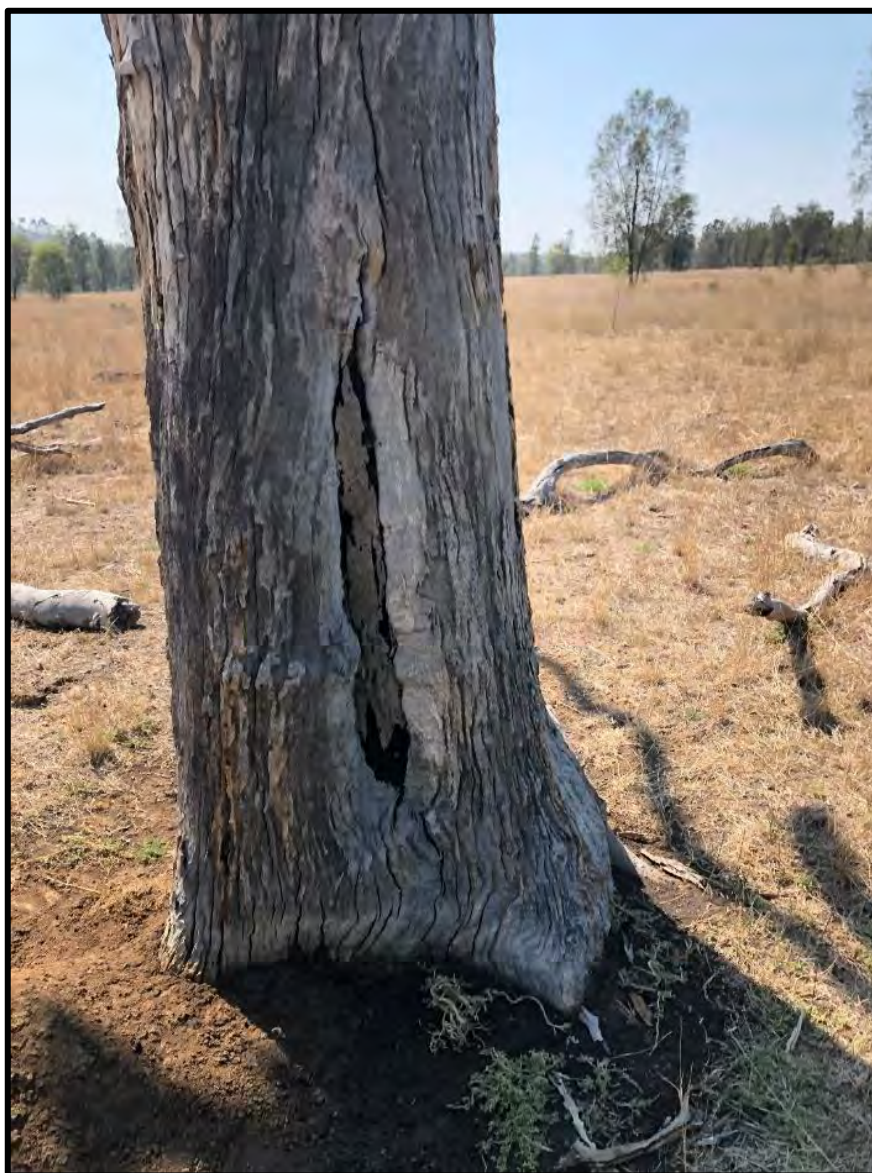
Sites: HVO-930

Although HVO-930 has been registered within both the HVO Aboriginal sites and the AHIMS databases as a culturally scarred tree, several members of the field team questioned this appraisal and contended that it should be deregistered as a valid site. Although not an unprecedented action for such sites in NSW, HVO may wish to consider engaging, with the CHWG's concurrence, a scarred tree expert to provide a specialist and final assessment prior to the scarred tree removal process commencing. Consideration of all currently registered scarred trees at HVO may be prudent if this course of action is undertaken.

Scarred tree HVO-930

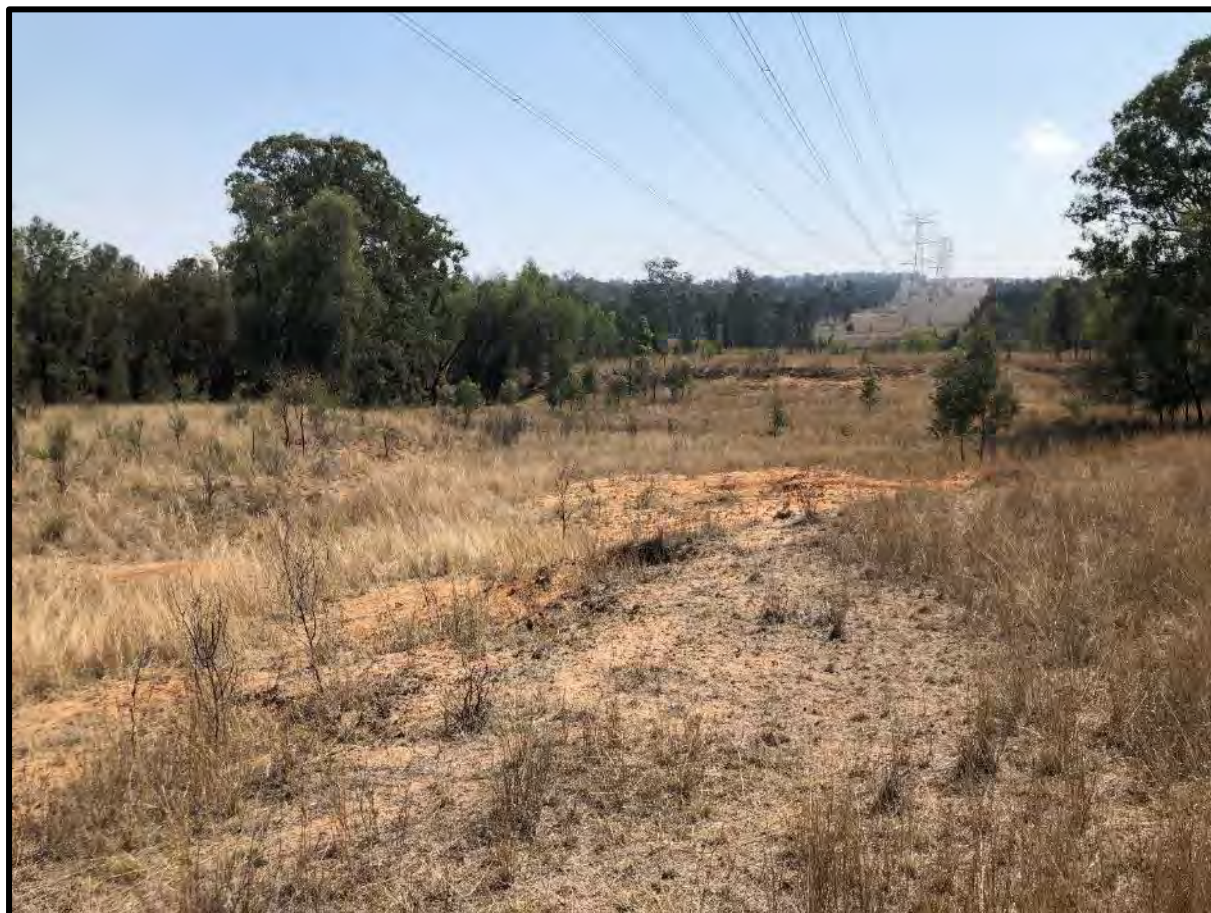
Sites: Ponds Creek (37-2-0190), T/L3/ Plashette (37-2-0562)

Both these sites were re-identified underneath power-lines within easements accessed by power companies. In both situations it is not feasible to erect fencing or barricading under the power-lines. As an alternative to alert power company staff, signage should be erected next to the tracks on all approaches to the sites stating that Aboriginal cultural material is located throughout the area and that vehicles should remain on formed tracks. Direct notification to the power companies could also be made.

Site TL/3/Plashette is located on exposures throughout both sides of Parnells Creek in between two power pylons

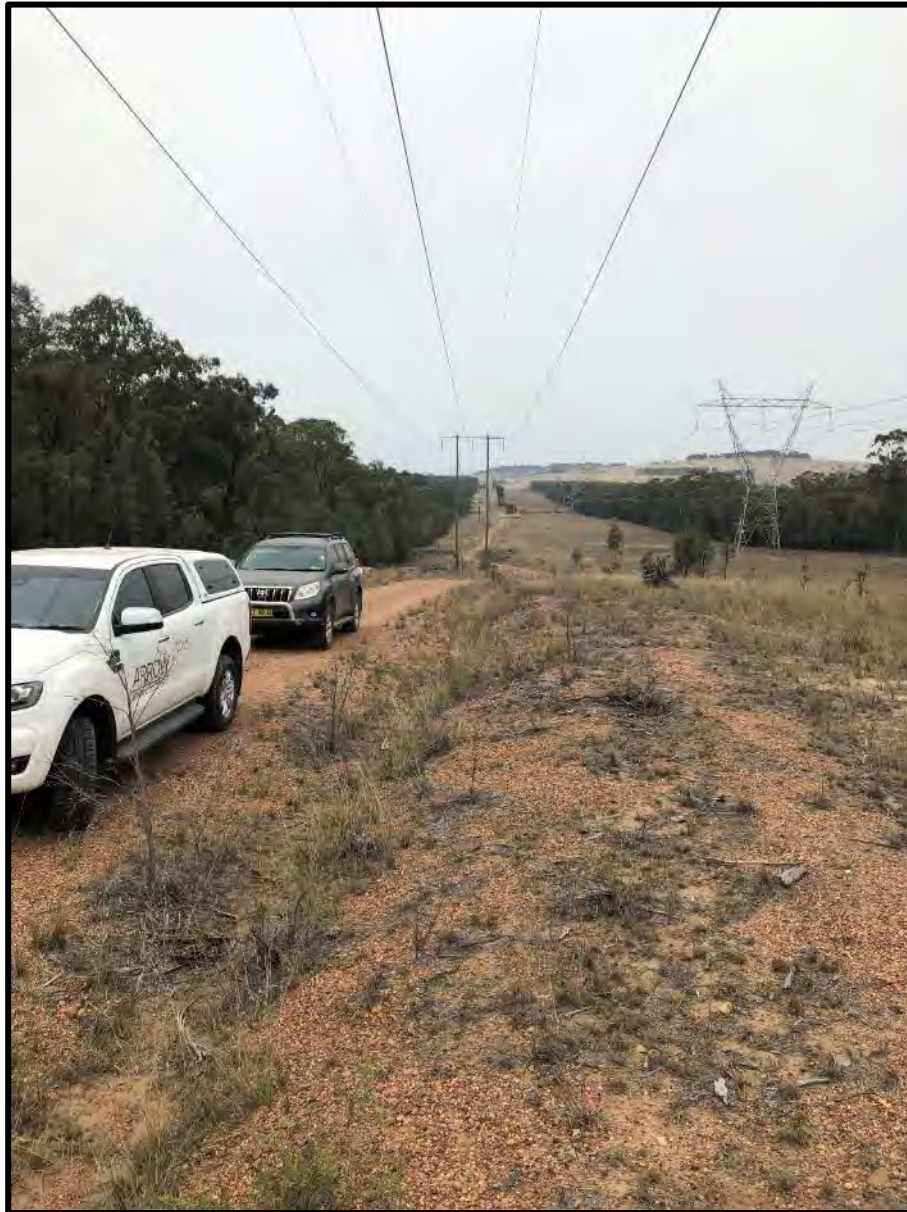
proximity does constrain access in some parts, particularly at the creek crossing. It is recommended that the fencing be altered so that it is installed along both sides of the track in those locations where sites are present to protect them from inadvertent vehicle disturbance – in effect, restricting vehicle movement off the track and onto areas containing artefacts.

View south along Greenleek powerline corridor across sites shown in Map 4

Alternatively, consideration may be given to grading a new track to the west within the powerline easement, which has been comprehensively surveyed for Aboriginal heritage sites. Regardless of which management action is decided, consultation with Transgrid/Ausgrid is recommended to devise the best strategy for managing this shared area.

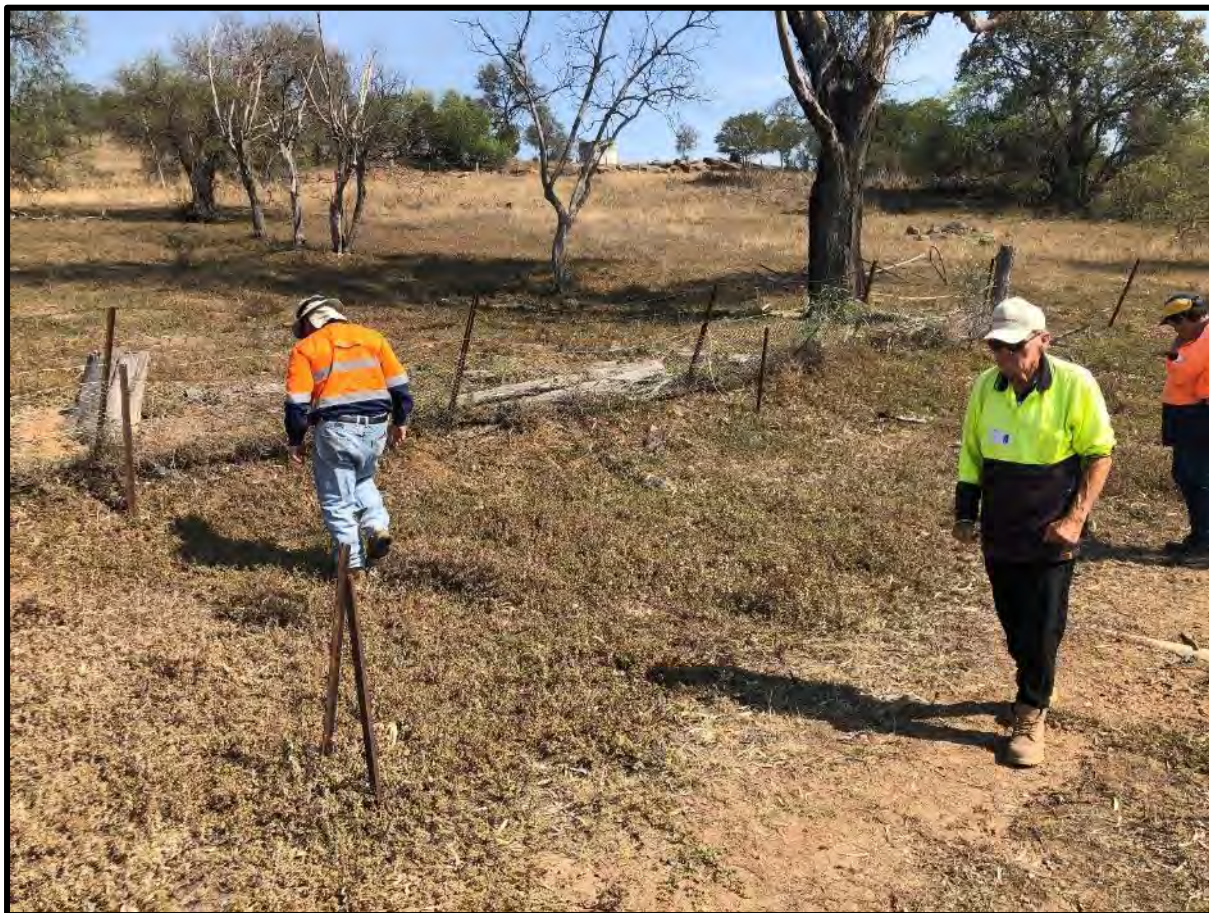
Location of HVO-985

salvaged. For completeness, these artefacts should also be salvaged at the same time. An AHIP is not required to implement this measure, as the salvage of these sites, with Aboriginal community participation, is authorised under the HVO South AHMP.

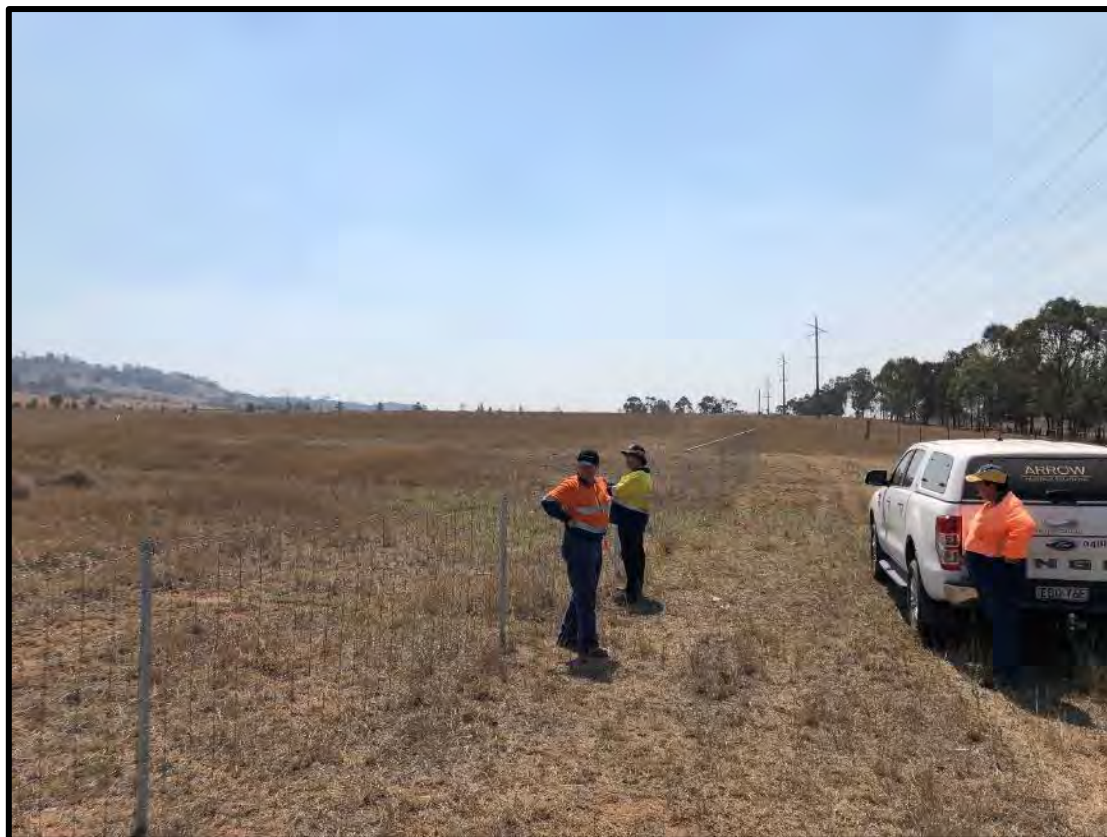
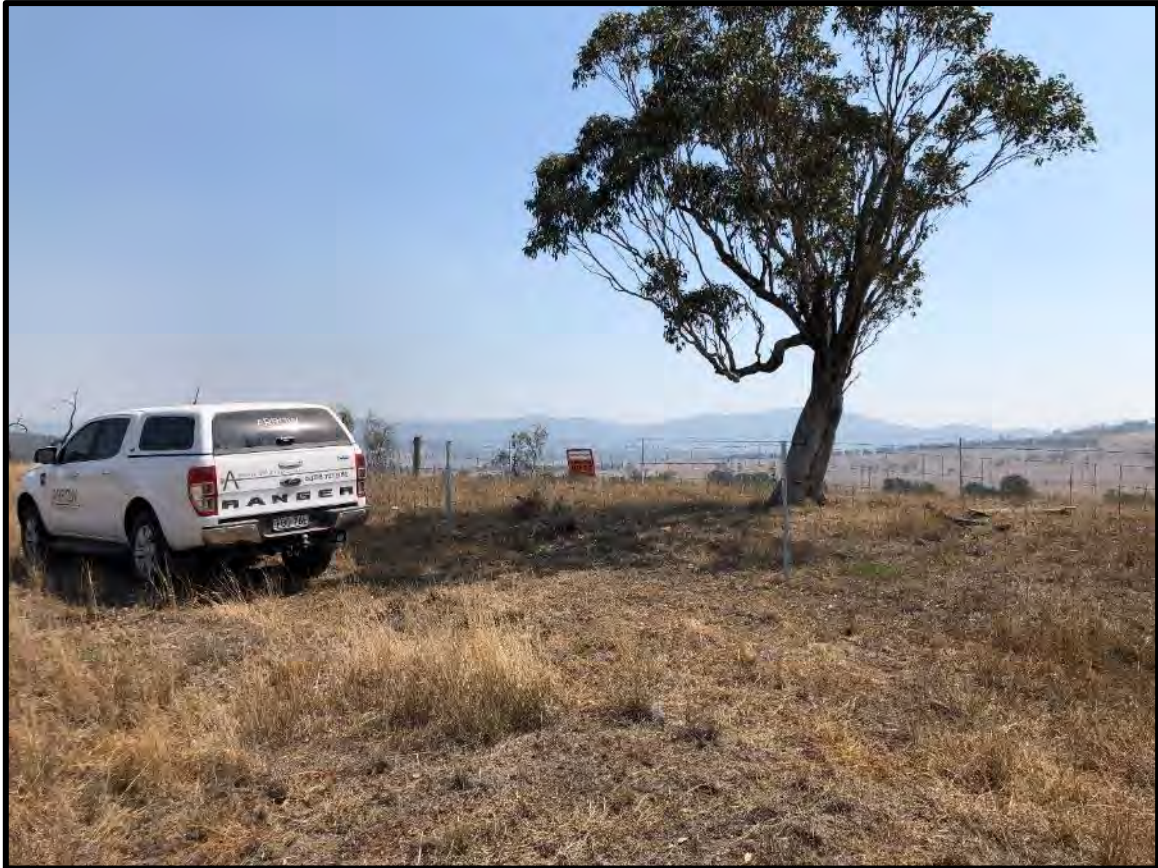
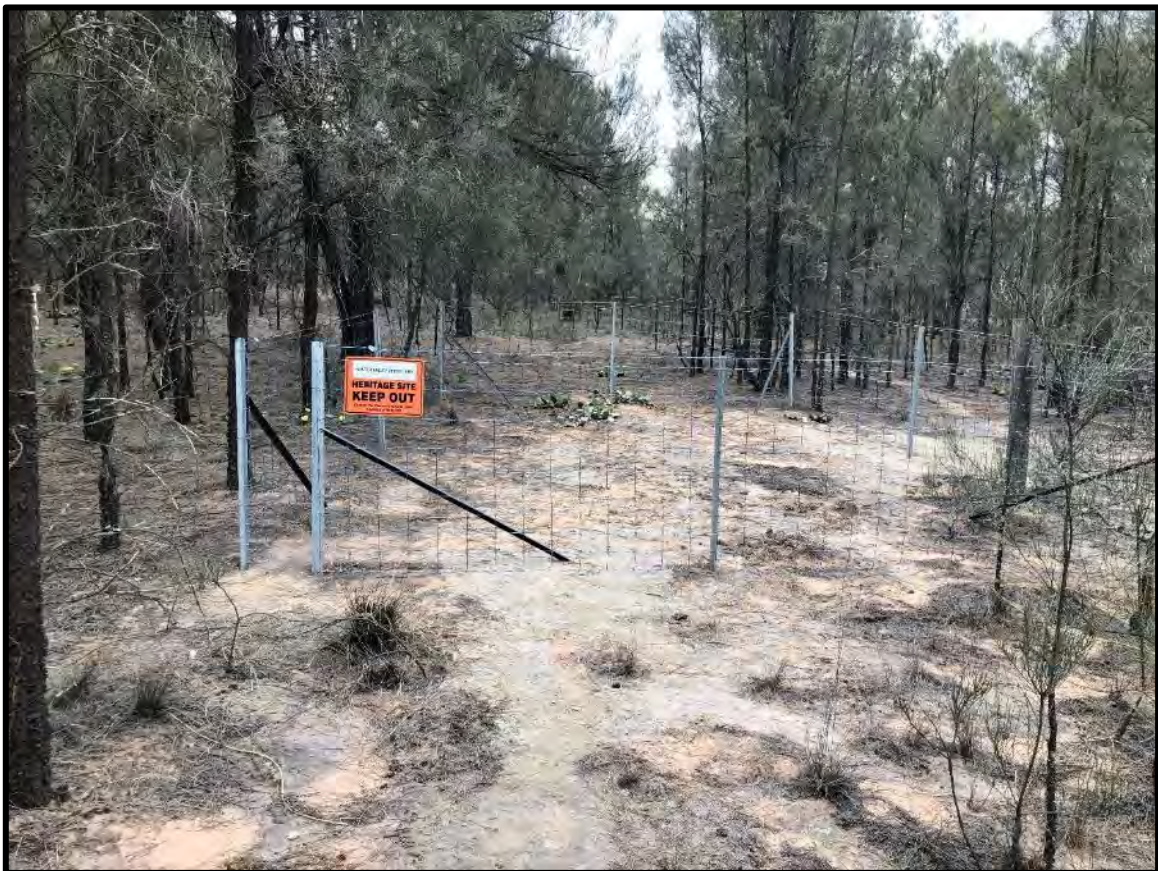
Photographs below show examples of new fencing, received positively by the RAPs, installed at HVO sites as per previous audit recommendations, (top: CM55, middle: HVO-1792, bottom: HVO-127)
