# HUNTER VALLEY OPERATIONS

**2020 Annual Environmental Review**

Date	31 March 2021

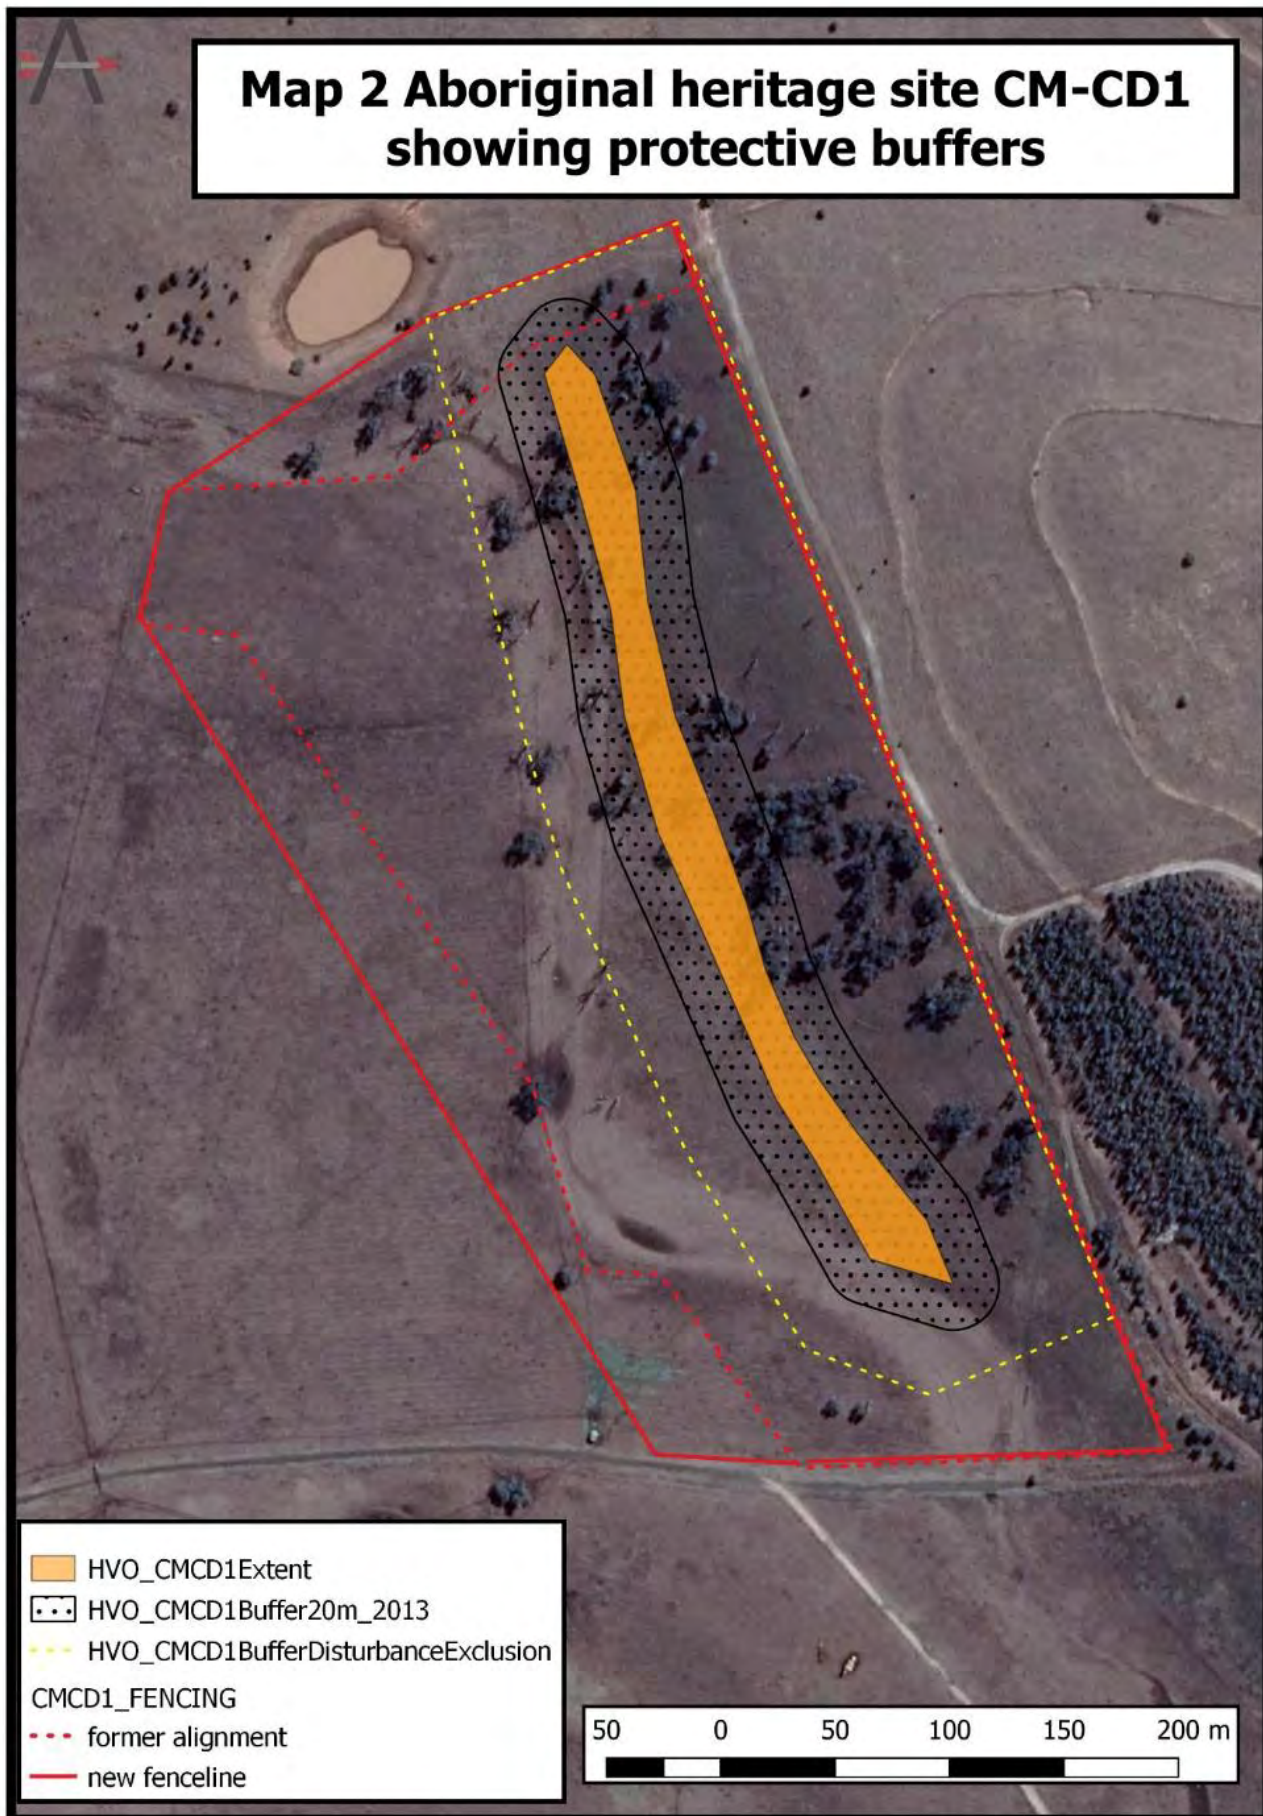
**The CM-CD1 exclusion area is zoned as Zone 1 in the HVO North CHZS.**

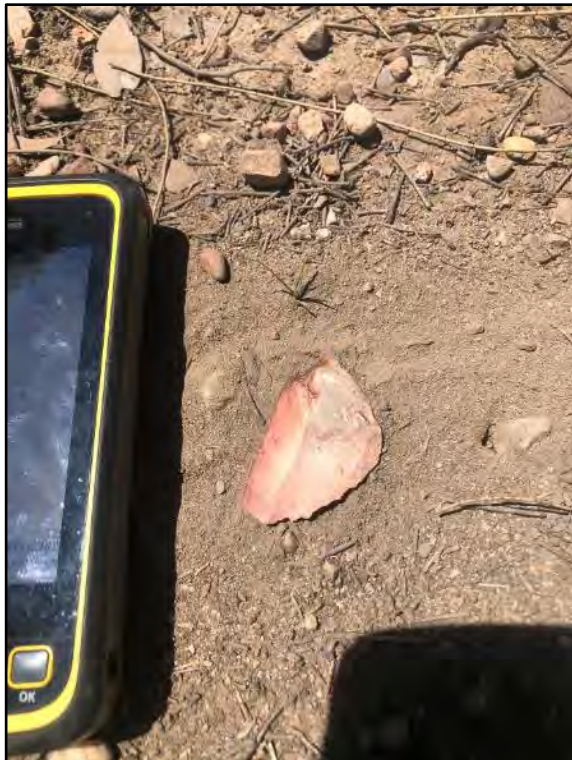
This site consists of dozens of flakes of mudstone and silcrete located mainly upon the existing power-line track that runs through the site. The site extends c.60 x 30m and may extend further, however visibility precluded the identification of artefacts outside the recorded boundary. Several artefact sites are located to the west of HVO-2139, on an elevated ridge above Sandy Hollow Creek.

***Mudstone flake at HVO-2138***

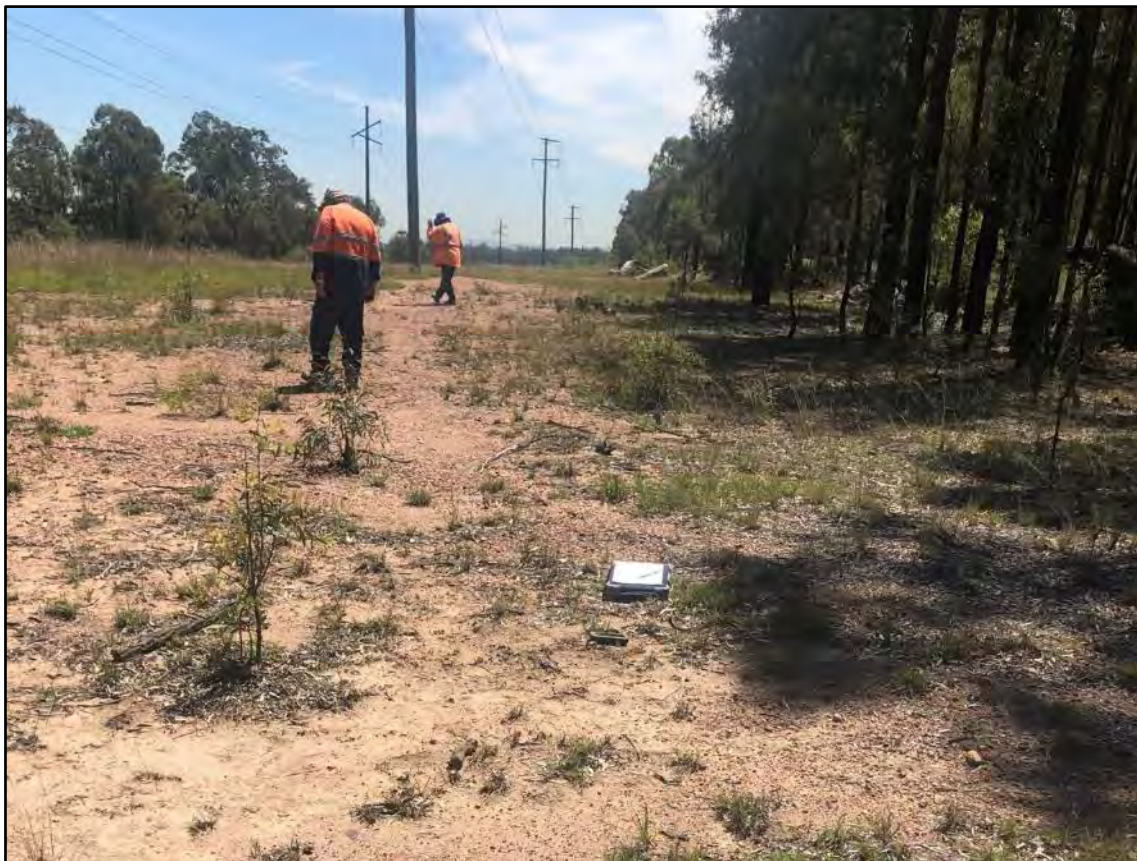
***View north through HVO-1534 within power-line easement***

These sites are located either on or within close proximity to an existing track used to access along the power-line easement. It is recommended that these sites be barricaded to protect them from inadvertent vehicle disturbance, which, in the northern section, would also result in the existing track being re-routed away from the site extent (see Map 4). Consultation with Transgrid/Ausgrid is recommended to devise the best strategy for managing this shared area.

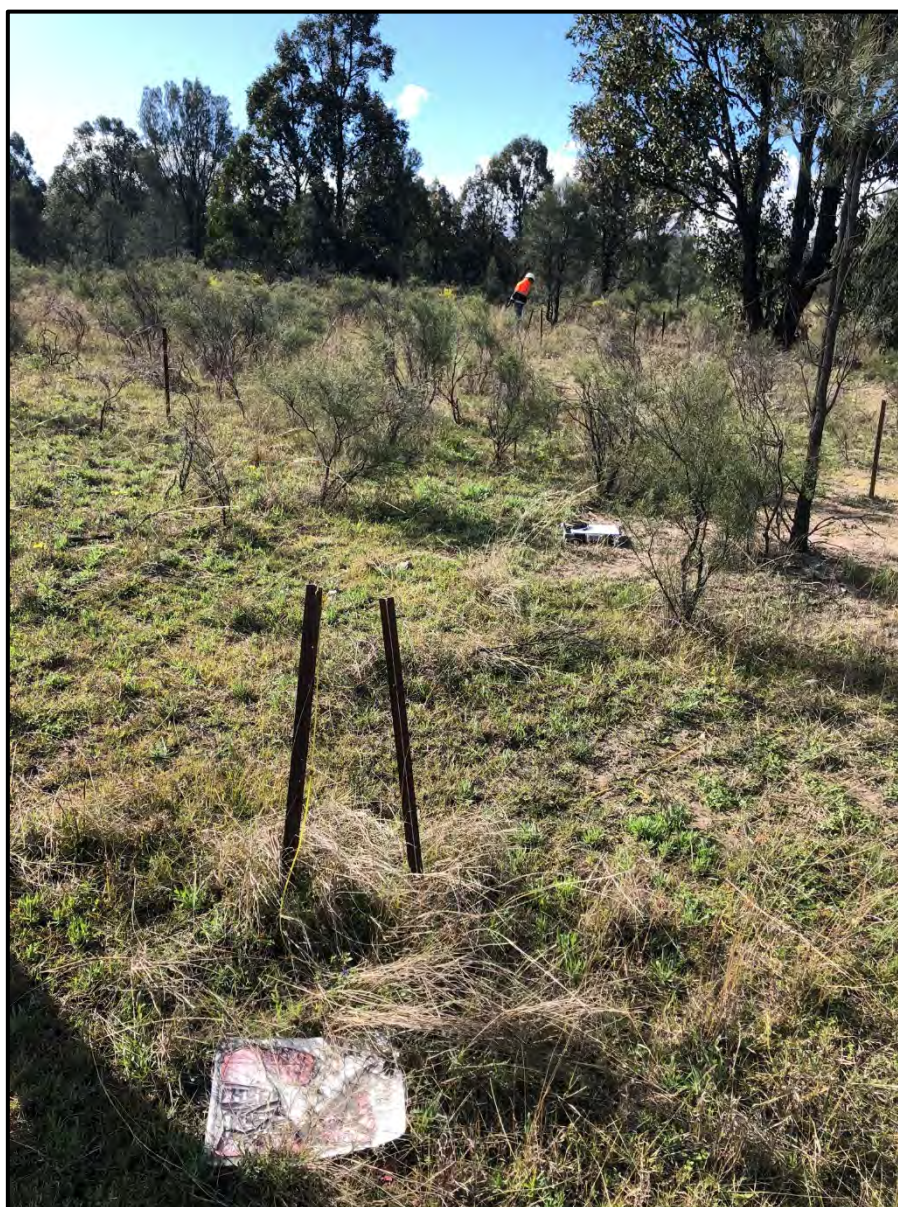
There are a number of sites that were inspected where hard fencing is recommended for their demarcation and protection. Many of these sites have been barricaded in the past and are located in areas that are regularly grazed. It should be noted that the new and upgraded ACH site fencing specification being trialled and installed at several ACH sites across HVO, including within the current inspection area, was received positively by the RAPs in attendance and is considered the favoured option when site protection is warranted.

**An example of dilapidated barricading at ACH sites HVO-105 and 106**

1. **Install hard fencing at ACH sites HVO-45, 46, 84-106, 136, 2134;**
2. **Consider the use of sediment fencing at ACH sites HVO-31, 33-35, 42, 43, 51-54, 107-109, and any sites to be fenced in the future that are liable to erosion and wash into nearby waterways;**
3. **Request further information from AHIMS to assist in determining the accurate location, nature and extent of ACH site 'Curlewis Comleroi';**
4. **ACH sites HVO-134, 135 should be considered for salvage to prevent further inadvertent damage; and**
5. **Salvage the remnant artefacts in the vicinity of the Hunter River haul road bridge associated with AHIMS site 37-5-0047. Ground cover in the area should be denuded prior to salvage to aid in artefact recovery.**

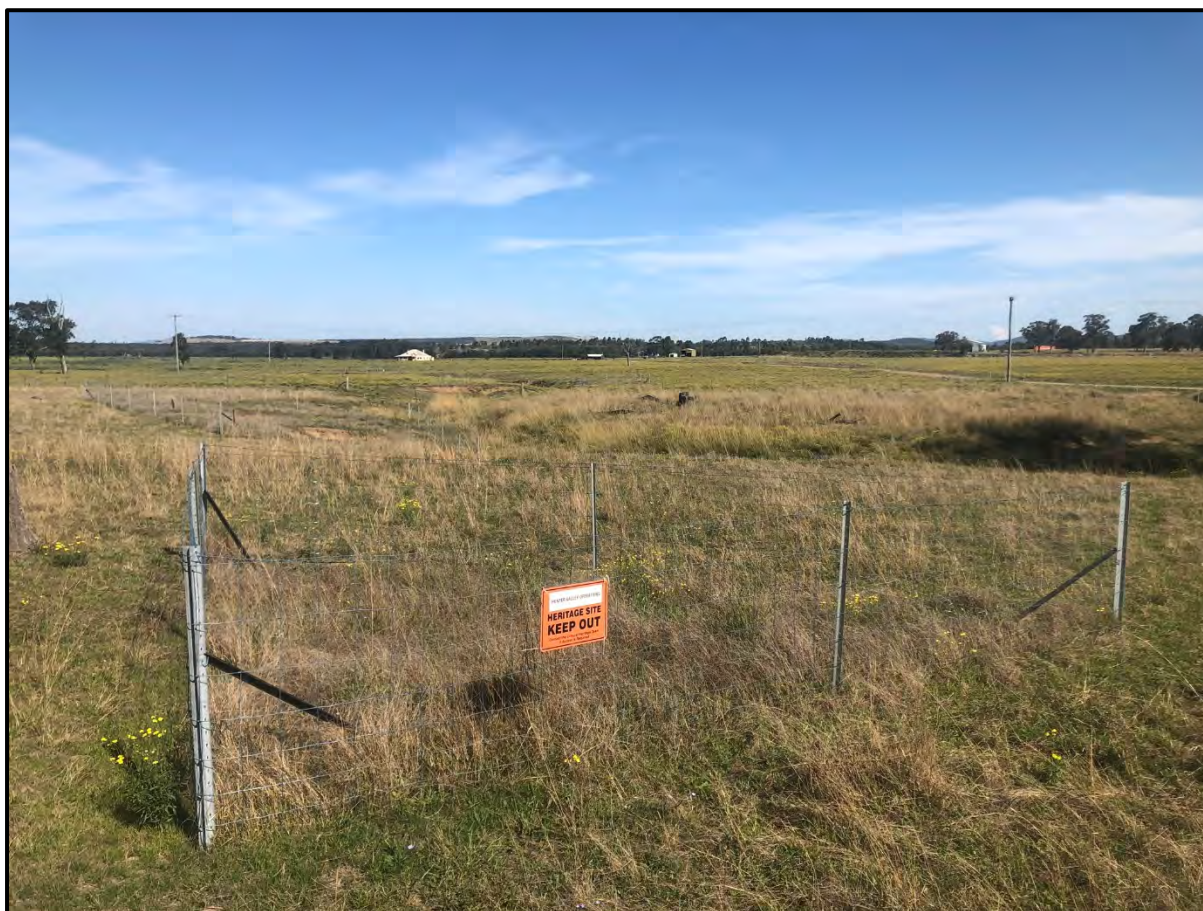
**Example of new ACH site fencing technique**

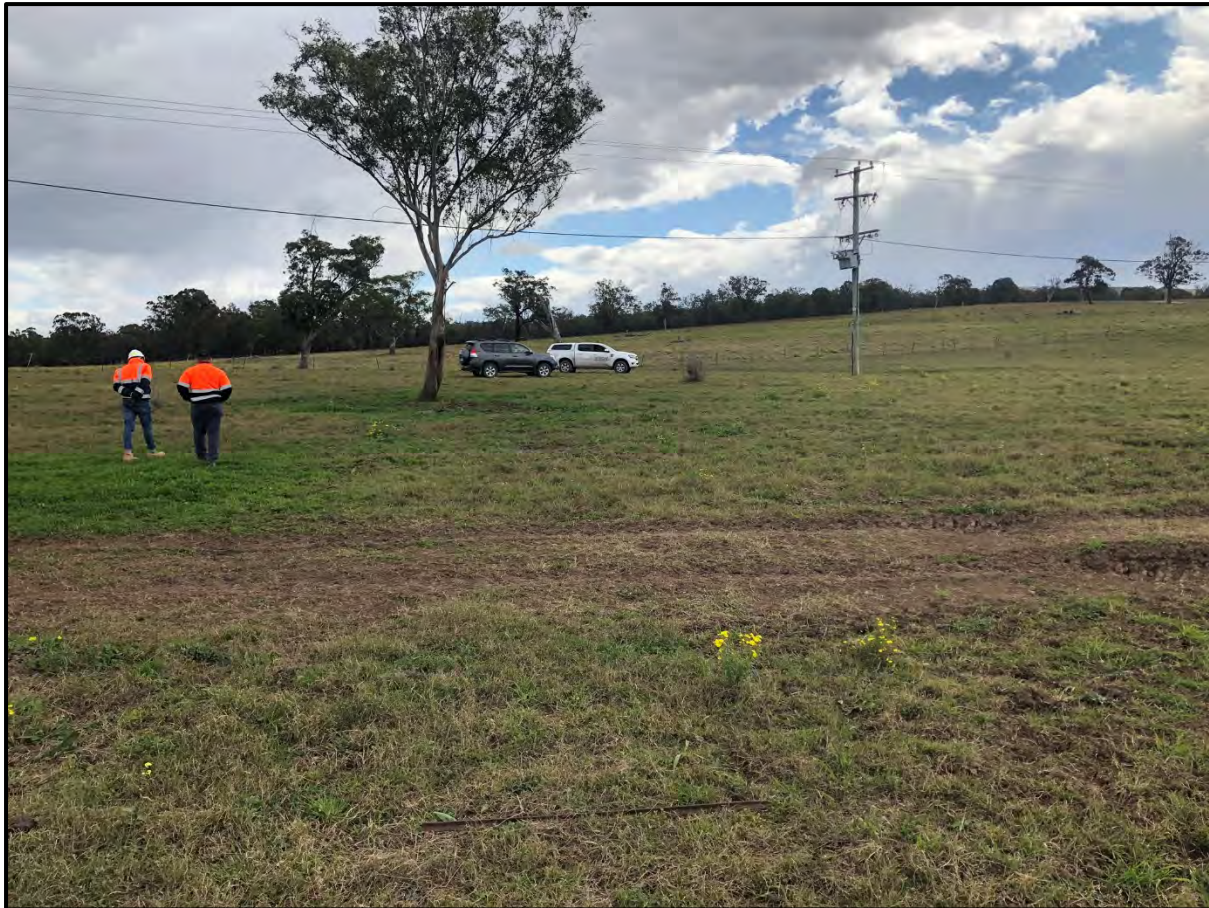
Both these sites are located within an active farming area, in close proximity to high traffic areas where fencing would not be a practical option. HVO-134 consists of a single mudstone flaked piece in a heavily grassed area within a gateway. HVO-135 consists of five flaked pieces of mudstone and a flaked piece of quartz within a 50m diameter area. This area is in a high impact area where cattle regularly gather. Due to the risk of further disturbance to these sites it was recommended by the CHWG representatives that they be salvaged. An AHIP is not required to implement this measure, as the salvage of these sites, with Aboriginal community participation, is authorised under the HVO South AHMP.

***Location of HVO-135 (between picket in foreground and vehicles)***
