Hunter Valley Operations South Aboriginal Heritage Management Plan April 2021 Compliance Audit Inspections

Report prepared for
Hunter Valley Operations

**HVO South April 2021
AHMP Compliance Inspection
Cheshunt ACH Sites**

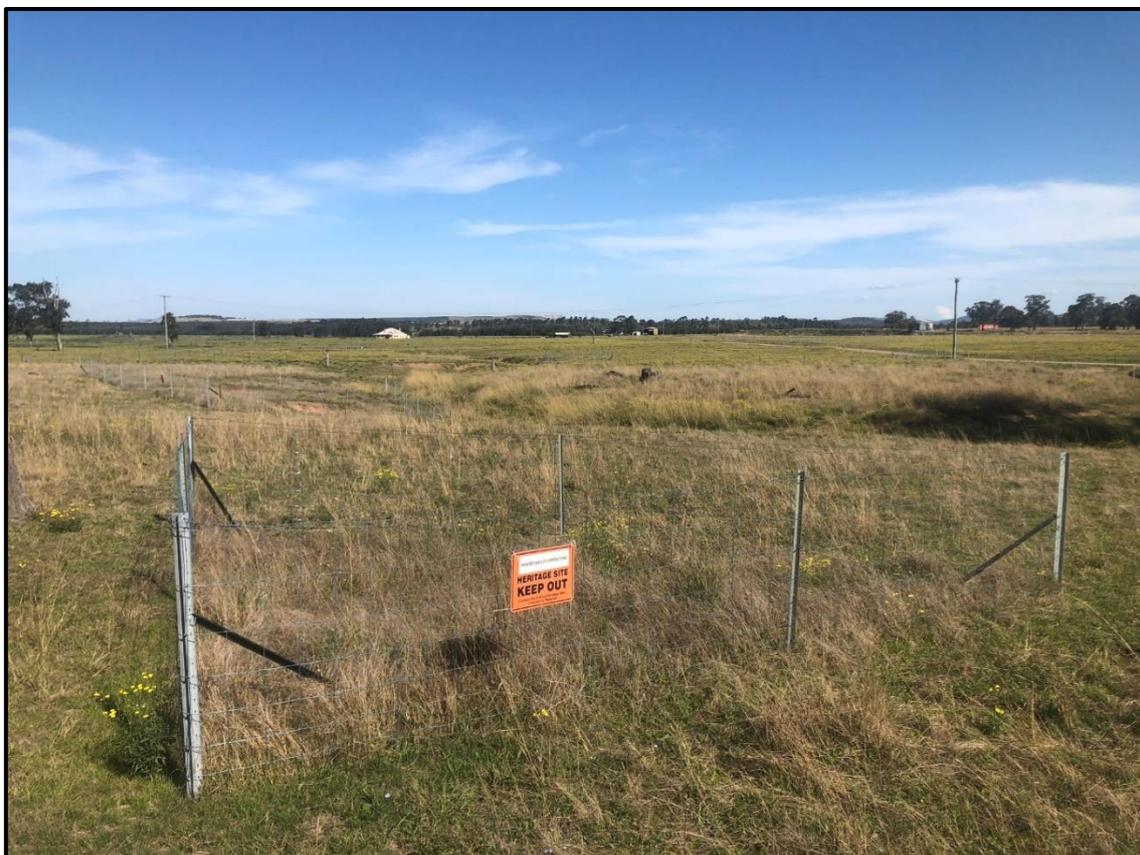
Example of new HVO ACH site fencing technique

It should be noted that the new and upgraded ACH site fencing specification being trialled and installed at several ACH sites across HVO has been received positively by CHWG members and is considered the favoured option when site protection is warranted. In this instance, two fences should be installed – one around HVO-1685 and a more extensive fence surrounding the remaining sites.
