HUNTER VALLEY OPERATIONS SOUTH MINE PROJECT

DOG LEG FENCE AND TIMBER BRIDGE SIGNIFICANCE ASSESSMENTS

20 NOVEMBER 2019
P0017219
PREPARED FOR HUNTER VALLEY OPERATIONS

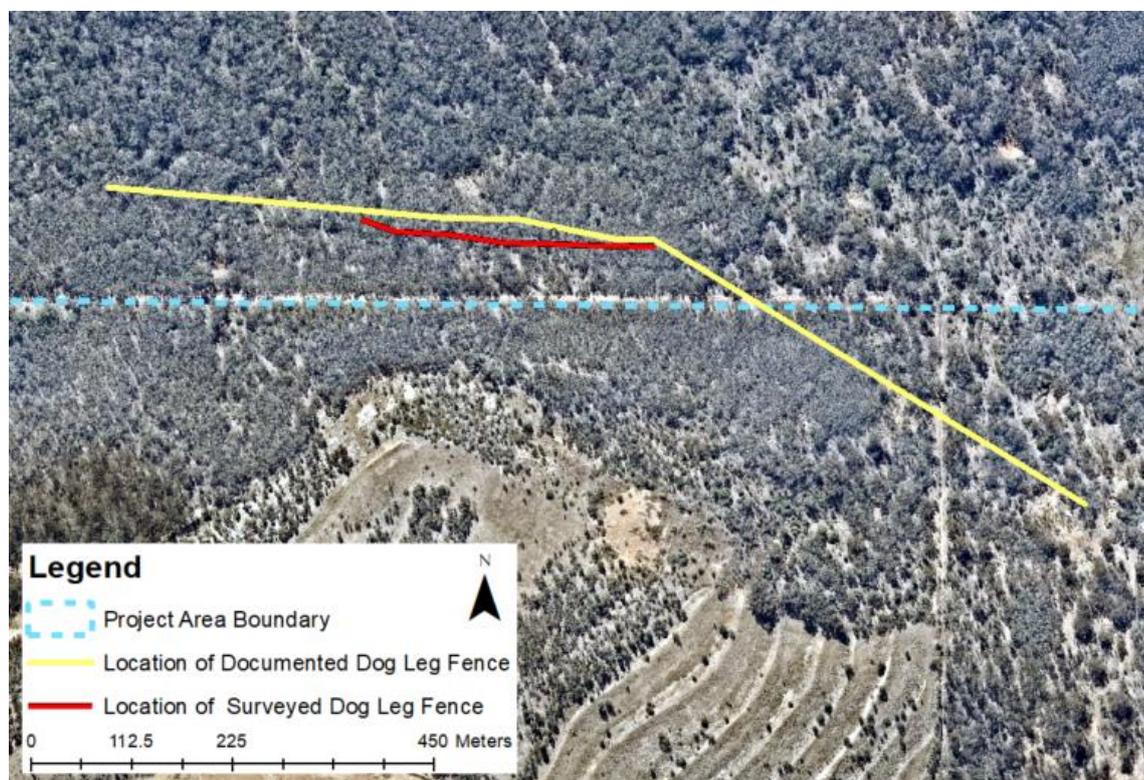
Figure 10 – Location of recorded fence

A total of 330m of dog leg fence was recorded during the survey (see Figure 10). The fence runs along a roughly east-west axis north of a more modern fenceline and firebreak. The surrounding area contains a great deal of regrowth likely around 20-30 years of age, with a number of fallen trees and branches limiting the visibility of the fence.

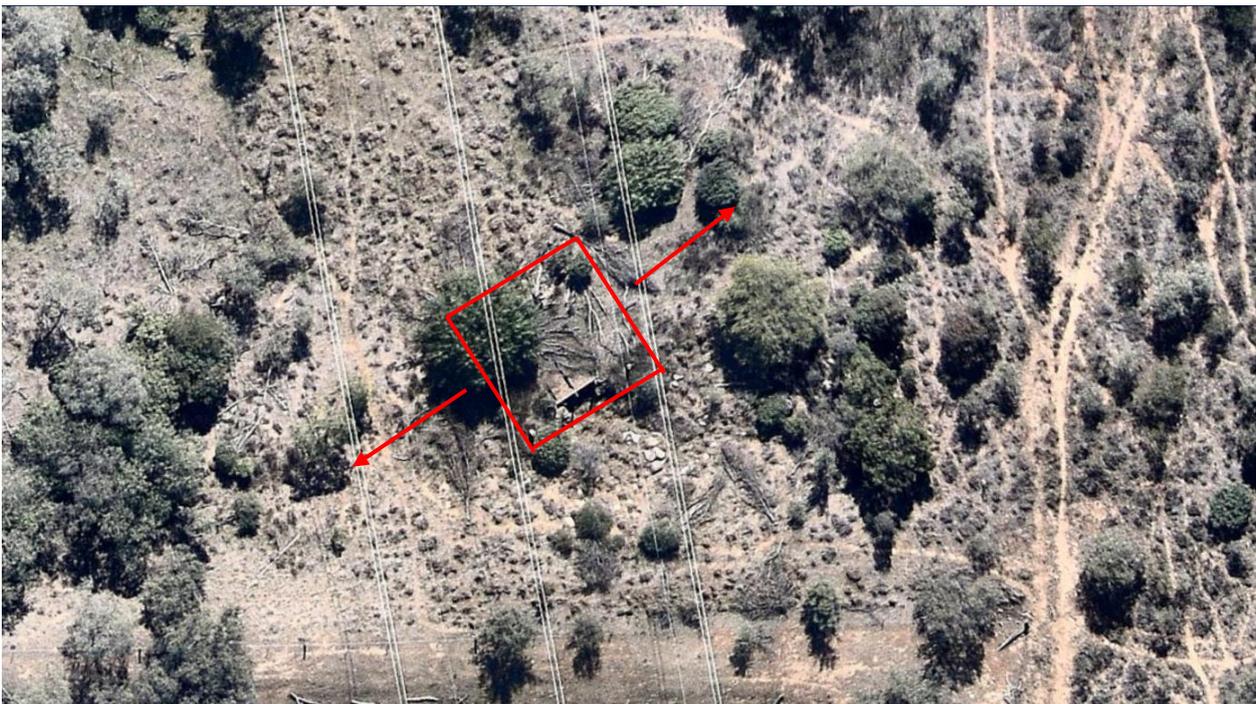
Figure 11 – Aerial photograph showing direction of the timber bridge

The feature comprises a single span timber girder bridge which sits on a north-east to south-west axis (see Figure 11). It sits within the powerline easement, with a dam adjacent to the south, and is surrounded by regrowth. It is partially covered by vegetation, and is visible upon approach from the south (Pictures 11 and 12).

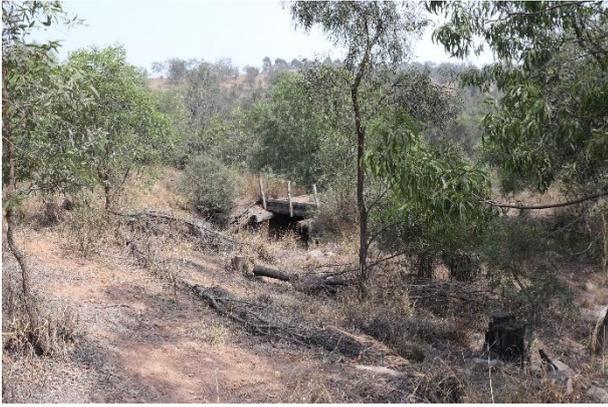
Picture 11 – View to bridge from south-east
Source: Urbis 2019

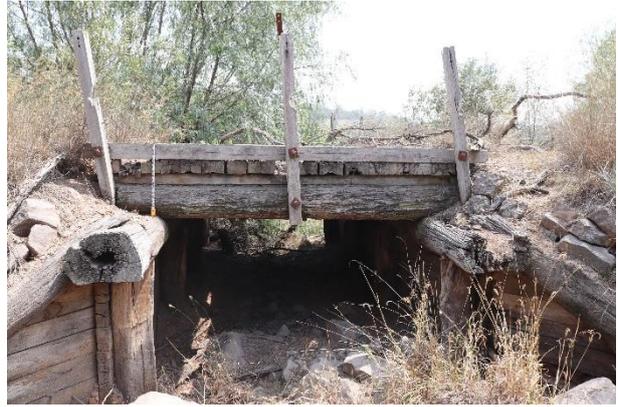
Picture 12 – View to bridge on approach from the south
Source: Urbis 2019

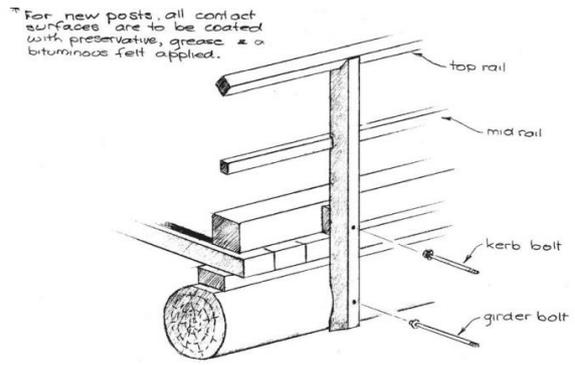
Figure 3.1 - Timber Barrier

The decking is supported by log girders (sitting on log headstocks), and also comprises the remains of traffic barrier system in the form of kerbing and a post and rail system. None of the rails remain. Posts are bolted into the kerb and girders (see Picture 17), similar to standard timber bridge construction (see Picture 18).

Picture 18 – Standard timber bridge railing system
