2021 Annual Environmental Review

Document Number: HVOOC-748212775-6

Name of Operations	Hunter Valley Operations
Name of Operator	HV Operations Pty Ltd
Development Consent /Project Approval	DA 450-10-2003 / PA 06_0261
Name of holder of development consent/project approval	HV Operations Pty Ltd
Mining Lease Number	Contained within Table 6 of this report
Name of Mining Lease Holder	Contained within Table 6 of this report
Water Licence Number	Contained within Table 8 of this report
Name of Water Licence Holder	Contained within Table 8 of this report
MOP/RMP Start Date	30/09/2020
MOP/RMP End Date	31/12/2022
Annual Review Start Date	01/01/2021
Annual Review End Date	31/12/2021
<p>I, Anthony Morris, certify that this audit report is a true and accurate record of the compliance status of Hunter Valley Operations for the period 1st January 2021 to 31st December 2021 and that I am authorised to make this statement on behalf of Hunter Valley Operations.</p> <p>Note.</p> <p>a) The Annual Review is an 'environmental audit' for the purposes of section 122B(2) of the Environmental Planning and Assessment Act 1979. Section 122E provides that a person must not include false or misleading informat

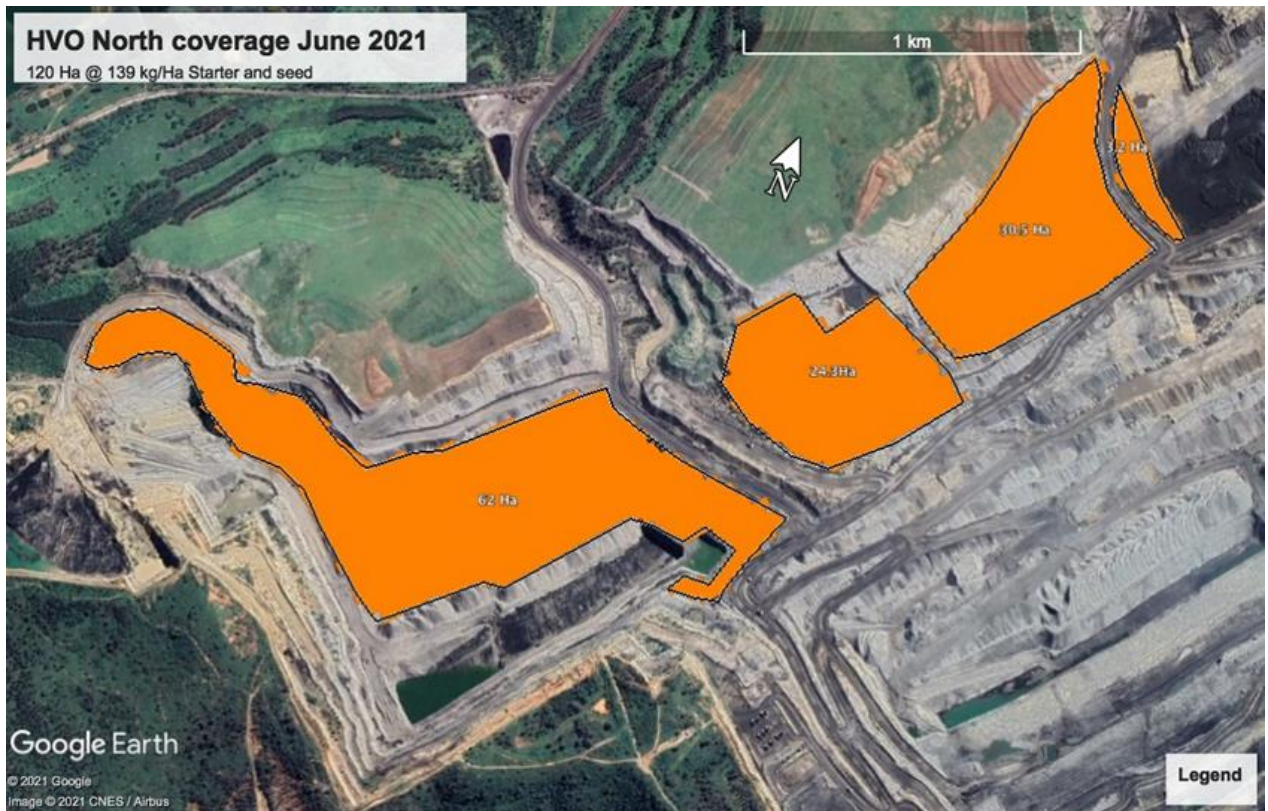
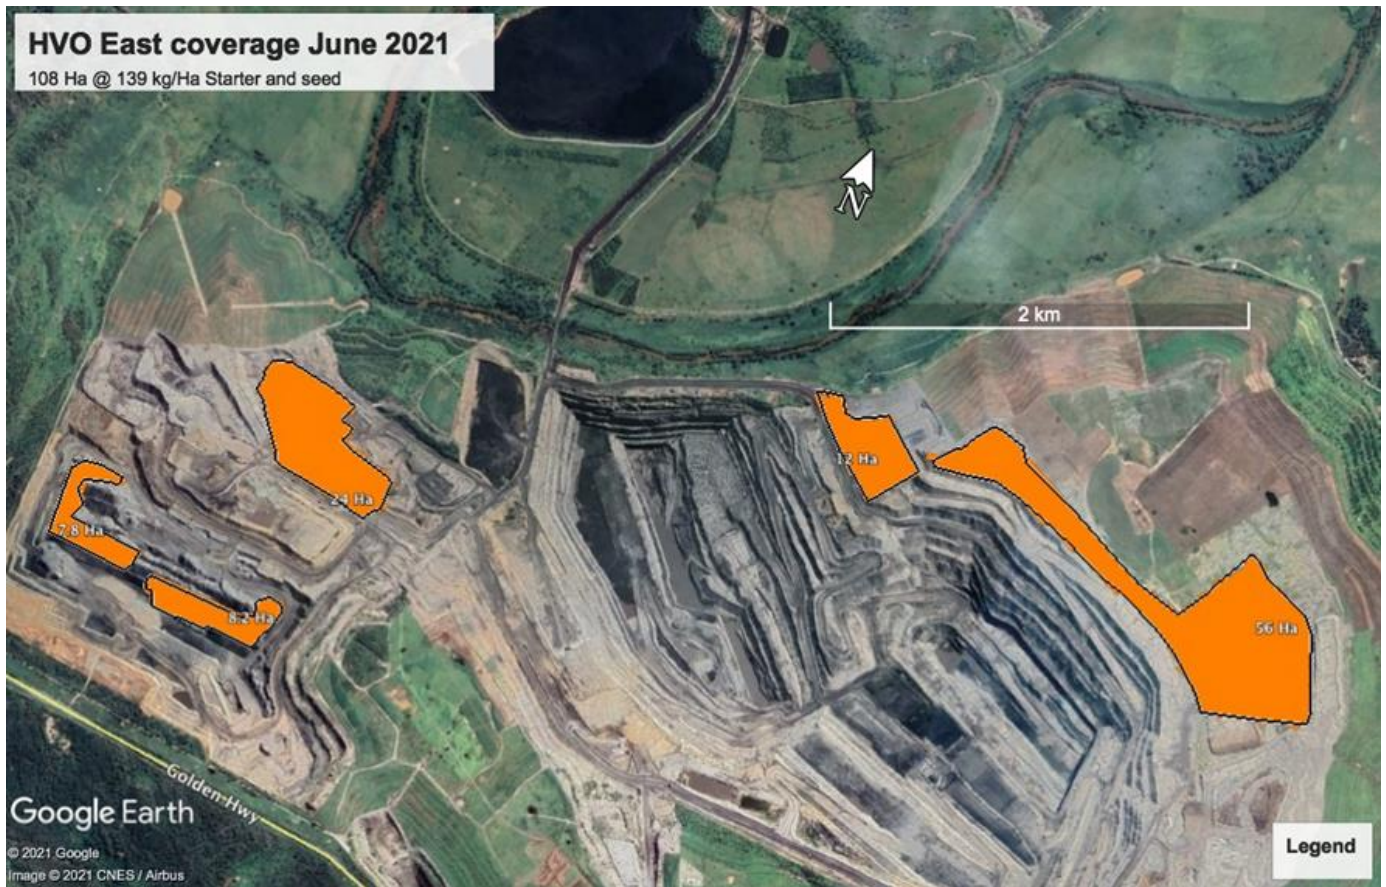
Aerial Seeding was undertaken in June 2021 by fixed wing aircraft to provide temporary cover to areas exposed to wind generated dust and erosion at HVO. Waste dumps and exposed areas were selected for seeding if they were not planned to be disturbed within six months. A total area of 335 ha was seeded which included waste dumps ahead of mining re-disturbance (**Figure 14 to Figure 16**). All areas were seeded using an exotic pasture and legume mix suitable for autumn sowing. A starter fertiliser was mixed with the seed prior to loading to provide sufficient nutrients for plant growth.

Figure 14 Areas Aerial Seeded in 2021 – HVO North (West Pit)

Figure 15 Areas Aerial Seeded in 2021 - HVO North (Carrington Pit)

Figure 16 Areas Aerial Seeded in 2021 - HVO South

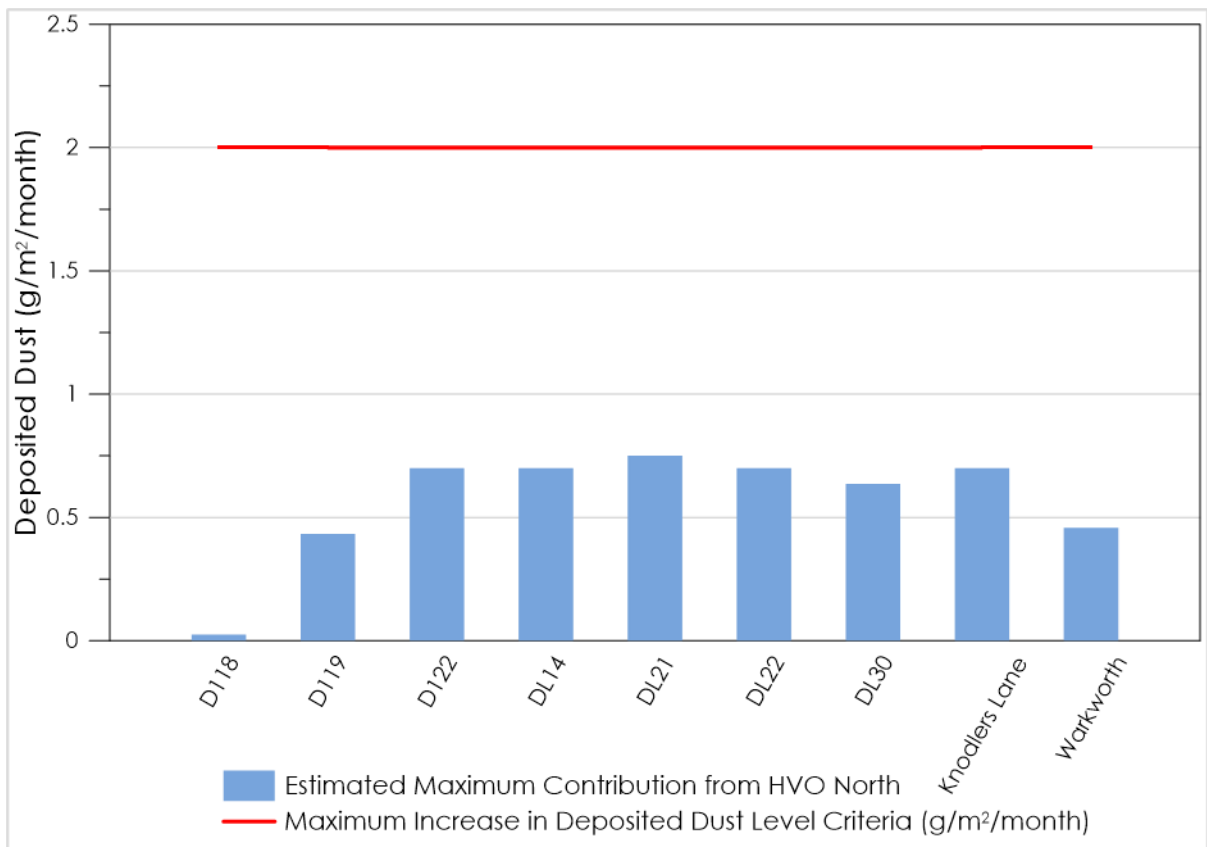
Figure 18 Maximum Allowable Increase in Deposited Dust Level 2021

The Warkworth monitoring location exceeded the annual average insoluble matter deposition rate criteria of 4 g/m²/month (HVO North only) during 2021. However, all results were below the maximum insoluble solids incremental increase criterion of 2 g/m²/month (**Figure 18**).

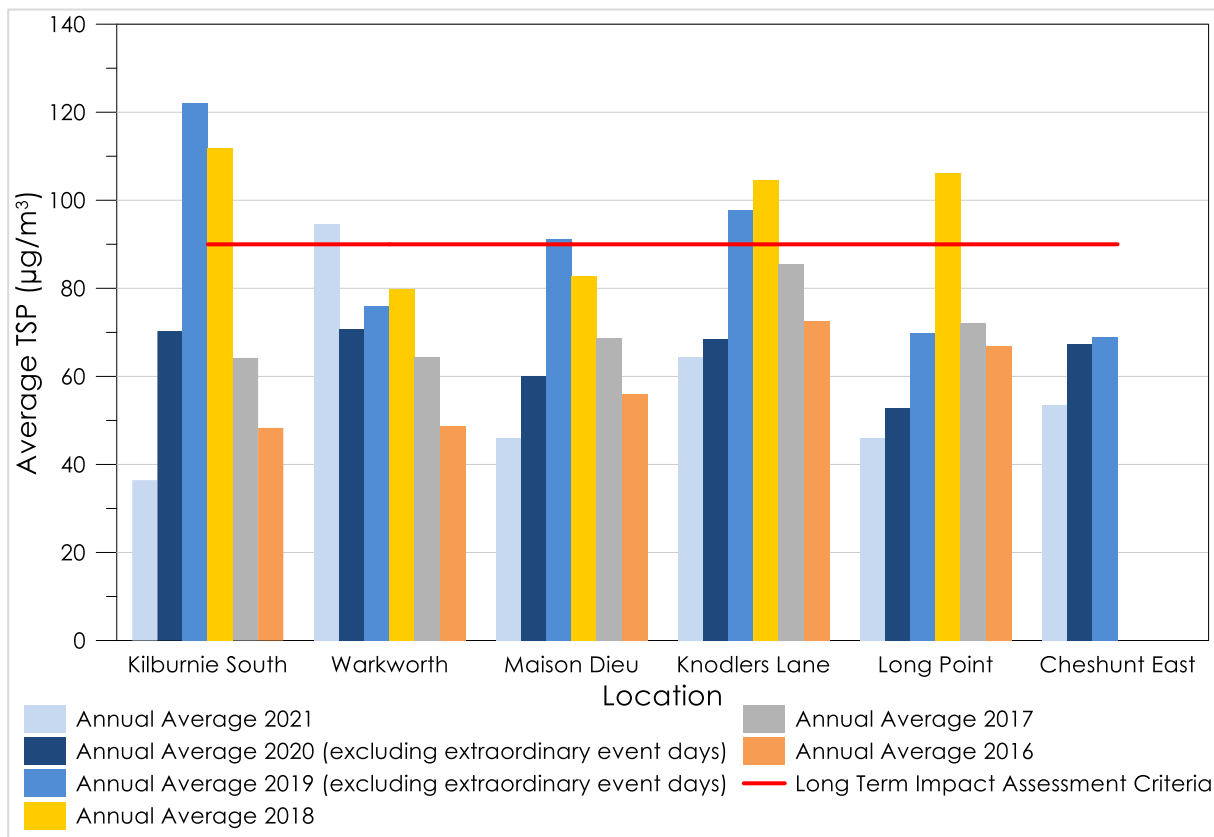
Figure 19 Annual Average TSP Concentrations 2017 to 2022 (Excludes Extraordinary Events)

Annual average TSP concentrations recorded in 2021 compared with the long-term impact assessment criterion and data from previous years are shown in **Figure 19**. TSP results in 2021 are considered to be generally lower than with those recorded in previous years, with the exception of Warkworth.

Annual average TSP levels were elevated above the impact assessment criteria at the Warkworth monitor. It is noted that the annual average level of 94.6µg/m³ measured is below the cumulative (HVO and other sources) Stage 2 modelled impact of 106µg/m³ at this location and there are no privately owned residences remaining in Warkworth represented by this monitor. The result at the Warkworth HVAS was investigated by an external specialist consultant (see **Appendix A**) to determine the level of contribution from HVO activities, in accordance with the AQGHMP.

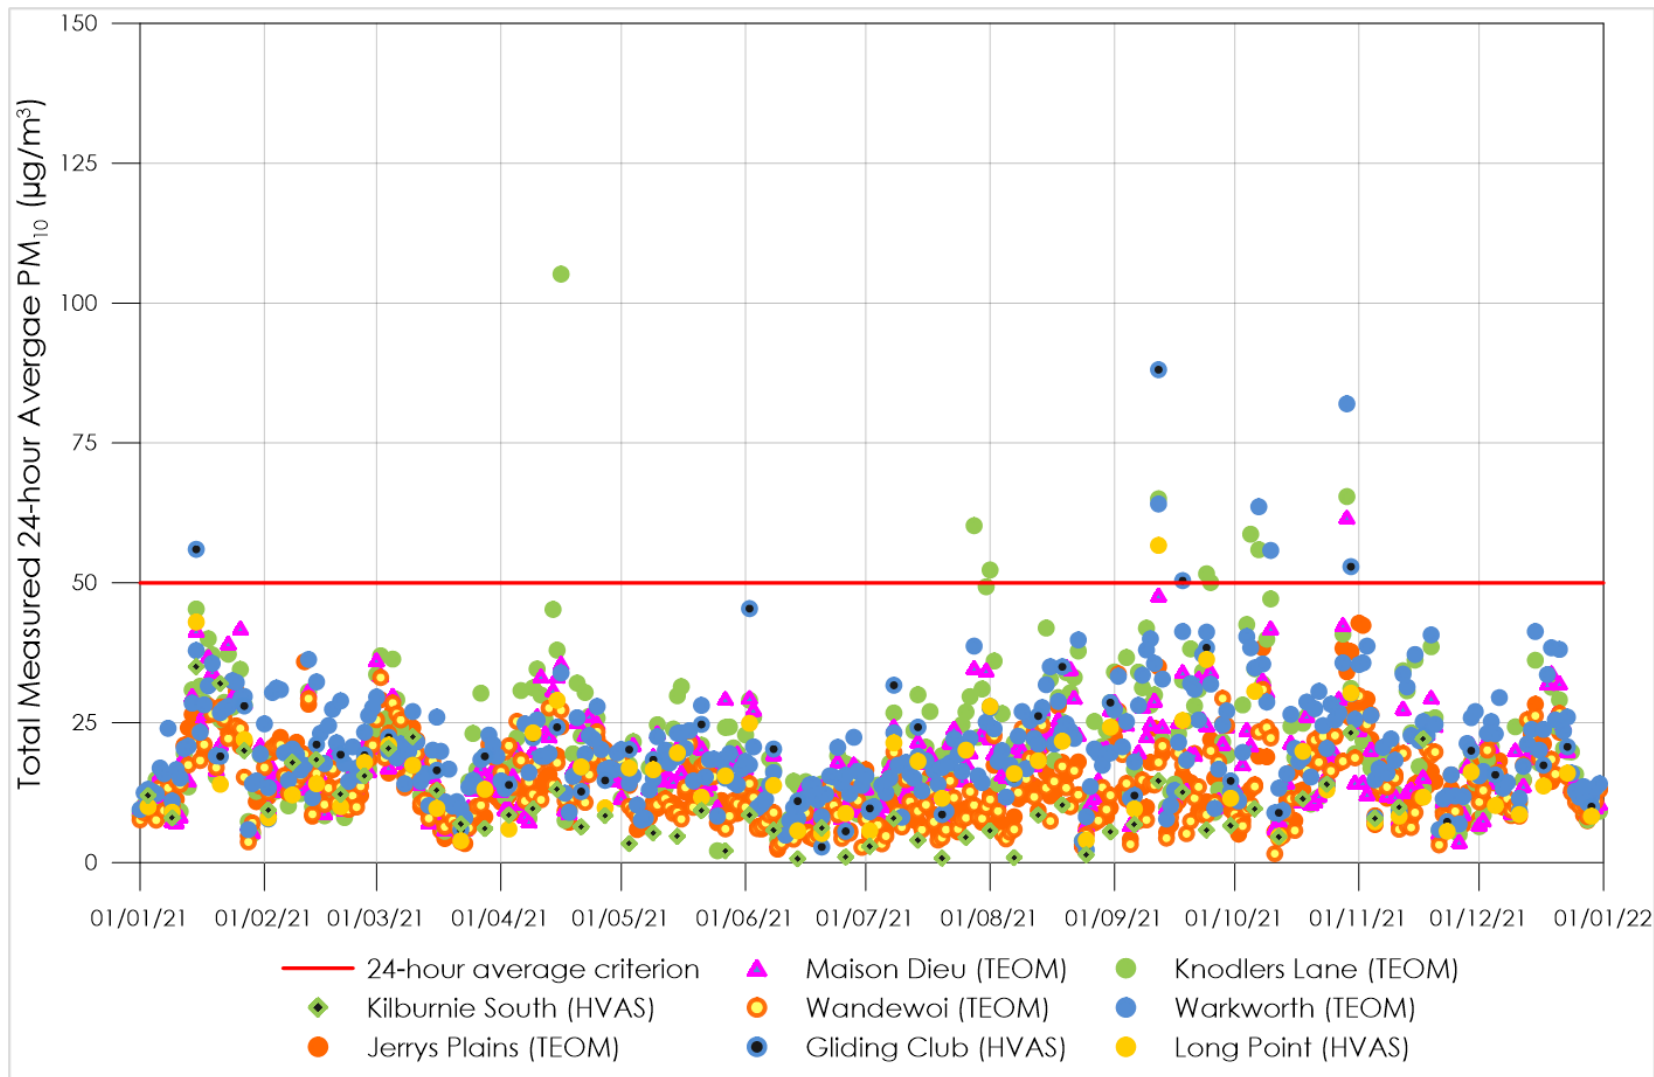
Figure 20 24-hour Average Total PM₁₀ results- 2021

Short term (24-hour average) results recorded by HVO's compliance monitoring network during 2021 is presented in **Figure 20**.

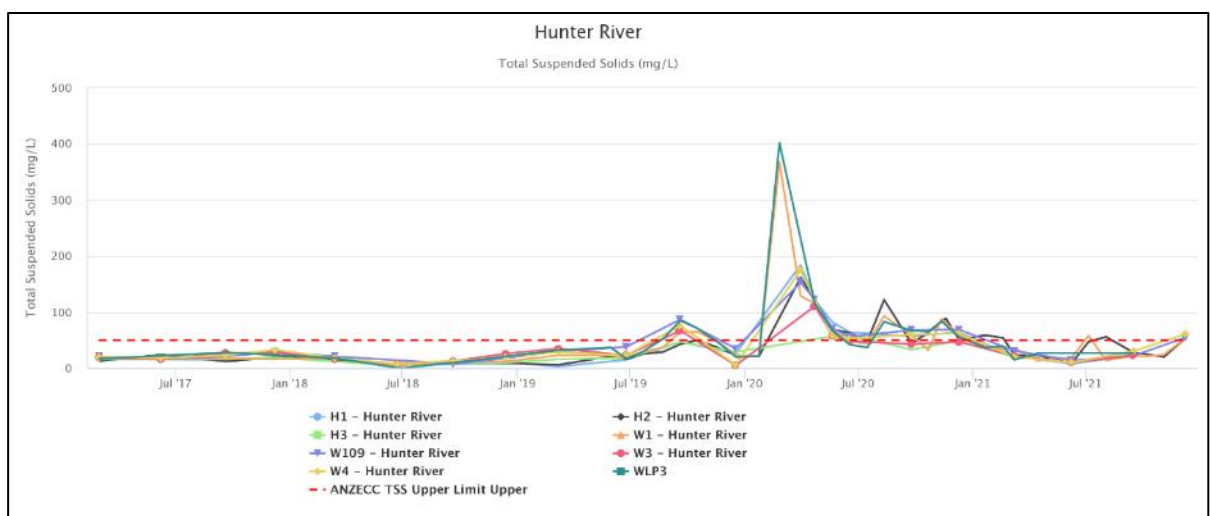
The Hunter River was sampled on 50 occasions from eight monitoring locations during 2021. Long term trends for pH, EC and TSS are shown in **Figure 27** to **Figure 29**.

Figure 27 Hunter River pH Trends 2017 – 2021

Figure 28 Hunter River EC Trends 2017- 2021

Figure 29 Hunter River TSS Trends 2017 - 2021

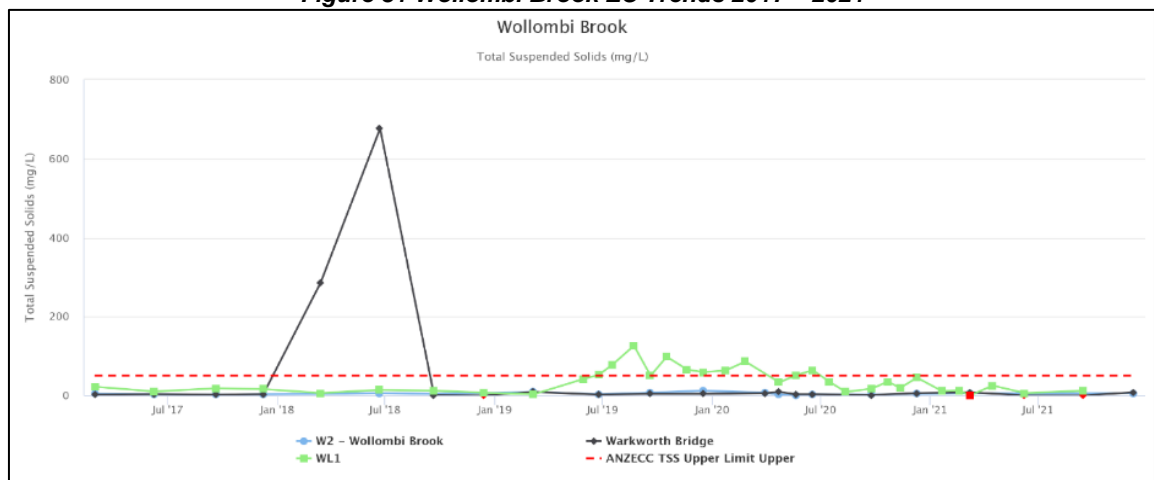
Wollombi Brook was sampled on 15 occasions from three monitoring locations during 2021. Long term trends for pH, EC and TSS from Wollombi Brook are shown in **Figure 30** to **Figure 32**.

Results were generally consistent with historical trends and acceptable ranges.

Figure 30 Wollombi Brook pH Trends 2017 – 2021

Figure 31 Wollombi Brook EC Trends 2017 – 2021

Figure 32 Wollombi Brook TSS Trends 2017 – 2021

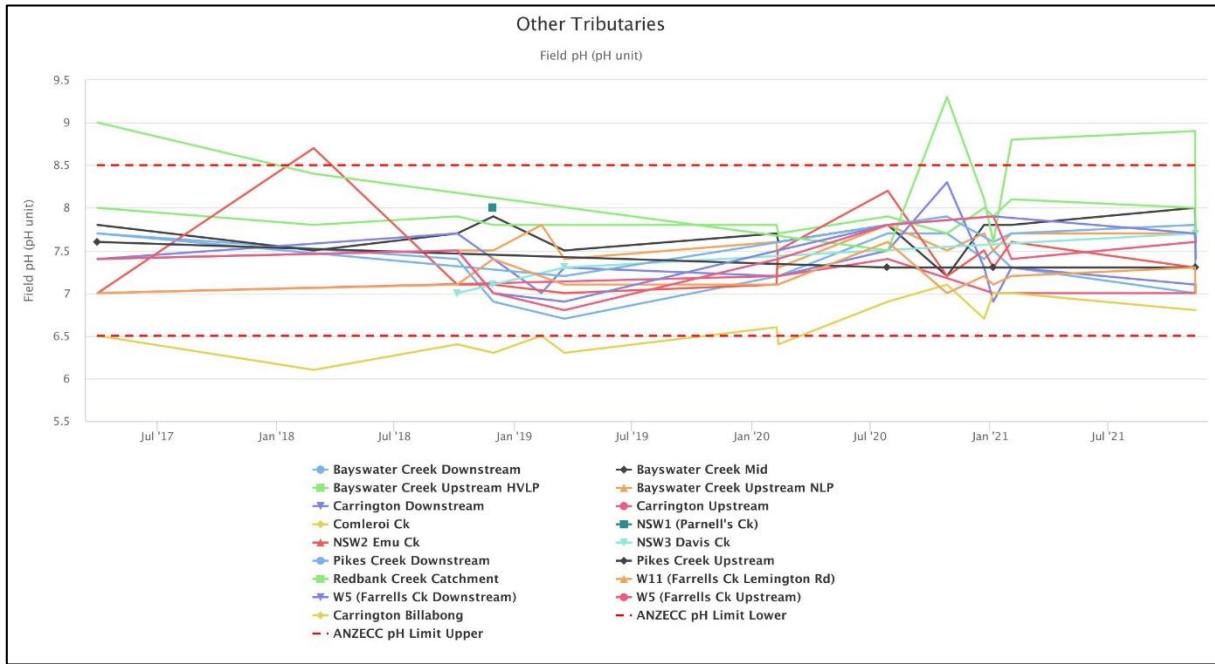
Long term trends for pH, EC and TSS are shown **Figure 33** to **Figure 36**. On occasion, some sampling sites recorded results outside of the internal trigger levels however, results for water quality remained generally consistent with historical trends. The ephemeral nature of these monitoring locations is the primary reason for the considerable variation in physical water quality.

Figure 33 Other Tributaries pH Trends 2017 – 2021

Figure 34 Other Tributaries EC Trends 2017 – 2021

Figure 35 Other Tributaries TSS Trends 2017 – 2021

Figure 36 NSW2 Emu Creek TSS Trends 2017 - 2021

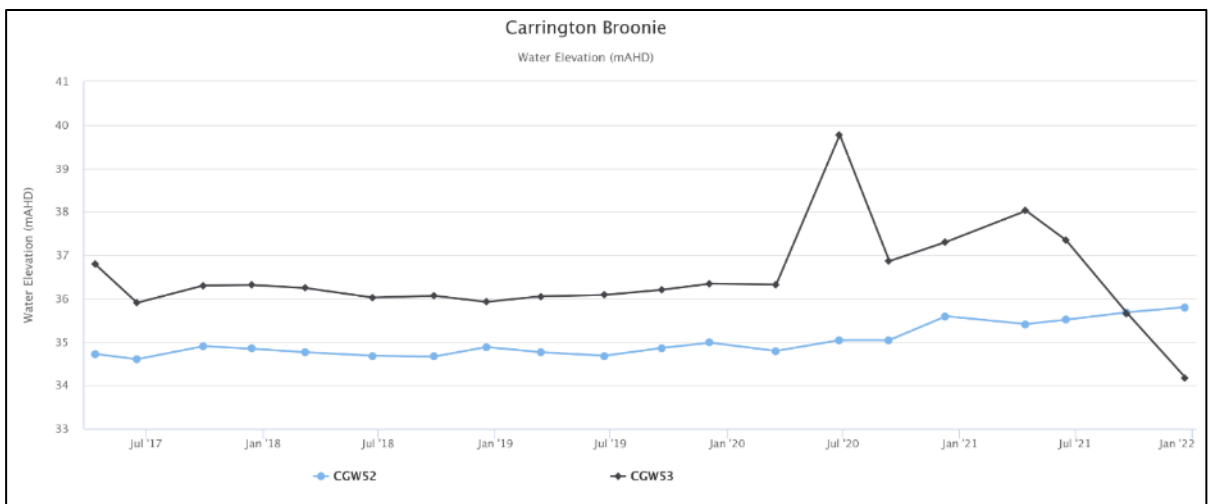
Figure 41 Carrington Broonie Groundwater pH Trends 2017 – 2021

Figure 42 Carrington Broonie Groundwater EC Trends 2017 – 2021

Figure 43 Carrington Broonie Groundwater SWL Trends 2017 – 2021

The EC, pH and SWL trends for 2017 to 2021 for Carrington Broonie Seam groundwater bores are shown in **Figure 41** to **Figure 43** respectively. Water quality results were generally consistent with historical ranges with some minor variation noted with pH and SWL results.

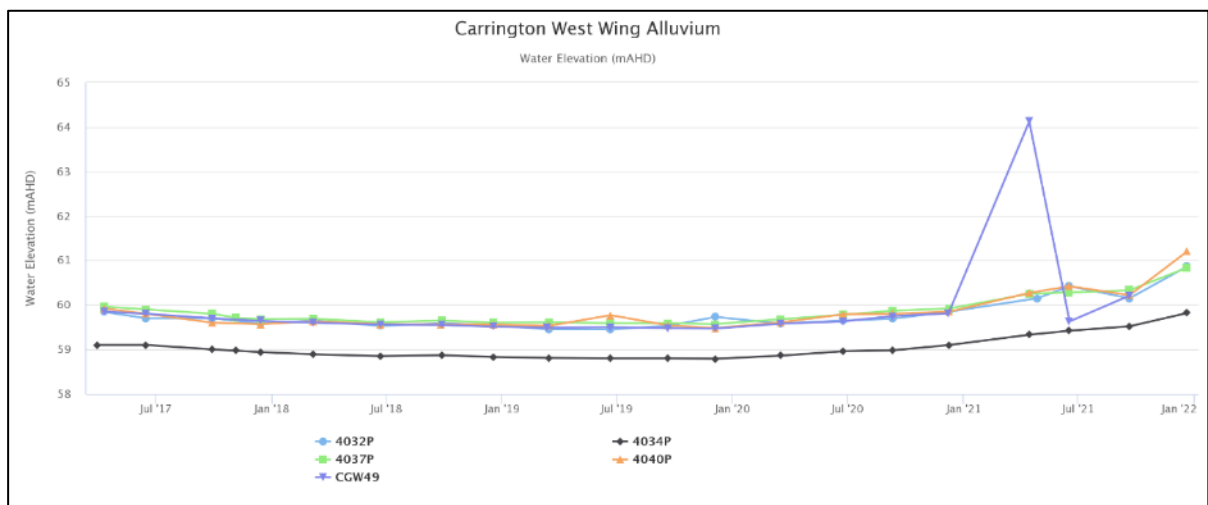
Figure 50 Carrington West Wing Alluvium Groundwater pH Trends 2017 – 2021

Figure 51 Carrington West Wing Alluvium Groundwater EC Trends 2017 – 2021

Figure 52 Carrington West Wing Alluvium Groundwater SWL Trends 2017 – 2021

Results are shown in **Figure 50** to **Figure 52**. Water quality results were generally consistent with historical trends.

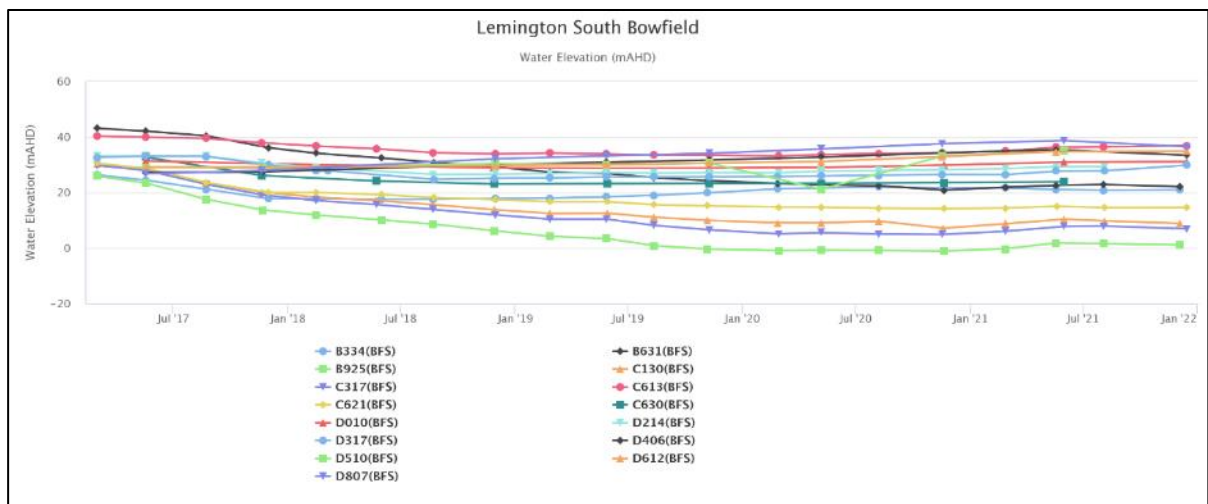
Figure 74 Lemington South Bowfield Groundwater pH Trends 2017 – 2021

Figure 75 Lemington South Bowfield Groundwater EC Trends 2017 – 2021

Figure 76 Lemington South Bowfield Groundwater SWL Trends 2017 – 2021

The pH, EC and SWL trends for 2017 to 2021 are shown in **Figure 74** to **Figure 76**. Water quality results were generally considered to be consistent with historical trends with the exception of B631(BFS) and C630(BFS) which exceeded internal triggers as listed in **Table 54**. The 2021 trigger value exceedances are not considered to reflect a mining related impact. Historical monitoring data from July 2011–December 2021 shows that EC values have exceeded the trigger value at bores B631(BFS), D010(GM) and C130(WDH) for approximately 10 years. Therefore, the EC trigger value for the Lemington South - Bowfield Seam, Glen Munro Seam and Woodlands Hill Seam is not considered appropriate to assess mining activity induced groundwater impacts. The WMP (HVO 2021) has been updated to reflect this observation and the assignment of trigger values has been removed for bores B631(BFS) and D010(GM). The draft WMP includes a revised upper EC trigger value for all Woodlands Hill seam bores, including C130(WDH), to 20,900 µS/cm. However, future monitoring results may still exceed this trigger value and therefore may not be suitable for C130(WDH). pH trigger values are no longer assigned to B631(BFS) in the updated draft WMP. In addition, the upper pH trigger value has been increased to 8.0 (from 7.9) for all other Bowfield Seam bores (in the Lemington South area).

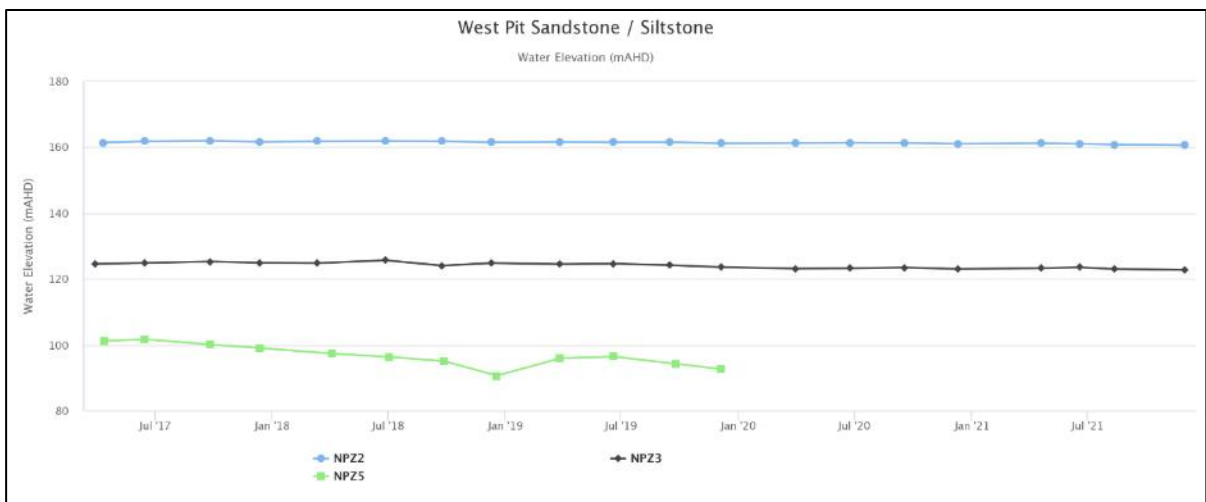
Figure 94 West Pit Sandstone/Siltstone Groundwater SWL Trends 2017 – 2021

The pH, EC and SWL trends for 2017 to 2021 are shown in **Figure 92** to **Figure 94**. Water quality results were generally consistent with historical trends. Historical data from July 2011–September 2021 shows that EC values have consistently been close to or above the EC trigger value at bore NPZ2. Groundwater salinity (as EC) began gradually increasing from July 2019. Groundwater levels have been stable at this location. The cause for the increasing trend is unclear as the monitoring bore is located north-west of mining-related activity (such as tailings storage, waste emplacement or active mining). The updated draft WMP (HVO 2021), no longer includes groundwater monitoring within the West Pit – Interburden.
