**HUNTER VALLEY  
OPERATIONS**

**Monthly Environmental  
Monitoring Report**

**Hunter Valley Operations**

**December 2018**

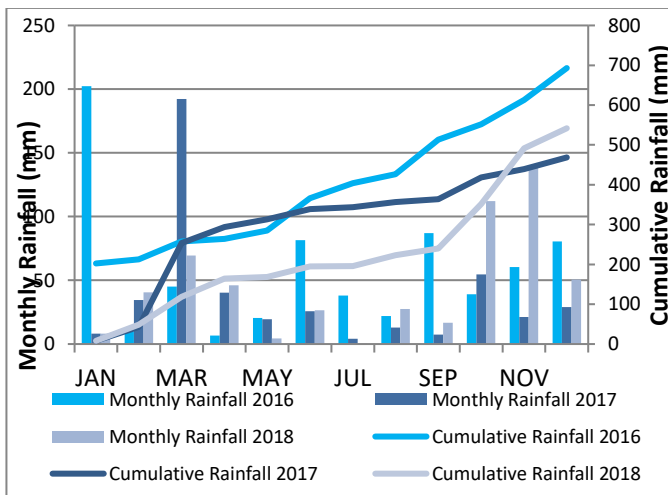
Figure 1: Rainfall Summary 2018

Rainfall for the period is summarised in Table 1, the 2018 trend and historical trend are shown in Figure 1.

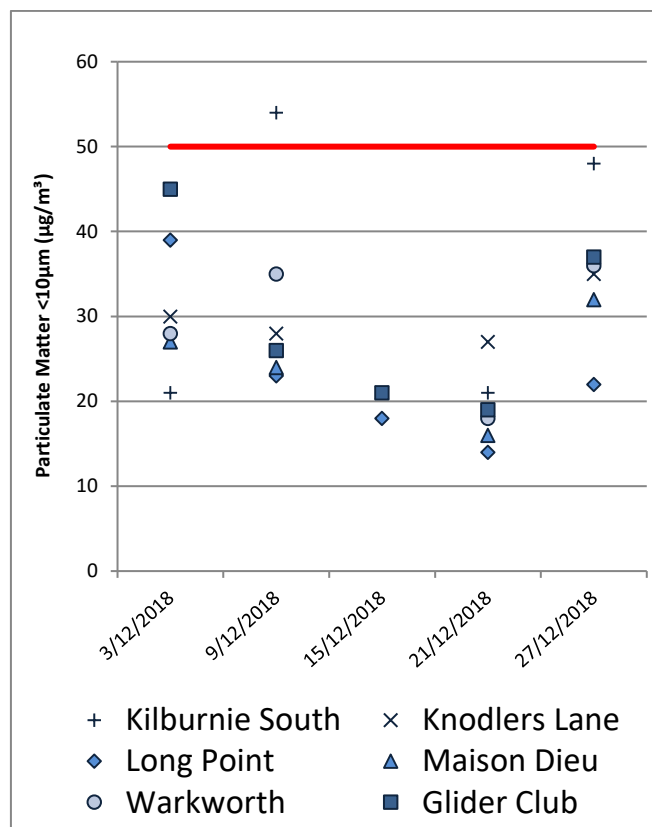
Figure 6: Individual PM<sub>10</sub> Results – December 2018

Figure 6 shows individual PM<sub>10</sub> results at each monitoring station against the short term impact assessment criteria of 50 µg/m<sup>3</sup>.

The PM<sub>10</sub> 24hr criterion was exceeded at Kilburnie South on 9 December. HVO's maximum contribution was calculated to be 29µg/m<sup>3</sup> or 53% of the measured result.

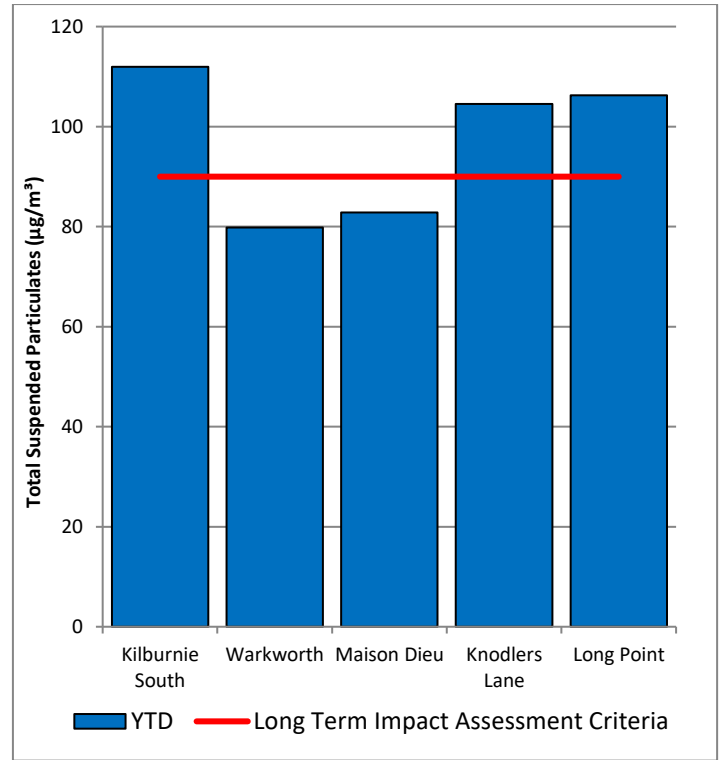
Figure 8: Year to Date Average Total Suspended Particulates – December 2018

Figure 8 shows the annual average TSP results compared against the long term impact assessment criteria of 90µg/m<sup>3</sup>.

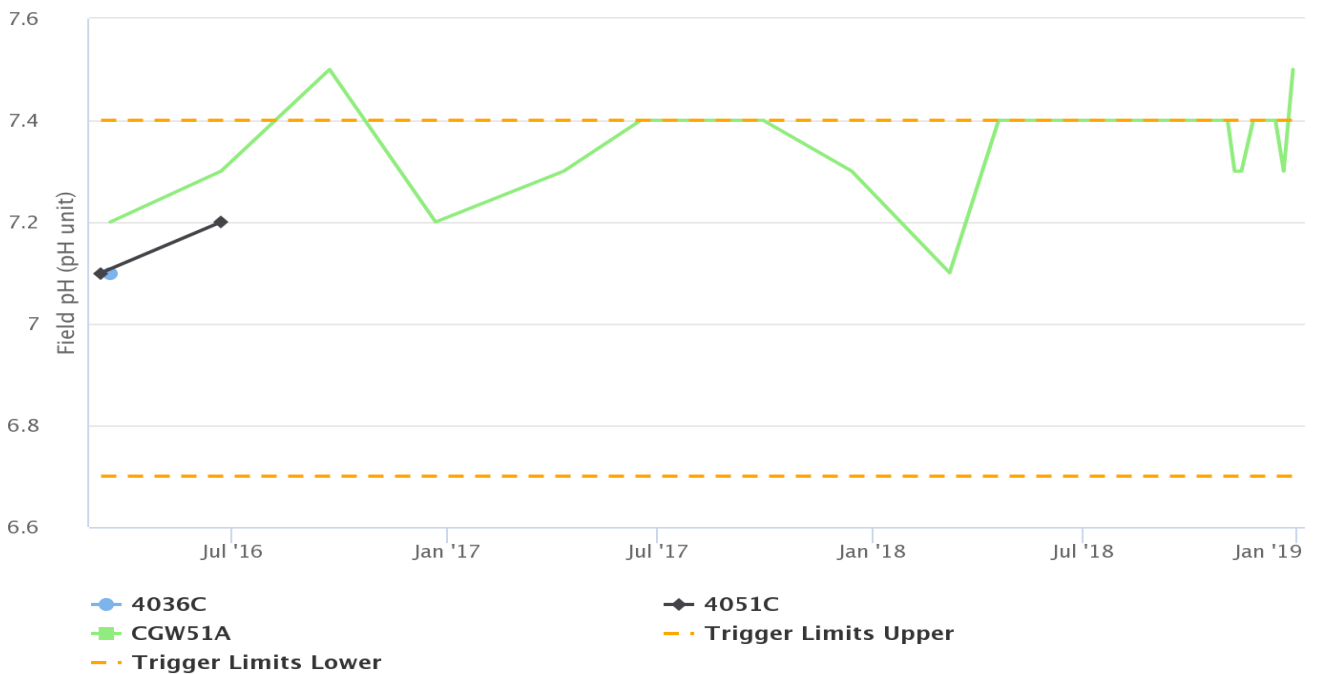
Figure 23 to Figure 76 show the long term trends (2016 – current) for ground water bores monitored at HVO.

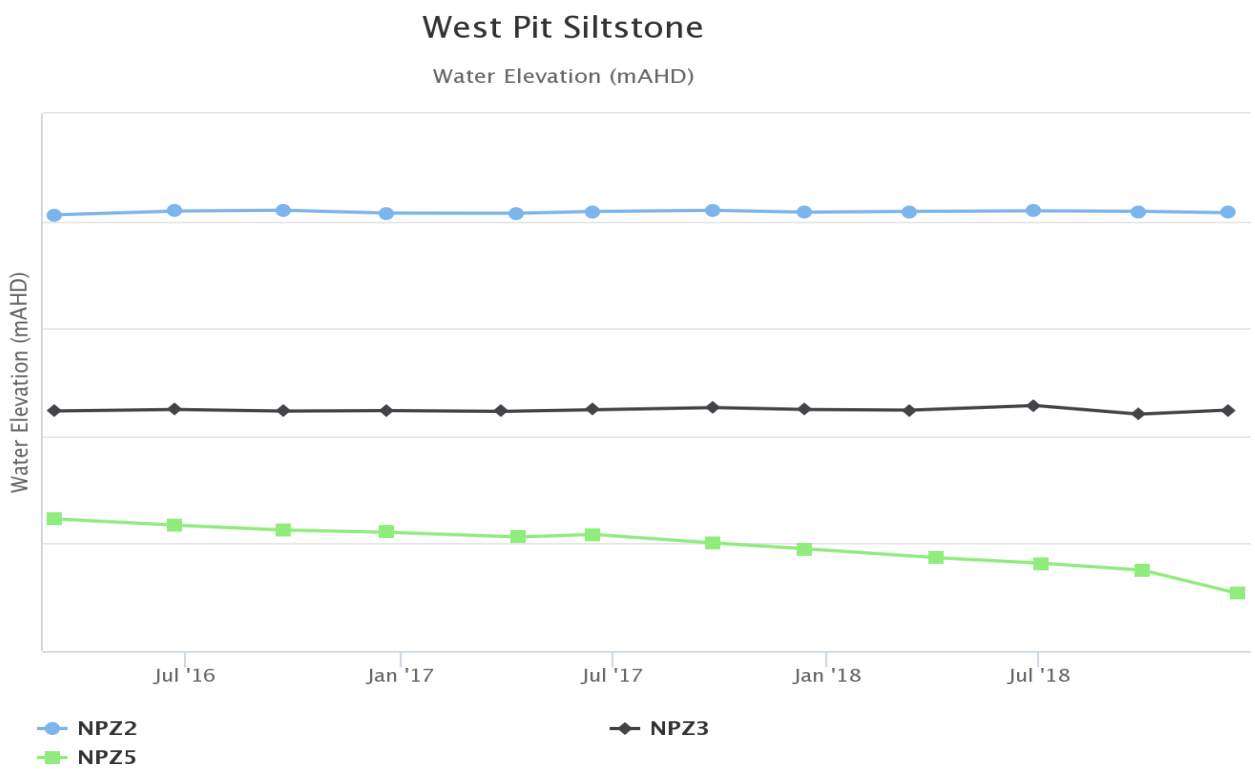
**Figure 67: West Pit Siltstone Standing Water Level – December 2018**

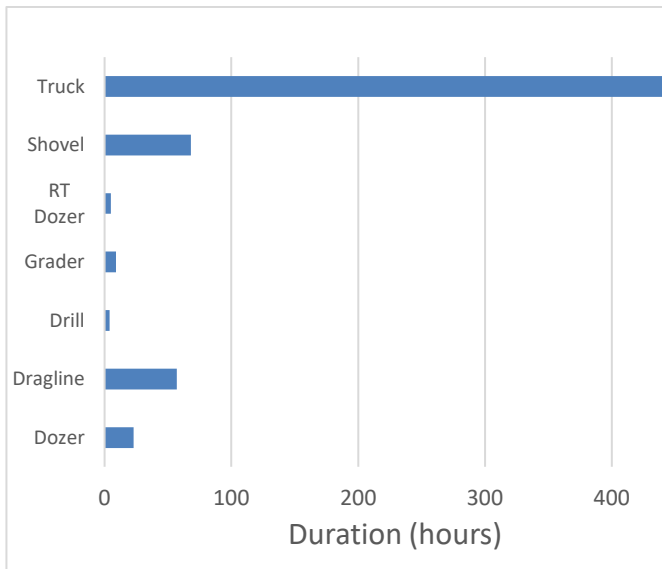
Figure 88: Operational Downtime by Equipment Type – December 2018

During December, a total of 628 hours of equipment downtime was logged in response to real time monitoring and visual inspections for environmental reasons such as dust, noise and meteorological conditions. Operational downtime by equipment type is shown in Figure 88.

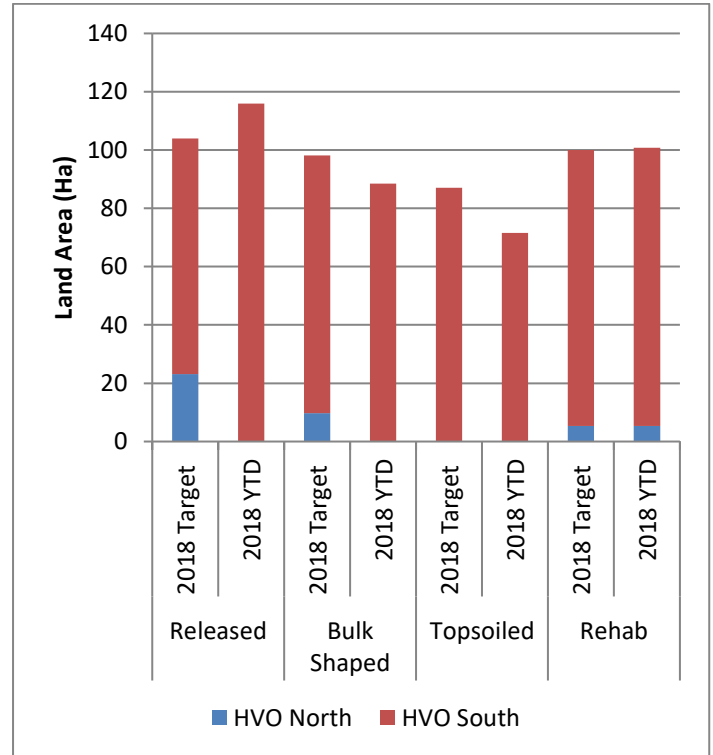
Figure 89: Rehabilitation YTD – December 2018

During December 18.32 Ha of land was released, 0.71 Ha of land was bulk shaped, 16.93 Ha of land was Topsoiled and 13.07 Ha of land was Rehabilitated. Year to date progress can be viewed in Figure 89.
