Rehabilitation Management Plan

Document Number: HVOOC-748212775-24

Hunter Valley Operations

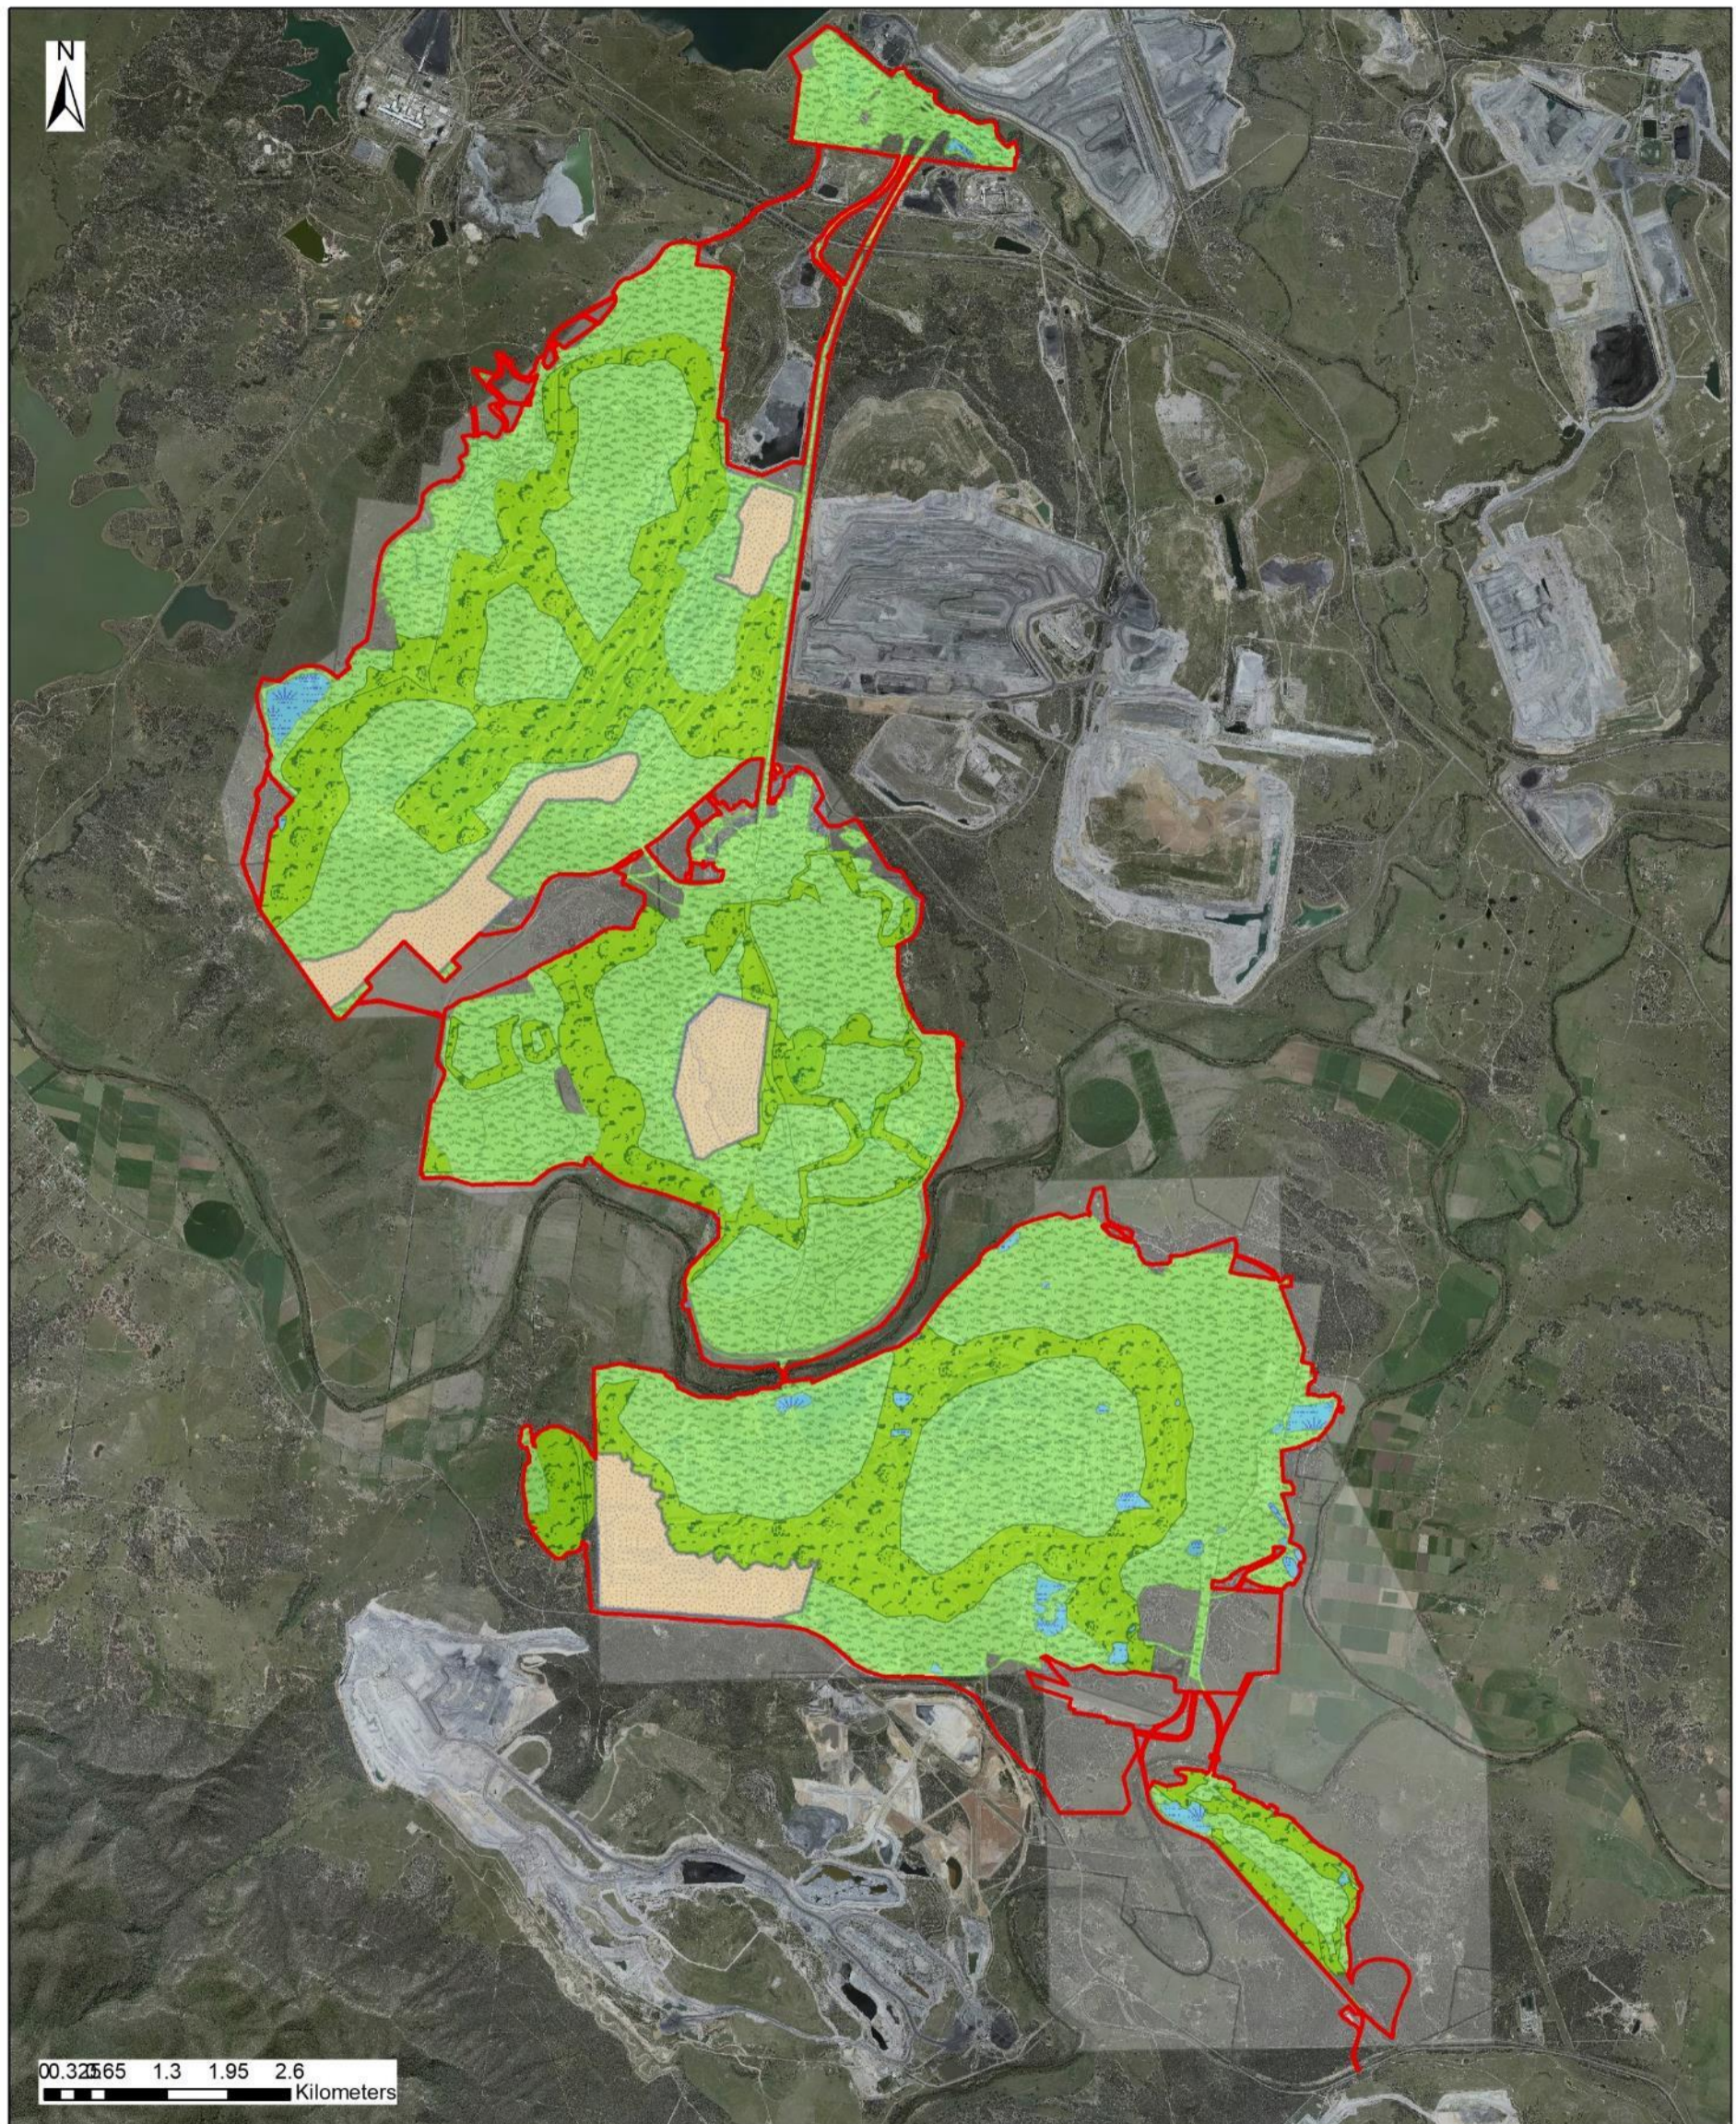
Plan 1: Final Landform Features

- Project Approval Boundary
- Coal Titles
- Final Landuse Domains
- Agricultural – Grazing
- Final Void
- Native Ecosystem
- Water Management Areas
- Final Landform Features

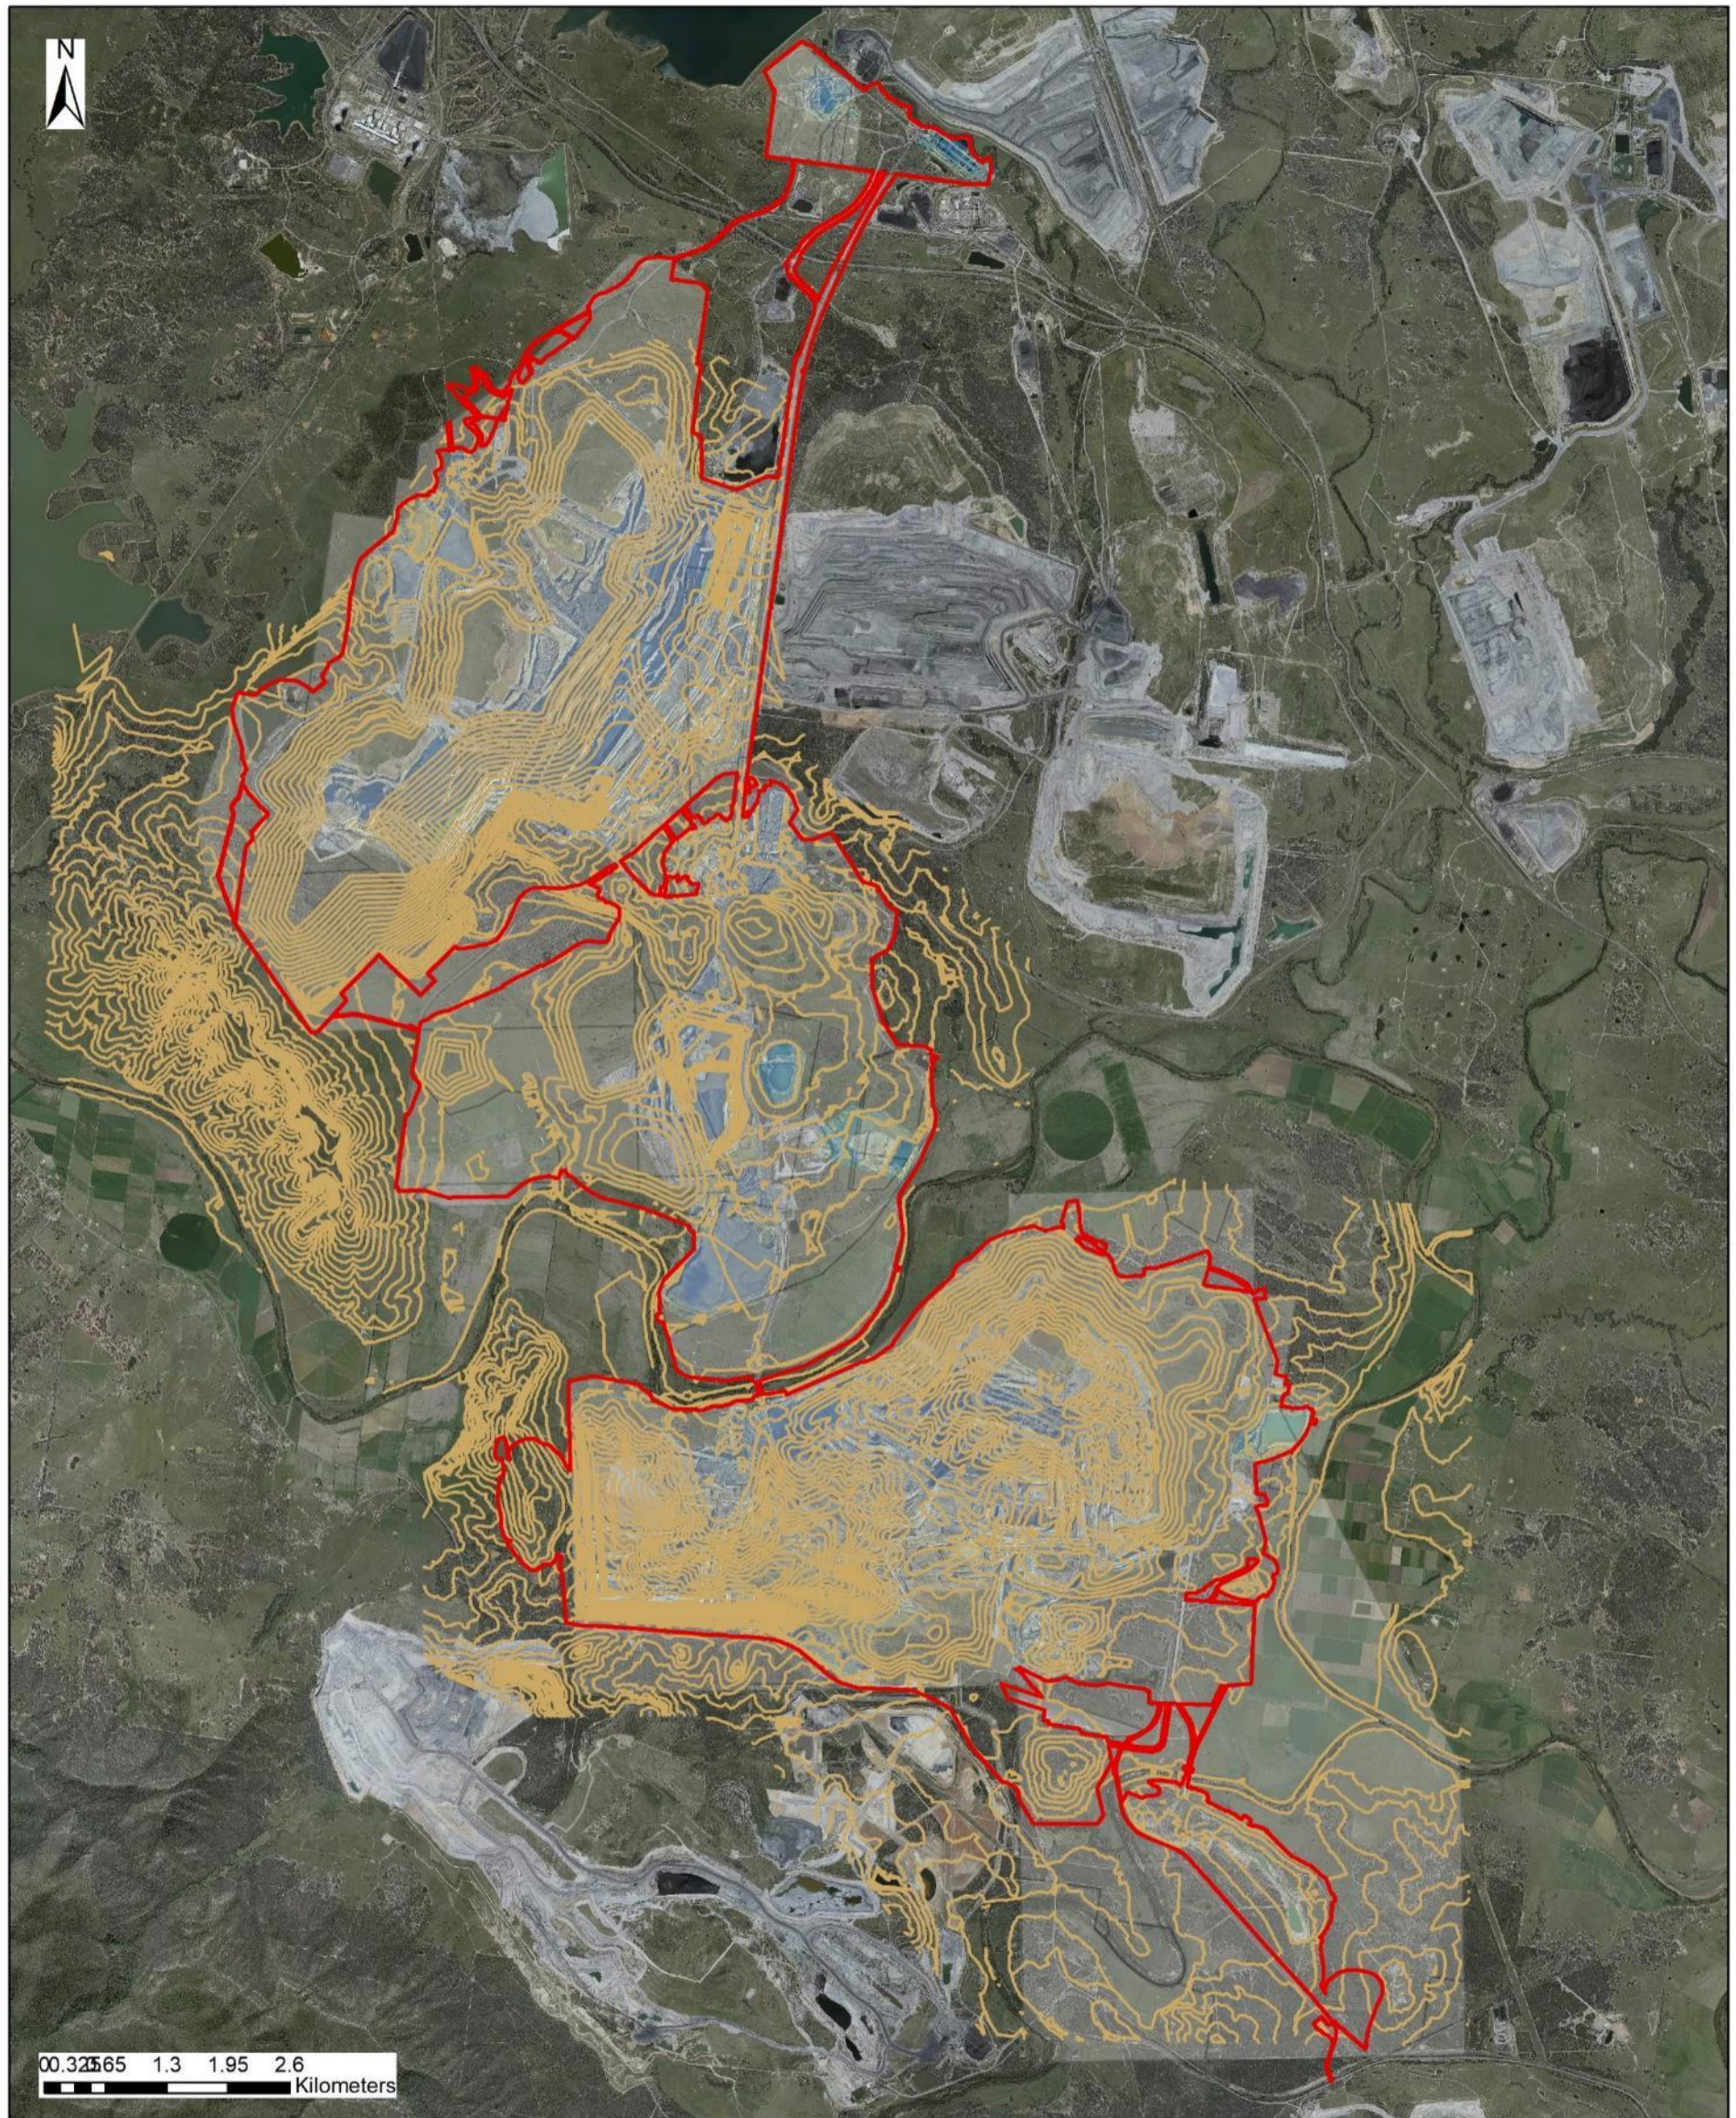
Plan 2: Final Landform Contours

- Project Approval Boundary
- Coal Titles
- Final Landform Contours
