**HUNTER VALLEY**  
OPERATIONS

**MONTHLY  
ENVIRONMENTAL  
MONITORING REPORT  
NOVEMBER 2023**

HVOOC-1797567310-4849

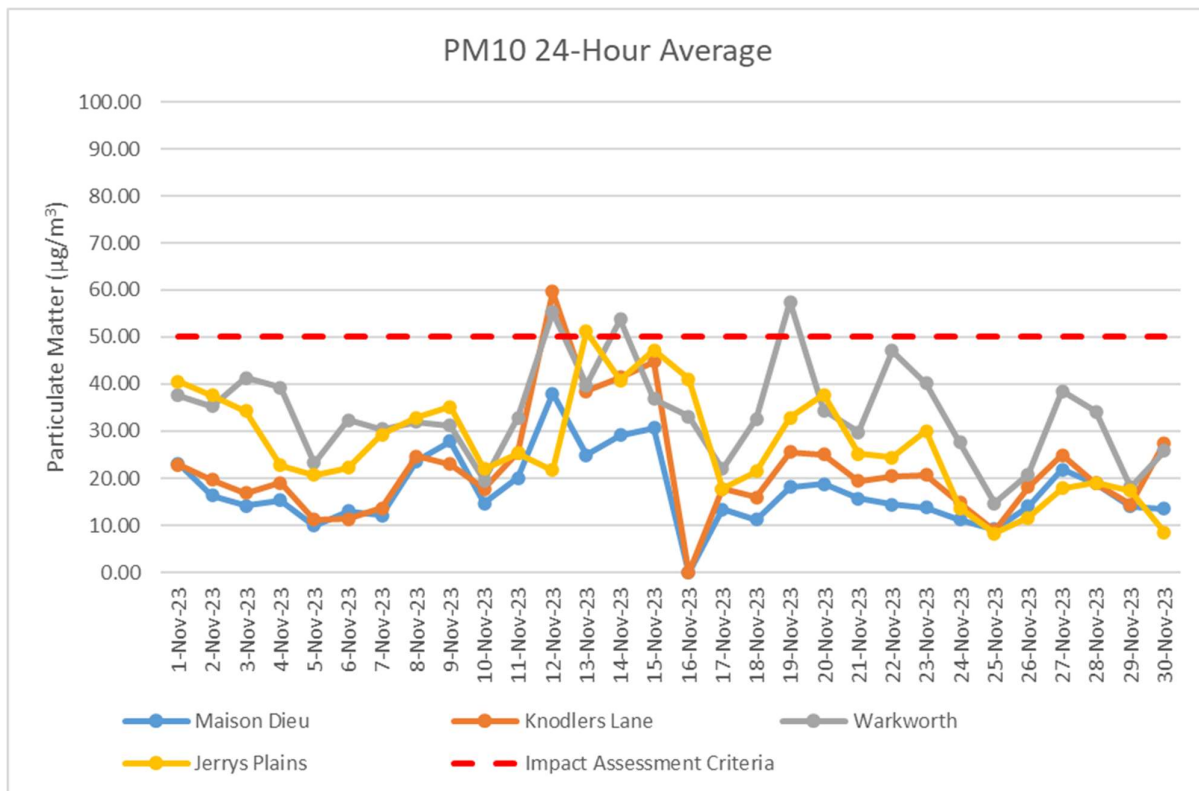
Figure 11 – Real Time PM<sub>10</sub> 24hr for the Reporting Period

Figure 11 shows the daily 24-hour average PM<sub>10</sub> result from the real time monitoring sites. During the reporting period, daily results were below the 24-hr average criteria of 50µg/m<sup>3</sup> with the exception of:

- Knodlers Lane monitor on 12 November; and
- Warkworth on 12, 14 and 19 November.

All exceedances were investigated internally by HVO and it was found that the maximum calculated HVO contribution was below the compliance limit.

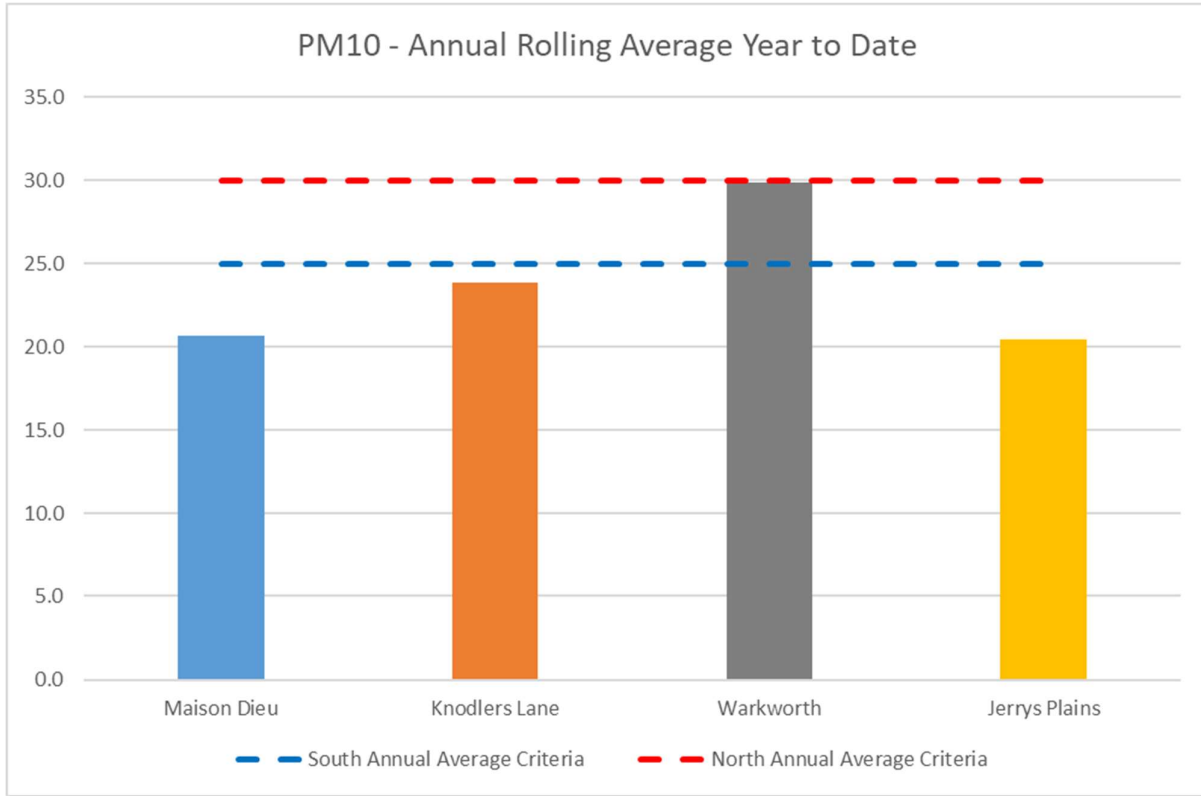
Figure 12 – Real Time PM<sub>10</sub> Annual Average for the Reporting Period

Figure 12 shows the annual rolling average PM<sub>10</sub> results from the real time monitoring sites. The Warkworth monitors annual average result is currently greater than the relevant long-term impact assessment criteria during the reporting period.

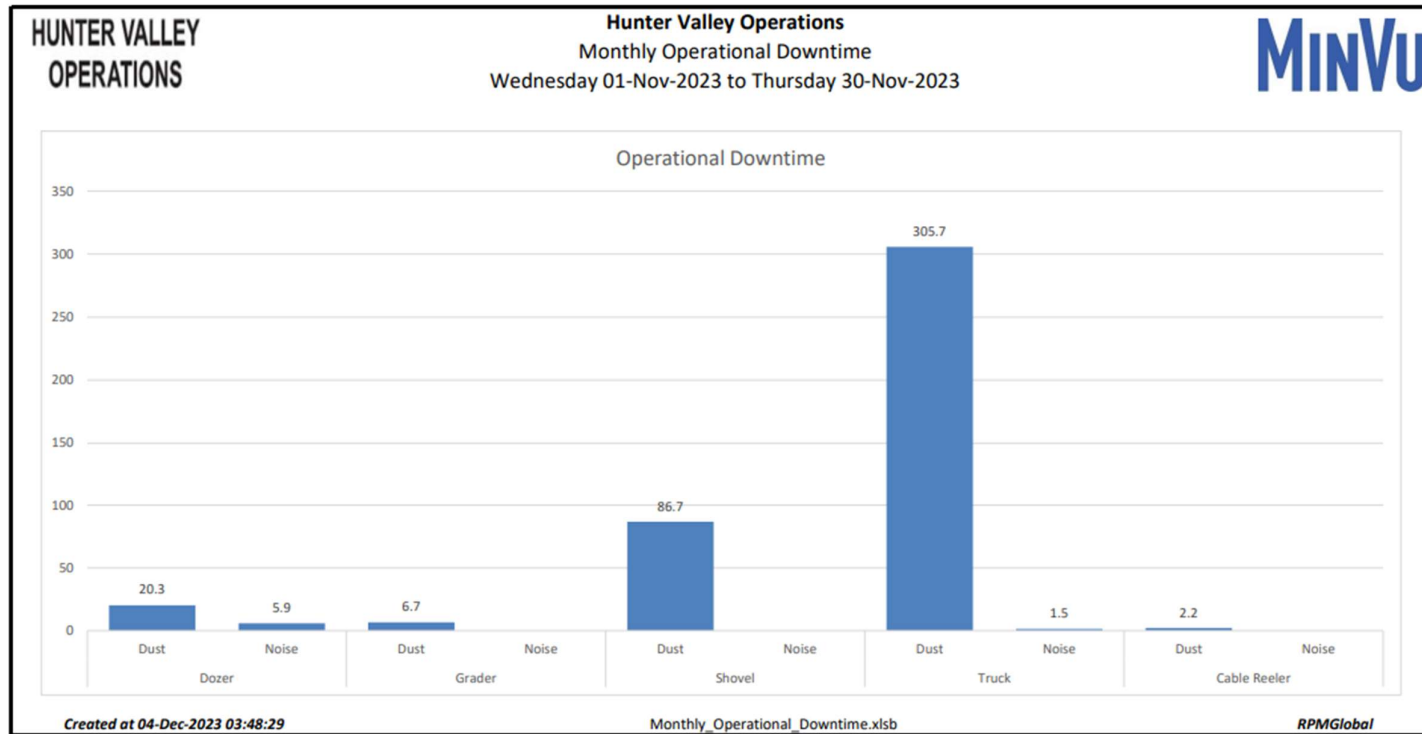
Figure 17 - Operational Downtime by Equipment Type for the Reporting Period

A total of four hundred and twenty-nine (429) hours of equipment downtime was logged in response to real time monitoring and inspections for environmental factors such as noise and dust during the reporting period. Operational downtime by equipment type is show in Figure 17. Note that these delays are instances where operations were completely stopped and does not include occasions where operations were changed/modified but not stopped (e.g. changed from exposed dump to in-pit dump).
