HUNTER VALLEY OPERATIONS

MONTHLY ENVIRONMENTAL MONITORING REPORT FEBRUARY 2025

DOCUMENT NUMBER
HVOOC-1797567310-5223

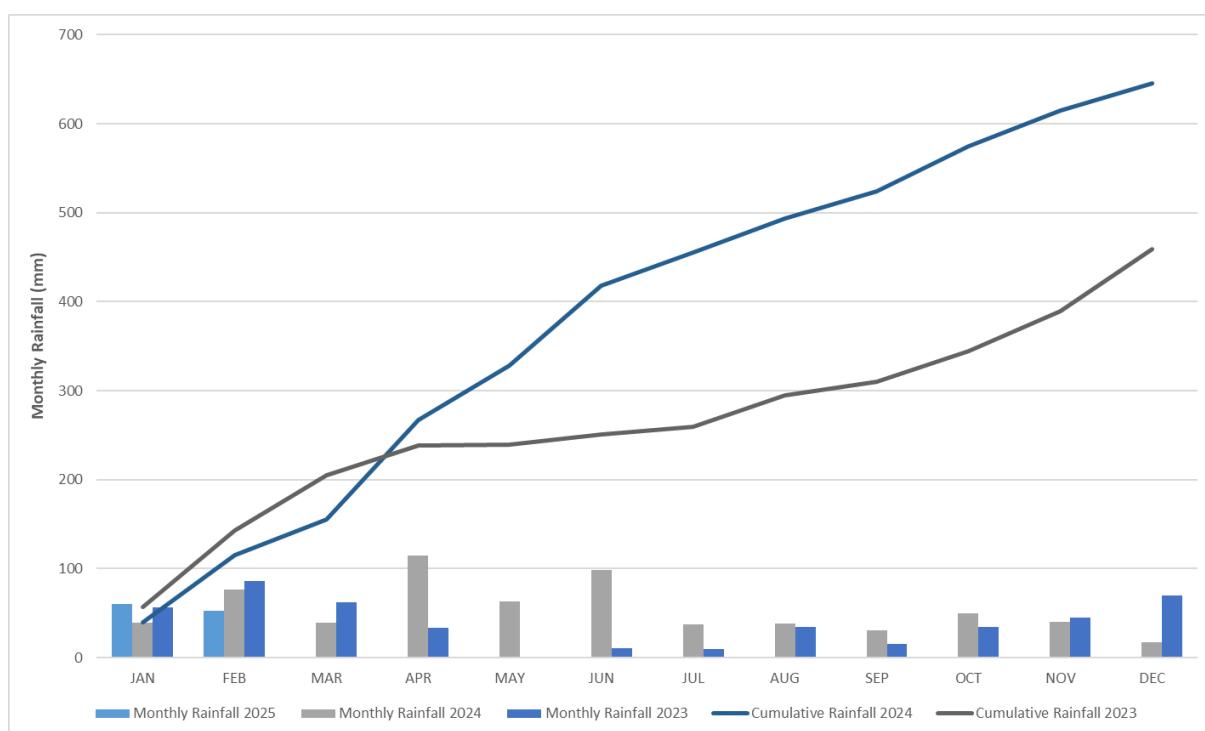
Figure 1 - Rainfall Summary 2023 – 2025

Rainfall recorded at the HVO Corporate weather station during the period is summarised in Table 1. The 2023, 2024 and 2025 trends are shown in Figure 1.

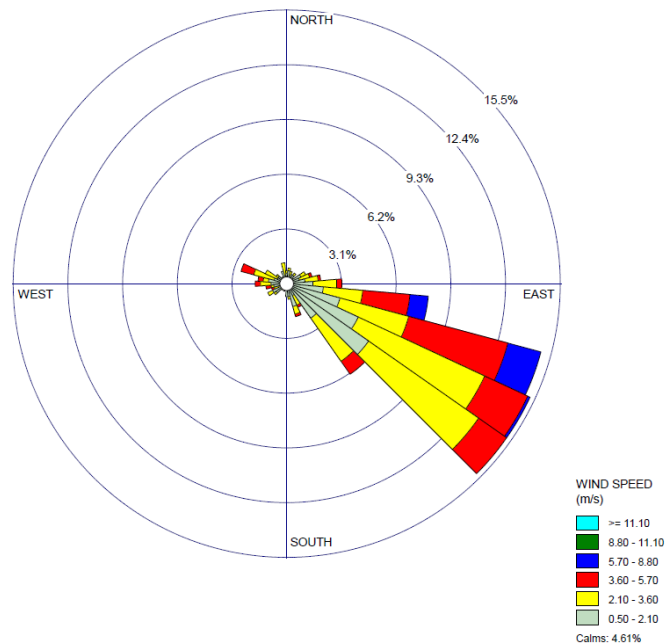
Figure 2 – HVO Corporate Wind Rose for the Reporting Period

Figure 2 and Figure 3 wind roses show wind speeds and directions during the reporting period at HVO Corporate and Cheshunt meteorological stations. South easterly winds were prevailing at both the HVO Corporate and HVO Cheshunt weather stations during the reporting period.

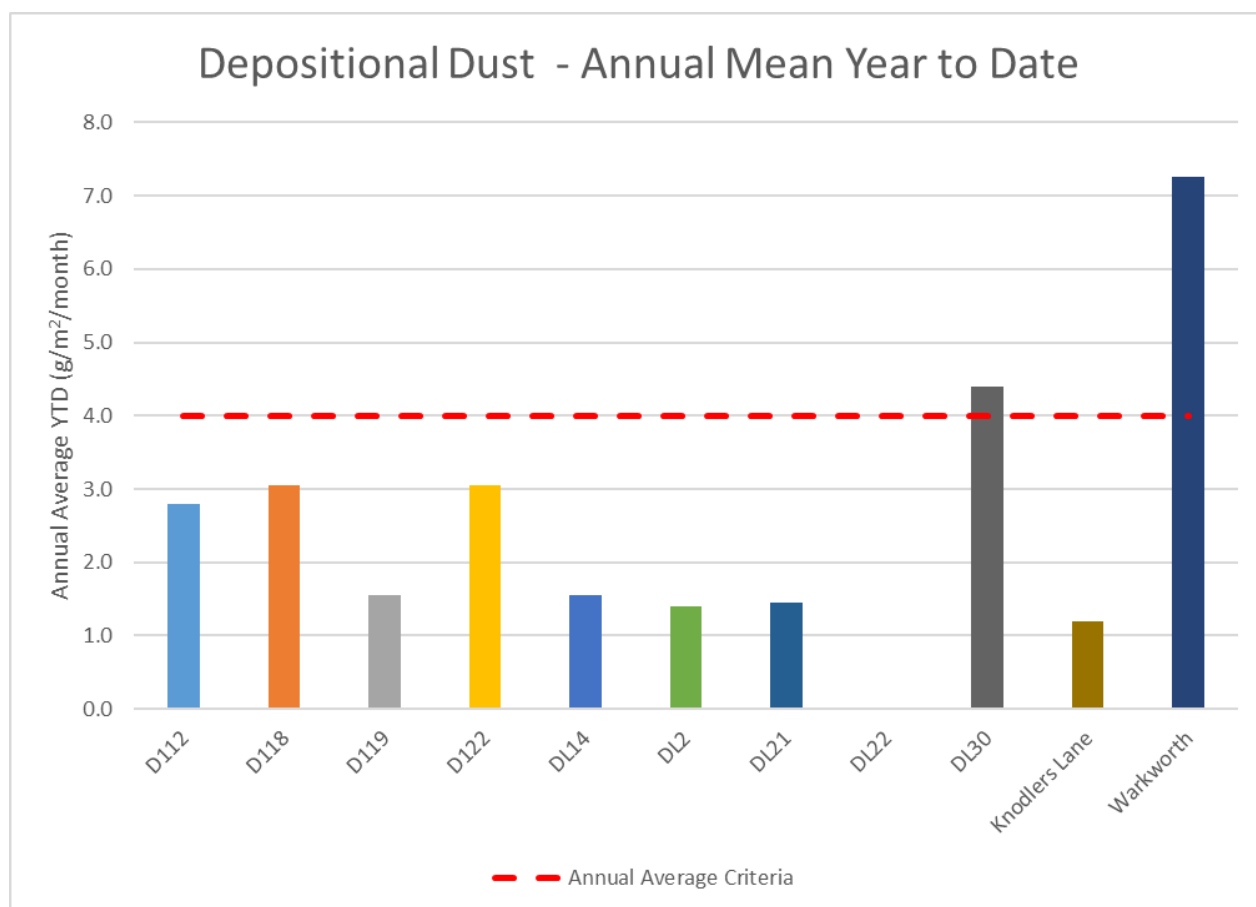
Figure 5 – YTD Depositional Dust Results as at end of the Reporting Period

Figure 5 displays year-to-date (YTD) insoluble solids results from depositional dust gauges during the reporting period compared against the annual impact assessment criteria. Any monthly results deemed to be contaminated (due to presence of bird droppings, insects, etc.) are not displayed. An assessment of HVO's contribution against the long-term impact assessment criteria will be provided in the 2025 Annual Review.

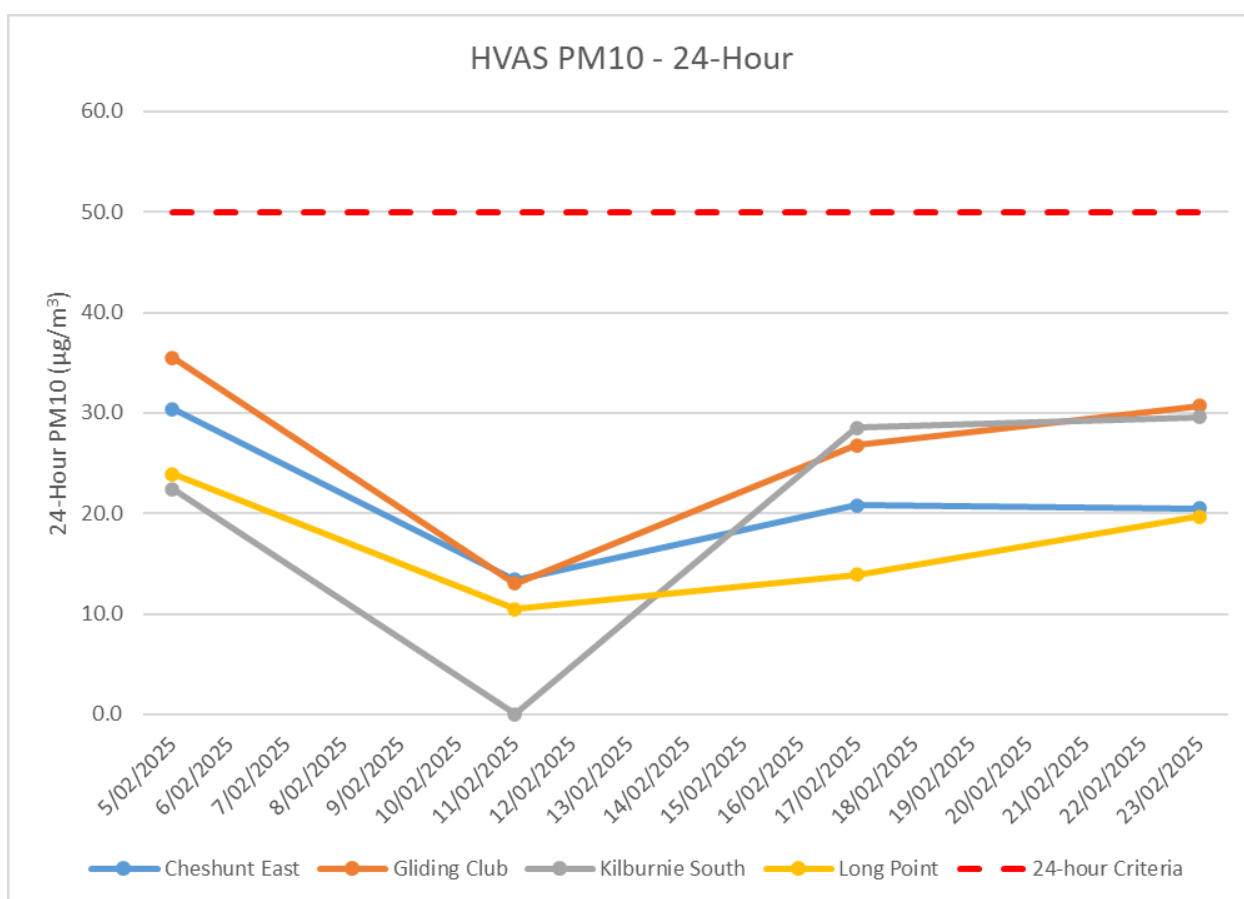
Figure 6 – Individual PM₁₀ Results for the Reporting Period

Figure 6 shows individual PM₁₀ results at each monitoring station against the short-term impact assessment criteria of 50µg/m³ for the reporting period. All monitors were below the short-term impact assessment criteria during the reporting period.

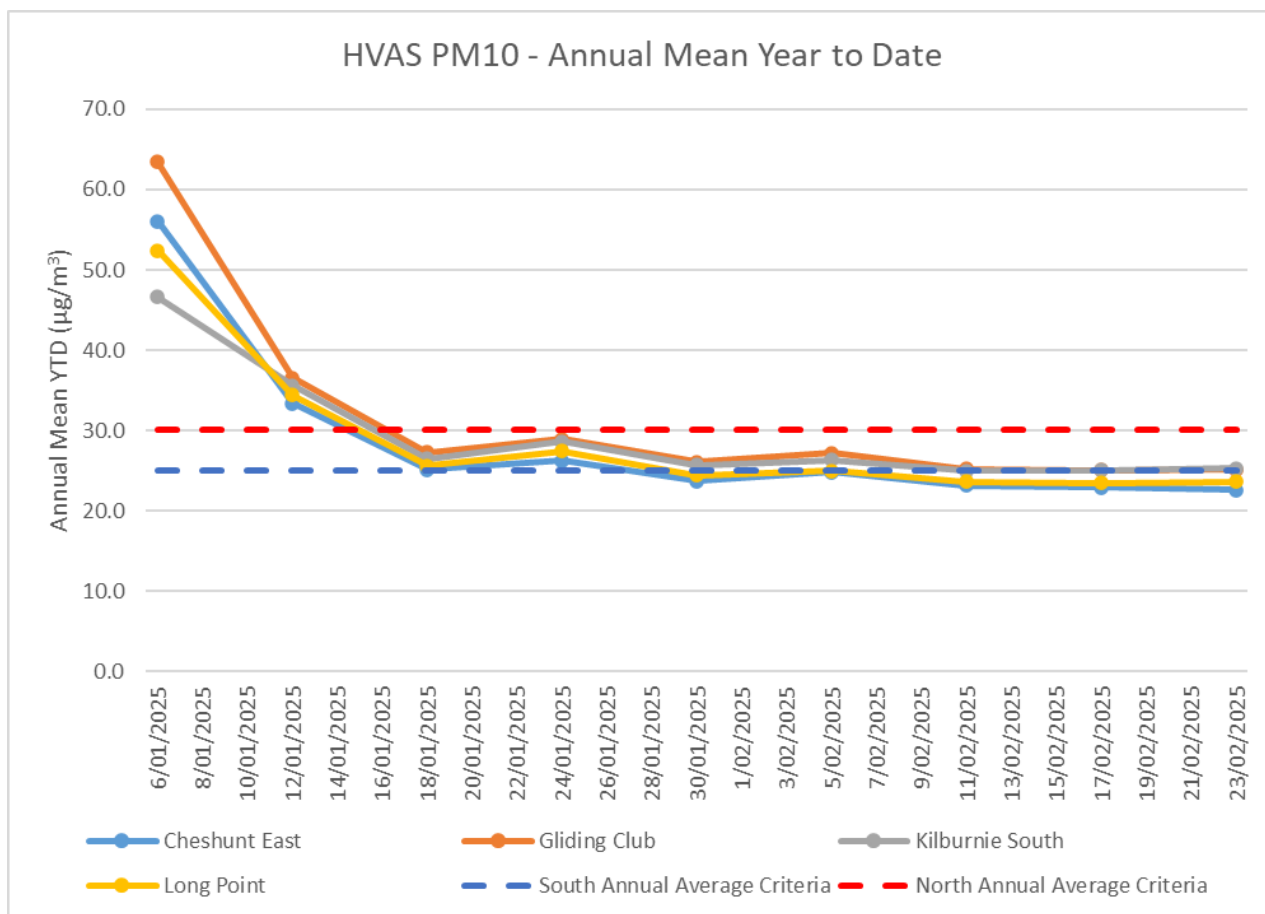
Figure 7 – Year to Date Average PM₁₀ as at end of the Reporting Period

Figure 7 shows the year-to-date rolling annual average PM₁₀ results. All site monitors annual averages reported at the end of the period were below the North Annual Average Criteria. Both Gliding Club and Kilburnie South monitoring sites were above the South Annual Average Criteria whereas Long Point and Cheshunt East sites were the only two below the South criteria.

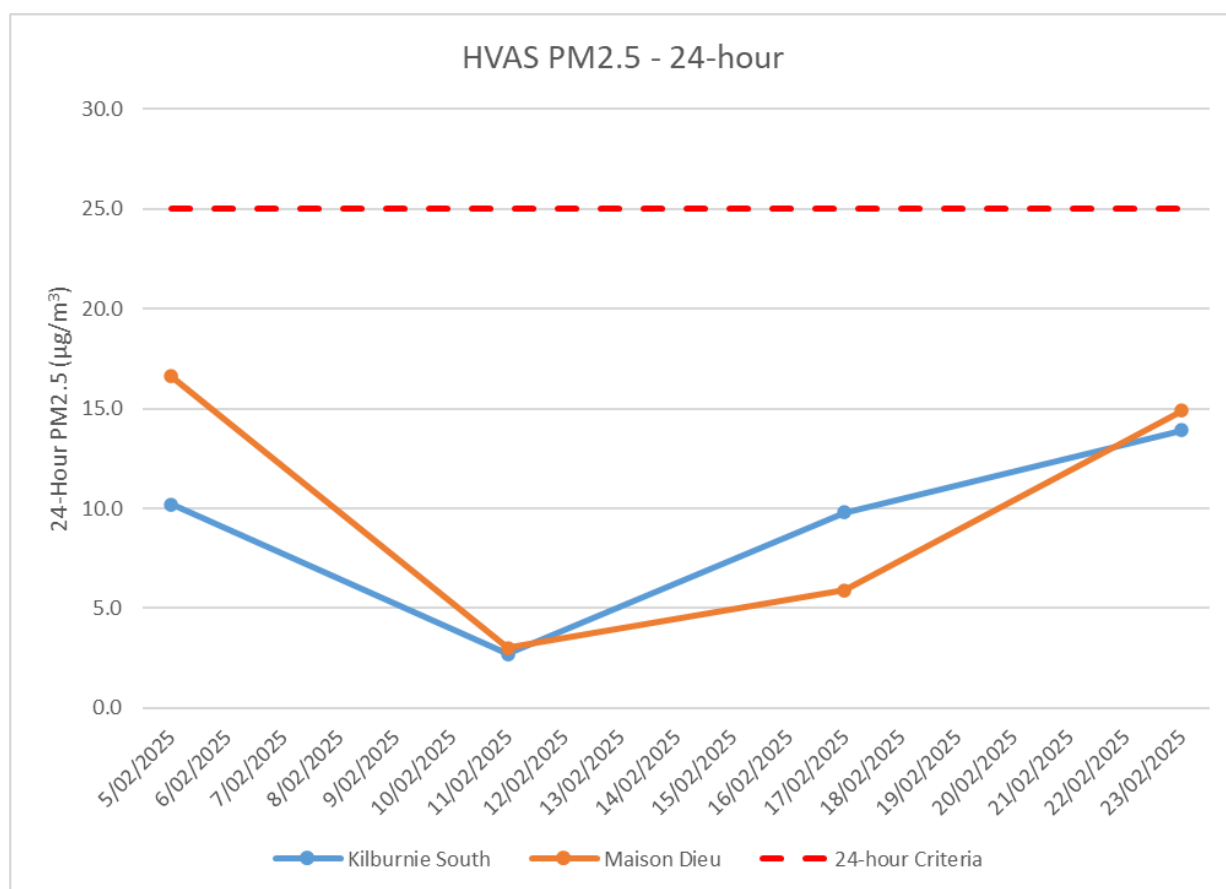
Figure 8 - Results for the Reporting Period

Figure 8 shows individual PM_{2.5} results at each monitoring station against the HVO South short-term impact assessment criteria of 25µg/m³ for the reporting period. Both monitors were below the relevant short-term impact assessment criteria during the reporting period.

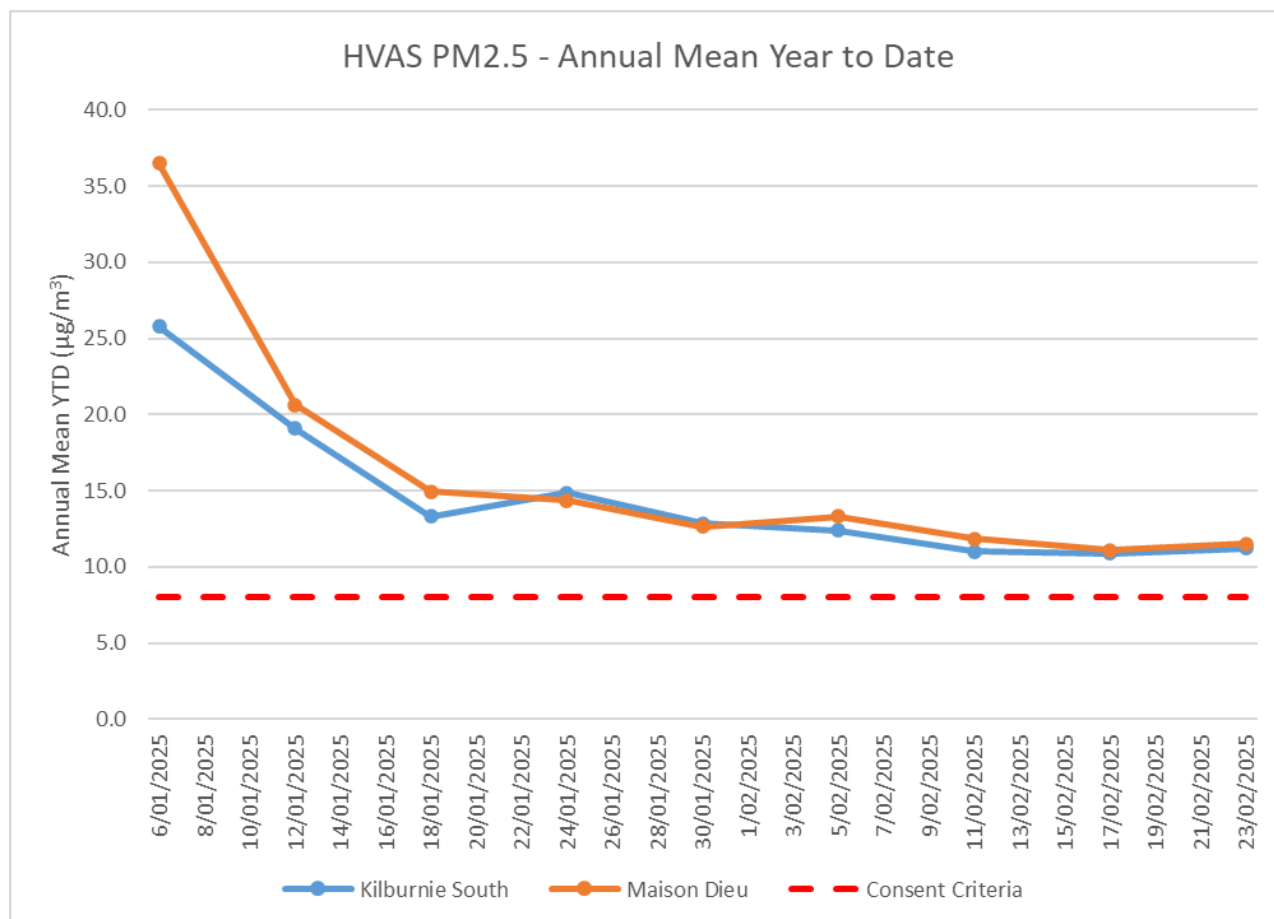
Figure 9 - Year to Date Average $PM_{2.5}$ as at end of the Reporting Period

Figure 9 shows the year-to-date annual average $PM_{2.5}$ results. During the reporting period, the annual average year to date results of both monitors were above the $PM_{2.5}$ annual rolling mean criteria of $8\mu g/m^3$. An assessment of HVO's contribution against the long-term impact assessment criteria will be provided in the 2025 Annual Review.

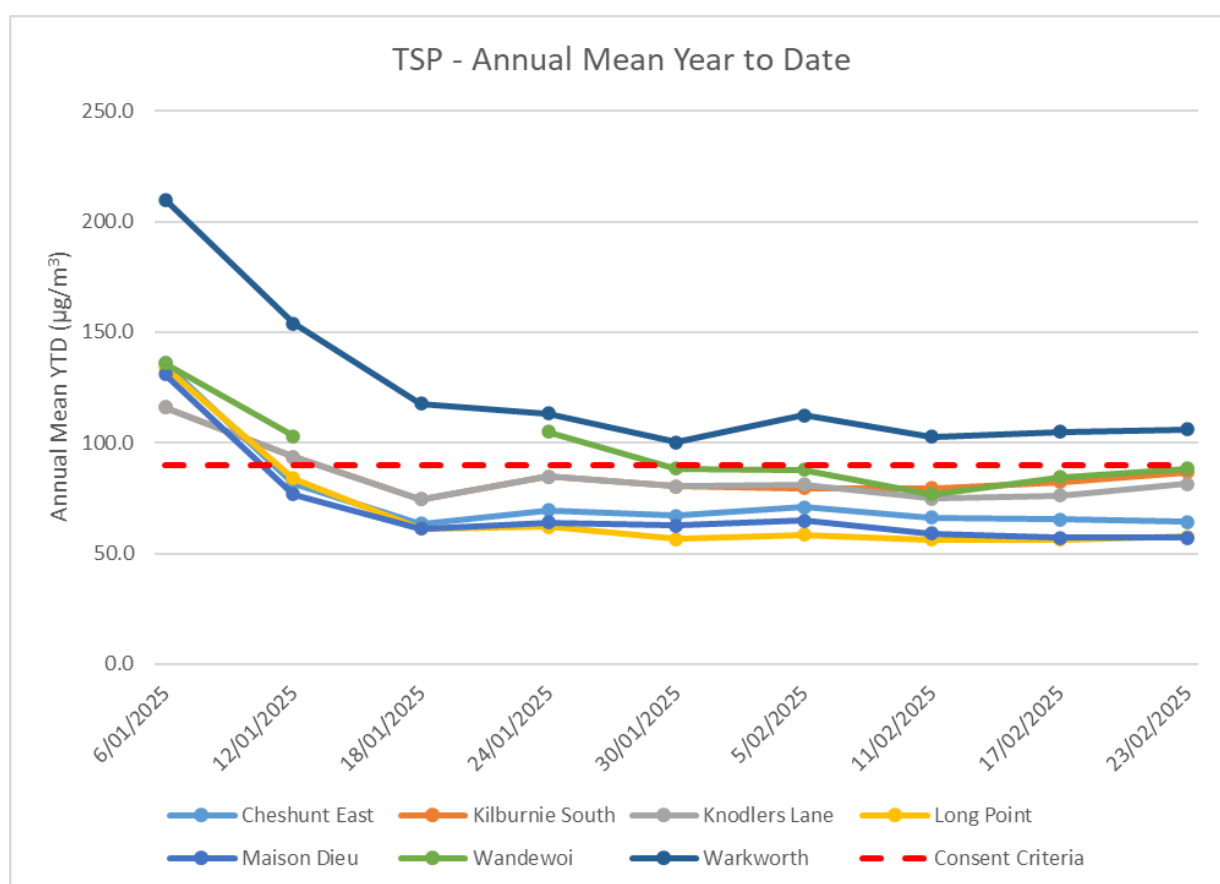
Figure 10 - Year to Date Average Total Suspended Particulates as at end of the Reporting Period

Figure 10 shows the annual average TSP results compared against the long-term impact assessment criteria of $90\mu\text{g}/\text{m}^3$.

All monitors, except for Warkworth, were below the relevant long-term impact assessment criteria during the reporting period.

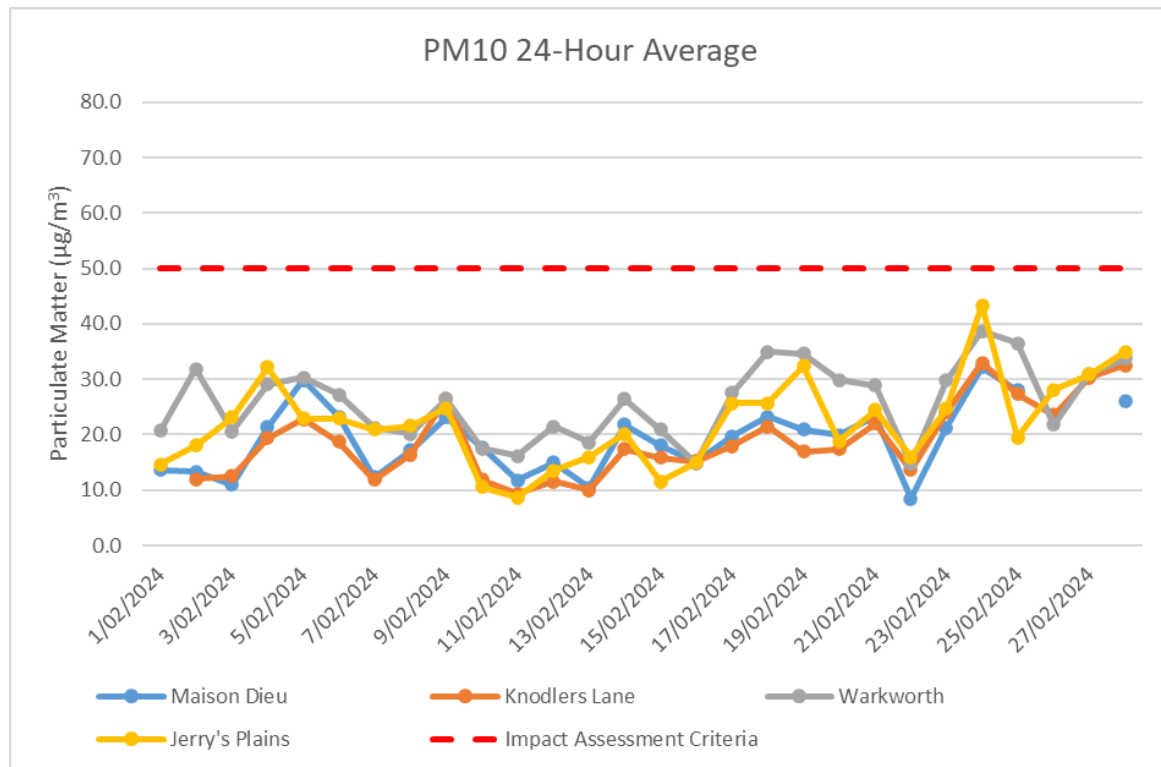
Figure 11 – Real Time PM_{10} 24hr for the Reporting Period

Figure 11 shows the daily 24-hour average PM₁₀ results from the real time monitoring sites. During the reporting period, daily results were below the 24-hr average criteria of 50µg/m³.

The below listed monitors reported data capture rates of less than 75% on the respective dates, therefore these results are not displayed on **Figure 11**.

- Knodlers Lane on 1 February; and
- Mason Dieu on 26 and 27 February.

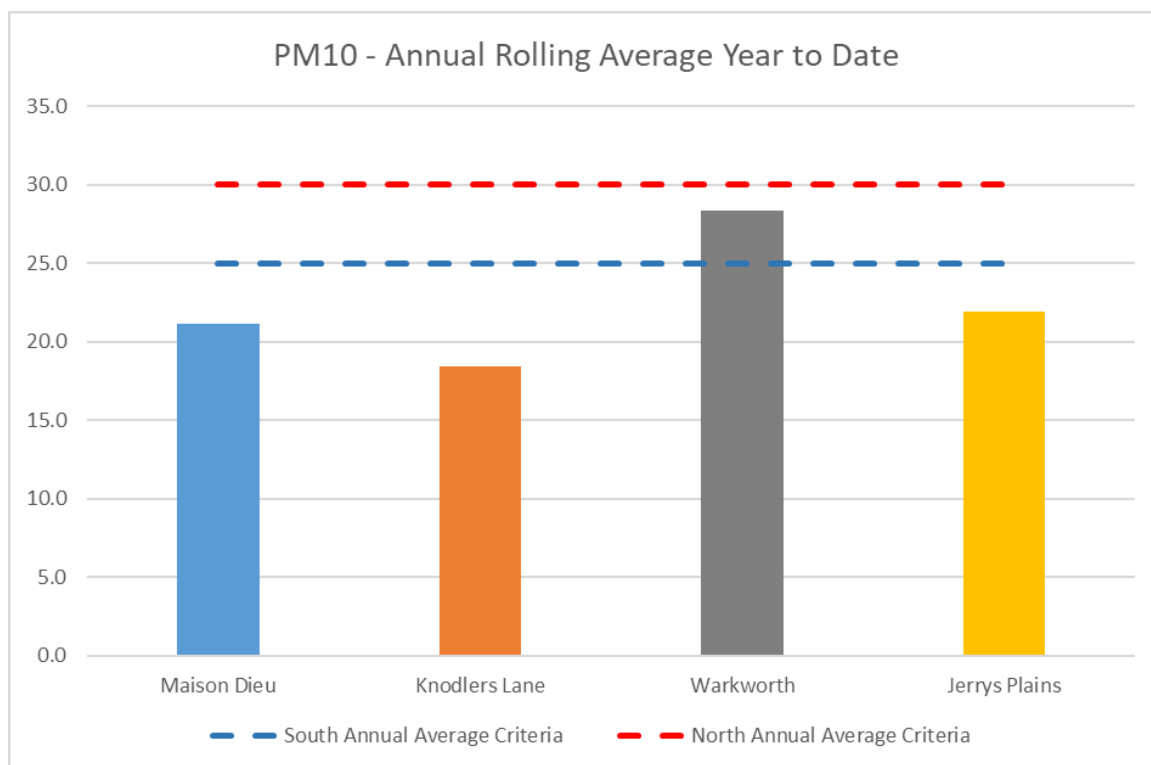
Figure 12 – Real Time PM_{10} Annual Average for the Reporting Period

Figure 12 shows the annual rolling average PM₁₀ results from the real time monitoring sites. All monitoring results were below the annual average for the relevant long-term impact assessment criteria for North and South during the reporting period, with the exception of Warkworth, which was below North but above South.

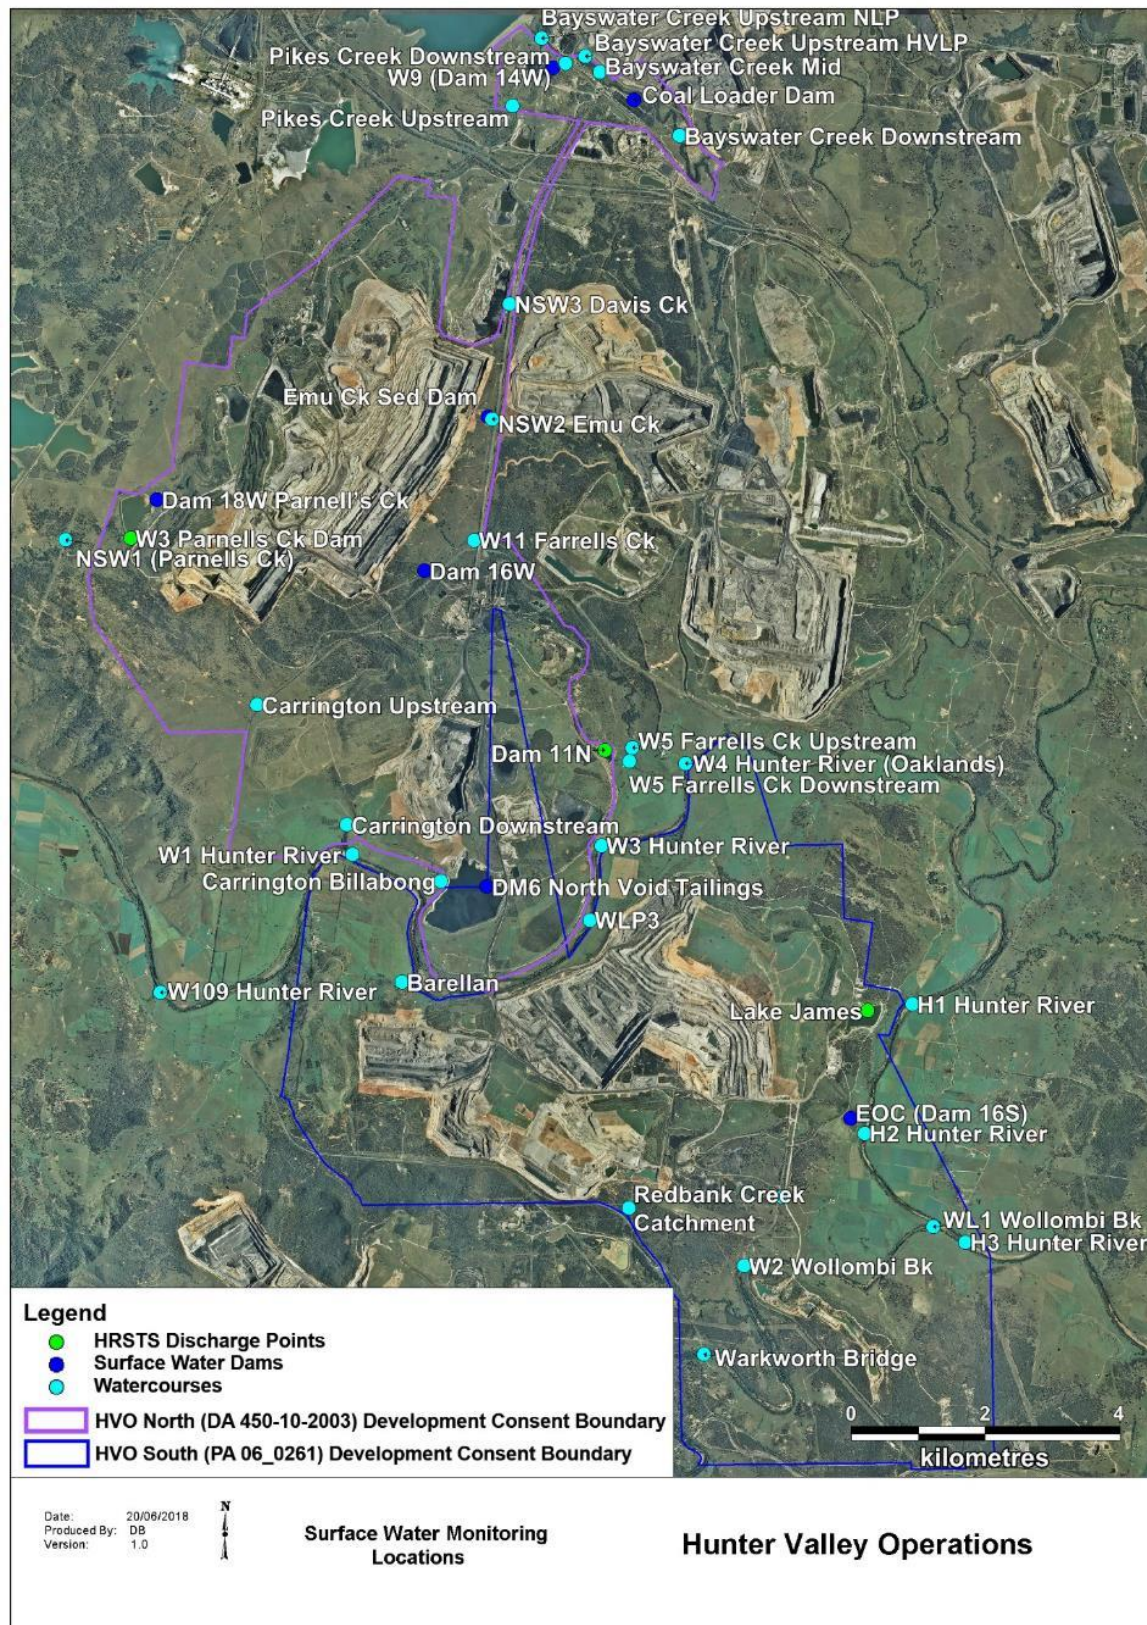
Figure 13 – HVO Surface Water Monitoring Locations

Surface watercourses are sampled on a quarterly sampling regime. Water quality is assessed through the parameters of pH, electrical conductivity (EC) and Total Suspended Solids (TSS). The location of surface water monitoring points across HVO is shown in Figure 13.

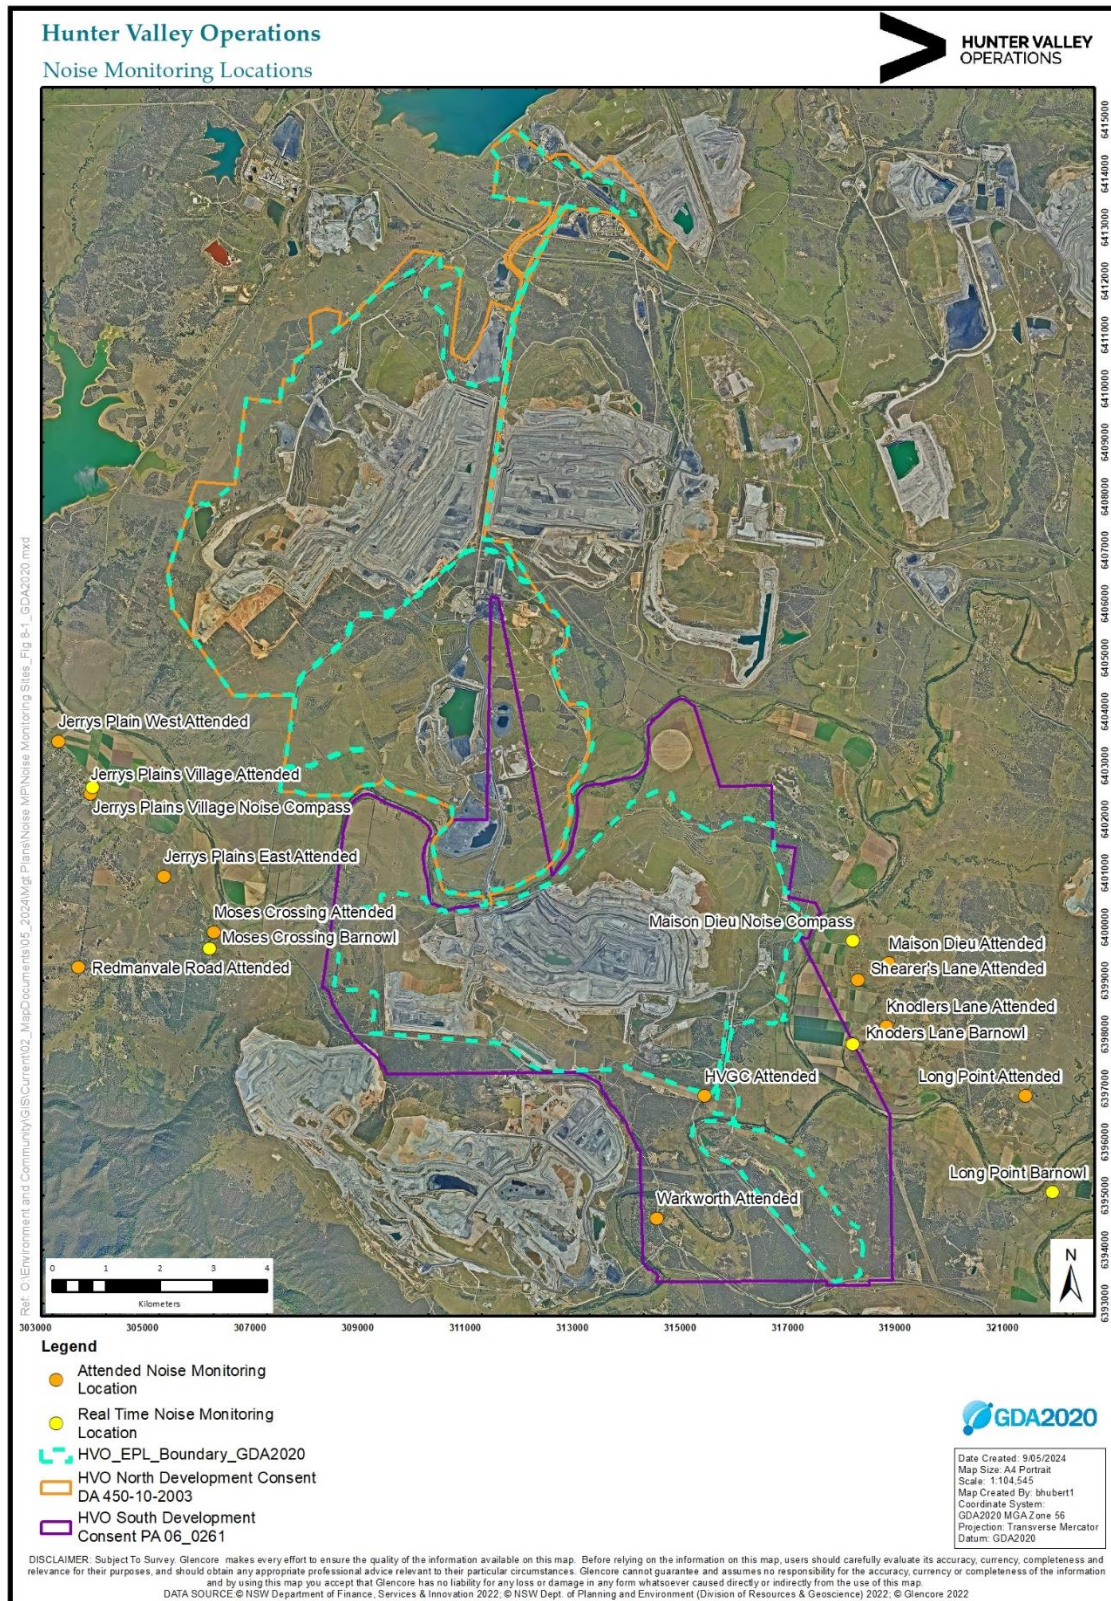
Figure 16 - Noise Monitoring Location Plan

Routine attended noise monitoring occurs at defined locations around HVO, as described in the HVO Noise Monitoring Programme. The noise monitoring aims to quantify and describe the acoustic environment around the site and compare results with specified limits. The attended noise monitoring locations are displayed in Figure 16.

HVO utilises a network of real-time directional noise monitors to manage noise impacts on a continuous basis, shown in Figure 16. Noise alarms are in place at five monitoring locations (Knodlers Lane, Maison Dieu, Jerrys Plains, Moses Crossing, and Long Point) which alert HVO staff to elevated noise levels that require investigation.

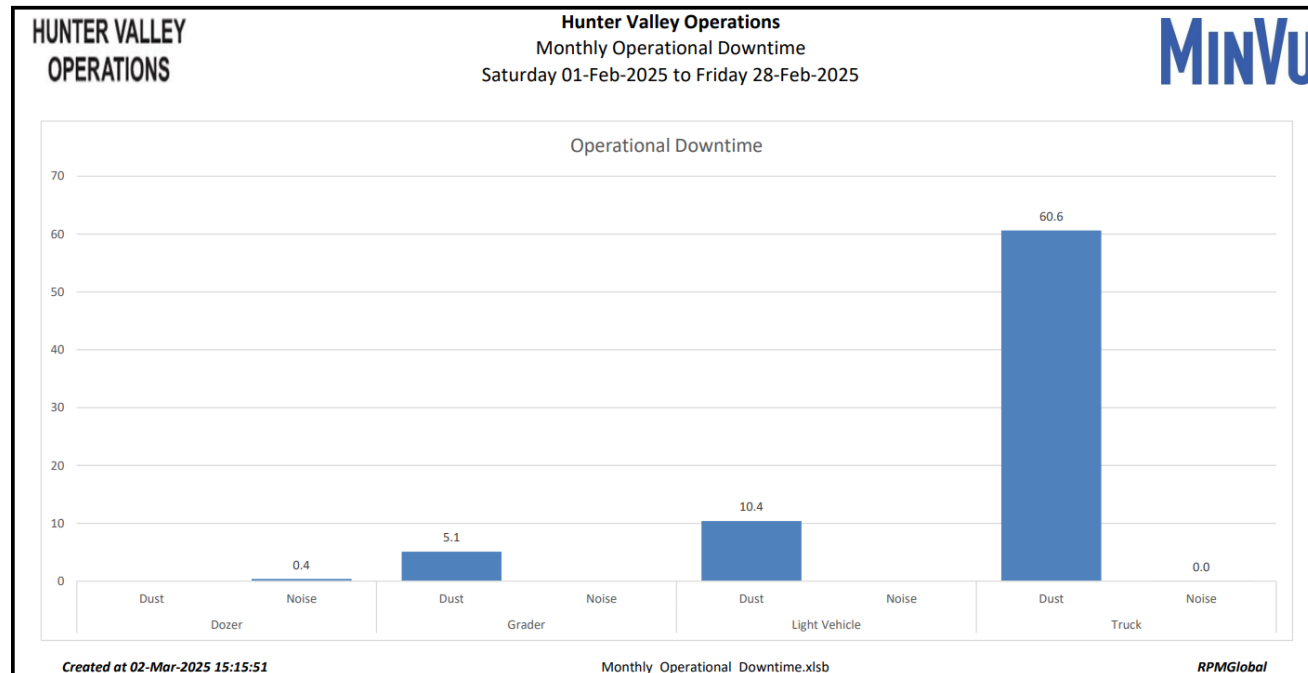
Figure 17 - Operational Downtime by Equipment Type for the Reporting Period

Operational downtime by equipment type is show in Figure 17. Note that these delays are instances where operations were completely stopped and does not include occasions where operations were changed/modified but not stopped (e.g. changed from exposed dump to in-pit dump).

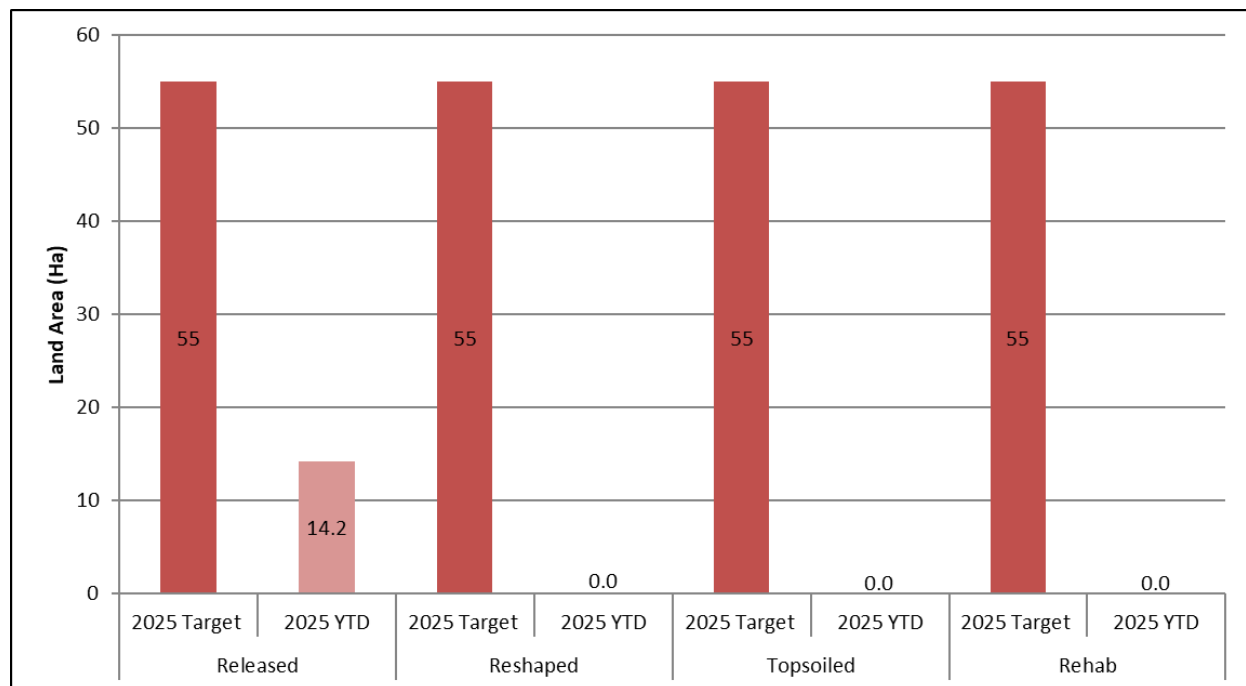
Figure 18 - Rehabilitation YTD February 2025

Year to date progress is shown in Figure 18.
