HUNTER VALLEY
OPERATIONS

**MONTHLY
ENVIRONMENTAL
MONITORING REPORT
NOVEMBER 2025**

DOCUMENT NUMBER
HVOOC-1797567310-5461

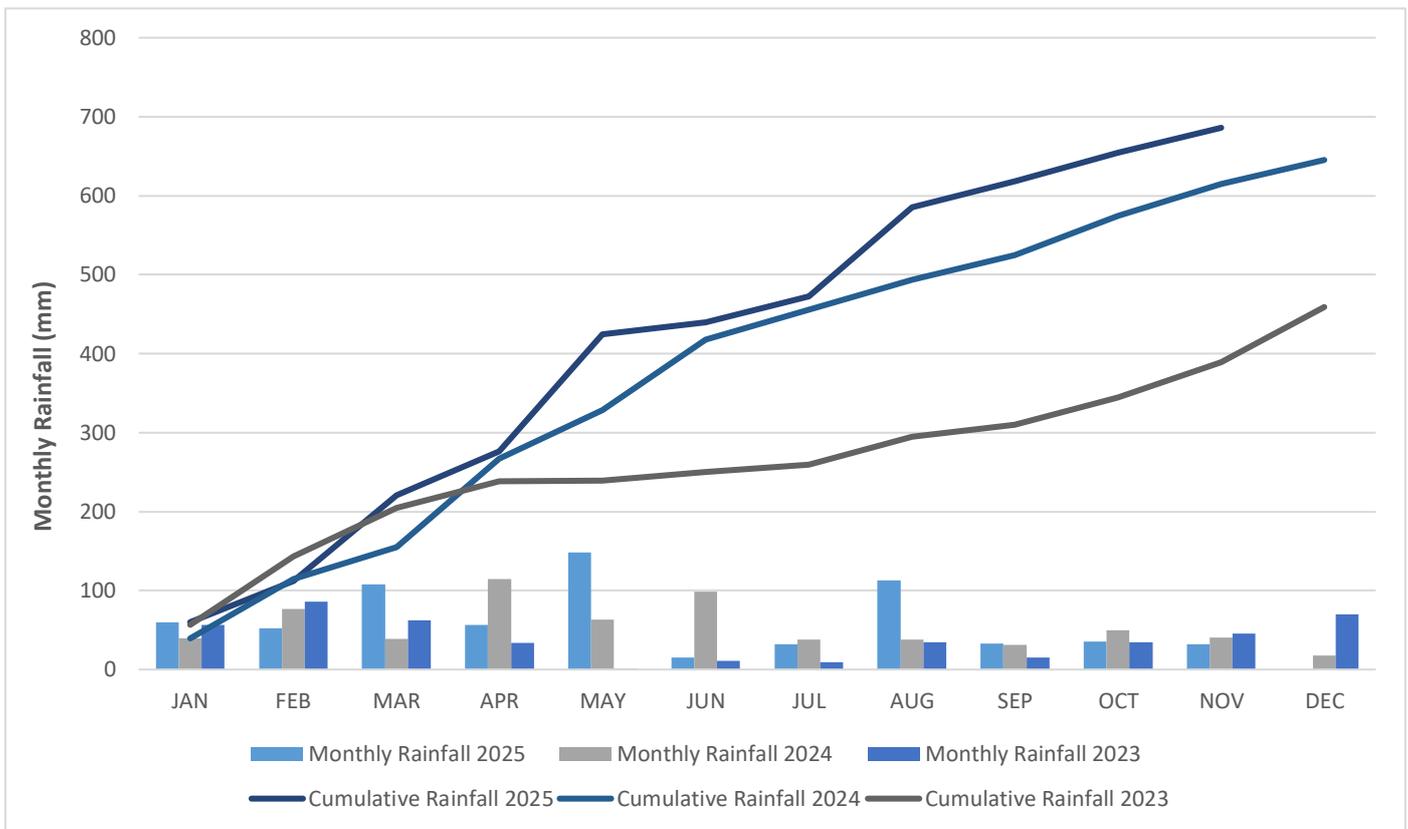
Figure 1 - Rainfall Summary 2023 – 2025

Rainfall recorded at the HVO Corporate weather station during the period is summarised in Table 1. The 2023, 2024 and 2025 trends are shown in Figure 1.

2025	Monthly Rainfall (mm)	Cumulative Rainfall (mm)
November	32.0	686.0

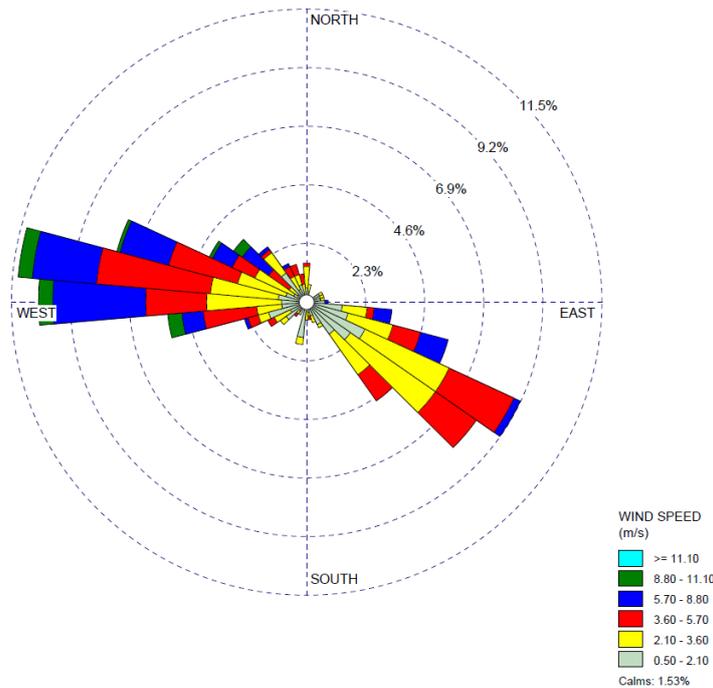
Figure 2 – HVO Corporate Wind Rose for the Reporting Period

Figure 2 and Figure 3 wind roses show wind speeds and directions during the reporting period at HVO Corporate and Cheshunt meteorological stations. Westerly and South Easterly winds were prevailing at HVO Corporate weather station, and North Westerly winds were prevailing at the HVO Cheshunt weather station during the reporting period.

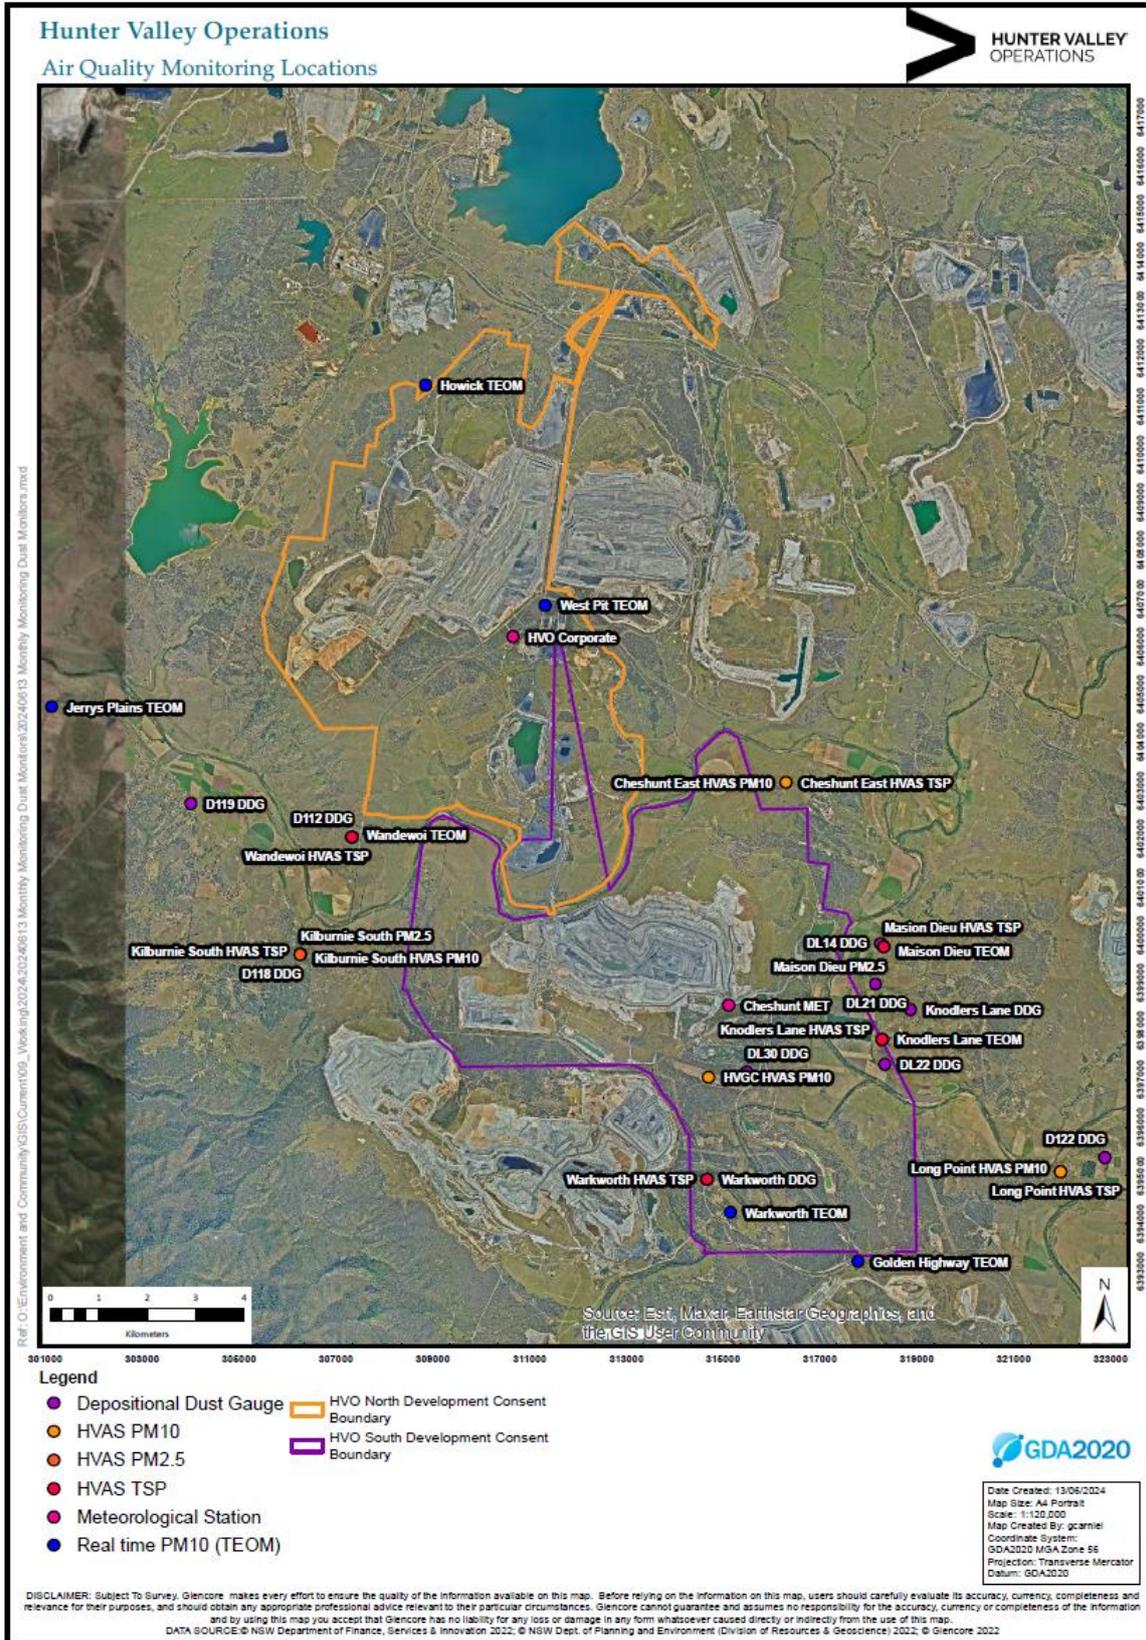
Figure 4 – Air Quality Monitoring Location Plan

HVO maintains two meteorological stations: 'HVO Corporate' and 'Cheshunt' (refer to Figure 4).

Suspended particles are measured by a network of High-Volume Air Samplers (HVAS) measuring Total Suspended Particulates (TSP) and Particulate Matter <10µm (PM10). The Kilburnie South and Maison Dieu HVAS also monitor Particulate Matter <2.5µm (PM2.5). The location of these monitors is presented in Figure 4. Each HVAS runs for 24-hours on a six-day cycle.

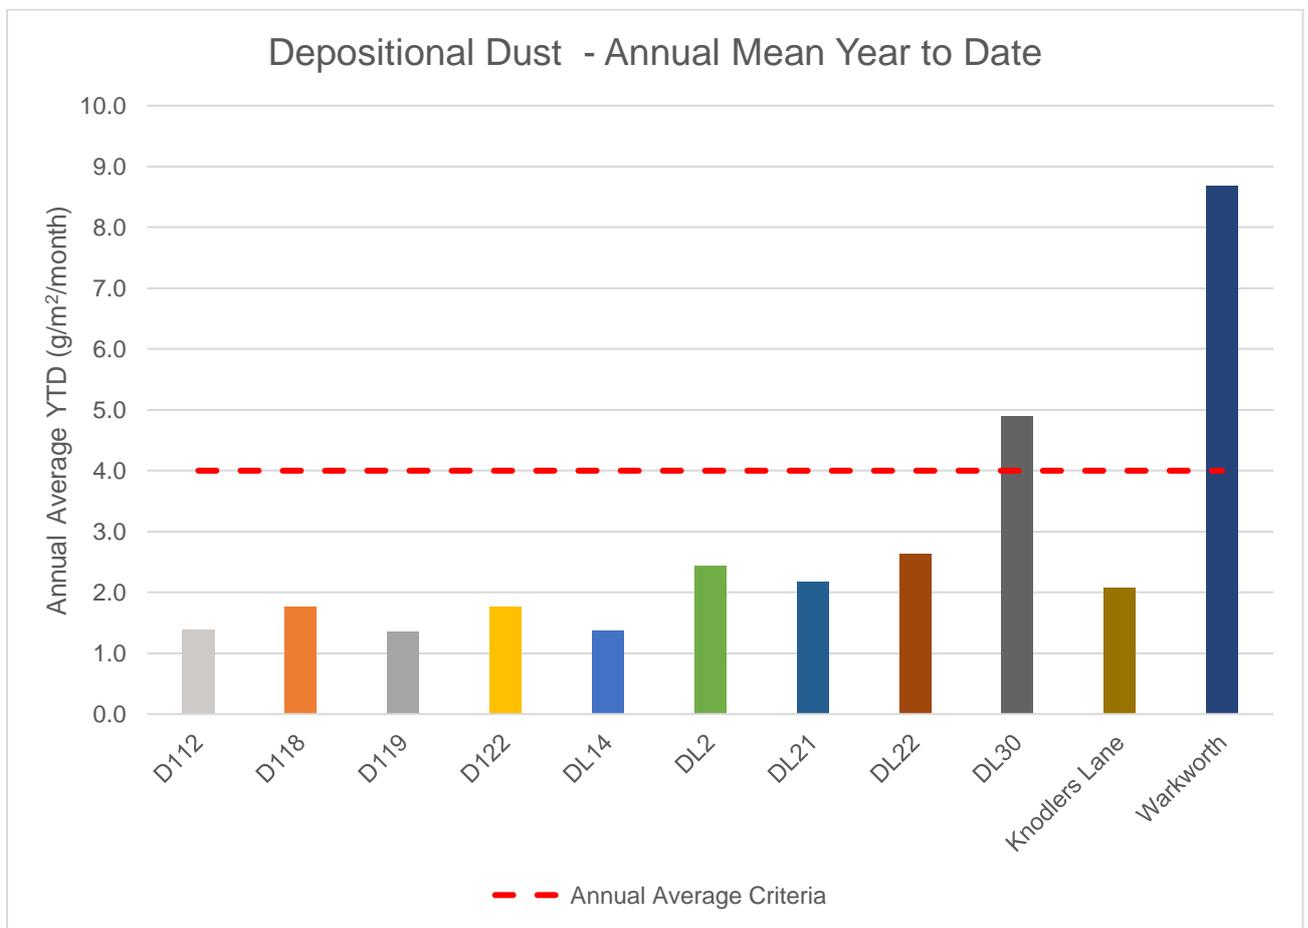
Figure 5 – YTD Depositional Dust Results as at end of the Reporting Period

Figure 5 displays year-to-date (YTD) insoluble solids results from depositional dust gauges during the reporting period compared against the annual impact assessment criteria. Any monthly results deemed to be contaminated (due to presence of bird droppings, insects, etc.) are not displayed. An assessment of HVO’s contribution against the long-term impact assessment criteria will be provided in the 2025 Annual Review.

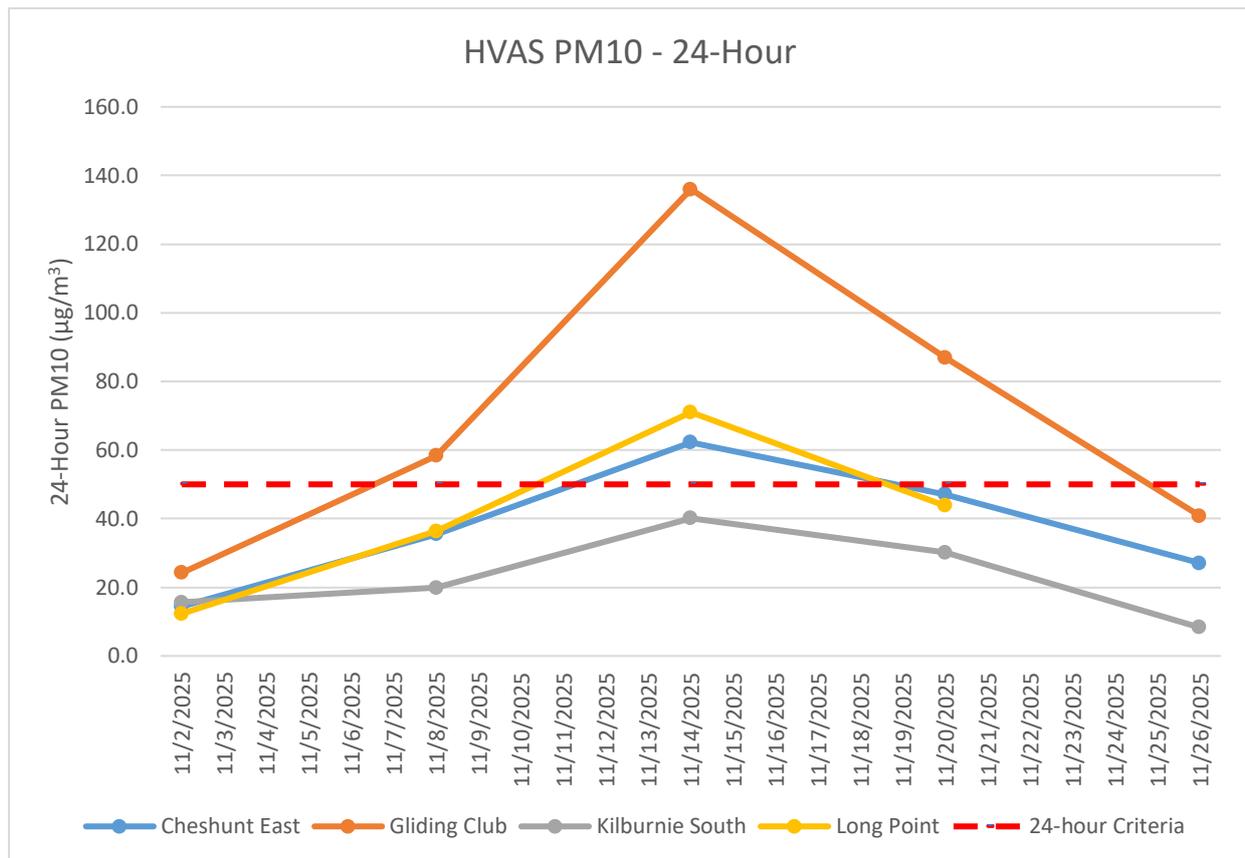
Figure 6 – Individual PM10 Results for the Reporting Period

Figure 6 shows individual PM10 results at each monitoring station against the short-term impact assessment criteria of 50µg/m³ for the reporting period. All monitors were below the short-term impact assessment criteria during the reporting period, with the exception of the Gliding Club on the 8, 14 and 20 of November and Long Point and Cheshunt East on the 14 of November. All potential exceedances investigated, where applicable, were below the short-term impact assessment criteria.

Long Point monitor did not report a result on 26 November due to a mis-capture event and therefore is not displayed for that date.

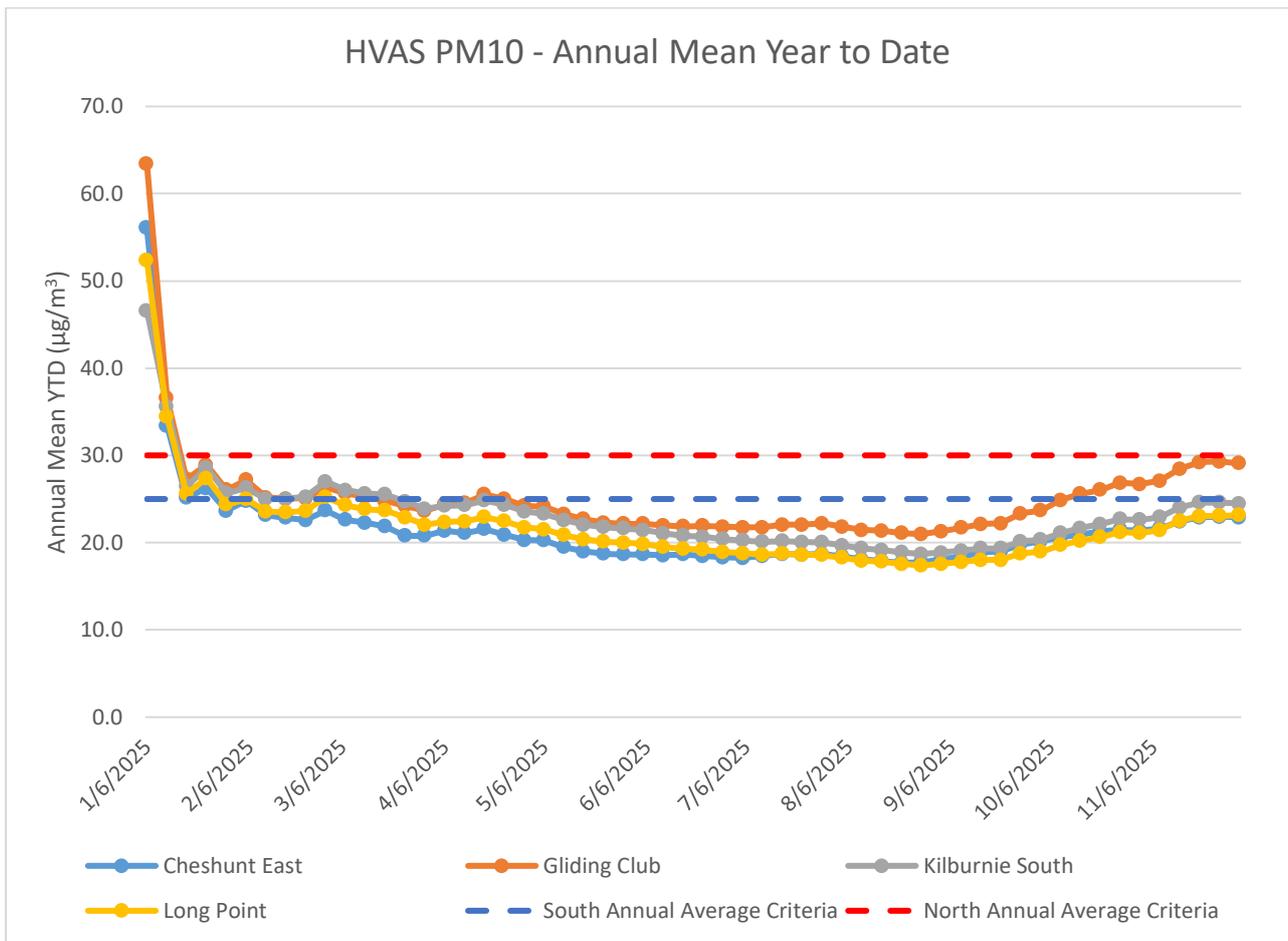
Figure 7 – Year to Date Average PM10 as at end of the Reporting Period

Figure 7 shows the year-to-date rolling annual average PM10 results. With the exception of the Gliding Club, which is above the South annual average criteria, all monitoring sites annual averages reported at the end of the period were below both South and North Annual Average Criteria.

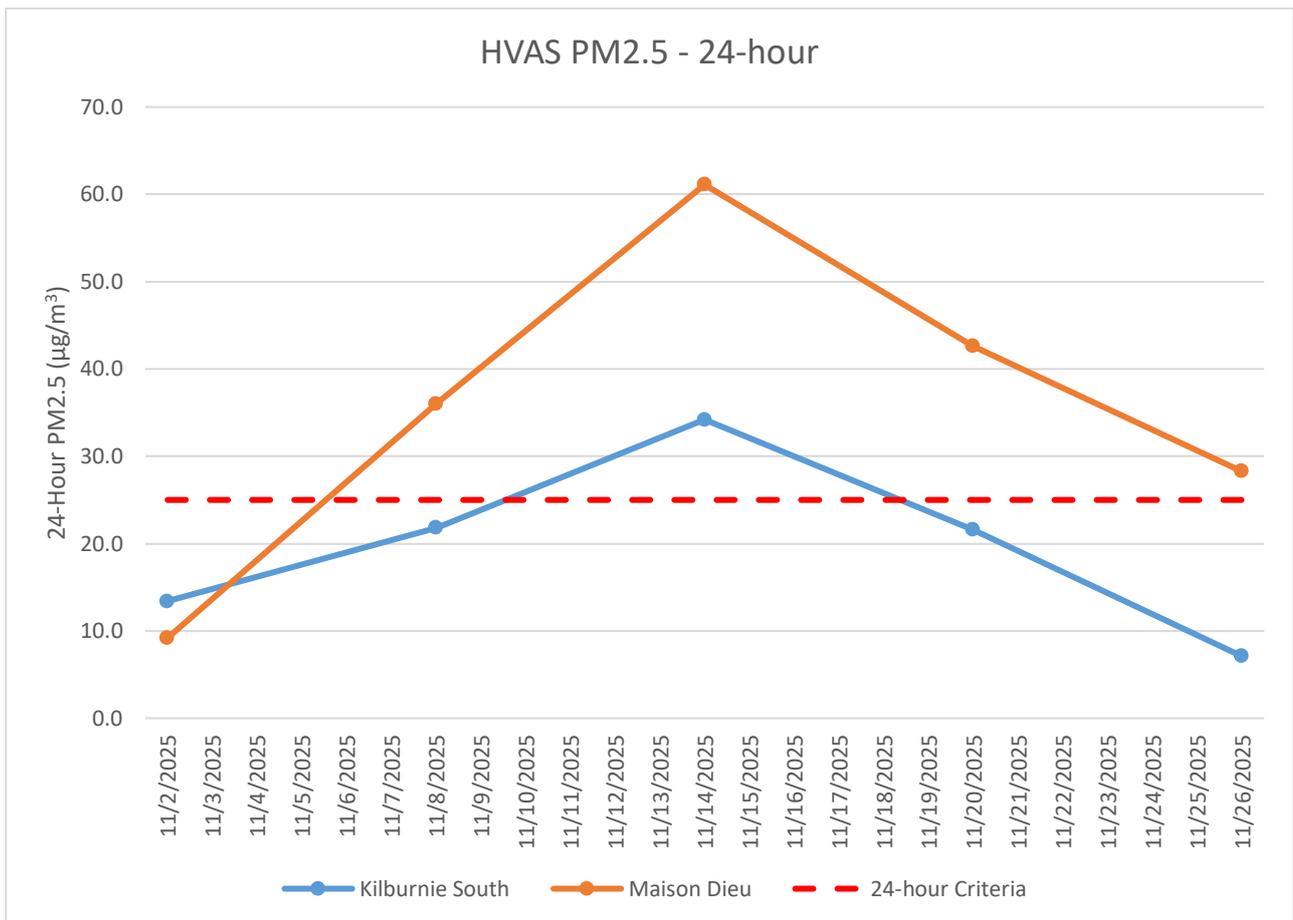
Figure 8 - Results for the Reporting Period

Figure 8 shows individual PM_{2.5} results at each monitoring station against the HVO South short-term impact assessment criteria of 25µg/m³ for the reporting period. Both monitors were below the relevant short-term impact assessment criteria during the reporting period, with the exception of Kilburnie South on the 14 of November and Maison Dieu on the 8, 14, 20 and 26 of November. The potential exceedances were investigated internally by HVO and it was found that the maximum calculated HVO contributions were below the compliance limit on all occurrences.

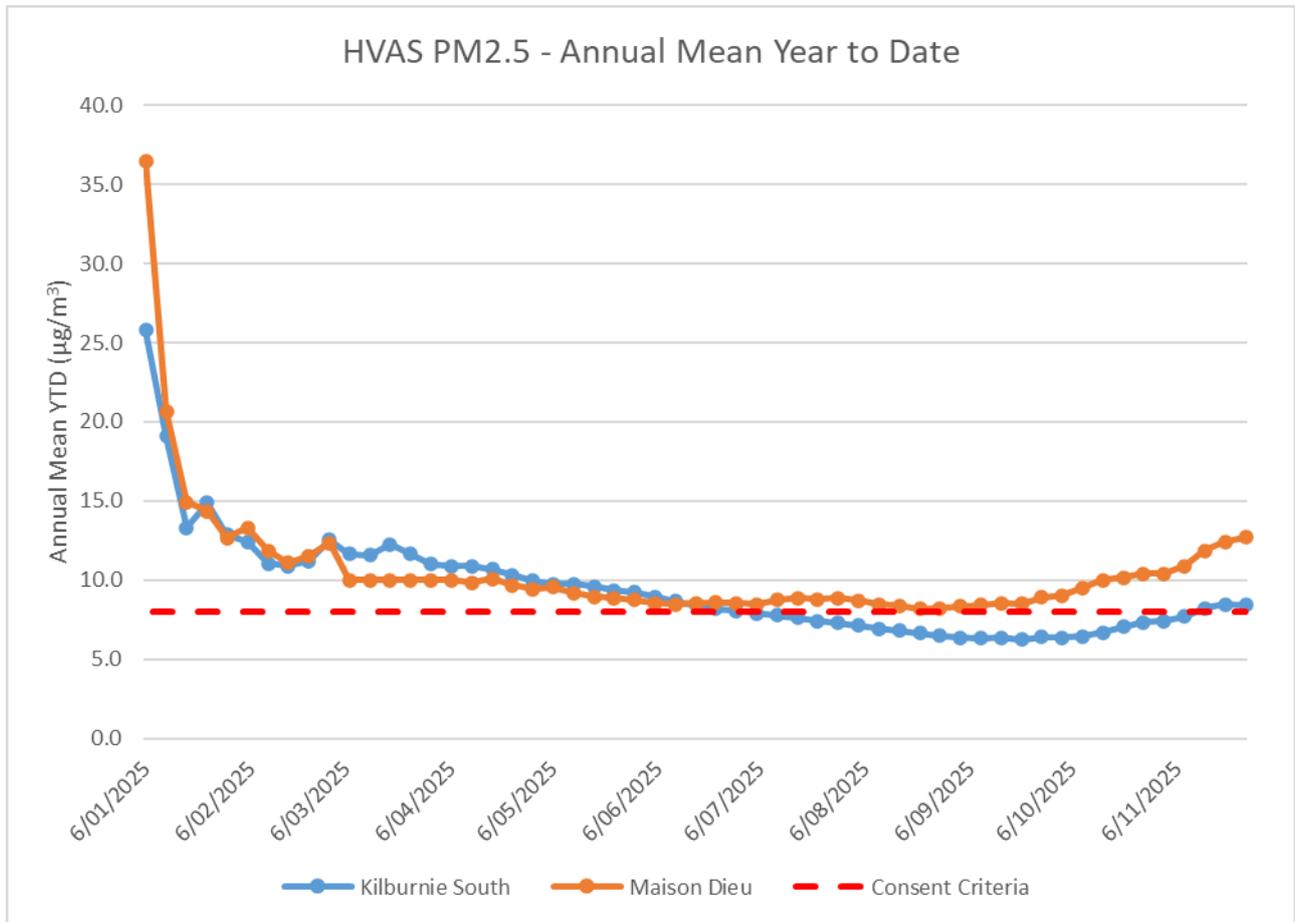
Figure 9 - Year to Date Average PM_{2.5} as at end of the Reporting Period

Figure 9 shows the year-to-date annual average PM_{2.5} results. During the reporting period, the annual average year to date results show Kilburnie South and Maison Dieu above the PM_{2.5} annual rolling mean criteria of 8µg/m³.

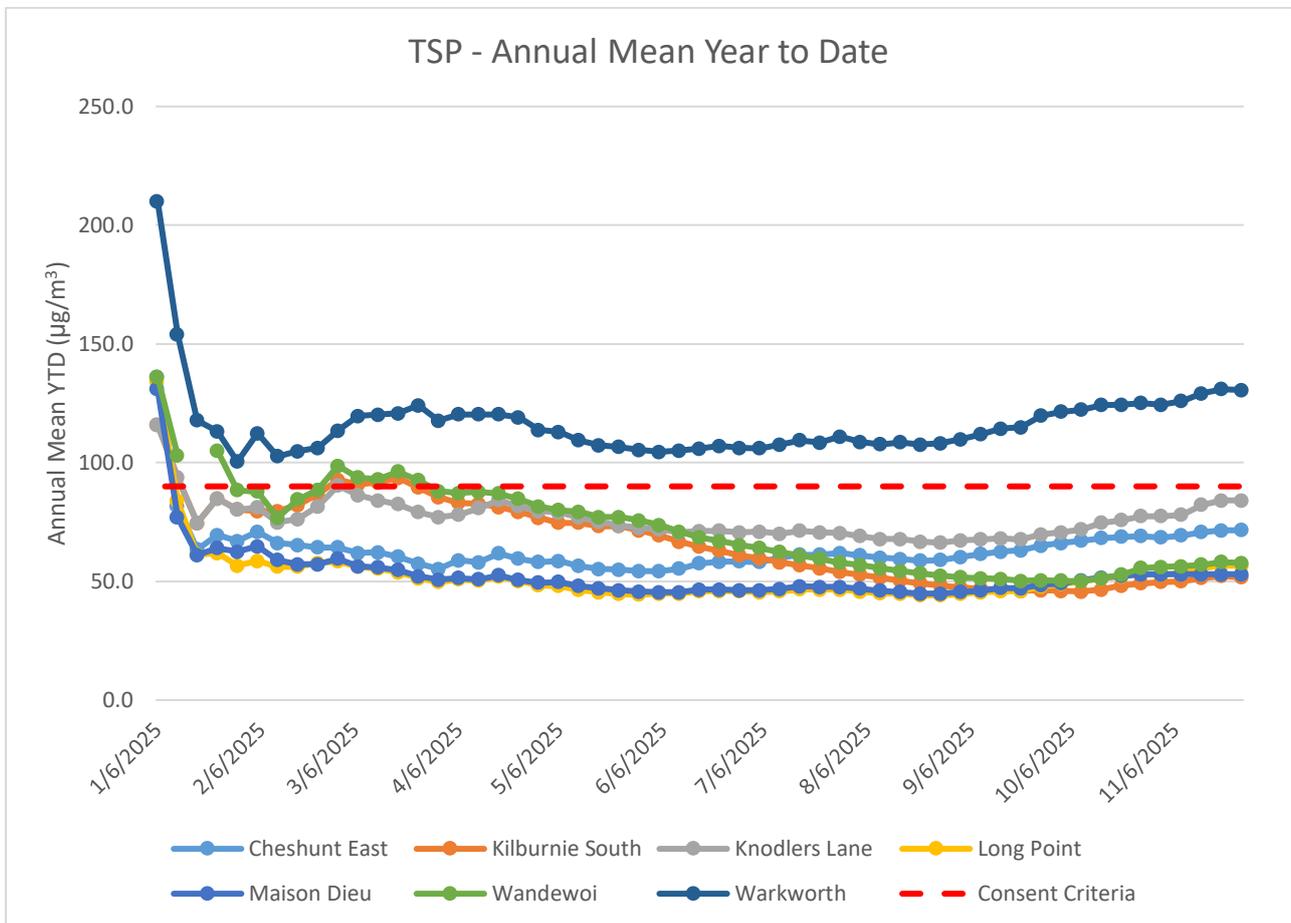
Figure 10 - Year to Date Average Total Suspended Particulates as at end of the Reporting Period

Figure 10 shows the annual average TSP results compared against the long-term impact assessment criteria of 90µg/m³.

All monitors, except for Warkworth, were below the relevant long-term impact assessment criteria during the reporting period.

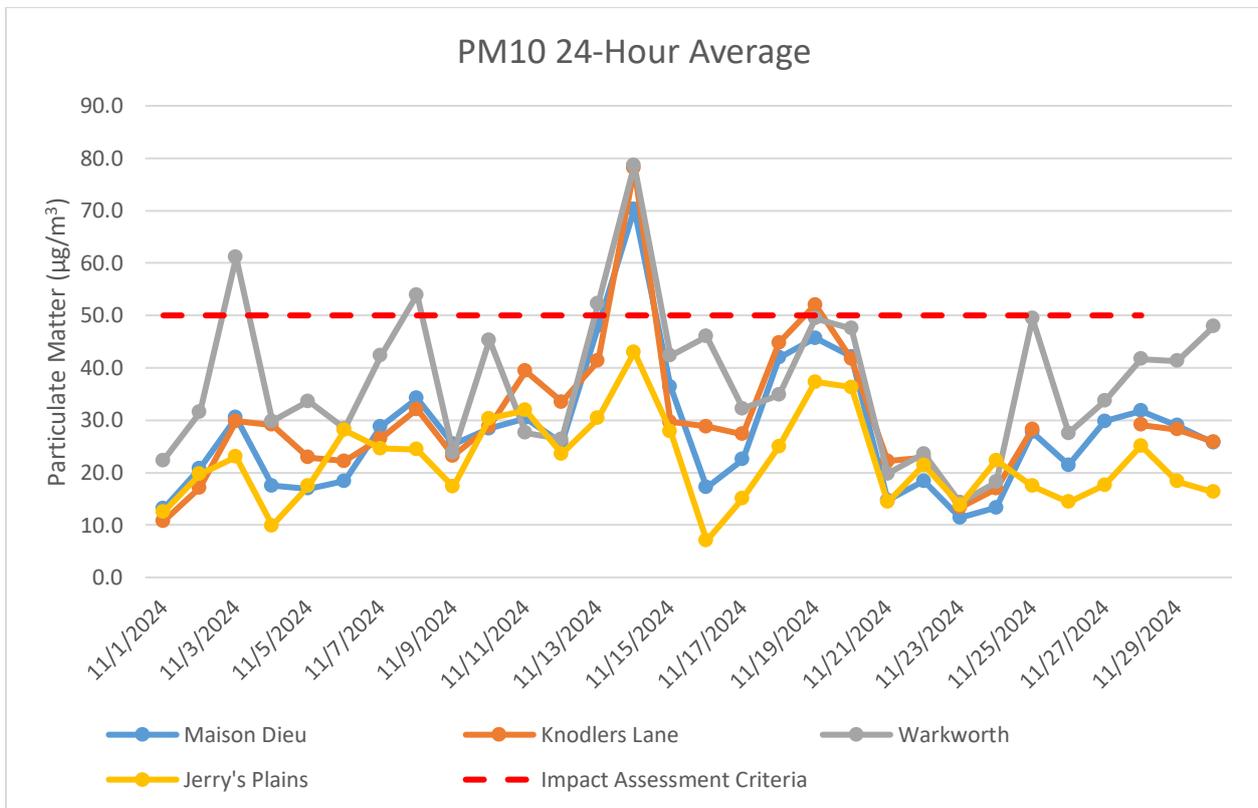
Figure 11 – Real Time PM₁₀ 24hr for the Reporting Period

Error! Reference source not found. shows the daily 24-hour average PM₁₀ results from the real time monitoring sites. During the reporting period, daily results were below the 24-hr average criteria of 50µg/m³, with the exception of:

- Warkworth on 3, 8, 13 and 14 November
- Knodlers Lane on 14 and 19 November
- Maison Dieu on 14 November

The potential exceedances were investigated internally by HVO and found that the maximum calculated HVO contributions were below the relevant compliance limits.

All monitors reported data capture rates of more than 75% on the respective dates, with the exception of Knodlers Lane monitor did not report a result on 26 and 27 November due to a mis-capture event and therefore is not displayed for that date

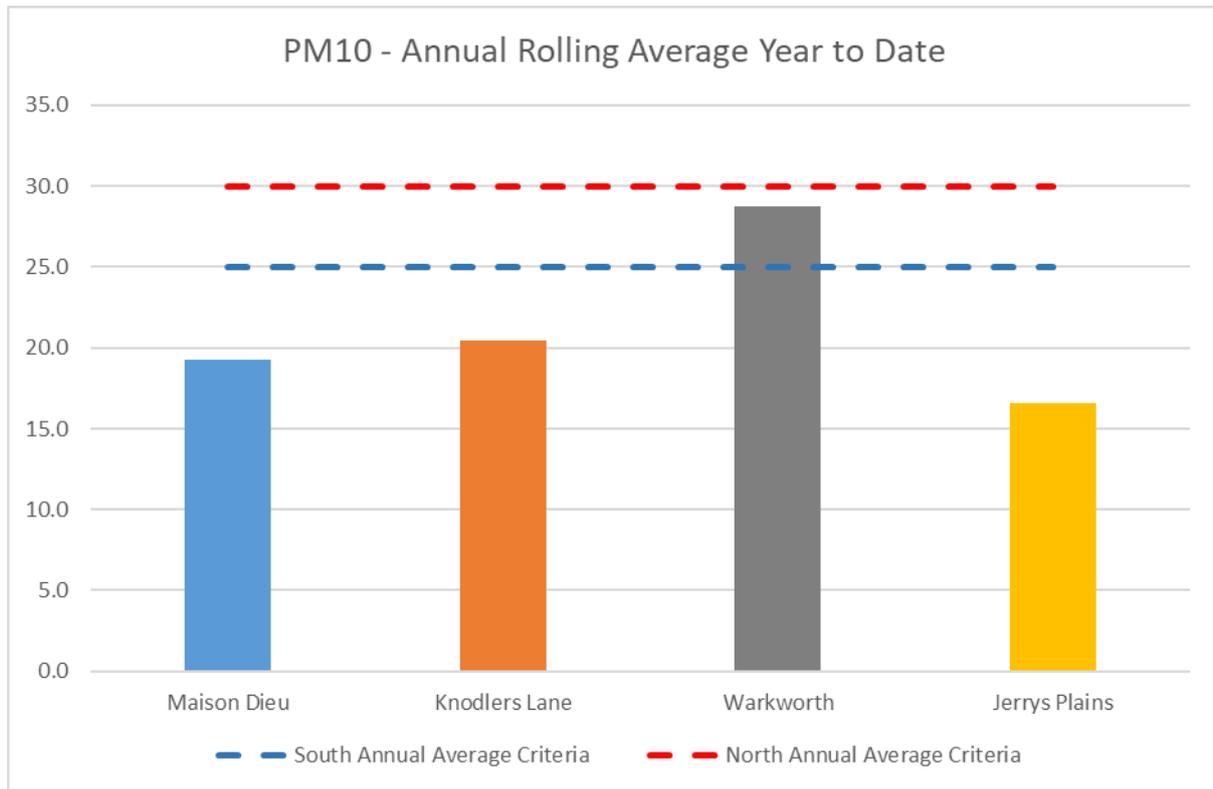
Figure 12 – Real Time PM₁₀ Annual Average for the Reporting Period

Figure 12 shows the annual rolling average PM₁₀ results from the real time monitoring sites. All monitoring results were below the annual average for the relevant long-term impact assessment criteria for North and South during the reporting period, with the exception of Warkworth, which was below North but above South Average Criteria.

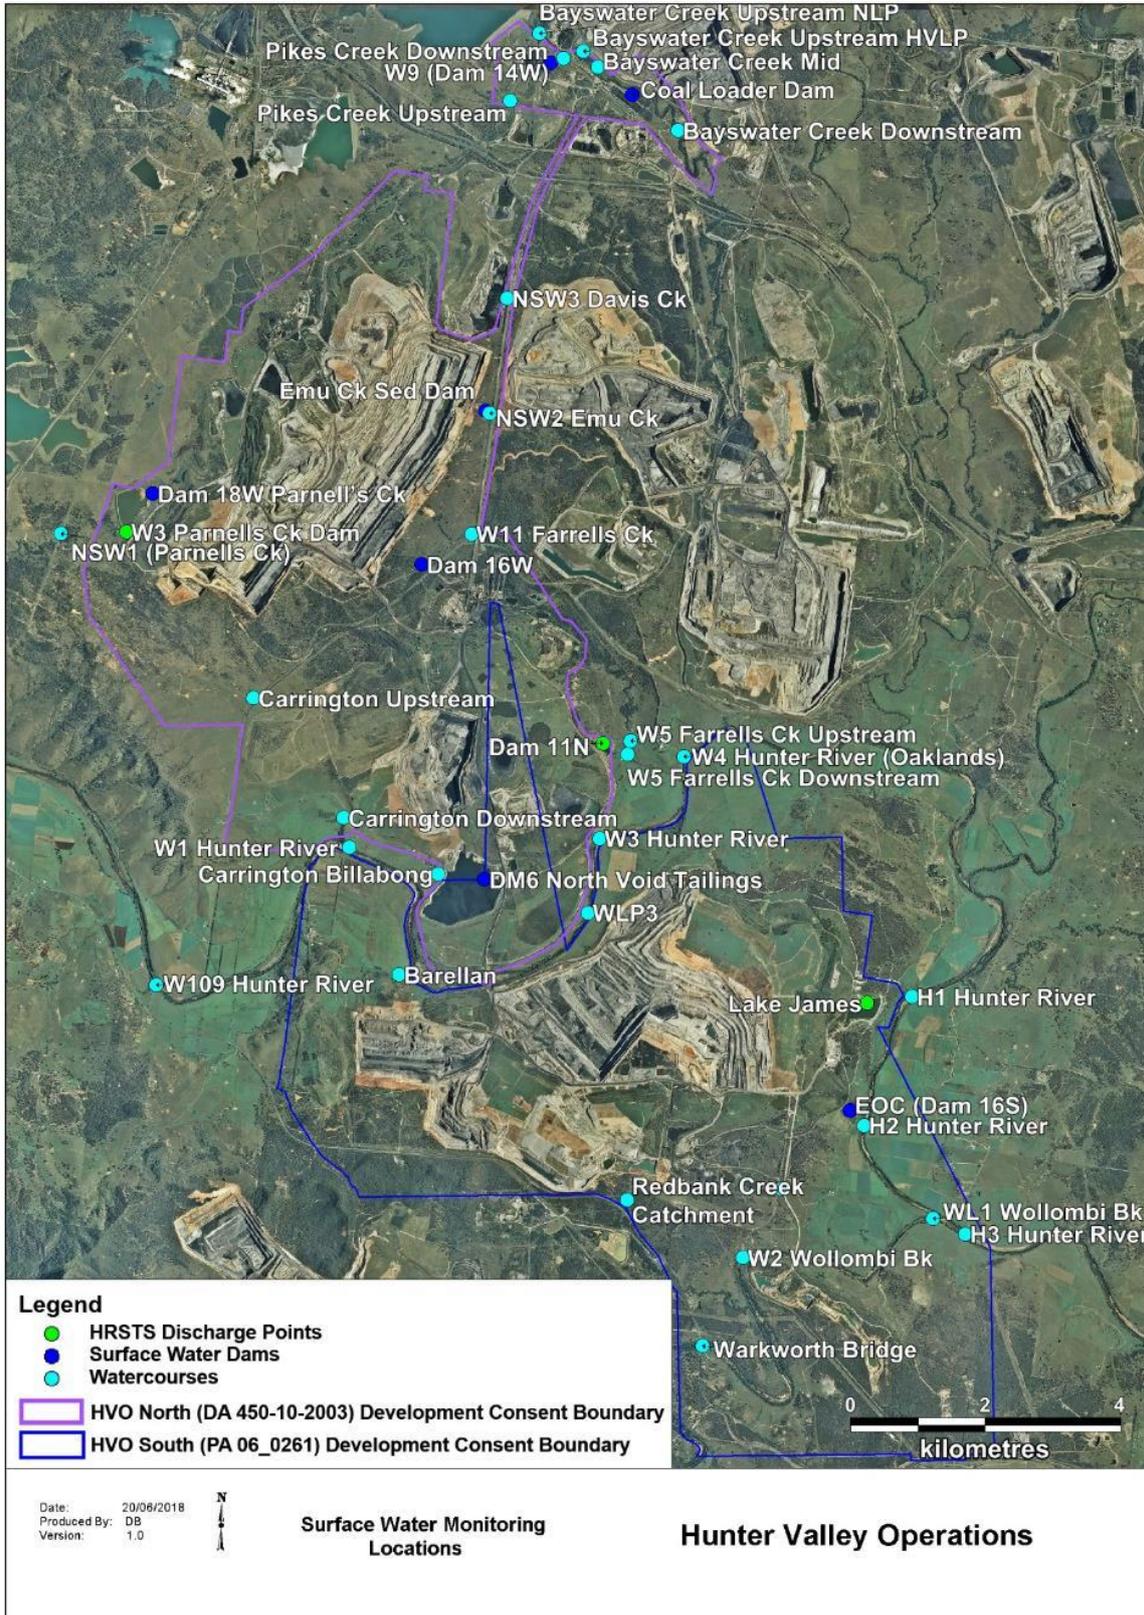
Figure 13 – HVO Surface Water Monitoring Locations

Surface watercourses are sampled on a quarterly sampling regime. Water quality is assessed through the parameters of pH, electrical conductivity (EC) and Total Suspended Solids (TSS). The location of surface water monitoring points across HVO is shown in Figure 13.

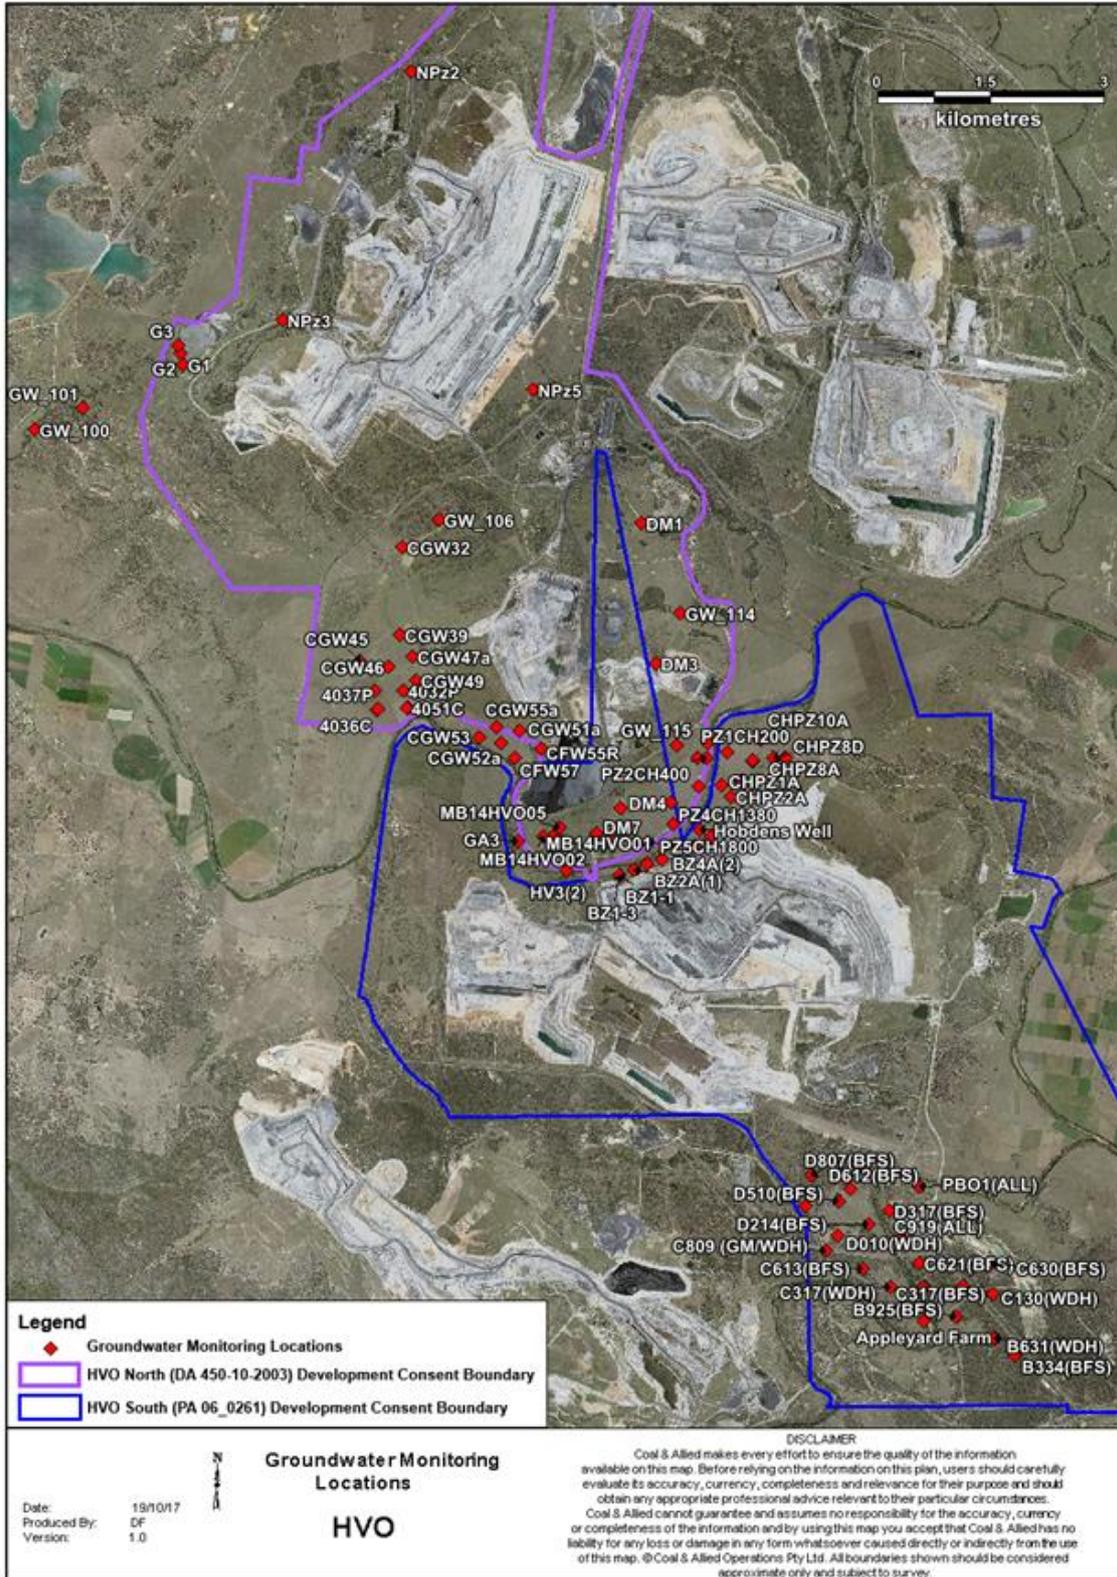
Figure 14 - Groundwater Monitoring Locations at HVO

Groundwater monitoring is undertaken on a quarterly basis in accordance with the HVO Water Management Plan and Groundwater Monitoring Programme. The location of groundwater monitoring points across HVO are show in Figure 14.

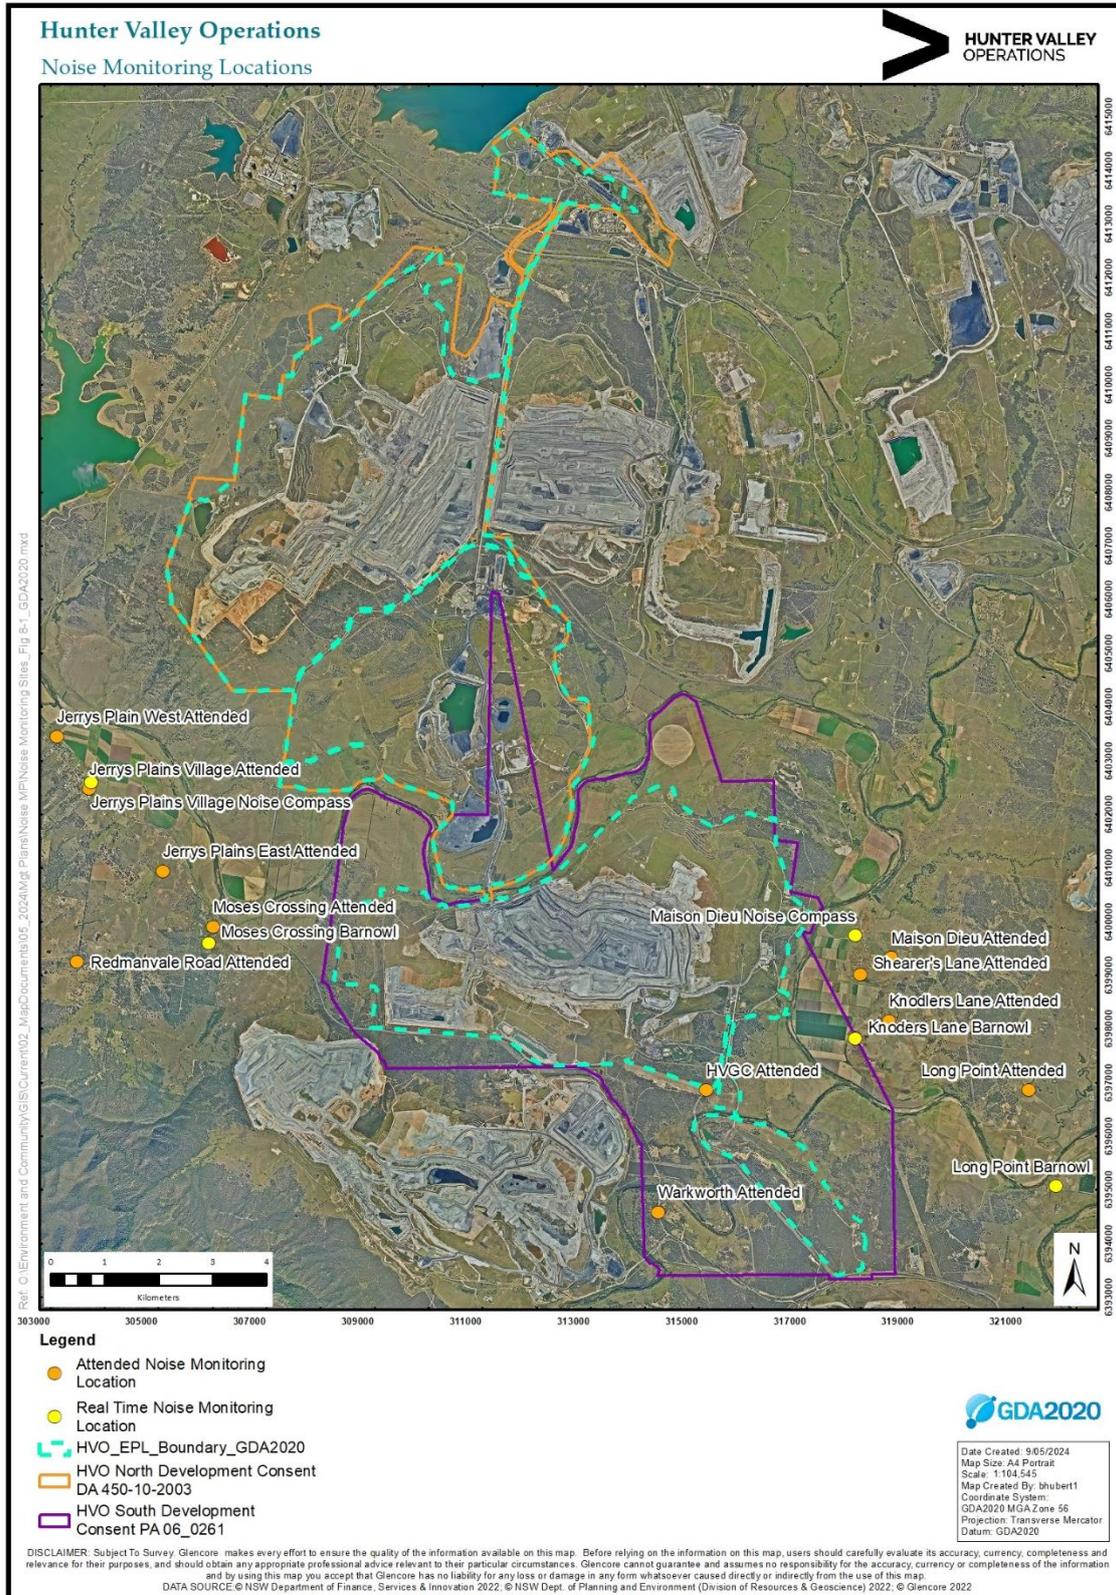
Figure 16 - Noise Monitoring Location Plan

Routine attended noise monitoring occurs at defined locations around HVO, as described in the HVO Noise Monitoring Programme. The noise monitoring aims to quantify and describe the acoustic environment around the site and compare results with specified limits. The attended noise monitoring locations are displayed in Figure 16.

HVO utilises a network of real-time directional noise monitors to manage noise impacts on a continuous basis, shown in Figure 16. Noise alarms are in place at five monitoring locations (Knodlers Lane, Maison Dieu, Jerrys Plains, Moses Crossing, and Long Point) which alert HVO staff to elevated noise levels that require investigation.

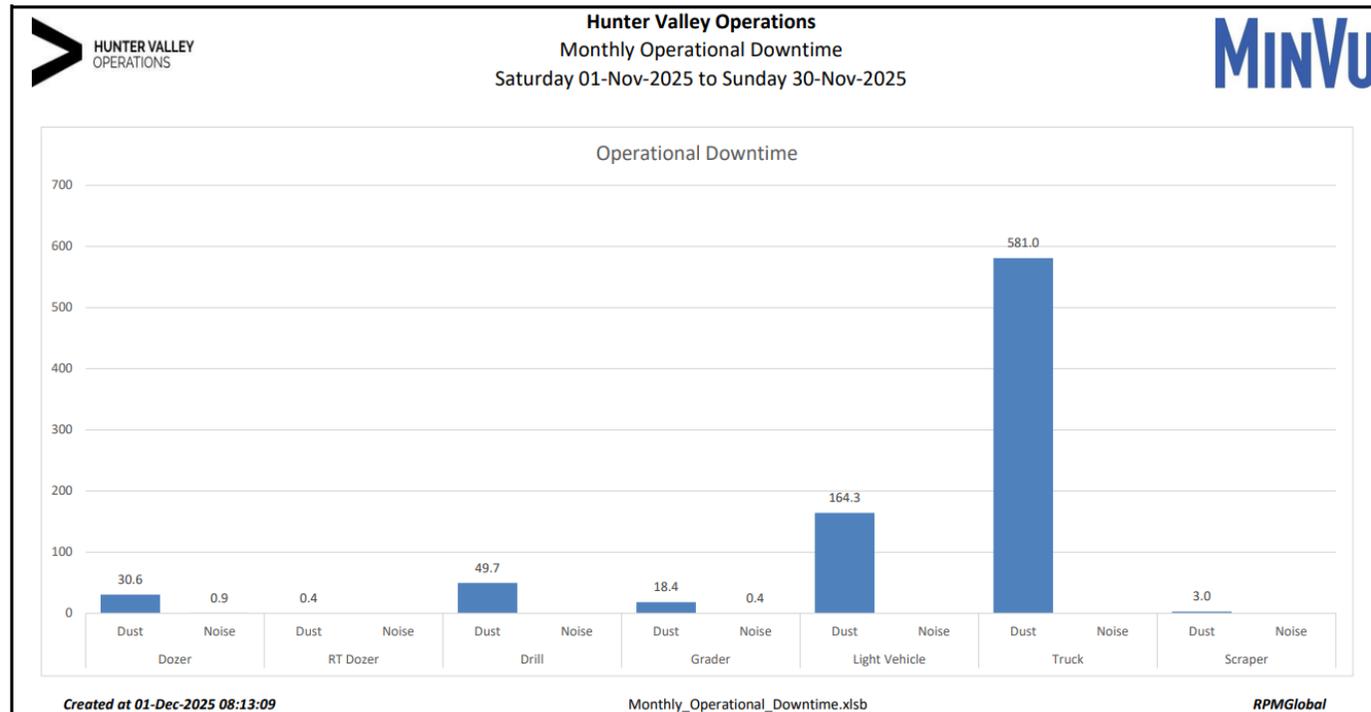
Figure 17 - Operational Downtime by Equipment Type for the Reporting Period

- Eight hundred and forty-seven point four (847.4) hours for dust, and
- One point three (1.3) hours for noise.

Operational downtime by equipment type is show in Figure 17. Note that these delays are instances where operations were completely stopped and does not include occasions where operations were changed/modified but not stopped (e.g. changed from exposed dump to in-pit dump).

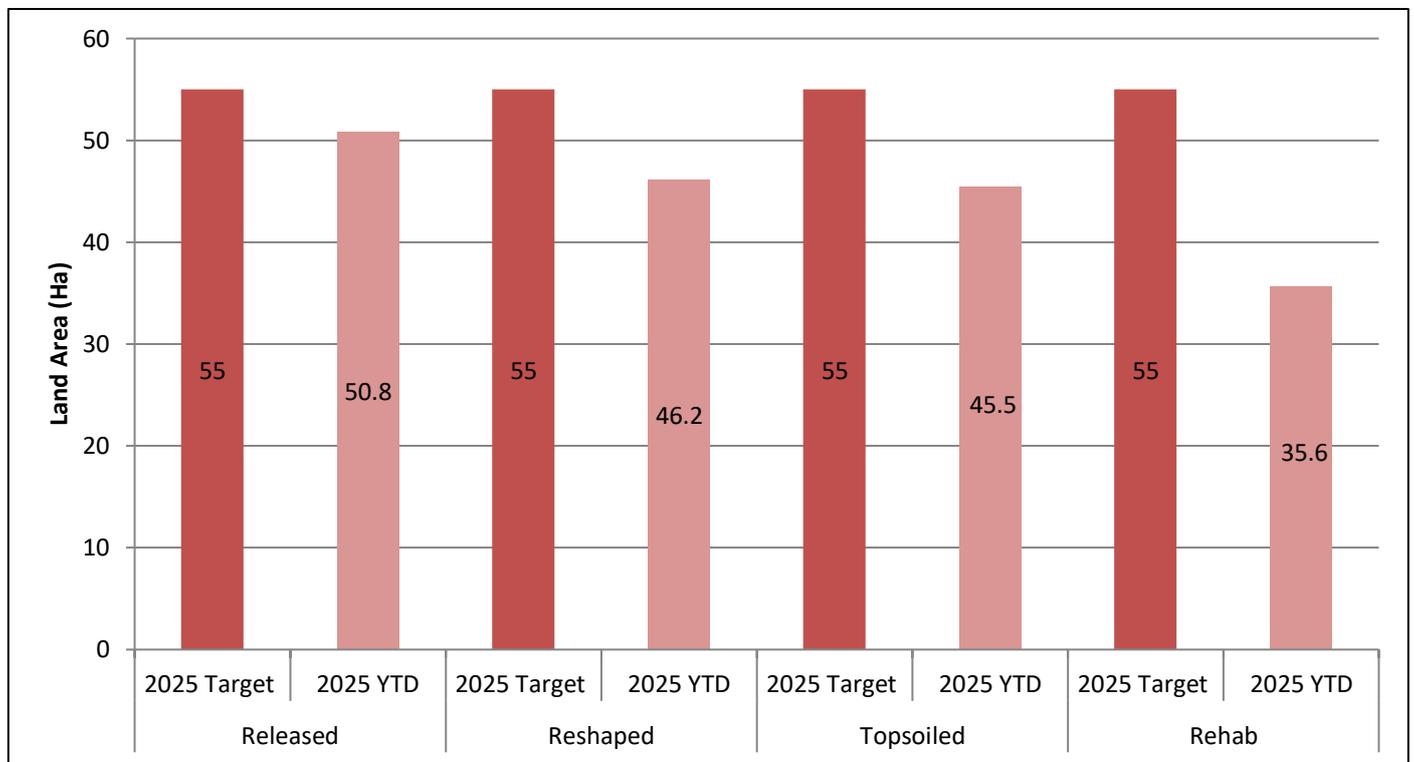
Figure 18 - Rehabilitation YTD November 2025

- 0.84ha of land was reshaped;
- 0ha of land was released (became available for the application of topsoil);
- 16.72ha of land was topsoiled; and
- 29.73ha of land was rehabilitated.

Year to date progress is shown in Figure 18.
