# Annexure C

Aquatic ecology and groundwater dependent ecosystems  
assessment

HVO Continuation Project- aquatic ecology and  
groundwater dependent ecosystem assessment

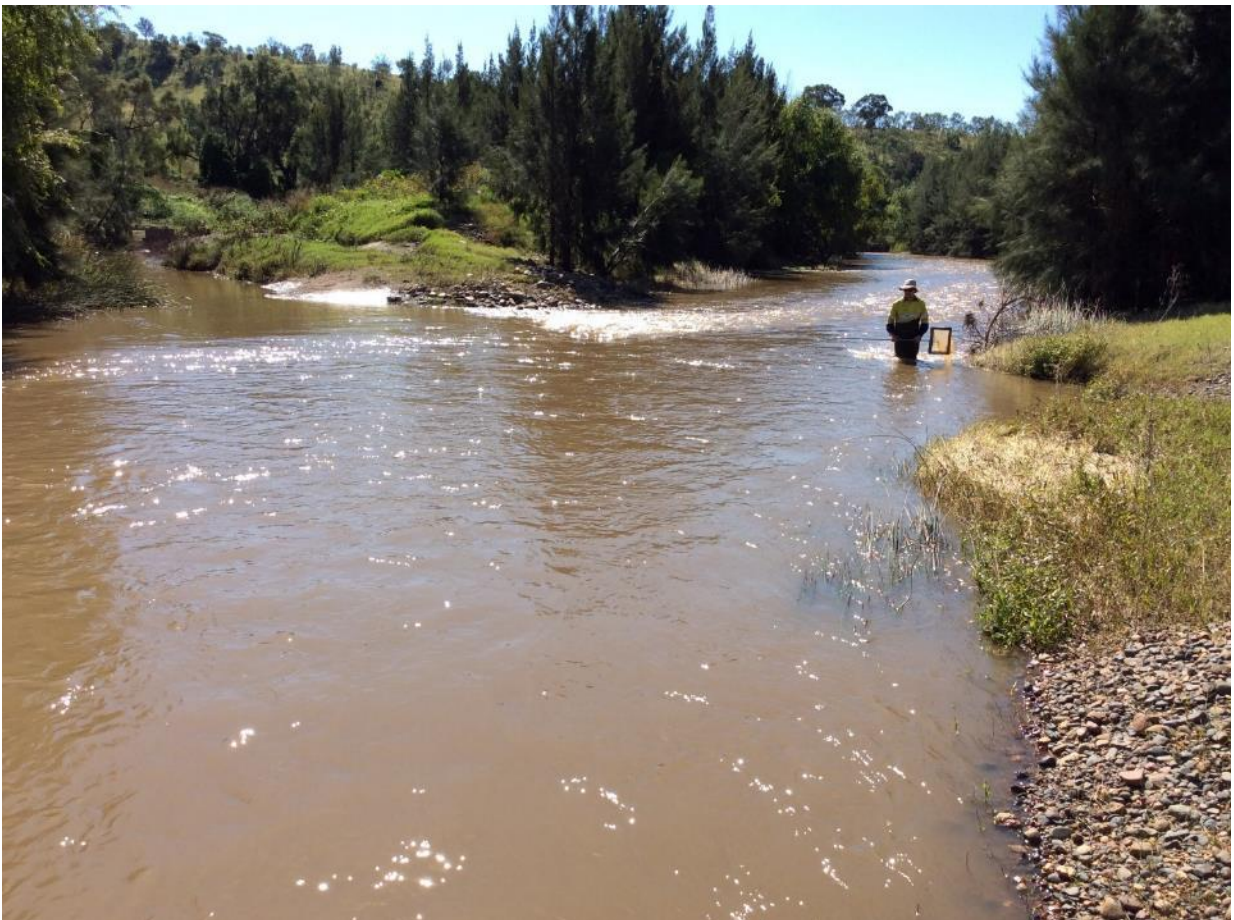
**Figure 10: Hunter River at HVO1 (Bowmans Crossing) showing riffle, backwater and run habitat, as well as submerged and trailing bankside vegetation (April 2020)**

At the time of the April and September 2020 surveys, the seven Hunter River sites all consisted of deep pools and had shallow riffles over a sand and gravel bed. The sites all had emergent and submerged macrophytes around the edges or in backwaters, and most contained large woody debris. Lateral sand and gravel bars lined the river, and these contained a mixed riparian zone of River Oak (*Casuarina* sp) and Willows (*Salix* sp). Debris from recent flooding was deposited along banks and in riparian vegetation. These sites had diverse range of aquatic habitats (Figure 10).

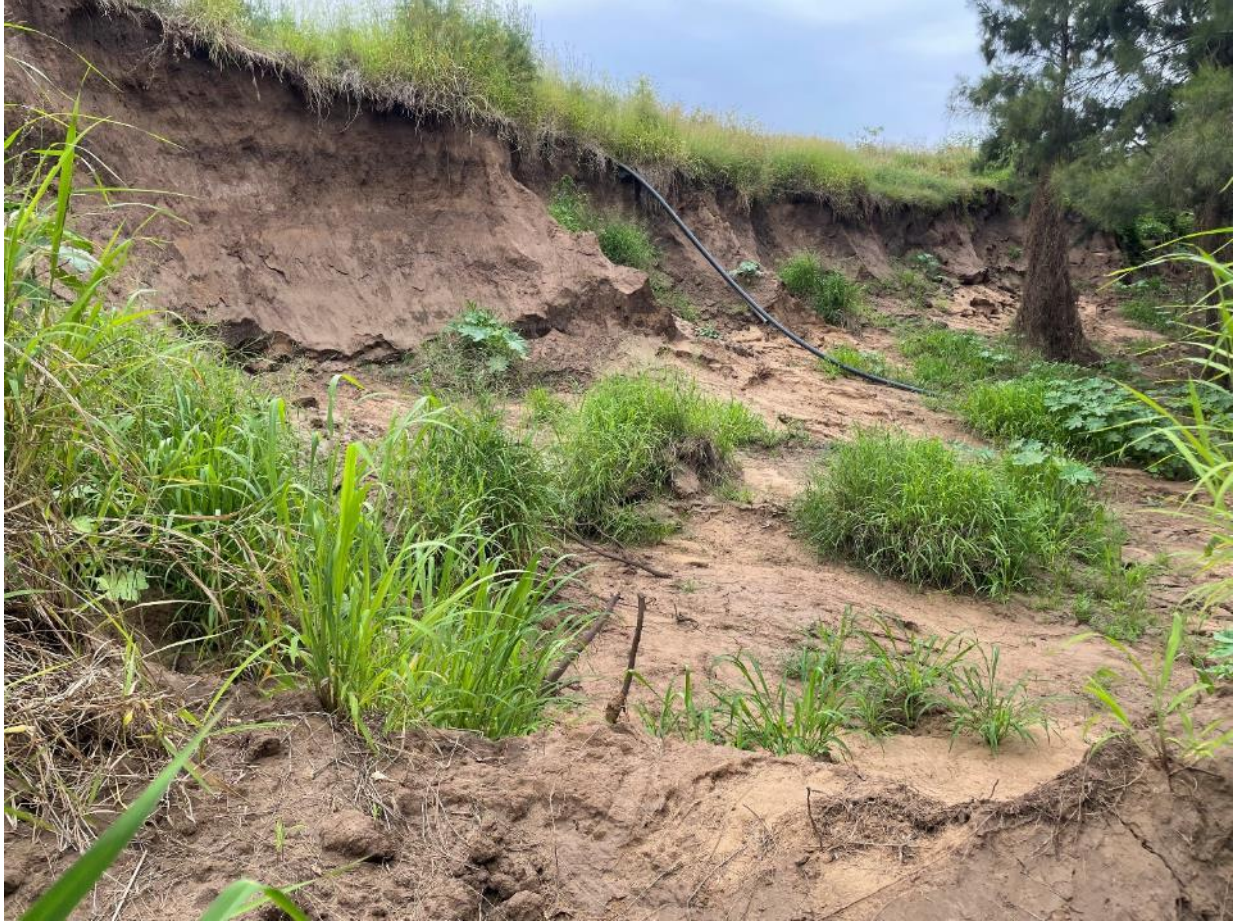
Figure 11: Recent bank erosion due to flooding at HVO12 on the Hunter River (photo taken during January 2022).

Between the September 2020 and January 2022 surveys, the Hunter River had experienced several large flow events, which caused scouring along the banks and removed some of the macrophyte beds (Figure 11). Flow was still high during September 2020 surveys. Woody debris was washed up along the banks at many sites, and sand and gravel beds experienced erosion and deposition in many places.

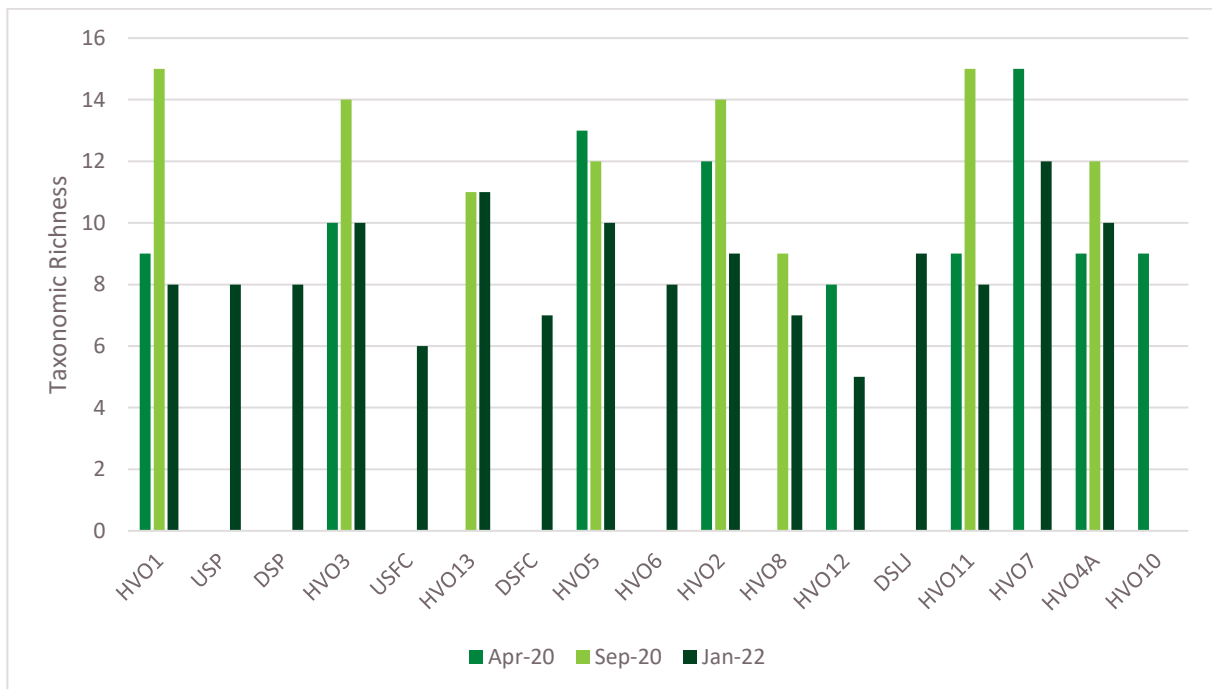
**Figure 12. Macroinvertebrate taxonomic richness at surface sites along the Hunter River and tributaries (sites are graphed in order from upstream to downstream. Refer to Figure 5 for location)**

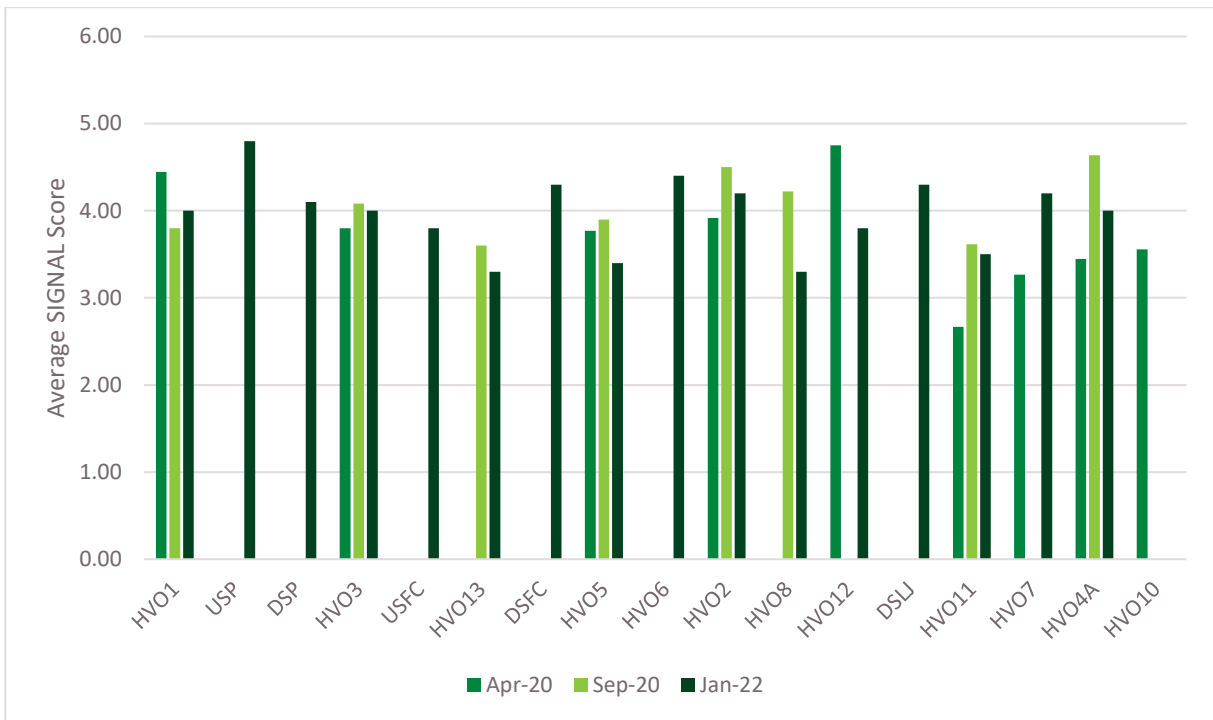
**Figure 13: Average SIGNAL scores for aquatic sites along the Hunter River and tributaries (sites are graphed in order from upstream to downstream. Refer to Figure 5 for location)**

The lowest scoring site was HVO11 in April 2020 (Figure 13). This is a Hunter River site approximately 3 km downstream of Glennies Creek confluence, and in April 2020 had a SIGNAL score of 2.7. It remained low (3.6 and 3.5) for the subsequent surveys. SIGNAL scores for individual survey periods were highest at USP (Hunter River upstream of Parnells Creek) (4.8) and HVO12 (Hunter River, H3) (4.7). HVO1 (Bowmans Crossing) and HVO2 (Moses Crossing) were the most consistently highest-scoring sites across all three surveys, with values between 3.8 and 4.5 across all surveys (Figure 13).

SIGNAL scores below 4 indicate severe pollution, while scores between 4 and 5 indicate moderate pollution. All the sites sampled were either severely or moderately polluted.

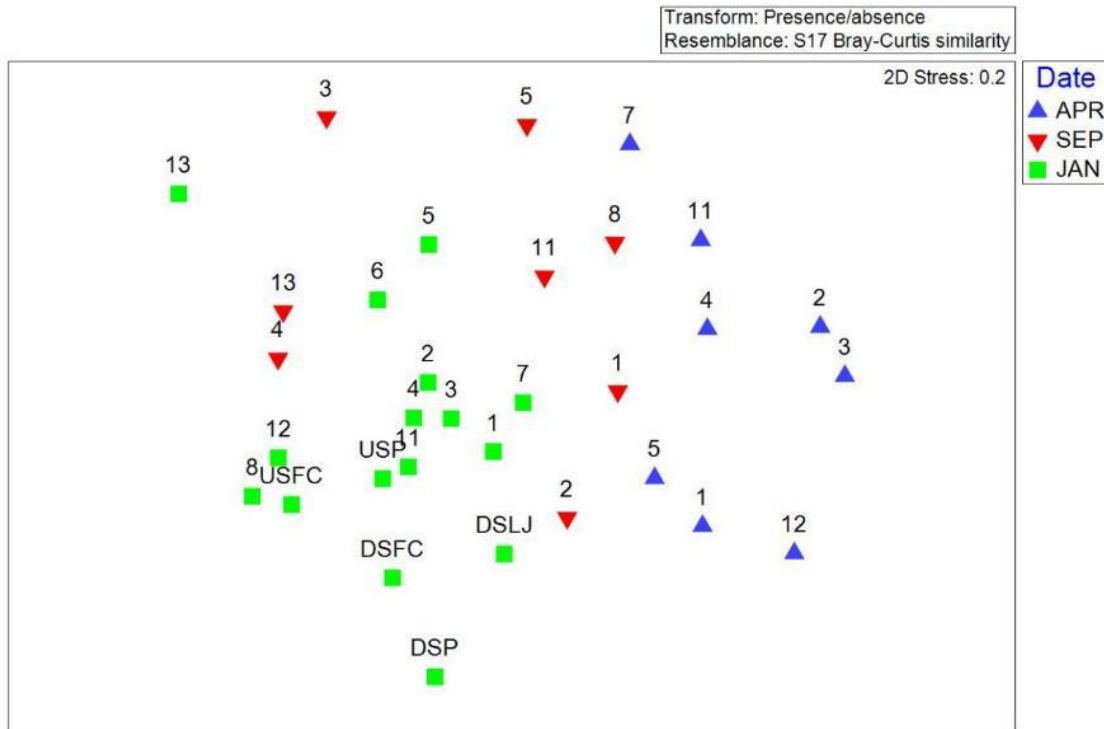
**Figure 14: Non-metric multidimensional scaling plot of macroinvertebrate community data at each site for April 2020 (blue triangles), September 2020 (red triangles), and January 2022 (green squares)**

Macroinvertebrate communities differed between dates (ANOSIM  $R = 0.45$ ,  $P < 0.01$ , Figure 14). The difference in communities is shown in the MDS plot in Figure 14 by the lack of overlap between the three clusters of sites representing the three survey dates. Atyidae, Leptoceridae, Ceratopogonidae and Cyclopoida were more common in September 2020 than April 2020, while in April the sites were characterised by Palaemonidae and Culicidae. In January 2022, sites were dominated by Atyidae, Leptoceridae, and Micronectidae.

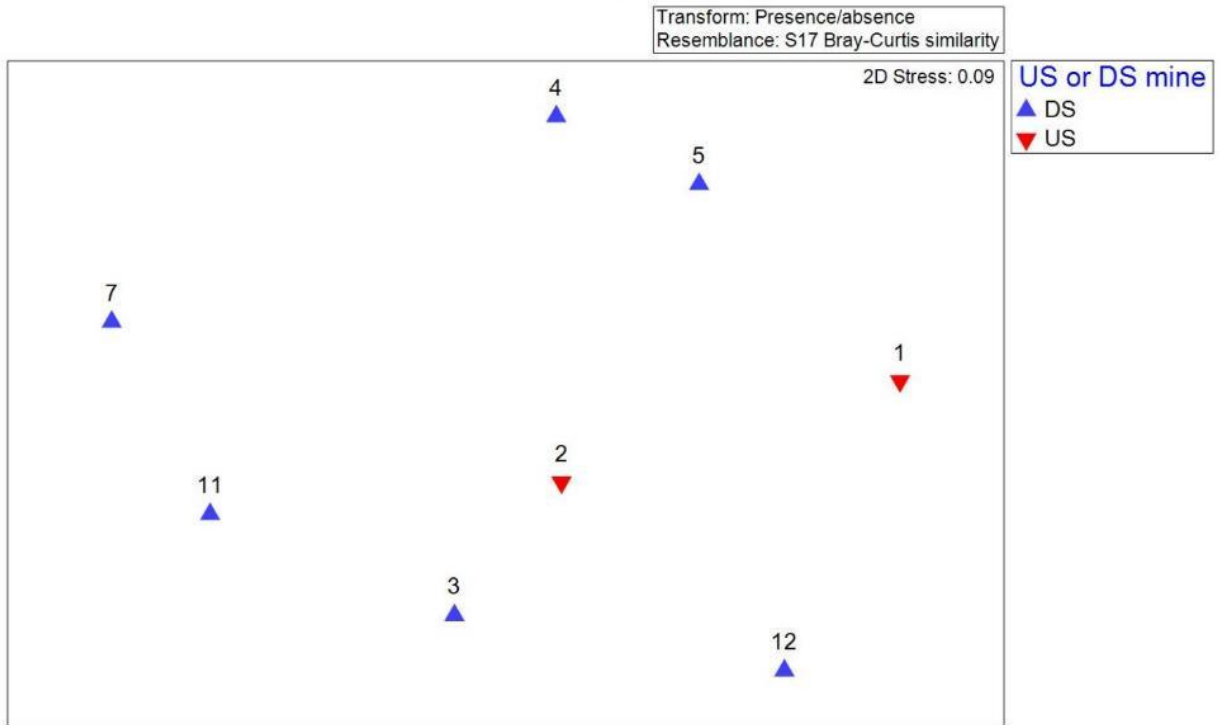
Figure 15: nMDS plot of macroinvertebrate communities at control (red triangles) and impact (blue triangle) sites during April 2020

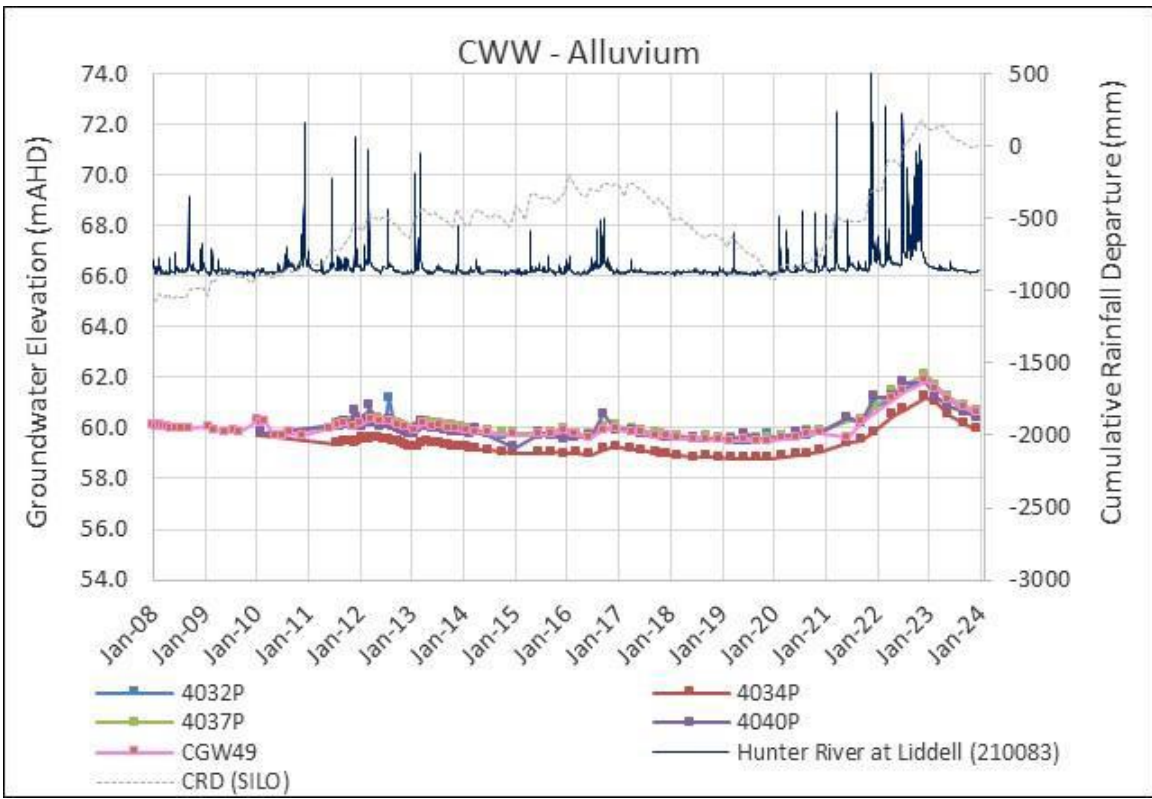
Figure 2. Groundwater levels in Carrington West Wing Alluvium (Umwelt 2024)

Water level in the alluvium has generally stayed the same or has risen slightly over the past 2 years, making it at least as accessible to groundwater dependent vegetation as during the field surveys. Rainfall, although lower than average (Umwelt 2024) has still been frequent (Figure 5), so it is possible

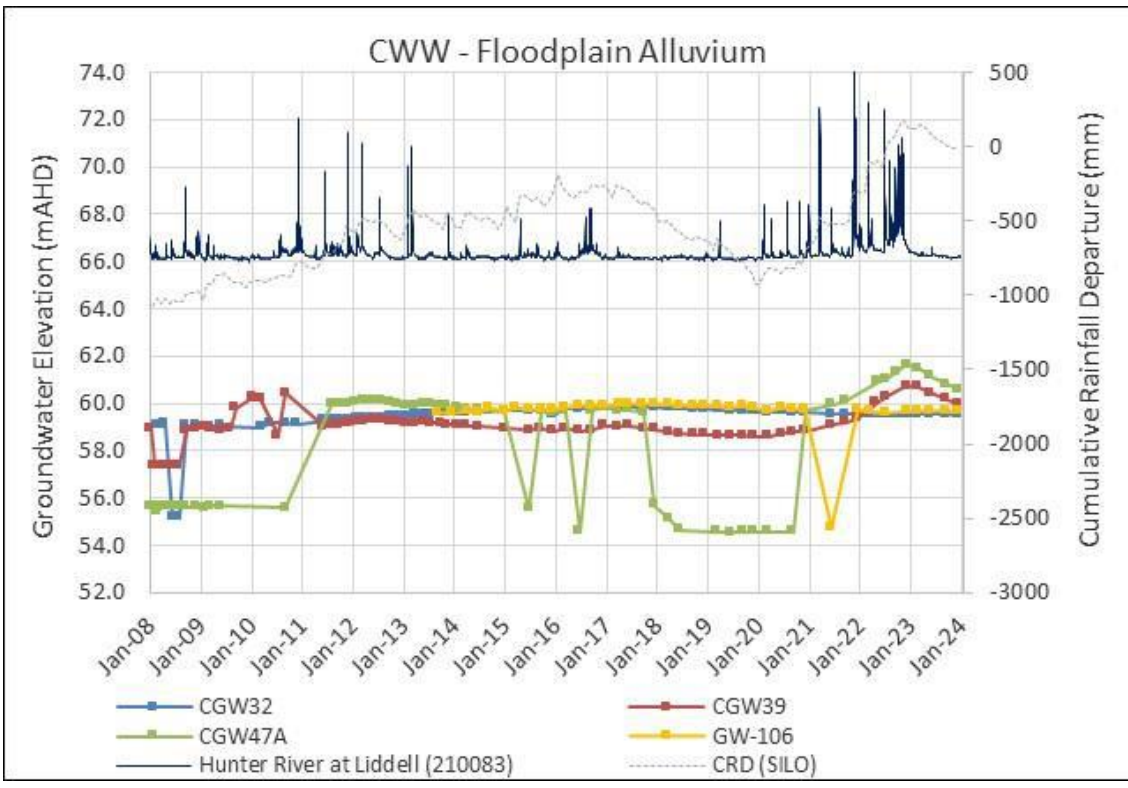
Figure 3. Groundwater levels at Carrington West Wing-Floodplain Alluvium

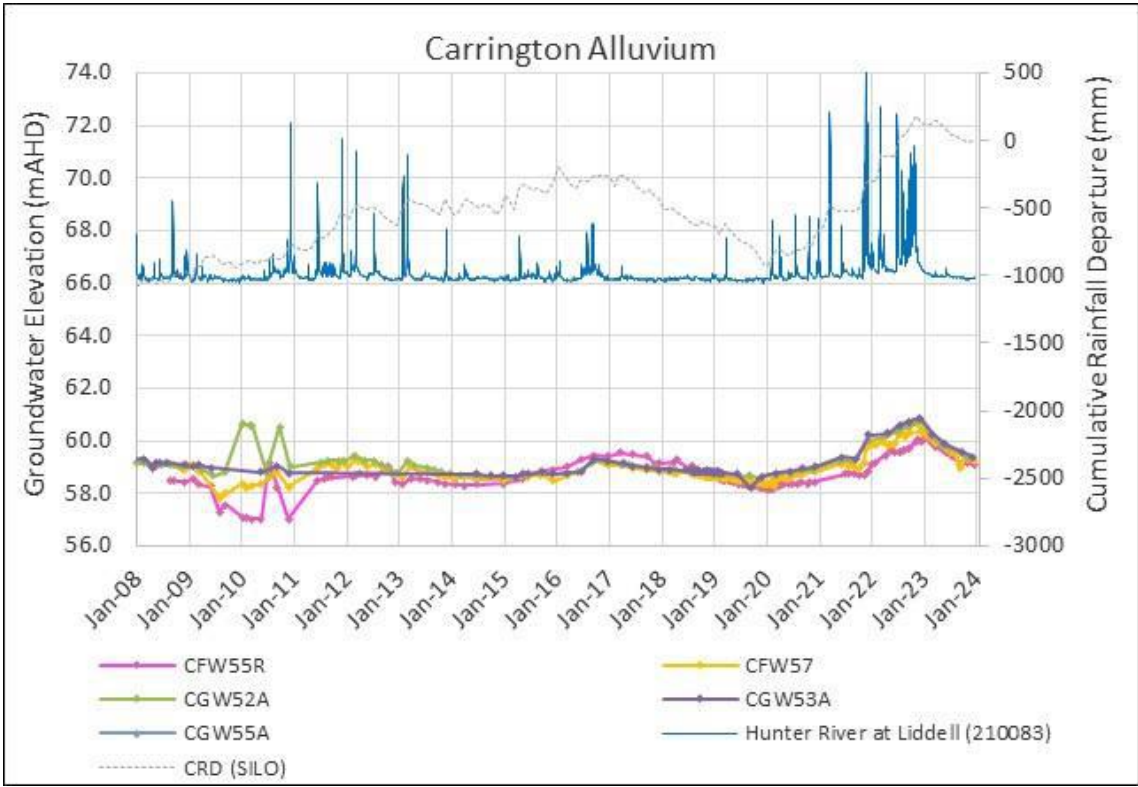
Figure 4. Groundwater levels at Carrington Alluvium
