HUNTER VALLEY OPERATIONS

REHABILITATION MANAGEMENT PLAN

HVOOC-1797567310-5041

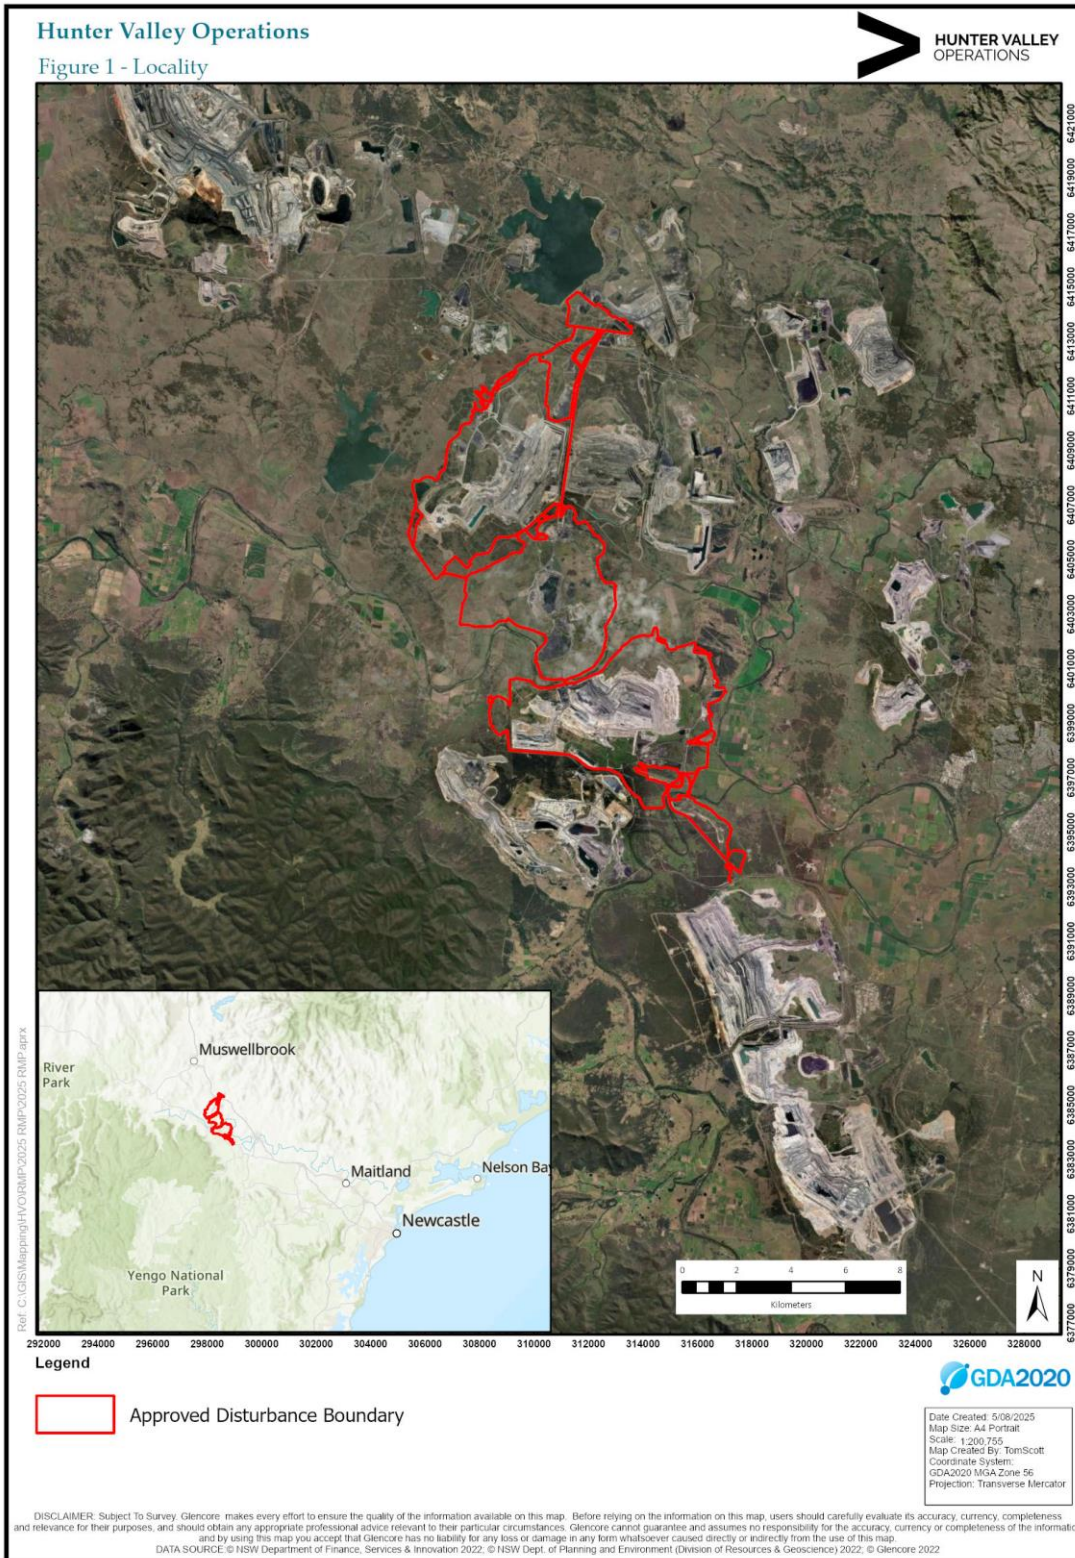
Figure 1-Locality

This Rehabilitation Management Plan (RMP) outlines the proposed rehabilitation and final land use considerations at Hunter Valley Operations (HVO). HVO comprises Hunter Valley Operations North (HVO North) and Hunter Valley Operations South (HVO South). HVO North and HVO South are separated by the Hunter River and are located approximately 24 kilometres (km) north-west of Singleton in New South Wales (NSW) (see **Figure 1**).

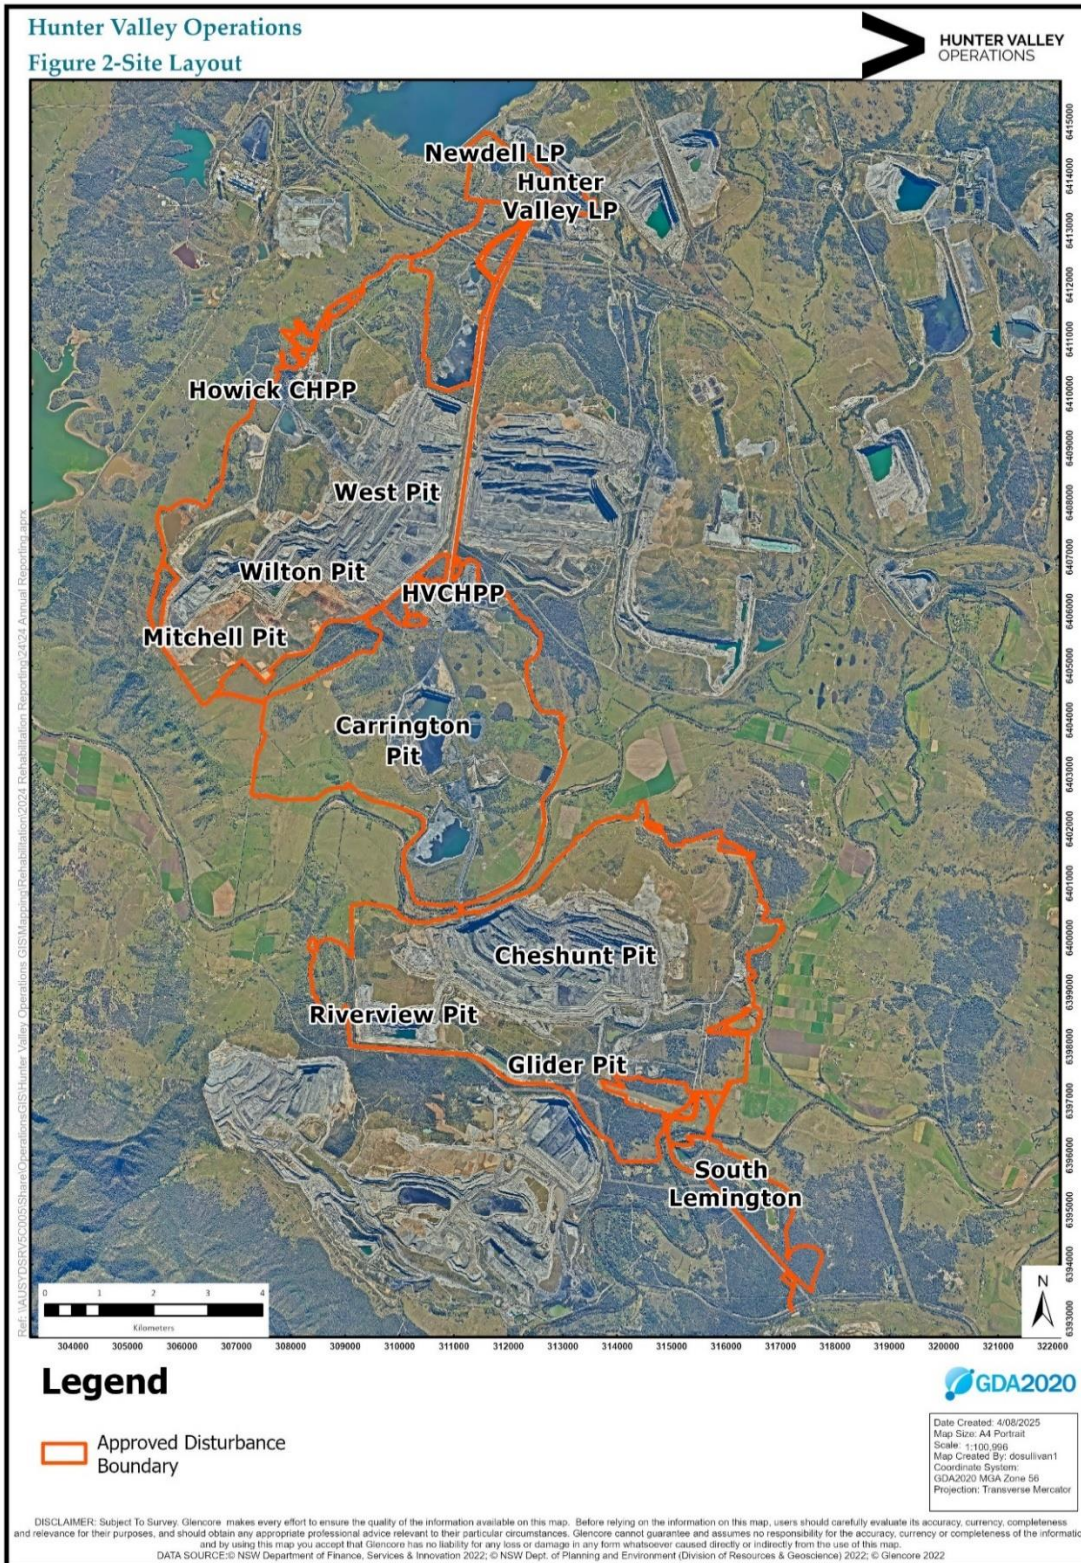
Figure 2-Site Layout

HVO North includes the Carrington Pit, West Pit (which includes the Mitchell Pit and Wilton Pit), North Pit Tailings Storage Facility (TSF), Dam 6W TSF, Cumnock Void TSF (under agreement with GCAA), Newdell Coal Preparation Plant (NCPP), Hunter Valley Coal Preparation Plant (HVCPP), Howick Coal Preparation Plant (HCPP), and the stockpiling/train loading facilities at Newdell Load Point (NLP) and Hunter Valley Load Point (HVLP) (see **Figure 2**).

HVO South includes Cheshunt Pit, Riverview Pit and Lemington South Pit (see **Figure 2**).

Intermittent deposition of tailings will occur at North Pit TSF, Dam 6W TSF and Central TSF as part of ongoing management towards decommissioning, subject to approval from the Regulator. TSF locations are shown on **Figure 2**, and **Section 6.1** | provides information on the plans for capping and rehabilitation of TSFs for the life of the operation.

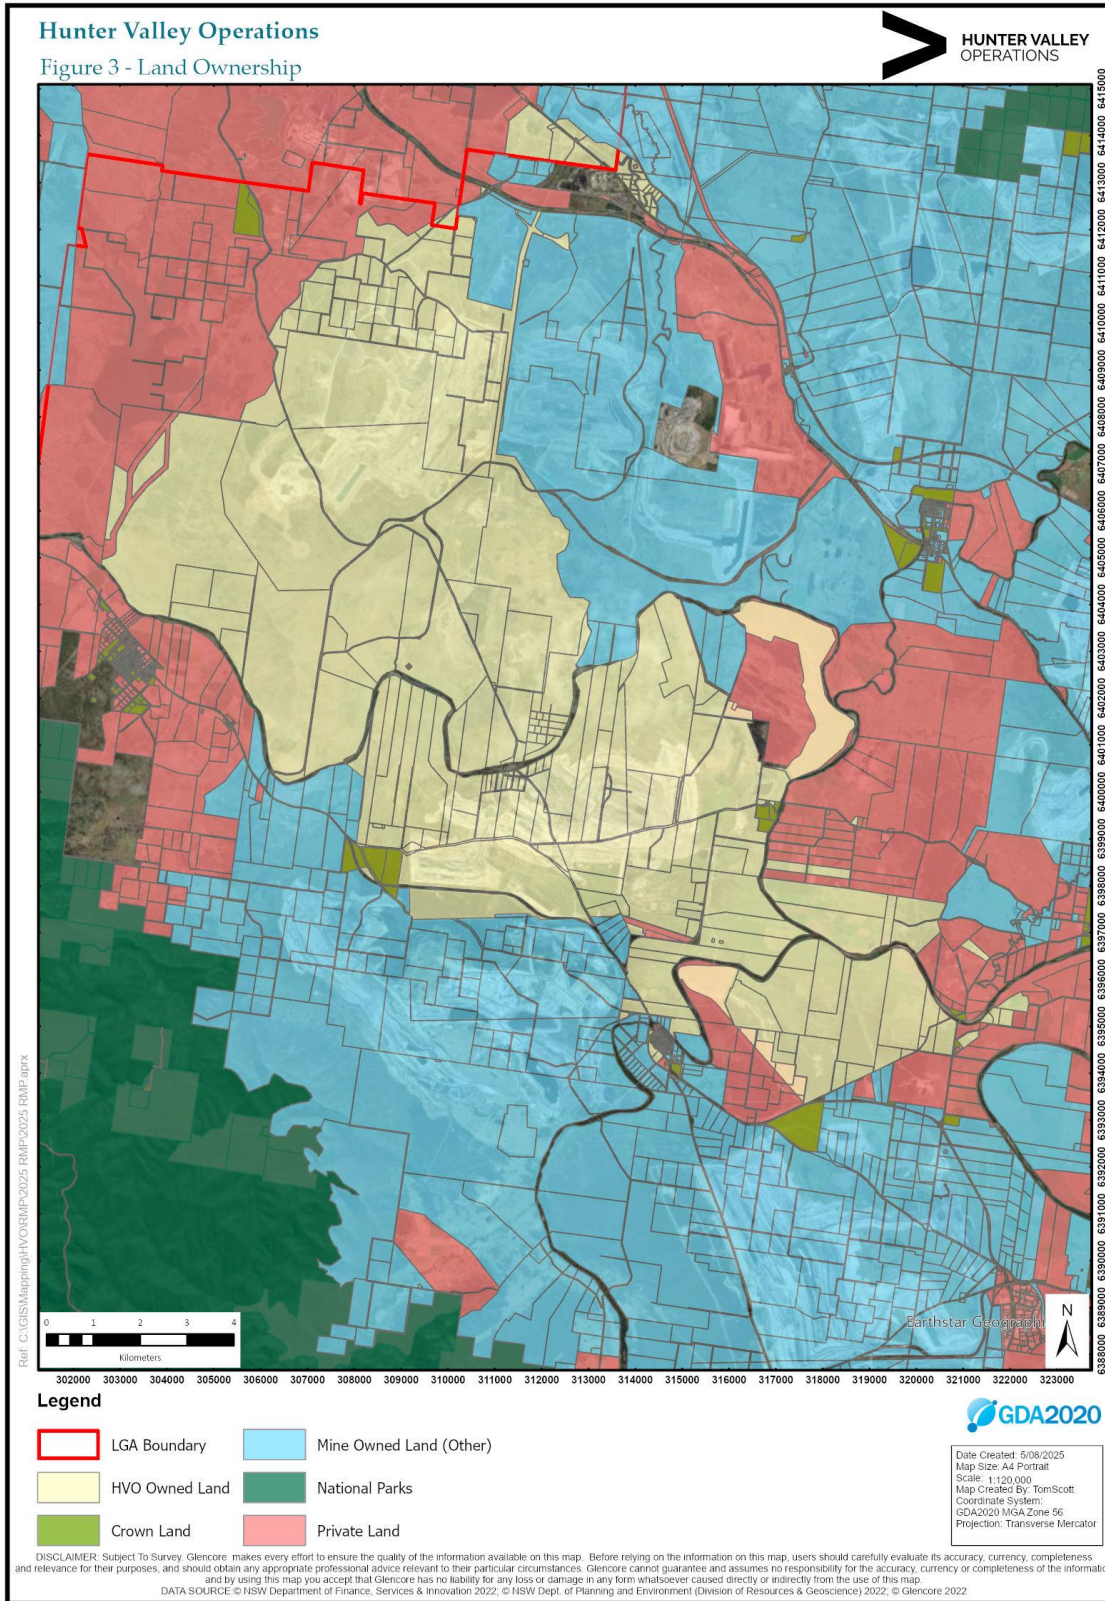
Figure 3- Land Ownership

HVO owns the majority of the lands within the existing leases area (**Figure 3**). A schedule of HVO land ownership on and adjacent to HVO coal leases is attached as (as reproduced from Appendix A of DA 450-10-2003 and PA 06_0261) and is shown on Error! Reference source not found..

The required land ownership and land use information has been separated into two figures (**Figures 3 and 4**) to facilitate clearer presentation and improve readability of the data.

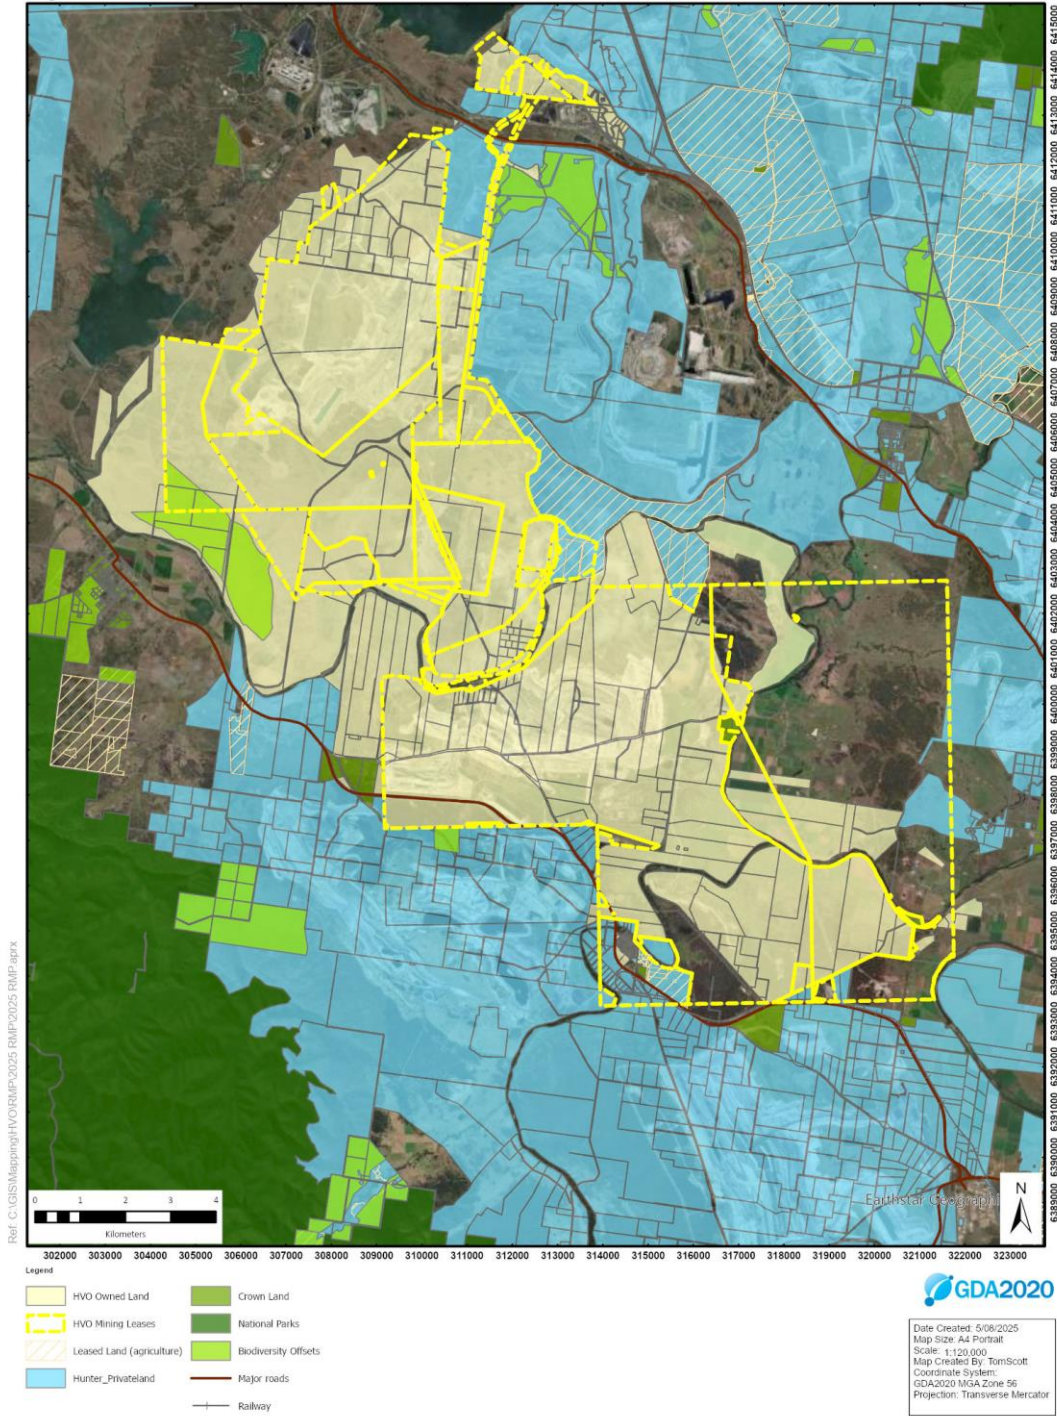
Figure 4-Current Land Use

HVO is situated in a landscape that is characterised by mining land, grazing land, more intensive agriculture on the Hunter River alluvial zone (cropping and dairying) and some private and public woodland (**Figure 4**Error! Reference source not found.). HVO is adjoined by Bayswater Power Station to the north, Ravensworth Operations to the northeast, grazing land to the east and west, grazing properties, residences and Mount Thorley Warkworth mining operations to the south east, and United Wambo Open Cut to the south west.
