**HUNTER VALLEY  
OPERATIONS**

# **REHABILITATION MANAGEMENT PLAN**

HVOOC-1797567310-5041

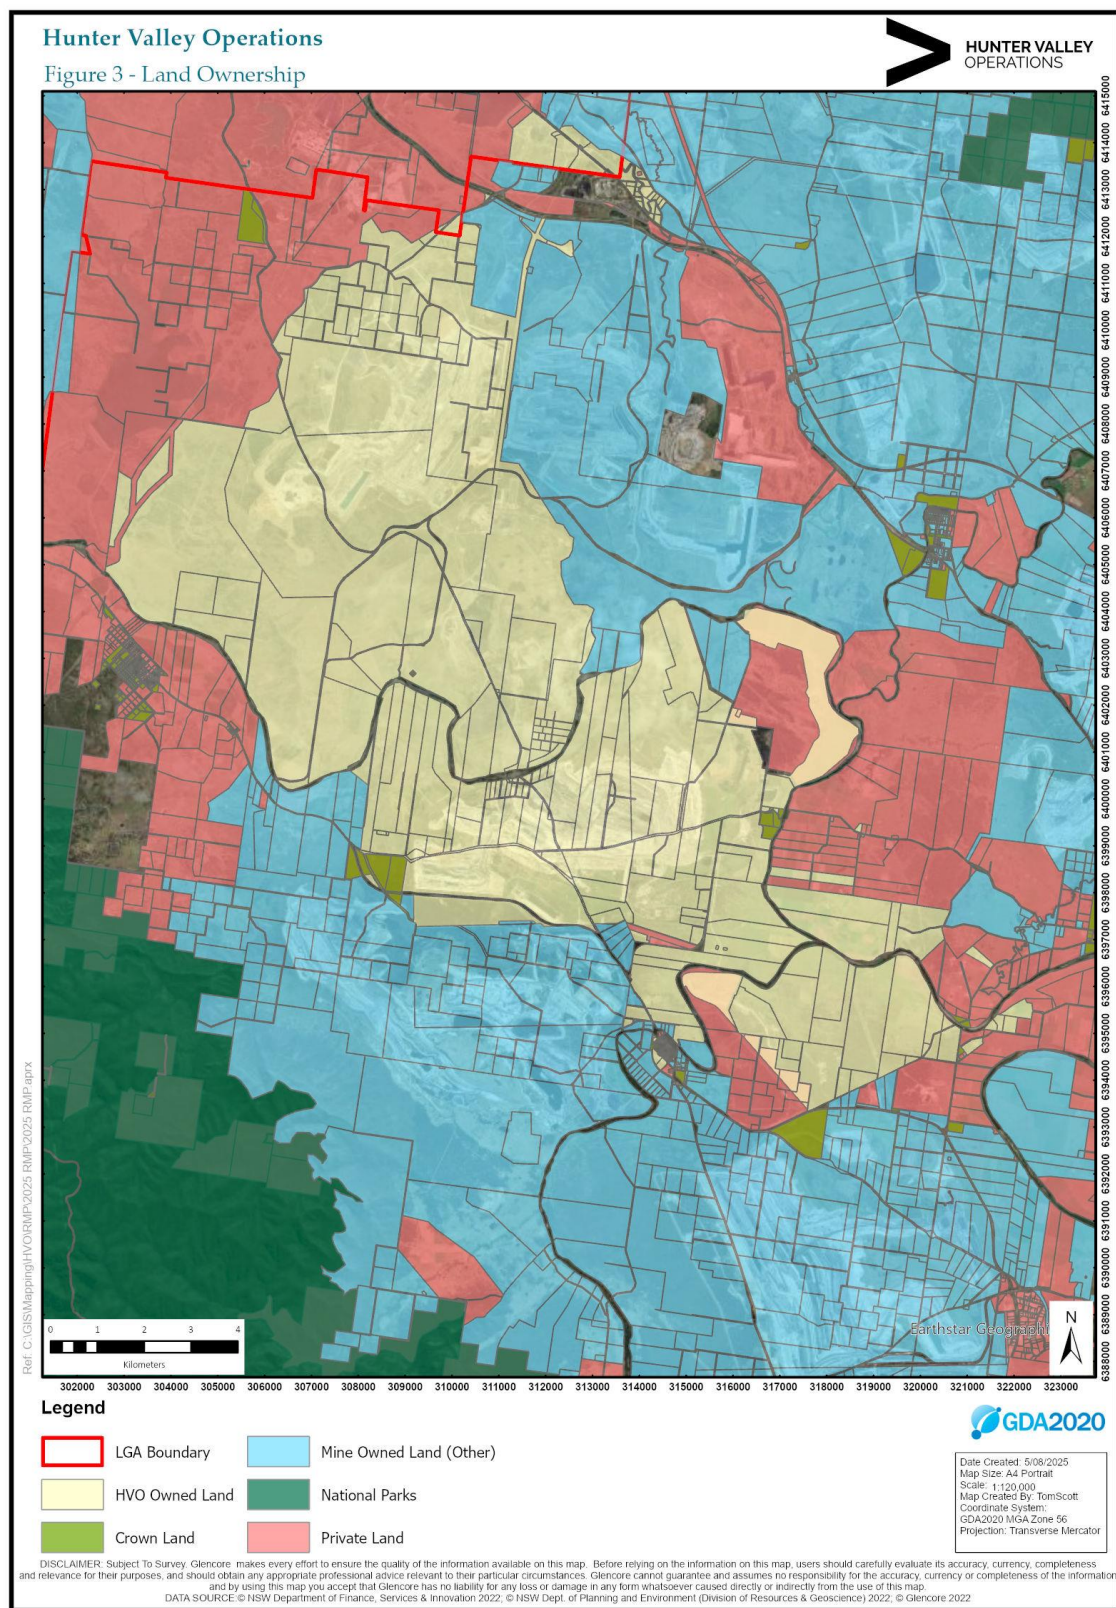
Figure 3- Land Ownership

HVO owns the majority of the lands within the existing leases area (**Figure 3**). A schedule of HVO land ownership on and adjacent to HVO coal leases is attached as (as reproduced from Appendix A of DA 450-10-2003 and PA 06\_0261) and is shown on Error! Reference source not found..

The required land ownership and land use information has been separated into two figures (**Figures 3 and 4**) to facilitate clearer presentation and improve readability of the data.

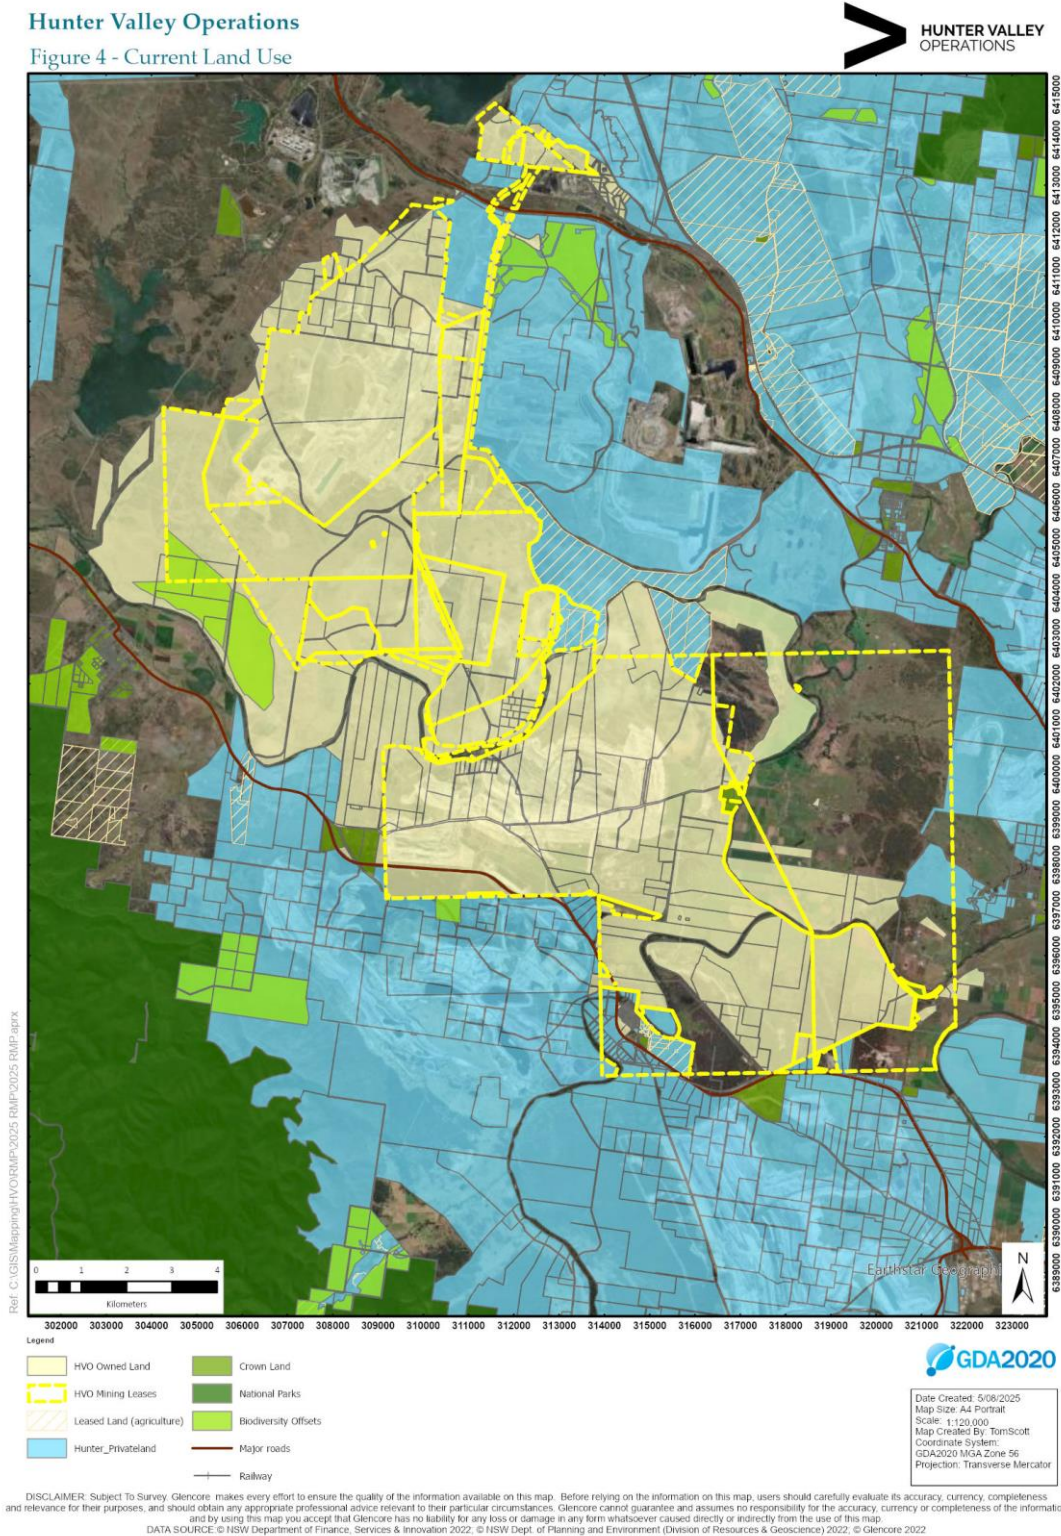
Figure 4-Current Land Use

HVO is situated in a landscape that is characterised by mining land, grazing land, more intensive agriculture on the Hunter River alluvial zone (cropping and dairying) and some private and public woodland (**Figure 4**Error! Reference source not found.). HVO is adjoined by Bayswater Power Station to the north, Ravensworth Operations to the northeast, grazing land to the east and west, grazing properties, residences and Mount Thorley Warkworth mining operations to the south east, and United Wambo Open Cut to the south west.

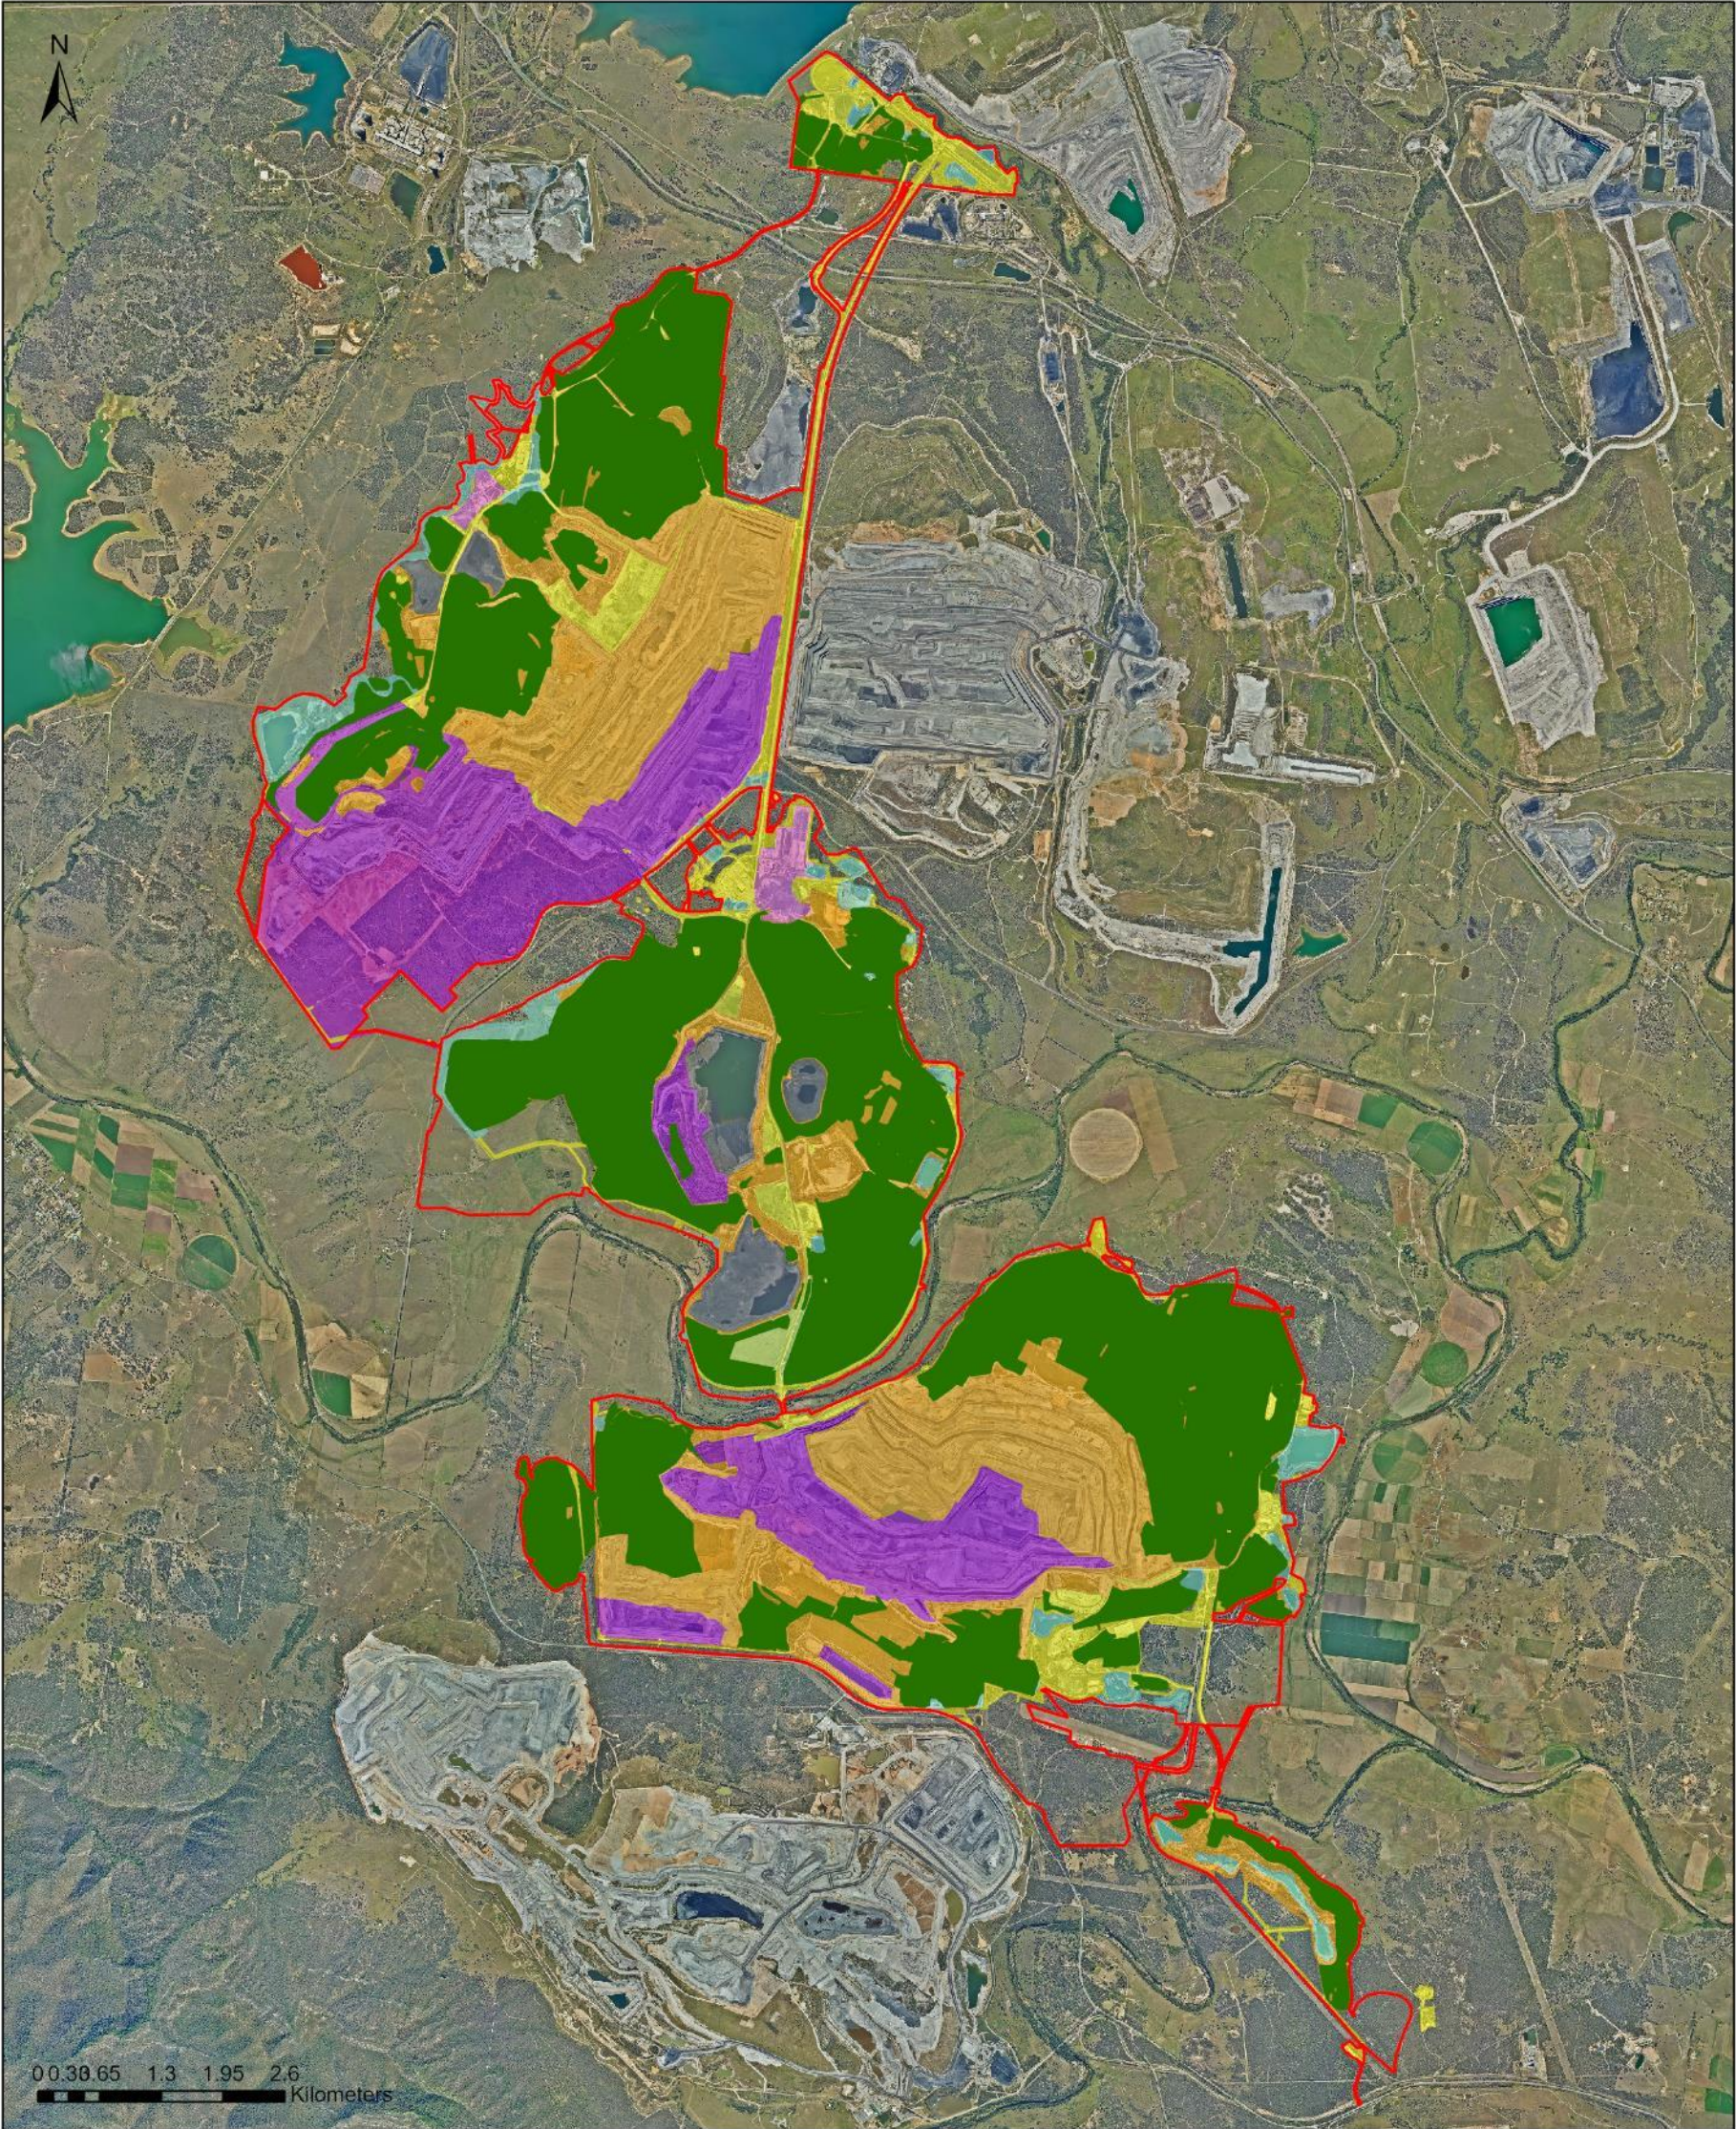
Plan 3: Rehabilitation Schedule 2025

The proposed rehabilitation schedule for the life of the mine is outlined on **Plans 3 – 9 in Appendix A**: This schedule assumes an average ROM production rate of 21mtpa and an average overburden removal rate of 110,000bcm per year. This schedule is an estimate only and may change due to changes in production/overburden rates, mine geological or geotechnical conditions, coal market requirement, mining methods and mining technology. This schedule is also based of the submitted EIS for the HVO Continuation project and is subject to change pending the approval of the project.
