**HUNTER VALLEY  
OPERATIONS**

# **MONTHLY ENVIRONMENTAL MONITORING REPORT - JULY 2026**

HVOOC-1797567310-5807

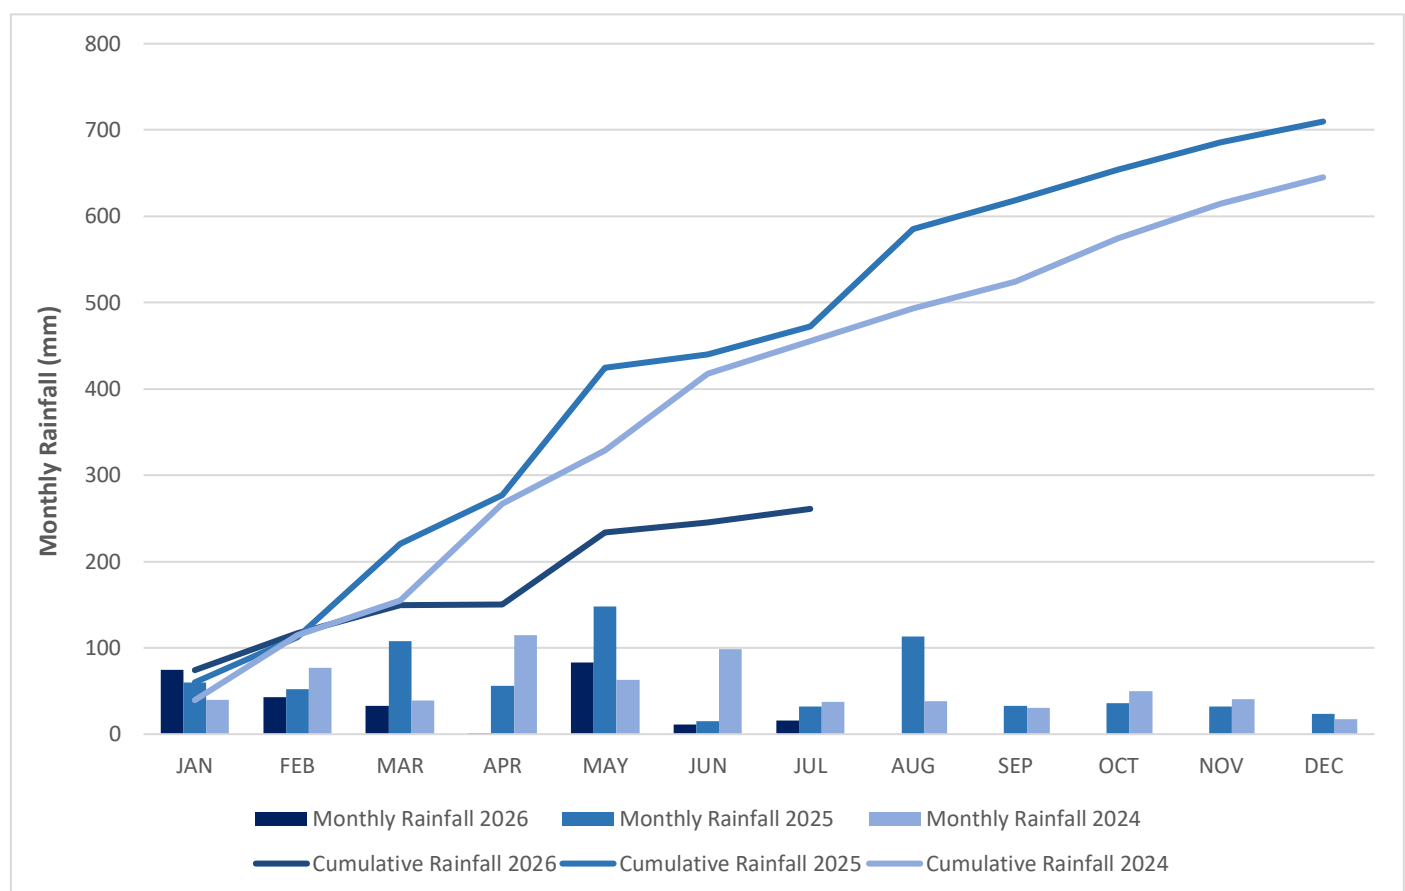
Figure 1 - Rainfall Summary 2024 – 2026

Rainfall recorded at the HVO Corporate weather station during the period is summarised in Table 1. The 2024, 2025 and 2026 trends are shown in Figure 1.

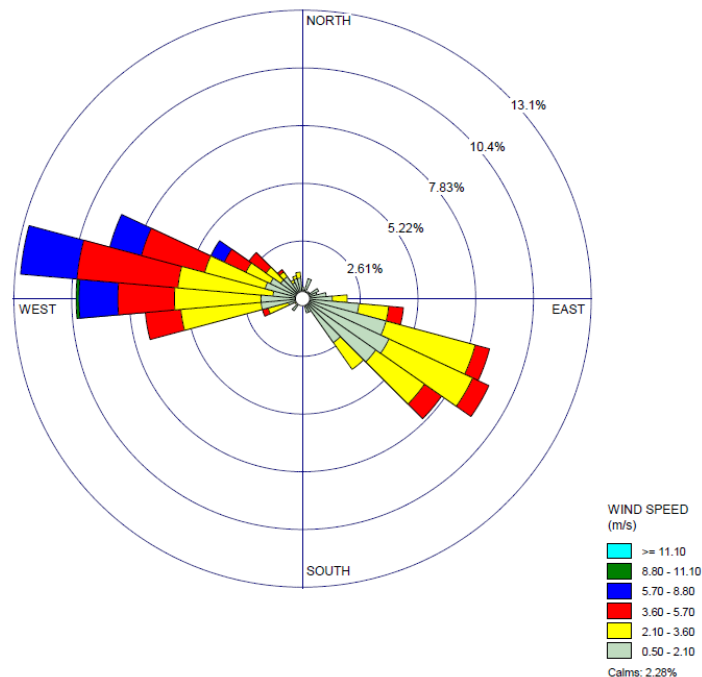
Figure 2 – HVO Corporate Wind Rose for the Reporting Period

Figure 2 and Figure 3 wind roses show wind speeds and directions during the reporting period at HVO Corporate and Cheshunt meteorological stations. The HVO Corporate station generally recorded winds from the west to west-northwest and east-southeast to southeast. While the Cheshunt station recorded winds ranging from the northwest to north-northwest and southeast to south-southeast.

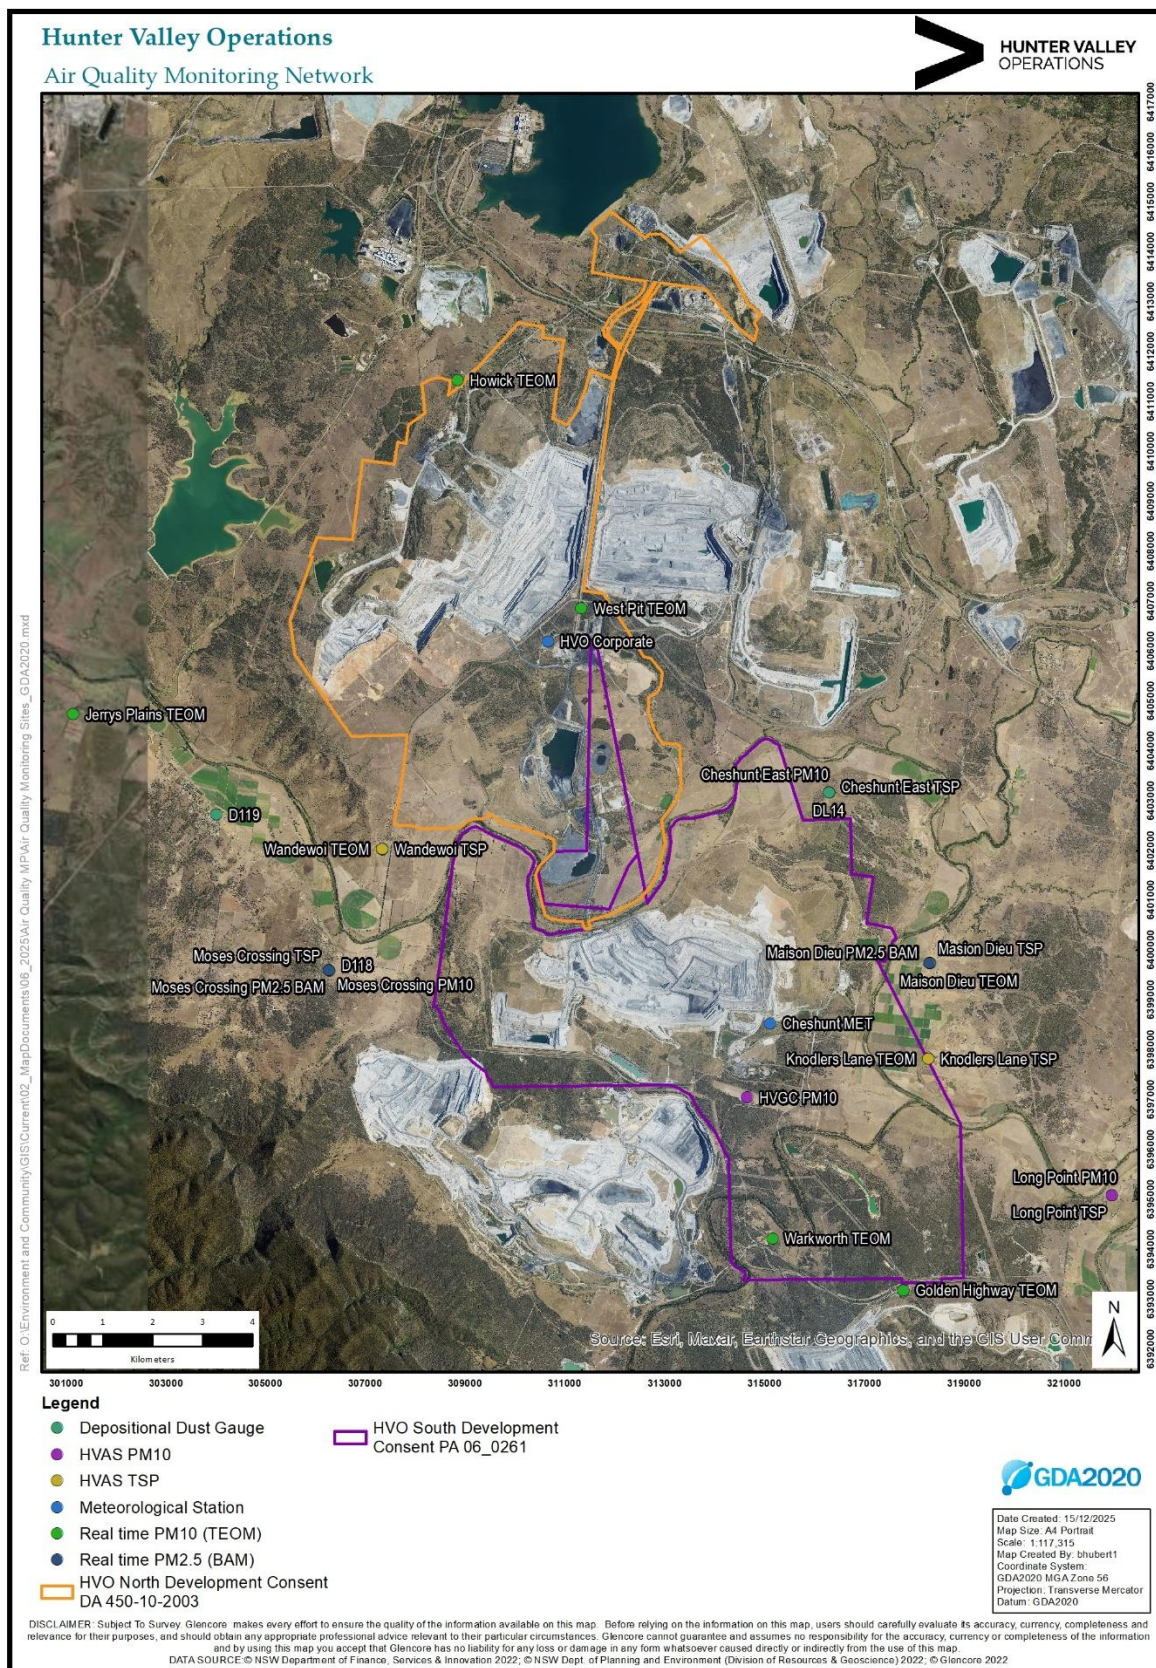
Figure 4 – Air Quality Monitoring Location Plan

HVO maintains two meteorological stations: 'HVO Corporate' and 'Cheshunt' (refer to Figure 4).

Suspended particles are measured by a network of High-Volume Air Samplers (HVAS) measuring Total Suspended Particulates (TSP) and Particulate Matter  $<10\mu\text{m}$  ( $\text{PM}_{10}$ ). The location of these monitors is presented in Figure 4. Each HVAS runs for 24-hours on a six-day cycle.

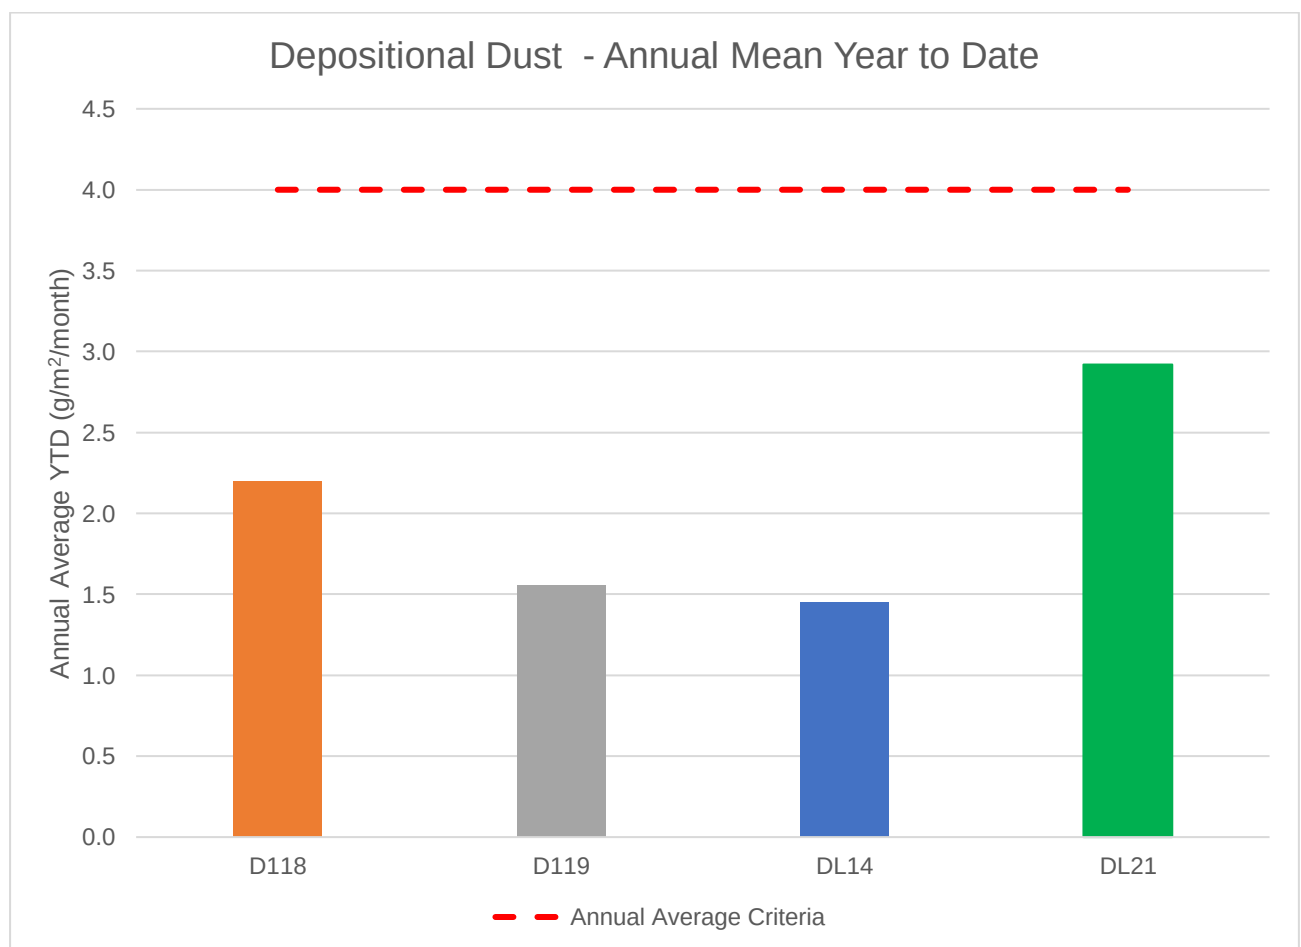
Figure 5 – YTD Depositional Dust Results as at end of the Reporting Period

**Error! Reference source not found.** displays insoluble solids results from depositional dust gauges during the reporting period compared against the annual impact assessment criteria. Any monthly results deemed to be contaminated (due to presence of bird droppings, insects, etc.) are not displayed. An assessment of HVO's contribution against the long-term impact assessment criteria will be provided in the 2026 Annual Review.

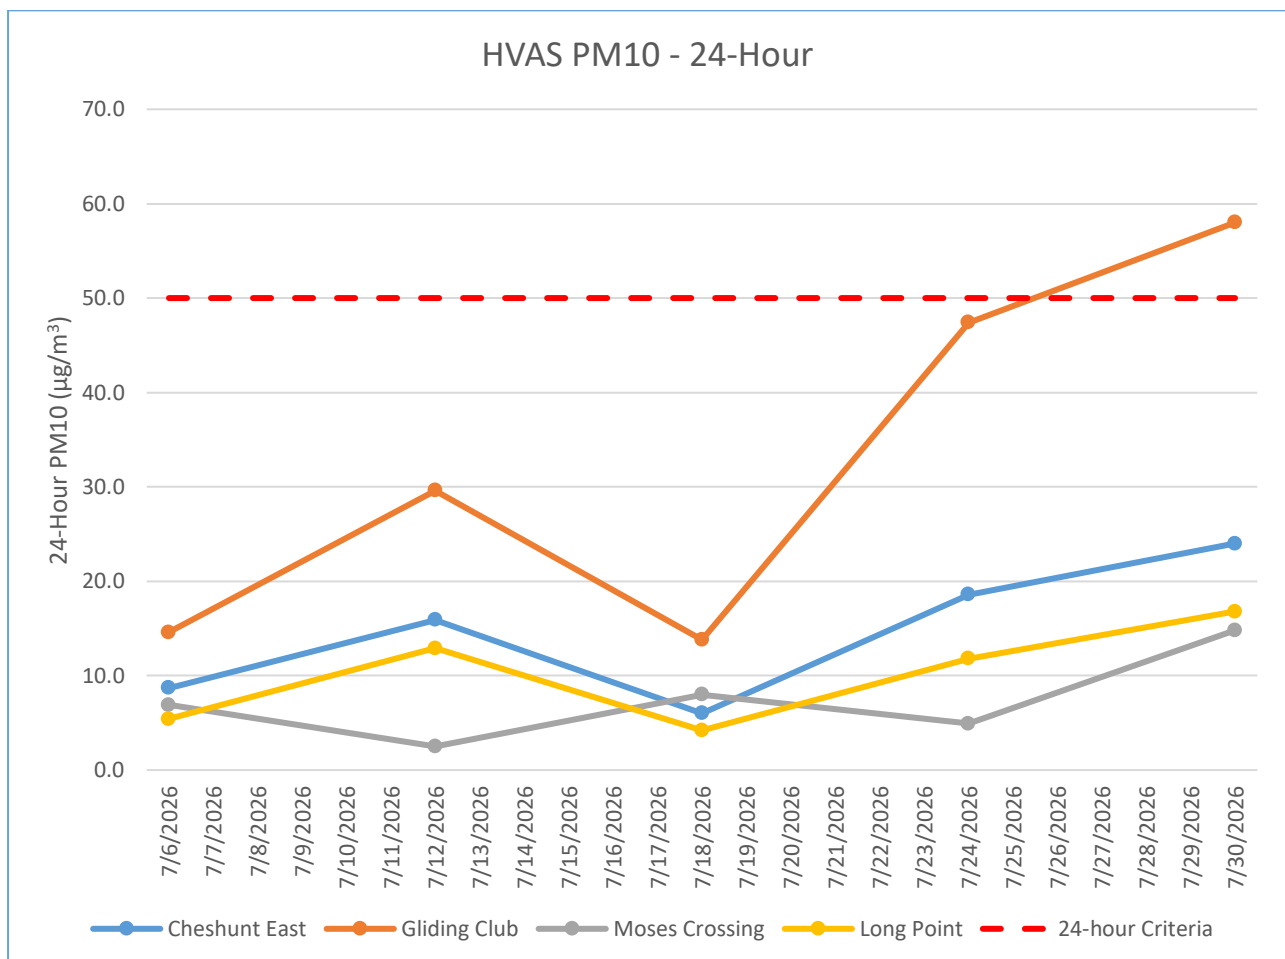
Figure 6 – Individual  $\text{PM}_{10}$  Results for the Reporting Period

Figure 6 shows individual  $\text{PM}_{10}$  results at each monitoring station against the short-term impact assessment criteria of  $50\mu\text{g}/\text{m}^3$  for the reporting period. All monitors except the gliding club on 30 July were below the short-term impact assessment criteria during the reporting period. All potential exceedances investigated, where applicable, were below the short-term impact assessment criteria.

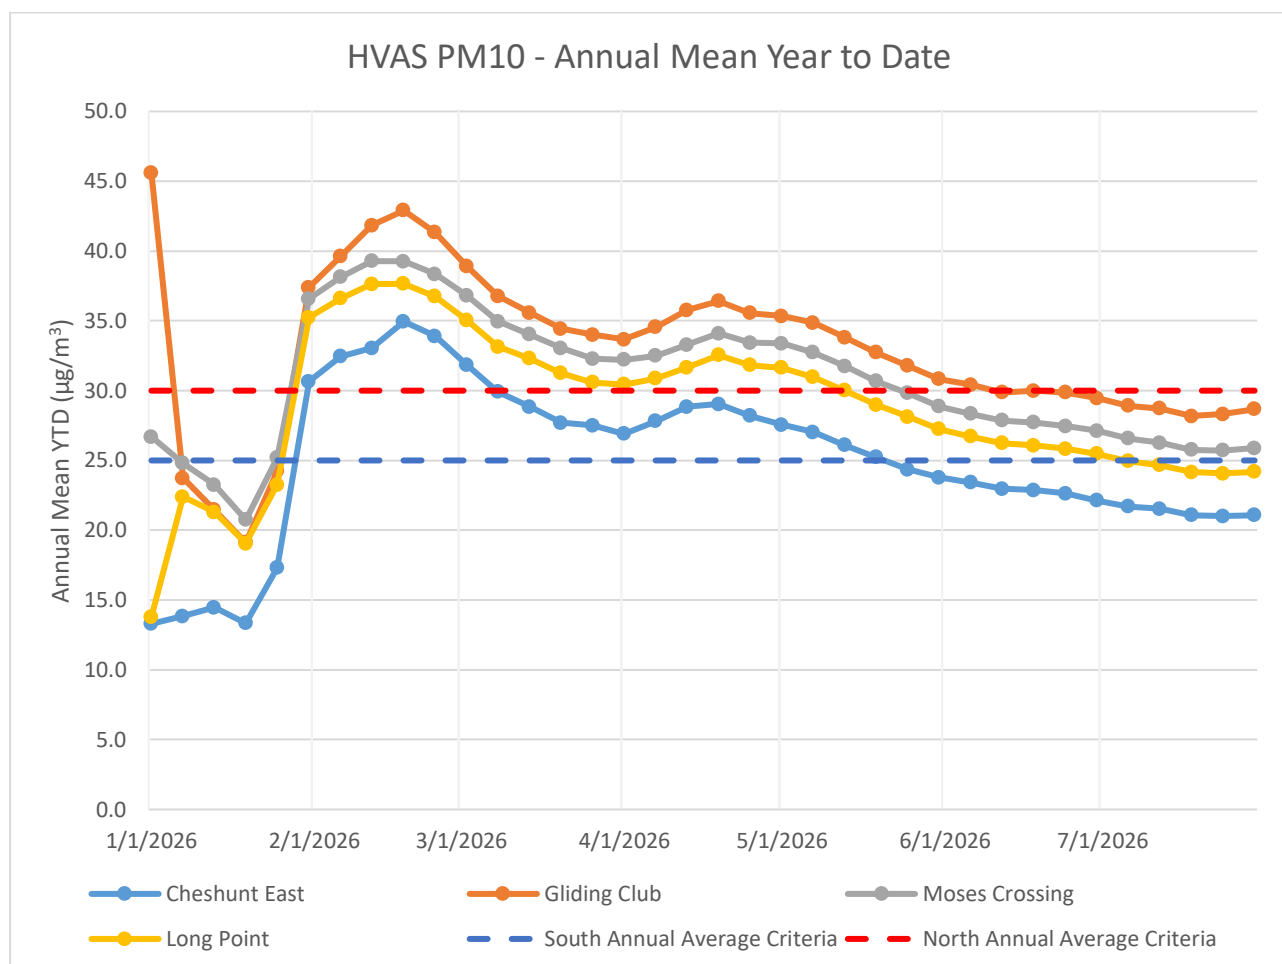
Figure 7 – Year to Date Average PM<sub>10</sub> as at end of the Reporting Period

Figure 7 shows the year-to-date rolling annual average PM<sub>10</sub> results. All monitoring sites annual averages reported at the end of the period were below the North Annual Average Criteria. All monitors were below the South Annual Average Criteria, except for the Gliding Club and Moses Crossing.

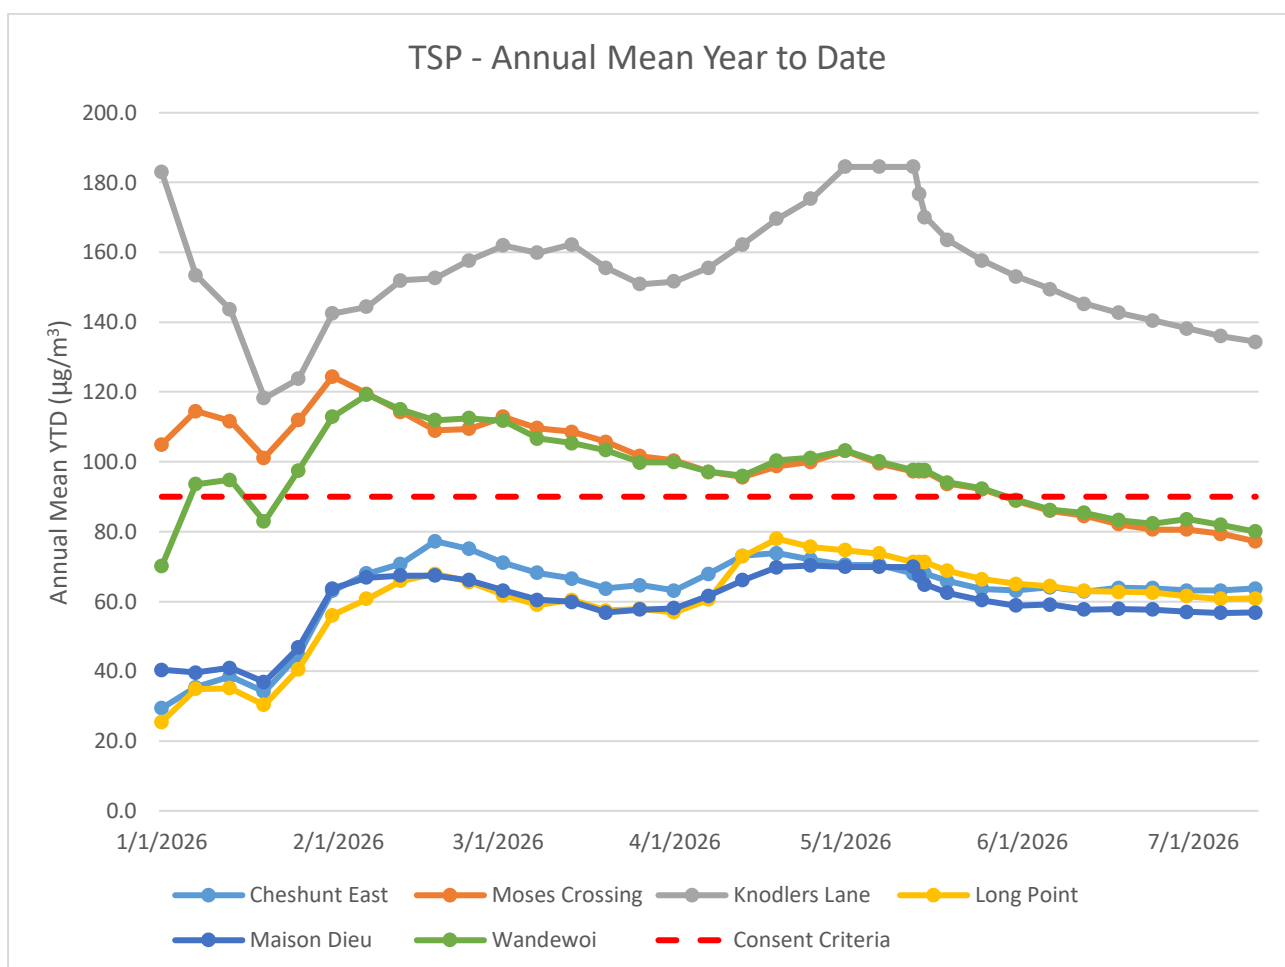
Figure 8 - Year to Date Average Total Suspended Particulates as at end of the Reporting Period

Figure 8 shows the annual average TSP results compared against the long-term impact assessment criteria of  $90\mu\text{g}/\text{m}^3$ .

All monitors, except for Knodlers Lane were below the relevant long-term impact assessment criteria during the reporting period.

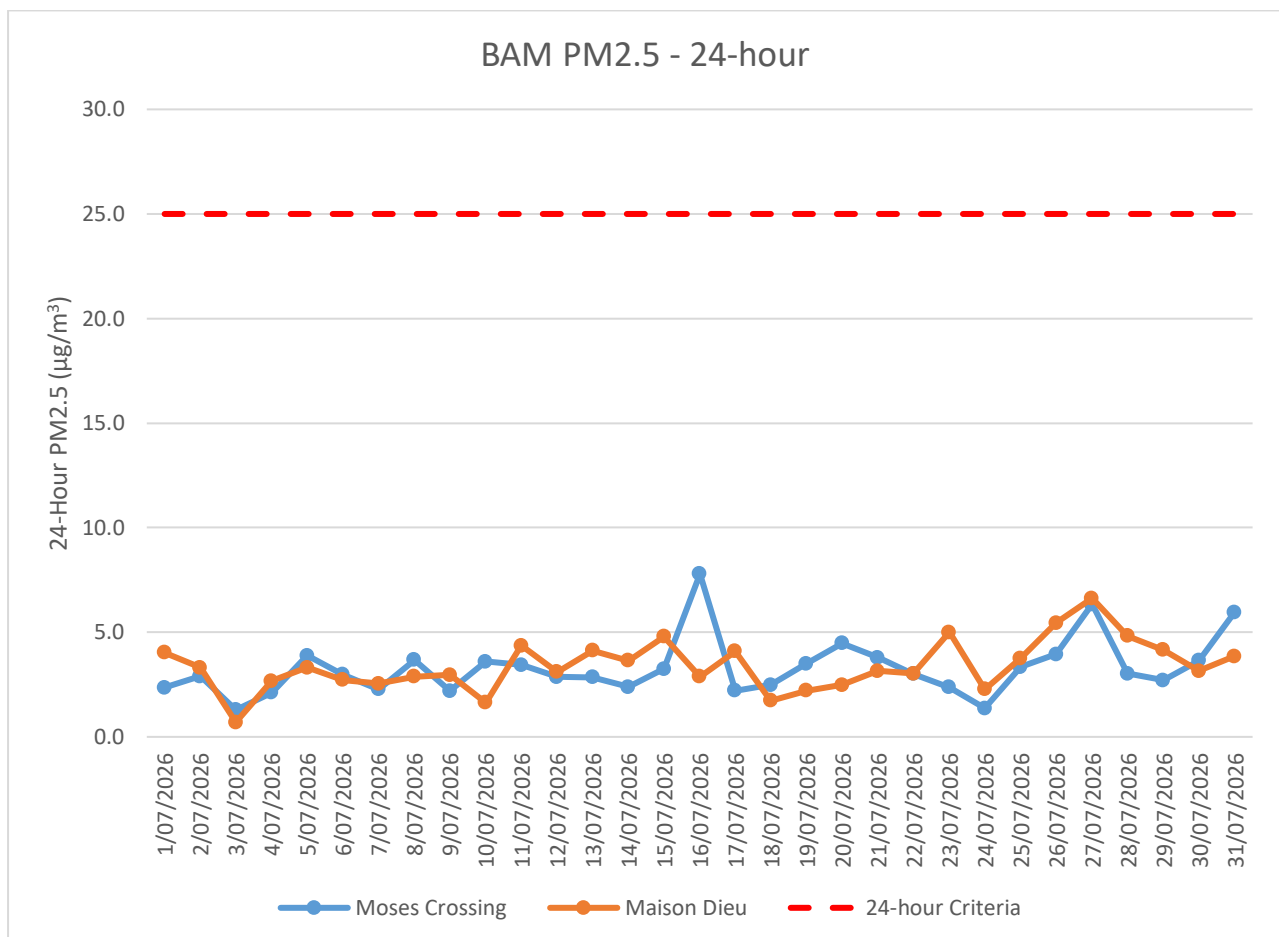
Figure 9 - Results for the Reporting Period

Figure 9 shows individual PM<sub>2.5</sub> results at each monitoring station against the HVO South short-term impact assessment criteria of 25µg/m<sup>3</sup> for the reporting period. Both monitors were below the relevant short-term impact assessment criteria during the reporting period.

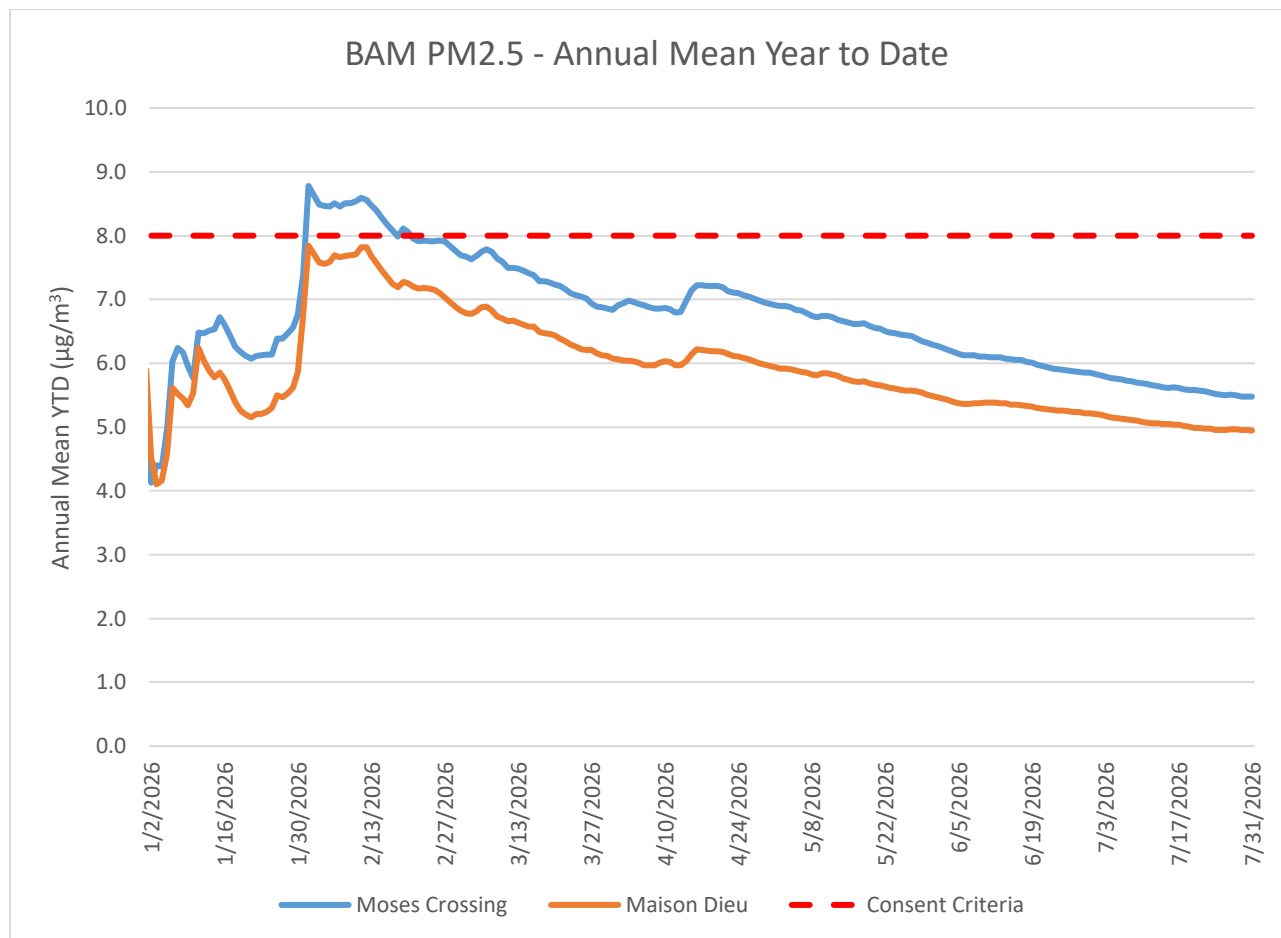
Figure 10 - Year to Date Average PM<sub>2.5</sub> as at end of the Reporting Period

Figure 10 shows the year-to-date annual average PM<sub>2.5</sub> results. During the reporting period, the annual average year to date results show Maison Dieu and Moses Crossing below the PM<sub>2.5</sub> annual rolling mean criteria of 8µg/m<sup>3</sup>.

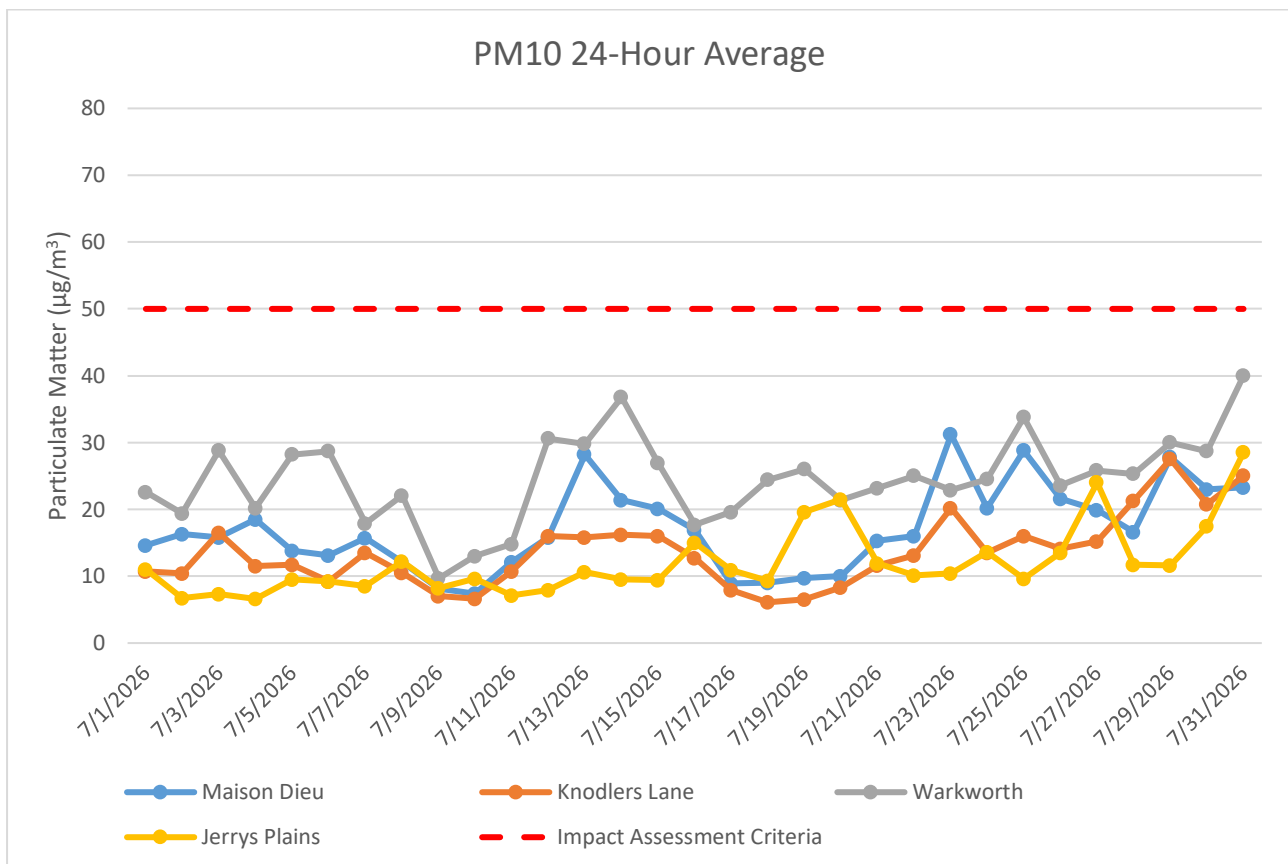
Figure 11 – Real Time PM<sub>10</sub> 24hr for the Reporting Period

Figure 11 shows the daily 24-hour average PM<sub>10</sub> results from the real time monitoring sites. During the reporting period, daily results were below the 24-hr average criteria of 50µg/m<sup>3</sup>.

All monitors reported data capture rates of more than 75% during the reporting period.

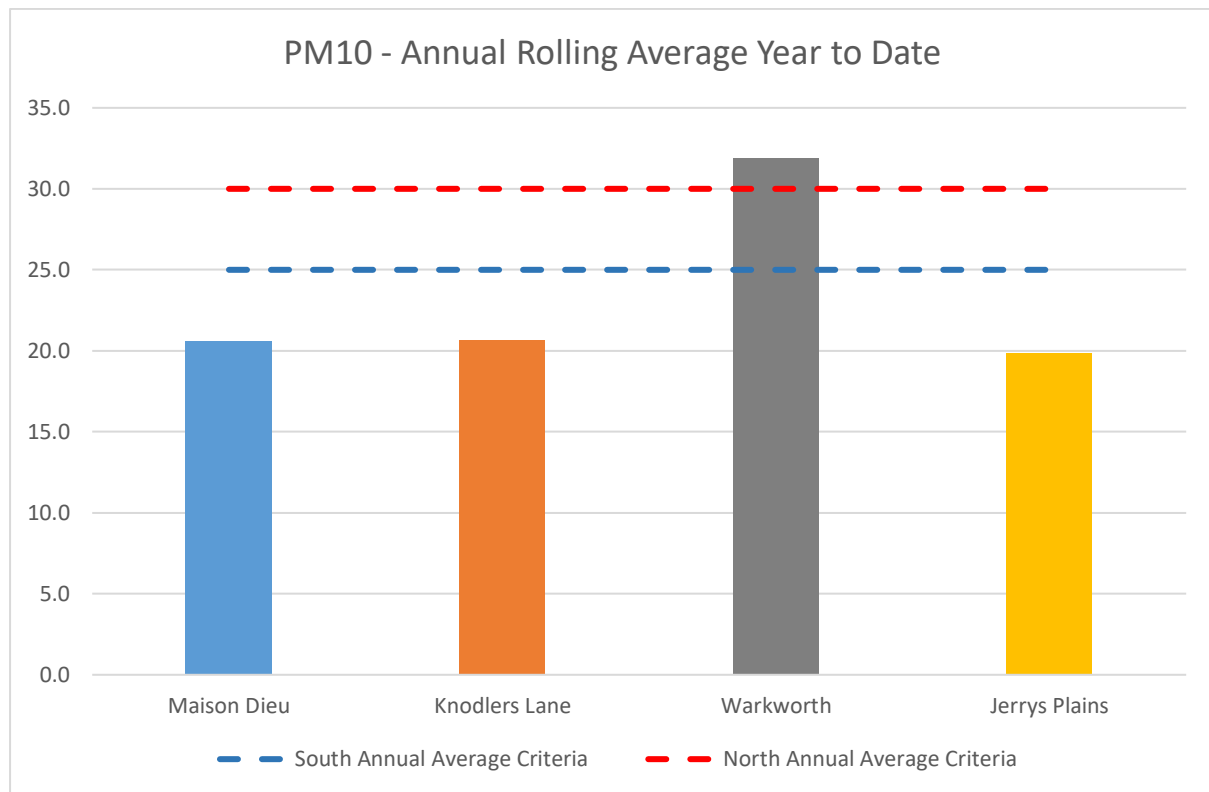
Figure 12 – Real Time PM<sub>10</sub> Annual Average for the Reporting Period

Figure 12 shows the annual rolling average PM<sub>10</sub> results from the real time monitoring sites. All monitoring results were below the annual average for the relevant long-term impact assessment criteria for both the North and South during the reporting period, except for Warkworth.

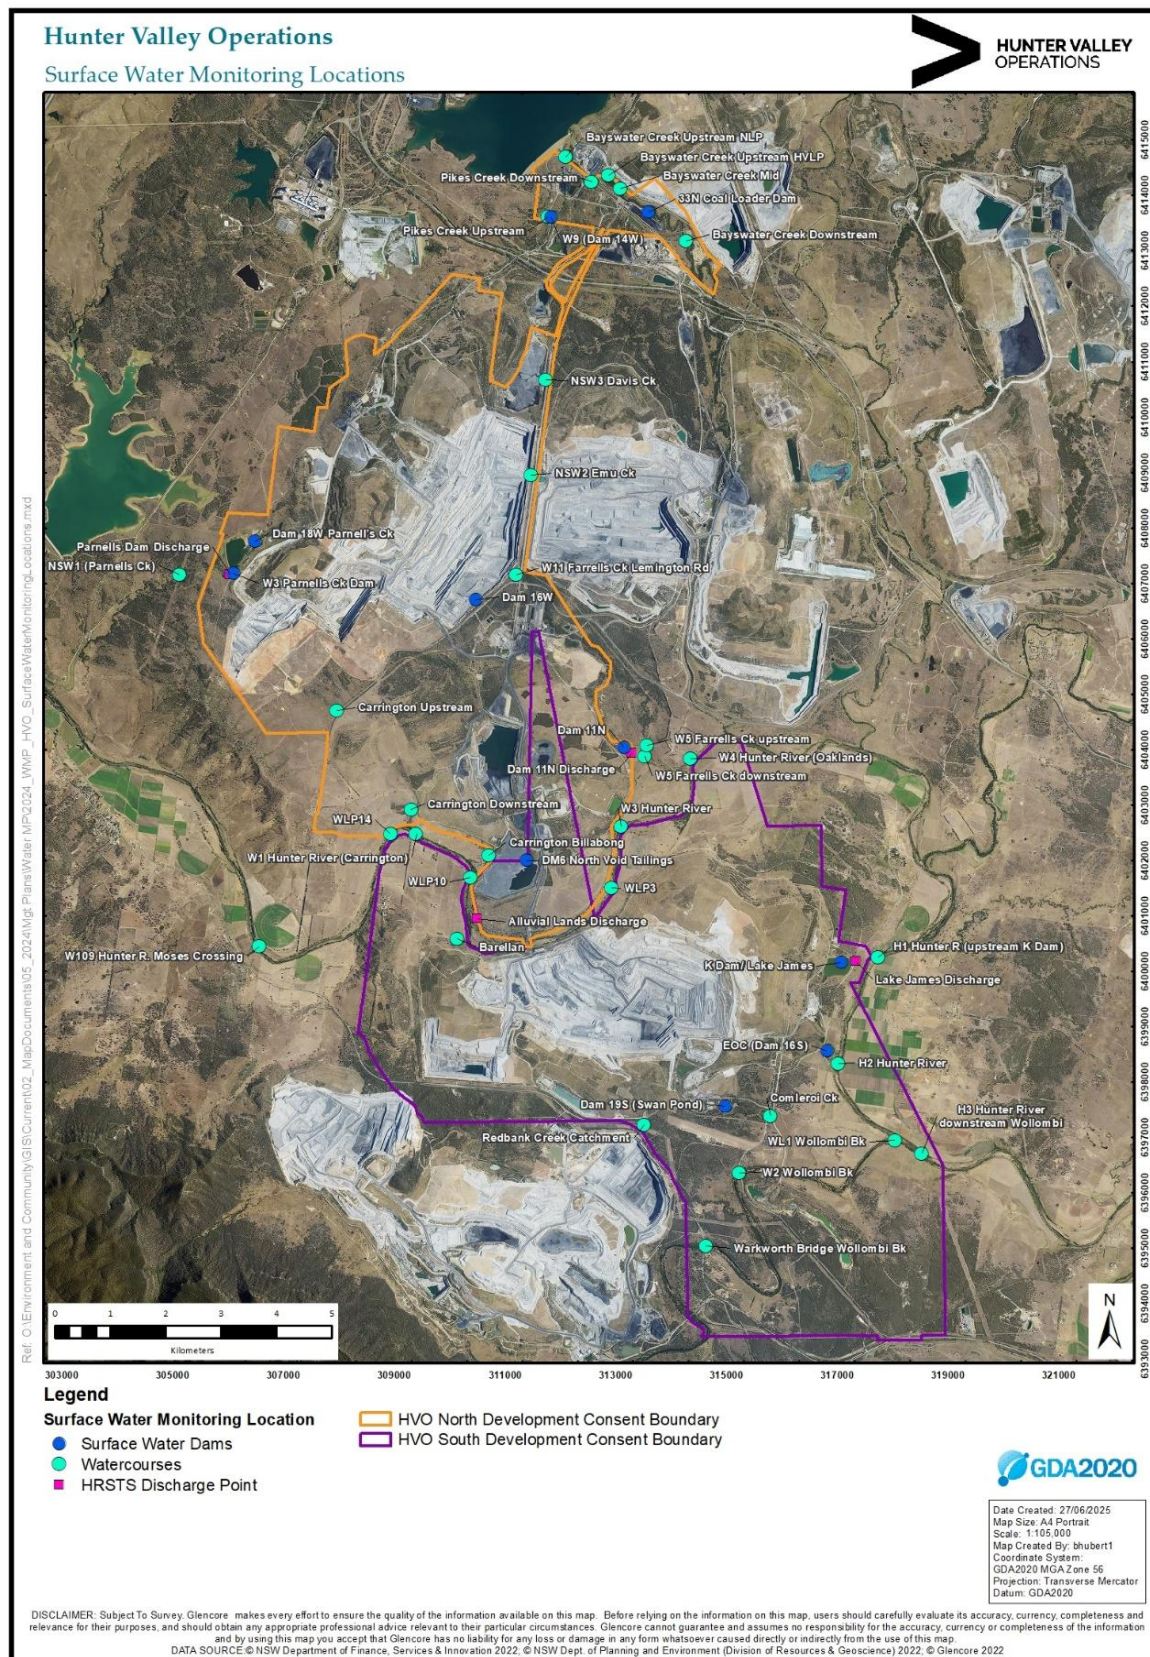
Figure 13 – HVO Surface Water Monitoring Locations

Surface watercourses are sampled on a quarterly sampling regime. Water quality is assessed through the parameters of pH, electrical conductivity (EC) and Total Suspended Solids (TSS). The location of surface water monitoring points across HVO is shown in Figure 13.

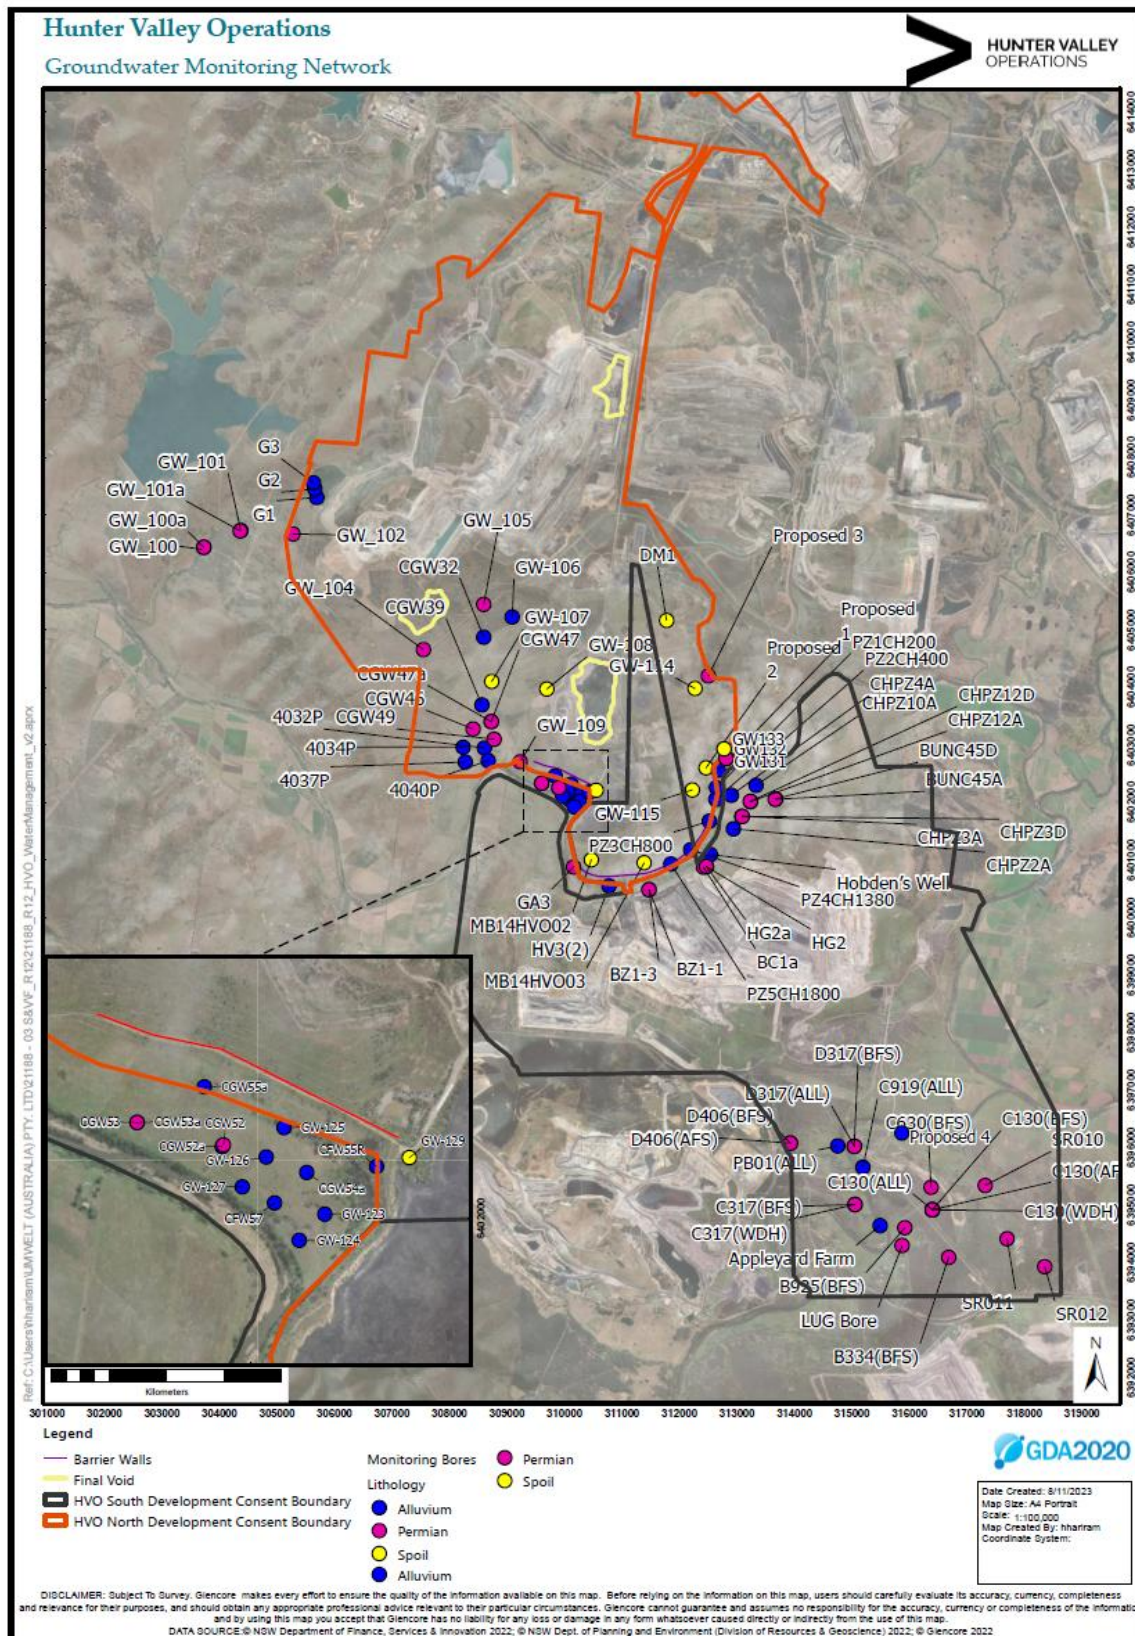
Figure 14 - Groundwater Monitoring Locations at HVO

Groundwater monitoring is undertaken on a quarterly basis in accordance with the HVO Water Management Plan and Groundwater Monitoring Programme. The location of groundwater monitoring points across HVO are show in Figure 14.

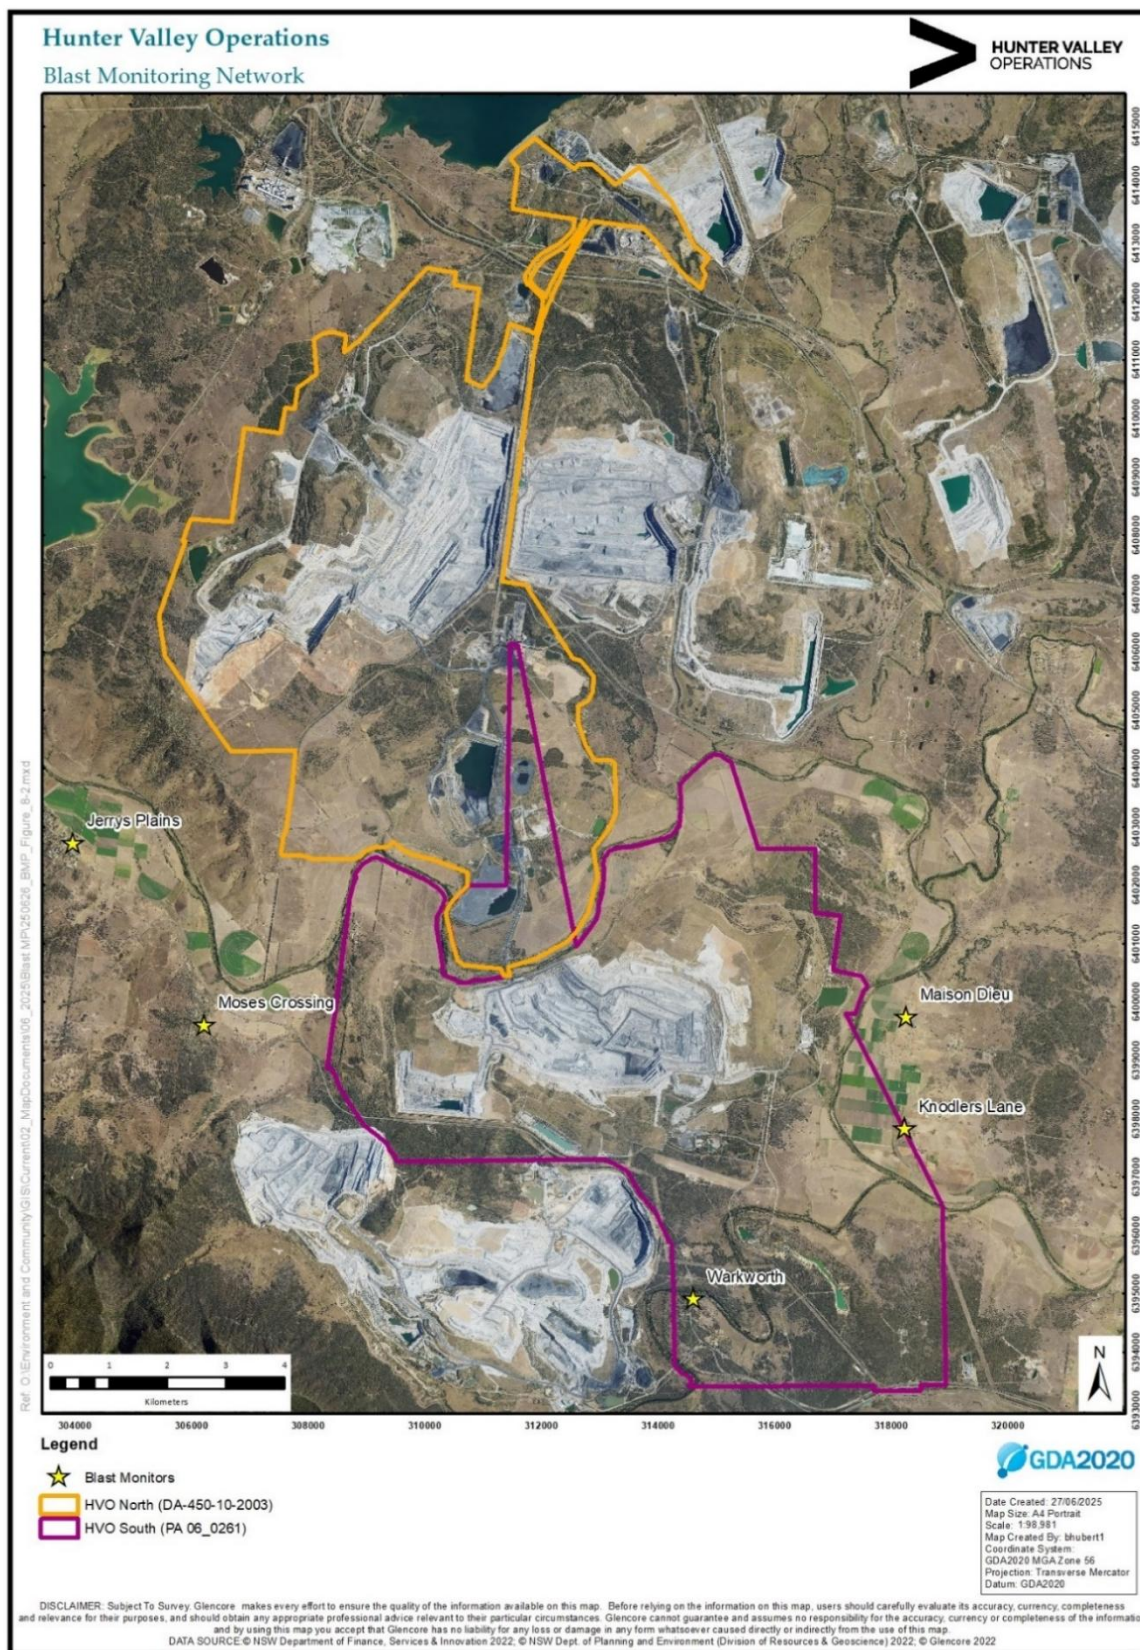
Figure 15 - Blast Monitoring Location Plan

HVO maintains a network of blast monitoring units located at nearby privately owned residences and function as regulatory compliance monitors. The location of these monitors can be found in *Figure 15*. Blasting criteria for HVO are summarised in Table 2.

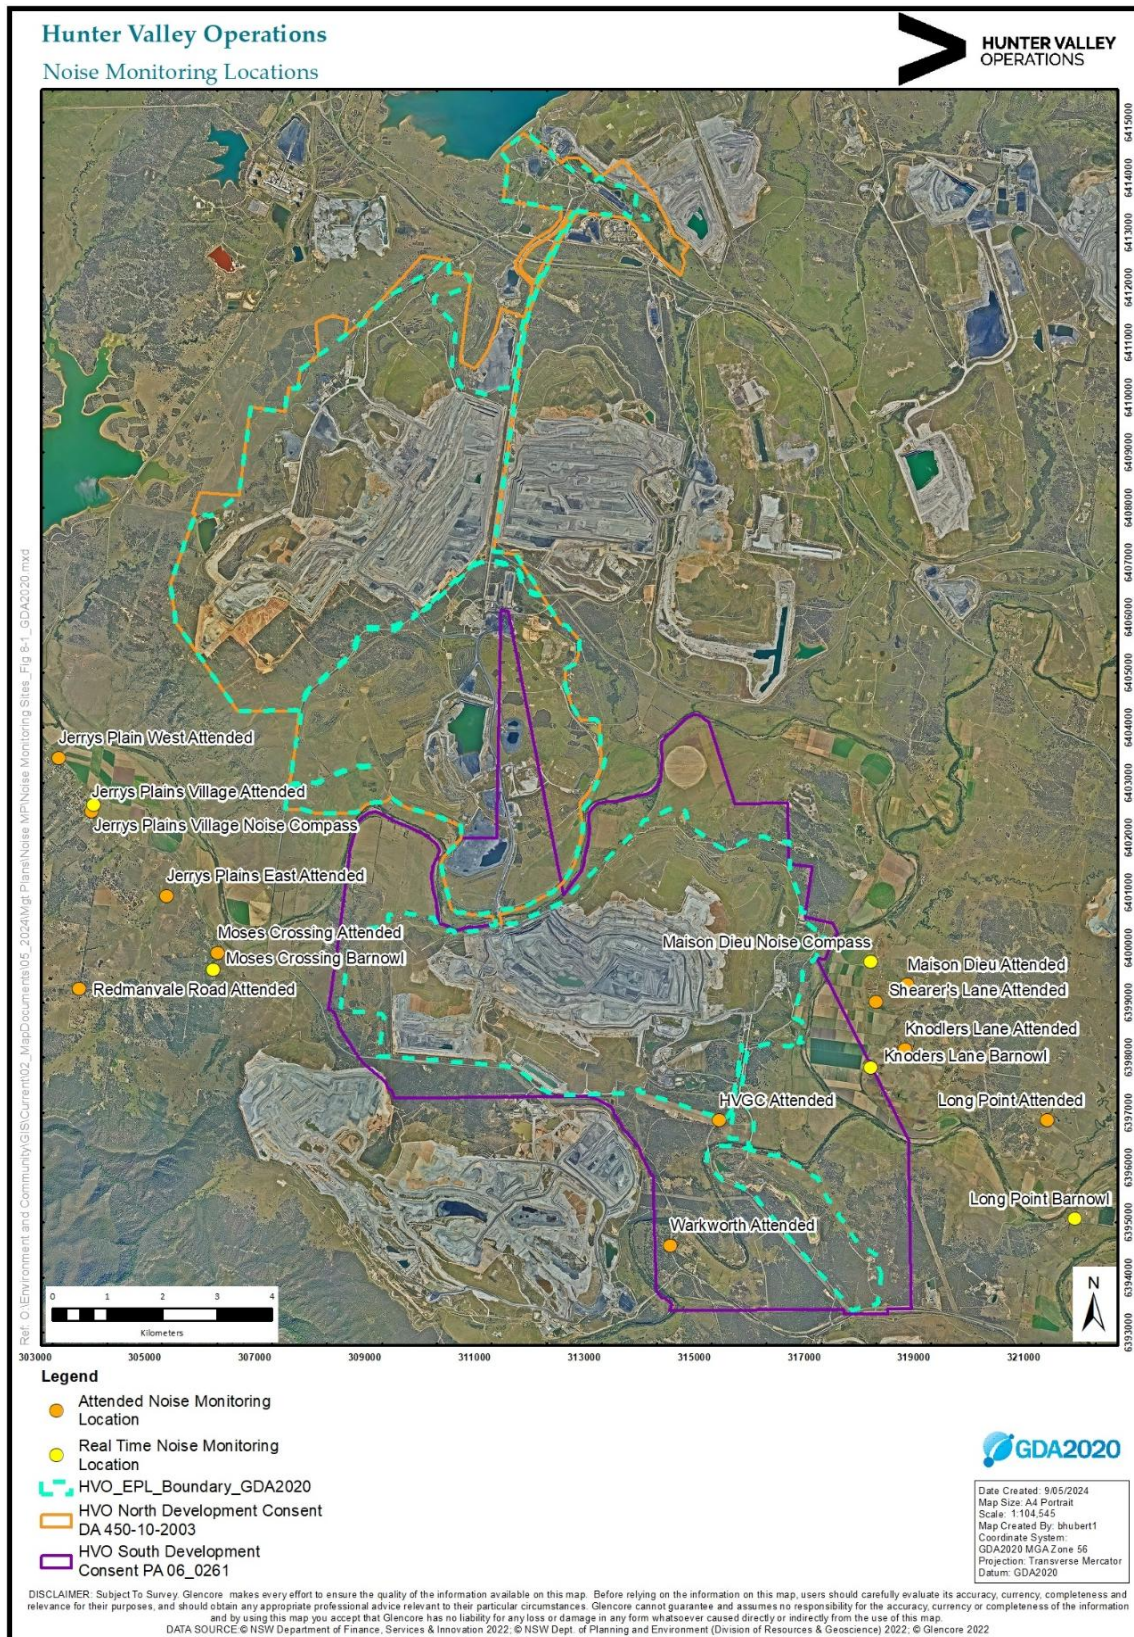
Figure 16 - Noise Monitoring Location Plan

Routine attended noise monitoring occurs at defined locations around HVO, as described in the HVO Noise Monitoring Programme. The noise monitoring aims to quantify and describe the acoustic environment around the site and compare results with specified limits. The attended noise monitoring locations are displayed in Figure 16.

HVO utilises a network of real-time directional noise monitors to manage noise impacts on a continuous basis, shown in Figure 16. Noise alarms are in place at five monitoring locations (Knodlers Lane, Maison Dieu, Jerrys Plains, Moses Crossing, and Long Point) which alert HVO staff to elevated noise levels that require investigation.
