**HUNTER VALLEY  
OPERATIONS**

# **MONTHLY ENVIRONMENTAL MONITORING REPORT - JULY 2026**

HVOOC-1797567310-5807

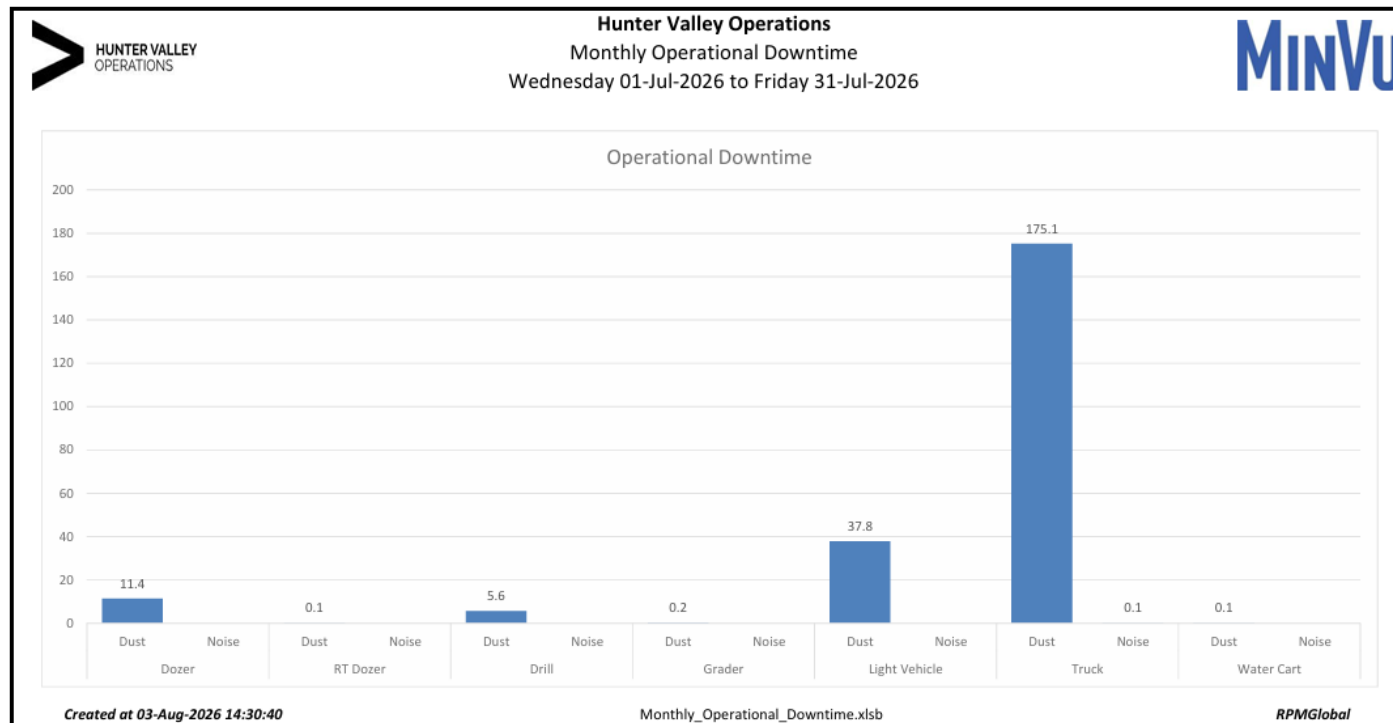
Figure 17 - Operational Downtime by Equipment Type for the Reporting Period

- Two hundred and thirty point two (230.2) hours for dust, and
- Zero point one (0.1) hours for noise.

Operational downtime by equipment type is show in Figure 17. Note that these delays are instances where operations were completely stopped and does not include occasions where operations were changed/modified but not stopped (e.g. changed from exposed dump to in-pit dump).

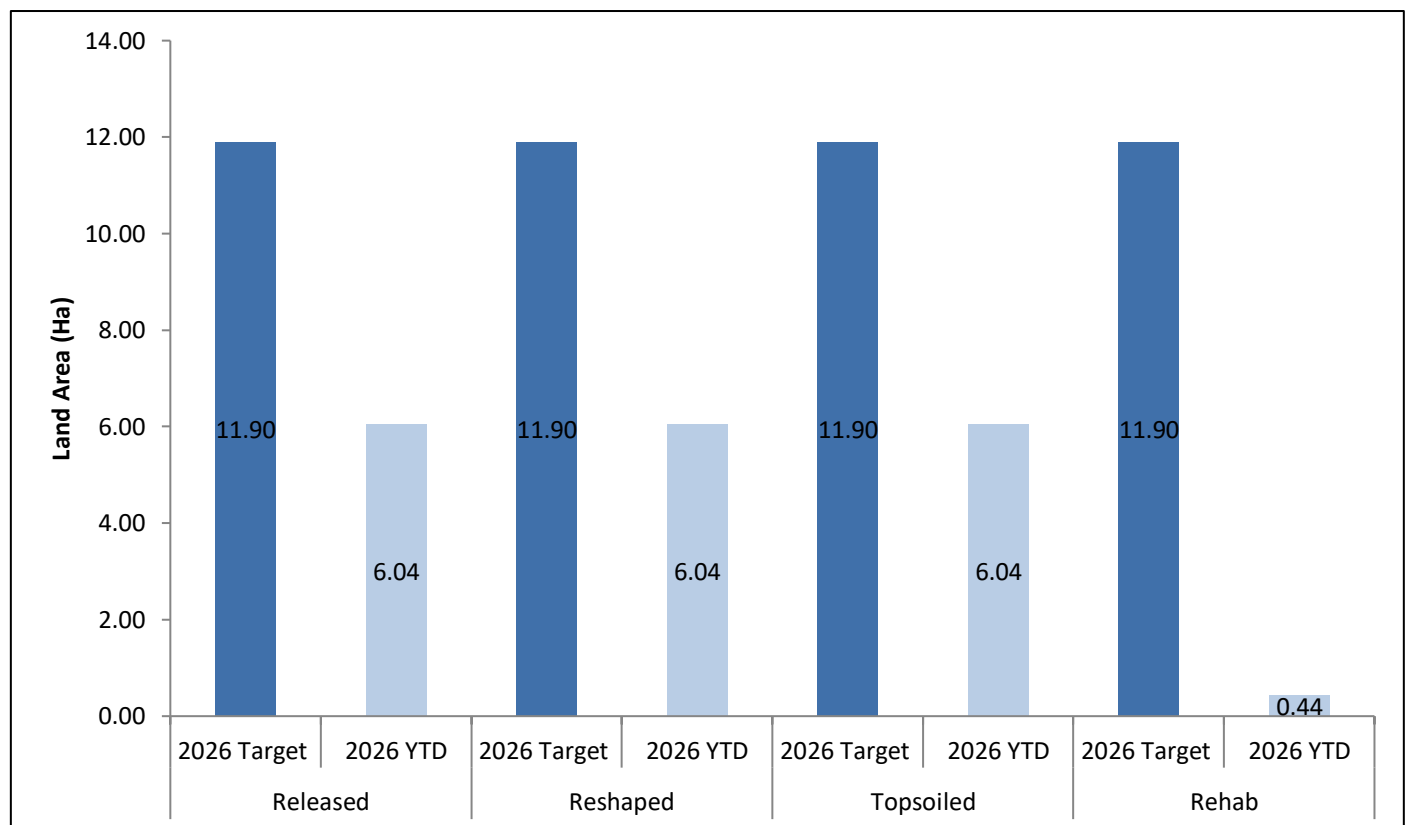
Figure 18 - Rehabilitation YTD February 2026

- 0.0ha of land was reshaped;
- 0.0ha of land was released (became available for the application of topsoil);
- 5.60ha of land was topsoiled; and
- 0.0ha of land was rehabilitated.

Year to date progress is shown in Figure 18.
