HUNTER VALLEY OPERATIONS

This report has been compiled to provide a monthly summary of environmental monitoring results for Hunter Valley Operations (HVO). This report includes all monitoring data collected for the period 1st to 31st August 2022 (the 'Reporting Period').

Monthly Environmental Monitoring Report – August 2022

Hunter Valley Operations MEMR

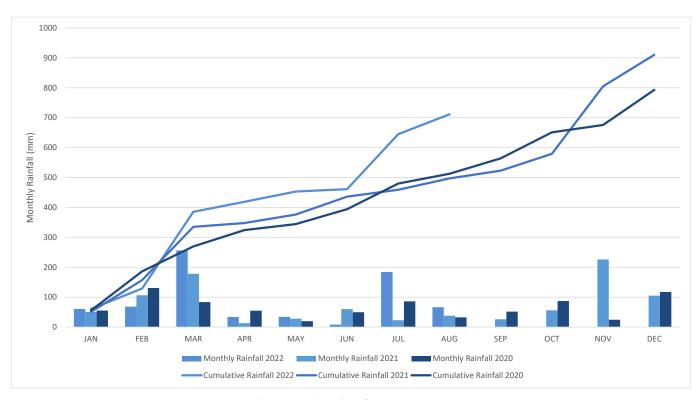
Figure 1 - Rainfall Summary 2022

Rainfall for the period is summarised in **Table 1**. The 2020, 2021 and 2022 trends are shown in **Figure 1**.

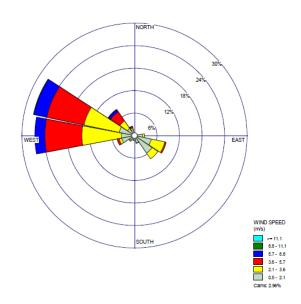
Figure 2 - HVO Corporate Wind Rose for the Reporting Period

North-westerly to westerly winds were prevailing during the reporting period as shown in **Figure 2** (HVO Corporate) and **Figure 3** (HVO Cheshunt).

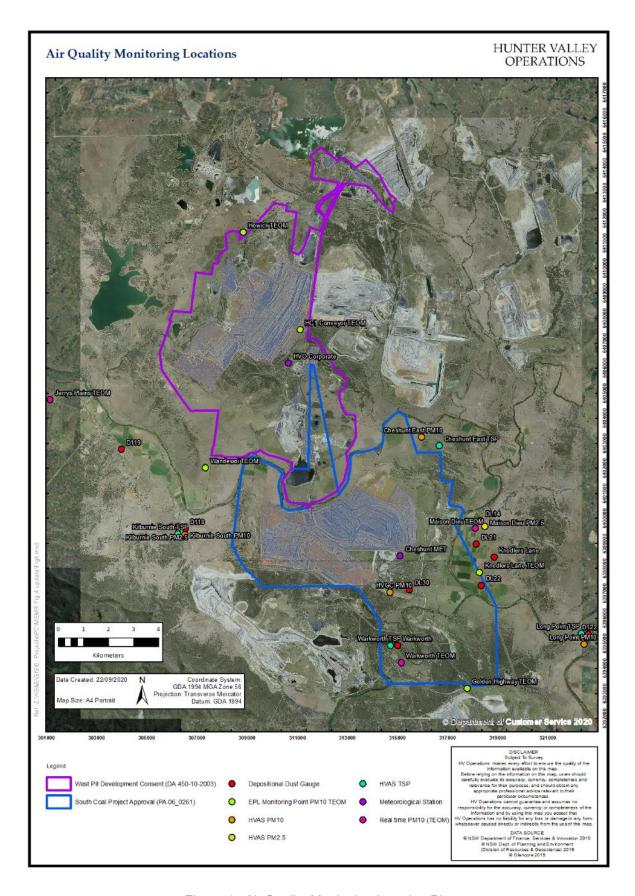
Figure 4 - Air Quality Monitoring Location Plan

HVO maintains two meteorological stations: 'HVO Corporate' and 'Cheshunt' (refer to Figure 4).

Suspended particles are measured by a network of High Volume Air Samplers (HVAS) measuring Total Suspended Particulates (TSP) and Particulate Matter <10µm (PM₁₀). The Kilburnie South and Maison Dieu HVAS also monitor Particulate Matter <2.5µm (PM_{2.5}). The location of these monitors is presented in Figure 4. Each HVAS runs for 24-hours on a six-day cycle.

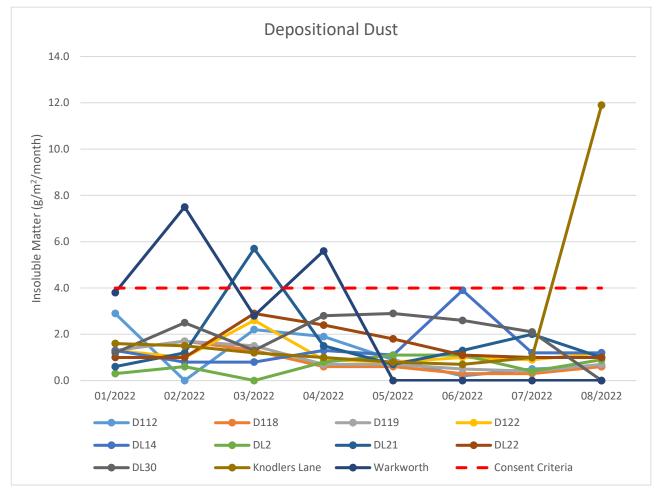
Figure 5 - Depositional Dust Results for the Reporting Period

Figure 5 displays insoluble solids results from depositional dust gauges during the reporting period compared against the annual impact assessment criteria. Any monthly results deemed to be contaminated (due to presence of bird droppings, insects, etc.) are not displayed. An assessment of HVO's contribution against the long-term impact assessment criteria will be provided in the 2022 Annual Review.

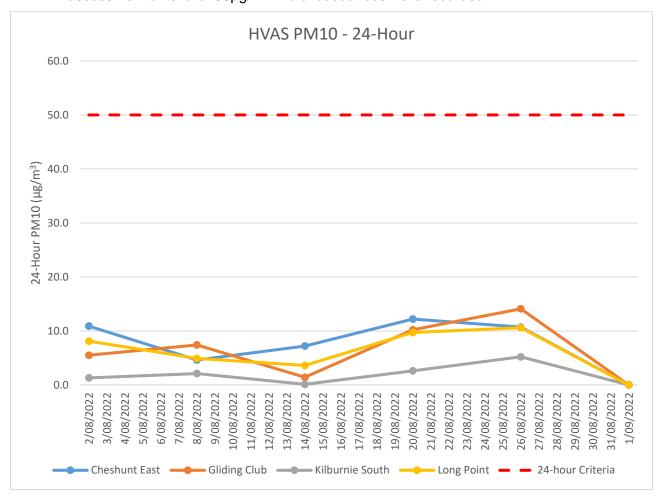
Figure 6 - Individual PM₁₀ Results for the Reporting Period

Figure 6 shows individual PM₁₀ results at each monitoring station against the short-term impact assessment criteria of 50µg/m³. No exceedances were recorded.

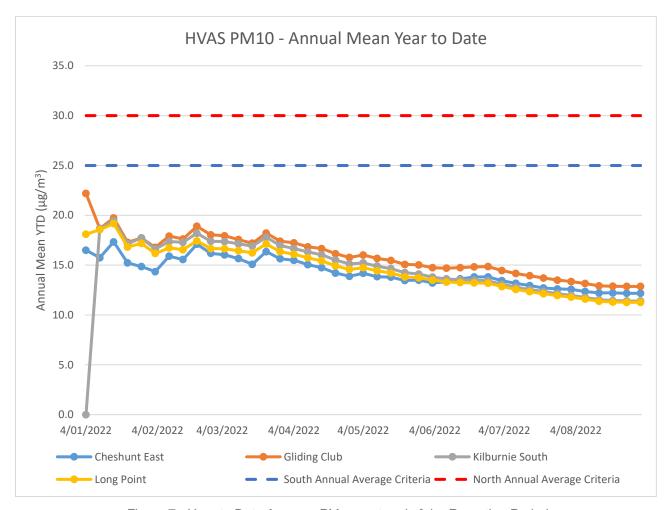
Figure 7 - Year to Date Average PM_{10} as at end of the Reporting Period

Figure 7 shows the year to date annual average PM_{10} results. All monitors were below the relevant long term impact assessment criteria during the reporting period. An assessment of HVO's contribution against the long-term impact assessment criteria will be provided in the 2022 Annual Review.

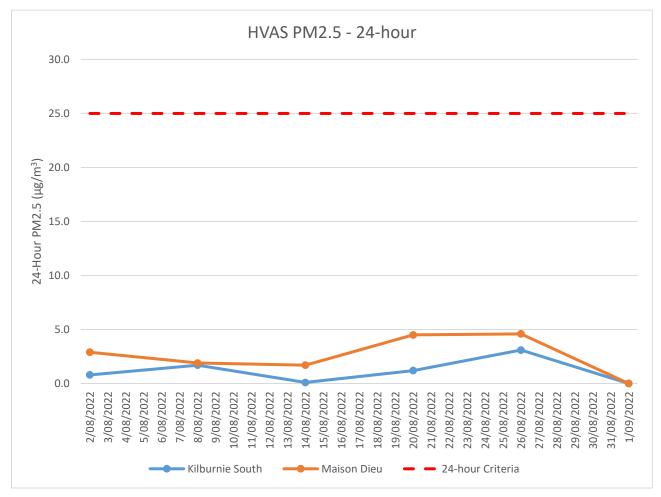
Figure 8 - Individual PM_{2.5} Results for the Reporting Period

Figure 8 shows individual PM_{2.5} results at each monitoring station against the HVO South shortterm impact assessment criteria of 25µg/m³.

All monitors were below the relevant short-term impact assessment criteria during the reporting period.

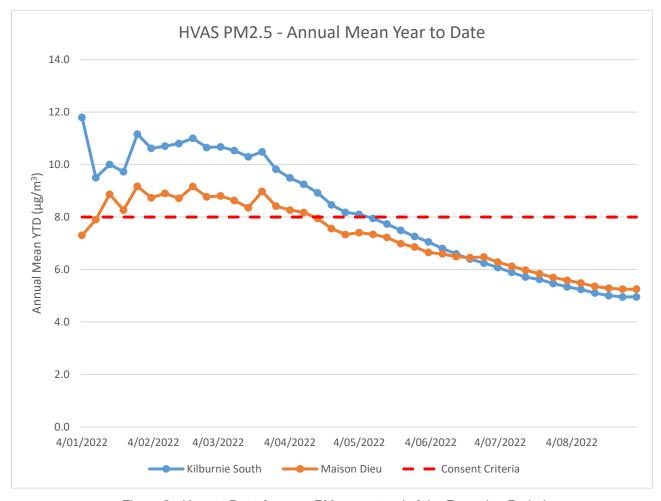
Figure 9 - Year to Date Average PM_{2.5} as at end of the Reporting Period

Figure 9 shows the year to date annual average PM_{2.5} results. During the reporting period, the Maison Dieu monitor and Kilburnie South monitor annual average year to date were below the PM_{2.5} Annual Rolling Mean criteria of 8µg/m³.

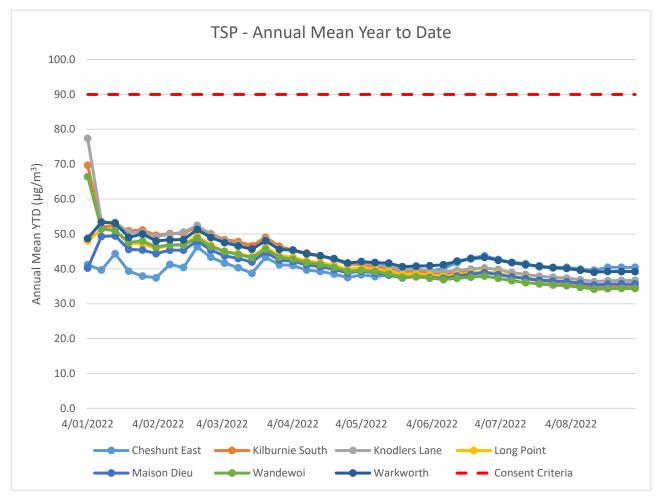
Figure 10 - Year to Date Average Total Suspended Particulates as at end of the Reporting Period

Figure 10 shows the annual average TSP results compared against the long-term impact assessment criteria of $90\mu g/m^3$.

All monitors were below the relevant long-term impact assessment criteria during the reporting period.

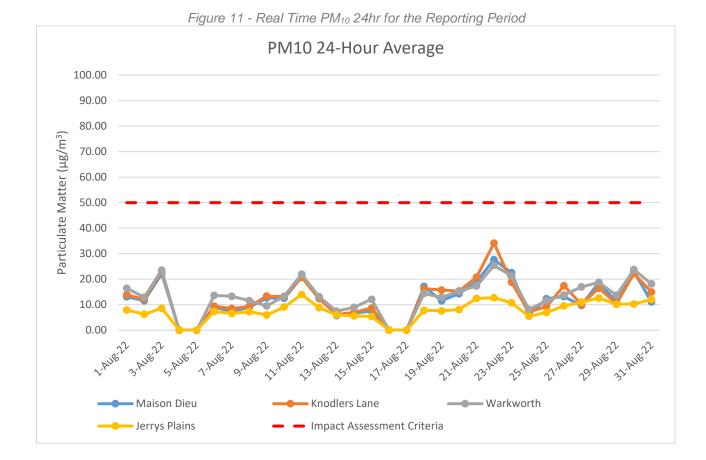
Figure 11 shows the daily 24-hour average PM₁₀ result from the real time monitoring sites which shows no exceedances reported for the period.

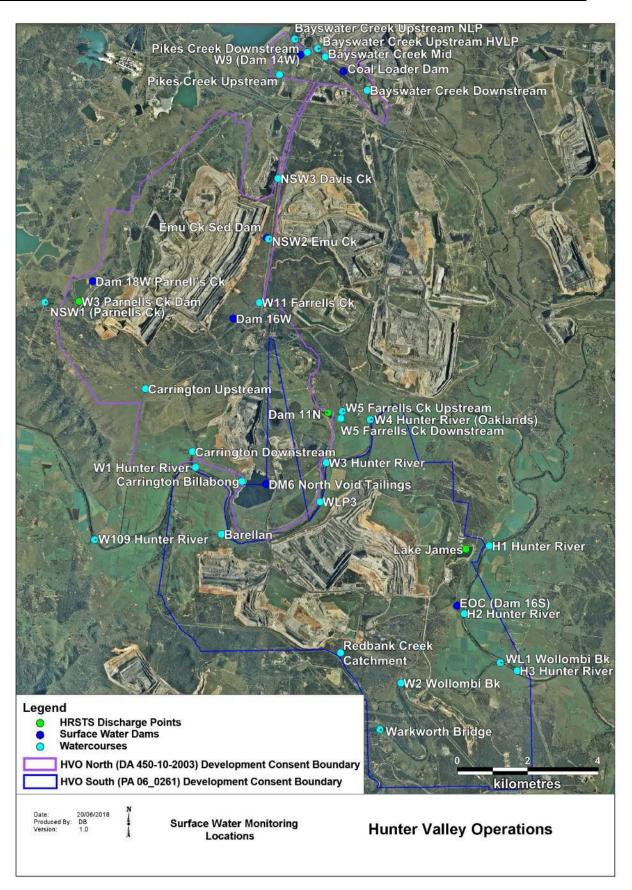
Figure 13 - HVO Surface Water Monitoring Locations

Surface watercourses are sampled on a quarterly sampling regime. Water quality is assessed through the parameters of pH, electrical conductivity (EC) and Total Suspended Solids (TSS). The location of surface water monitoring points across HVO is shown in Figure 13.

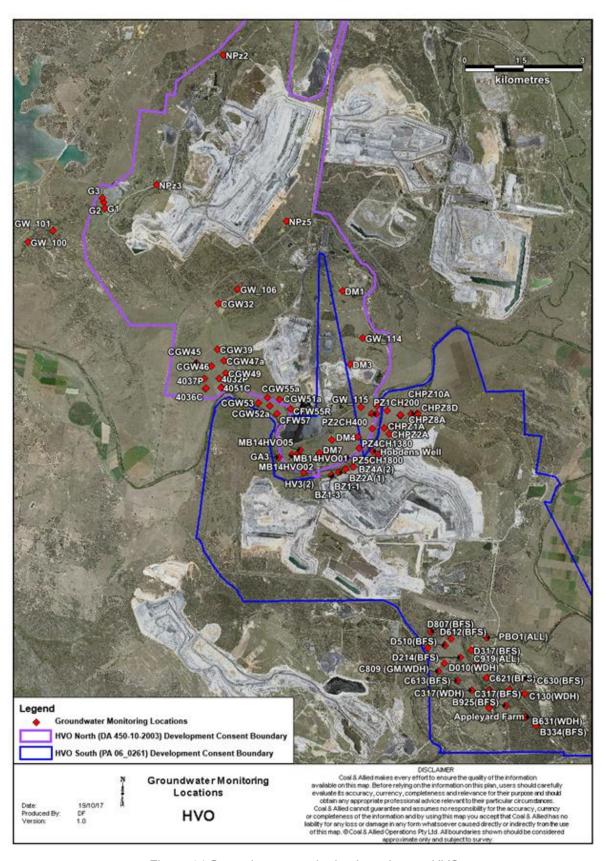
Figure 14 Groundwater monitoring Locations at HVO

Groundwater monitoring is undertaken on a quarterly basis in accordance with the HVO Water Management Plan and Groundwater Monitoring Program. The location of groundwater monitoring points across HVO are show in **Figure 14.**

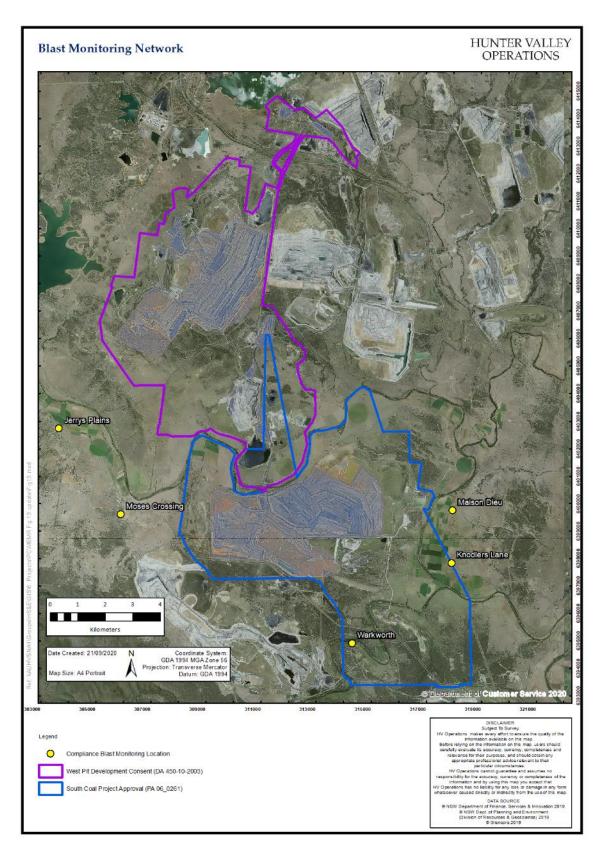
Figure 15 - Blast Monitoring Location Plan

HVO maintains a network of blast monitoring units located at nearby privately owned residences and function as regulatory compliance monitors. The location of these monitors can be found in Figure 15. Blasting criteria for HVO are summarised in Table 2.

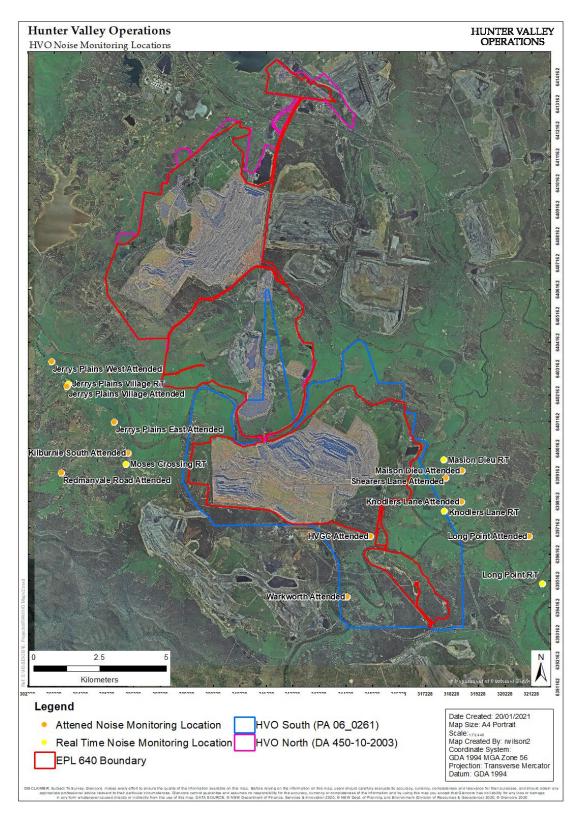
Figure 16 - Noise Monitoring Location Plan

Routine attended noise monitoring occurs at defined locations around HVO, as described in the HVO Noise Monitoring Program. The noise monitoring aims to quantify and describe the acoustic environment around the site and compare results with specified limits. The attended noise monitoring locations are displayed in **Figure 16**.

HVO utilises a network of real-time directional noise monitors to manage noise impacts on a continuous basis, shown in Figure 16. Noise alarms are in place at five monitoring locations (Knodlers Lane, Maison Dieu, Jerrys Plains, Moses Crossing, and Long Point) which alert HVO staff to elevated noise levels that require investigation.

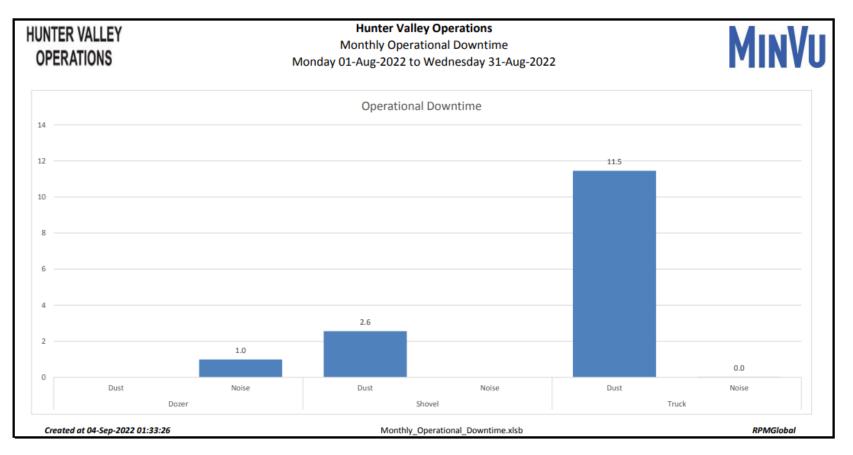
Figure 17 - Operational Downtime by Equipment Type for the reporting period

A total of 15.1 hours of equipment downtime was logged in response to real time monitoring and inspections for environmental factors such as noise and dust during the reporting period. Operational downtime by equipment type is show in **Figure 17.** Note that these delays are instances where operations were completely stopped and does not include occasions where operations were changed/modified but not stopped (e.g. changed from exposed dump to in-pit dump).

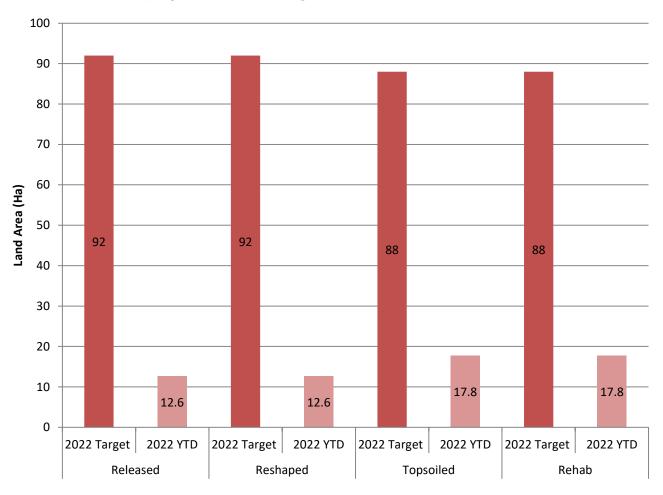
Figure 18 - Rehabilitation YTD August 2022

- 0.63 Ha of land was reshaped
- 0.63 Ha of land was released (became available for the application of topsoil)
- 5.59 Ha of land was topsoiled
- 9.48 Ha of land was rehabilitated

Year to date progress is shown in Figure 18.
